PEACH BOTTOM ATOMIC POWER STATION
UNITS 2 AND 3
UPDATED FINAL SAFETY ANALYSIS REPORT

FIGURE Q.5.1

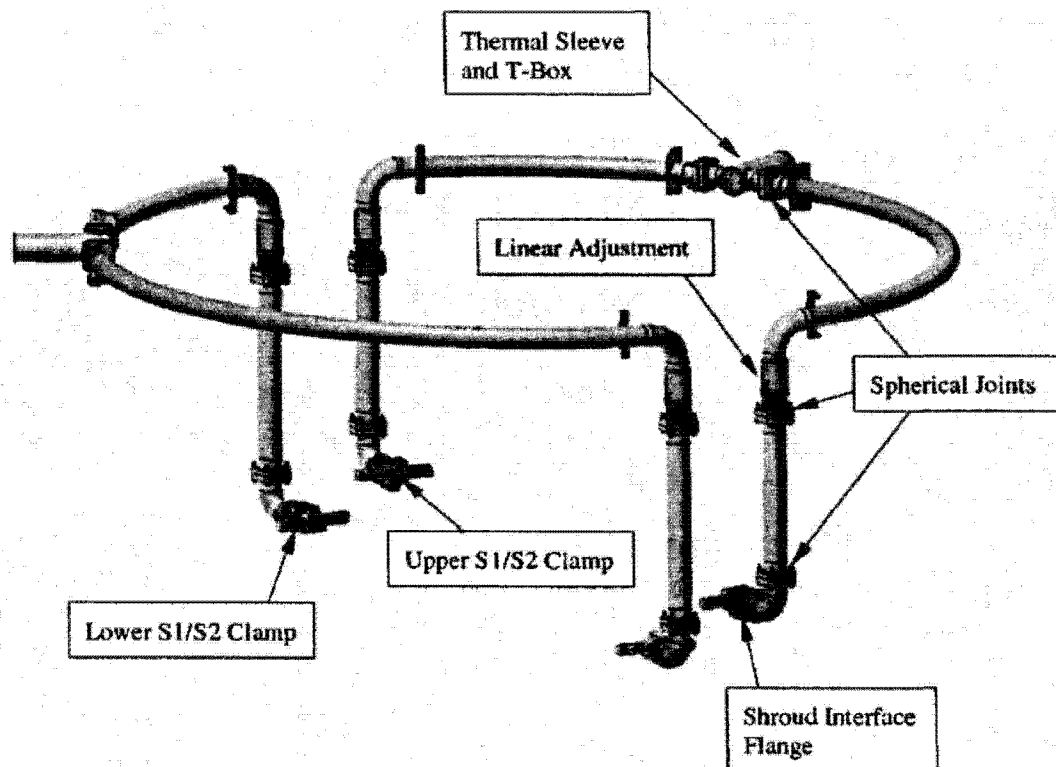
Clamps installed on the replacement core spray sparger pipes structurally replacing welds at each of the four sparger T-box locations
