GPC-07-102
Revision 0
June 1983
GPC007.0102

DESIGN REPORT
FOR
WELD OVERLAY REPAIRS
AND FLAW EVALUATIONS
IN
RECIRCULATION AND RHR SYSTEMS
AT
E. I. HATCH NUCLEAR POWER PLANT
UNIT 2

Prepared for
Georgia Power Company

Prepared by
NUTECH Engineers, Inc.
San Jose, California

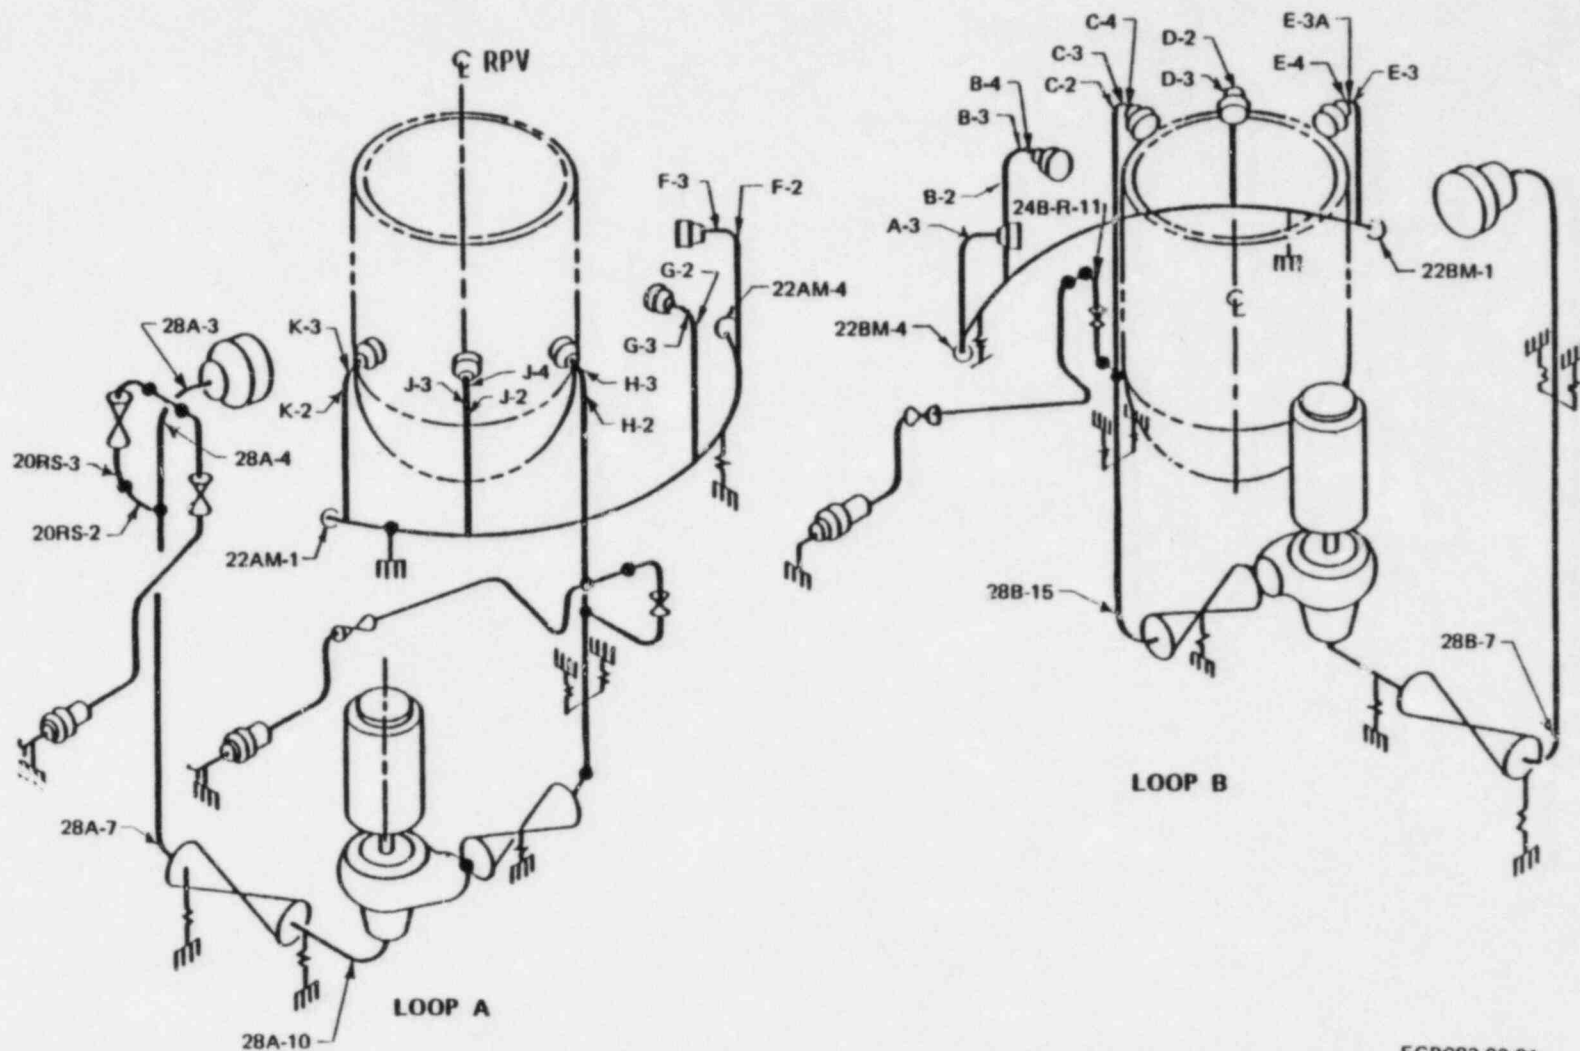
Figure 1.1 shows all the welds in relation to the Reactor Pressure Vessel and other portions of the Recirculation and RHR systems. Table 1.1 lists the welds evaluated in this report, describes the indications found at each location, and identifies the type of repair (as defined in Section 2) performed. All of the existing affected RHR and Recirculation system materials are Type 304 stainless steel.

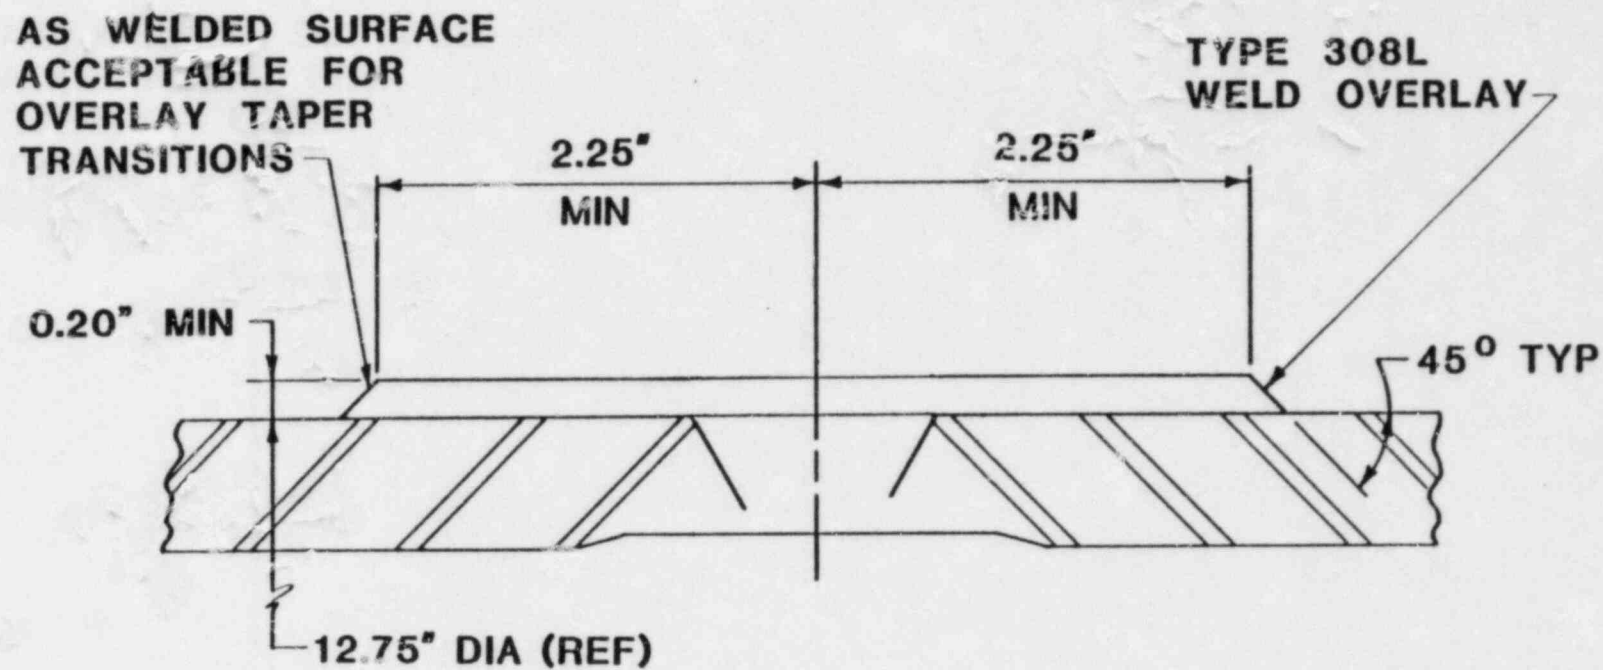
STANDARD OVERLAY DESIGN 12" RECIRCULATION PIPING

UT indications were detected in the heat-affected zones on the pipe side of the weld between four recirculation inlet safe ends and the recirculation piping. Three of the indications had maximum depths of less than 30% of the wall thickness. The mini overlay shown in Figure 2.2 was used to repair these locations. The 12BR-C-4 weld had an indication with a maximum depth of 32% of the wall thickness (see Table 1.1). The standard overlay shown in Figure 2.1 was used to repair this location.

with the mini-overlay design (Figure 2.2) and one elbow weld, 12BR-C-3, was repaired with the standard overlay design (Figure 2.1).

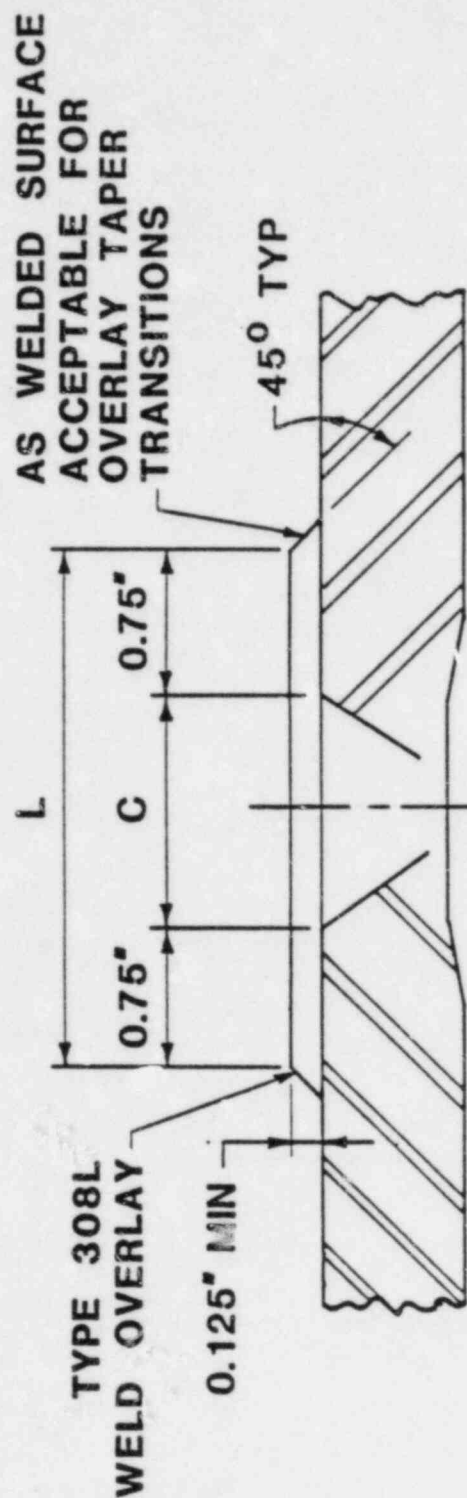
Figure 2.2

$$L \text{ MINIMUM} = 1.5" + C$$

$C = \text{WELD CROWN WIDTH}$

MINI - WELD OVERLAY 12" RECIRCULATION PIPING

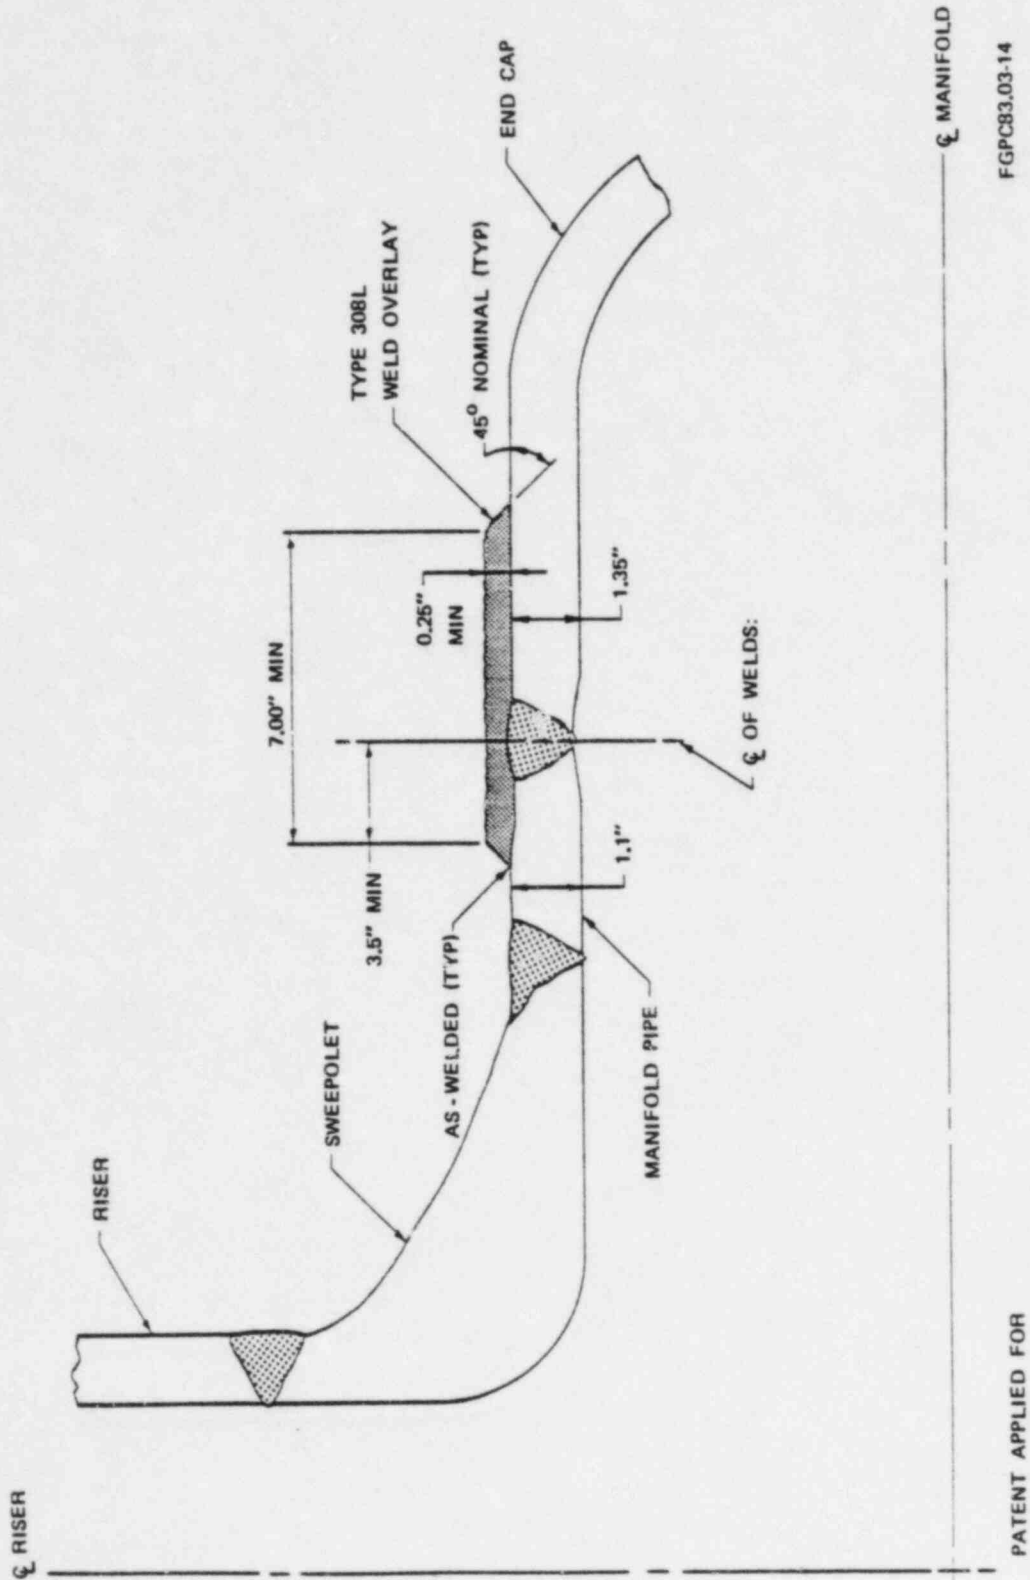
Figure 2.3
CONFIGURATION OF END CAP WELD OVERLAY

The heat-affected zones of four of the welds between the 22" pipe and the end cap have several circumferential UT indications. The largest of the indications was estimated to have a depth of approximately 42% percent of the wall thickness. Although at least one of the end cap welds could have been shown to be acceptable without repair, Georgia Power Company conservatively decided to repair or replace all four welds.

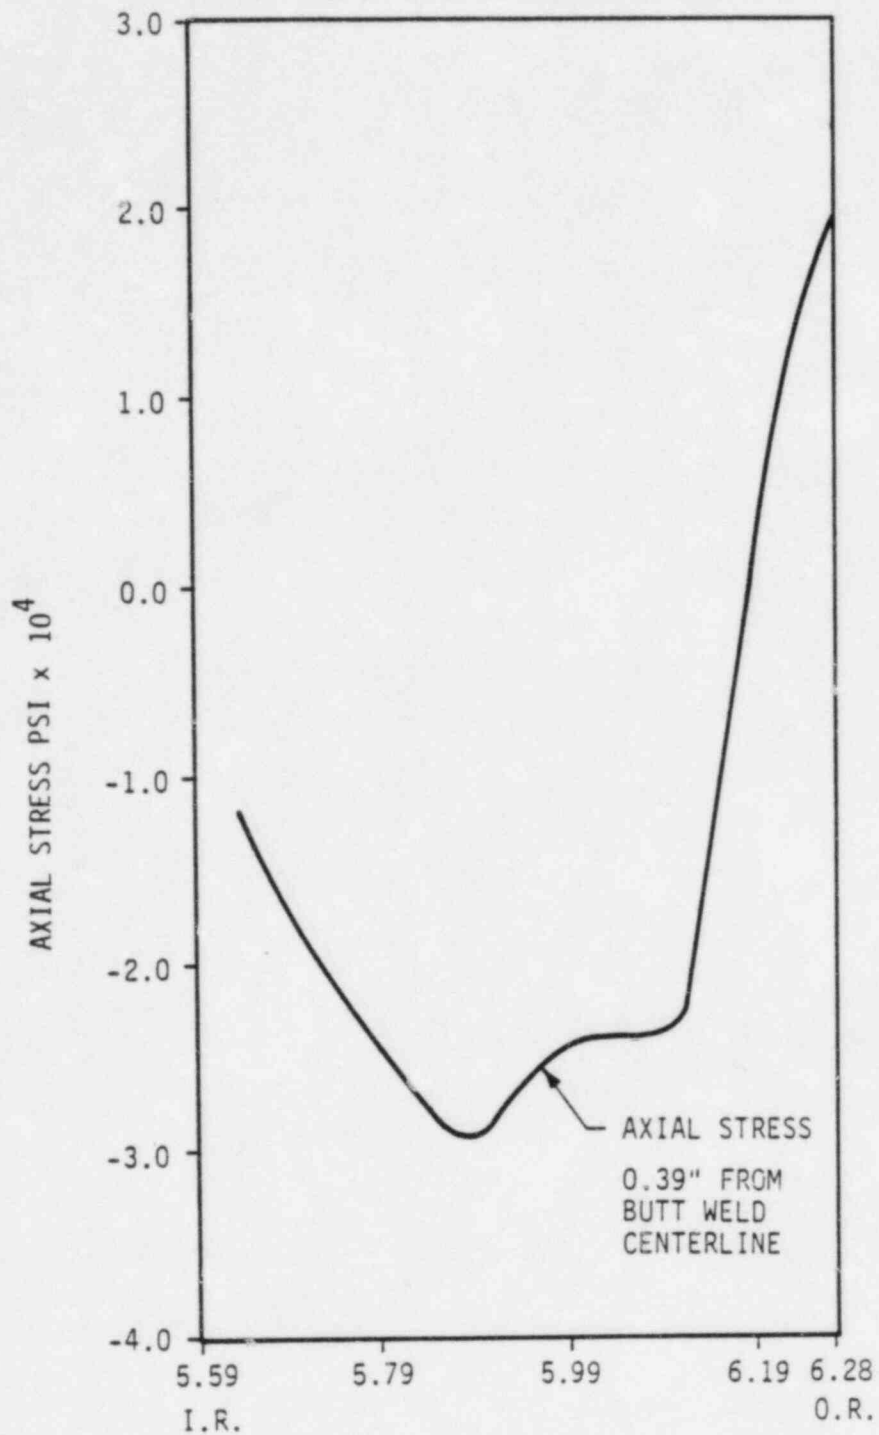
Figure 5.1
WELDING RESIDUAL STRESS FOR SAFE END
STANDARD WELD OVERLAY

that the weld overlay produces significant axial compressive stress in the original pipe cross section. These stress profiles will prevent or mitigate the growth of cracks, as shown in Section 5.2. Only axial residual stress profiles are presented, since all of the observed cracks are circumferentially oriented.

IGSCC crack growth was calculated using the overlay residual stress distributions shown in Figures 5.1 and 5.2 and the upper bound crack growth law for weld-

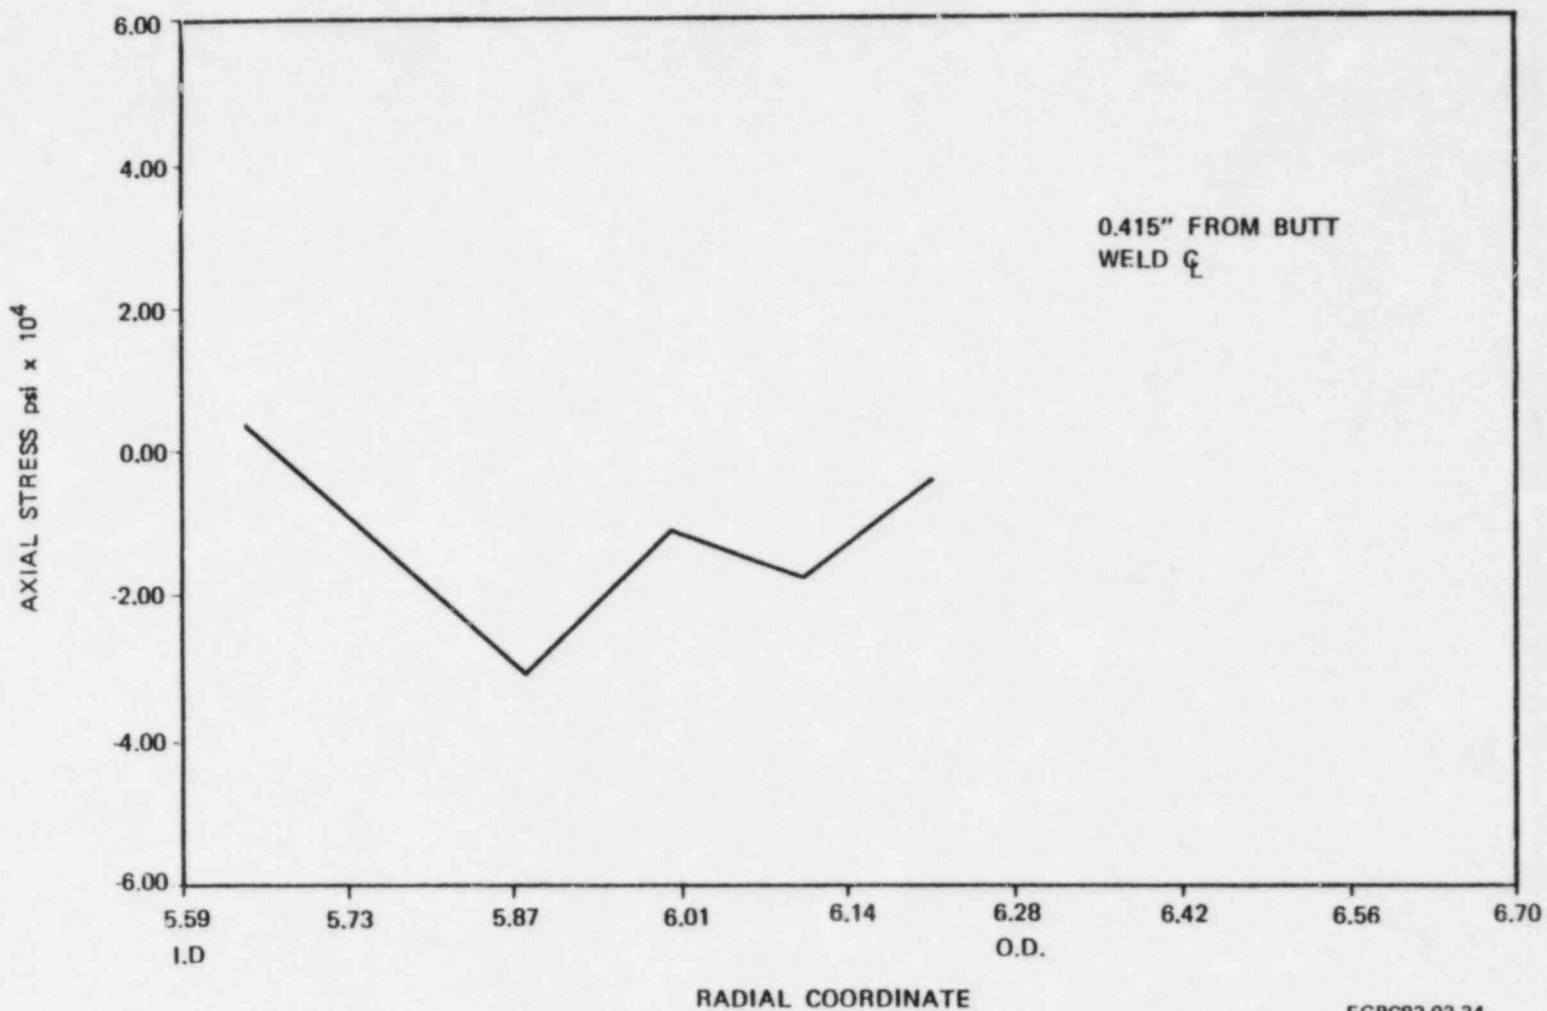
Figure 5.2

WELDING RESIDUAL STRESS FOR SAFE END

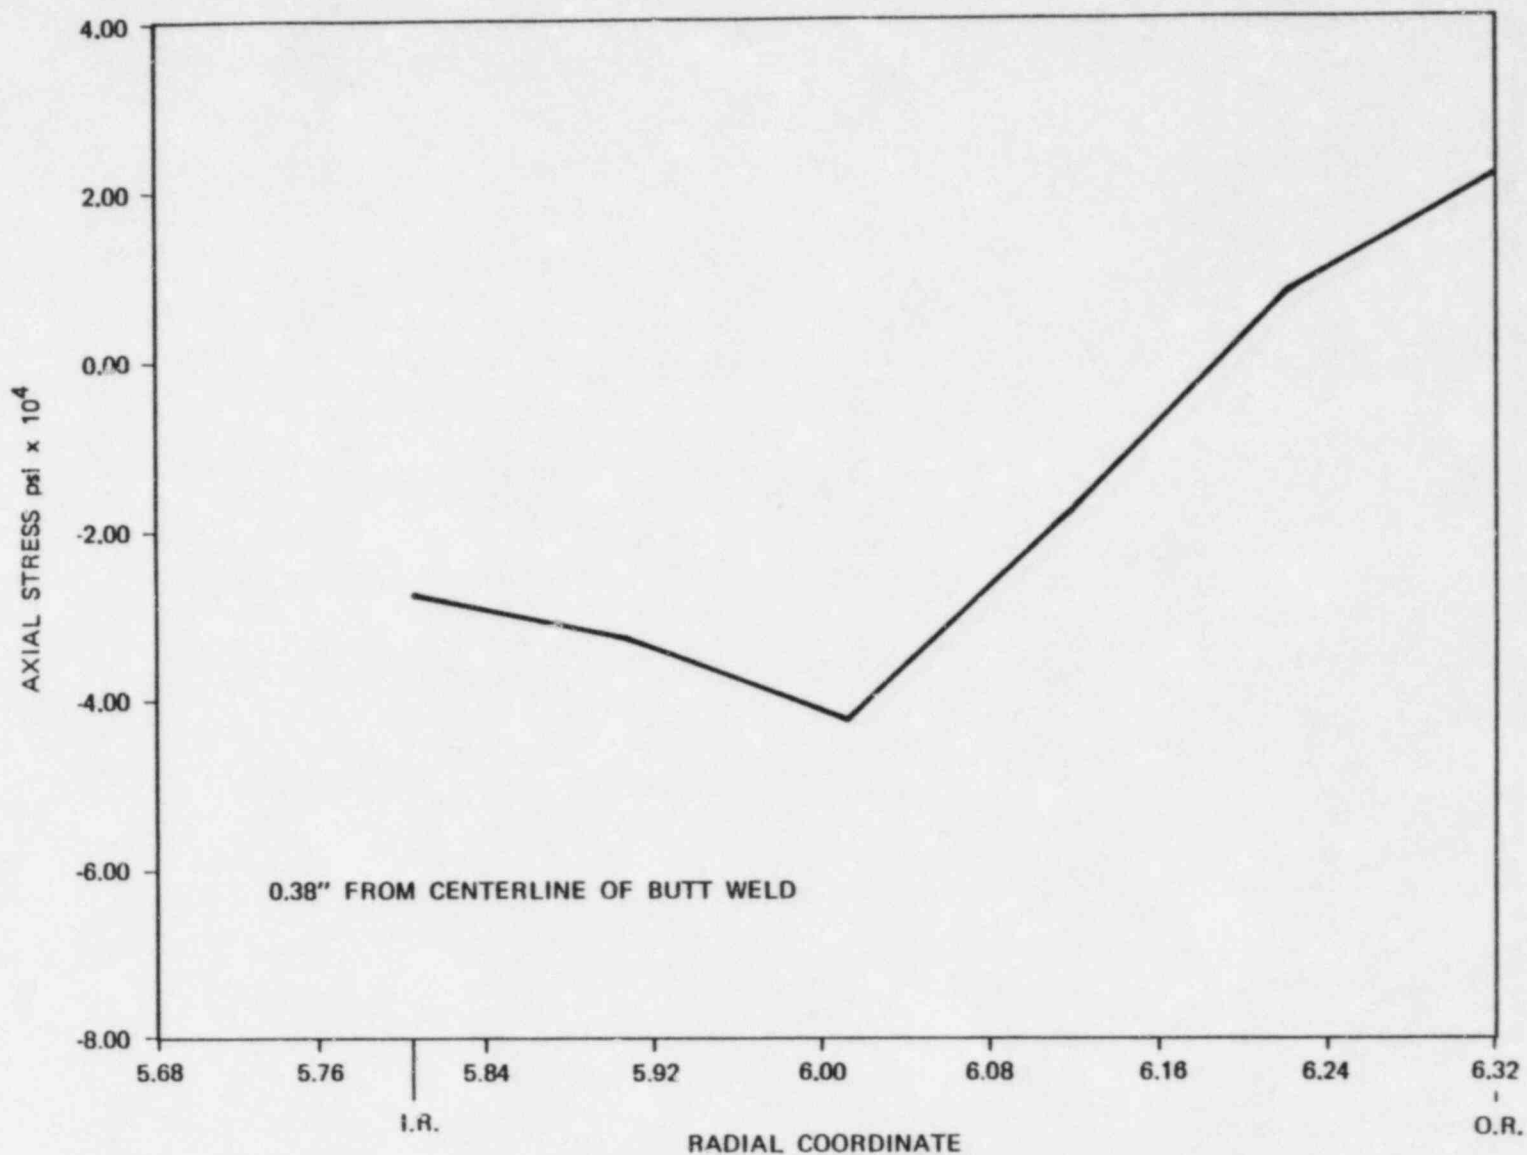
Figure 5.3
WELDING RESIDUAL STRESS FOR ELBOW STANDARD WELD OVERLAY

IGSCC crack growth was calculated using the overlay residual stress patterns shown in Figures 5.3 and 5.4. The steady state loads of pressure, dead weight, thermal expansion and axial weld shrinkage (Section 5.4) were also applied. The results are shown in Figure 5.16. The fatigue crack growth due to five years of the cycles shown in Figure 5.10 is less than 0.01 inch. Inspection of Figure 5.16 will show that maximum crack depth after five years is predicted to be 0.22 which is less than the allowable crack depth. The weld overlay repairs are therefore acceptable for at least 5 years.

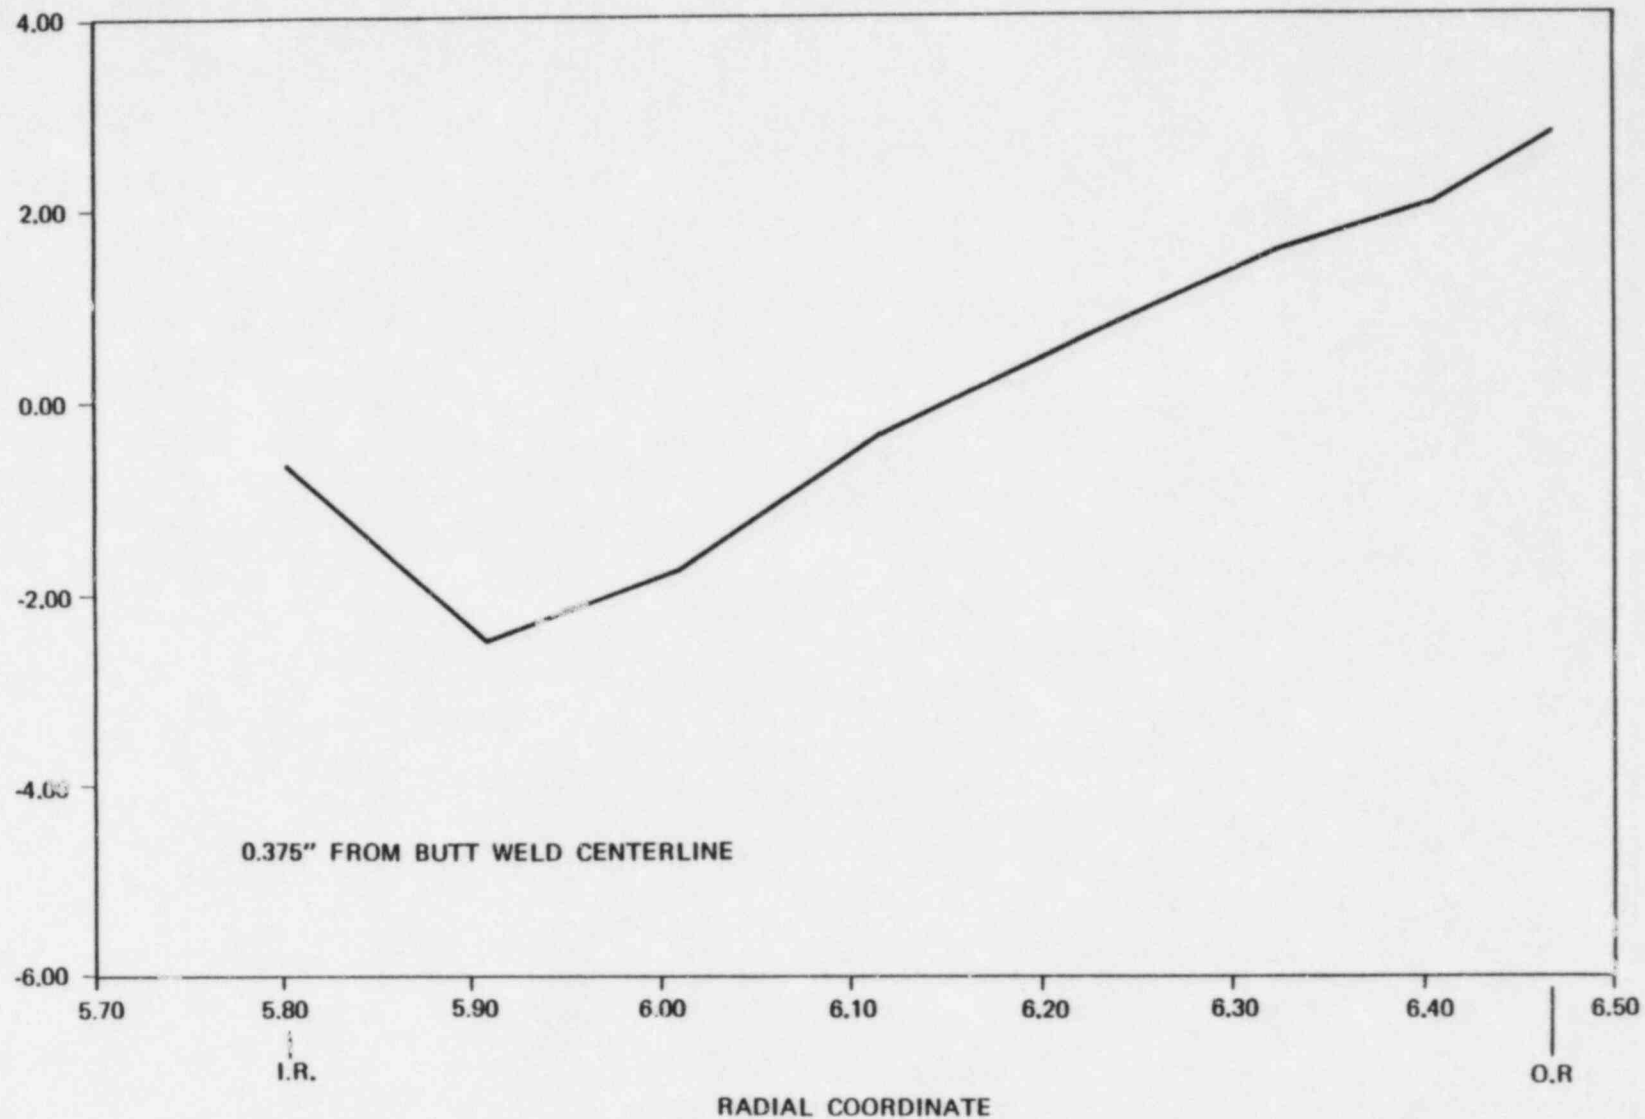
Figure 5.4

WELDING RESIDUAL STRESS FOR ELBOW MINI-WELD OVERLAY

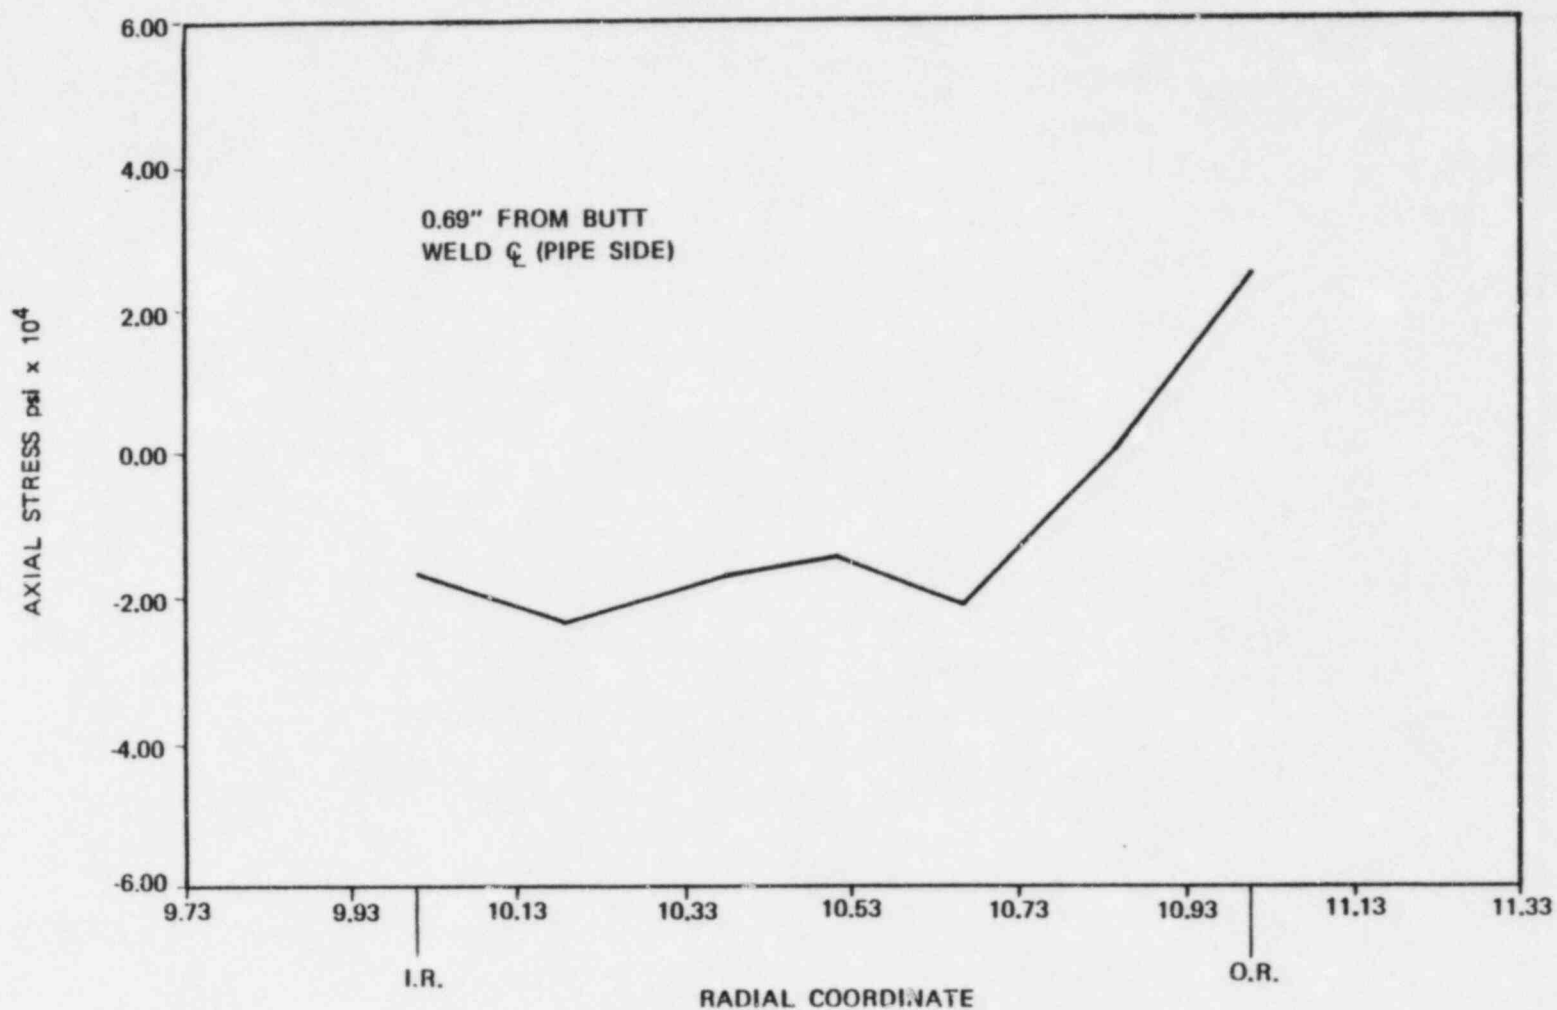
Figure 5.5

WELDING RESIDUAL STRESS FOR END
CAP WELD OVERLAY

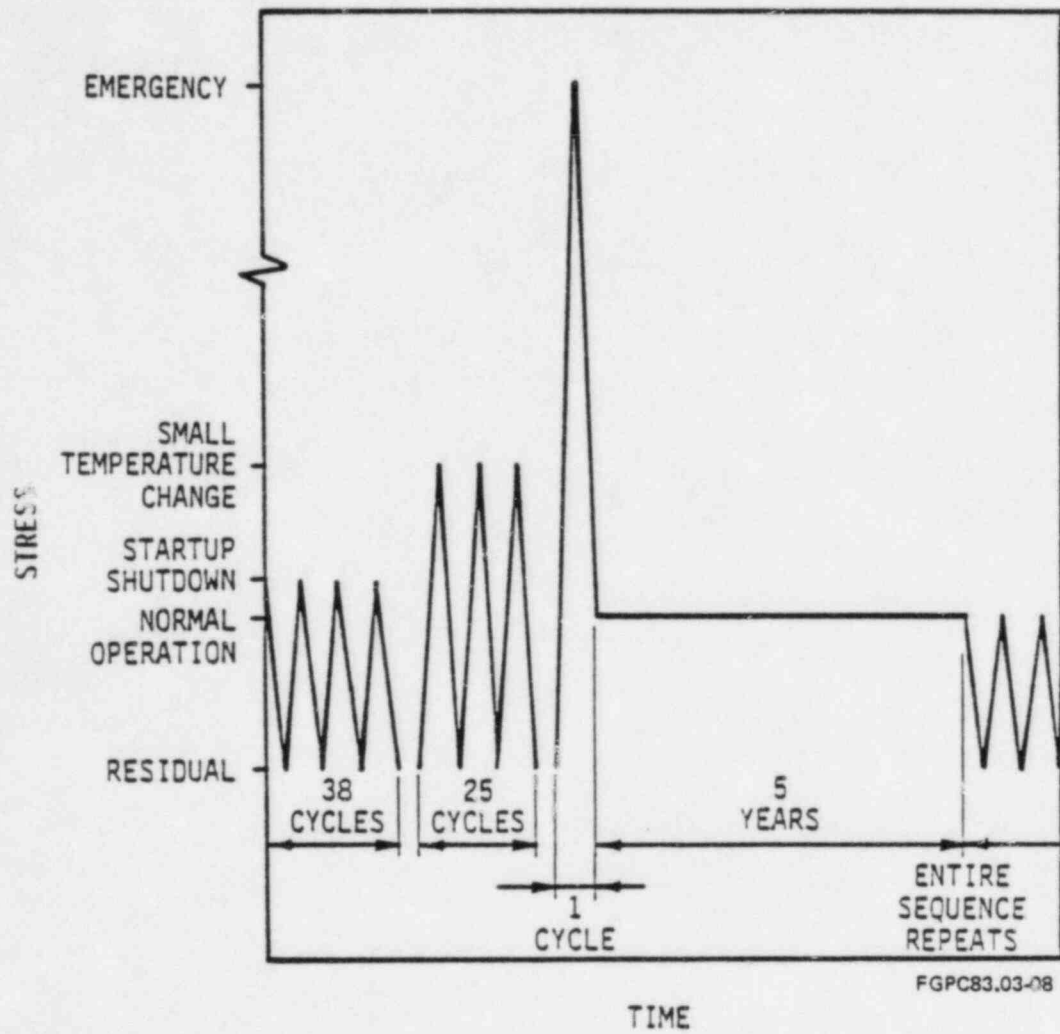
Figure 5.10
THERMAL TRANSIENTS

The existing cracks could grow due to both fatigue and stress corrosion. Fatigue crack growth due to the three types of thermal transients defined in Section 4.2 was calculated using the material properties from Reference 14. The fatigue cycles considered are shown in Figure 5.10. The fatigue crack growth for 5 years was calculated to be less than 0.01 inch.

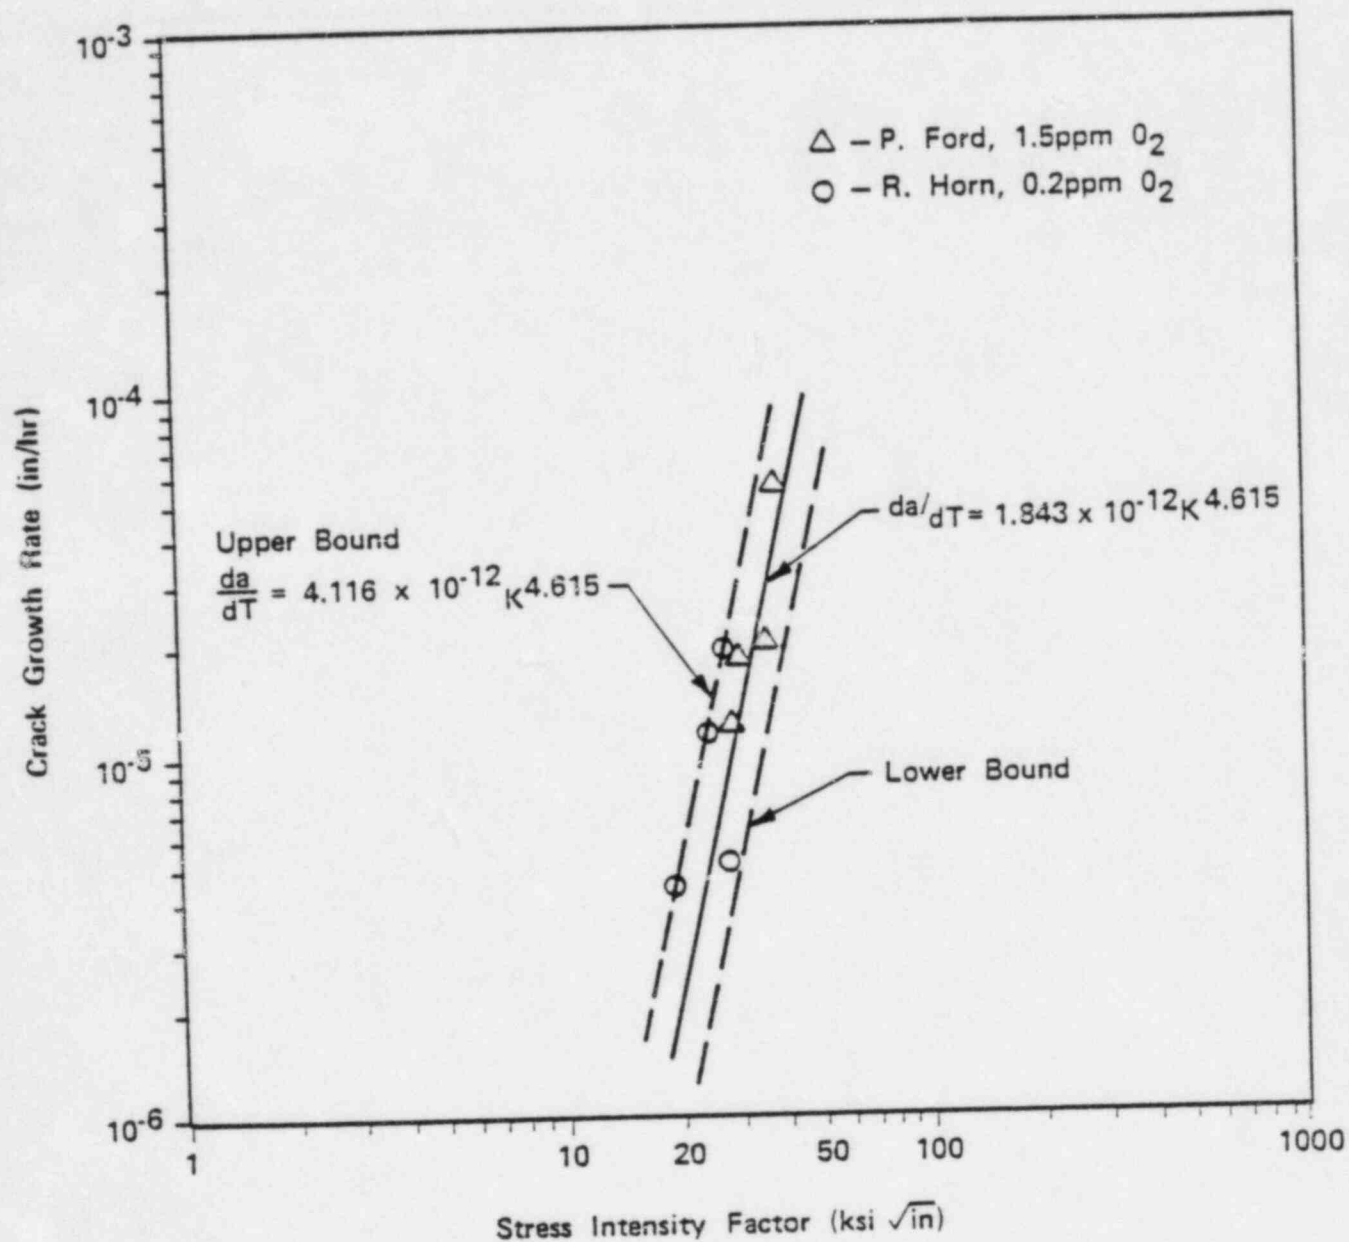
Figure 5.11
 TYPICAL IGSCC CRACK GROWTH DATA
 (WELD SENSITIZED 304SS IN BWR ENVIRONMENT)

sensitized stainless steel (Figure 5.11). The steady state loads of pressure, dead weight, thermal expansion and axial weld shrinkage (Section 5.4) were also applied. The results are shown in Figure 5.12.

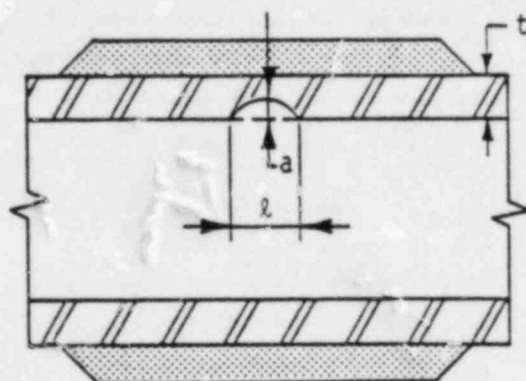
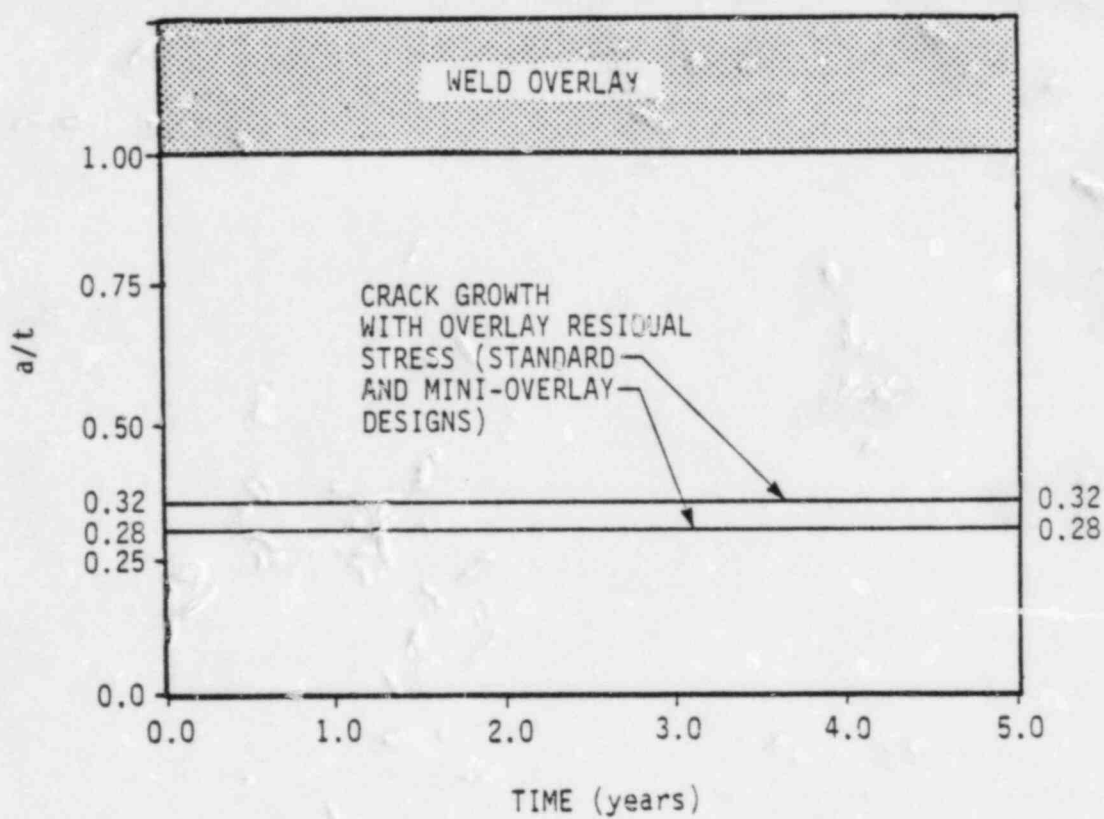
Inspection of Figure 5.12 will show that the maximum depth achieved after five years by a 360° circumferential crack is approximately 0.23 inch, which is well below the allowable size.

SAFE END CRACK GROWTH

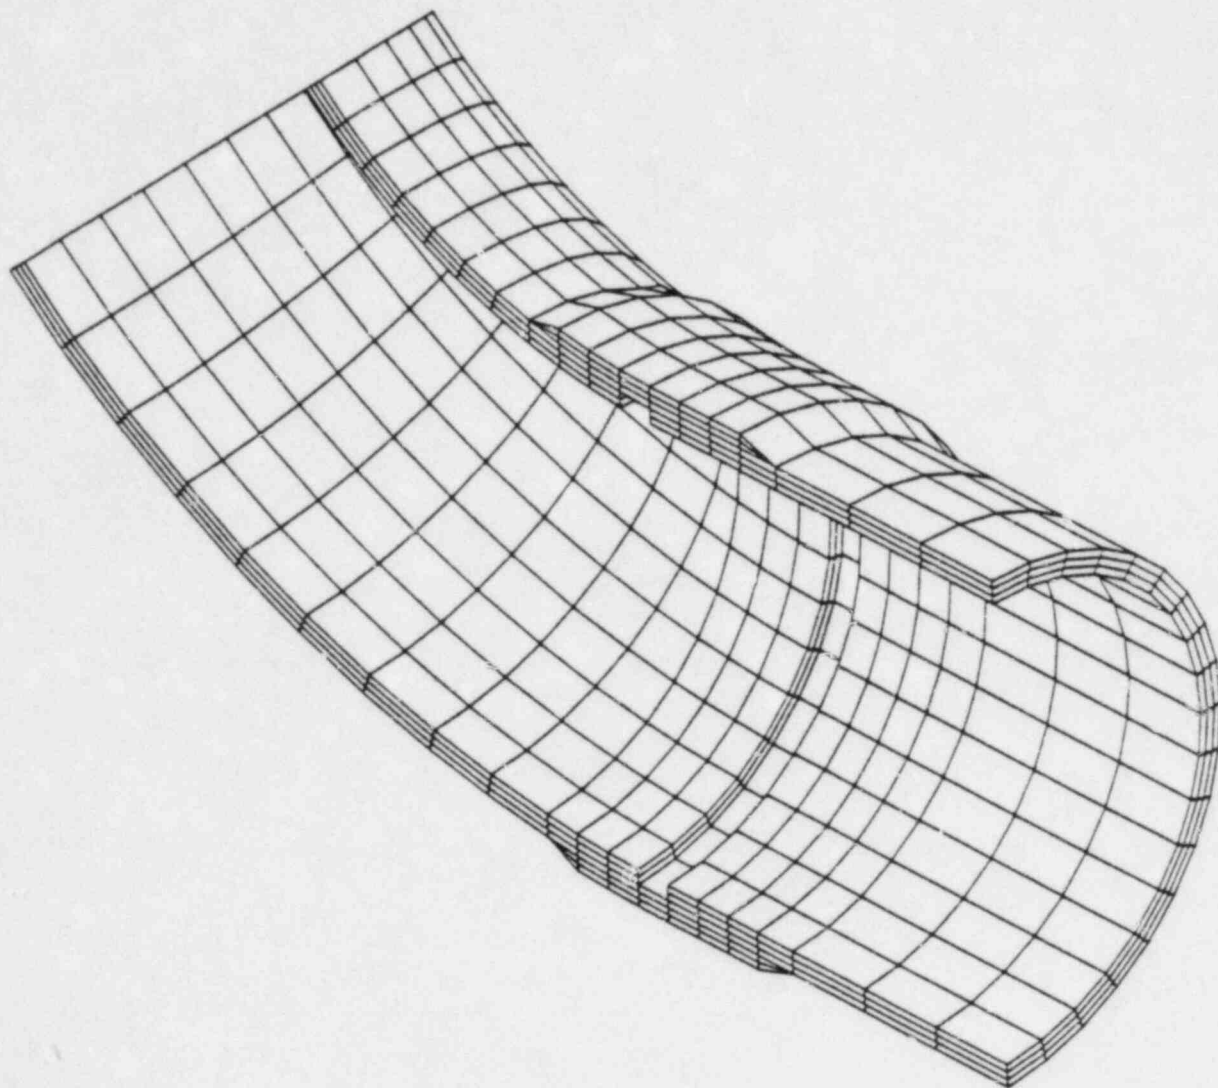
Figure 5.14
THREE DIMENSIONAL 12"
ELBOW FINITE ELEMENT MODEL

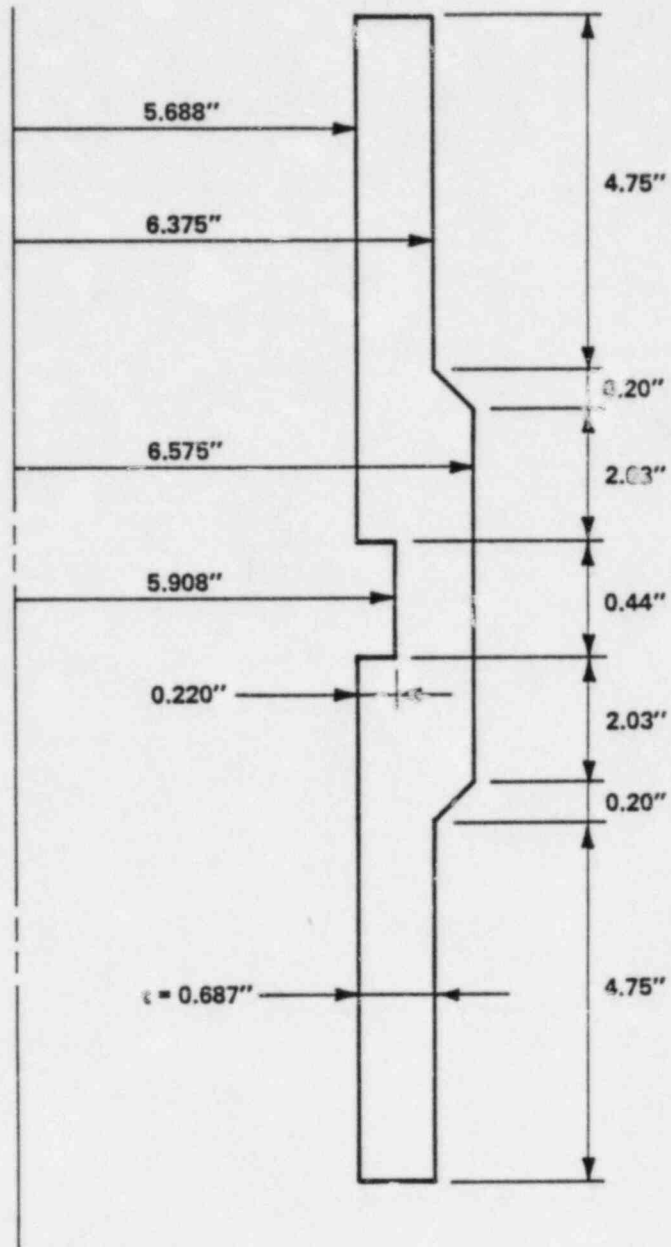
Figure 5.15

a = FLAW DEPTH = $0.32t$
 a = 0.220 "
 FLAW LENGTH = $2a$
 $2a$ = 0.440 "

BOSOR 4 MODEL FOR 12" ELBOW
 STANDARD WELD OVERLAY DESIGN

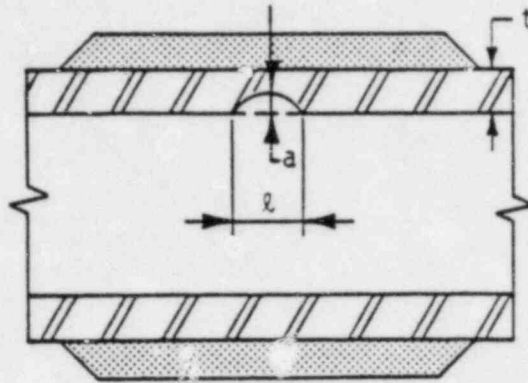
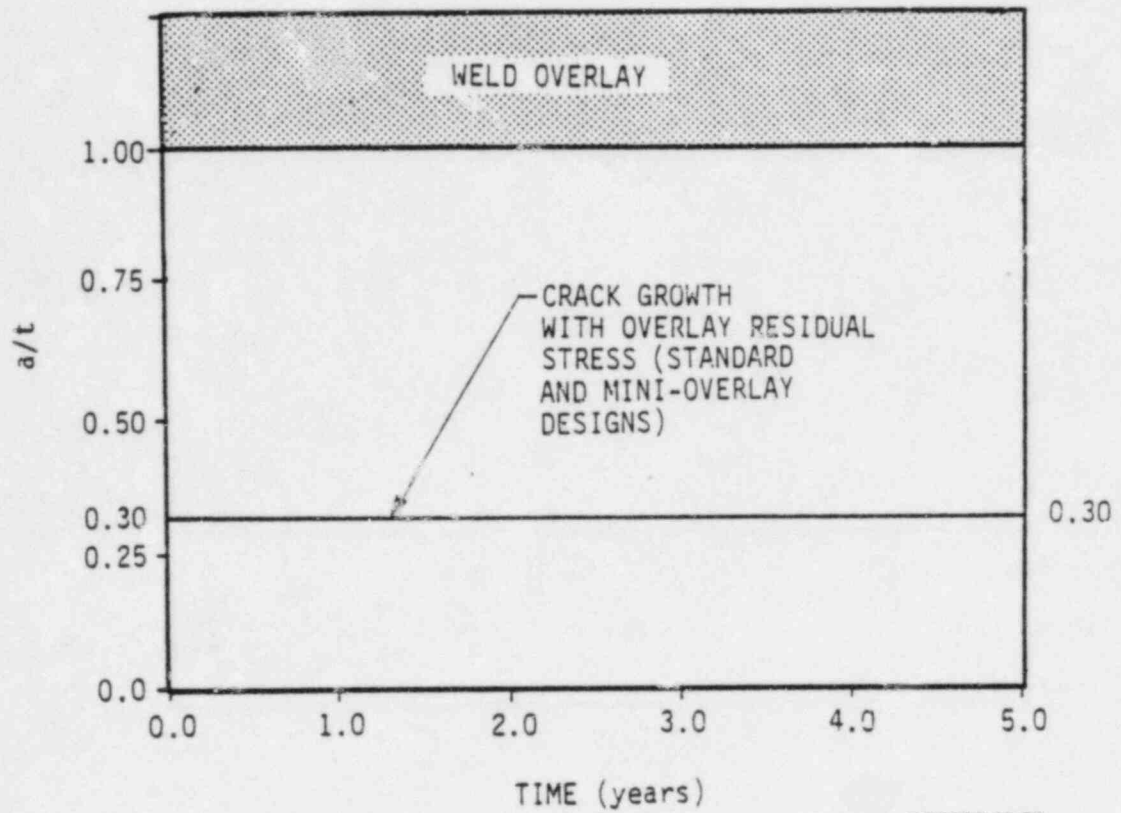
Figure 5.16

12" ELBOW CRACK GROWTH

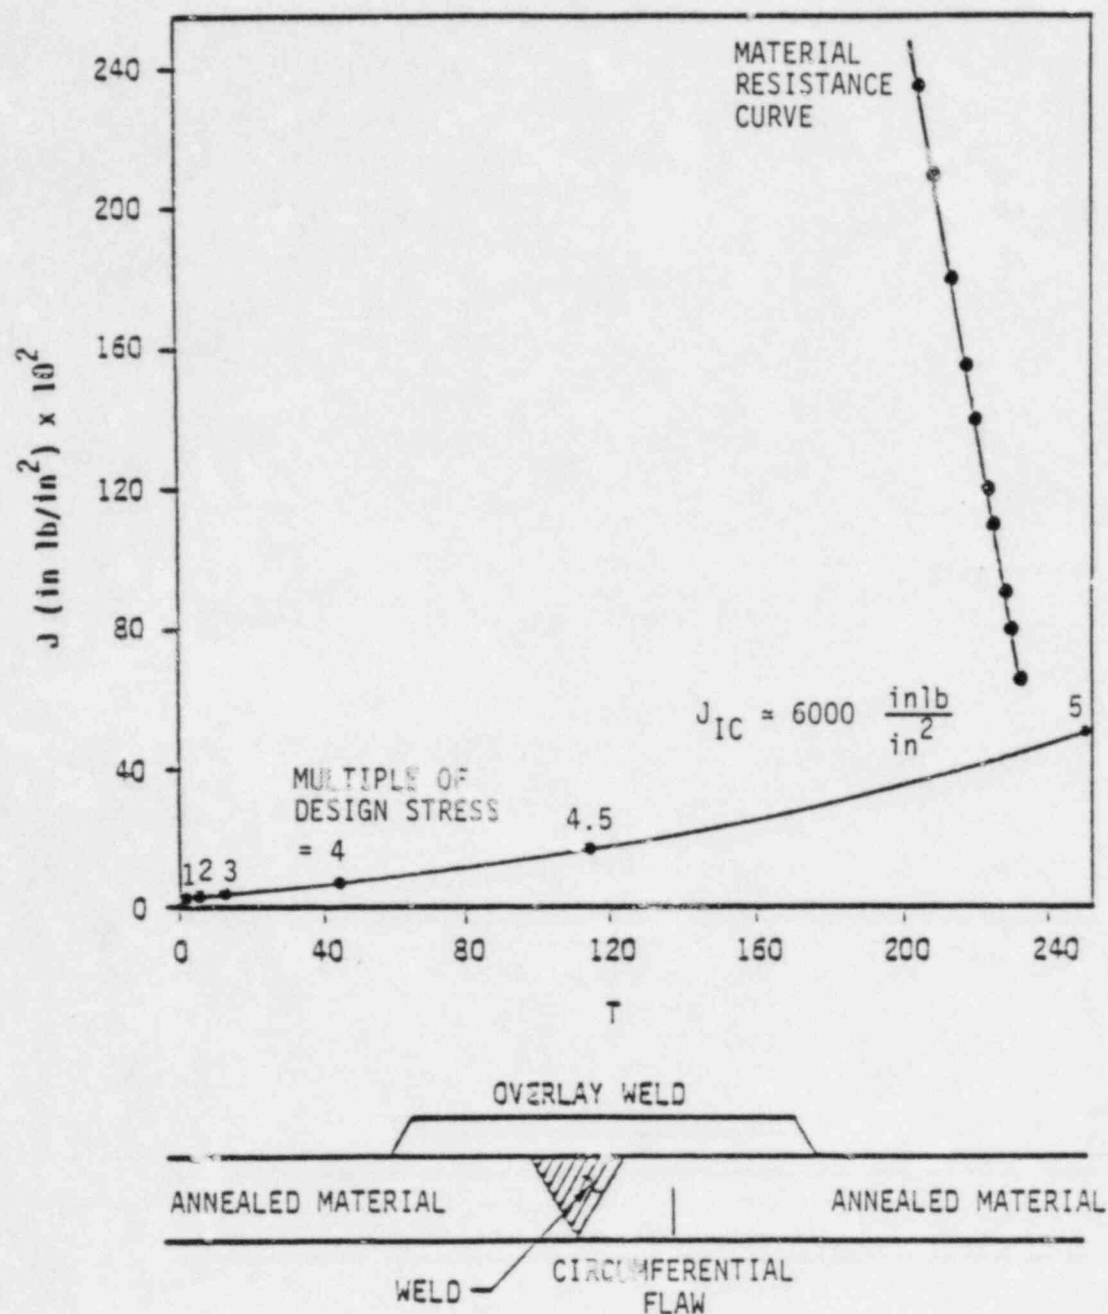
shown in Figure 5.17. The upper dotted line represents the inherent material resistance to unstable fracture in terms of J-integral and Tearing Modulus, T. The line originating at the origin represents the applied loading. Increasing load results in applied J-T combinations moving up this line, and unstable fracture is predicted at the intersection of this applied loading line with the material resistance line.

Figure 5.17 shows that the predicted failure load is in excess of 4 times the normal operating loads. Thus, there is a safety factor on normal operating loads, including OBE seismic, of at least 4, which is in excess of the safety factor inherent in the ASME Code, even in the presence of this worst case assumed crack.

12" ELBOW TEARING MODULUS

A tearing modulus evaluation was performed for a 360° crack of depth equal to that calculated above. The normal operating loads of OBE seismic, pressure, and dead weight were applied.
