GPC-07-102
Revision 0
June 1983
GPC007.0102

DESIGN REPORT
FOR
WELD OVERLAY REPAIRS
AND FLAW EVALUATIONS
IN
RECIRCULATION AND RHR SYSTEMS
AT
E. I. HATCH NUCLEAR POWER PLANT
UNIT 2

Prepared for
Georgia Power Company

Prepared by
NUTECH Engineers, Inc.
San Jose, California

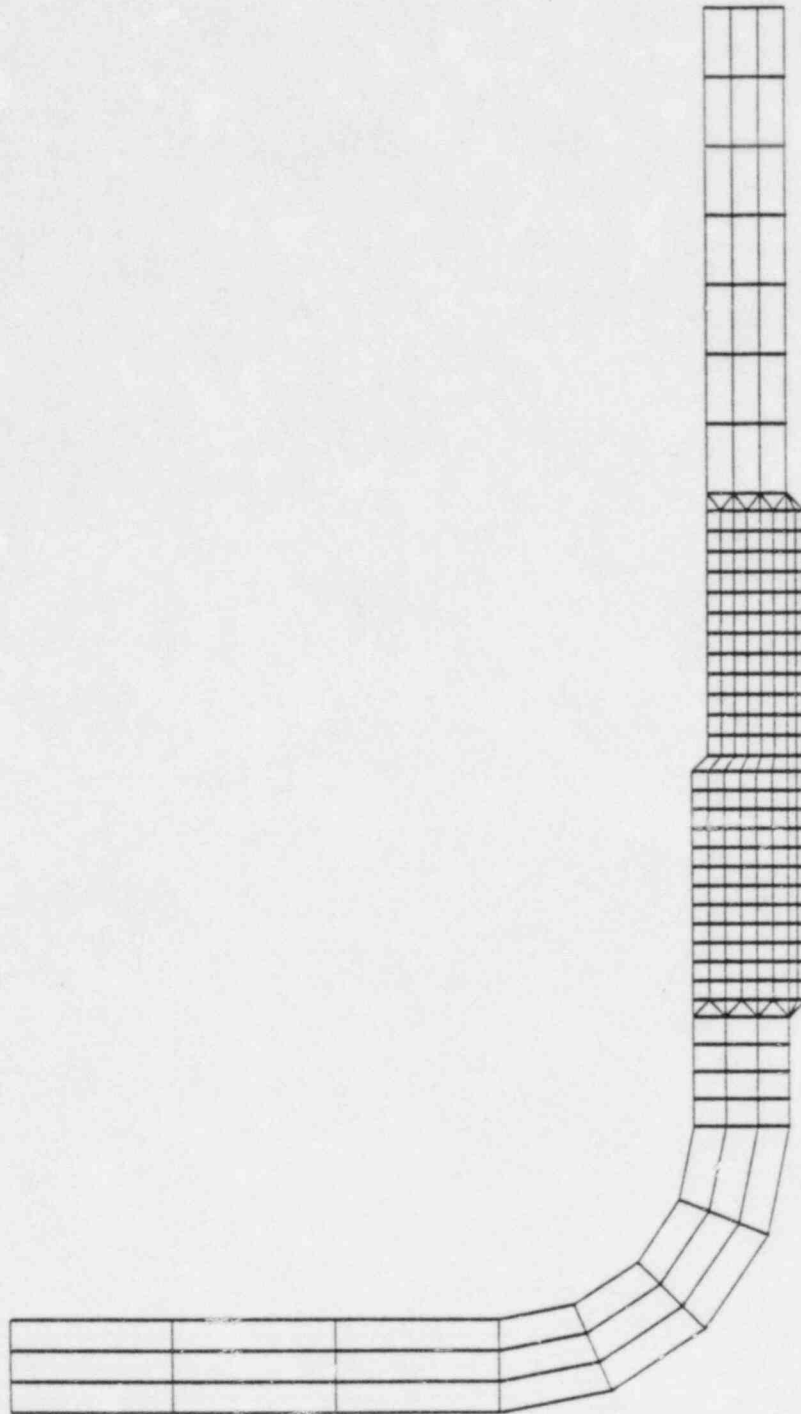
Figure 5.18

A finite element model of the repaired end caps was prepared using ANSYS as above. This model is shown in Figure 5.18. The stress in the end cap due to design pressure as described in Section 4.1 was calculated with the finite element model. The thermal analysis was performed in the same manner as for the safe end (Section 5.2.1), with appropriate dimensional changes.

END CAP FINITE ELEMENT MODEL

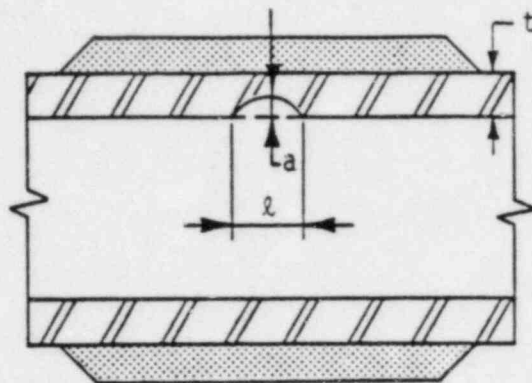
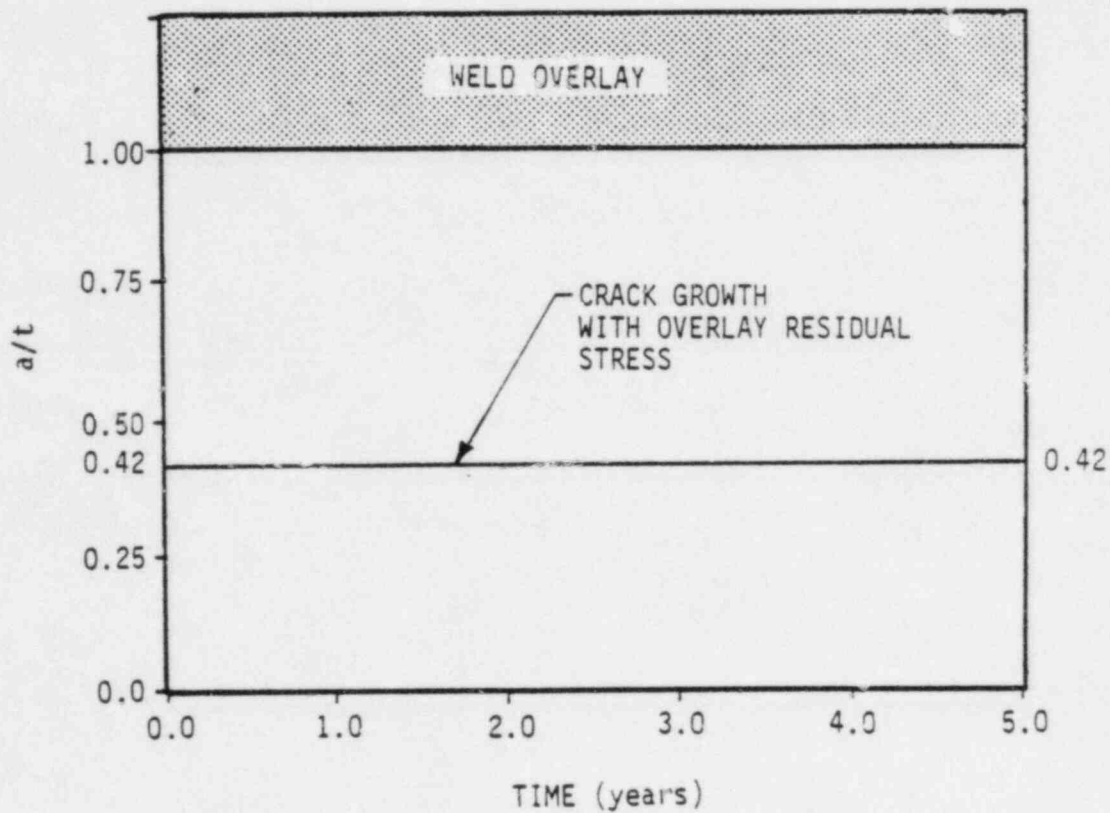
Figure 5.19

END CAP CRACK GROWTH

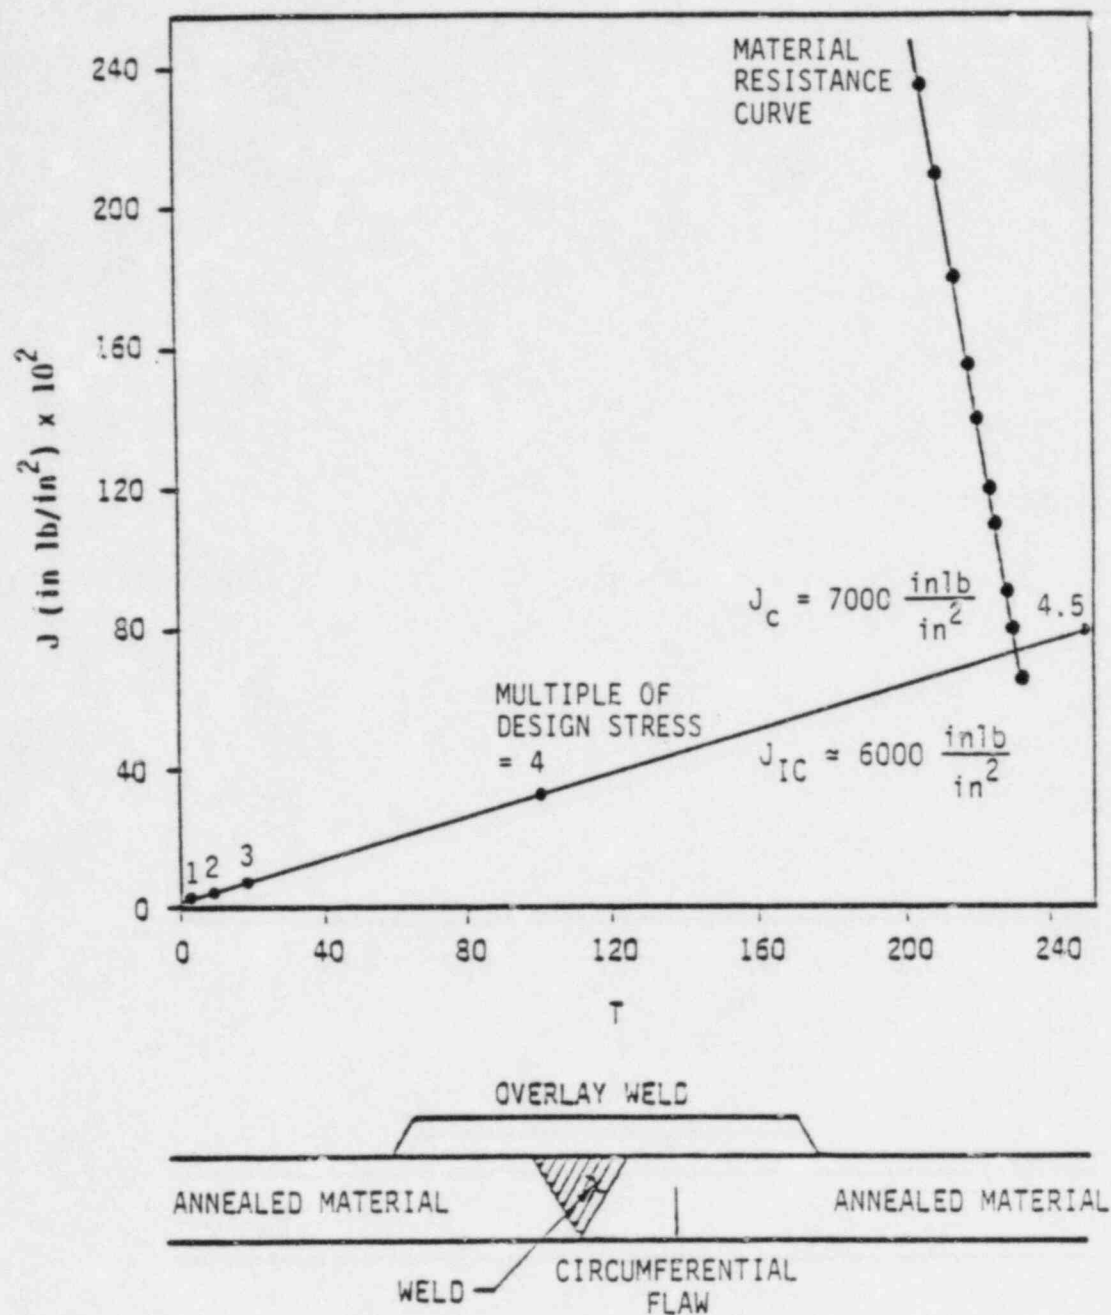
Figure 5.20

END CAP TEARING MODULUS

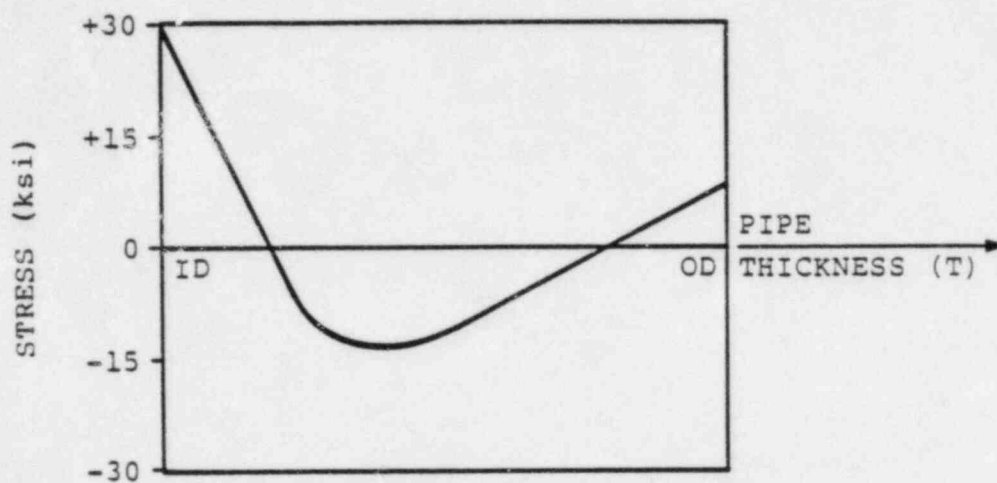
T%	STRESS (ksi)
0	+30.0
19	0.0
25	- 9.9
39	-14.2
50	-12.0
81	0.0
100	+ 8.1

Figure 5.21
AXIAL RESIDUAL STRESS
PIPE DIAMETER OF 20" TO 28"

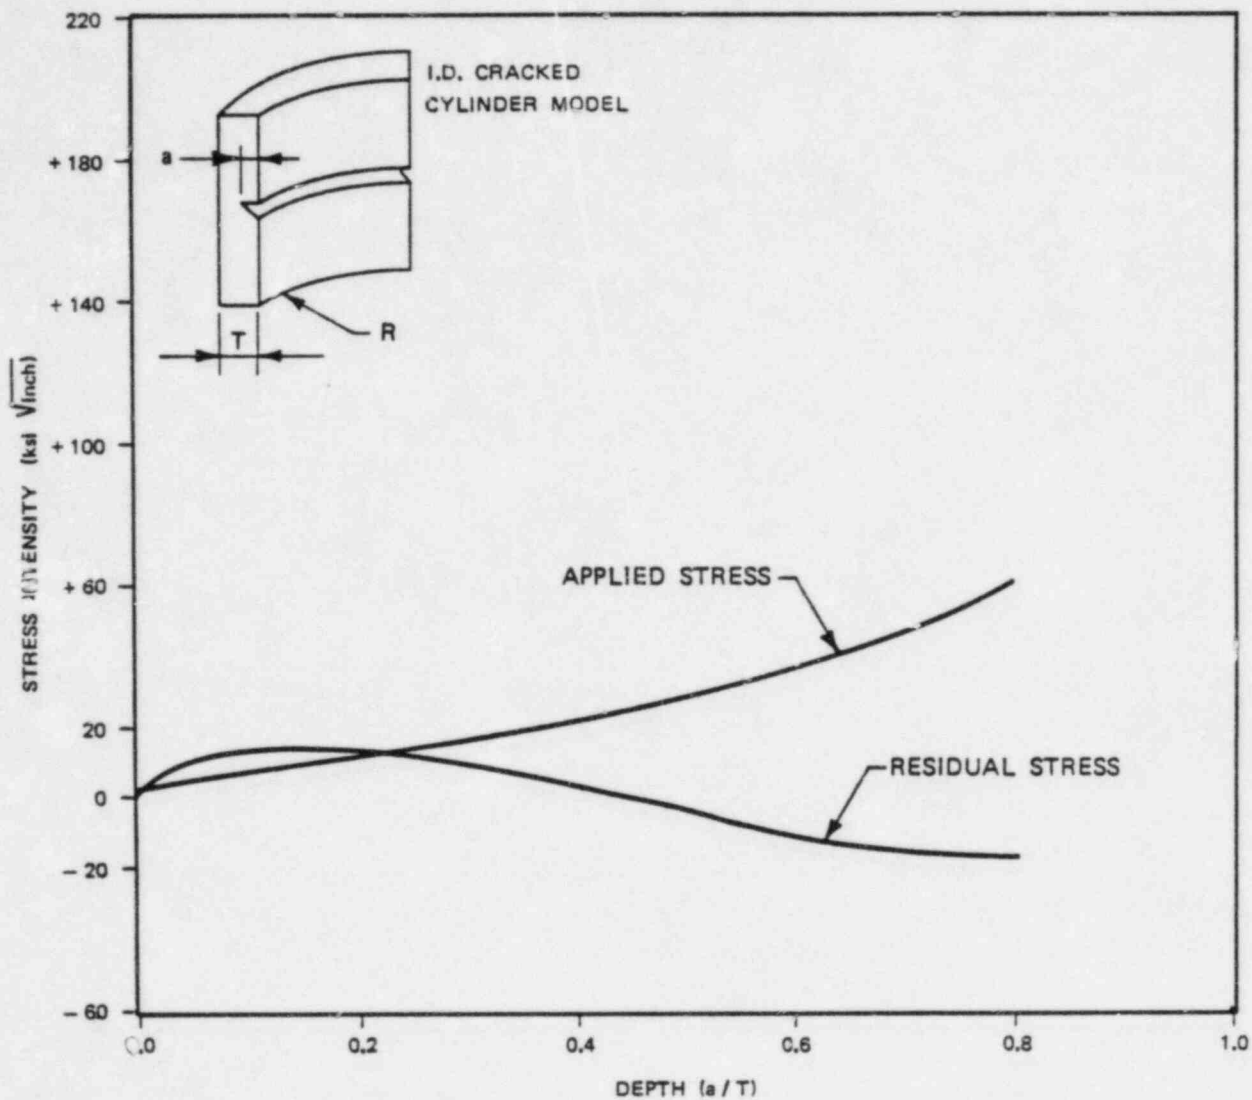
Figure 5.22
STRESS INTENSITY FACTOR FOR
RECIRCULATION SYSTEM WELD 28B - 15

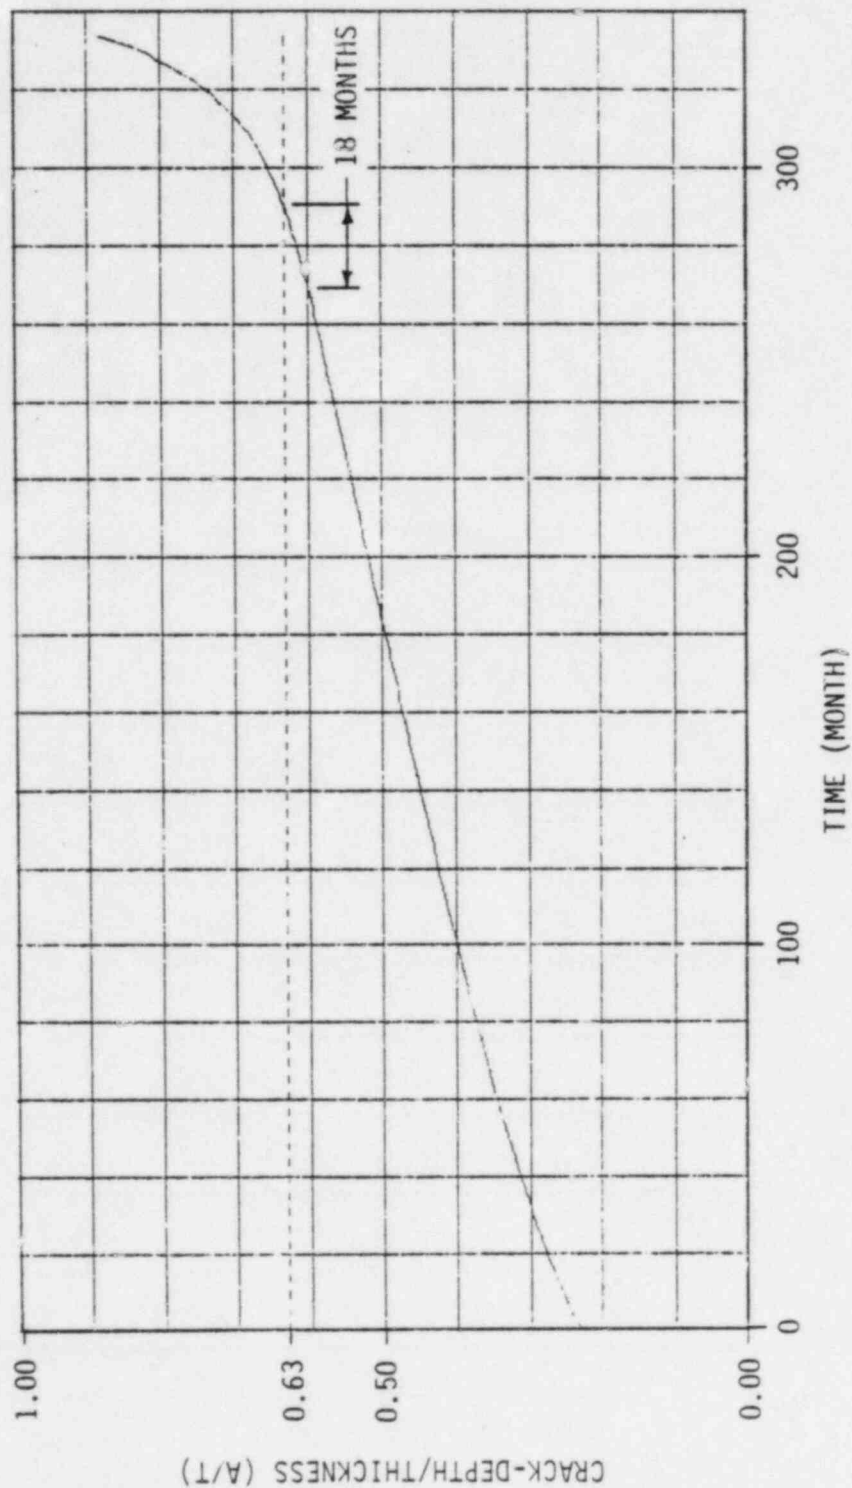
Figure 5.23

--- ALLOWABLE A/T AT THE END OF FUEL CYCLE

CRACK GROWTH FOR RECIRCULATION SYSTEM WELD 28B-15

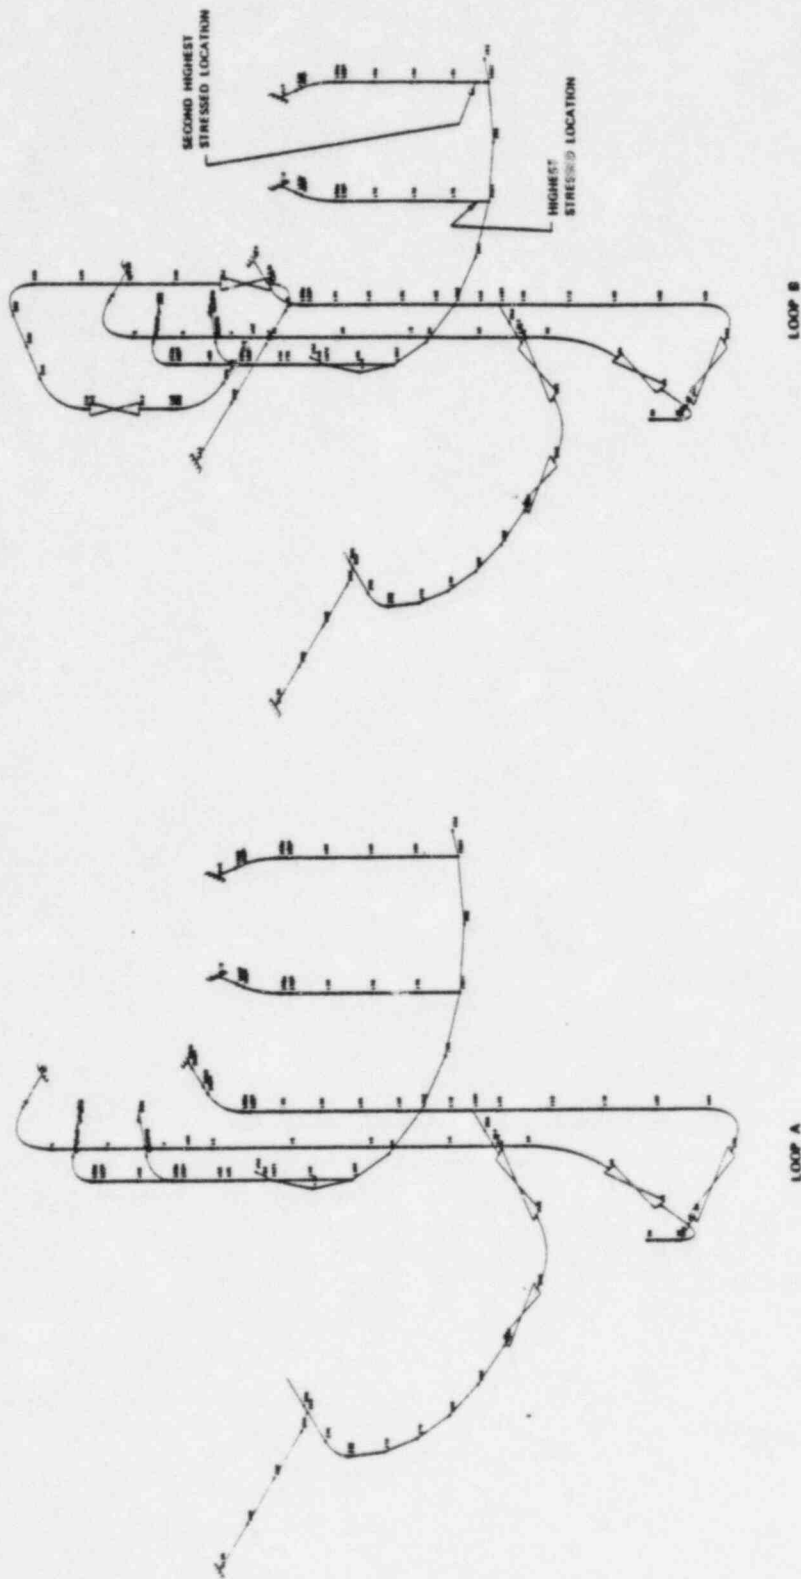
Figure 5.24
PIPING MODEL

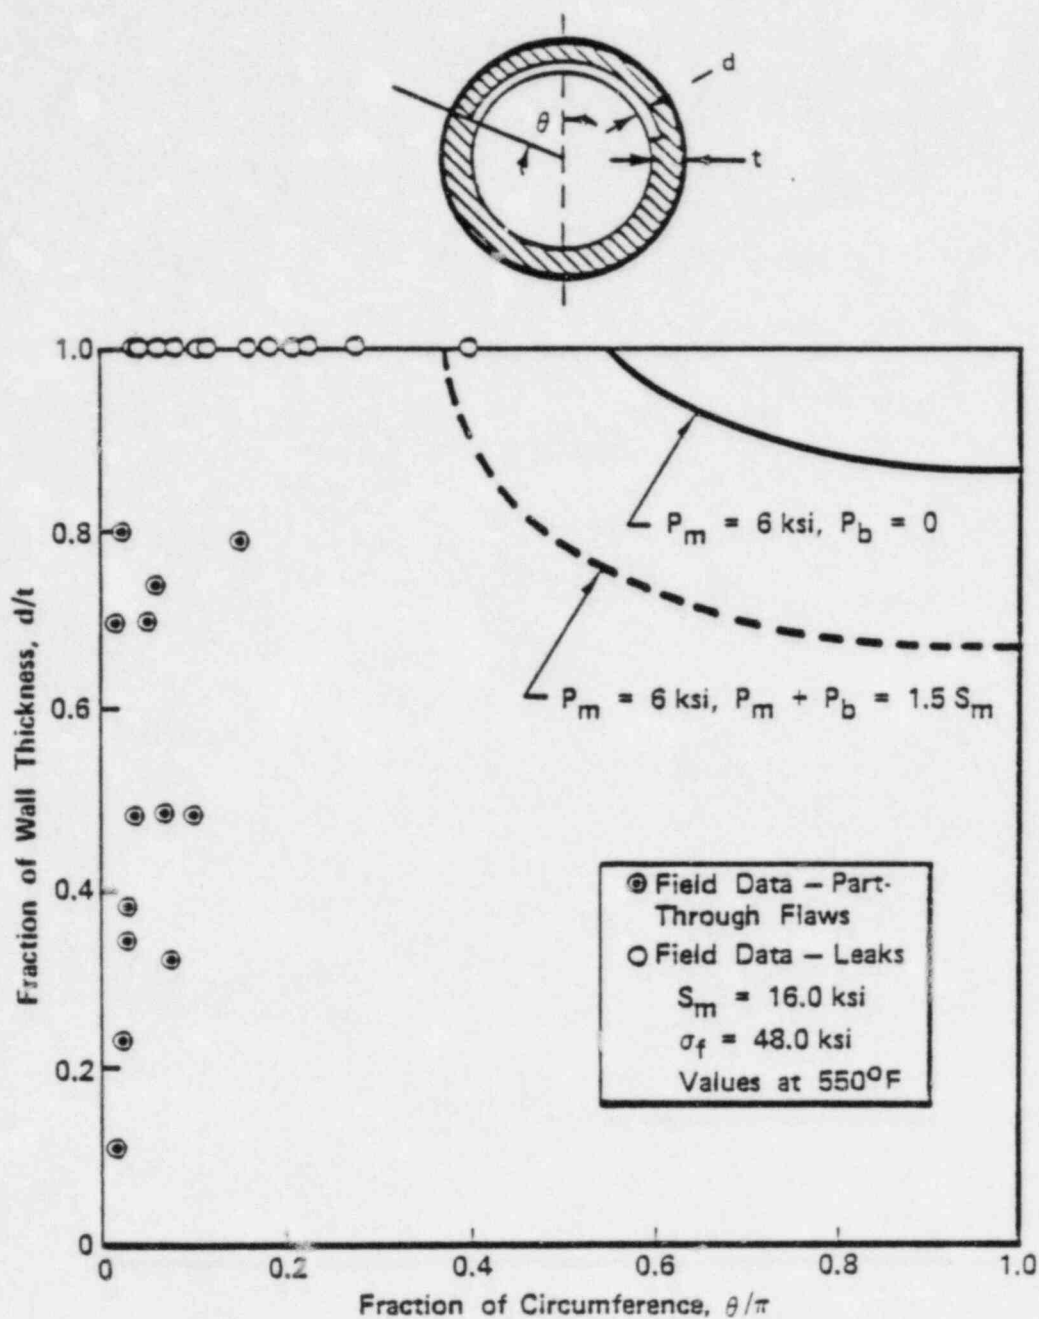
Figure 6.1
TYPICAL RESULT OF NET SECTION COLLAPSE ANALYSIS OF
CRACKED STAINLESS STEEL PIPE

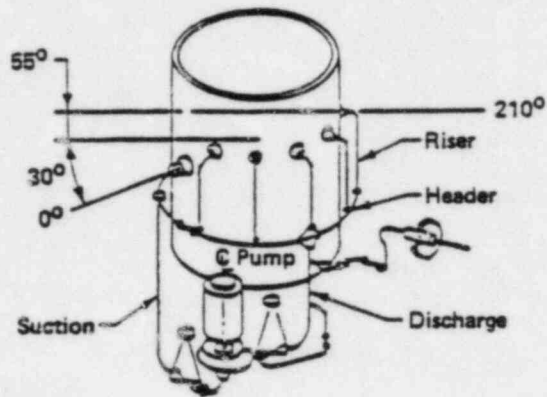
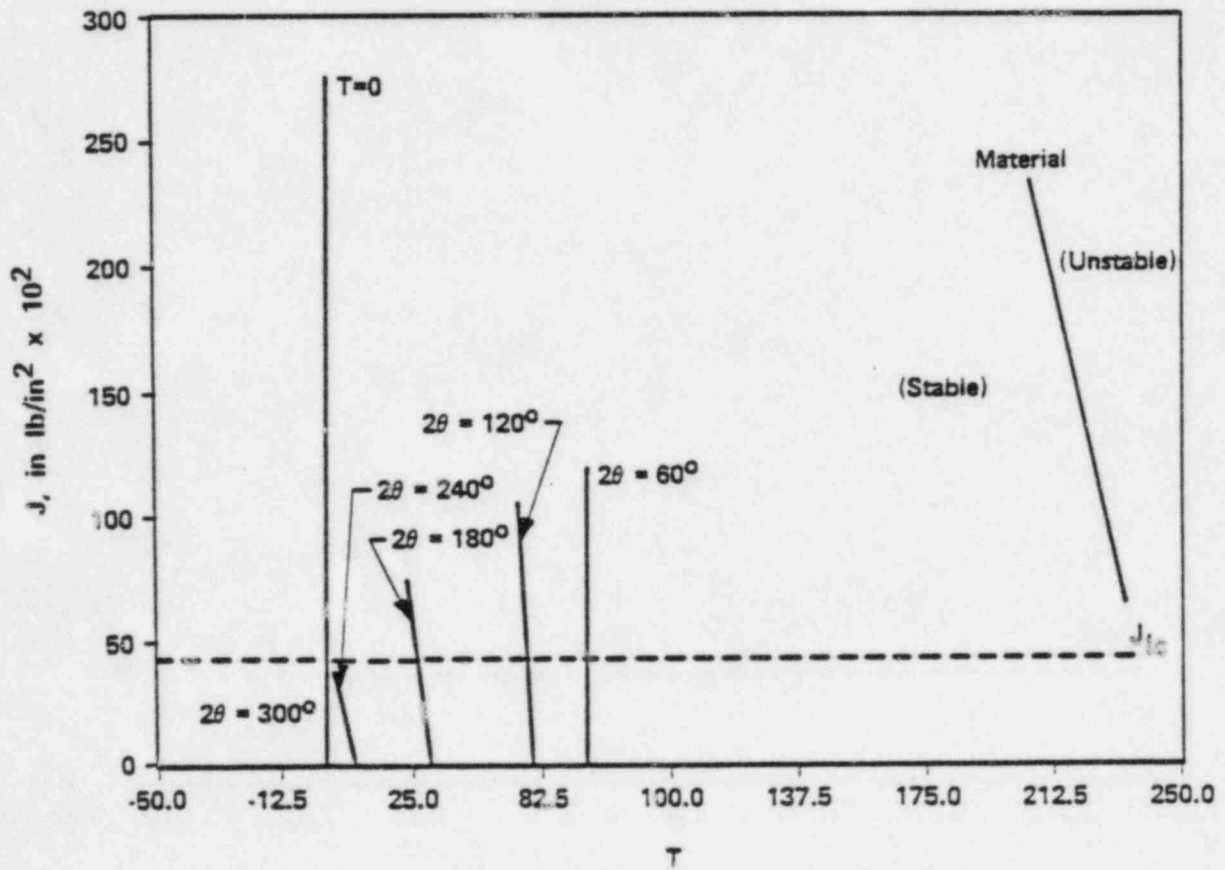
Figure 6.2
STABILITY ANALYSIS FOR BWR RECIRCULATION SYSTEM
(STAINLESS STEEL)

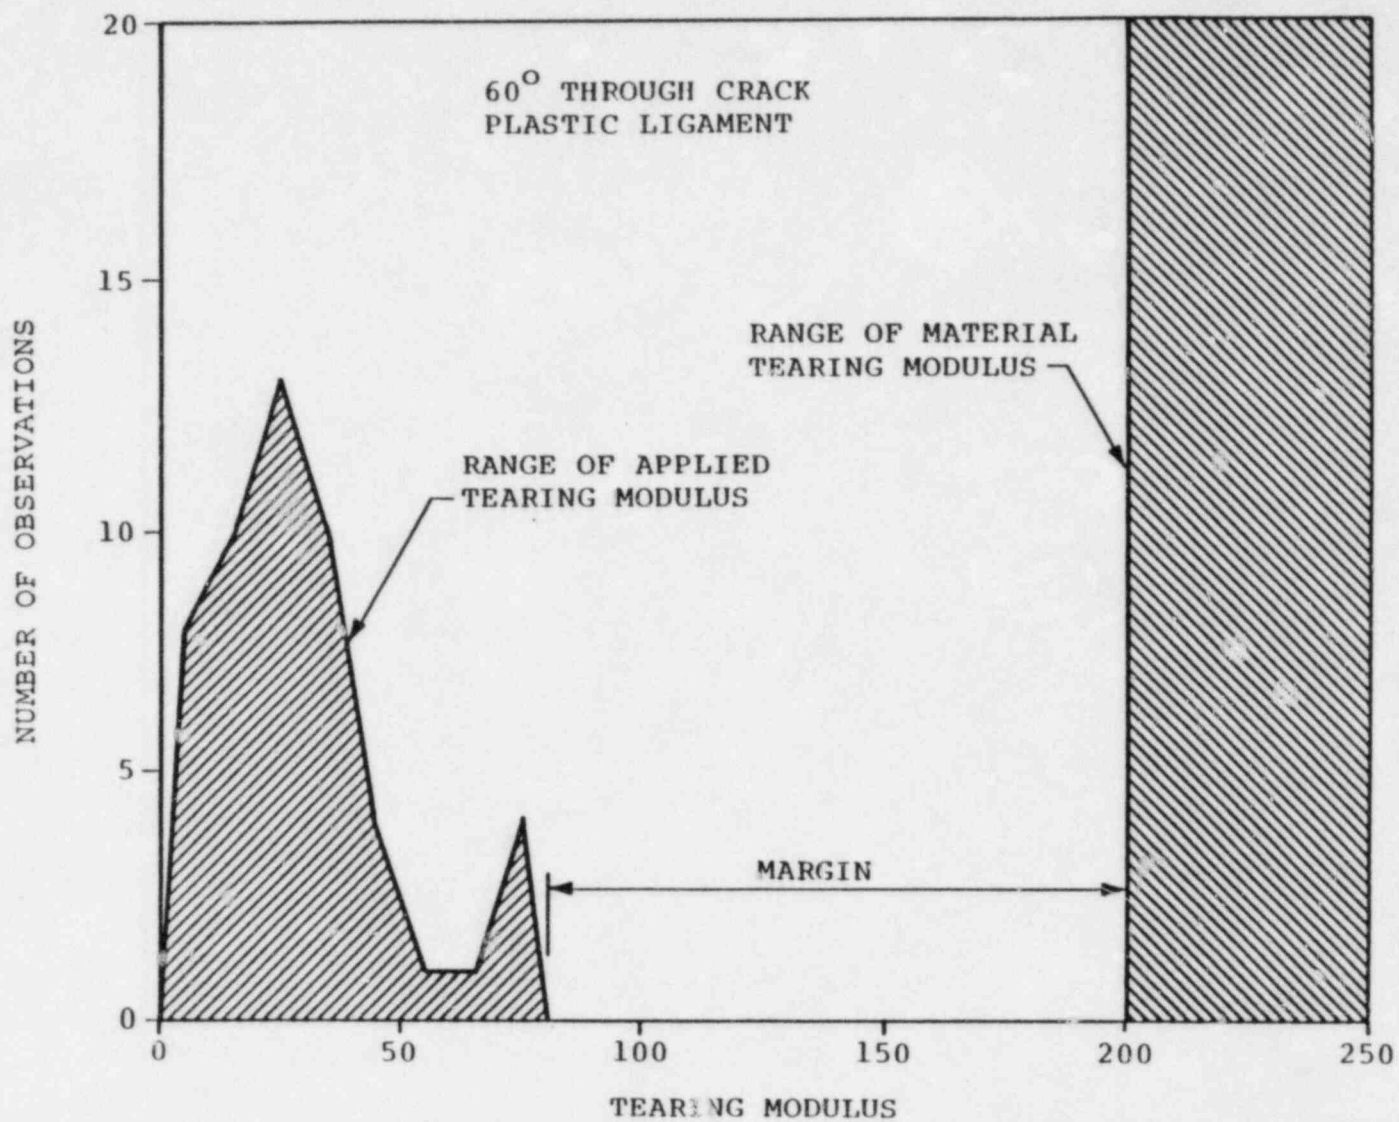
Figure 6.3
SUMMARY OF LEAK BEFORE BREAK ASSESSMENT
OF BWR RECIRCULATION SYSTEM

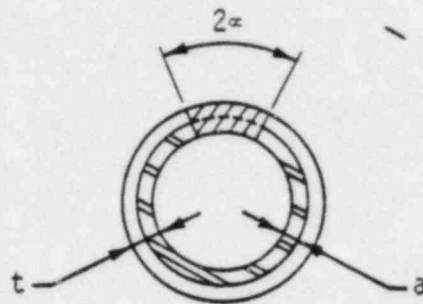
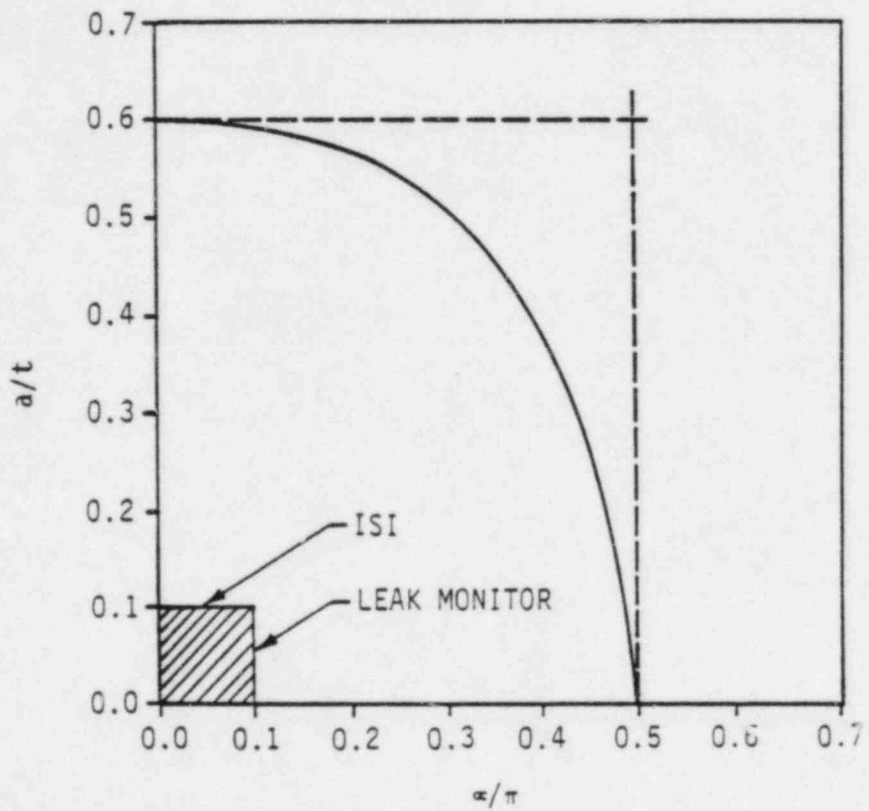
PIPE CROSS SECTION

Figure 6.4
TYPICAL PIPE CRACK FAILURE LOCUS FOR COMBINED
THROUGH - WALL PLUS 360° PART - THROUGH CRACK
