Westinghouse
Electric Corporation

SUBJECT: AP600 MULTIPLE STEAM GENERATOR TUBE RUPTURE ANALYSIS IN
SUPPORT OF RAIS 440.27 AND 440.170 (Revision 2)

AP600 Multiple Steam Generator Tube Rupture Analysis

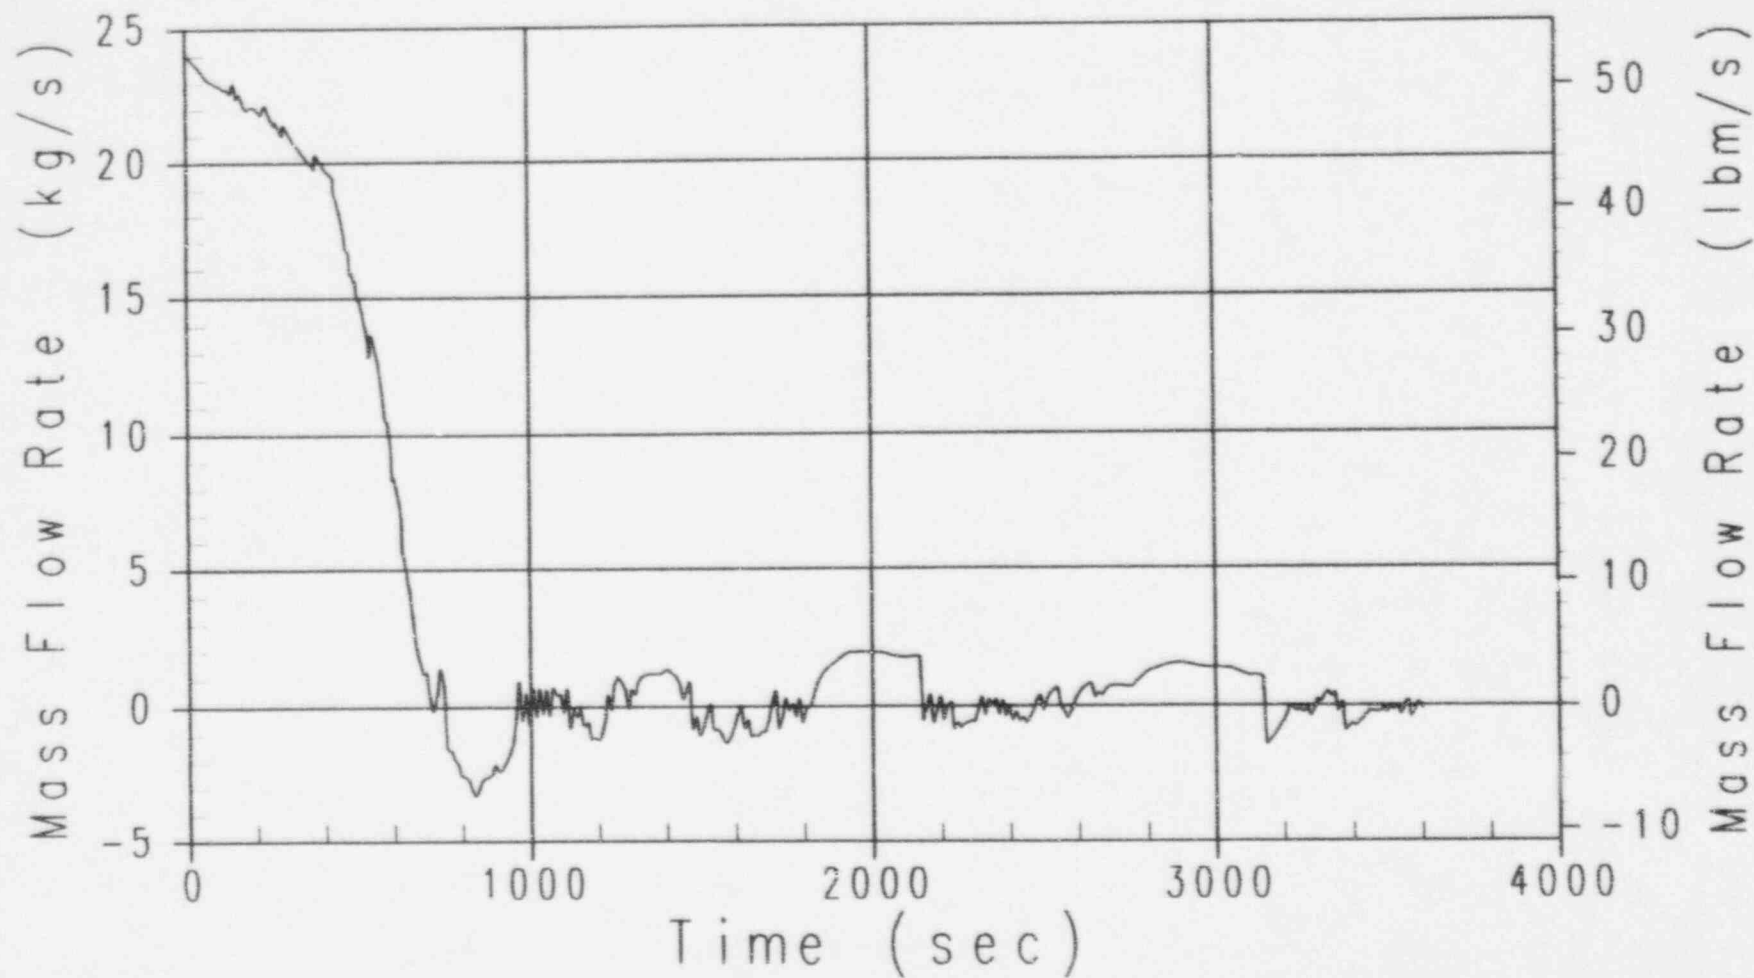
Figure 1

into the broken steam generator (Figure 1). The RCS pressure (Figure 2) decreases and at 132 seconds the reactor scrams due to high steam generator narrow range level. The steam generator secondary system and the main feedwater system are isolated and startup feedwater is initiated. Steam generator pressure (Figure 3) increases to the setpoint of the secondary PORVs valves which begin relieving secondary steam to the environment at 221 seconds. Steam generator water level (Figure 4) increases due to startup feedwater injection and decreased heat transfer after reactor scram. The broken steam generator water level increases more than the unbroken steam generator due to the addition of primary system water, as well as feedwater.

AP600 1 Tube Cold Side SGTR at Tubesheet
Tube Rupture Break Flow

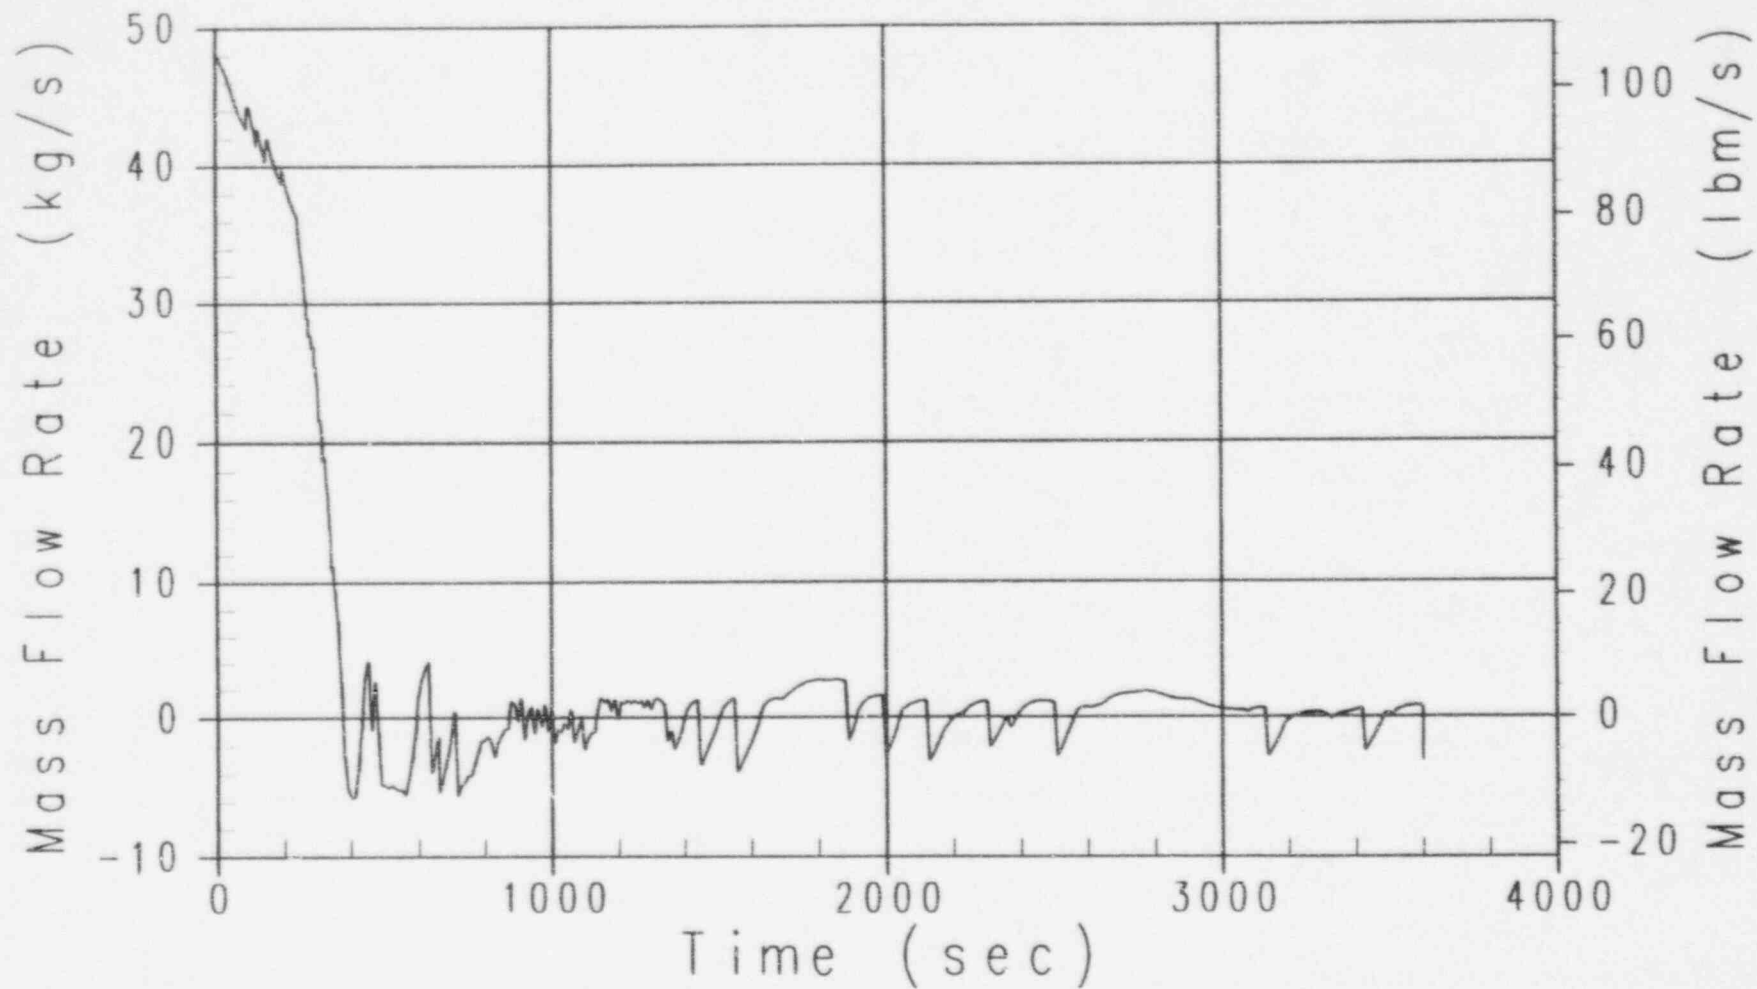
Figure 10

The AP600 two-tube SGTR case, SG2, is a double-ended guillotine break of two cold-side steam generator tubes at the tubesheet elevation. The MAAP4 results for case SG2 are presented in Figures 10 through 18. At time zero, the tube rupture occurs, relieving primary system water into the broken steam generator (Figure 10). The RCS pressure (Figure 11) decreases and at 92 seconds the reactor scrams due to high steam generator narrow range level. The steam generator secondary system and the main feedwater system are isolated and startup feedwater is initiated.

AP600 2 Tube Cold Side Multiple SGTR at Tubesheet
Tube Rupture Break Flow

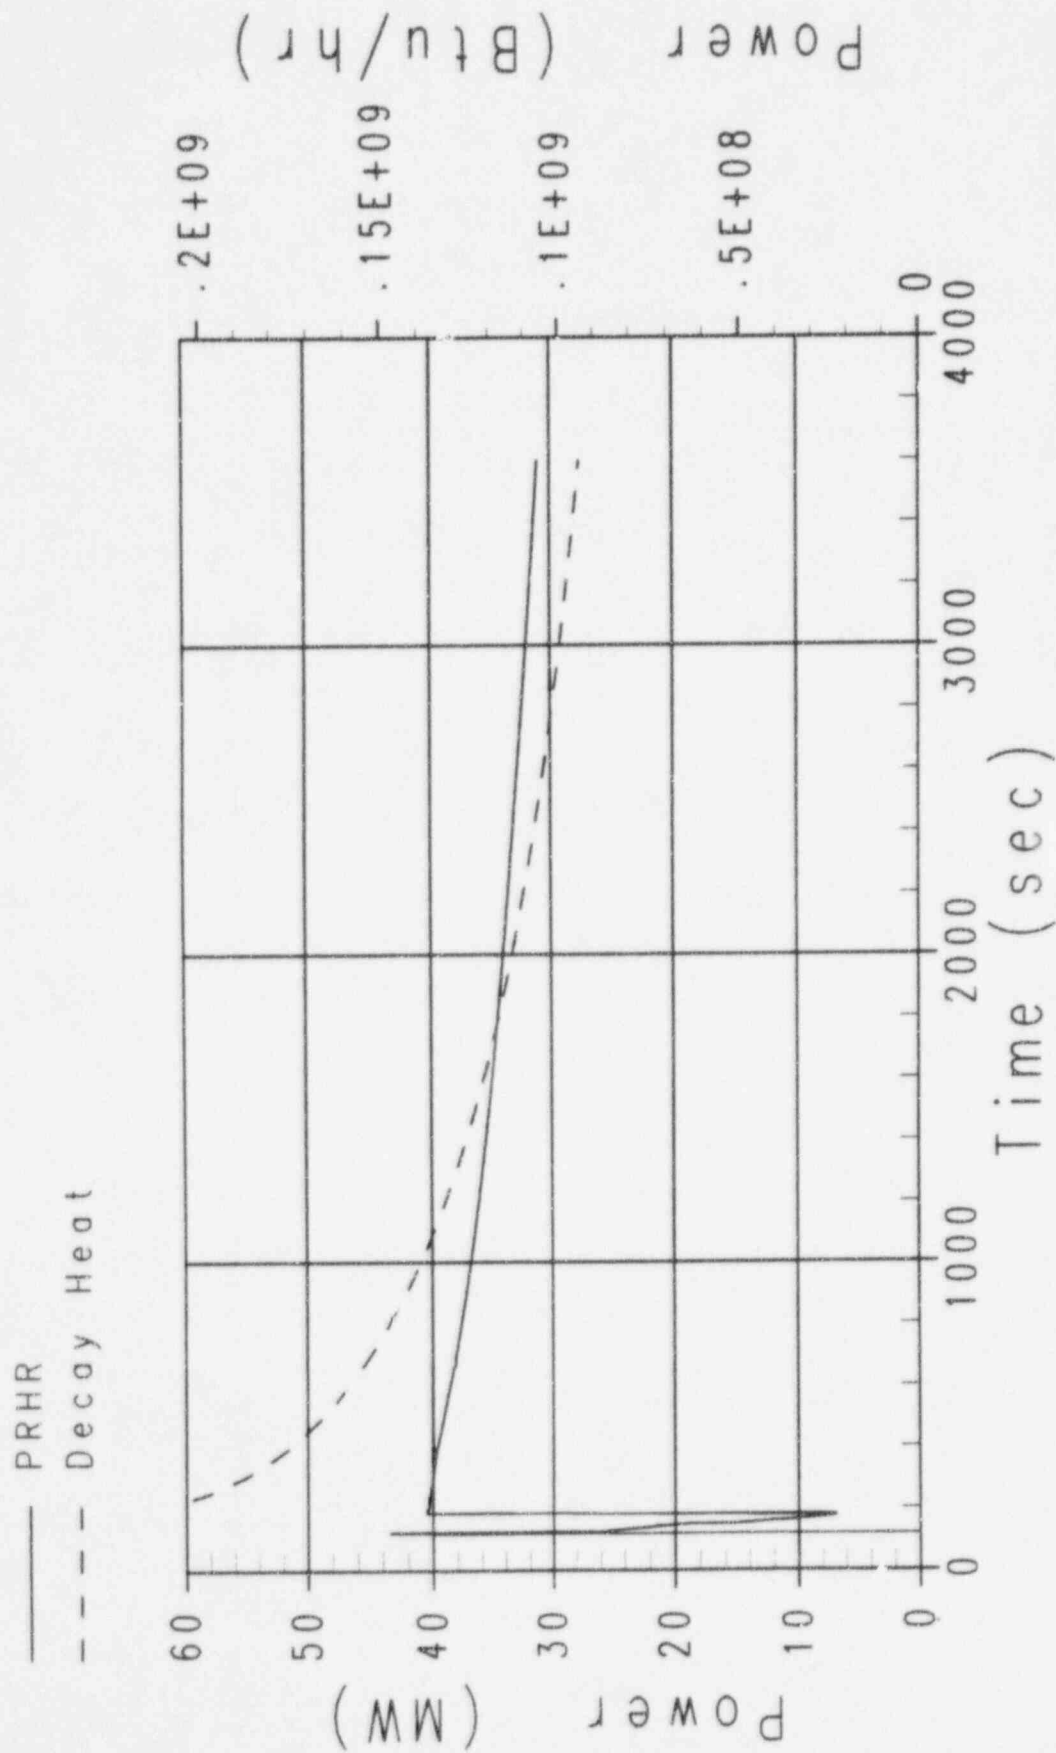
Figure 17

The passive RHR heat exchanger is actuated by the CMT injection signal (Figure 17). The heat removal by the PRHR decreases and maintains the primary system and faulted steam generator pressure below the secondary system relief valve setpoints, stopping the loss of coolant from the system at 285 seconds. The flow between the primary and secondary systems fluctuates around zero (Figure 10), and the full primary system water level is maintained throughout the transient (Figure 18). The secondary safety valves do not open since the pressure in the faulted steam generator remains below the safety valve actuation pressure throughout the entire accident scenario (Figure 12). The water level in the core makeup tank (Figure 16) does not decrease due to the recirculation injection mode. Therefore, automatic depressurization of the RCS does not occur.

AP600 2 Tube Cold Side Multiple SGTR at Tubesheet
PRHR Heat Removal

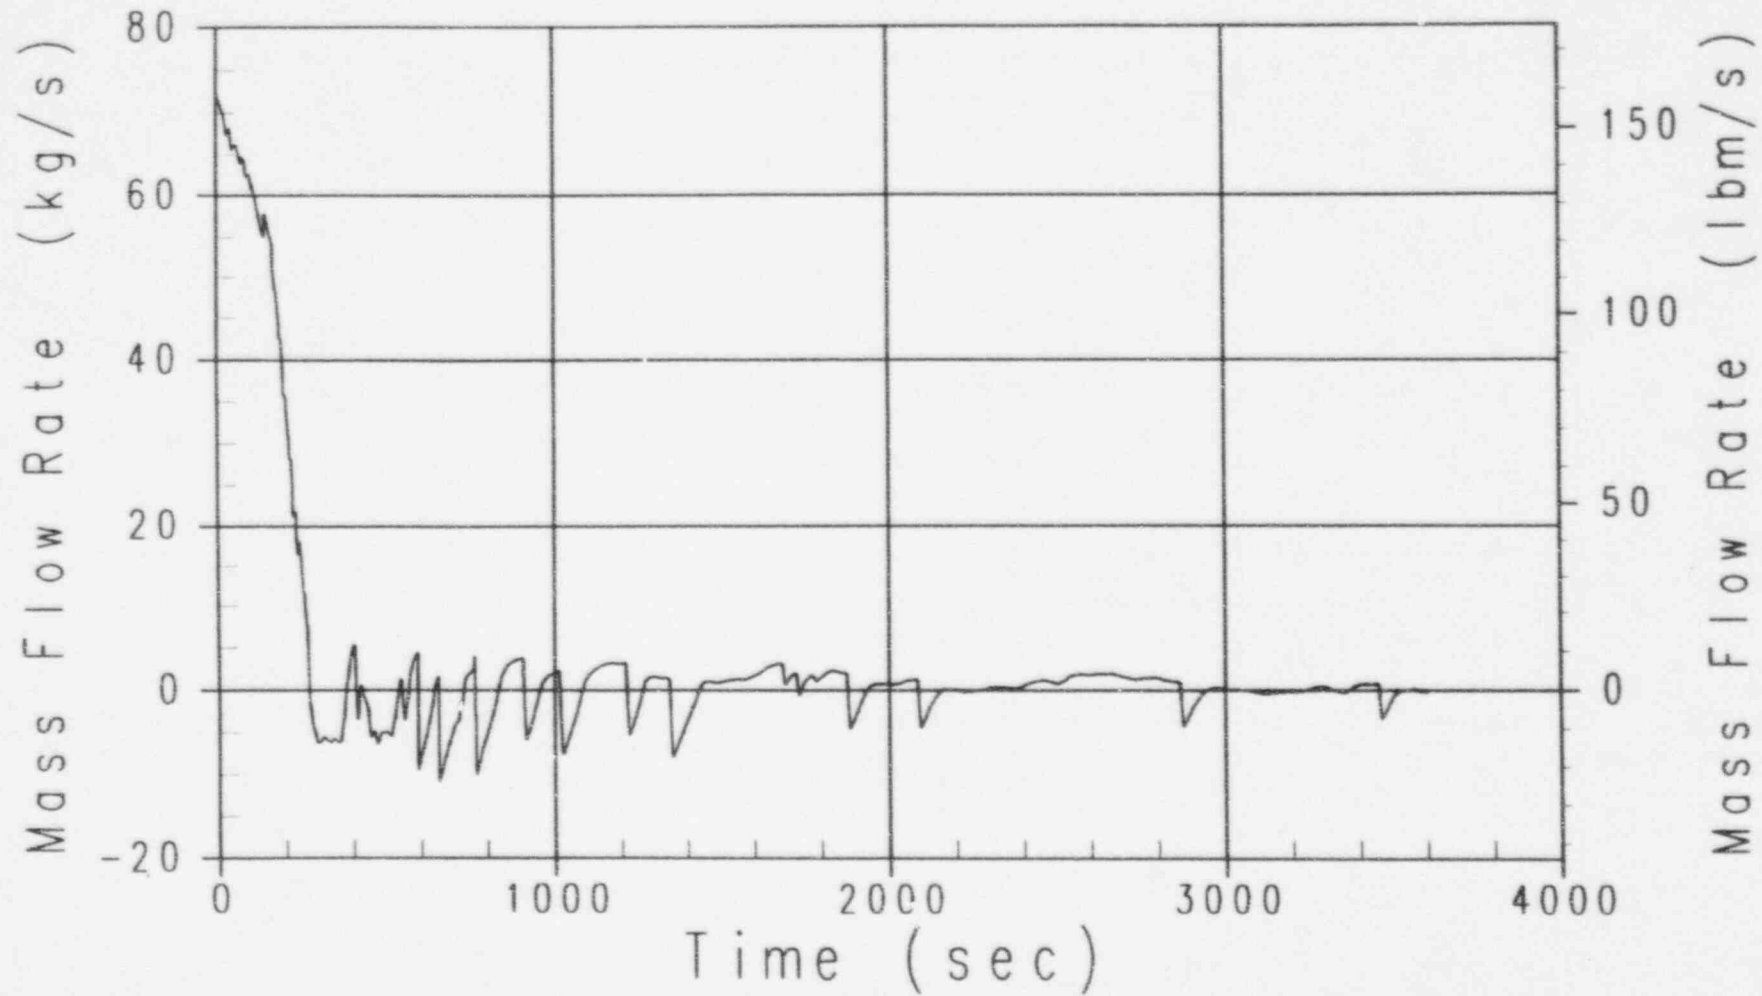
Figure 19

The AP600 three-tube SGTR case, SG3, is a double-ended guillotine break of three cold-side steam generator tubes at the tubesheet elevation. The MAAP4 results for case SG3 are presented in Figures 19 through 27. At time zero, the tube rupture occurs, relieving primary system water into the broken steam generator (Figure 19). The RCS pressure (Figure 20) decreases and at 74 seconds the reactor scrams due to high steam generator narrow range level. The steam generator secondary system and the main feedwater system are isolated and startup feedwater is initiated. Steam generator pressure (Figure 21) increases to the setpoint of the secondary PORVs which begin relieving secondary steam to the environment at 143 seconds. Steam generator water level (Figure 22) increases due to startup feedwater injection and decreased heat transfer after reactor

AP600 3 Tube Cold Side Multiple SGTR at Tubesheet
Tube Rupture Break Flow

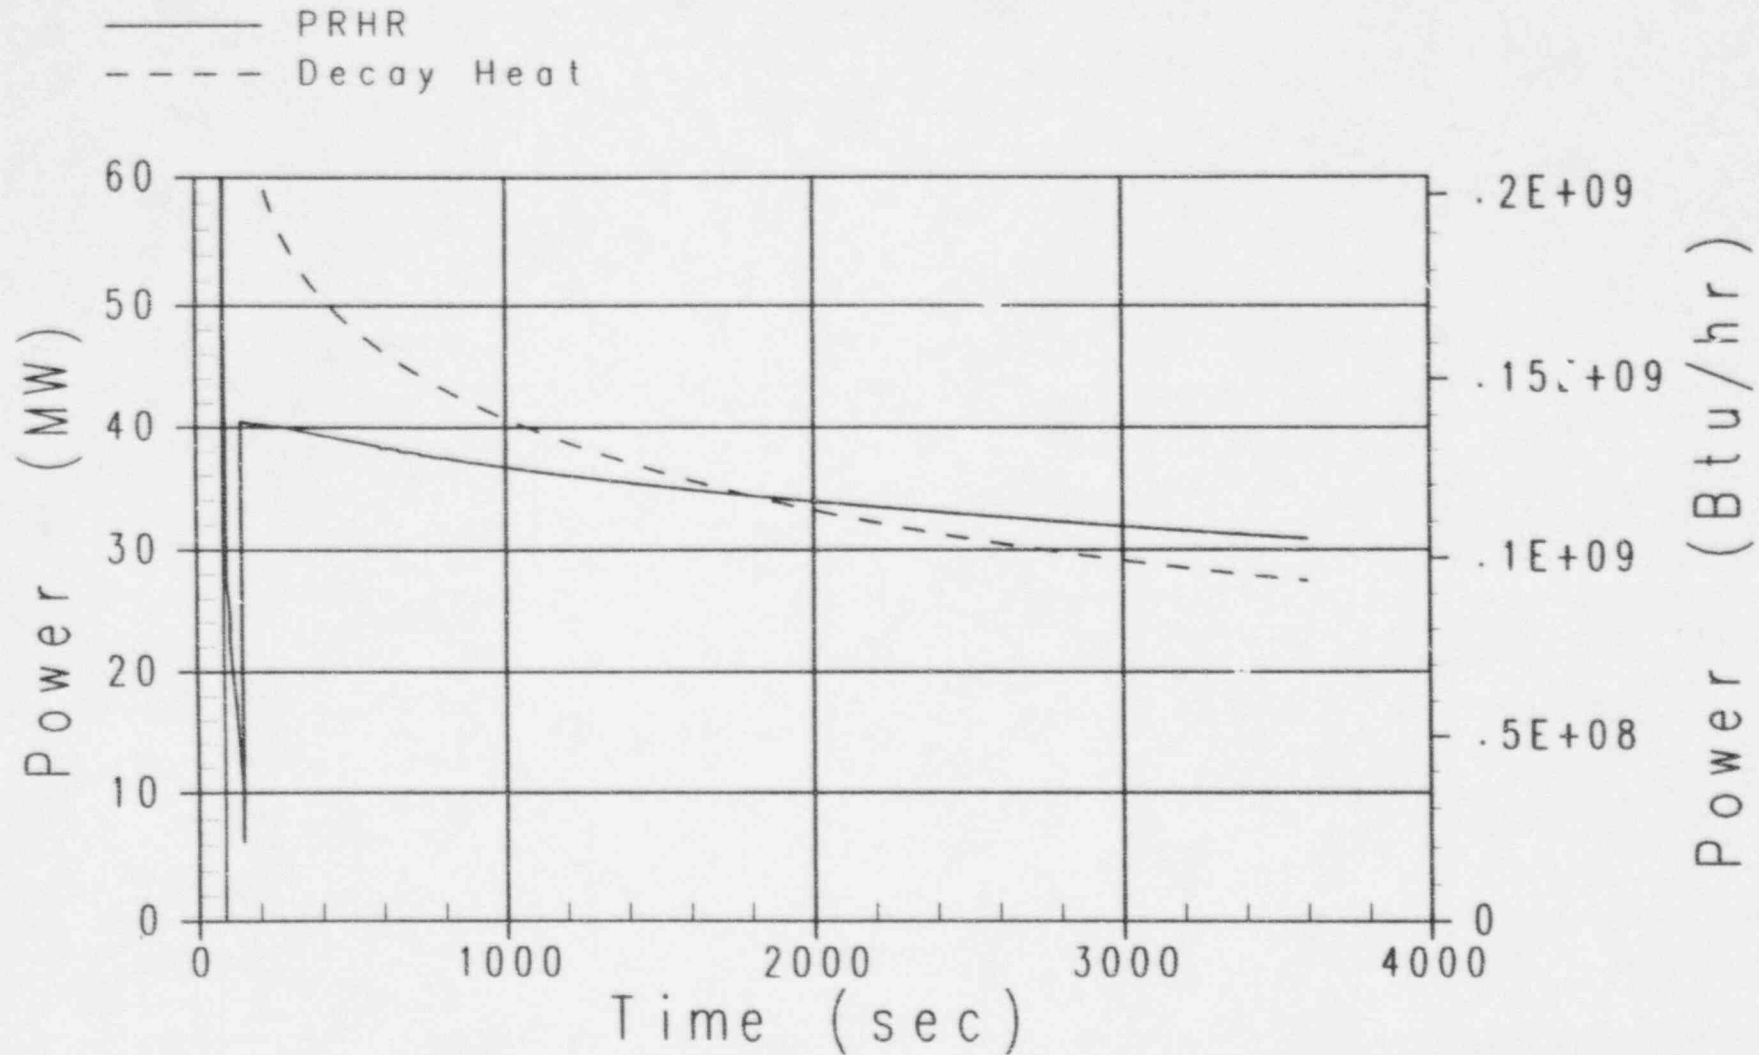
Figure 26

The passive RHR heat exchanger is actuated by the CMT injection signal (Figure 26). The heat removal by the PRHR decreases and maintains the primary system and faulted steam generator pressure below the secondary system relief valve setpoints, stopping the loss of coolant from the system at 239 seconds. The flow between the primary and secondary systems fluctuates around zero (Figure 19), and the full primary system water level is maintained throughout the transient (Figure 27). The secondary safety valves do not open since the pressure in the faulted steam generator remains below the safety valve actuation pressure throughout the entire accident scenario (Figure 21). The water level in the core makeup tank (Figure 25) does not decrease due to the recirculation injection mode. Therefore, automatic depressurization of the RCS does not occur.

AP600 3 Tube Cold Side Multiple SGTR at Tubesheet
PRHR Heat Removal

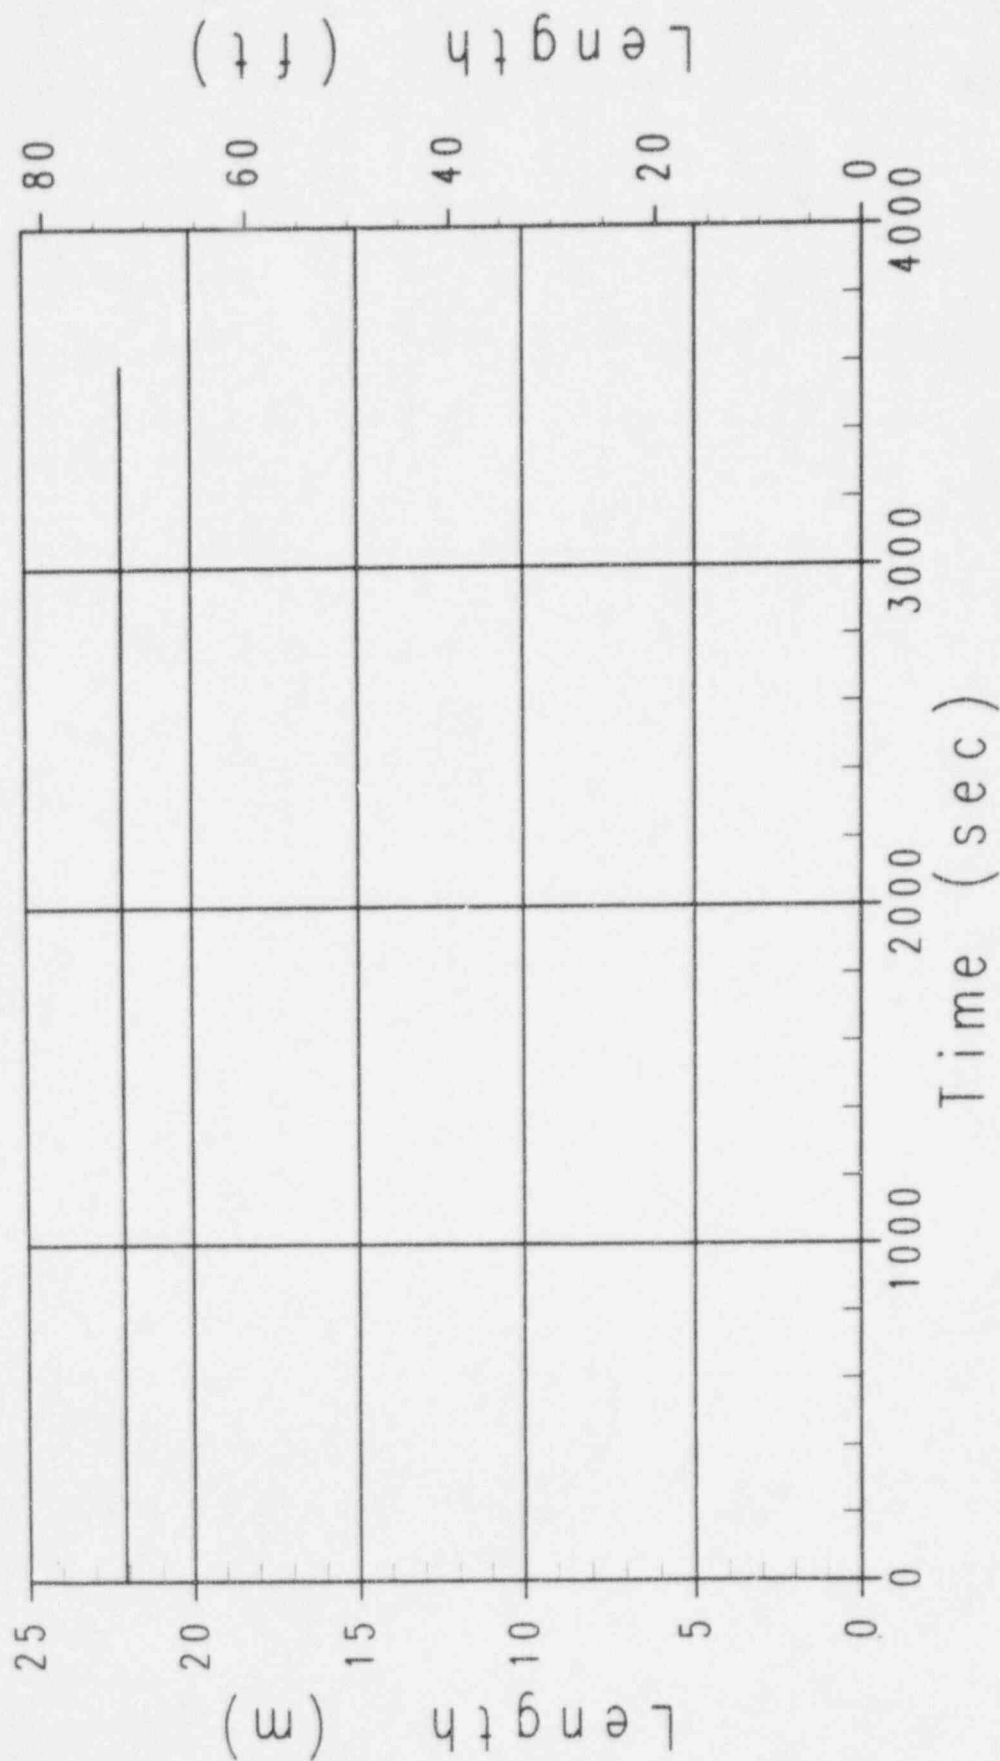
Figure 27

AP600 3 Tube Cold Side Multiple SGTR at Tubesheet
RCS Water Level

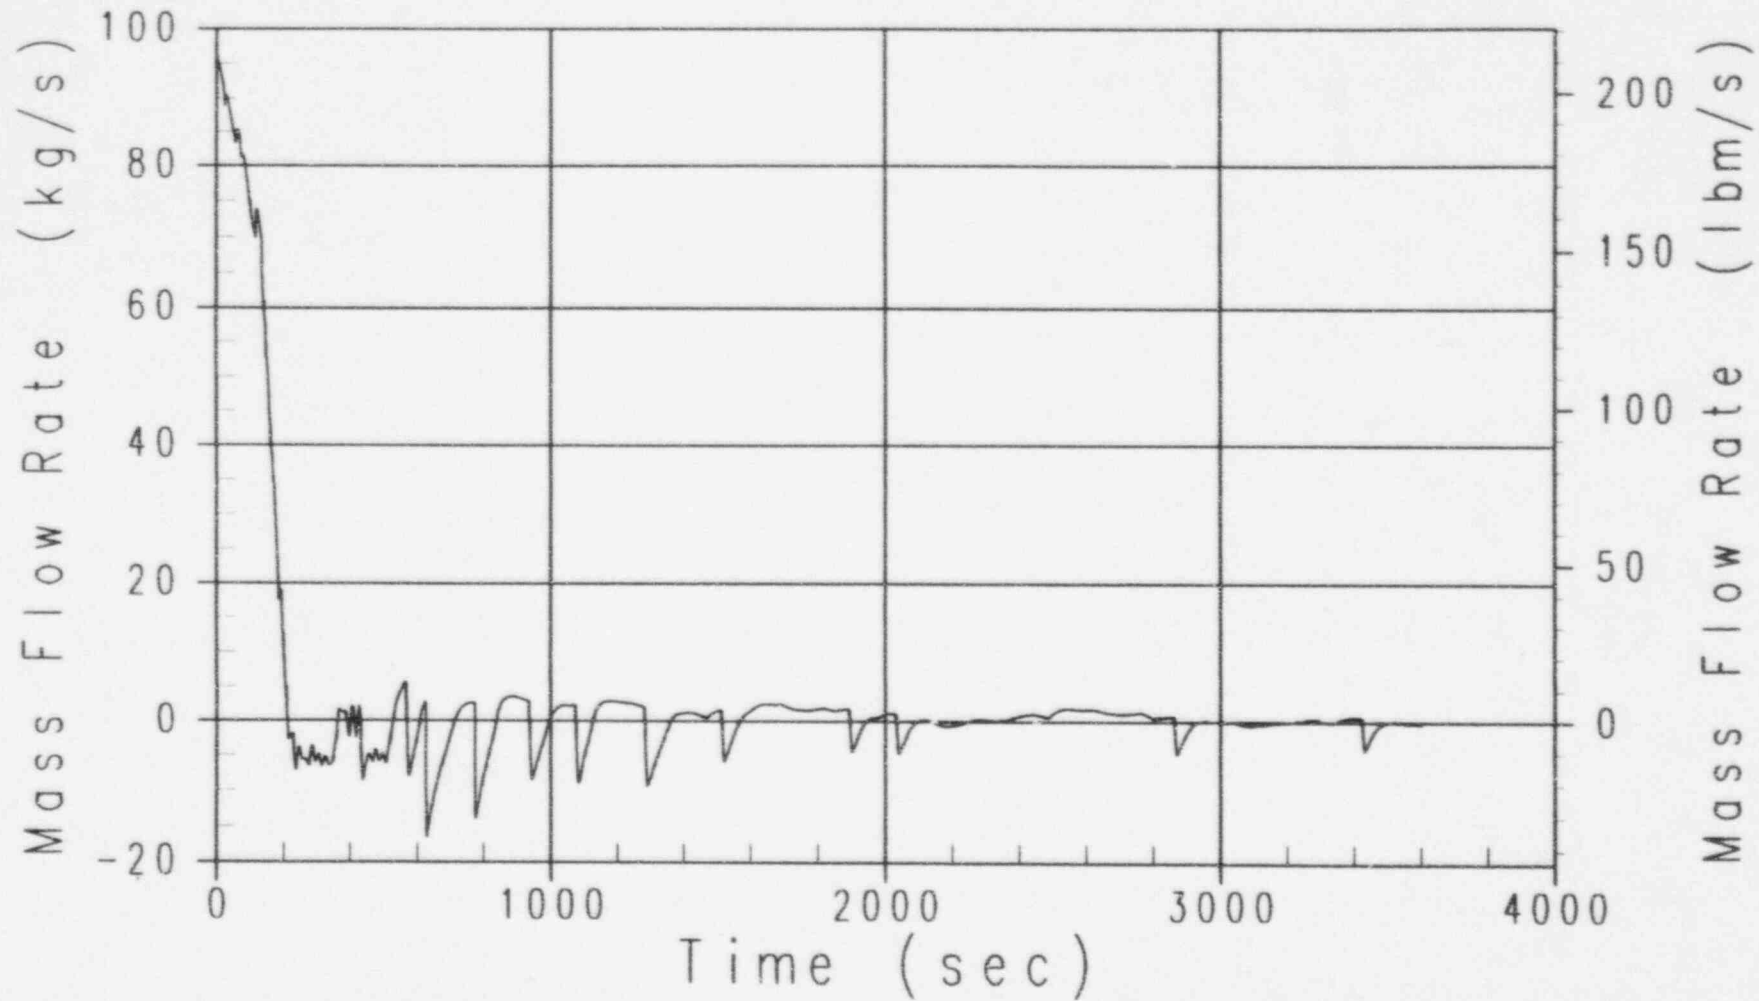
Figure 28

The AP600 four-tube SGTR case, SG4, is a double-ended guillotine break of four cold-side steam generator tubes at the tubesheet elevation. The MAAP4 results for case SG4 are presented in Figures 28 through 36. At time zero, the tube rupture occurs, relieving primary system water into the broken steam generator (Figure 28). The RCS pressure (Figure 29) decreases and at 58 seconds the reactor scrams due to high steam generator narrow range level. The steam generator secondary system and the main feedwater system are isolated and startup feedwater is initiated. Steam generator pressure (Figure 30) increases to the setpoint of the secondary PORVs valves which begin relieving secondary steam to the environment at 119 seconds. Steam generator water level (Figure 31) increases due to startup feedwater injection and decreased heat transfer after reactor scram. The broken steam generator water level increases more than the unbroken steam generator due to the addition of primary system water, as well as feedwater.

AP600 4 Tube Cold Side Multiple SGTR at Tubesheet
Tube Rupture Break Flow

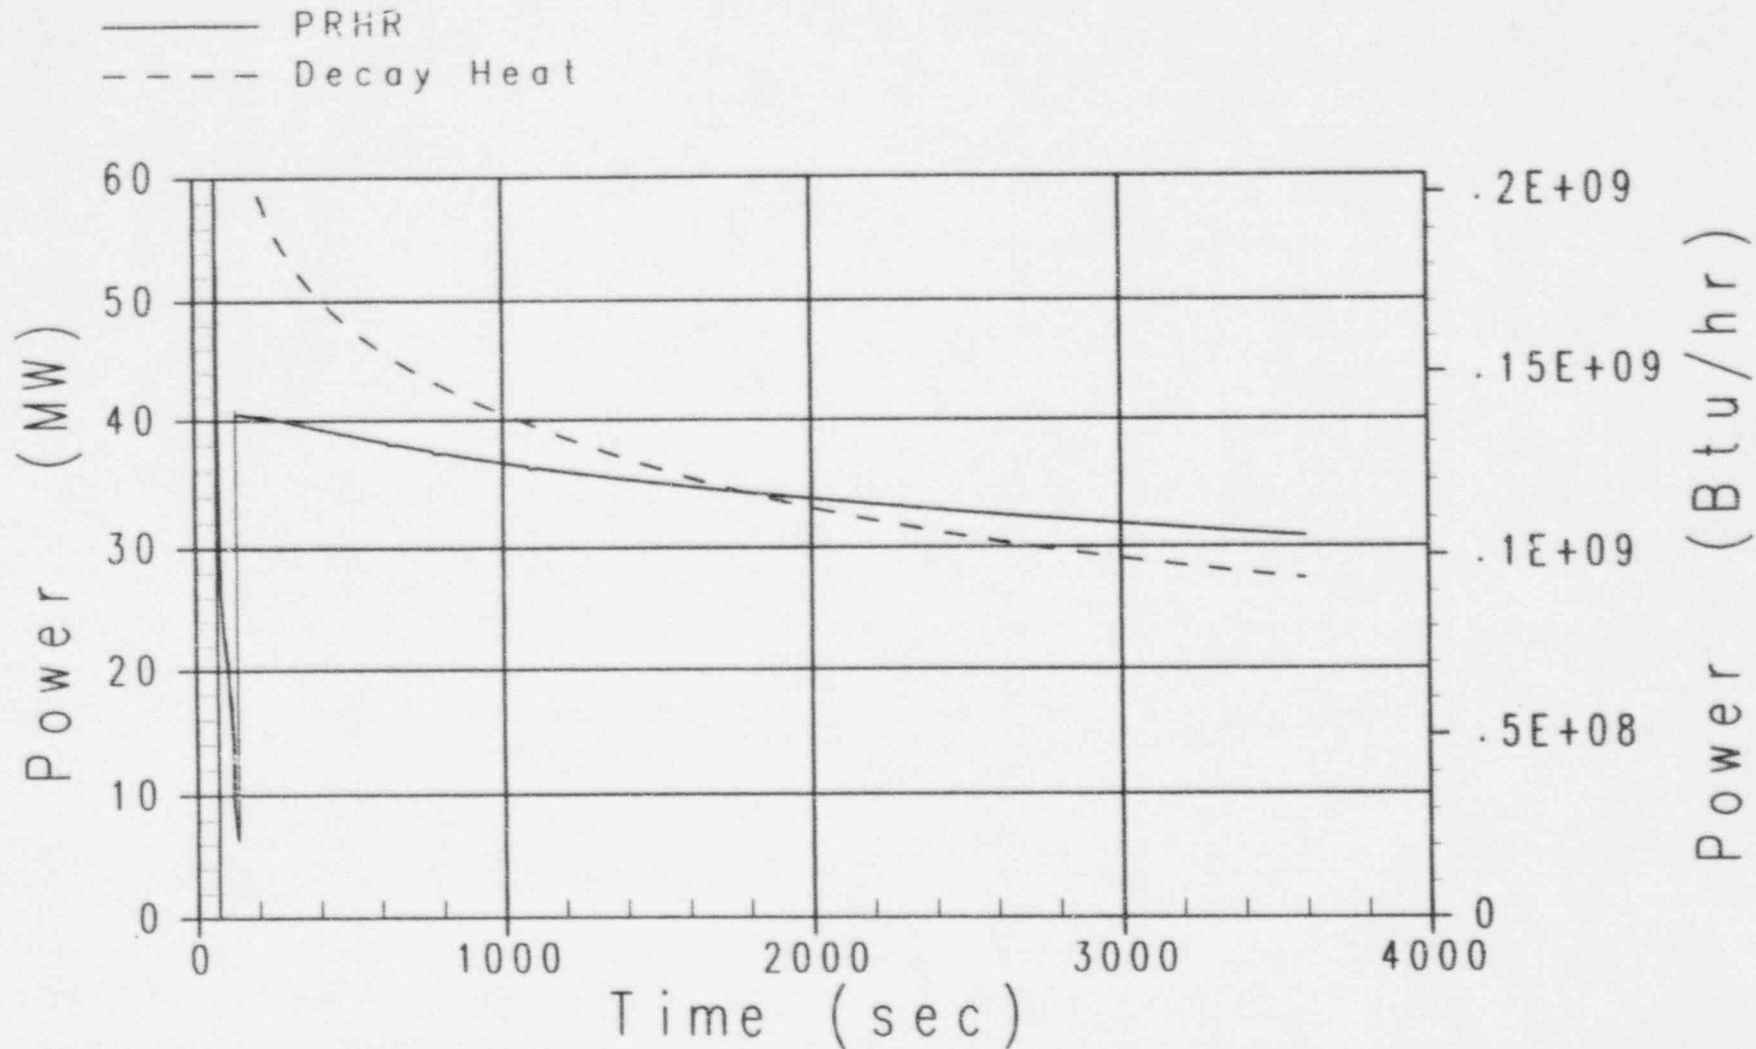
Figure 35

The passive RHR heat exchanger is actuated by the CMT injection signal (Figure 35). The heat removal by the PRHR decreases and maintains the primary system and faulted steam generator pressure below the secondary system relief valve setpoints, stopping the loss of coolant from the system at 185 seconds. The flow between the primary and secondary systems fluctuates around zero (Figure 28), and the full primary system water level is maintained throughout the transient (Figure 36). The secondary safety valves do not open since the pressure in the faulted steam generator remains below the safety valve actuation pressure throughout the entire accident scenario (Figure 30). The water level in the core makeup tank (Figure 34) does not decrease due to the recirculation injection mode. Therefore, automatic depressurization of the RCS does not occur.

AP600 4 Tube Cold Side Multiple SGTR at Tubesheet
PRHR Heat Removal

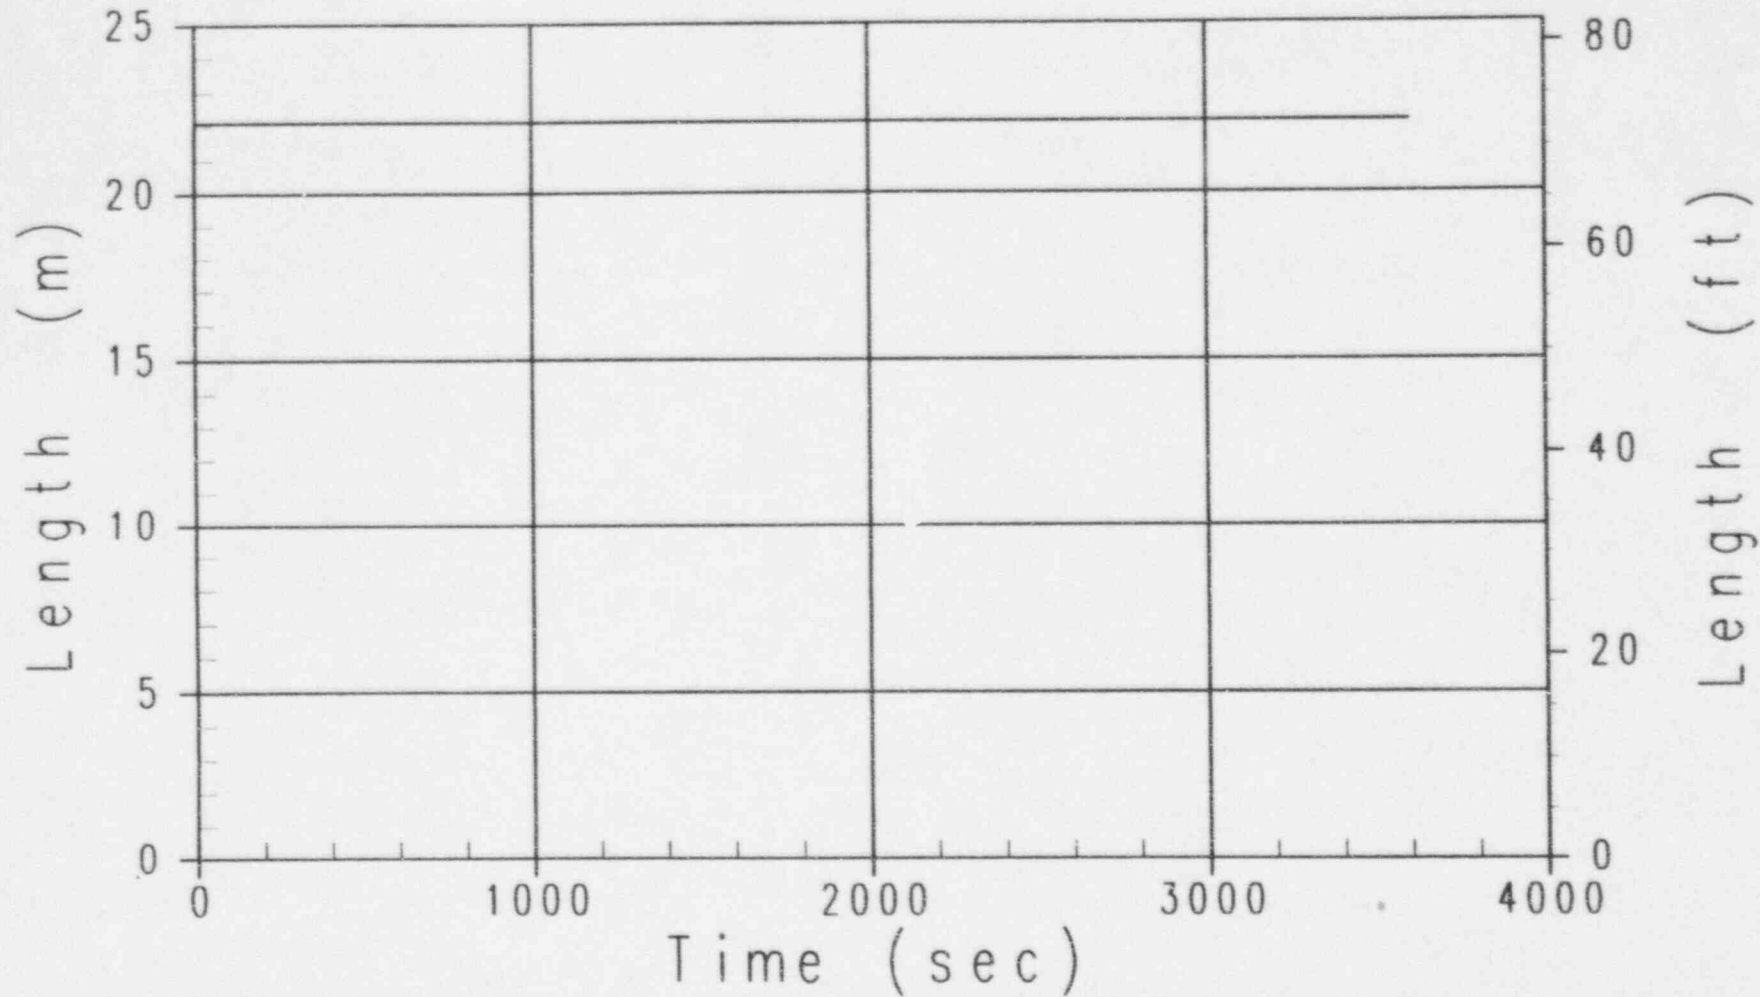
Figure 36

AP600 4 Tube Cold Side Multiple SGTR at Tubesheet
RCS Water Level

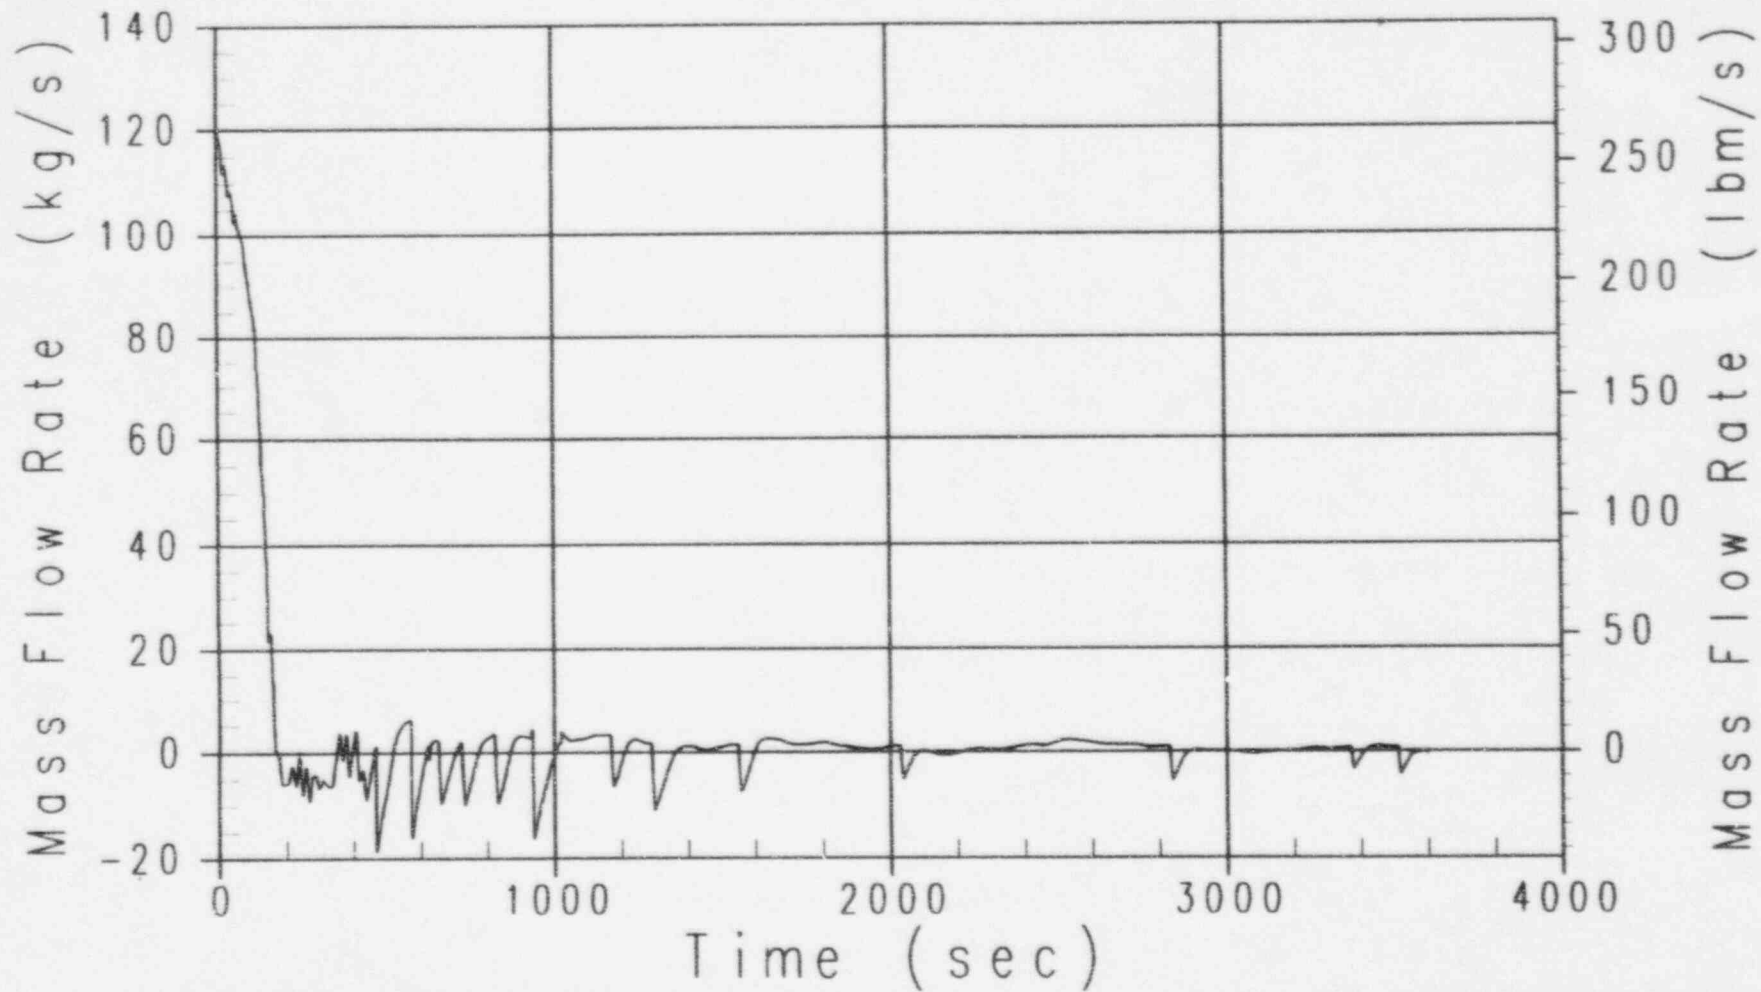
Figure 37

The AP600 five-tube SGTR case, SG5, is a double-ended guillotine break of five cold-side steam generator tubes at the tubesheet elevation. The MAAP4 results for case SG5 are presented in Figures 37 through 45. At time zero, the tube rupture occurs, relieving primary system water into the broken steam generator (Figure 37). The RCS pressure (Figure 38) decreases and at 49 seconds the reactor scrams due to high steam generator narrow range level. The steam generator secondary system and the main feedwater system are isolated and startup feedwater is initiated. Steam generator pressure (Figure 39) increases to the setpoint of the secondary PORVs valves which begin relieving secondary steam to the environment at 107 seconds. Steam generator water level (Figure 40) increases due to startup feedwater injection and decreased heat transfer after reactor scram. The broken steam generator water level increases more than the unbroken steam generator due to the addition of primary system water, as well as feedwater.

AP600 5 Tube Cold Side Multiple SGTR at Tubesheet
Tube Rupture Break Flow

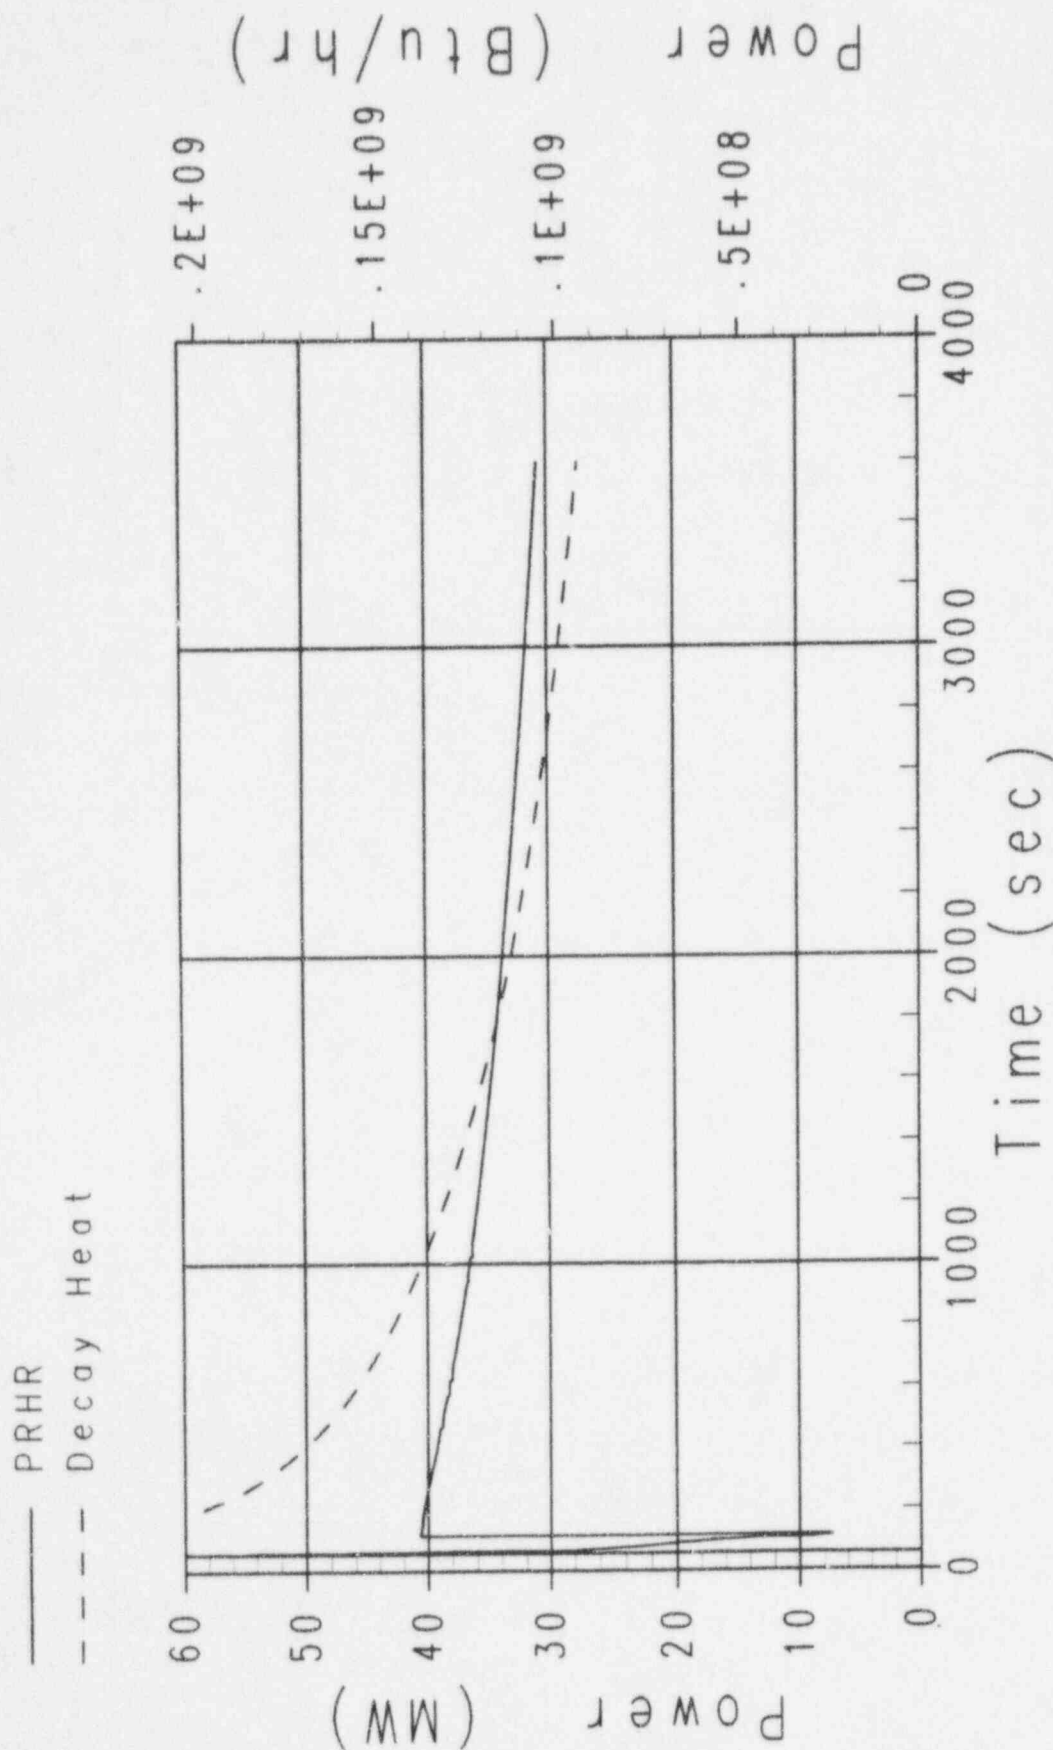
Figure 44

The passive RHR heat exchanger is actuated by the CMT injection signal (Figure 44). The heat removal by the PRHR decreases and maintains the primary system and faulted steam generator pressure below the secondary system relief valve setpoints, stopping the loss of coolant from the system at 132 seconds. The flow between the primary and secondary systems fluctuates around zero (Figure 37), and the full primary system water level is maintained throughout the transient (Figure 45). The secondary safety valves do not open since the pressure in the faulted steam generator remains below the safety valve actuation pressure throughout the entire accident scenario (Figure 39). The water level in the core makeup tank (Figure 43) does not decrease due to the recirculation injection mode. Therefore, automatic depressurization of the RCS does not occur.

AP600 5 Tube Cold Side Multiple SGTR at Tubesheet
PRHR Heat Removal
