Westinghouse
Electric Corporation

SUBJECT: AP600 MULTIPLE STEAM GENERATOR TUBE RUPTURE ANALYSIS IN
SUPPORT OF RAIS 440.27 AND 440.170 (Revision 2)

AP600 Multiple Steam Generator Tube Rupture Analysis

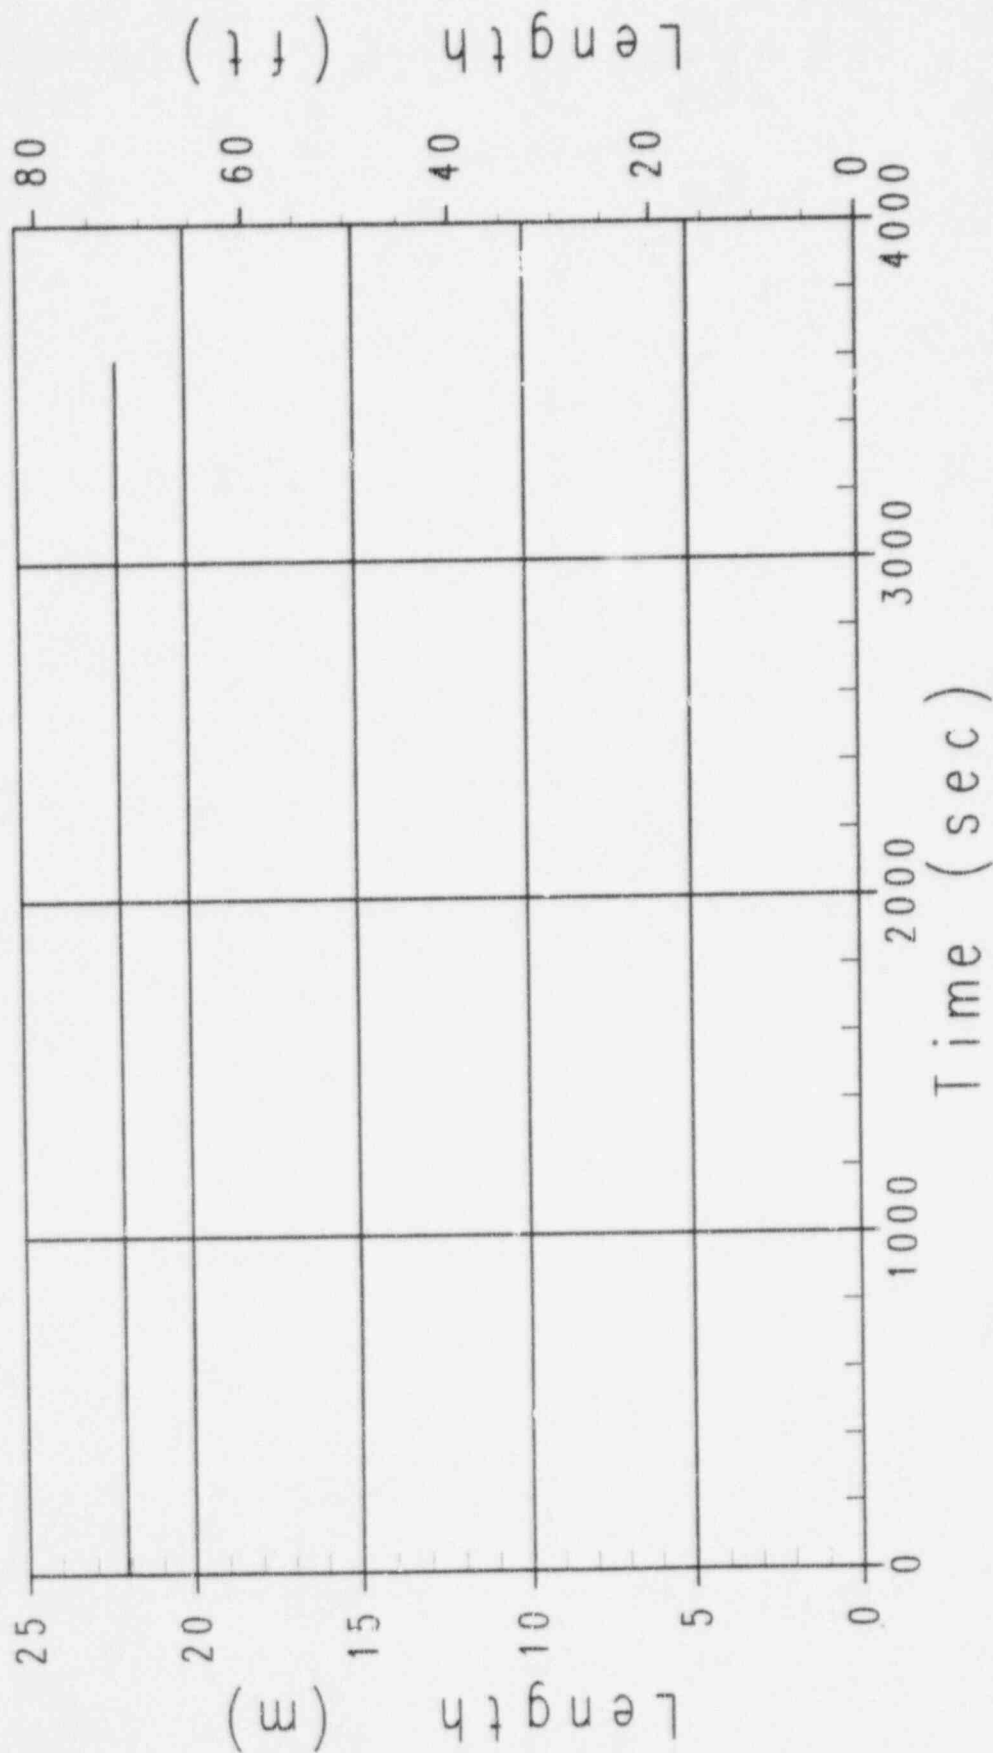
Figure 45

AP600 5 Tube Cold Side Multiple SGTR at Tubesheet
RCS Water Level

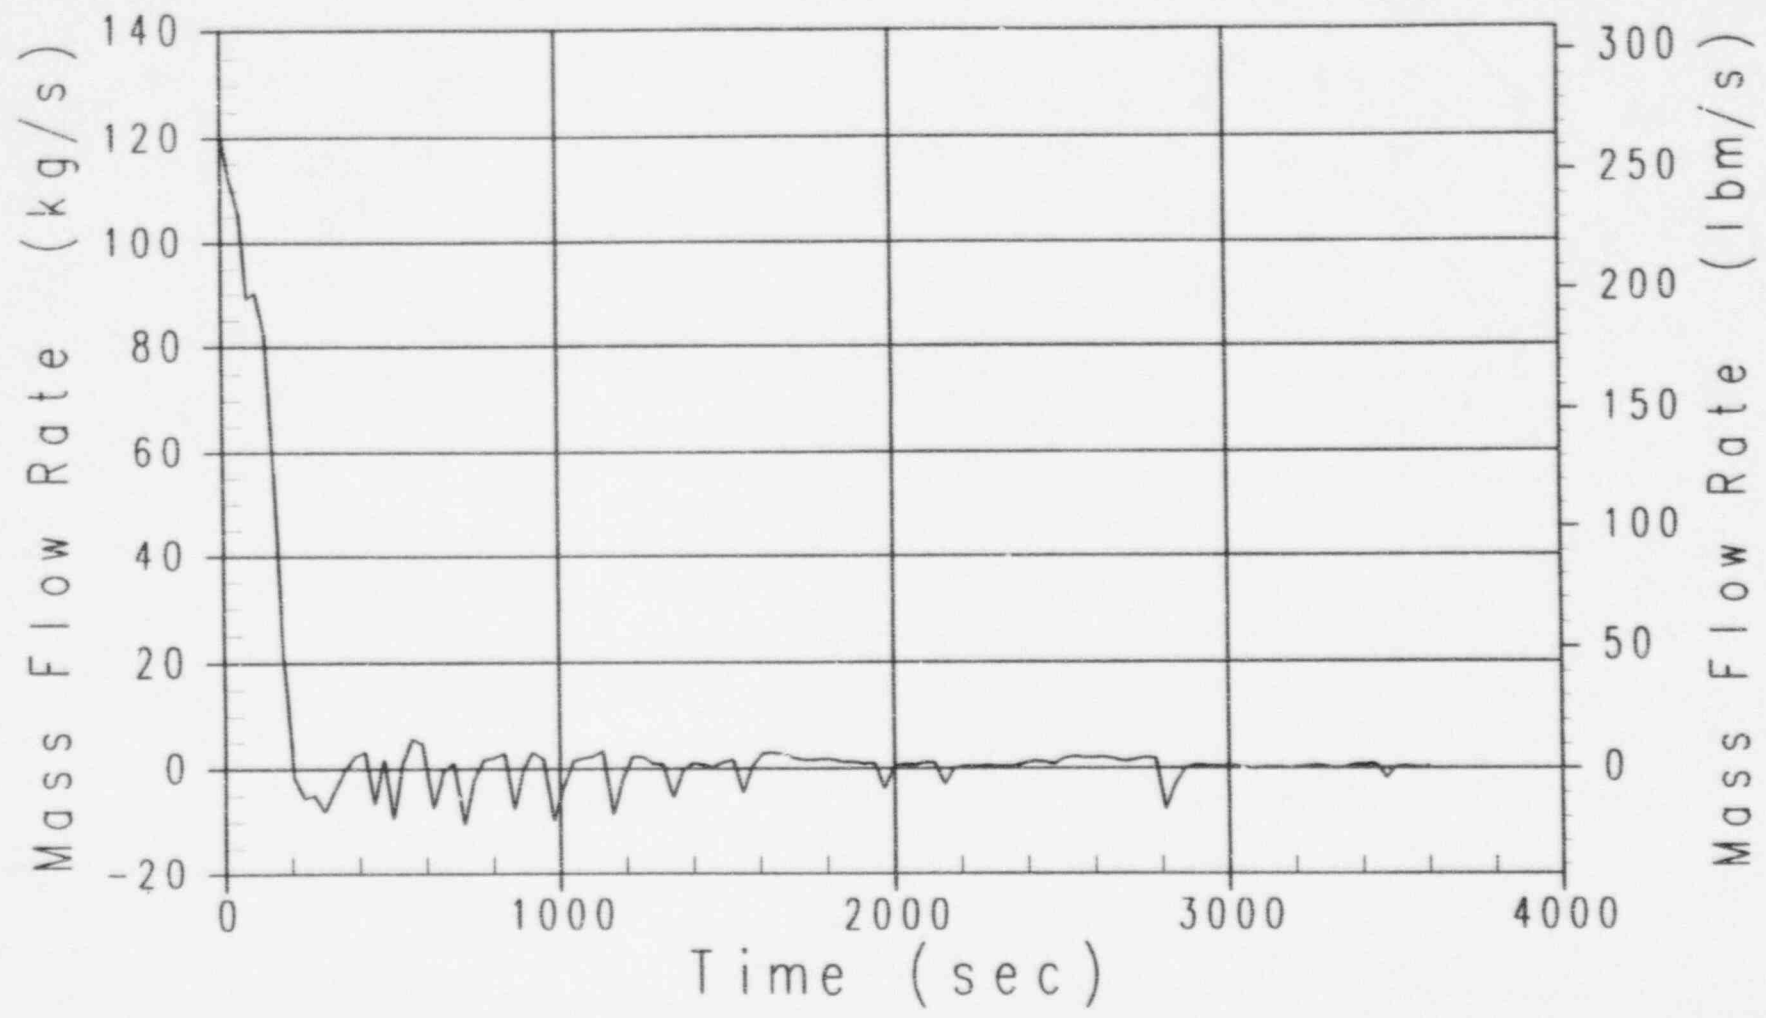
Figure 46

Case SG5B is initiated by a five-tube multiple SGTR at the top of the steam generator tube bundle. Each of the breaks in the base cases were assumed to occur at the top of the tubesheet. The results of the MAAP4 analysis are presented in Figures 46 through 54. As in the base case, the CMTs remain full of water throughout the transient (Figure 52) and the PRHR heat removal (Figure 53) stops the loss of coolant through the break. Therefore, no ADS actuation is predicted. The pressure in the faulted steam generator remains below the safety valve actuation pressure throughout the entire accident scenario (Figure 48). The results do not show a sensitivity to break elevation.

AP600 5 Tube Multiple SGTR - Break Elevation Sensitivity
Tube Rupture Break Flow

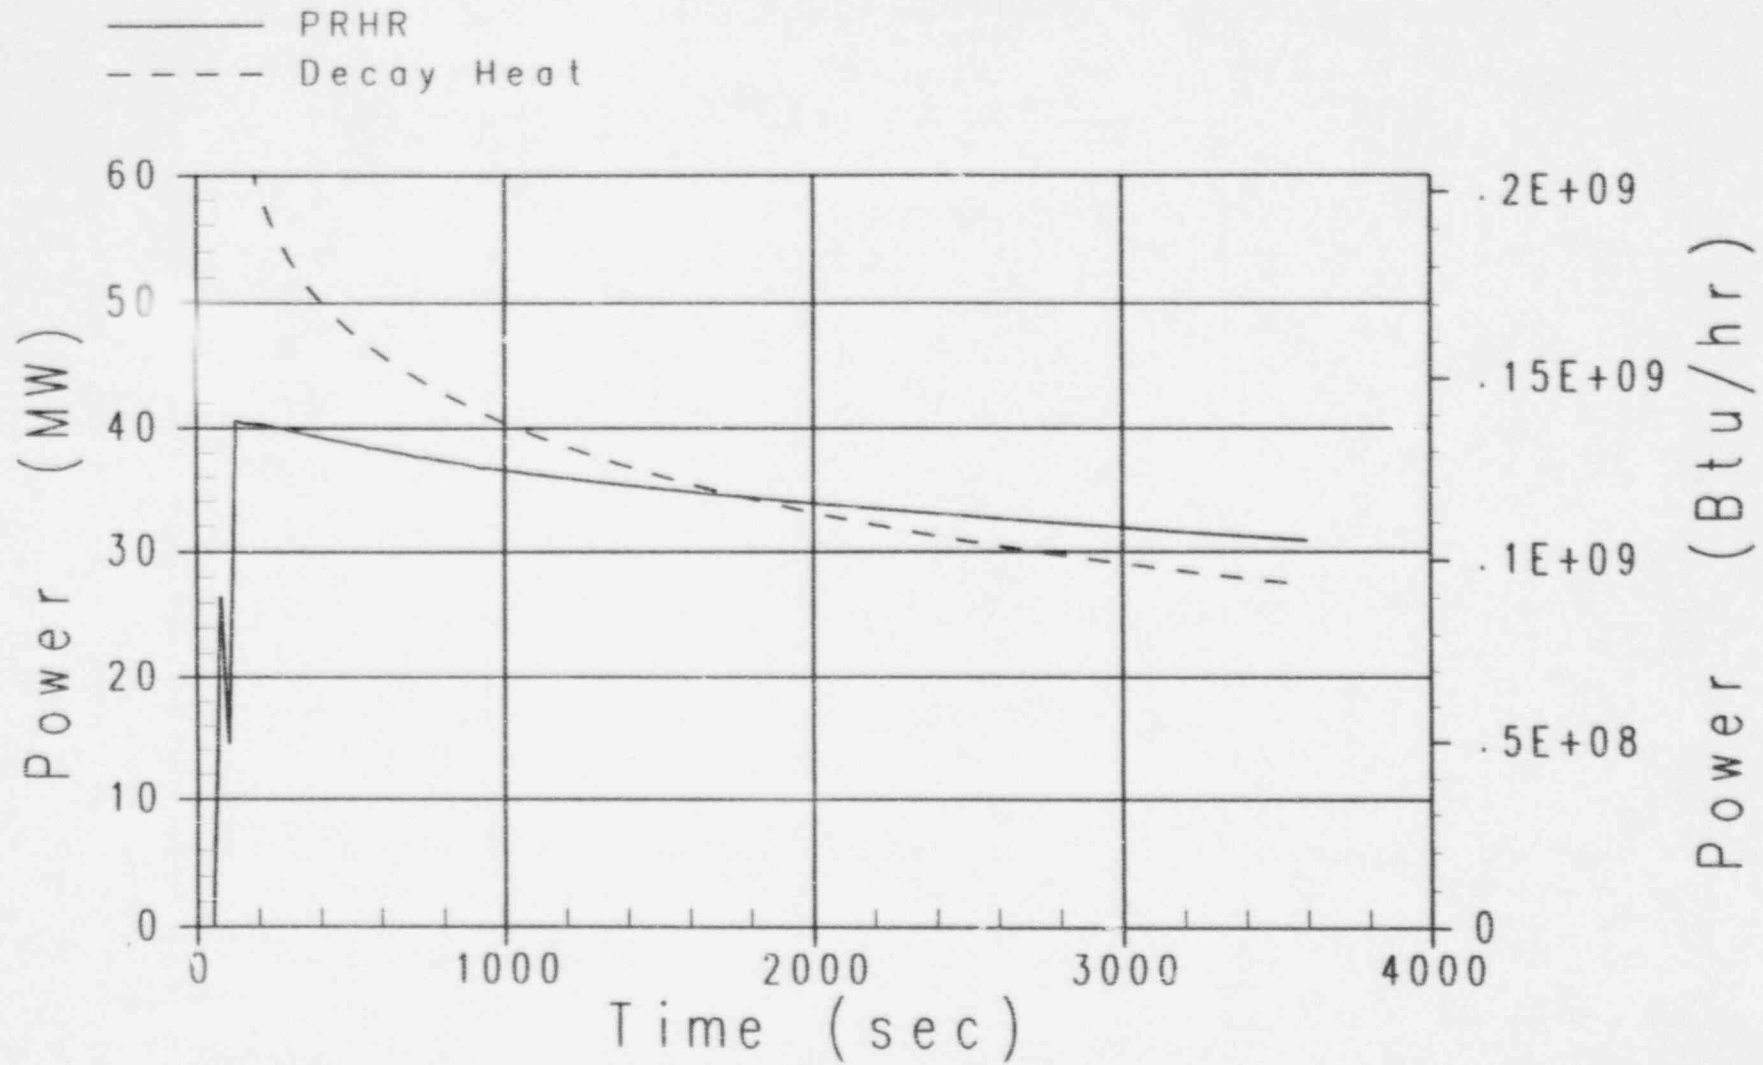
Figure 53

AP600 5 Tube Multiple SGTR - Break Elevation Sensitivity
PRHR Heat Removal

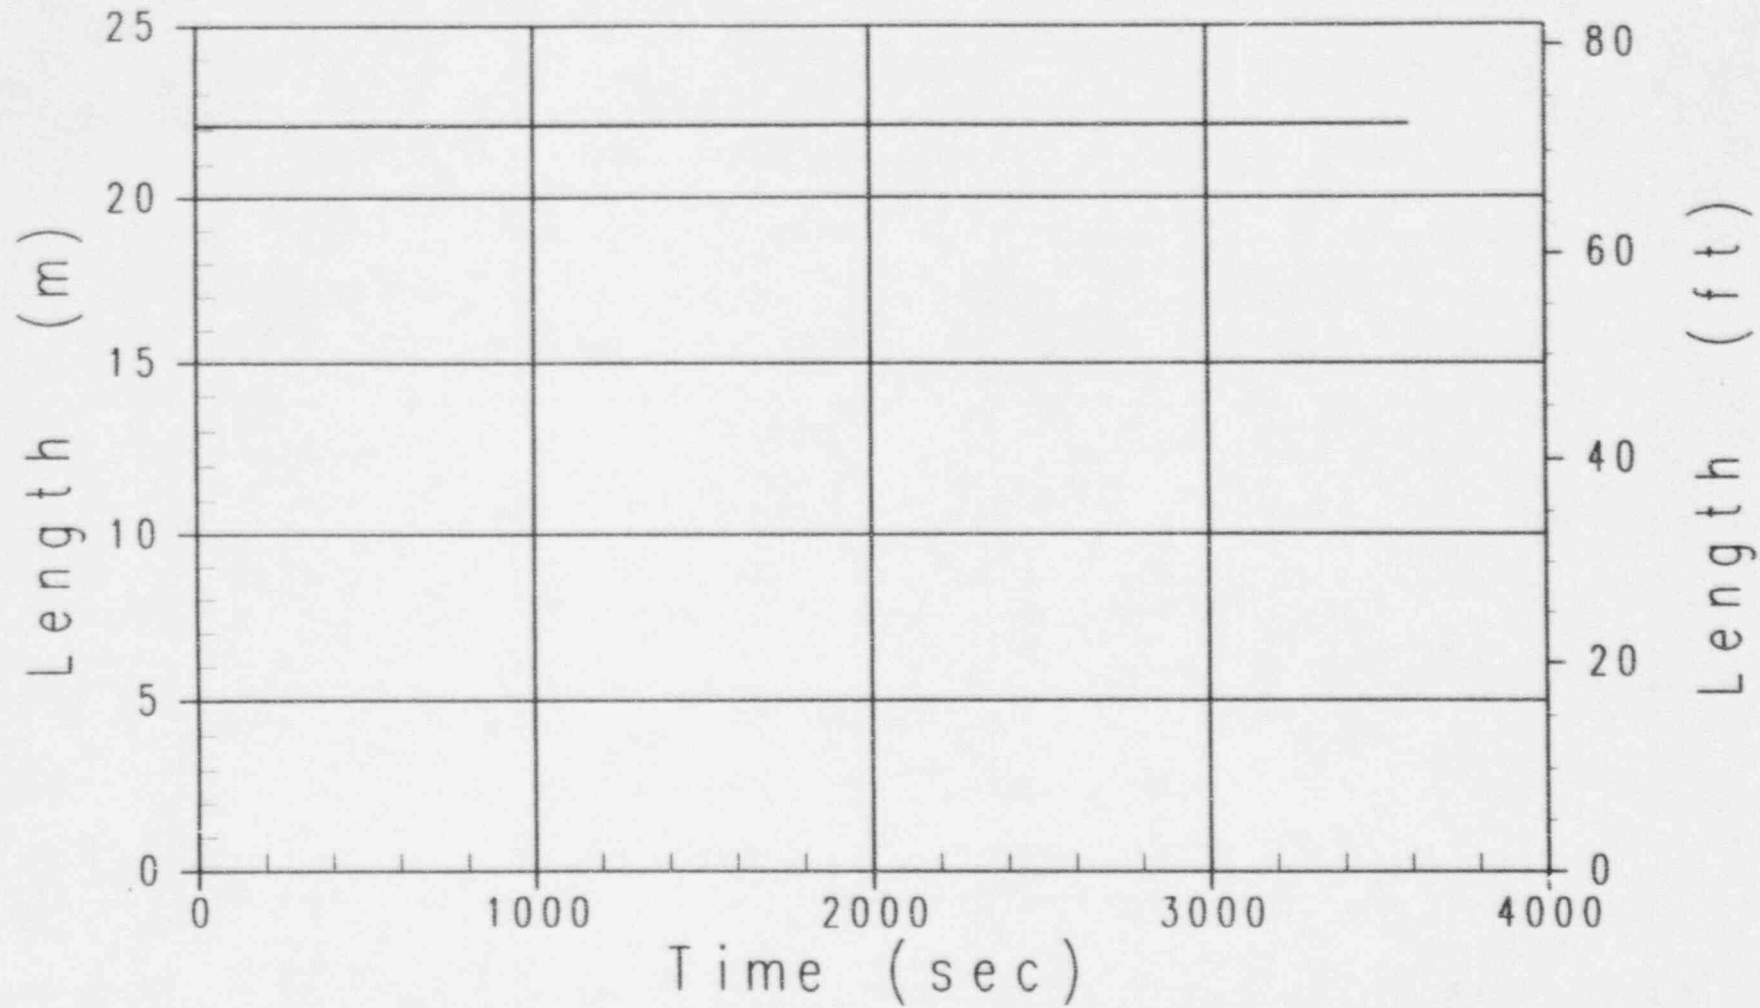
Figure 54

AP600 5 Tube Multiple SGTR - Break Elevation Sensitivity
RCS Water Level

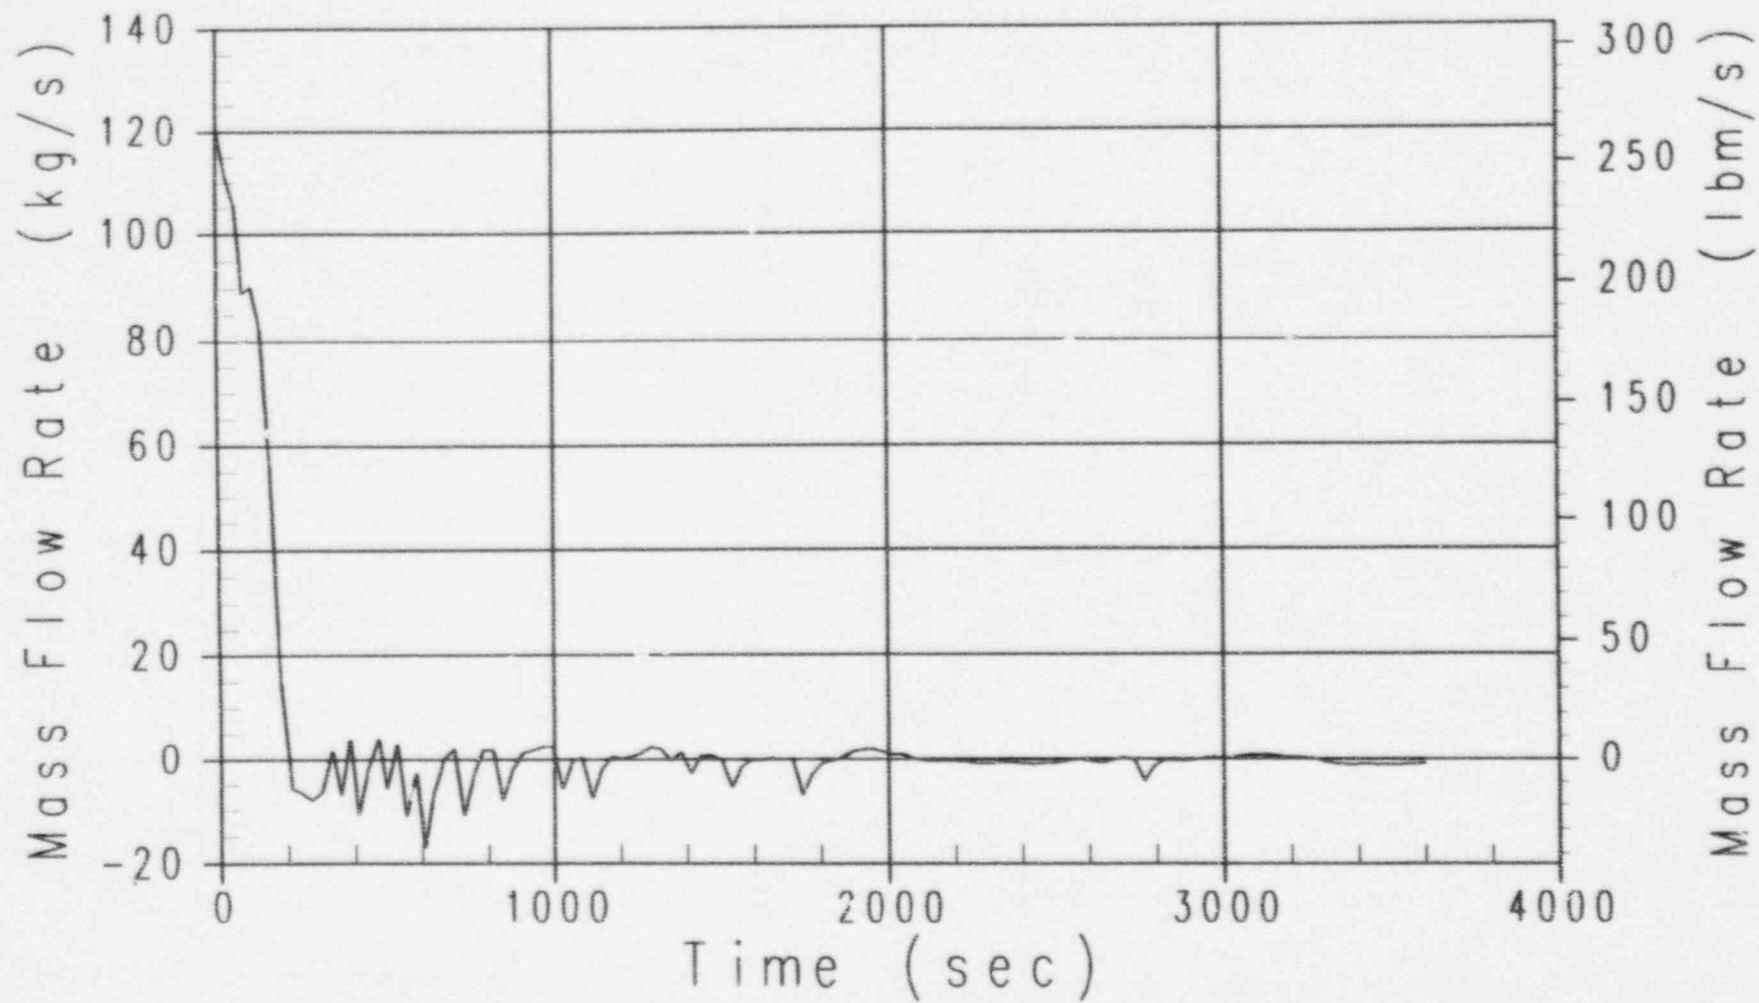
Figure 55

Case SG5max is initiated by a five-tube multiple SGTR at the top of the tubesheet. The maximum expected PRHR performance is modeled. The base cases model best-estimate PRHR performance. The MAAP4 results of the analysis are presented in Figures 55 through 63. As in the base cases, the CMTs remain full of water throughout the transient (Figure 61) and the PRHR heat removal (Figure 62) stops the loss of coolant through the break. Therefore, no ADS actuation is predicted. The pressure in the faulted steam generator remains below the safety valve actuation pressure throughout the entire accident scenario (Figure 57). The results do not show a sensitivity to the increase in PRHR heat removal.

AP600 5 Tube Multiple SGTR - Max PRHR HX Sensitivity
Tube Rupture Break Flow

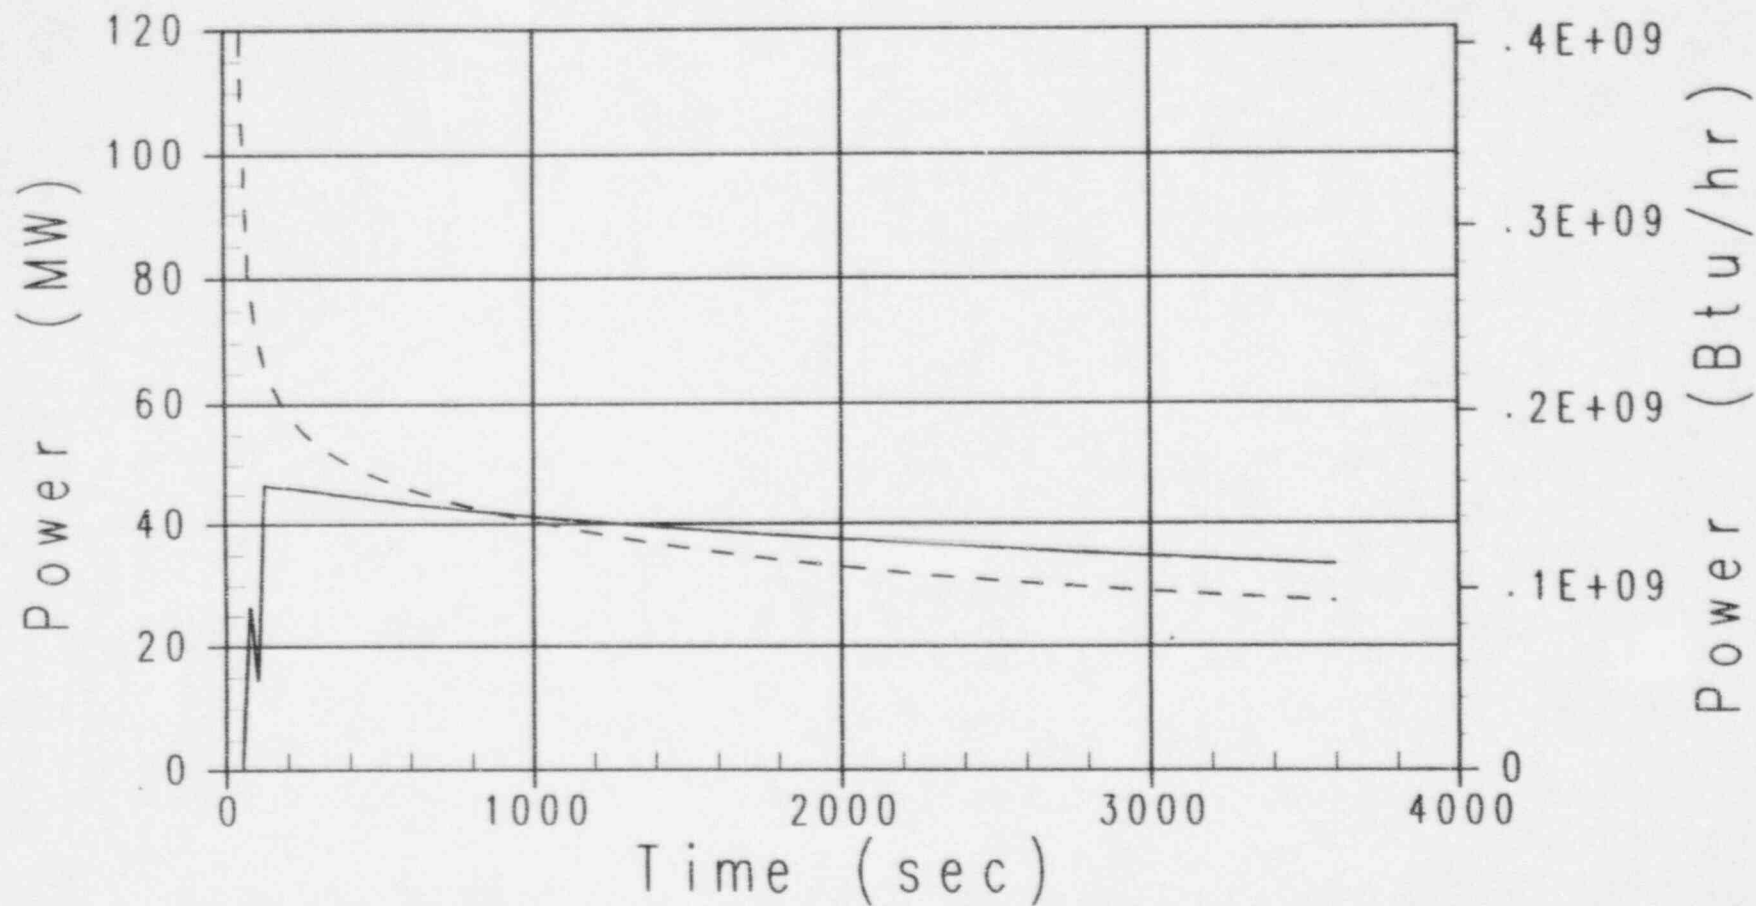
AP600 5 Tube Multiple SGTR - Max PRHR HX Sensitivity
PRHR Heat Removal

—— PRHR
---- Decay Heat

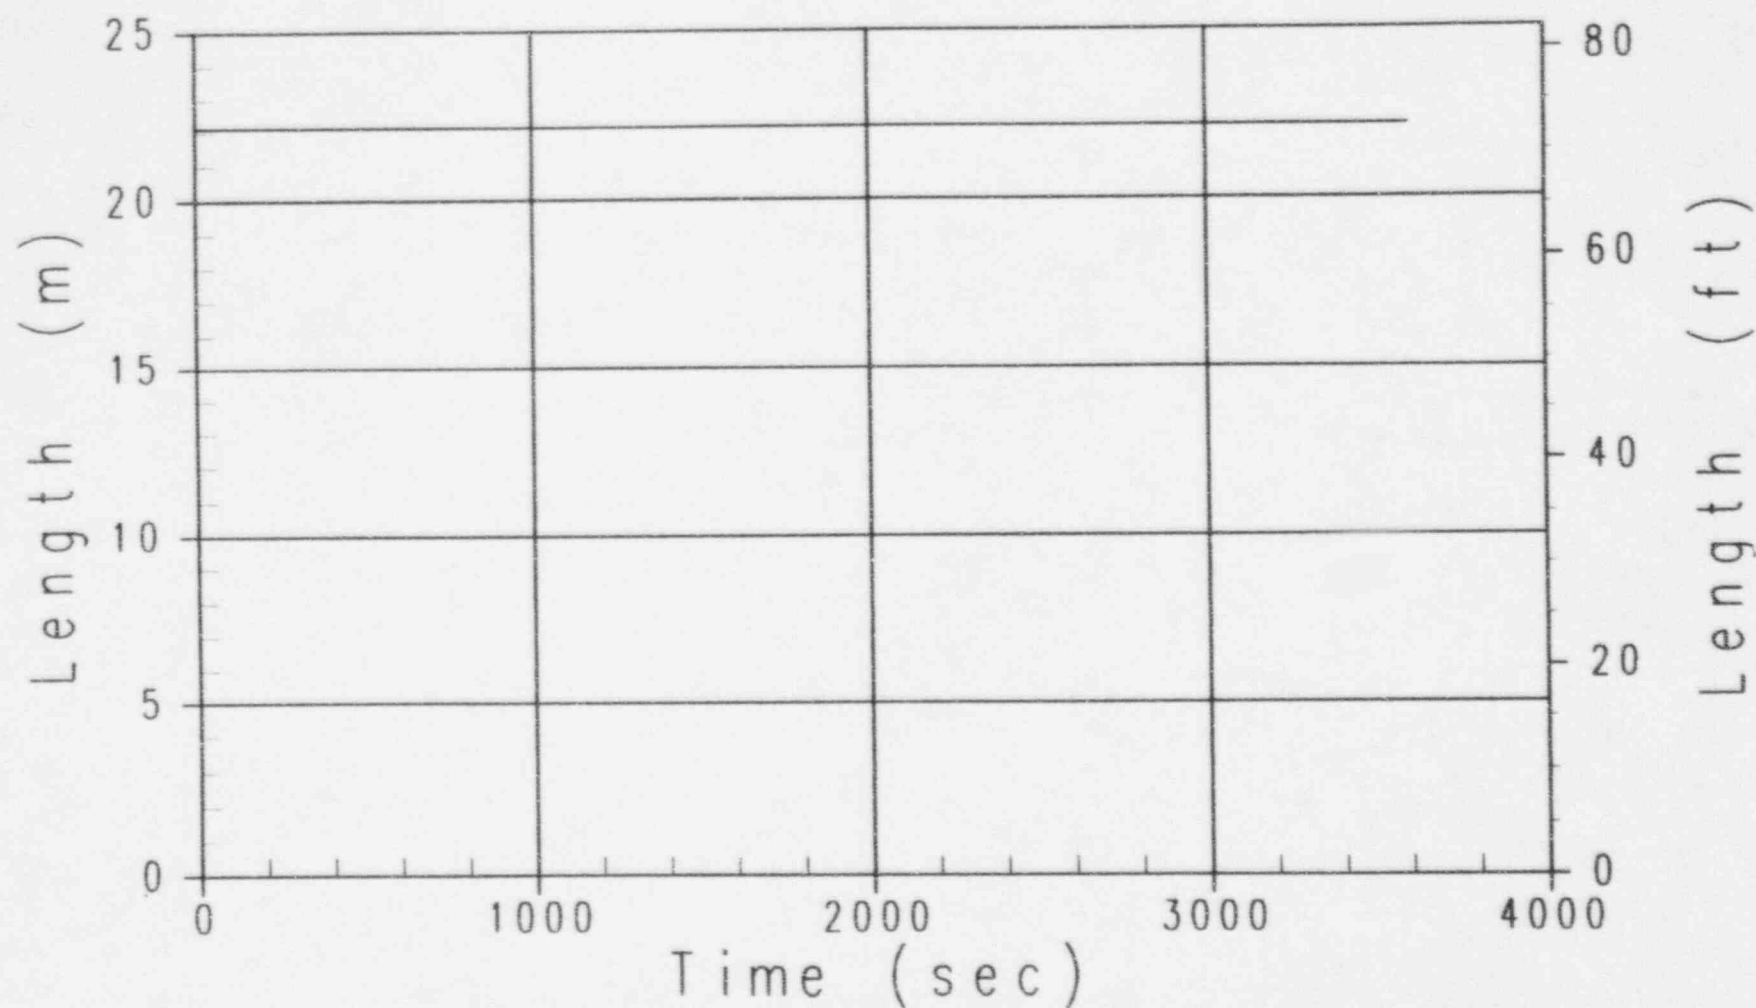
Figure 63

AP600 5 Tube Multiple SGTR - Max PRHR HX Sensitivity
RCS Water Level

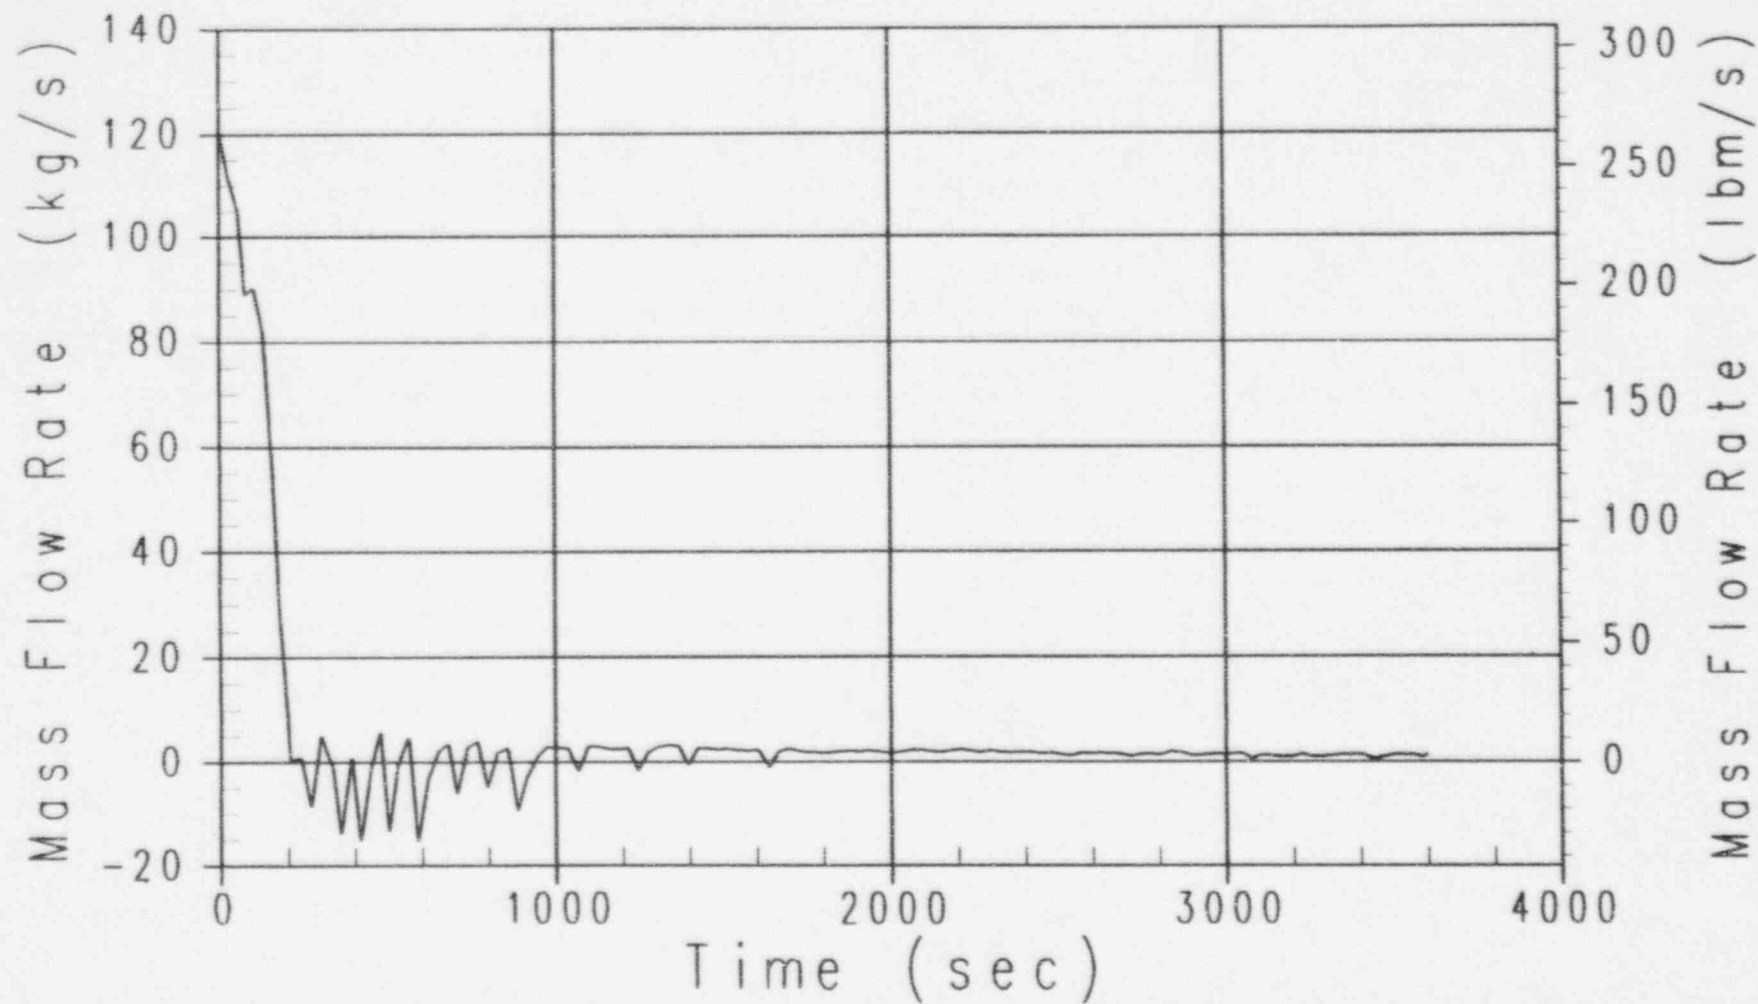
Figure 64

Case SG5min is initiated by a five-tube multiple SGTR at the top of the steam generator tubesheet. The heat removal capability of the PRHR heat exchanger is assumed to be the minimum expected performance. The base cases model best-estimate PRHR performance. The MAAP4 results of the analysis are presented in Figures 64 through 72. As in the base case, the CMT remains full of water throughout the transient (Figure 70) and the heat removal of the PRHR (Figure 71) stops the loss of coolant through the break. Therefore, no ADS actuation is predicted. The pressure in the faulted steam generator remains below the safety valve actuation pressure throughout the entire accident scenario (Figure 66). The results do not show a sensitivity to a significant decrease in PRHR heat removal.

AP600 5 Tube Multiple SGTR - Min PRHR HX Sensitivity
Tube Rupture Break Flow

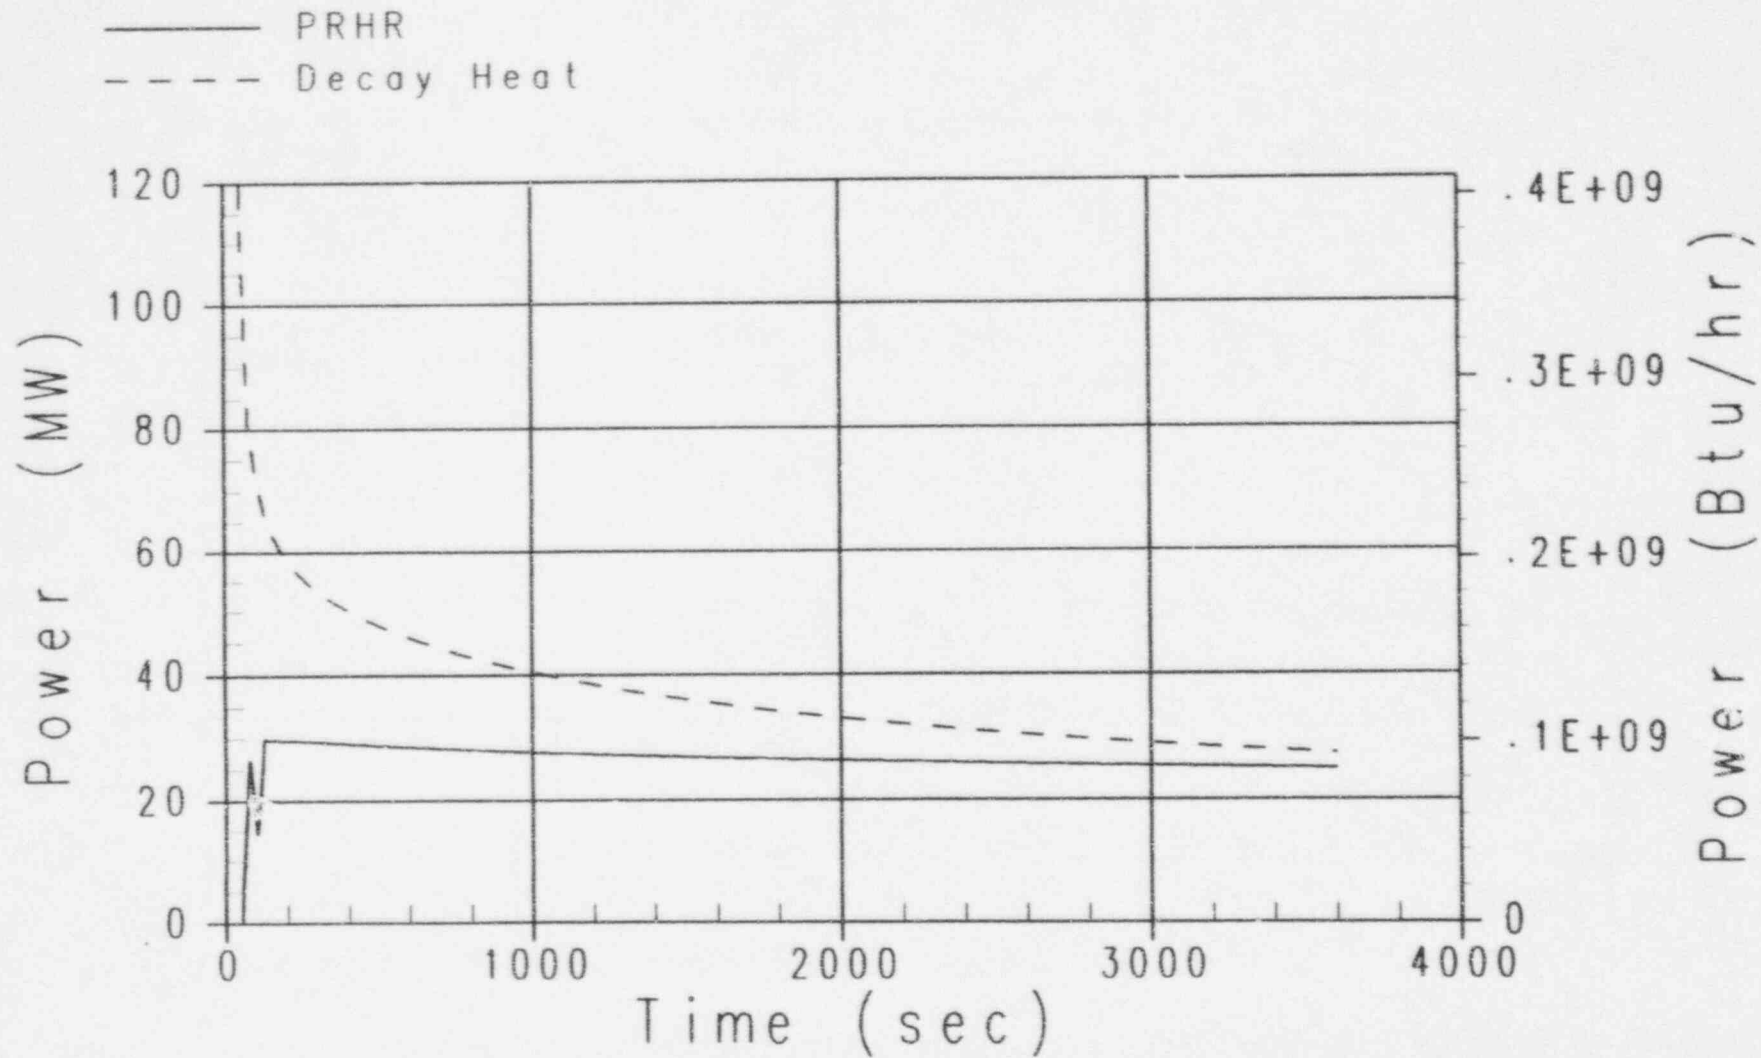
Figure 71

AP600 5 Tube Multiple SGTR - Min PRHR HX Sensitivity
PRHR Heat Removal

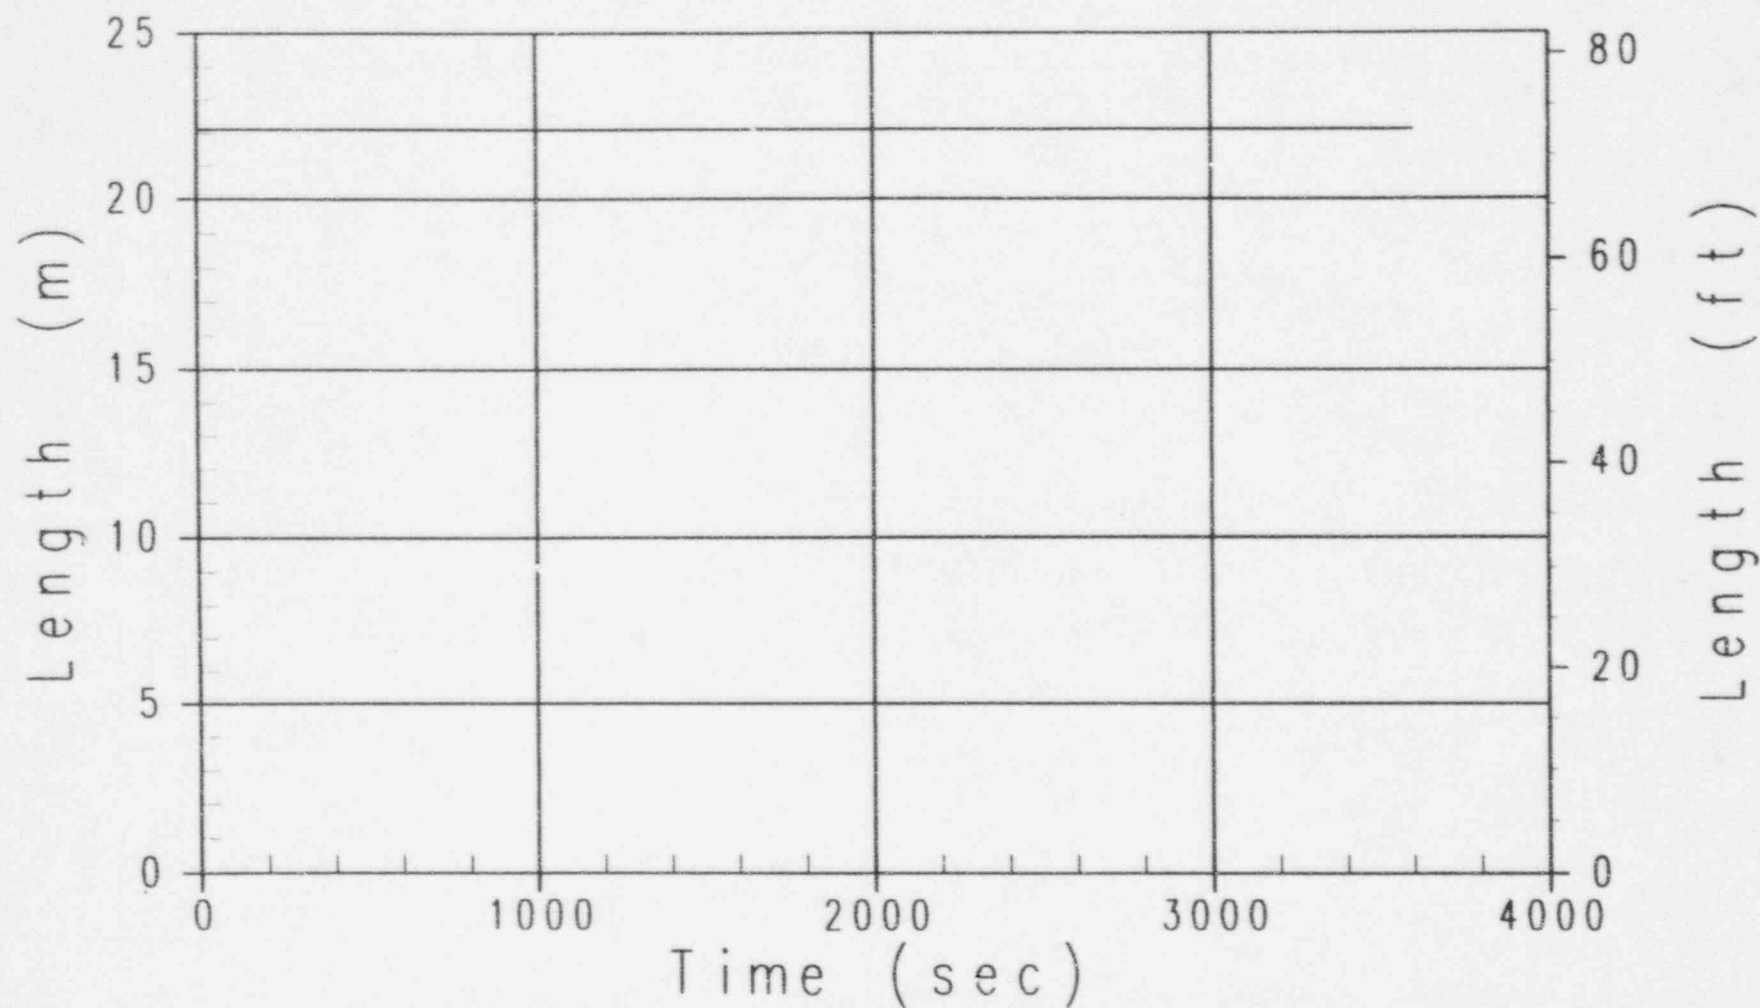
Figure 72

AP600 5 Tube Multiple SGTR - Min PRHR HX Sensitivity
RCS Water Level

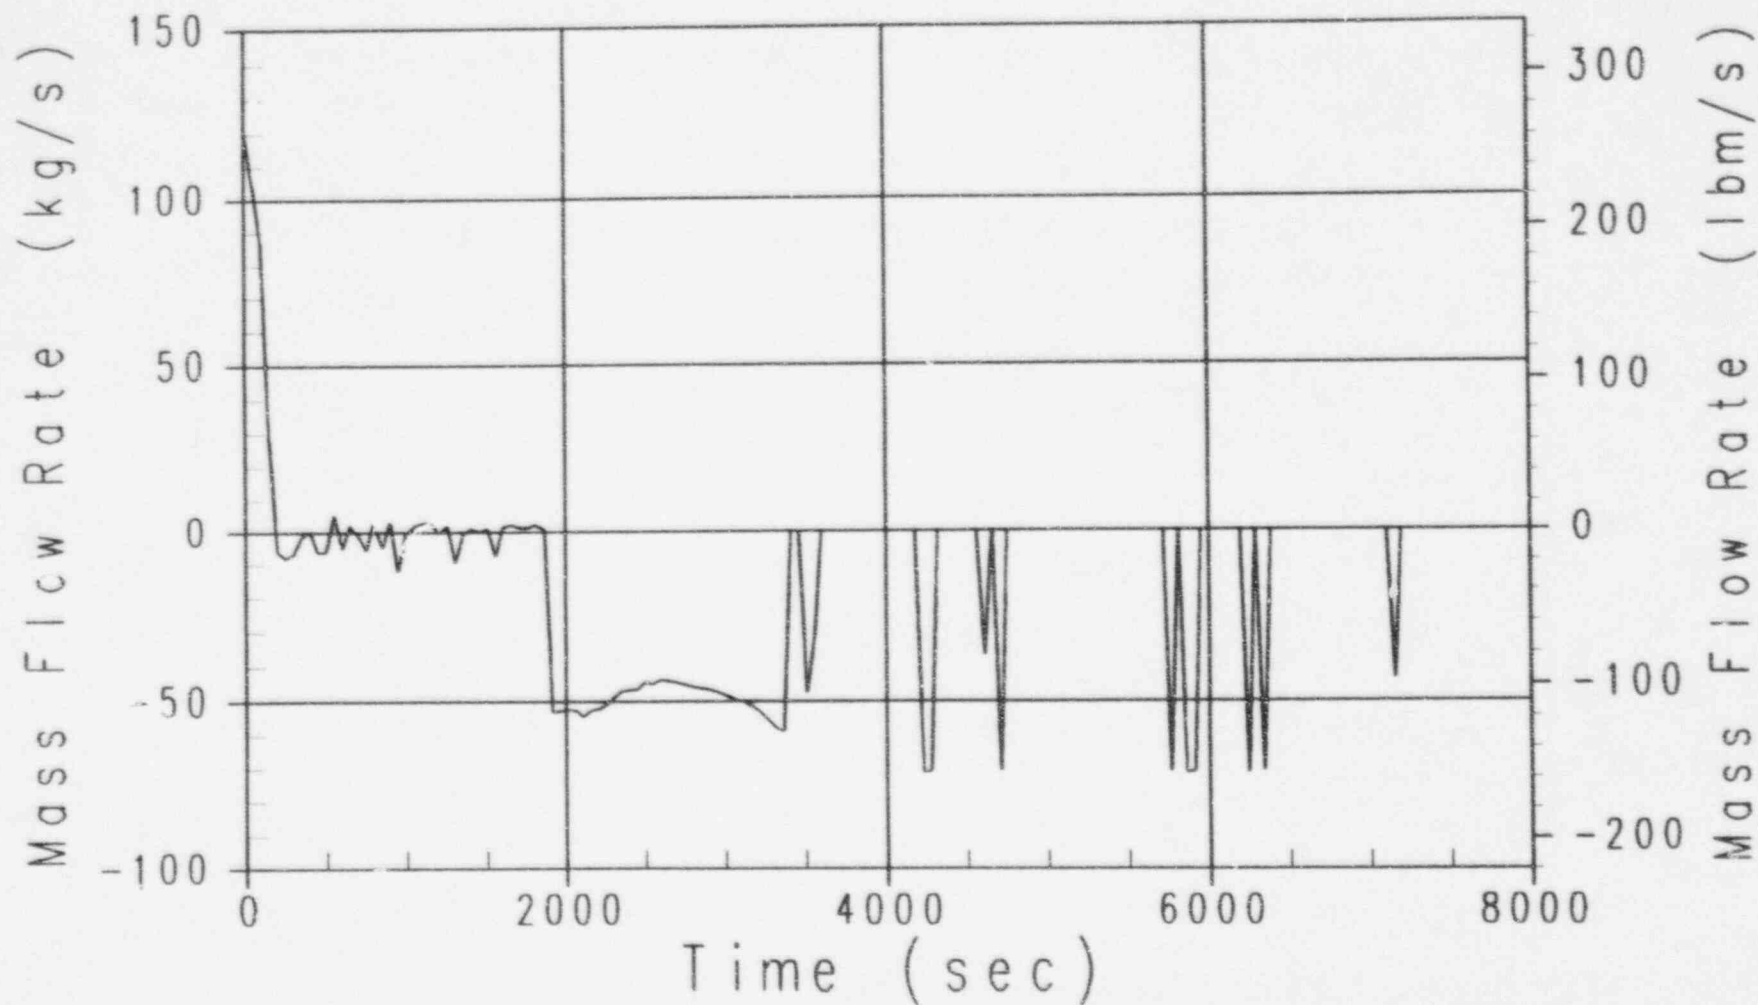
Figure 73

Case SG5A is initiated by a five-tube multiple SGTR at the top of the steam generator tubesheet. The operator is assumed to manually depressurize the RCS at 1800 seconds. This time was chosen as a point in which the SG5 base case had become relatively stabilized. Both flow paths of each of the first three ADS stages are assumed to open sequentially. Two of four stage four ADS valves are assumed to open. The results of the analysis are presented in Figures 73 through 81.

AP600 5 Tube Multiple SGTR - Manual ADS at 1800 sec
Tube Rupture Break Flow

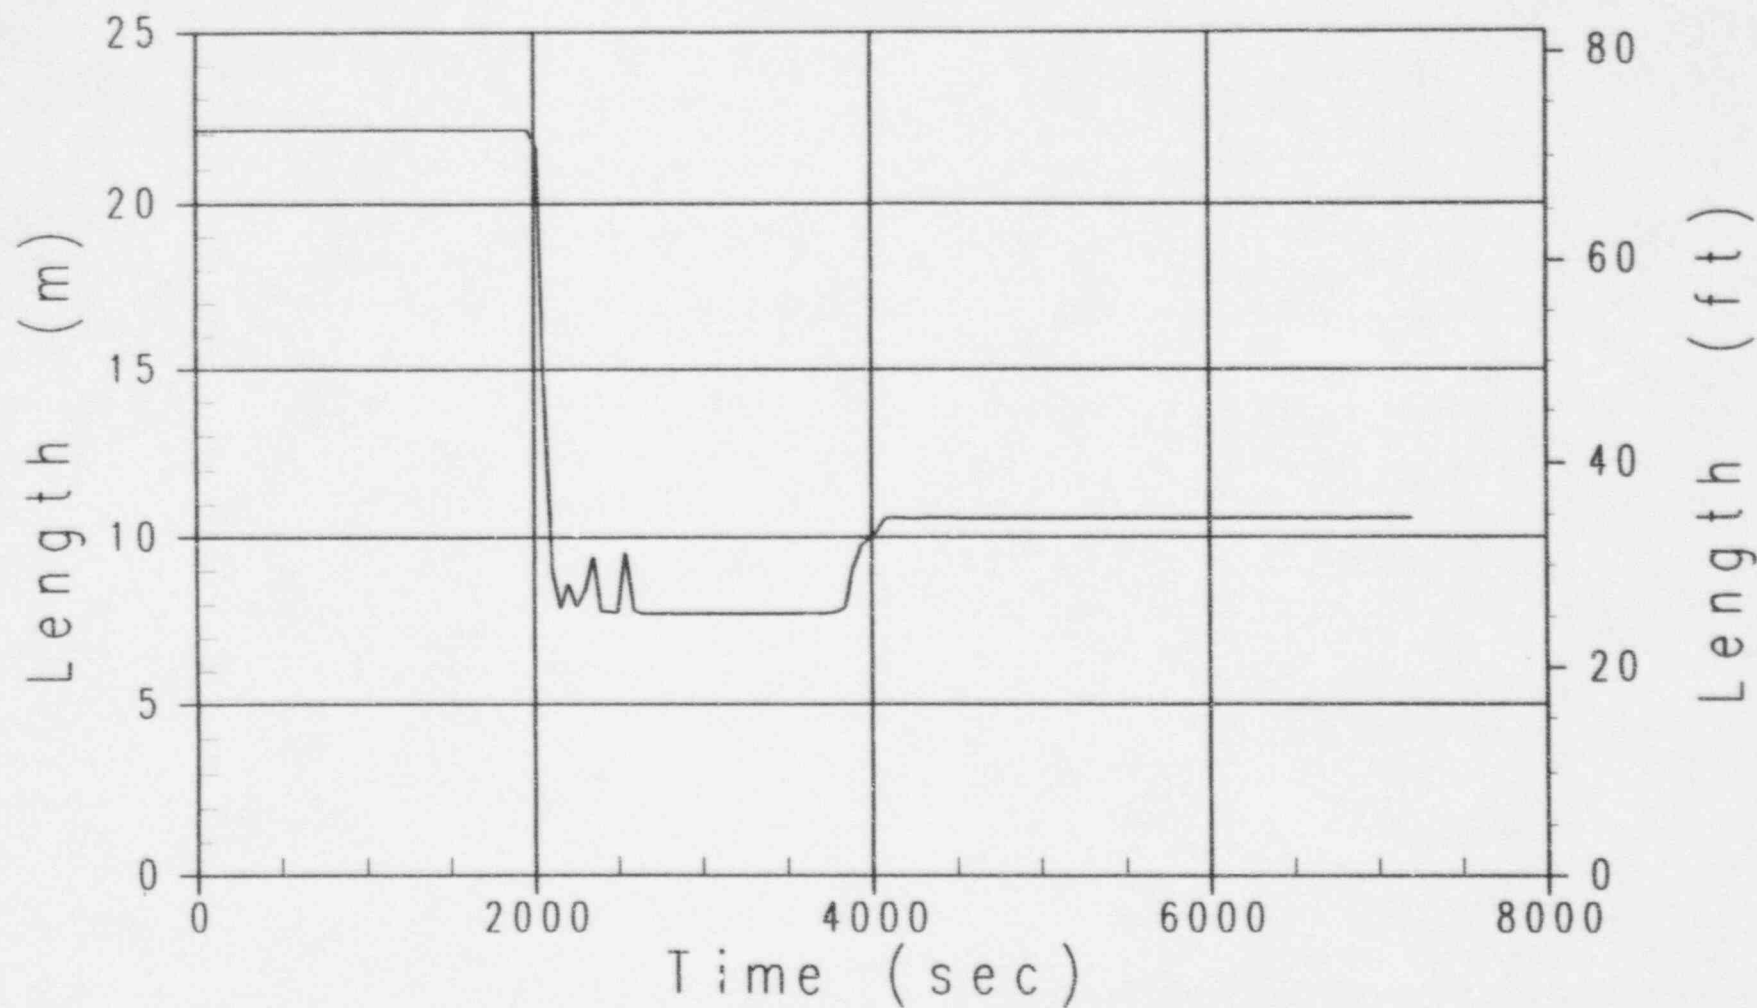
Figure 81

The fourth stage flow path opens when the CMT water level (Figure 79) reaches a low-low setpoint at 5771 seconds. IRWST injection begins at approximately 5500 seconds. The RCS water level never falls below the top of the core.

AP600 5 Tube Multiple SGTR - Manual ADS at 1800 sec
RCS Water Level
