Westinghouse
Electric Corporation

SUBJECT: AP600 MULTIPLE STEAM GENERATOR TUBE RUPTURE ANALYSIS IN
SUPPORT OF RAIS 440.27 AND 440.170 (Revision 2)

AP600 Multiple Steam Generator Tube Rupture Analysis

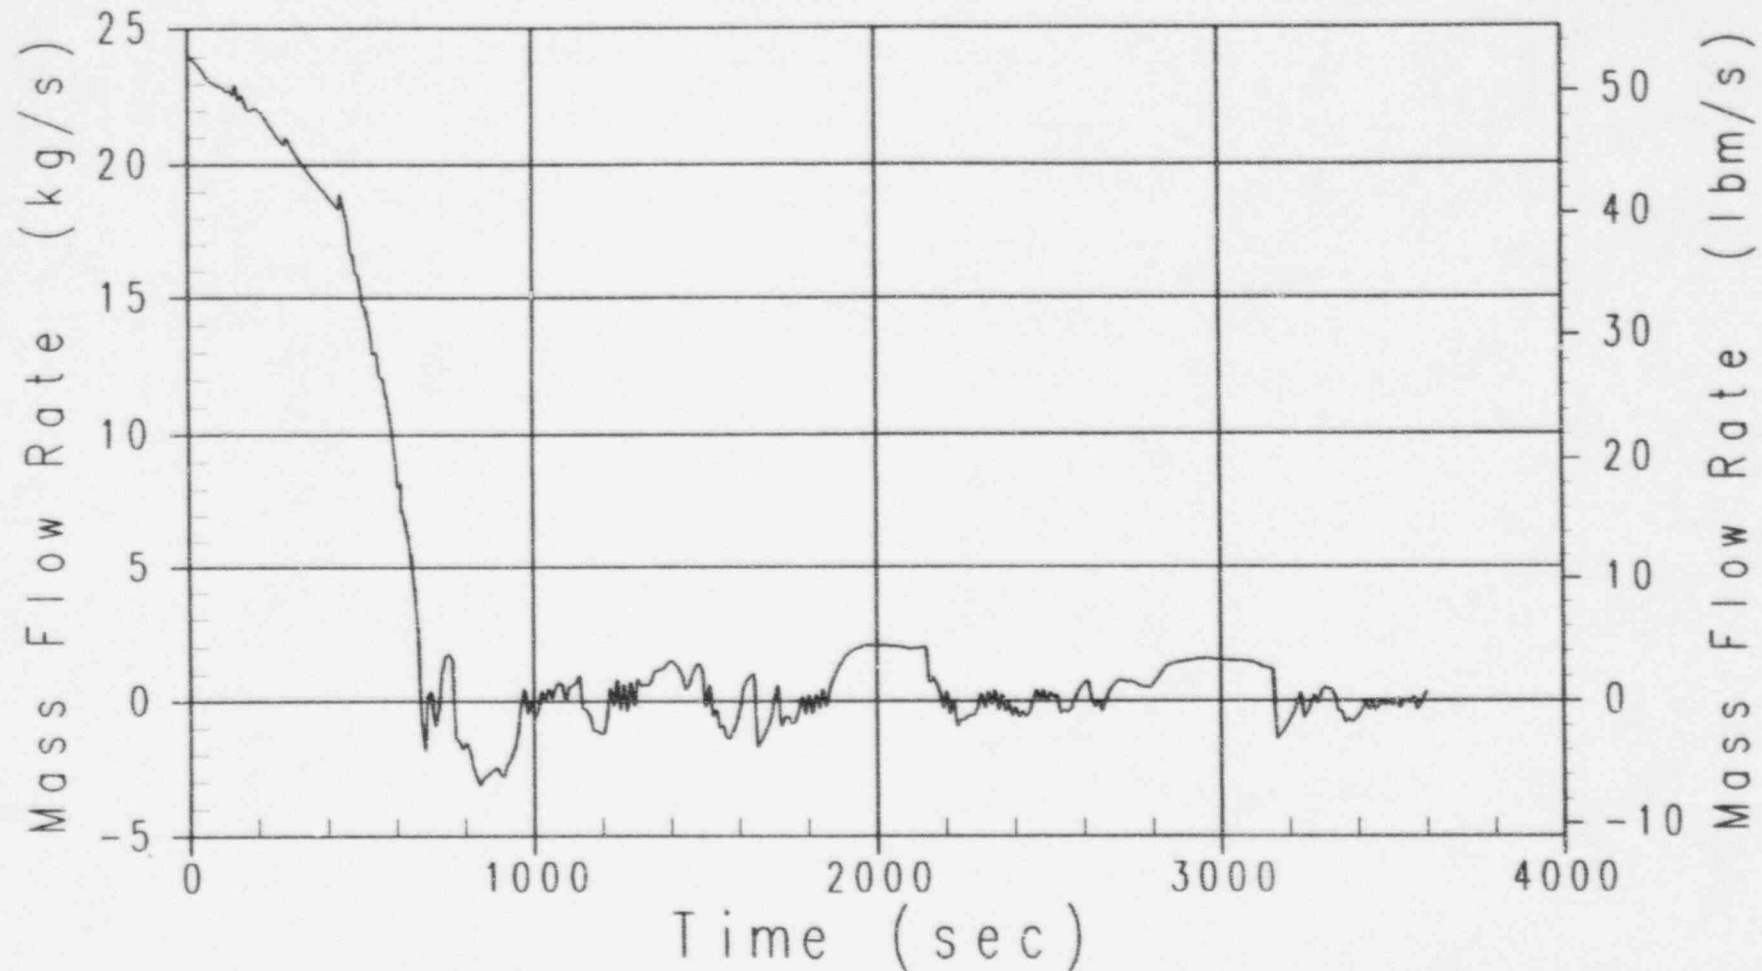
Figure 82

Each of the base one through five tube multiple-SGTR cases is analyzed assuming the failure of both of the secondary PORVs to open. The results of these cases are presented in Figures 82 through 126. A summary of the accident sequence timing for the PORV failure cases is presented in Table 3. In each of the cases, the failure of the PORVs allowed the secondary pressure to increase to the 1100 psig opening setpoint of the secondary safety valve. Following opening of the secondary safety valve the event progressed to a stable state in the same fashion as cases in which the steam generator PORVs were modeled to open.

AP600 1 Tube SGTR with PORV Failure
Tube Rupture Break Flow

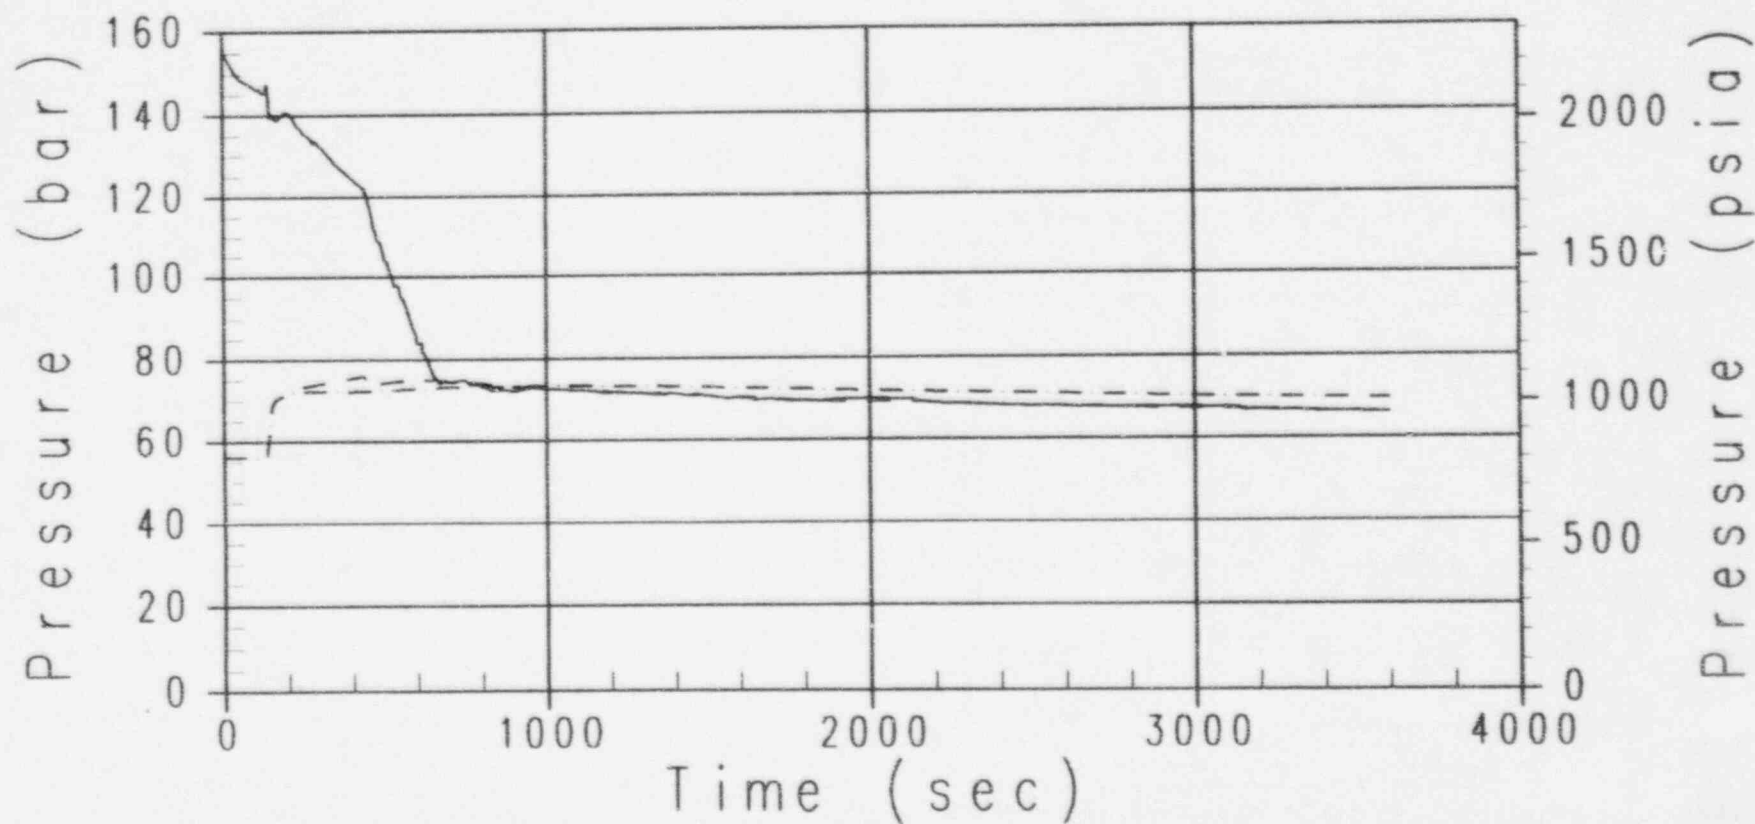
Figure 83

AP600 1 Tube SGTR with PORV Failure RCS and Secondary Systems Pressures

— RCS
- - - Faulted SG
- - - Unfaulted SG

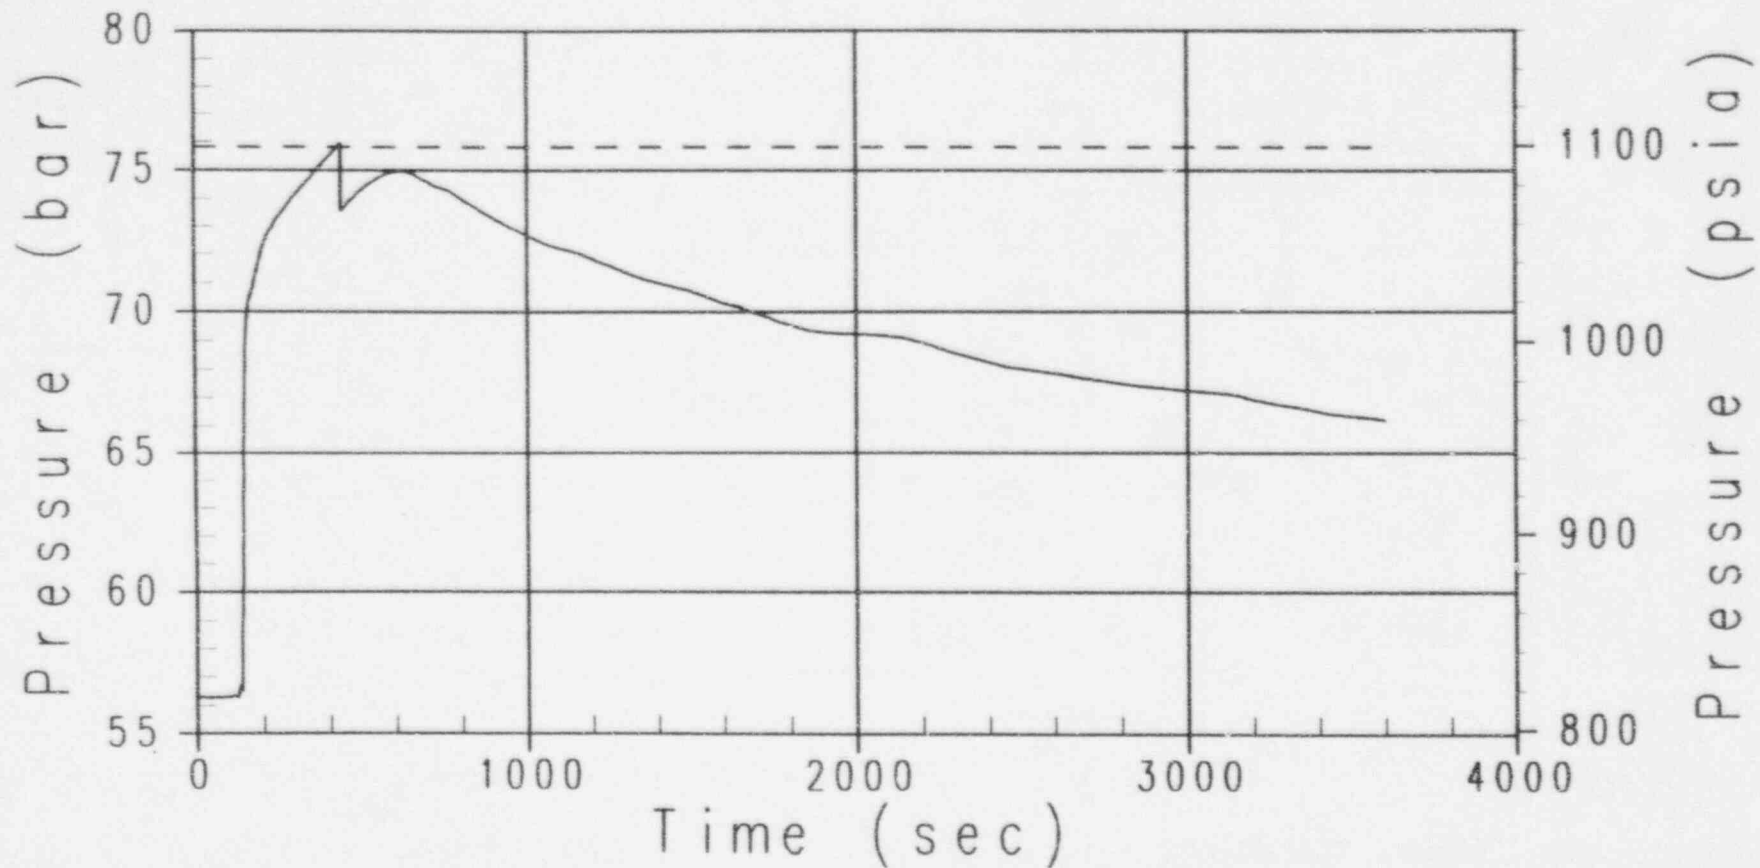
Figure 84

AP600 1 Tube SGTR with PORV Failure Faulted Steam Generator Pressure

—— Faulted SG
---- Safety Valve Setpoint

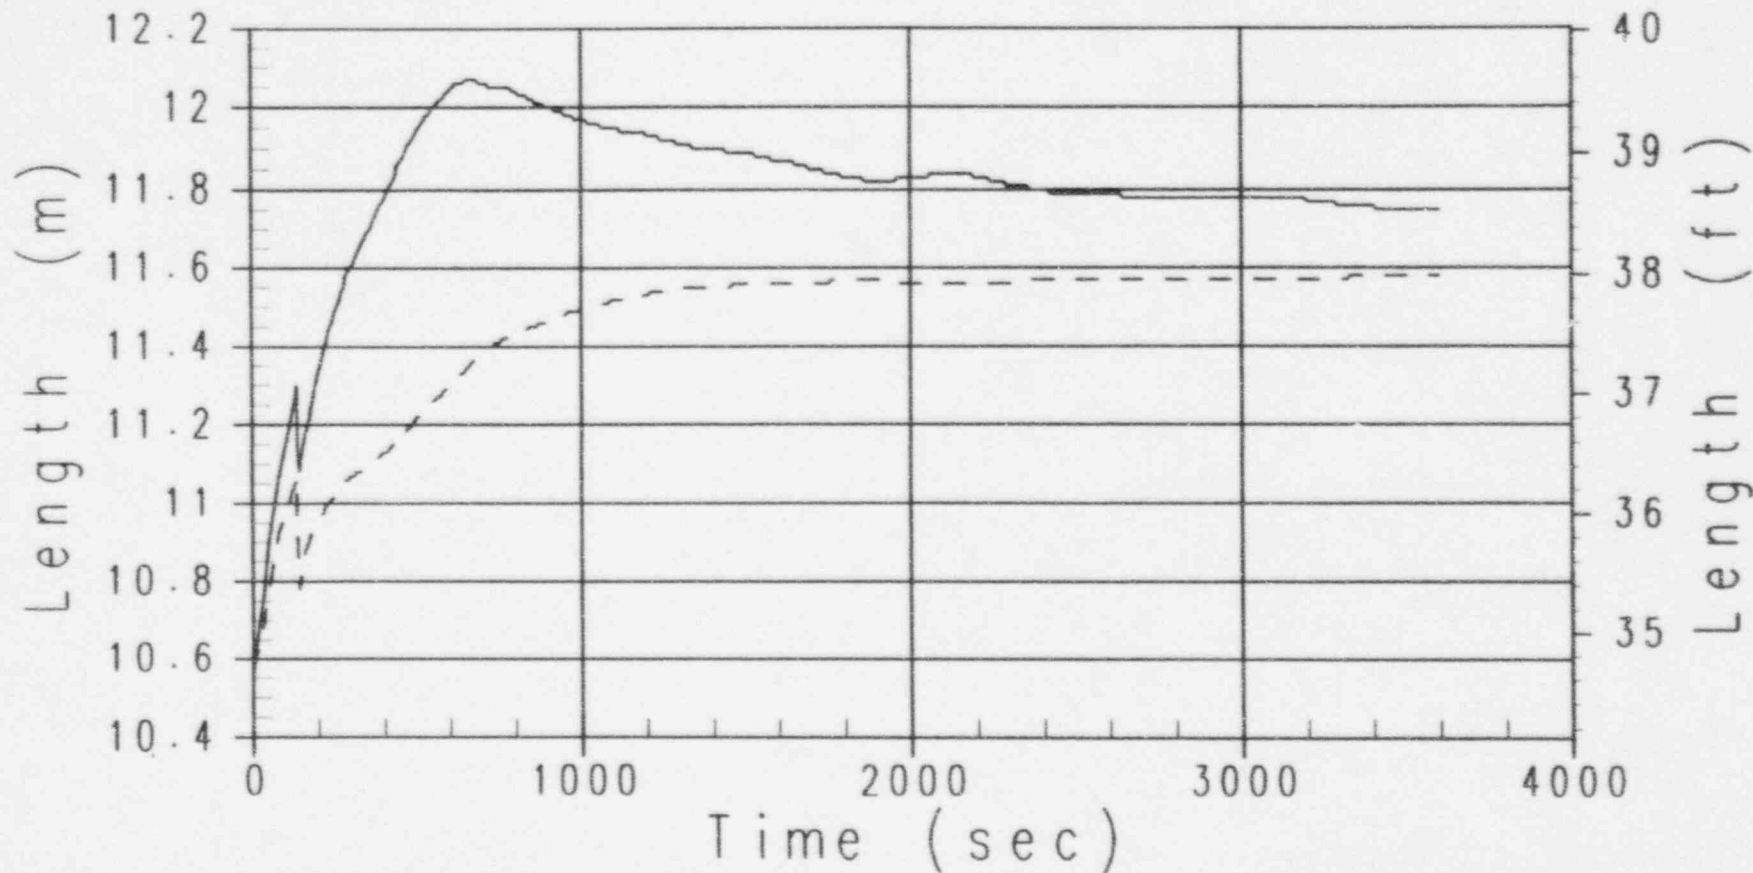
Figure 85

AP600 1 Tube SGTR with PORV Failure
Steam Generator Downcomer Water Level

— Faulted SG
- - - Unfaulted SG

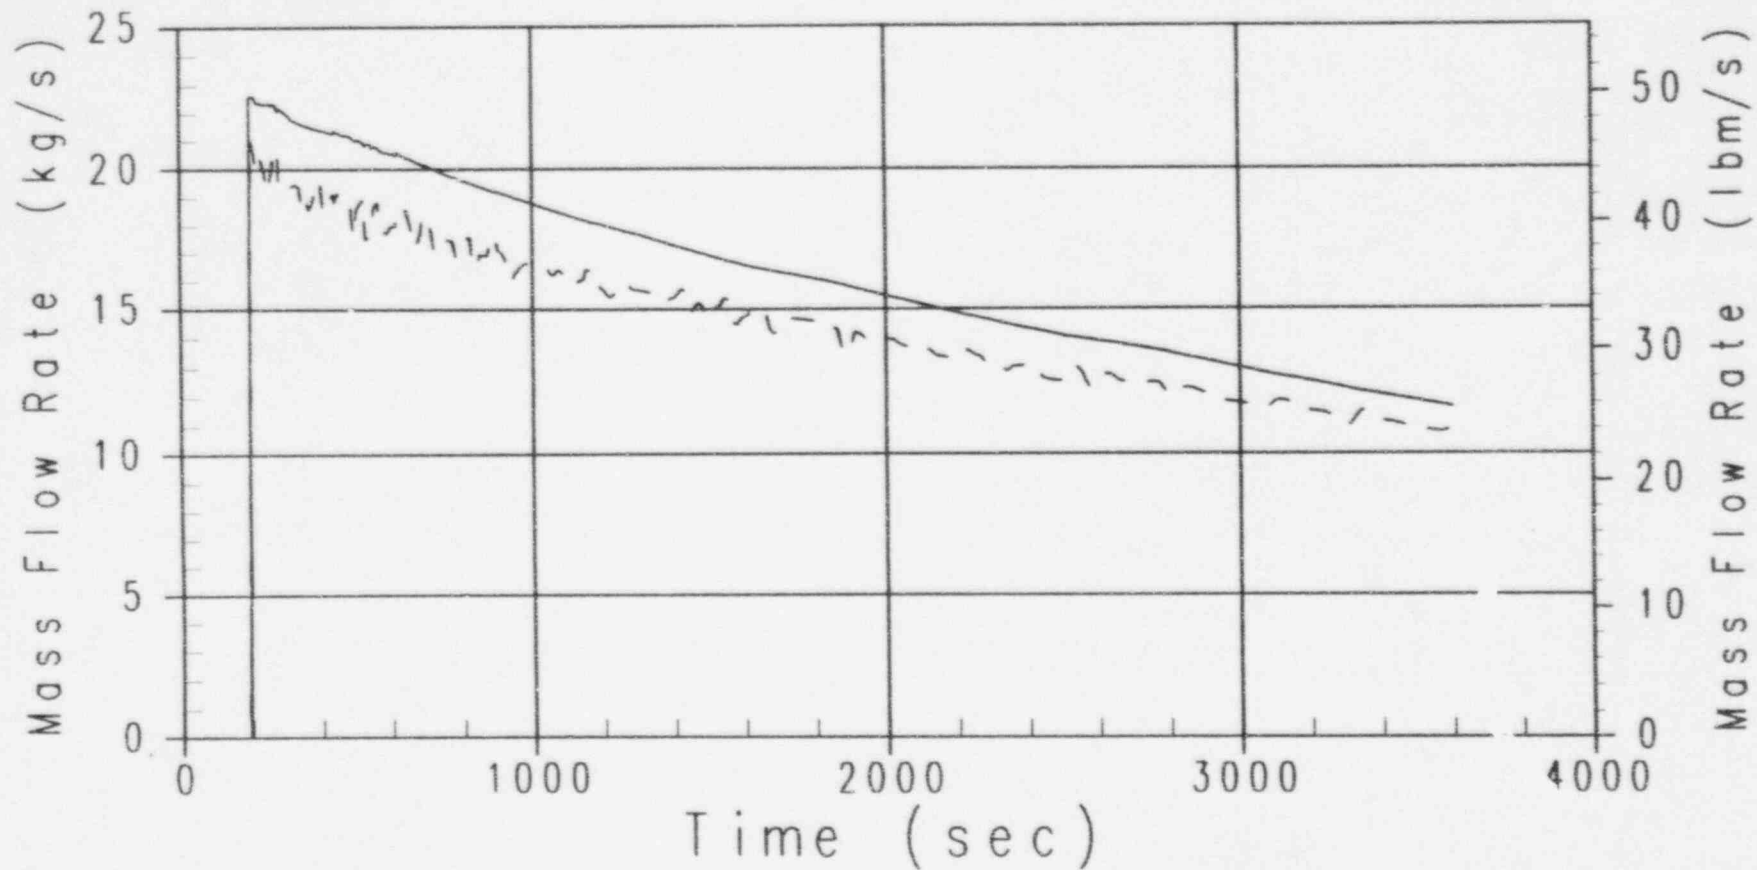
Figure 86

AP600 1 Tube SGTR with PORV Failure CMT Water Mass Flowrates

— Discharge Line
- - - Balance Line

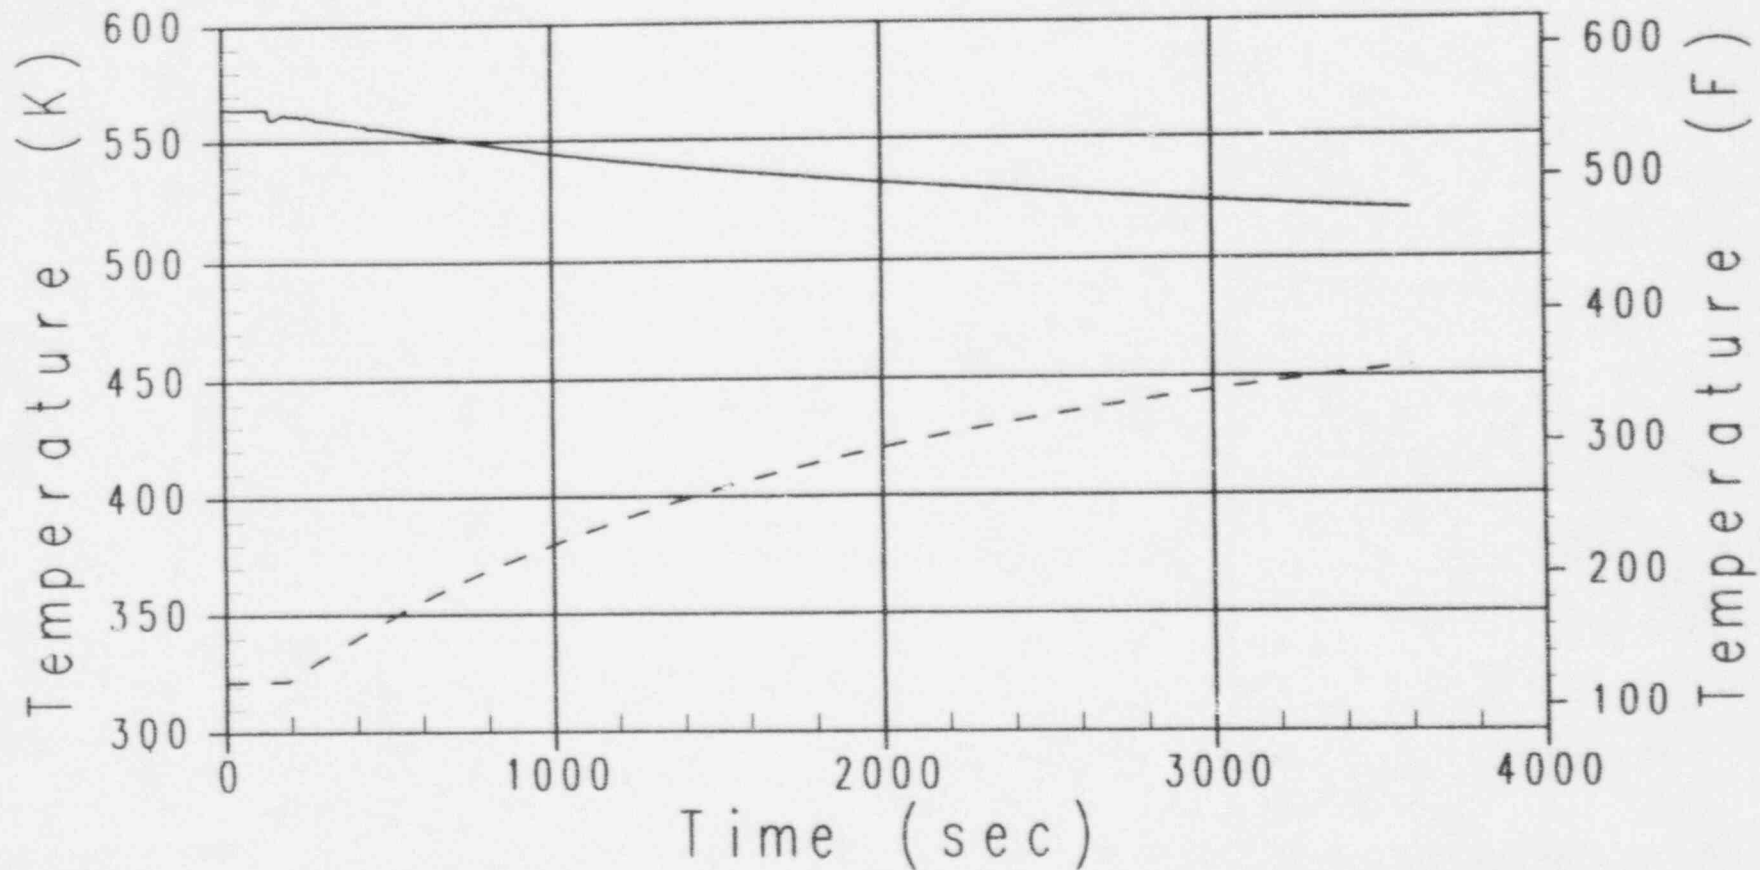
Figure 87

AP600 1 Tube SGTR with PORV Failure RCS and CMT Water Temperatures

— RCS Core Water
--- CMT Water

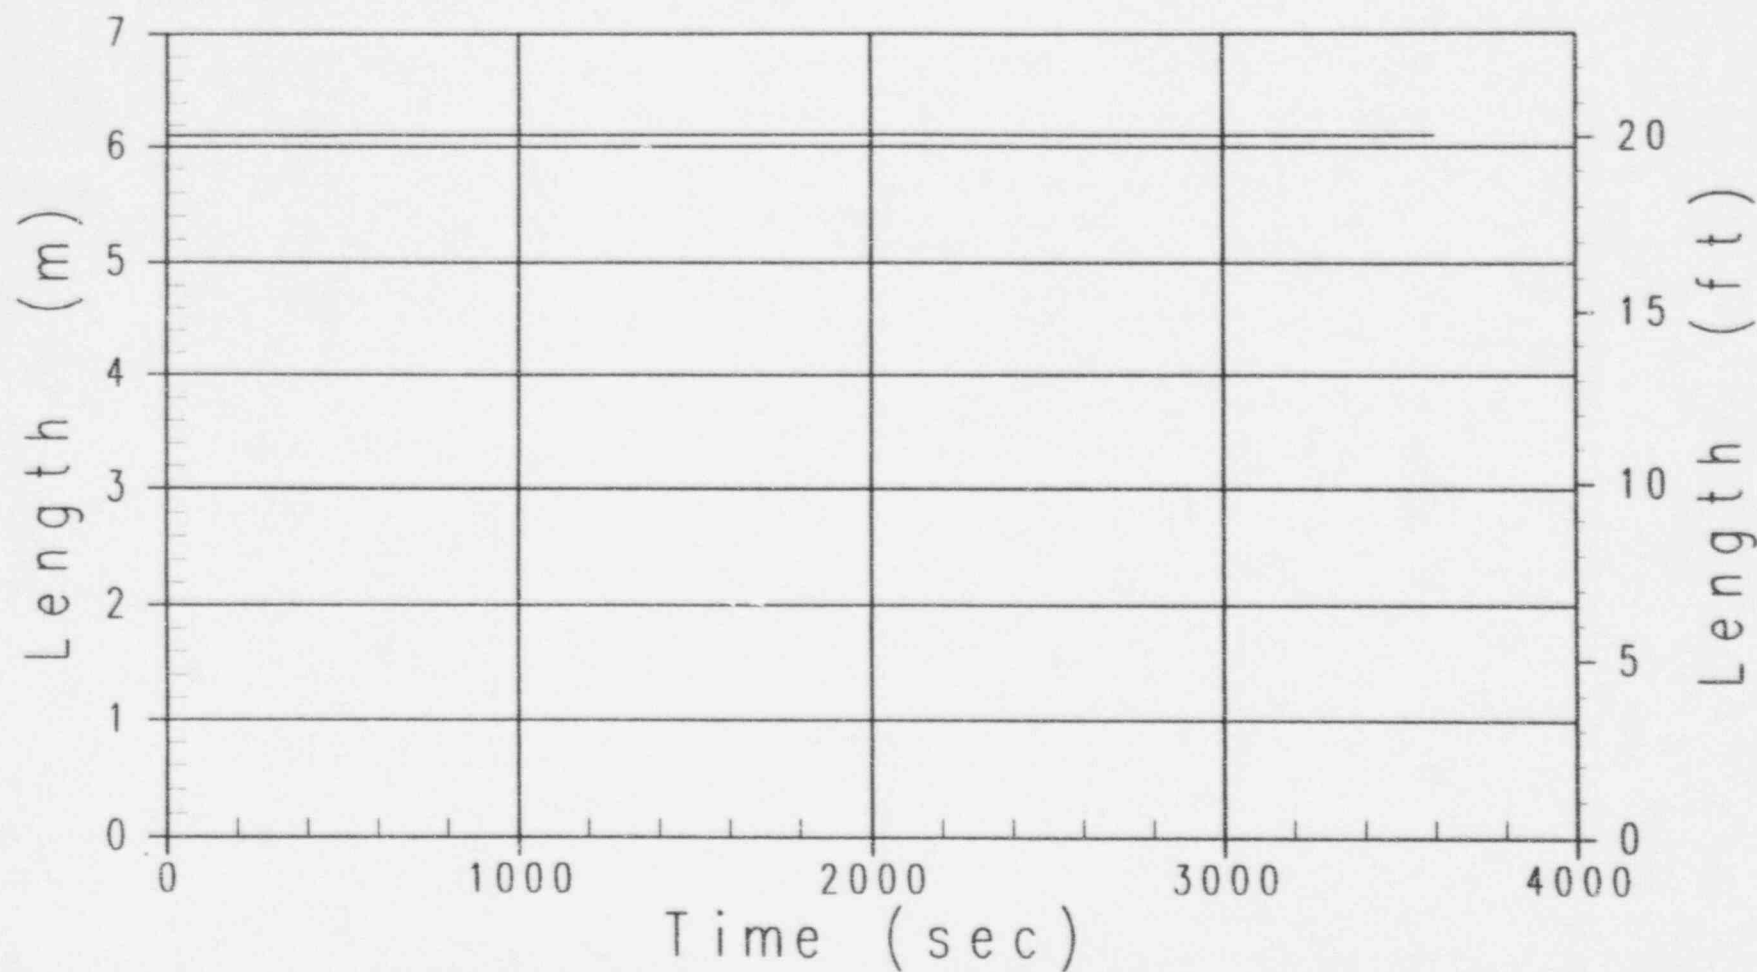
Figure 88

AP600 1 Tube SGTR with PORV Failure
CMT Water Level

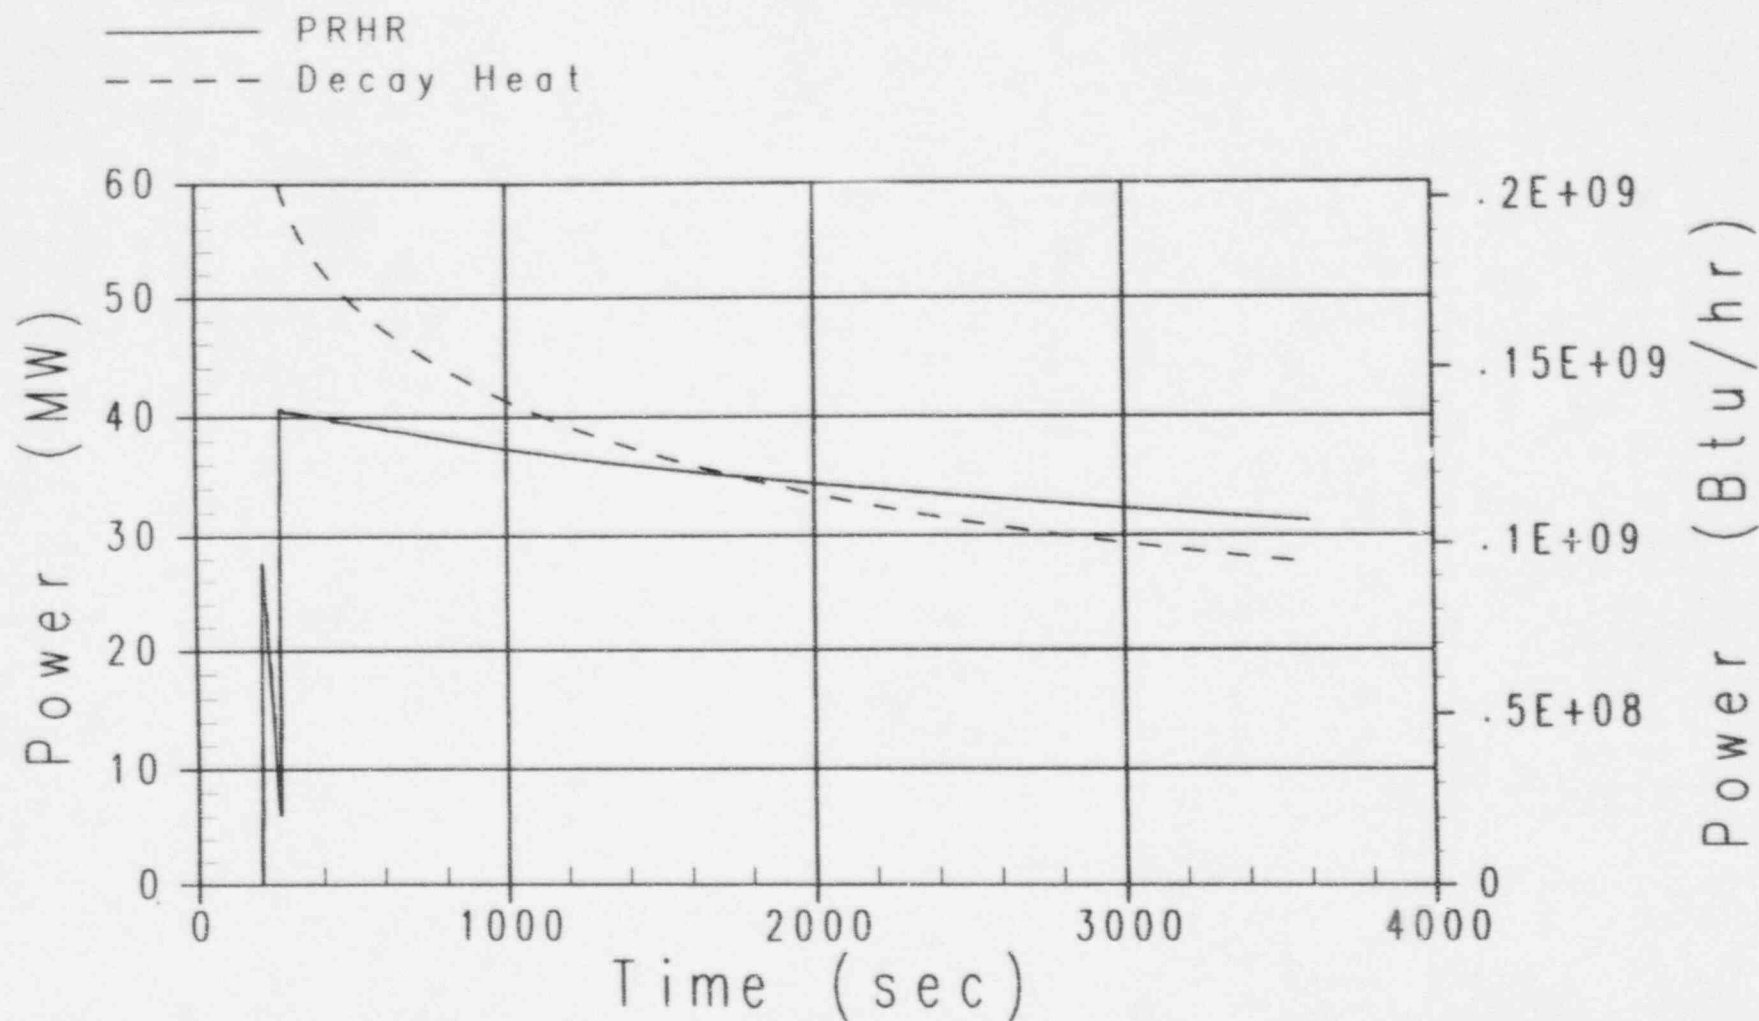
Figure 89

AP600 1 Tube SGTR with PORV Failure
PRHR Heat Removal

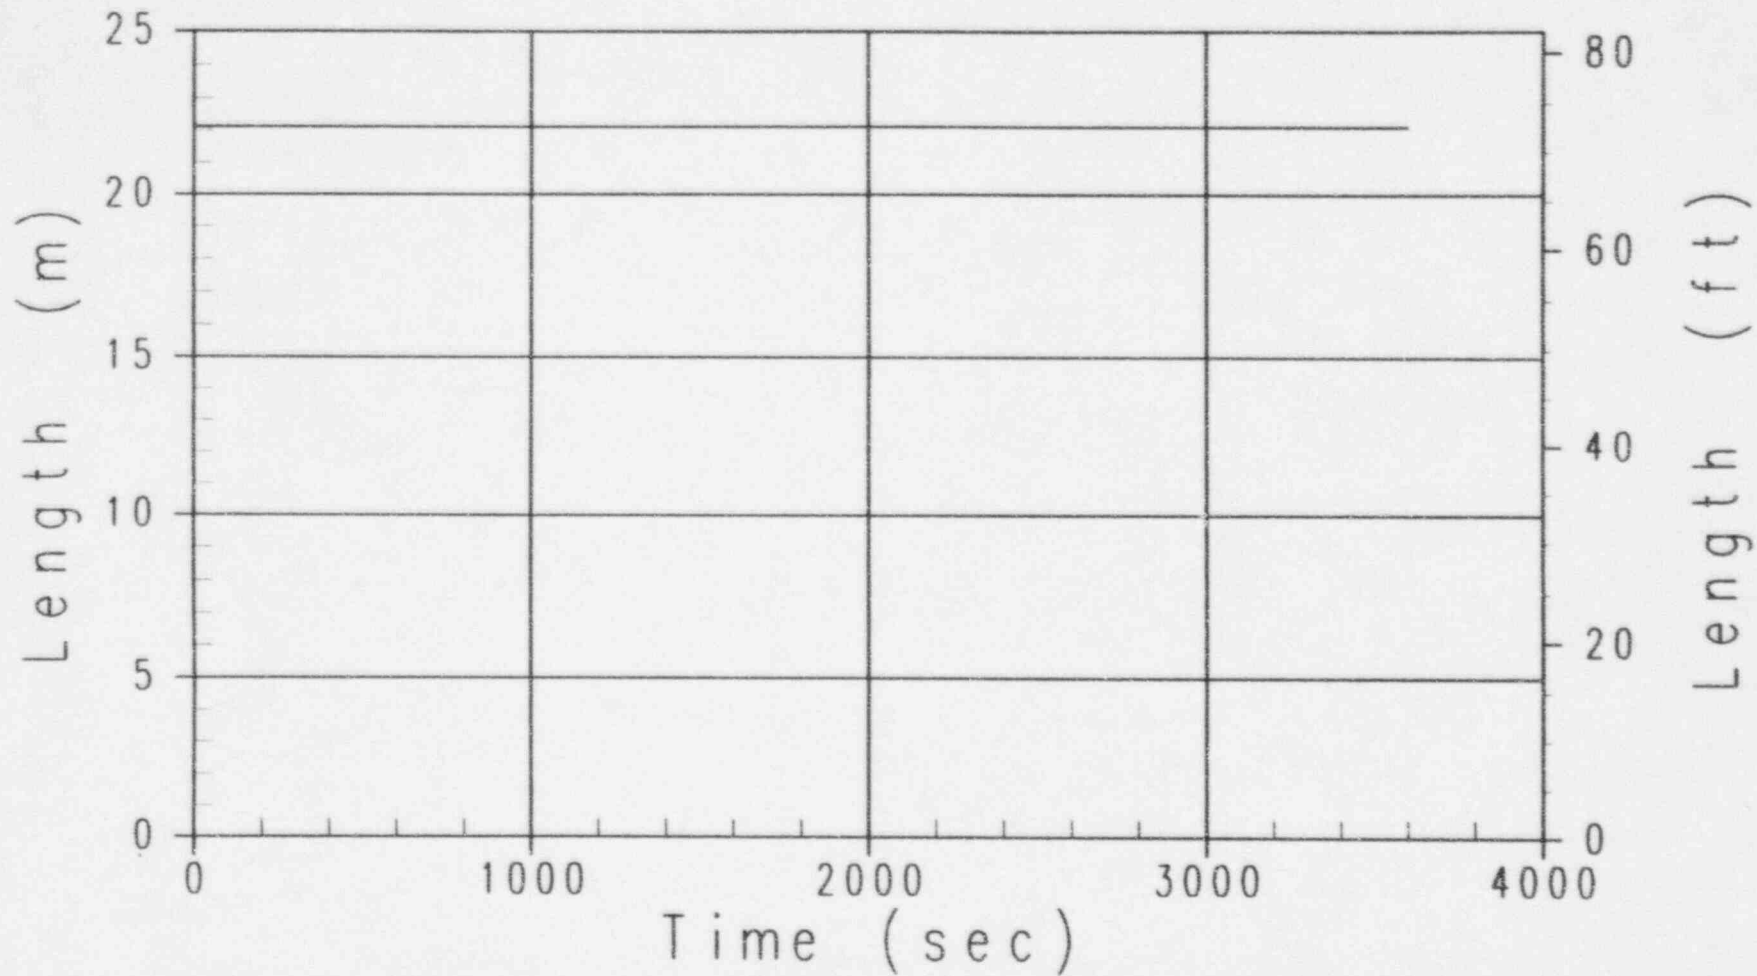
Figure 90

AP600 1 Tube SGTR with PORV Failure
RCS Water Level

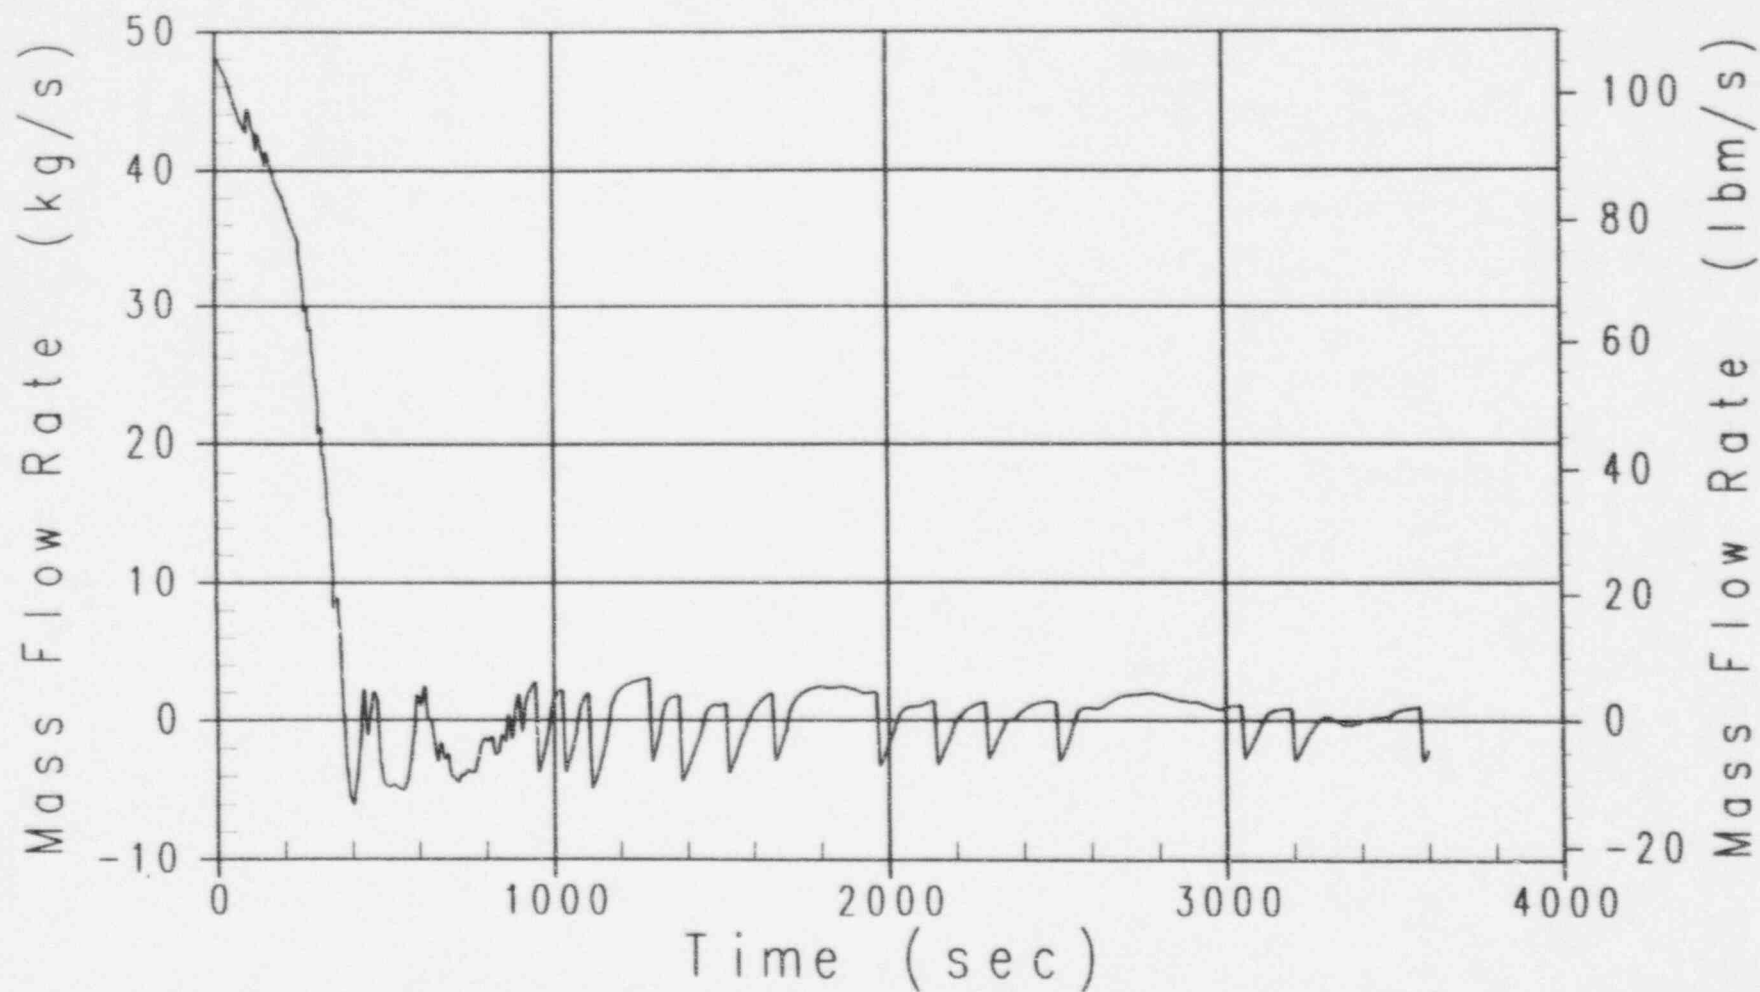
Figure 91

AP600 2 Tube Multiple SGTR with PORV Failure
Tube Rupture Break Flow

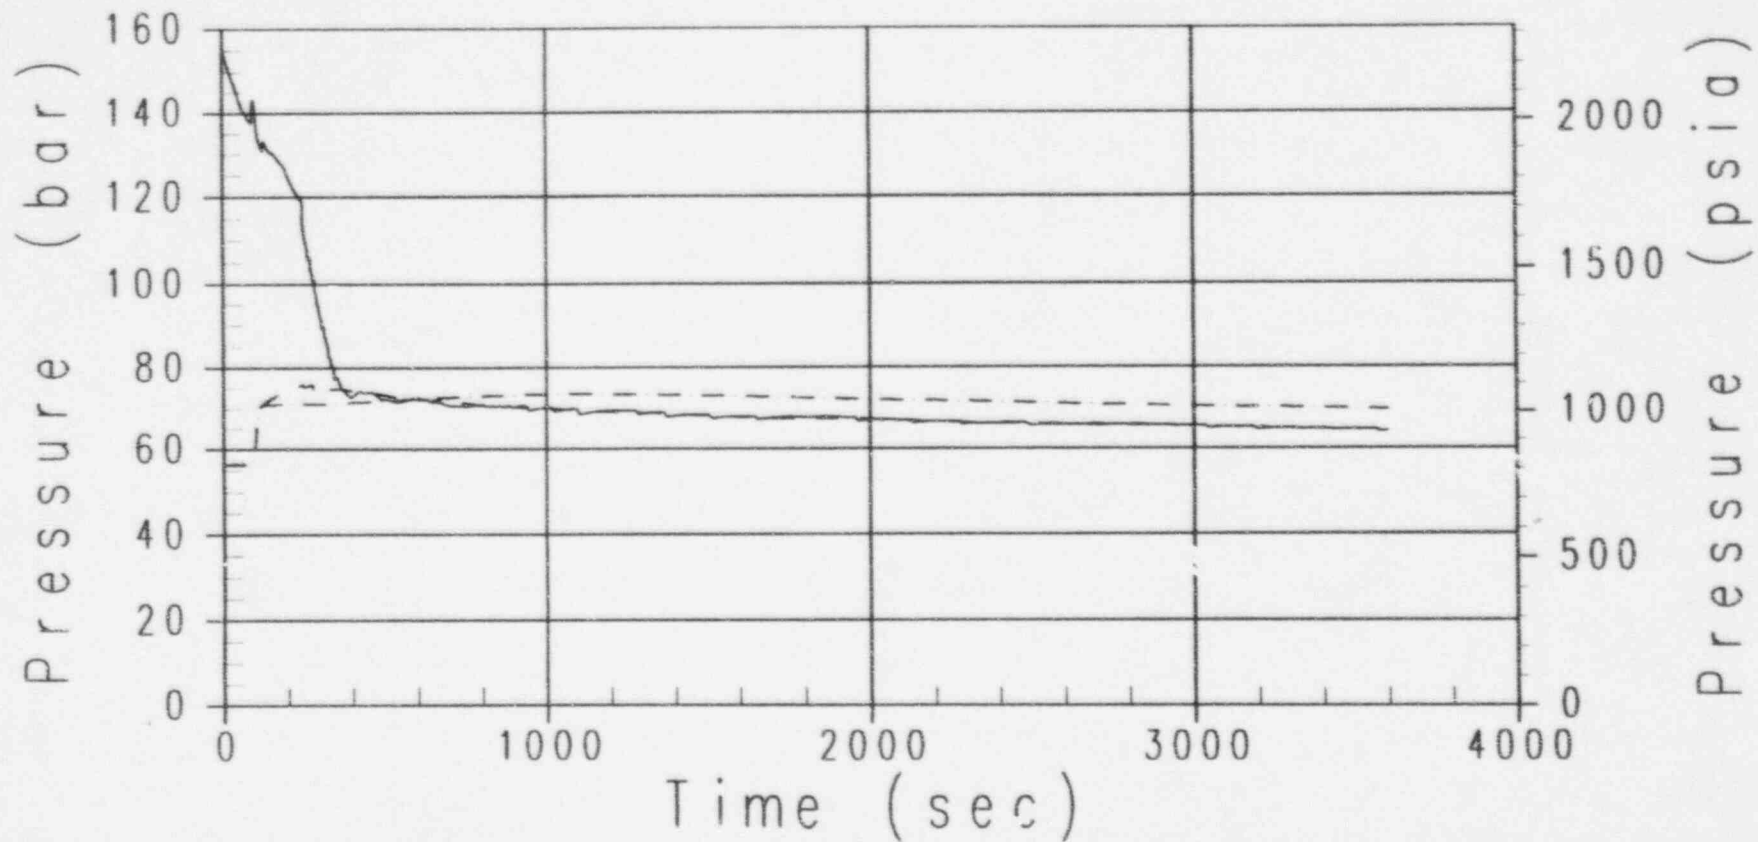
Figure 92

AP600 2 Tube Multiple SGTR with PORV Failure
RCS and Secondary Systems Pressures

—— RCS
- - - - Faulted SG
- - - - Unfaulted SG

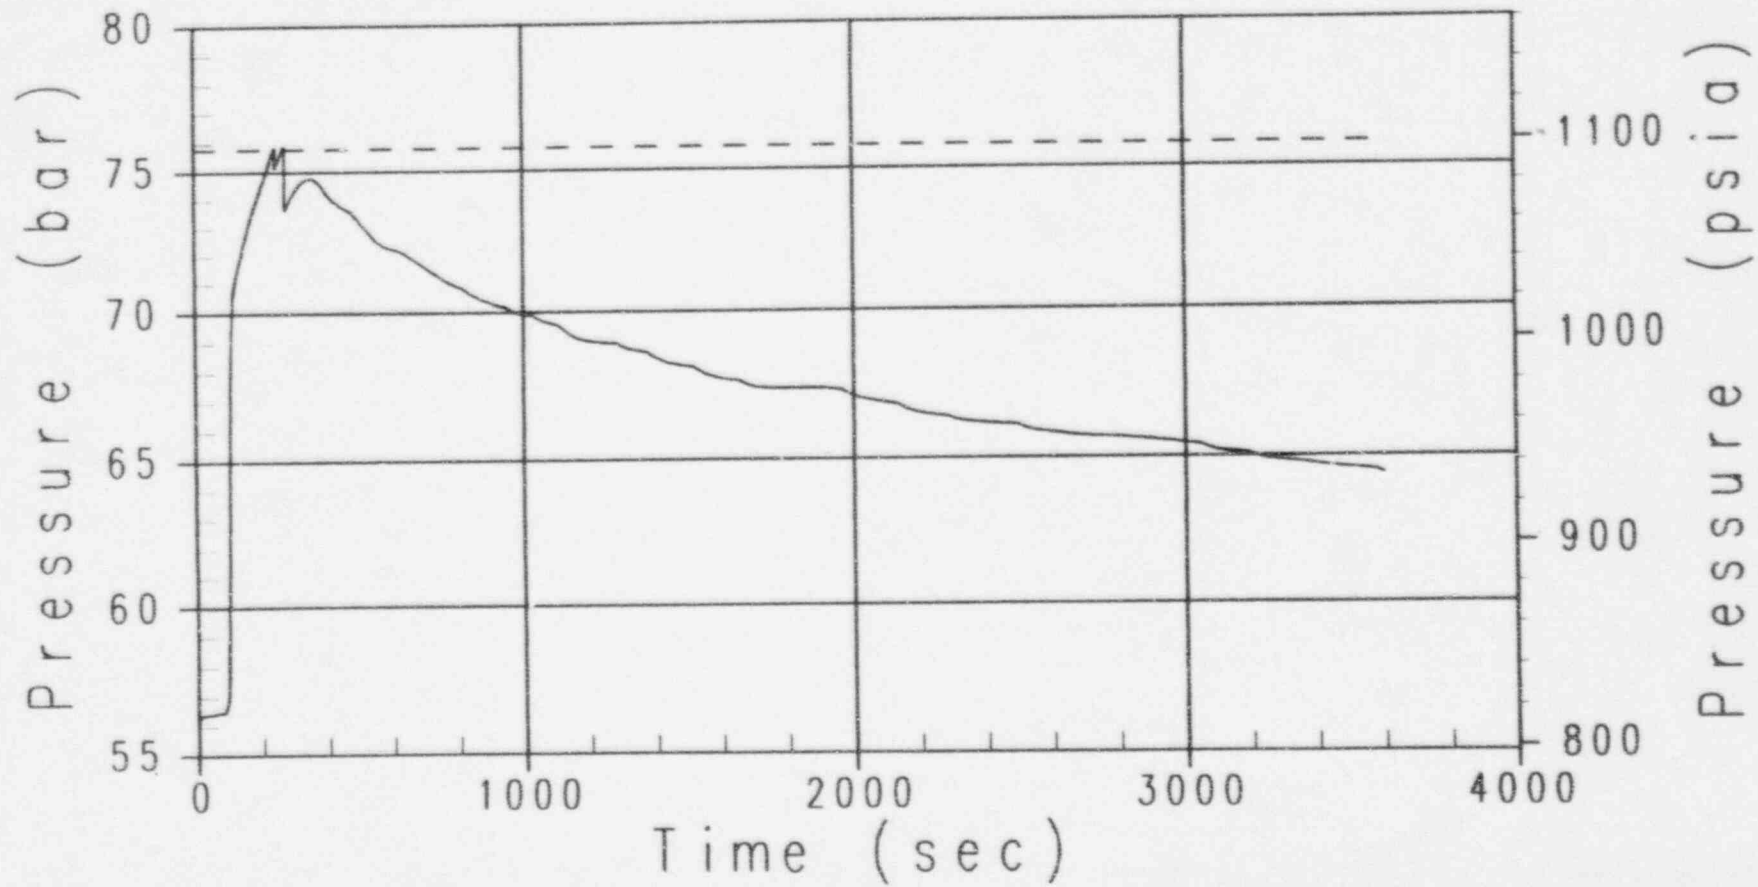
Figure 93

AP600 2 Tube Multiple SGTR with PORV Failure
Faulted Steam Generator Pressure

— Faulted SG
- - - Safety Valve Setpoint

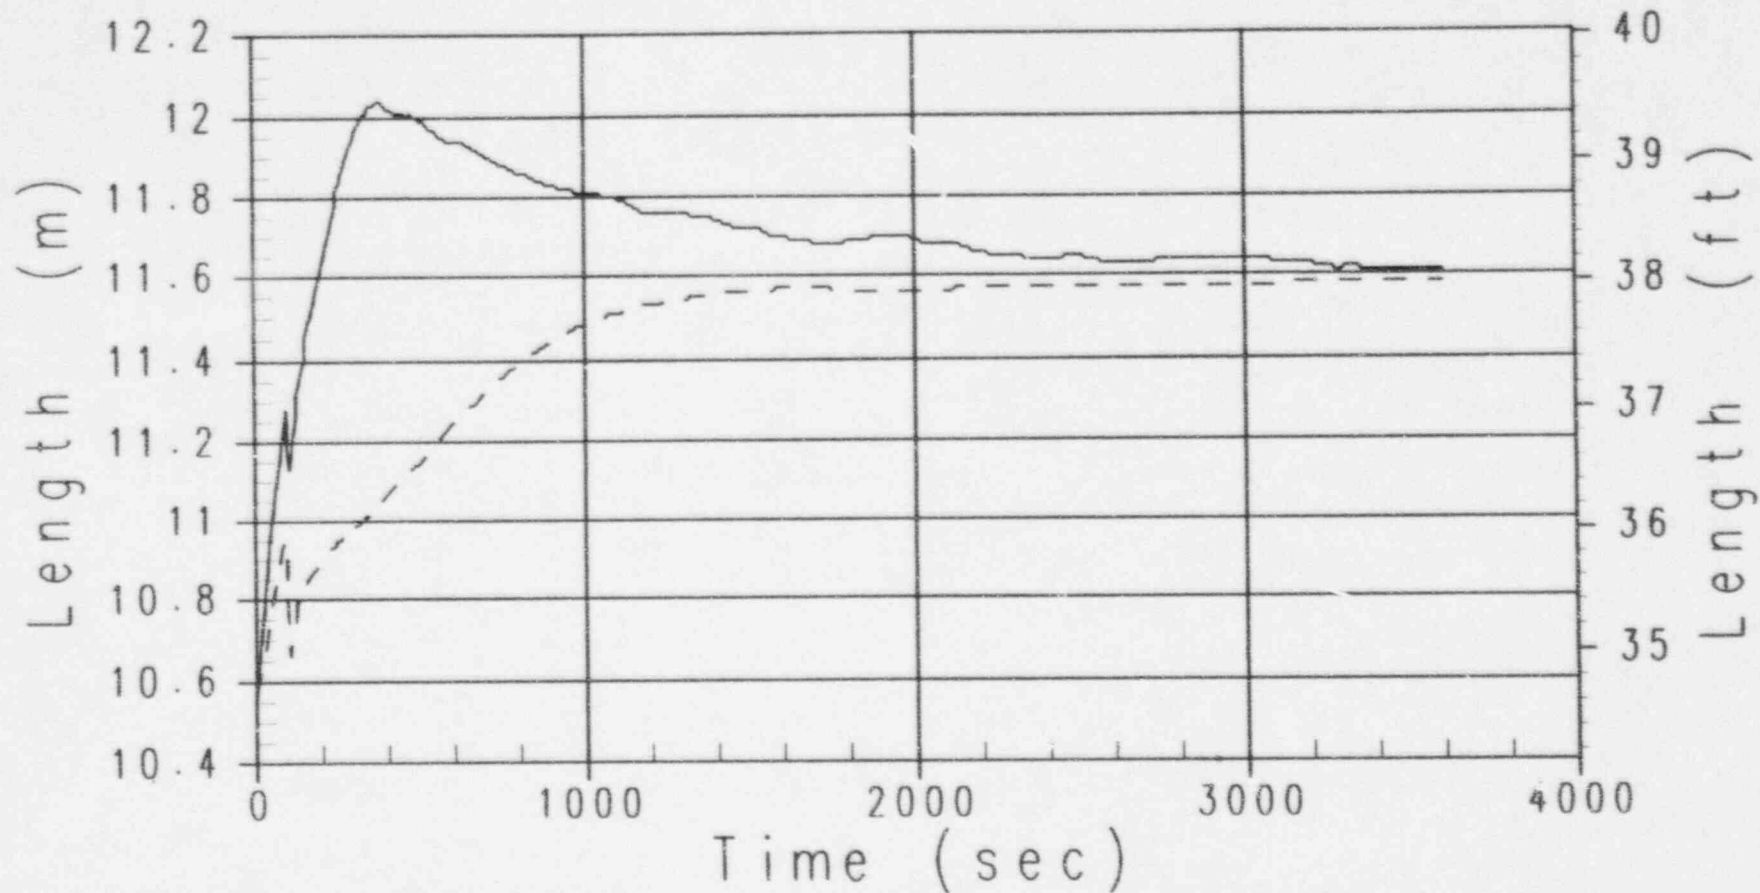
Figure 94

AP600 2 Tube Multiple SGTR with PORV Failure
Steam Generator Downcomer Water Level

—— Faulted SG
- - - - Unfaulted SG

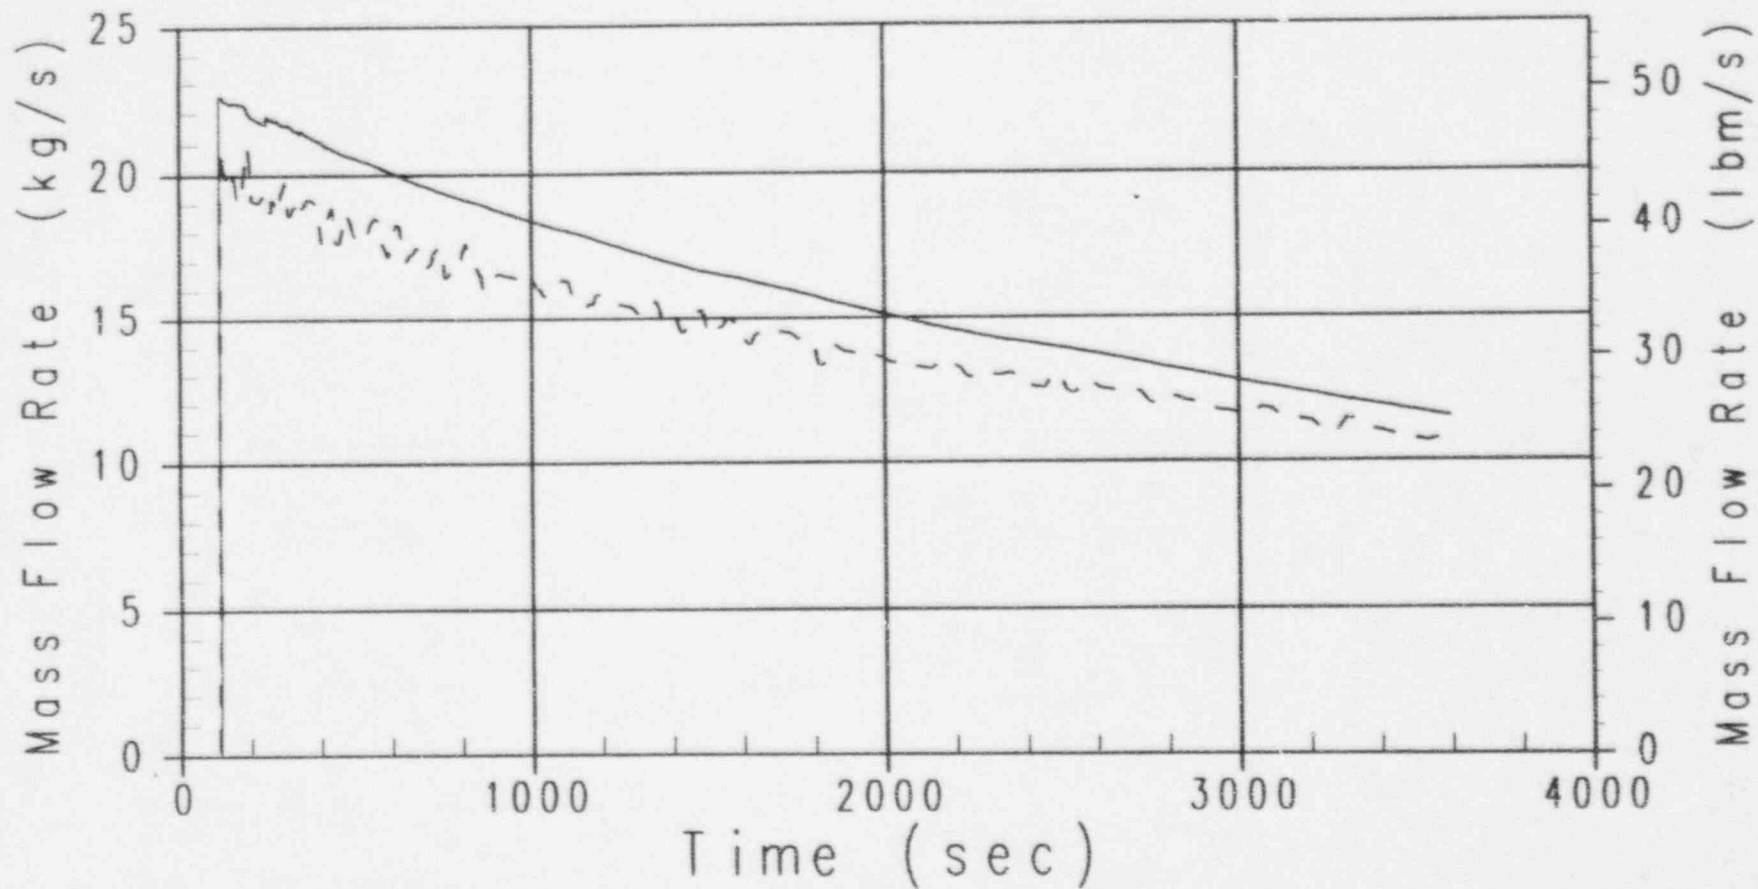
Figure 95

AP600 2 Tube Multiple SGTR with PORV Failure
CMT Water Mass Flowrates

— Discharge Line
- - - Balance Line
