Westinghouse
Electric Corporation

SUBJECT: AP600 MULTIPLE STEAM GENERATOR TUBE RUPTURE ANALYSIS IN
SUPPORT OF RAIS 440.27 AND 440.170 (Revision 2)

AP600 Multiple Steam Generator Tube Rupture Analysis

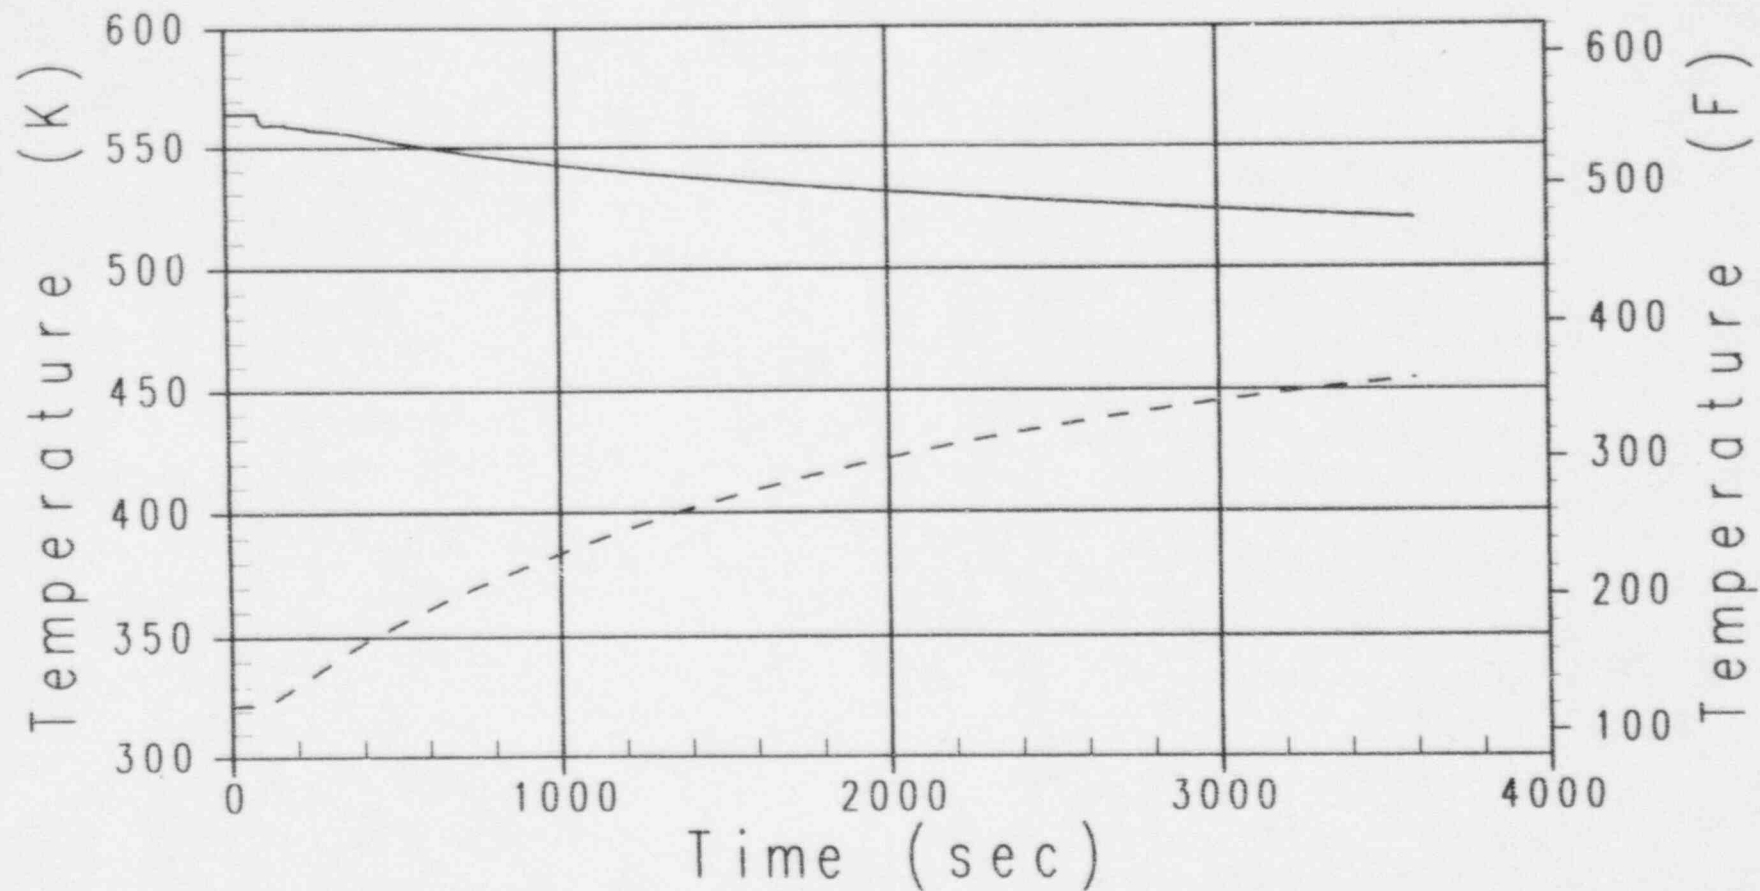
Figure 96

AP600 2 Tube Multiple SGTR with PORV Failure
RCS and CMT Water Temperatures

— RCS Core Water
--- CMT Water

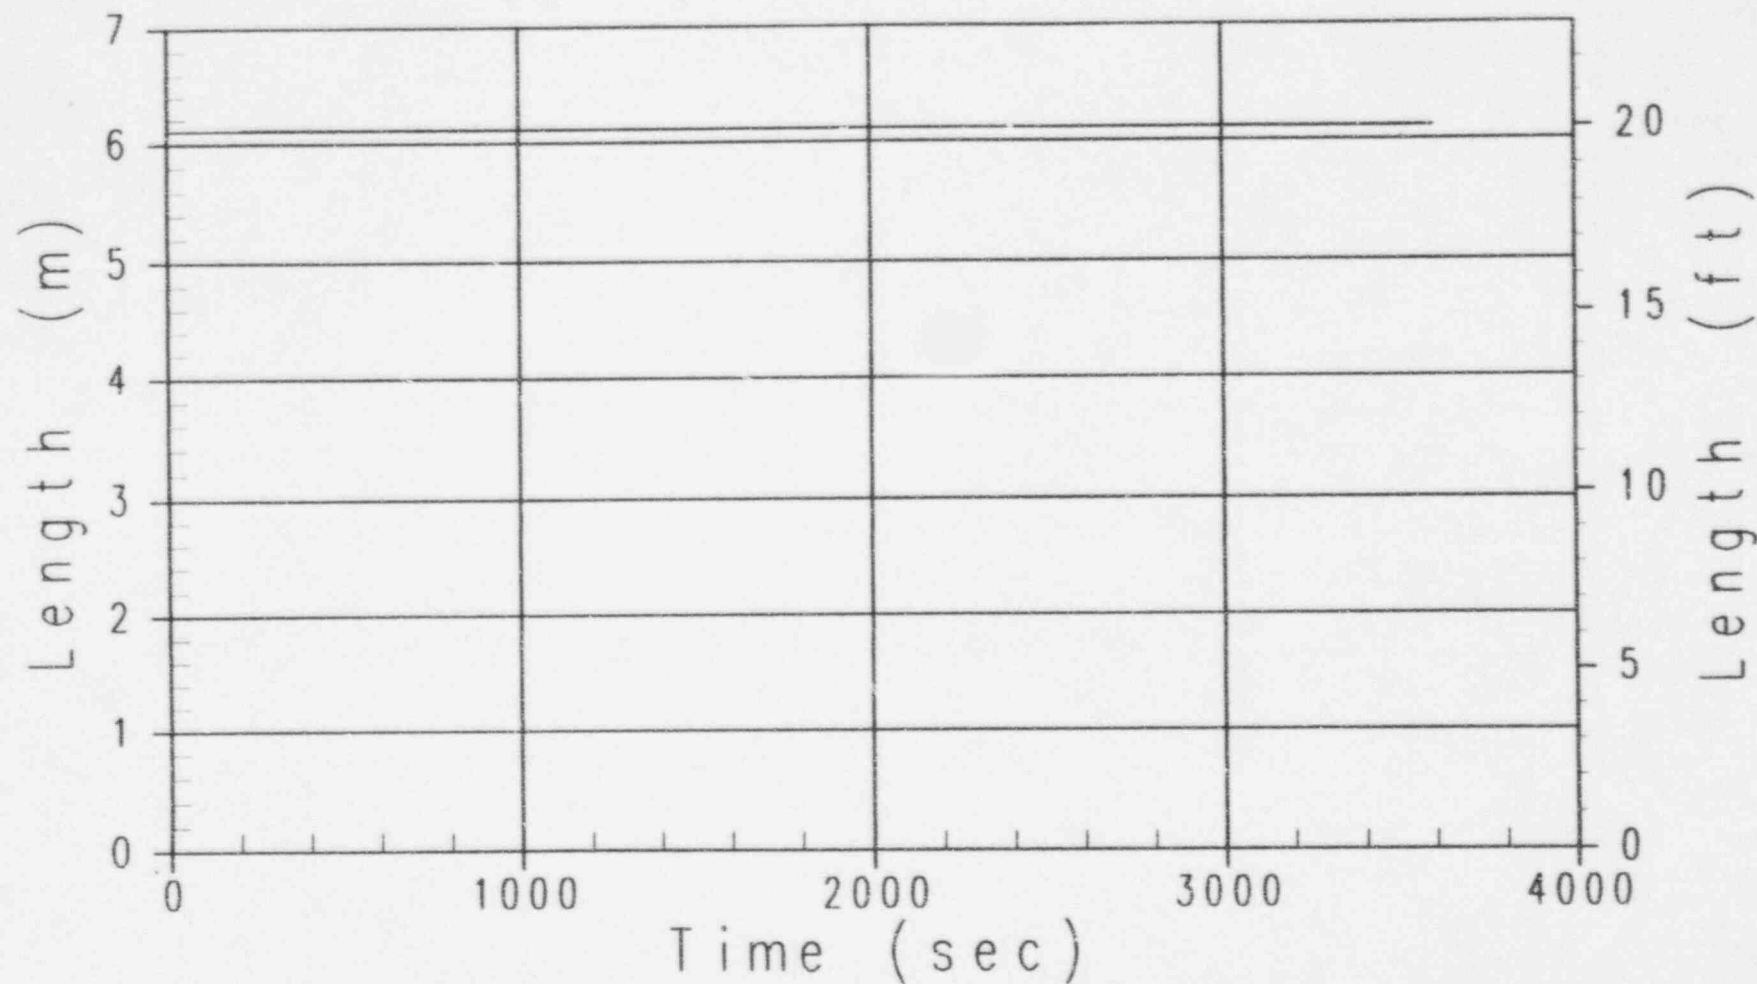
Figure 97

AP600 2 Tube Multiple SGTR with PORV Failure
CMT Water Level

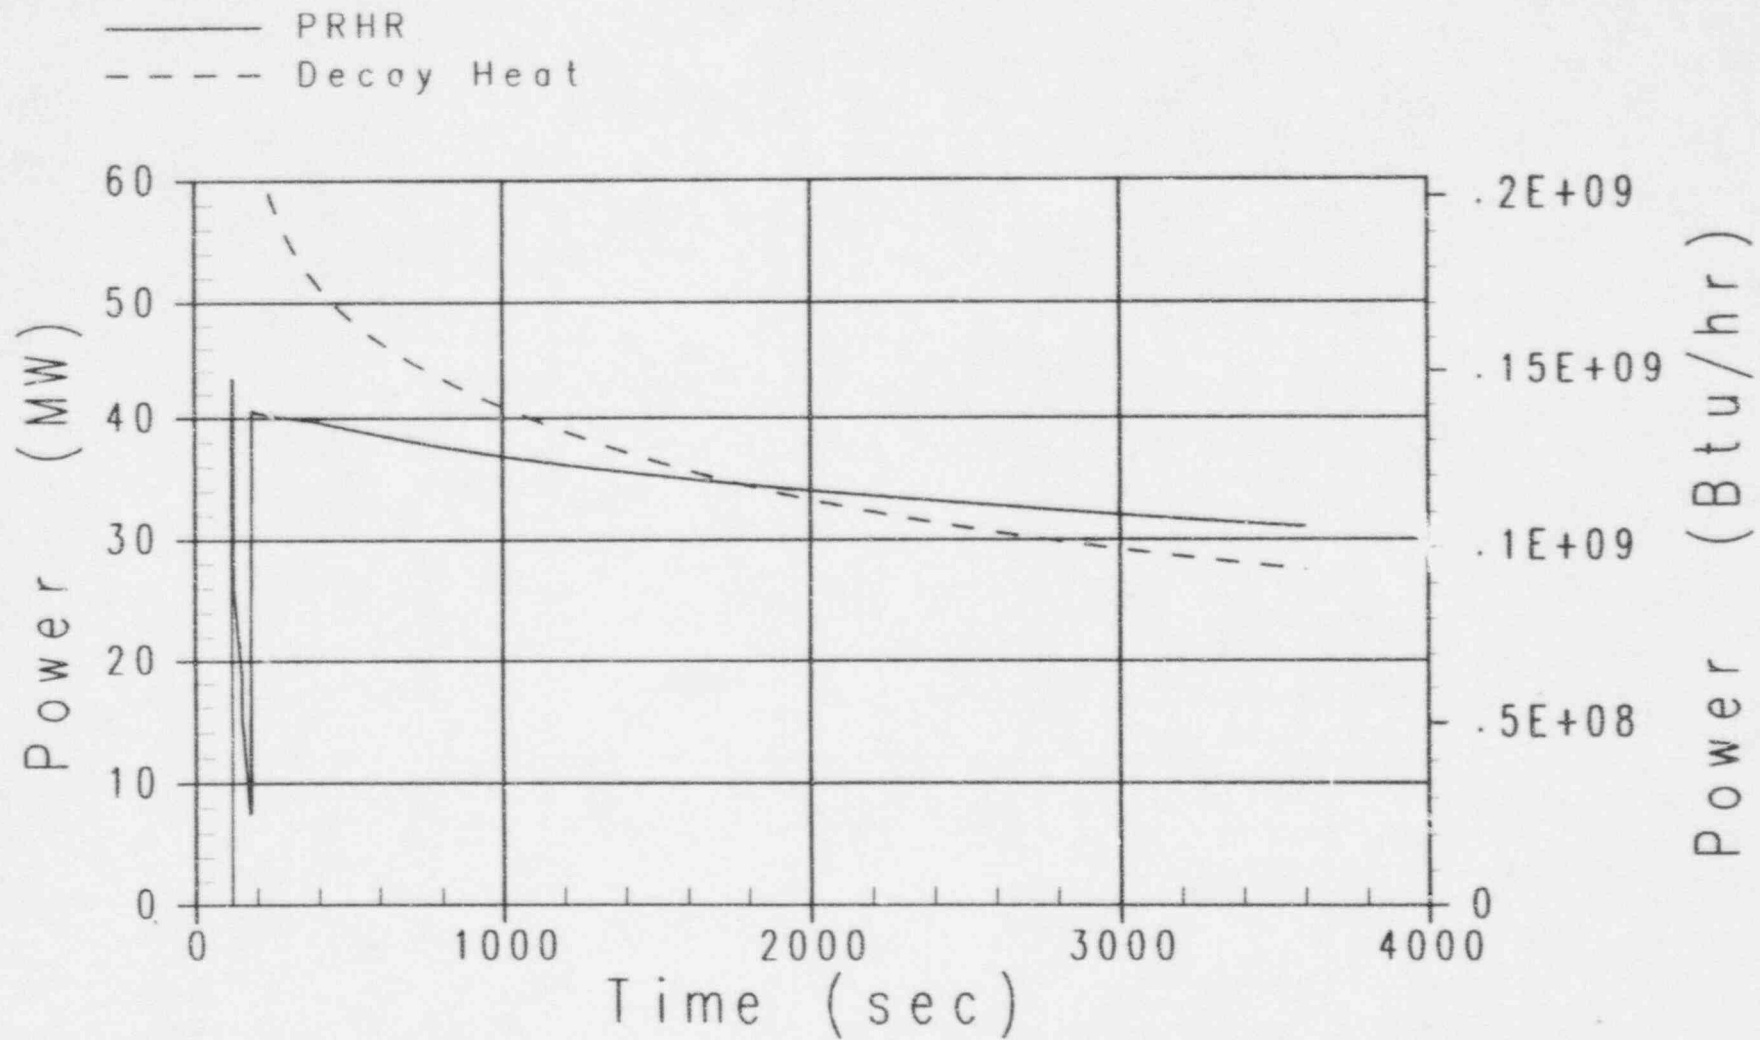
Figure 98

AP600 2 Tube Multiple SGTR with PORV Failure
PRHR Heat Removal

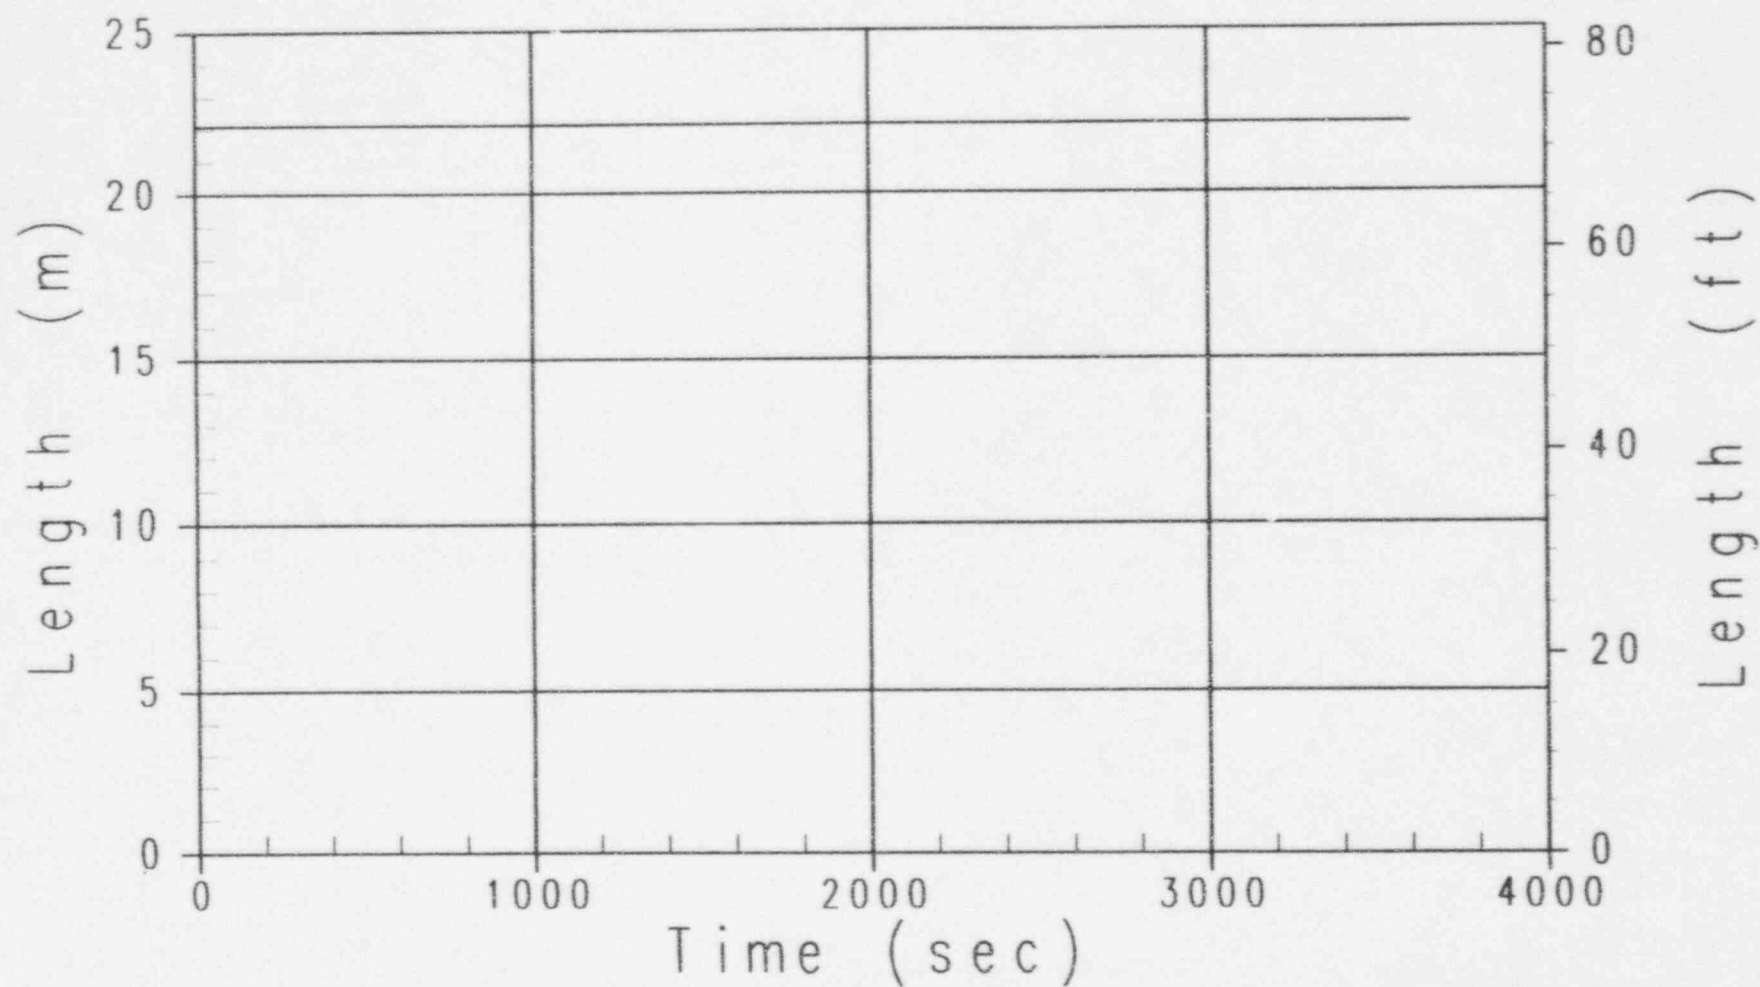
Figure 99

AP600 2 Tube Multiple SGTR with PORV Failure
RCS Water Level

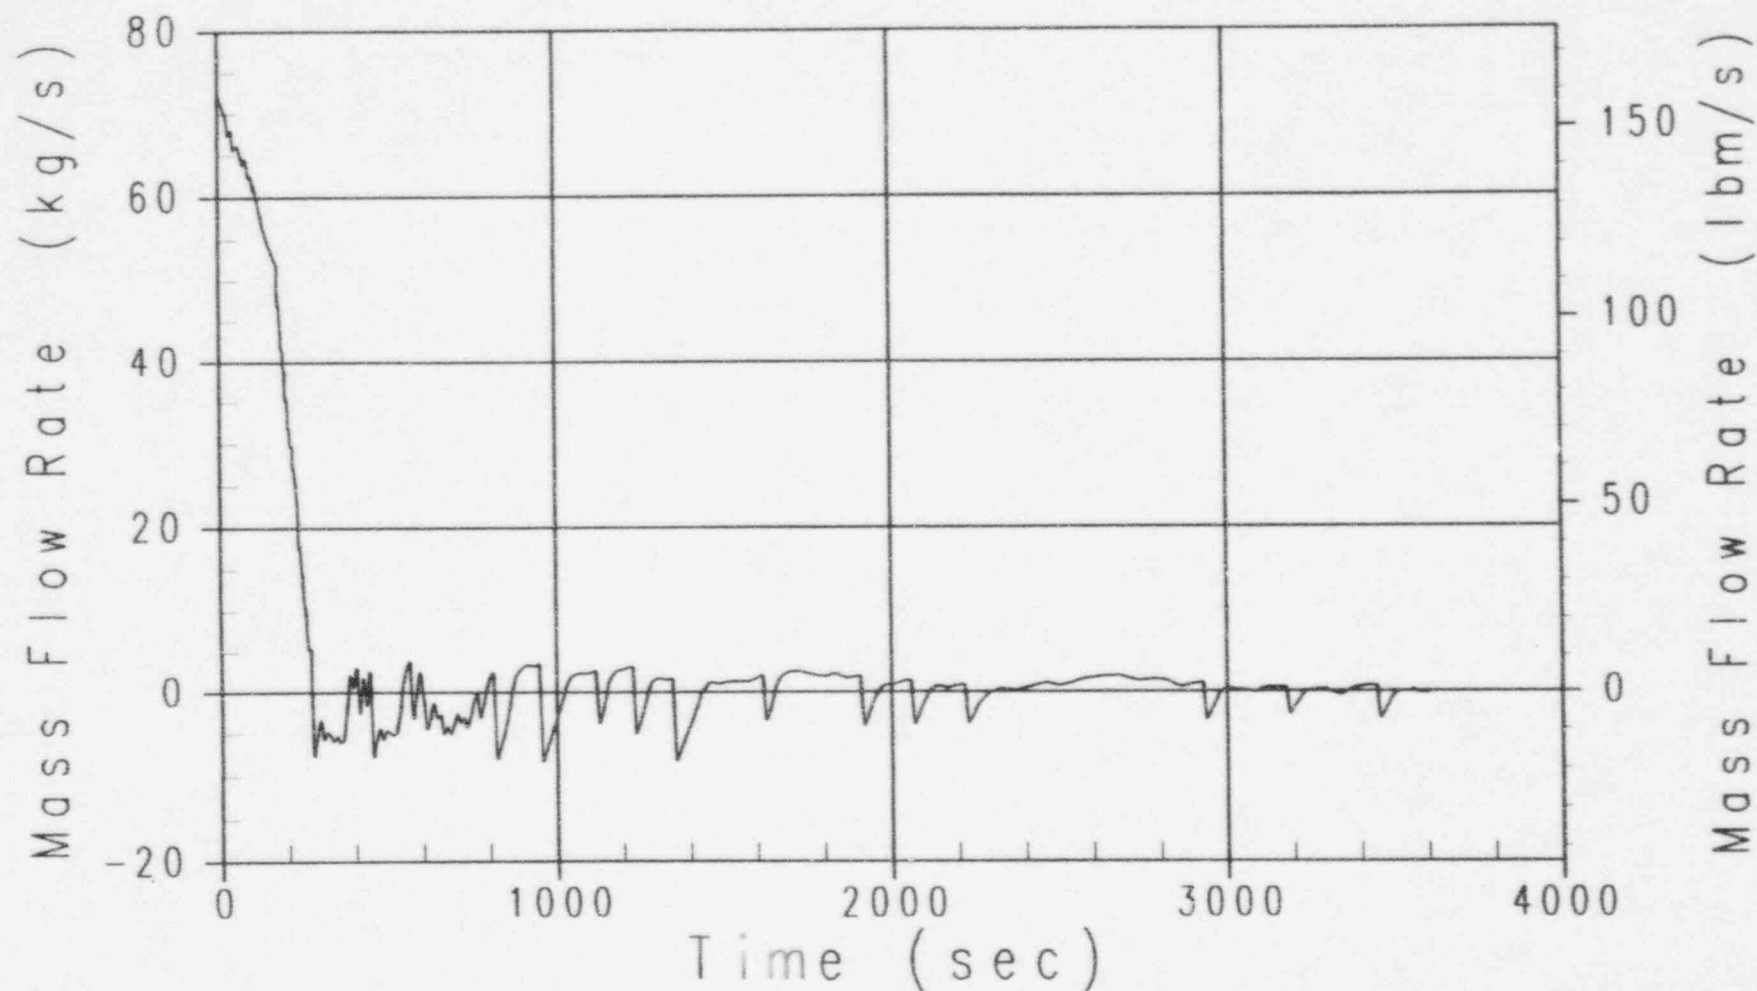
Figure 100

AP600 3 Tube Multiple SGTR with PORV Failure
Tube Rupture Break Flow

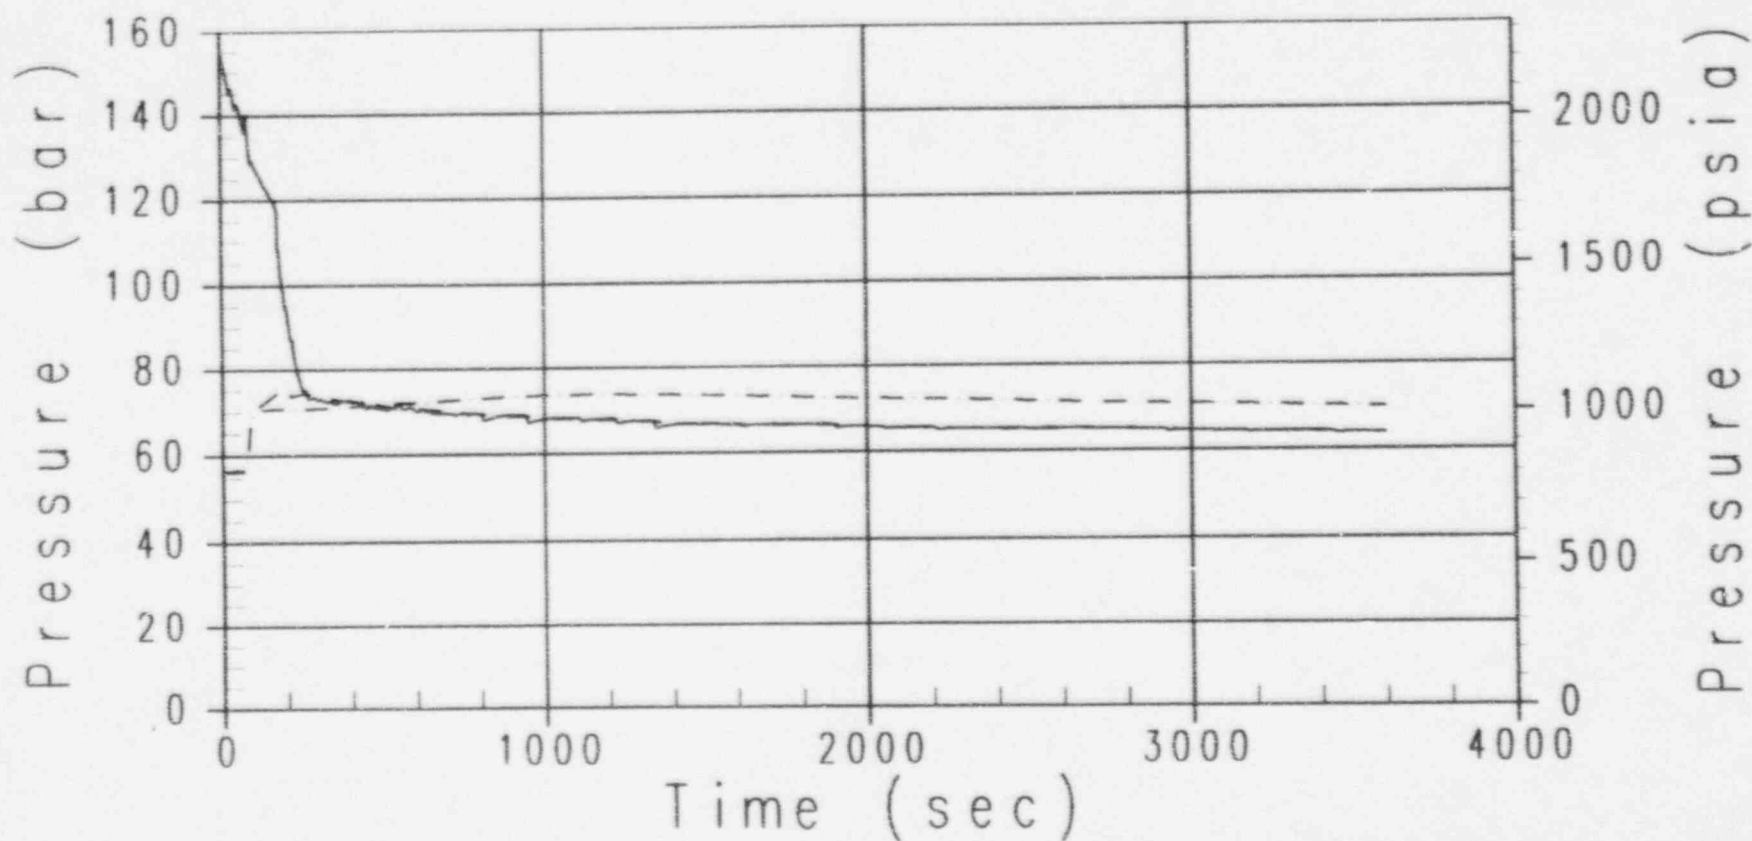
Figure 101

AP600 3 Tube Multiple SGTR with PORV Failure
RCS and Secondary Systems Pressures

—— RCS
- - - - Faulted SG
- - - - Unfaulted SG

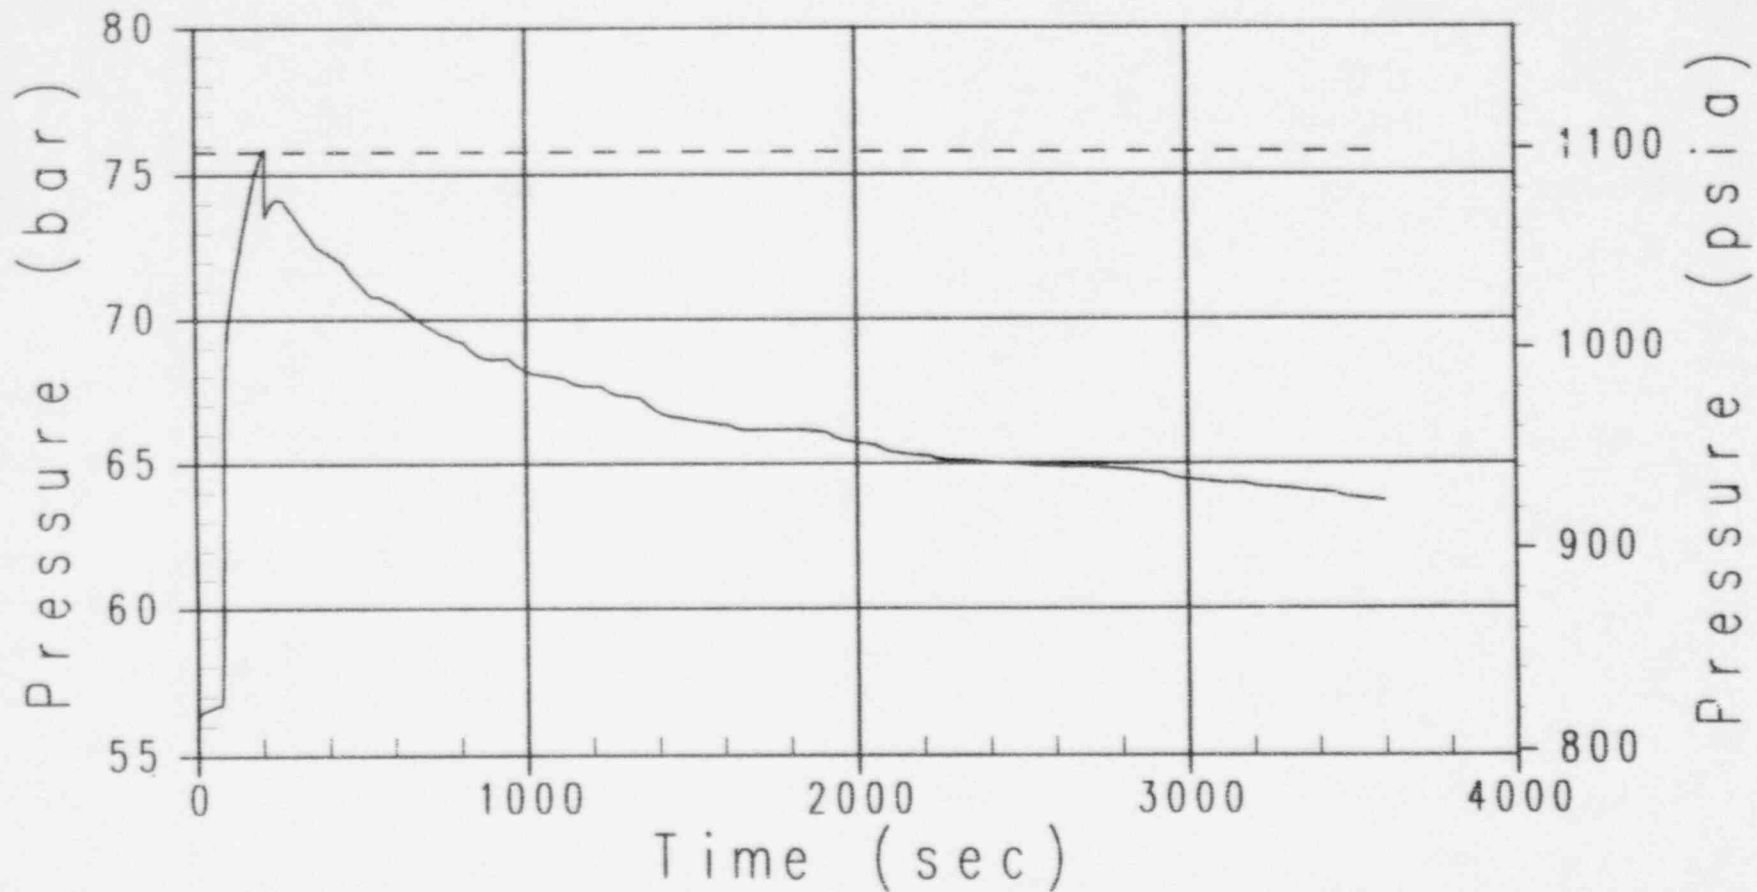
Figure 102

AP600 3 Tube Multiple SGTR with PORV Failure
Faulted Steam Generator Pressure

— Faulted SG
--- Safety Valve Setpoint

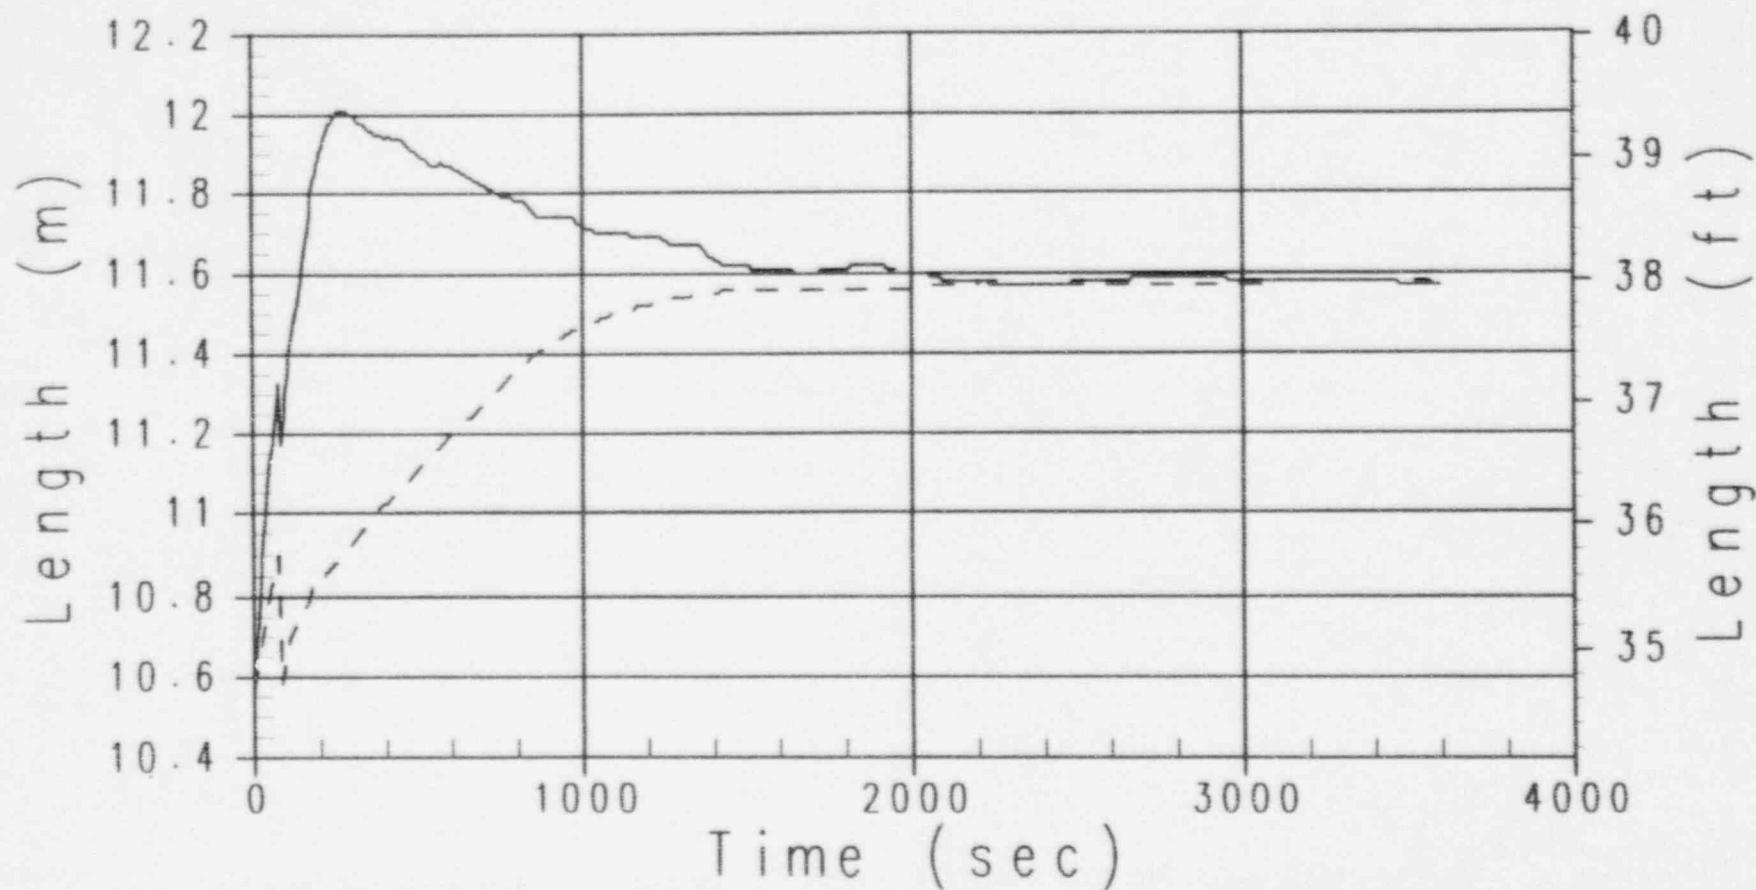
Figure 103

AP600 3 Tube Multiple SGTR with PORV Failure
Steam Generator Downcomer Water Level

—— Faulted SG
- - - Unfaulted SG

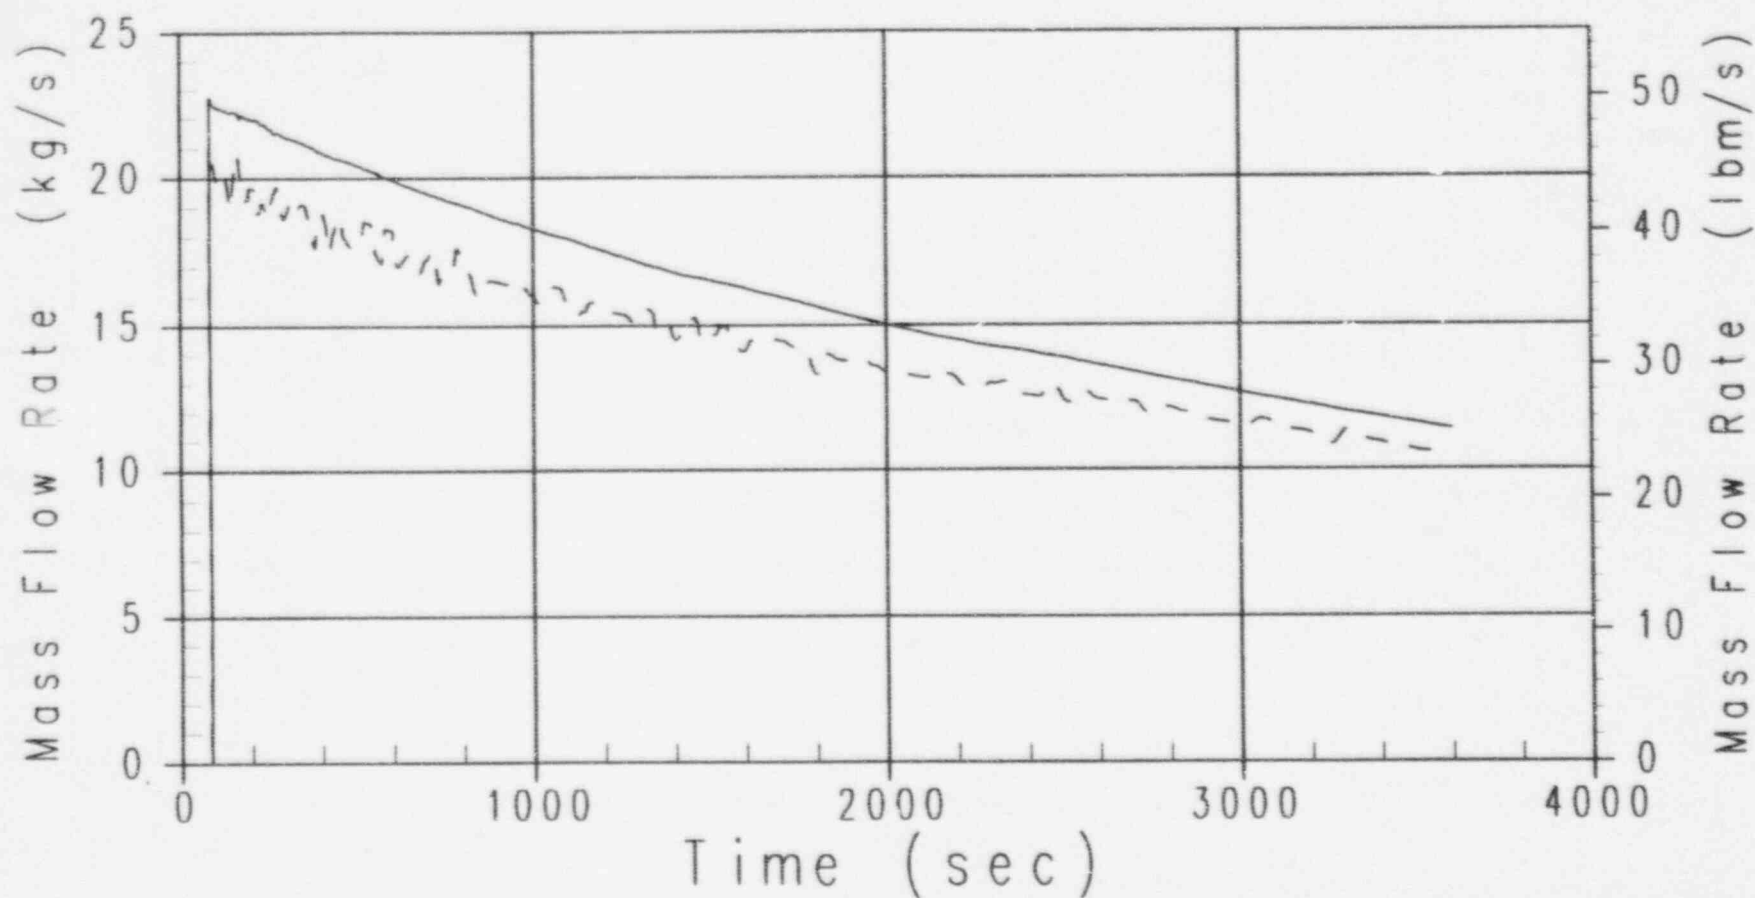
Figure 104

AP600 3 Tube Multiple SGTR with PORV Failure
CMT Water Mass Flowrates

—— Discharge Line
---- Balance Line

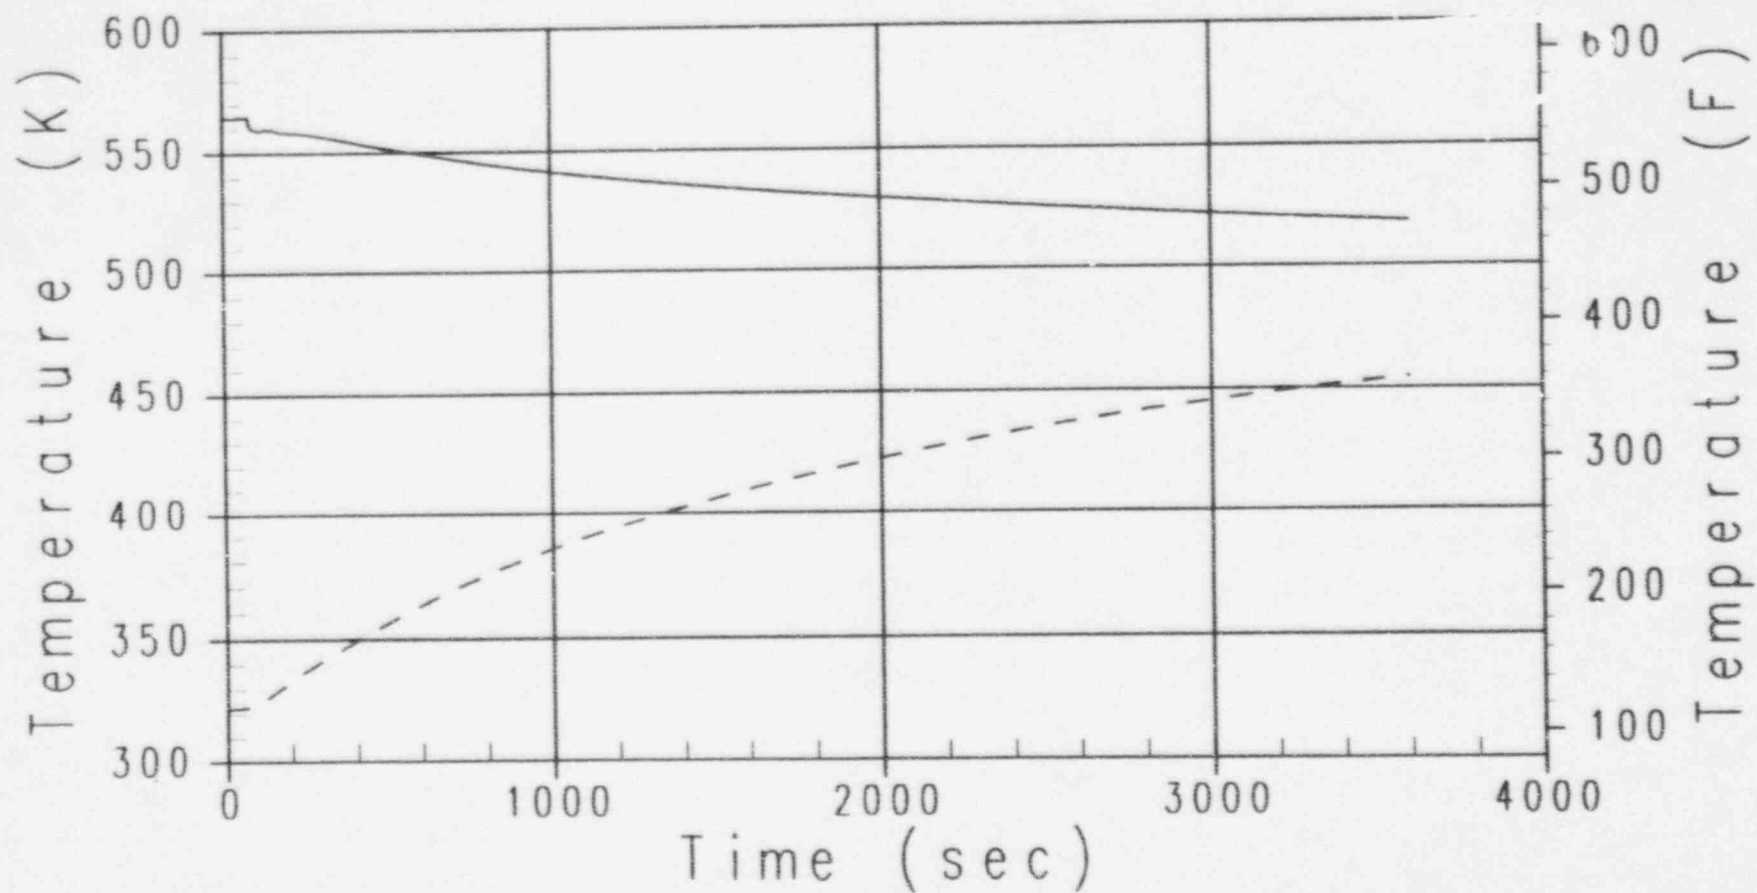
Figure 105

AP600 3 Tube Multiple SGTR with PORV Failure
RCS and CMT Water Temperatures

—— RCS Core Water
---- CMT Water

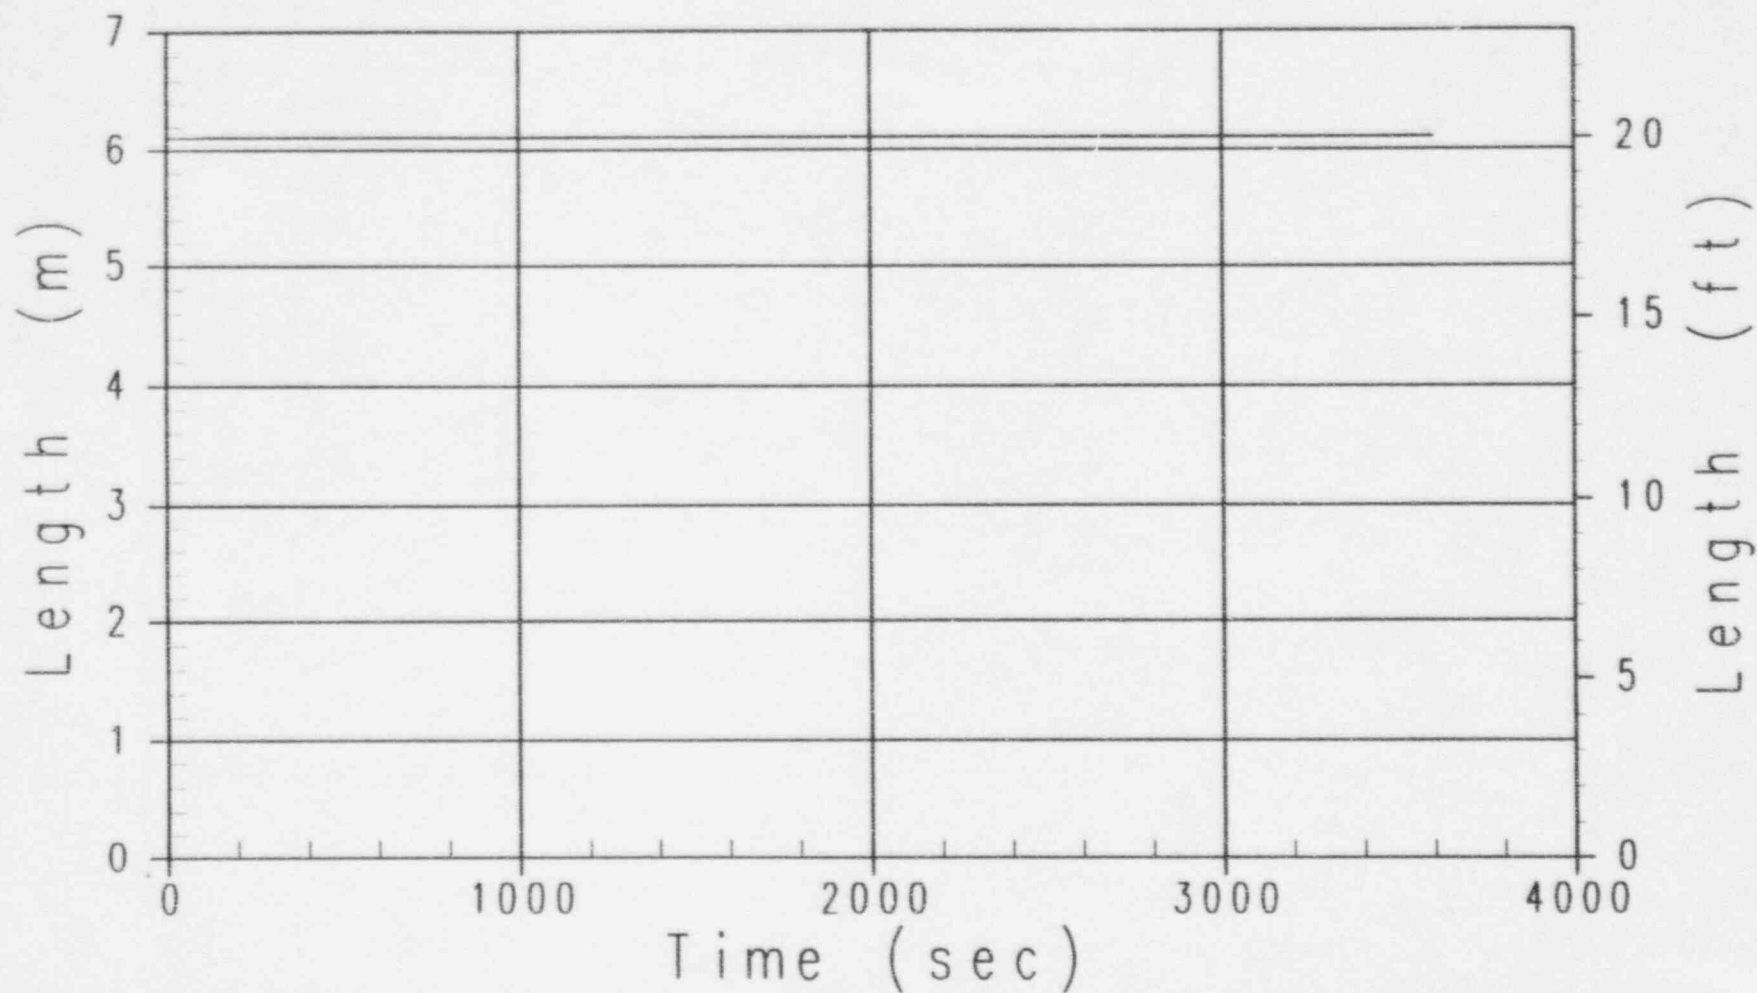
Figure 106

AP600 3 Tube Multiple SGTR with PORV Failure
CMT Water Level

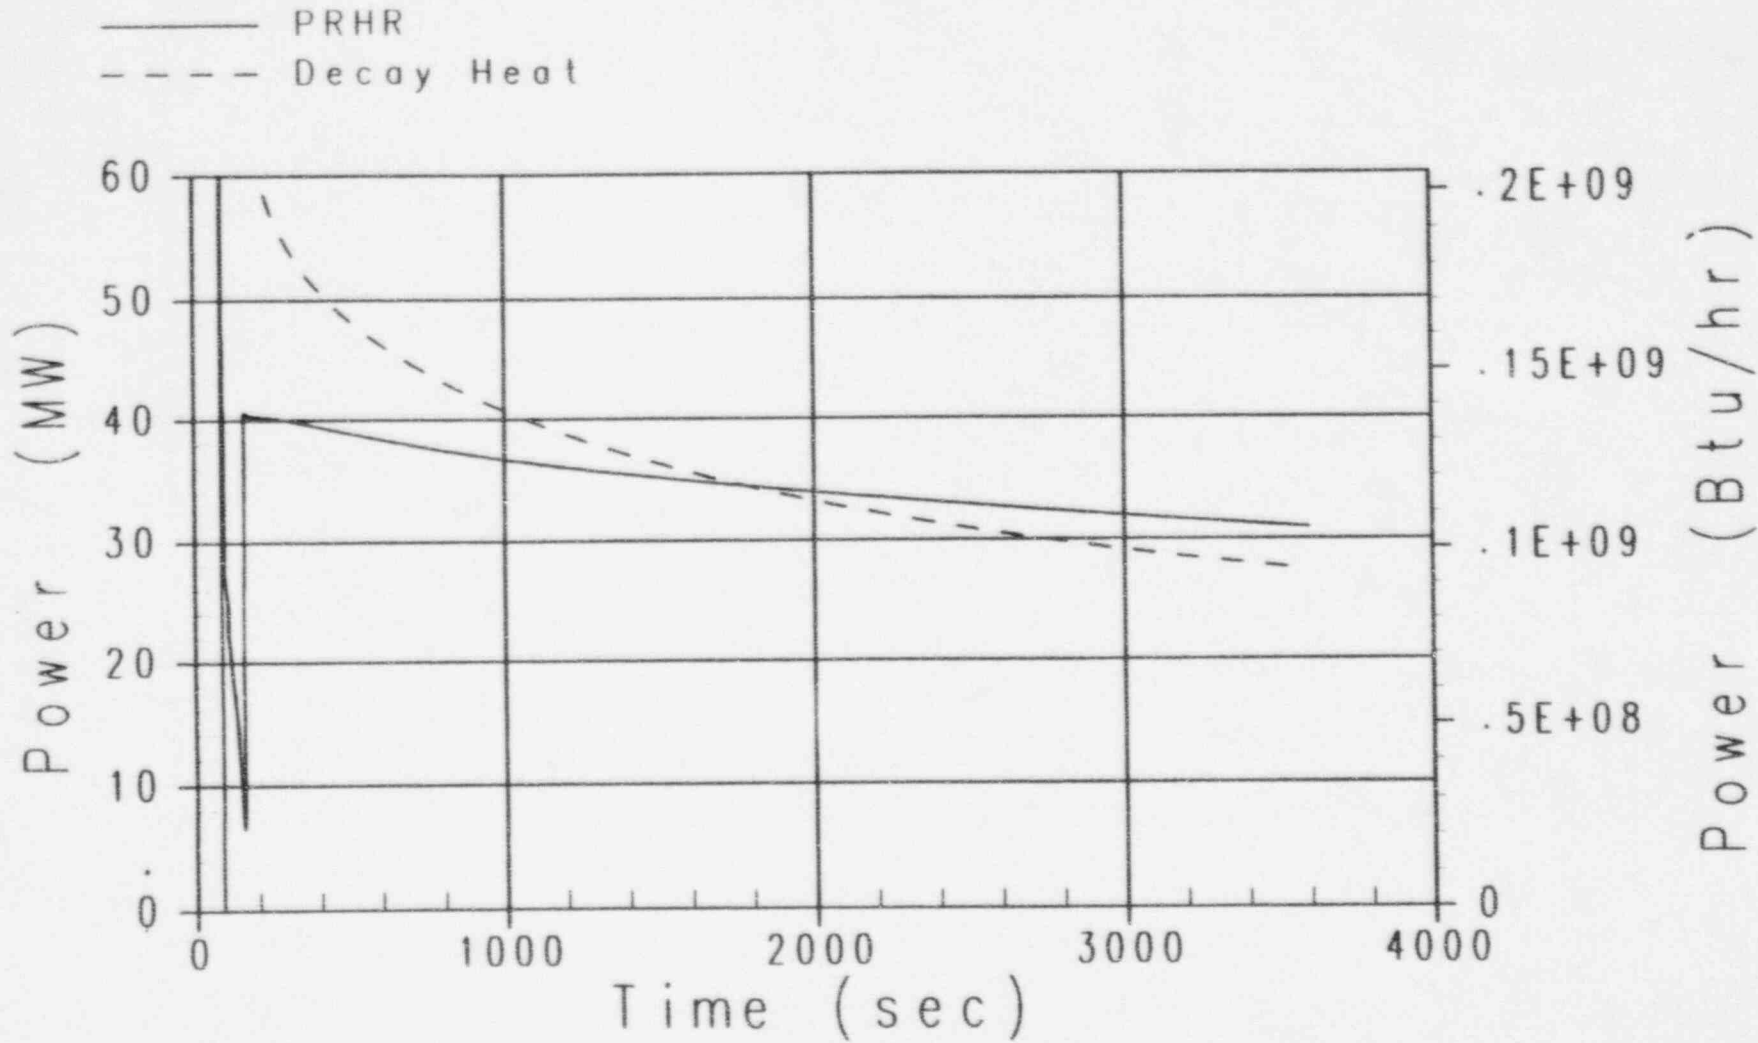
Figure 107

AP600 3 Tube Multiple SGTR with PORV Failure
PRHR Heat Removal

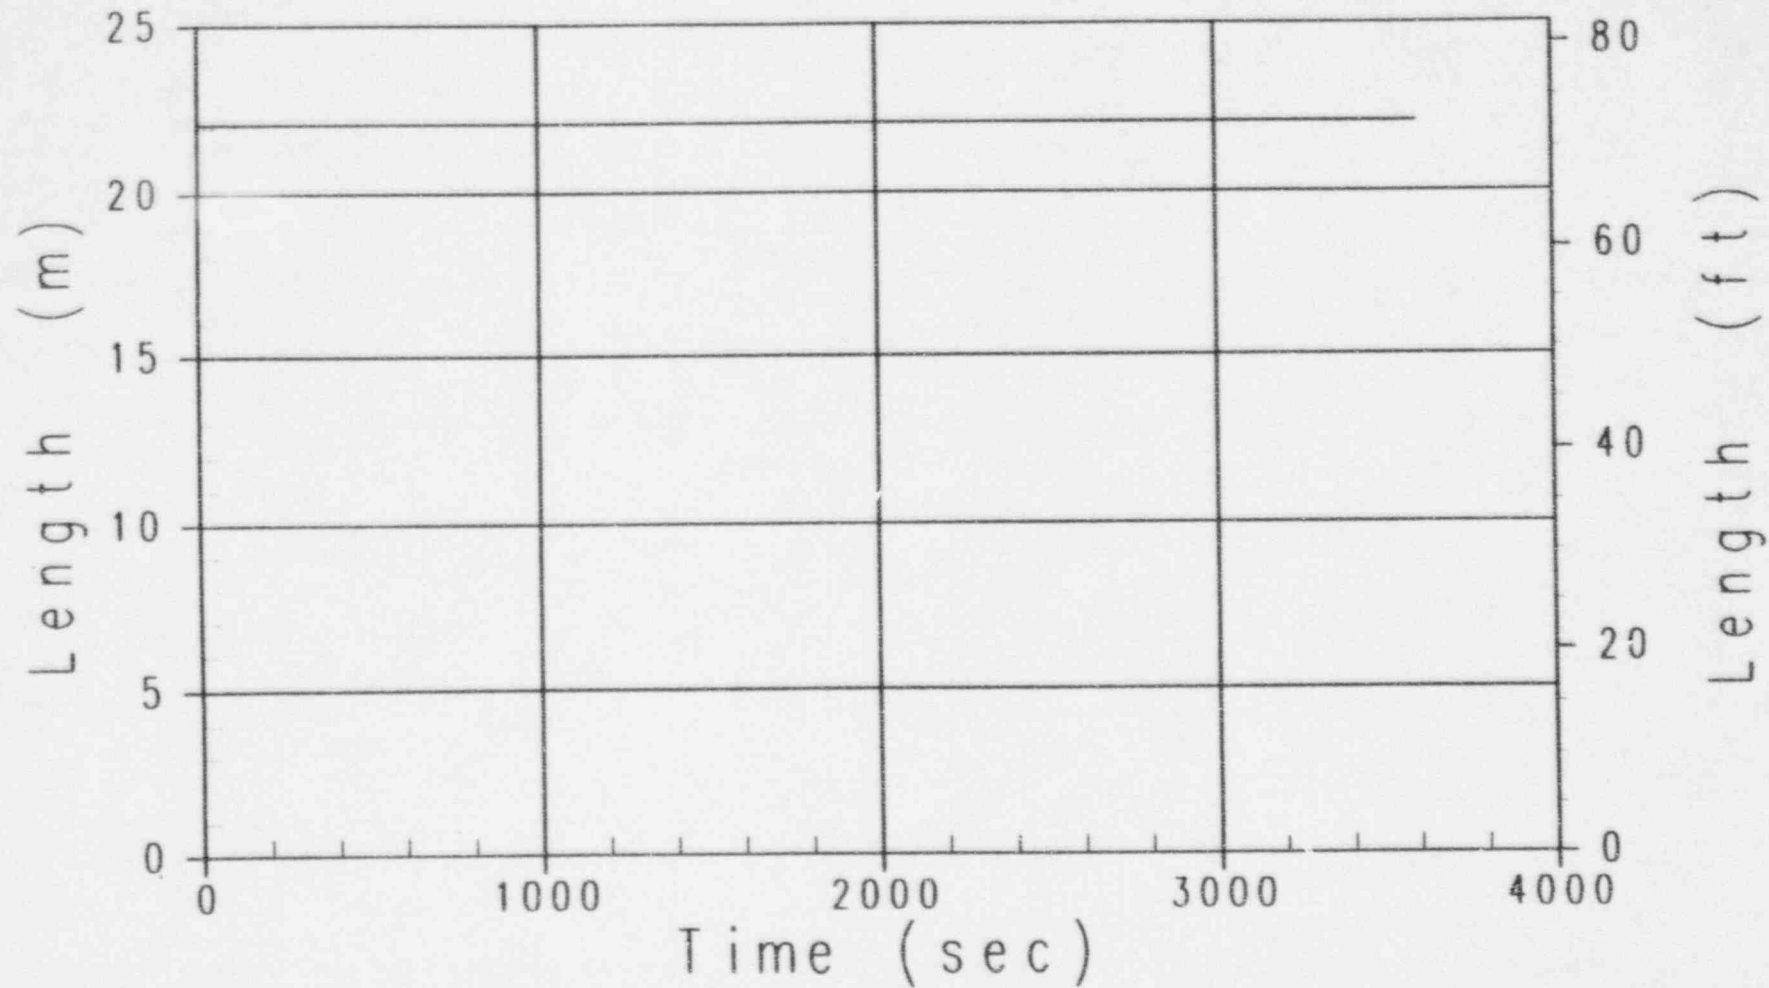
Figure 108

AP600 3 Tube Multiple SGTR with PORV Failure
RCS Water Level
