Westinghouse
Electric Corporation

SUBJECT: AP600 MULTIPLE STEAM GENERATOR TUBE RUPTURE ANALYSIS IN
SUPPORT OF RAIS 440.27 AND 440.170 (Revision 2)

AP600 Multiple Steam Generator Tube Rupture Analysis

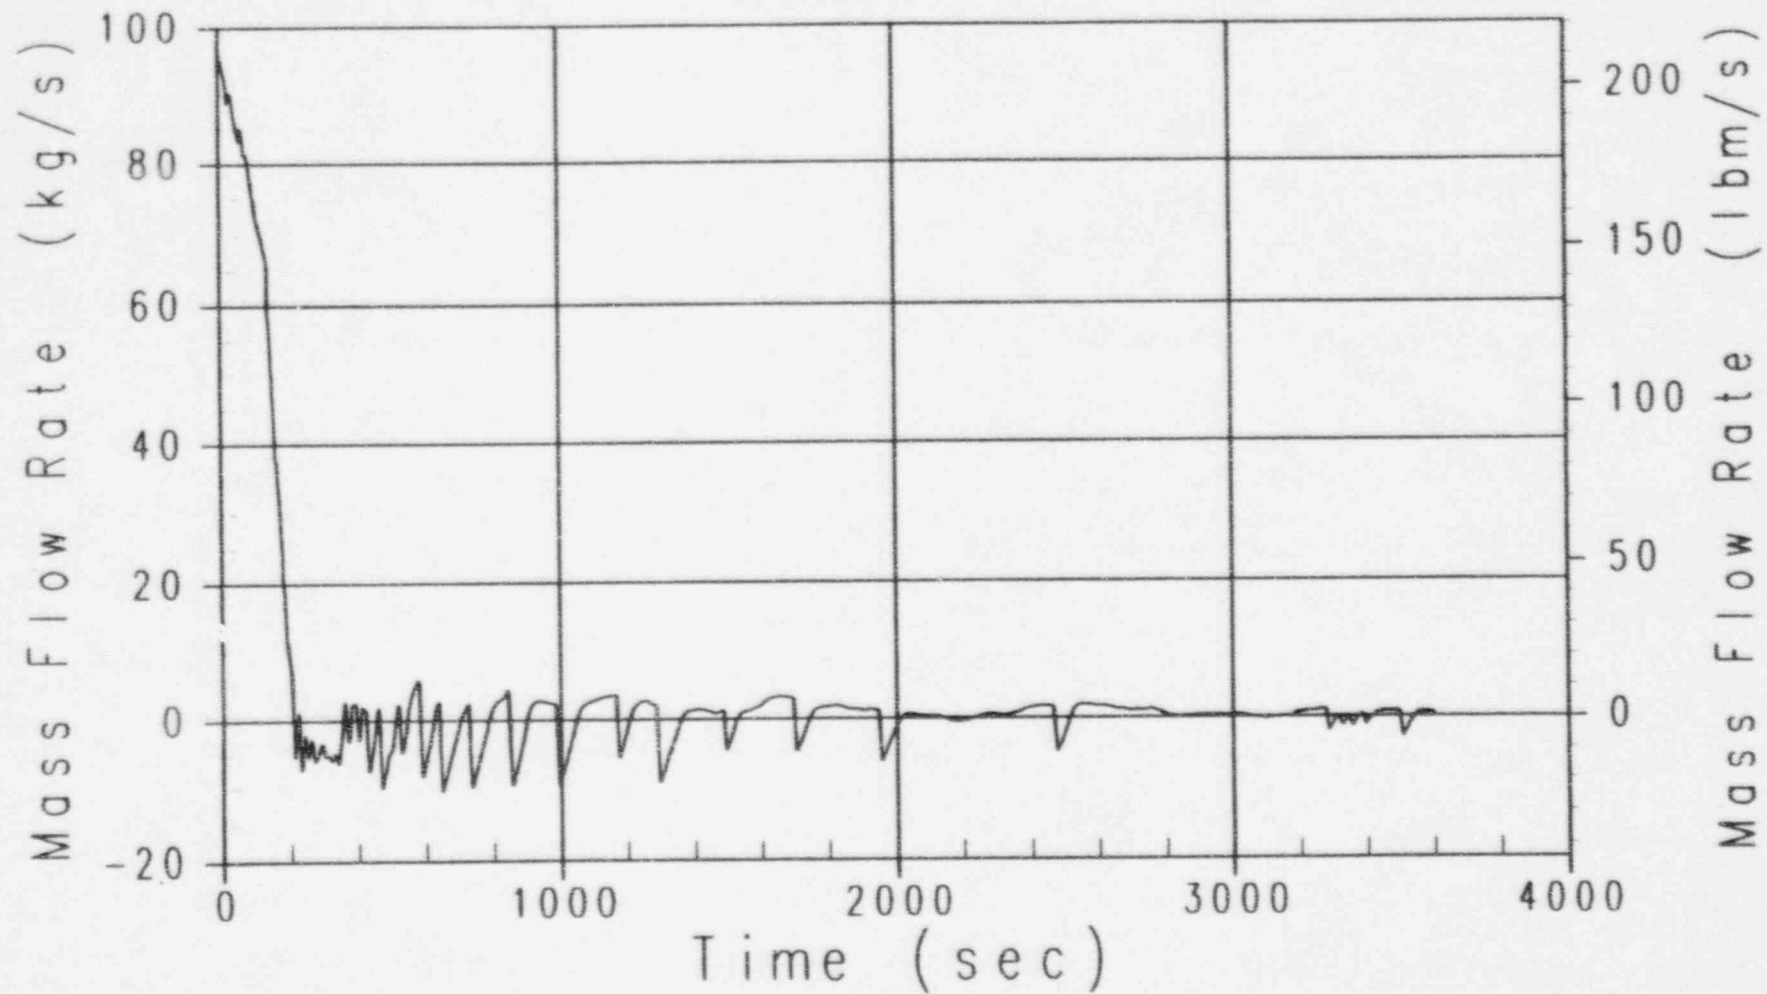
Figure 109

AP600 4 Tube Multiple SGTR with PORV Failure
Tube Rupture Break Flow

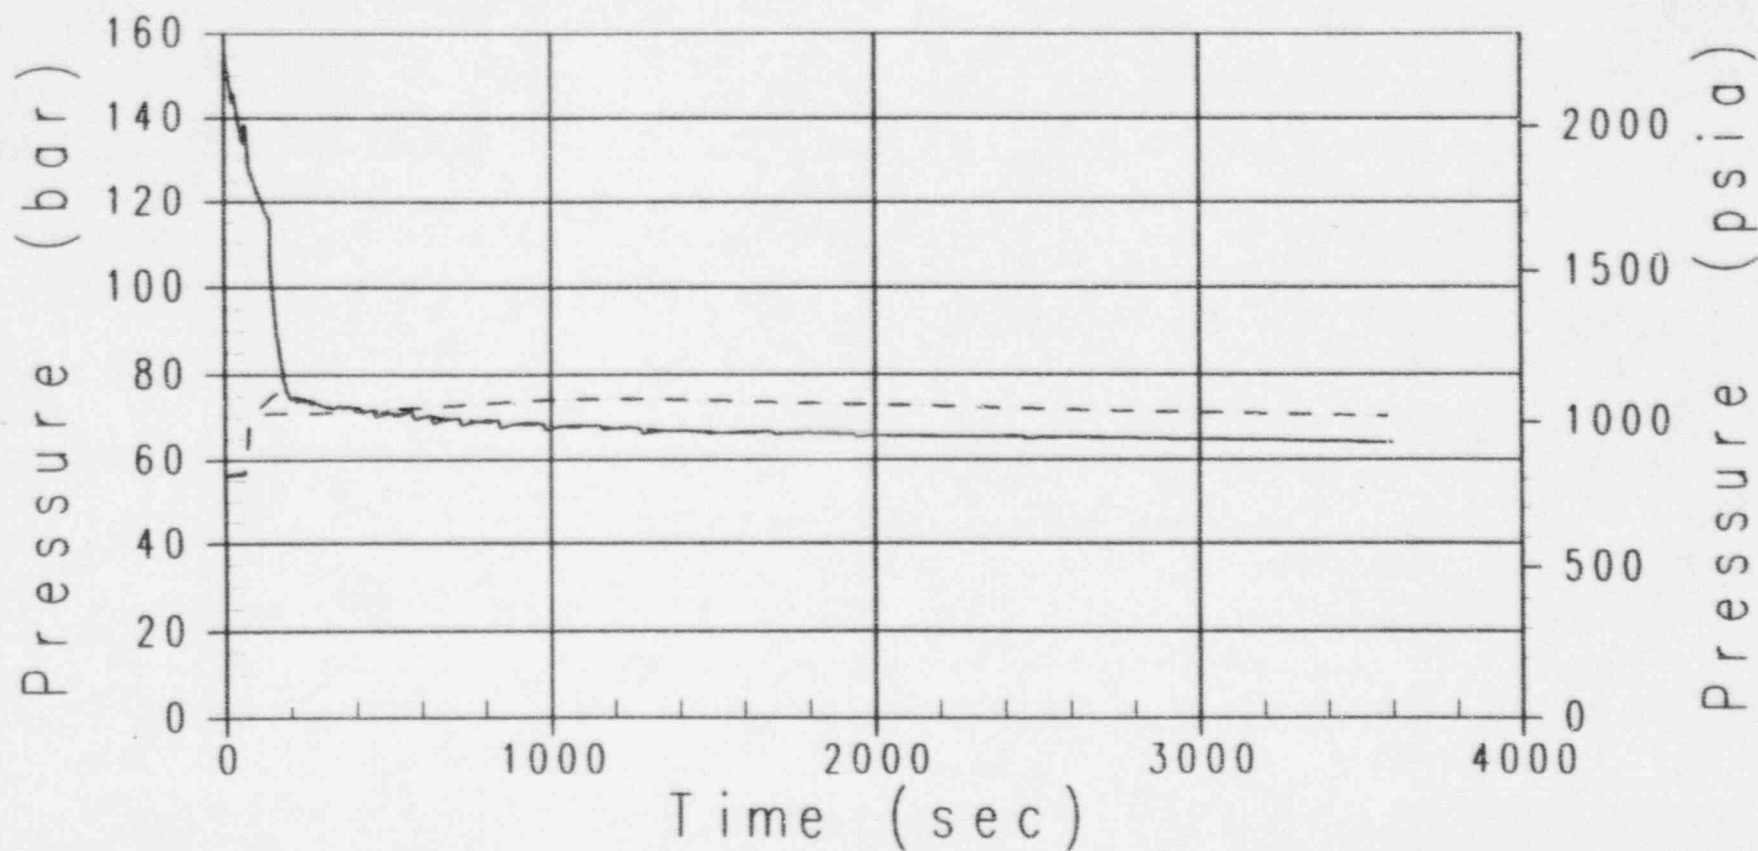
Figure 110

AP600 4 Tube Multiple SGTR with PORV Failure
RCS and Secondary Systems Pressures

—— RCS
- - - - Faulted SG
- - - - Unfaulted SG

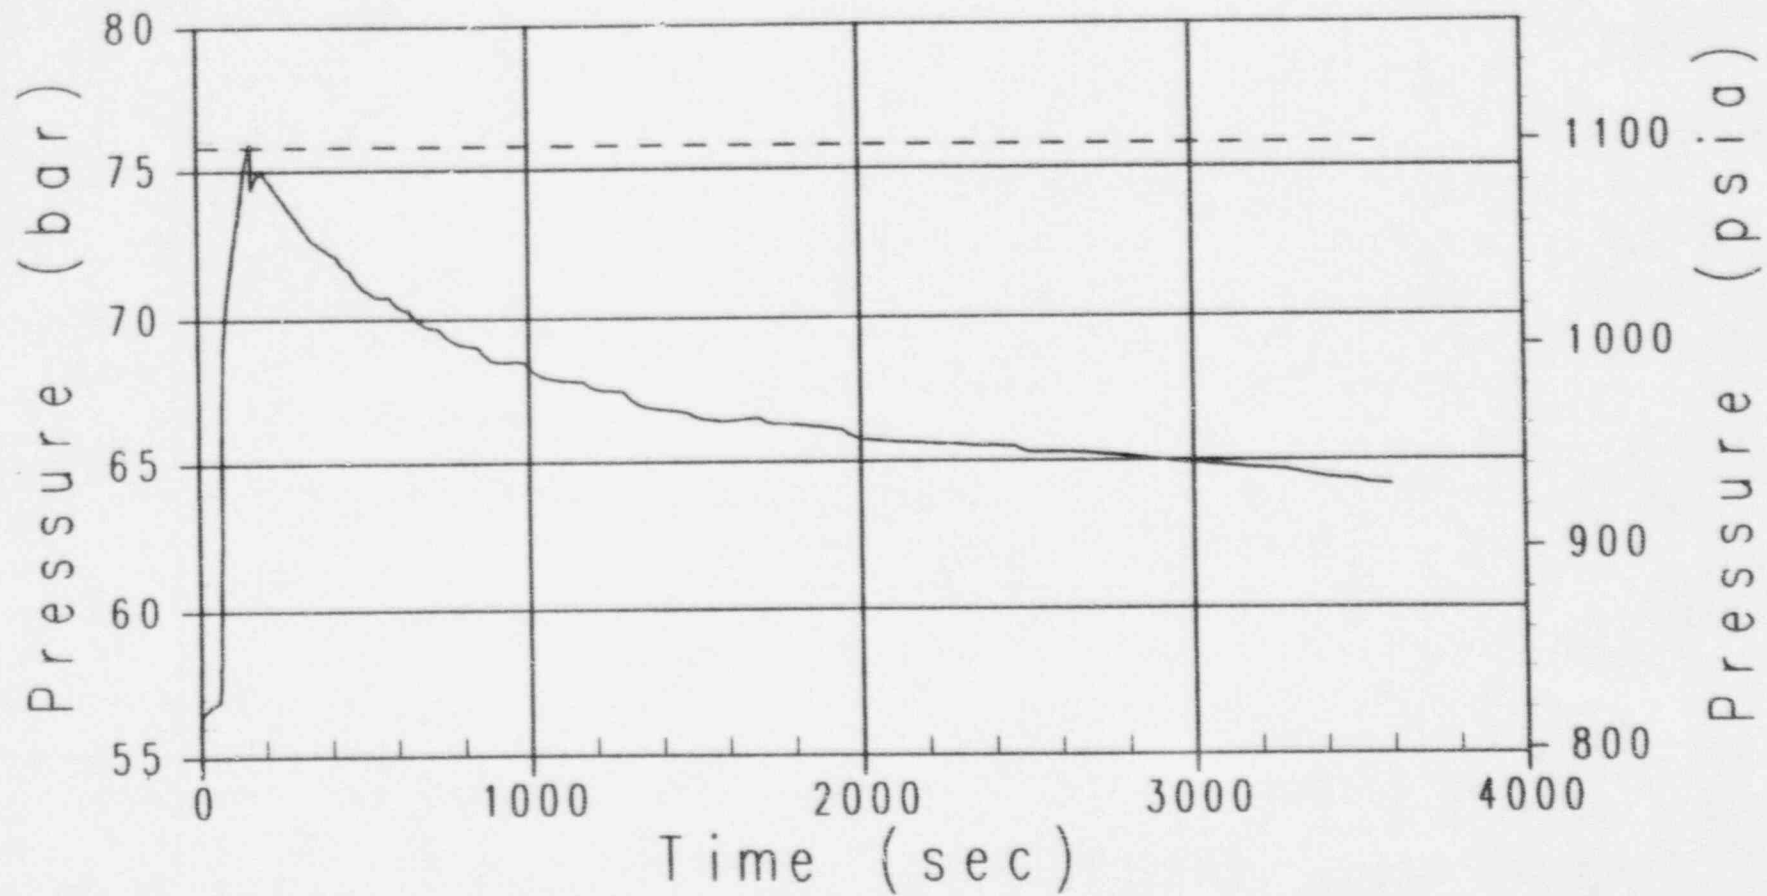
Figure 111

AP600 4 Tube Multiple SGTR with PORV Failure
Faulted Steam Generator Pressure

—— Faulted SG
---- Safety Valve Setpoint

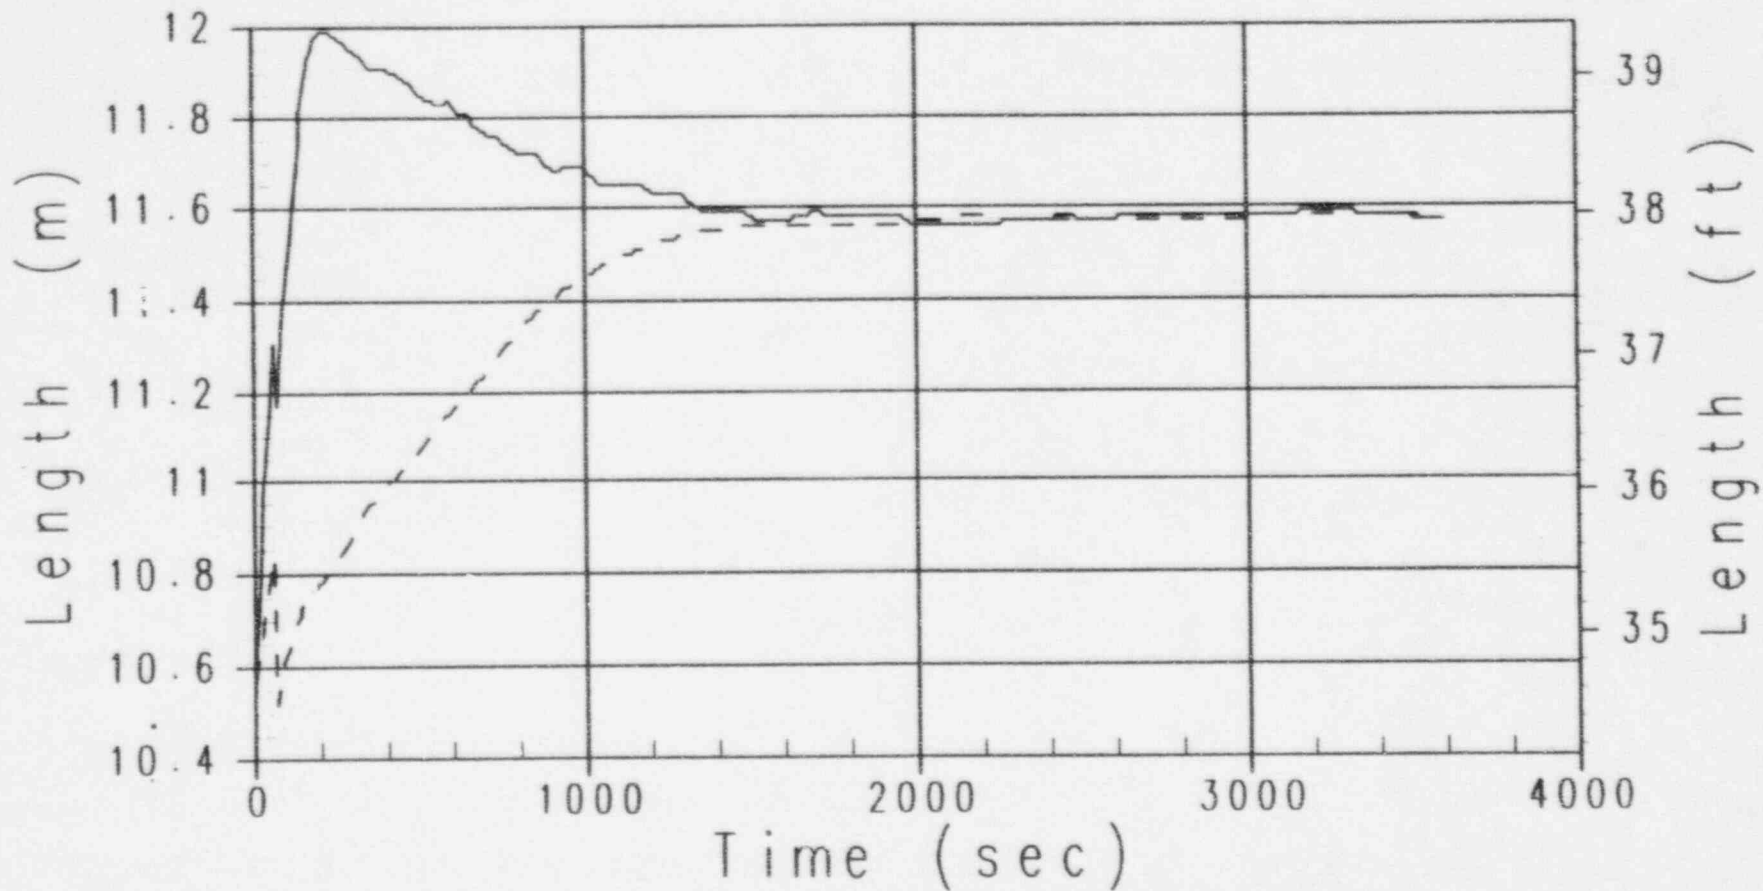
Figure 112

AP600 4 Tube Multiple SGTR with PORV Failure
Steam Generator Downcomer Water Level

———— Faulted SG
----- Unfaulted SG

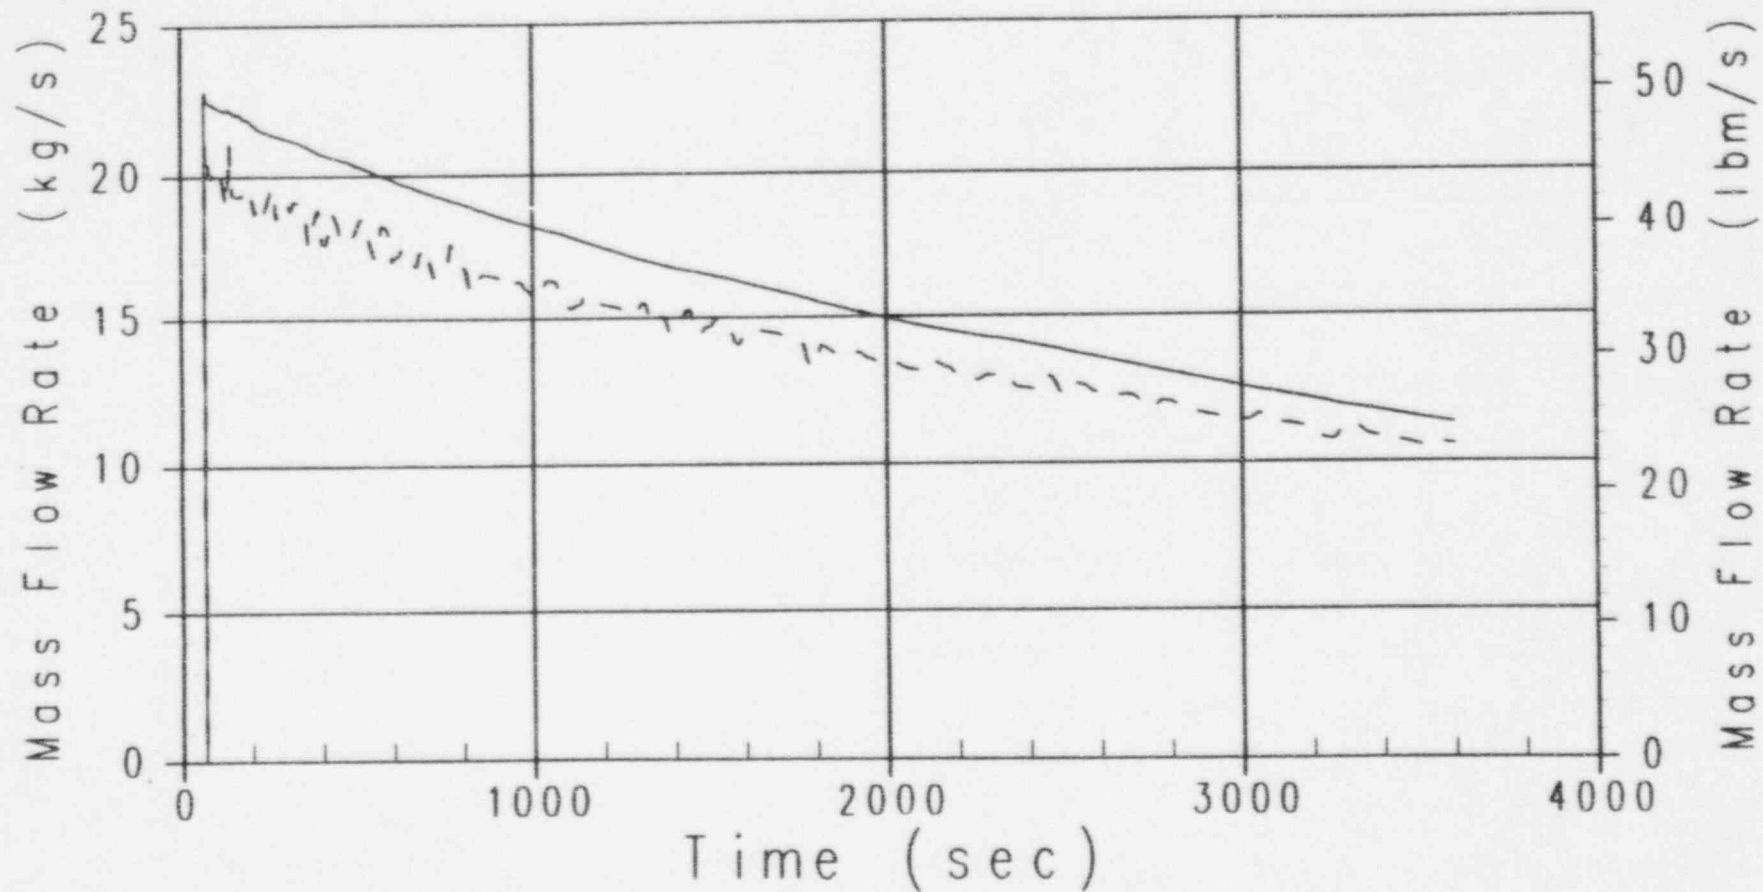
Figure 113

AP600 4 Tube Multiple SGTR with PORV Failure
CMT Water Mass Flowrates

— Dischage Line
--- Balance Line

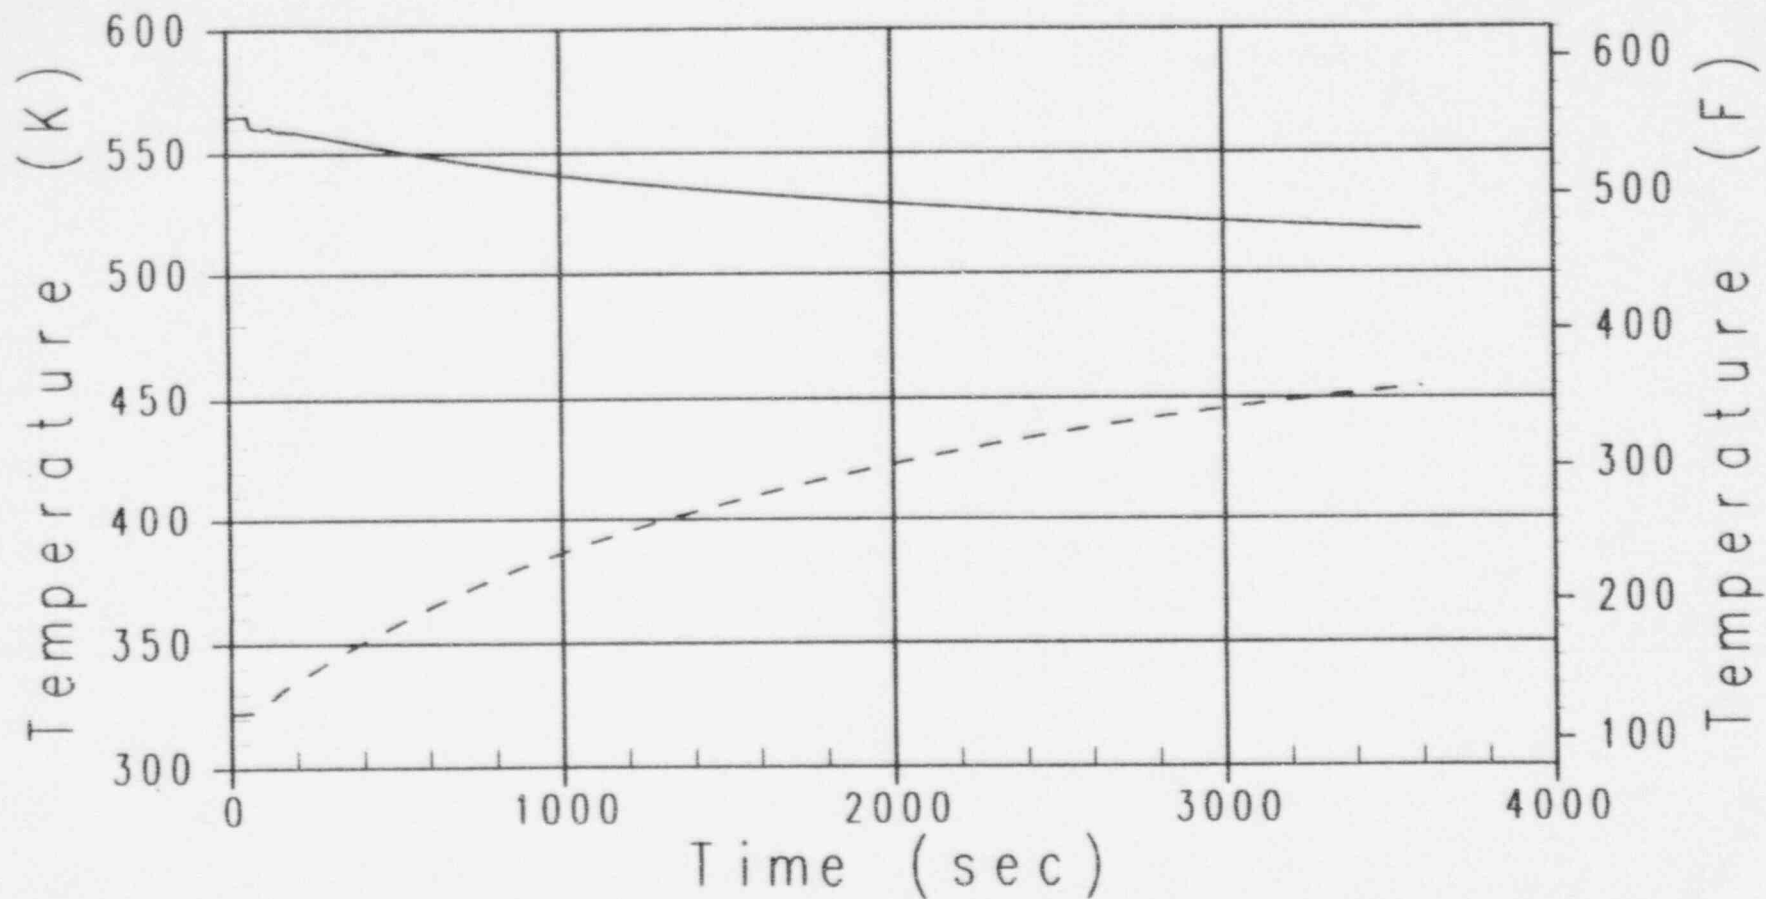
Figure 114

AP600 4 Tube Multiple SGTR with PORV Failure
RCS and CMT Water Temperatures

— RCS Core Water
- - - CMT Water

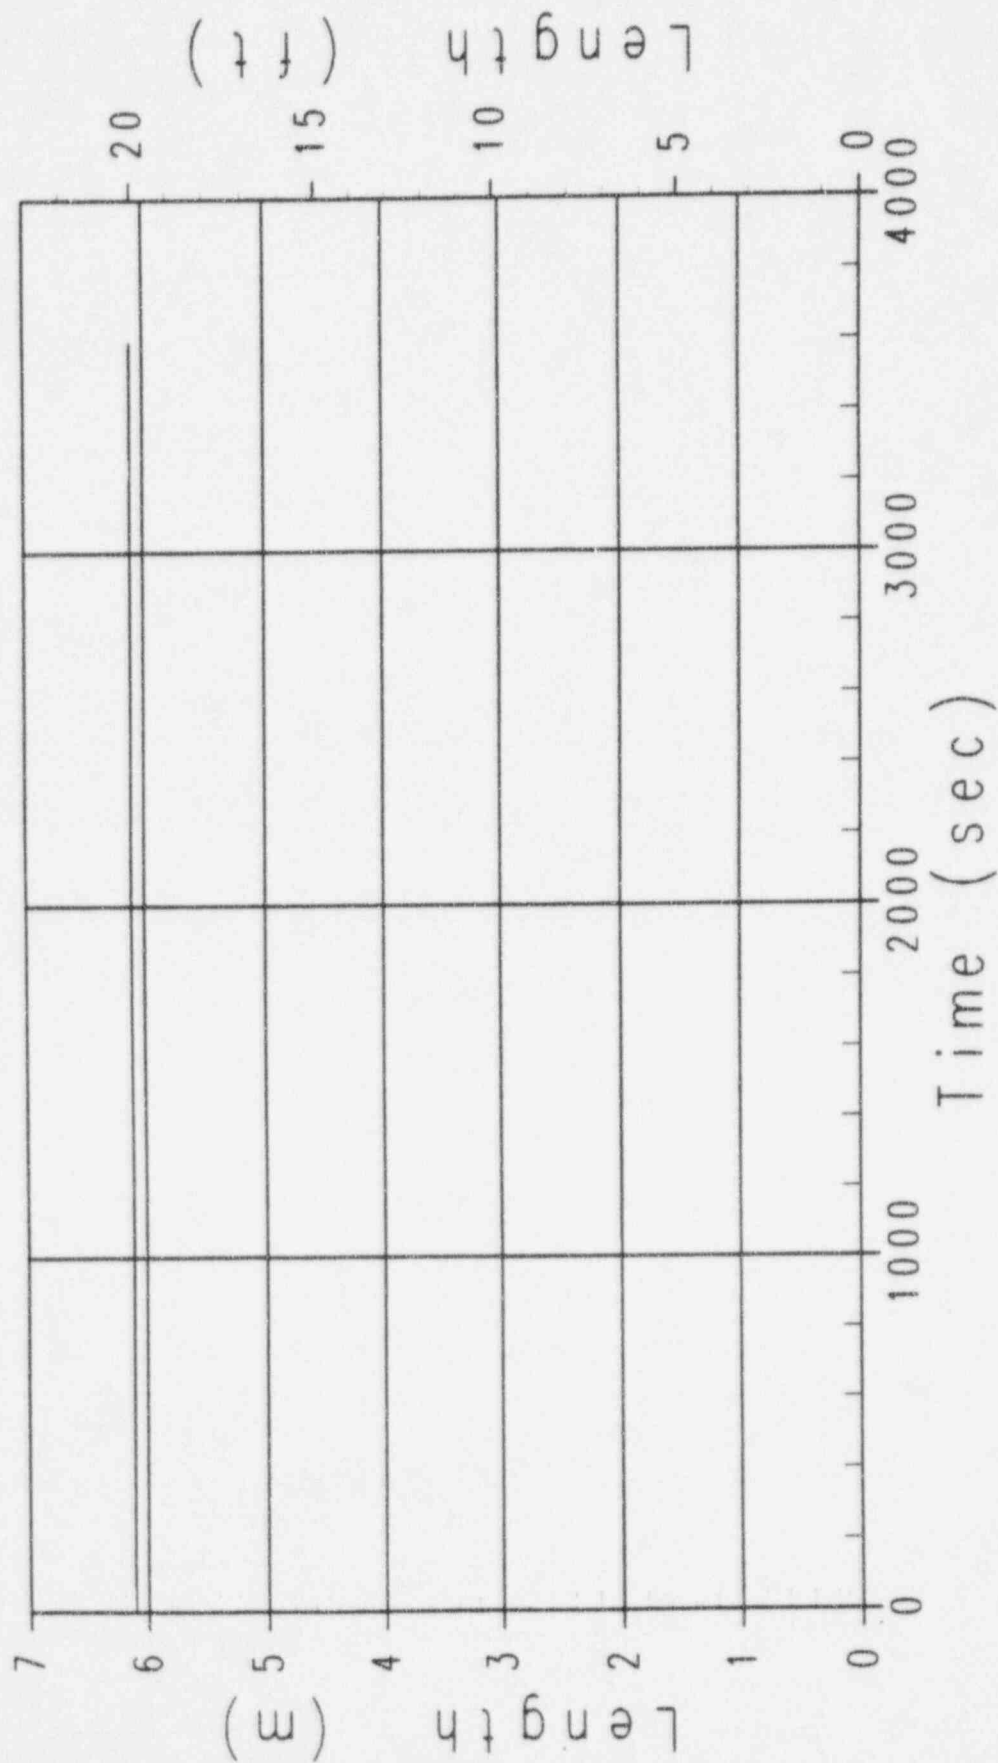
Figure 115

AP600 4 Tube Multiple SGTR with PORV Failure
CMT Water Level

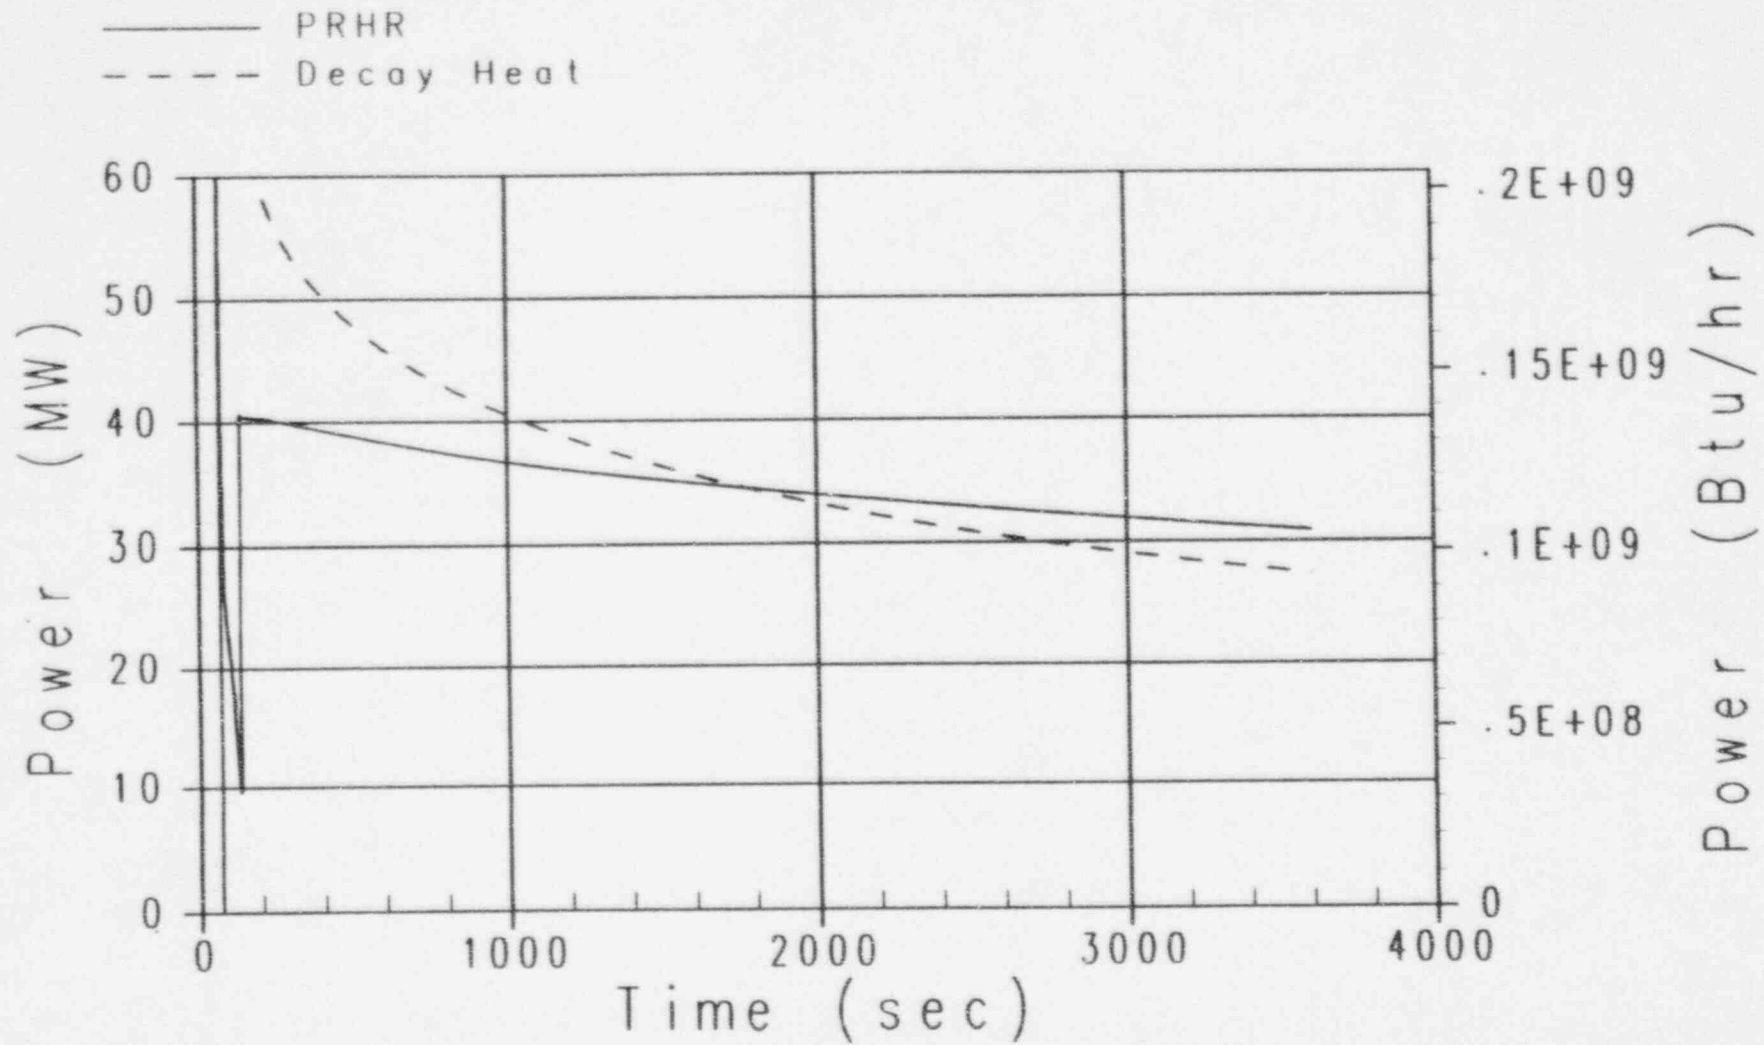
Figure 116

AP600 4 Tube Multiple SGTR with PORV Failure
PRHR Heat Removal

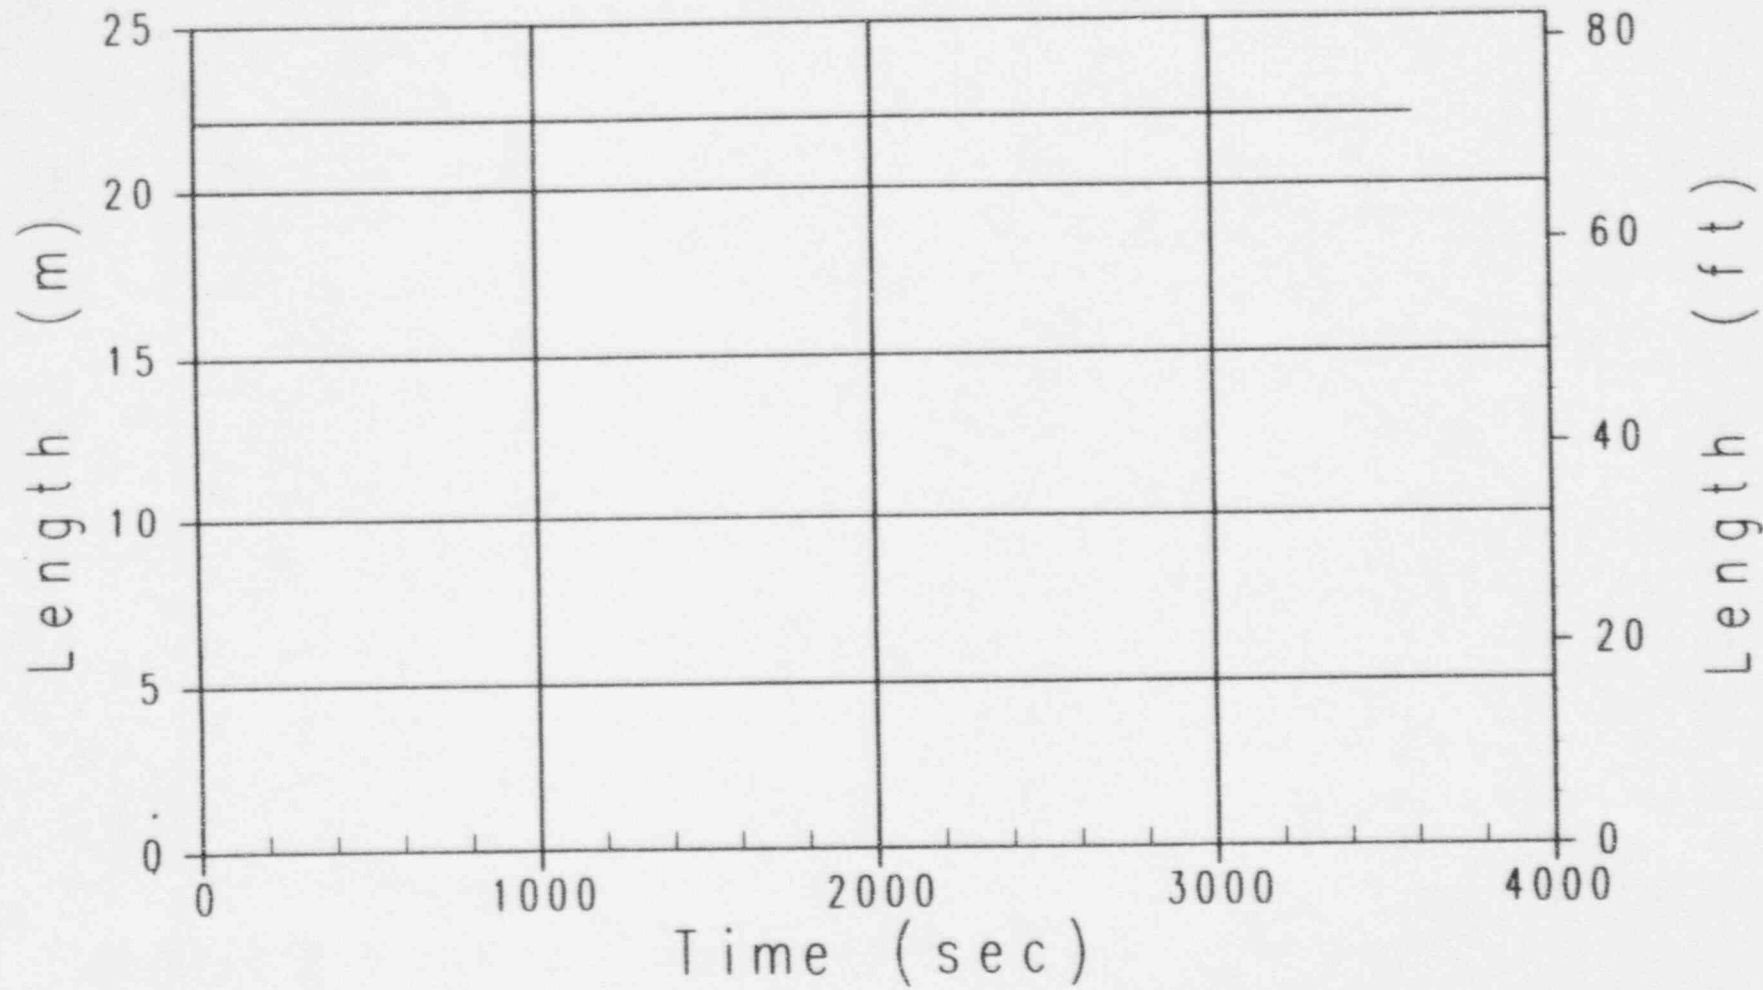
Figure 117

AP600 4 Tube Multiple SGTR with PORV Failure
RCS Water Level

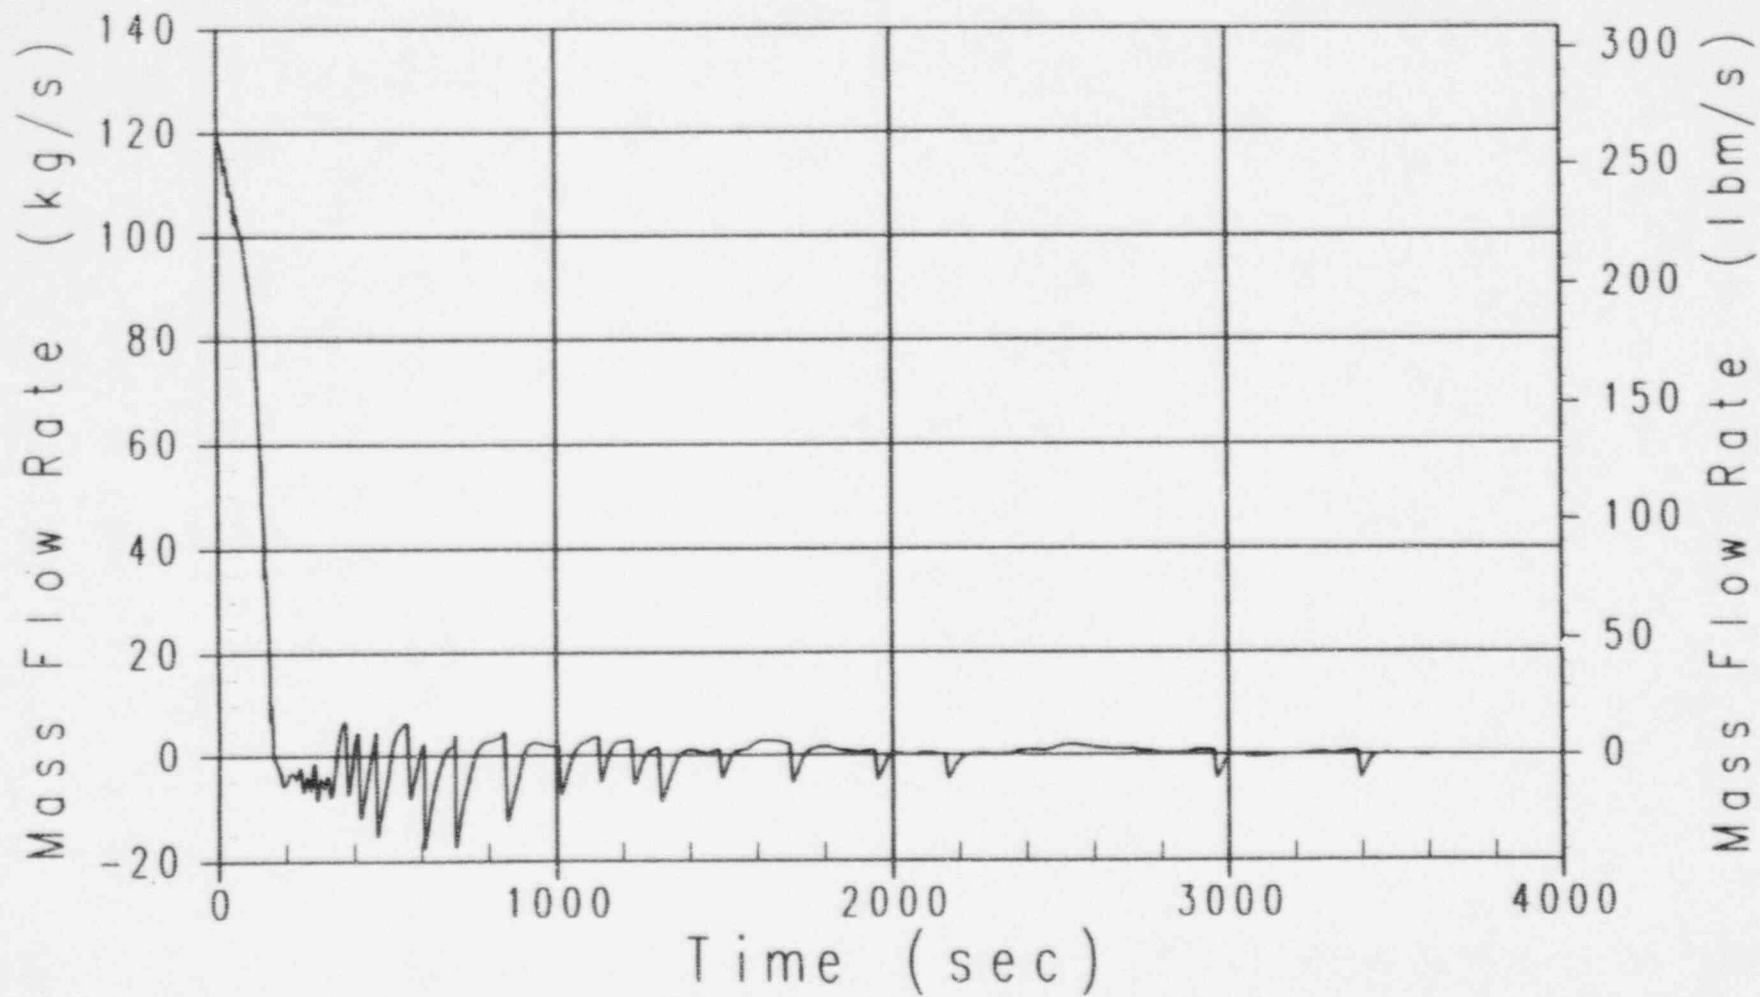
Figure 118

AP600 5 Tube Multiple SGTR with PORV Failure
Tube Rupture Break Flow

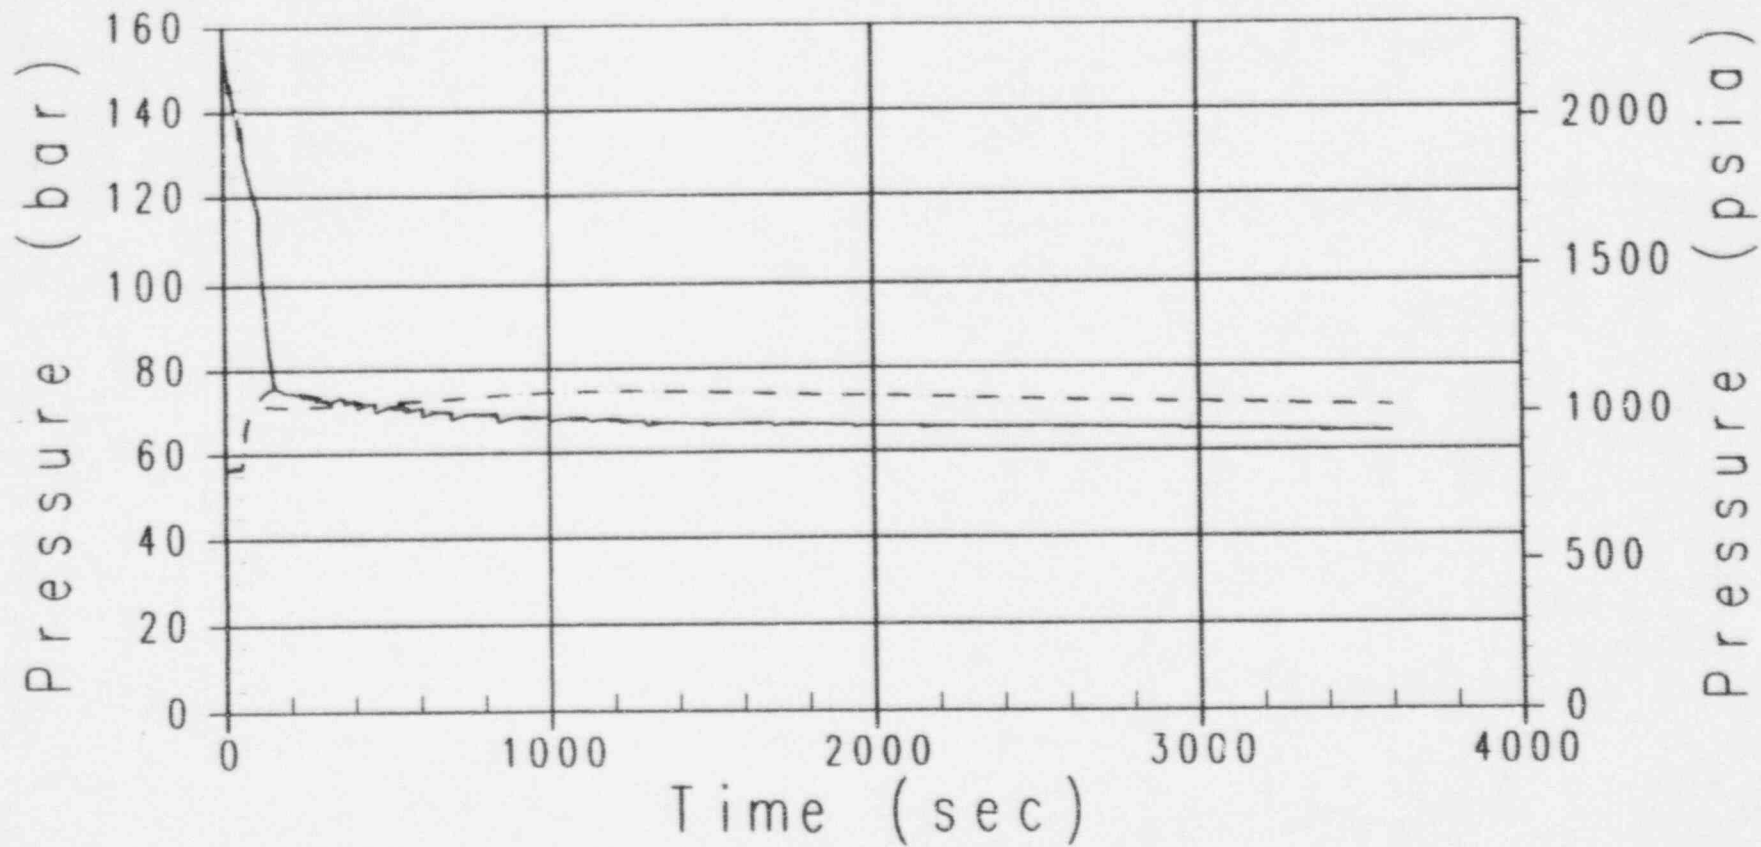
Figure 119

AP600 5 Tube Multiple SGTR with PORV Failure
RCS and Secondary Systems Pressures

—— RCS
---- Faulted SG
---- Unfaulted SG

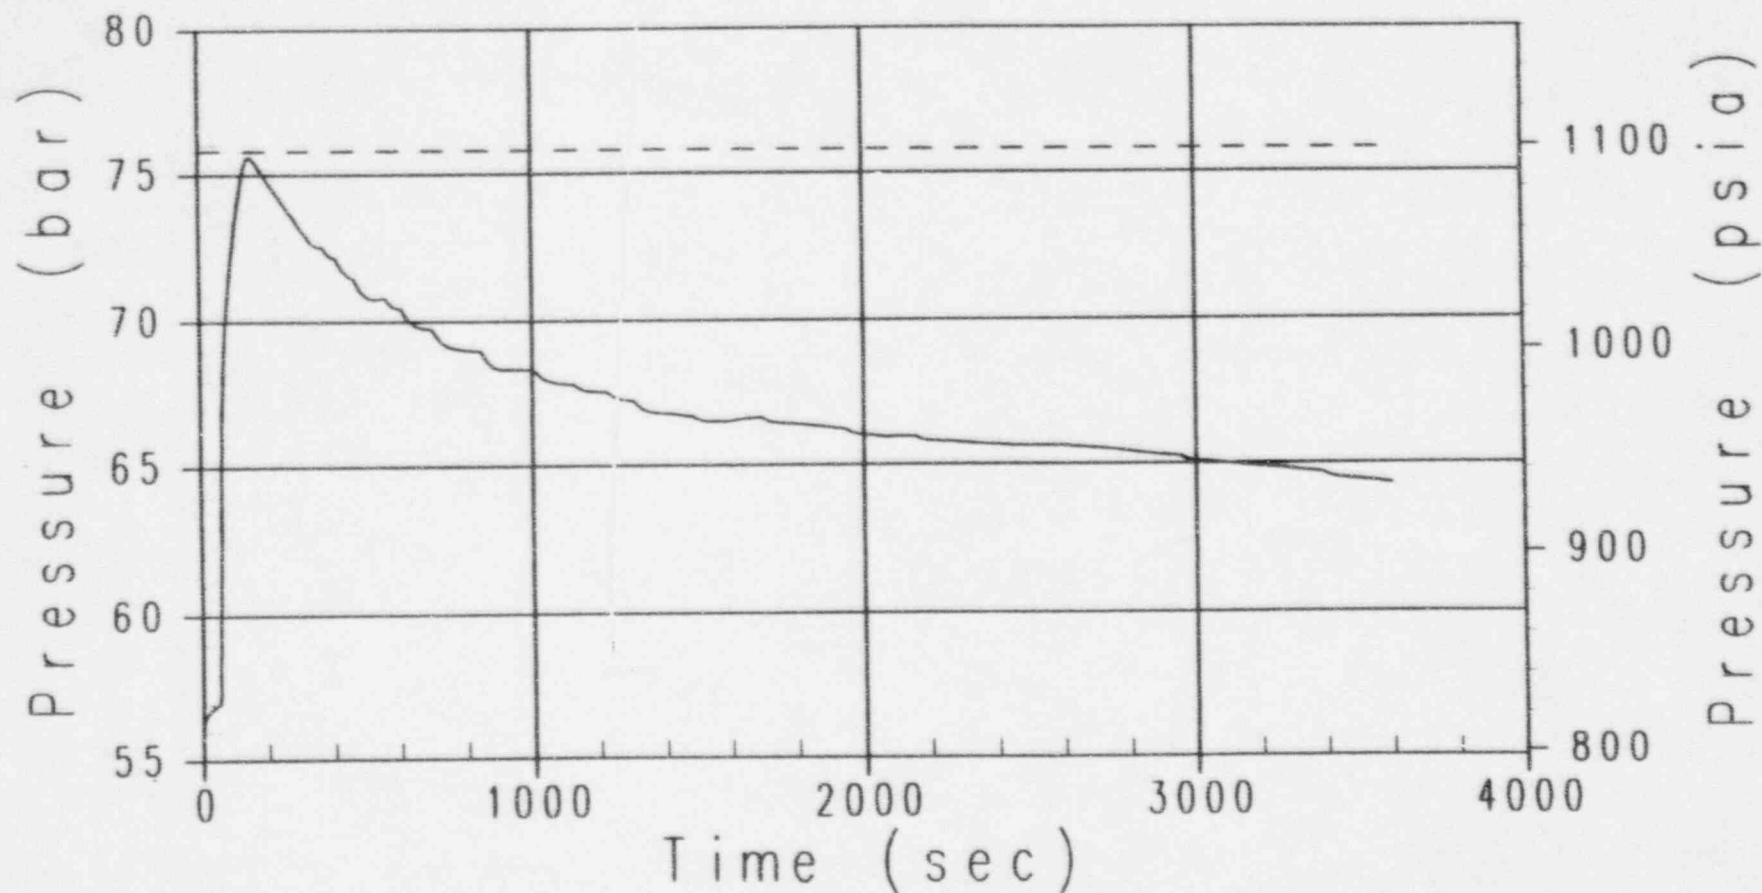
Figure 120

AP600 5 Tube Multiple SGTR with PORV Failure
Faulted Steam Generator Pressure

—— Faulted SG
---- Safety Valve Setpoint

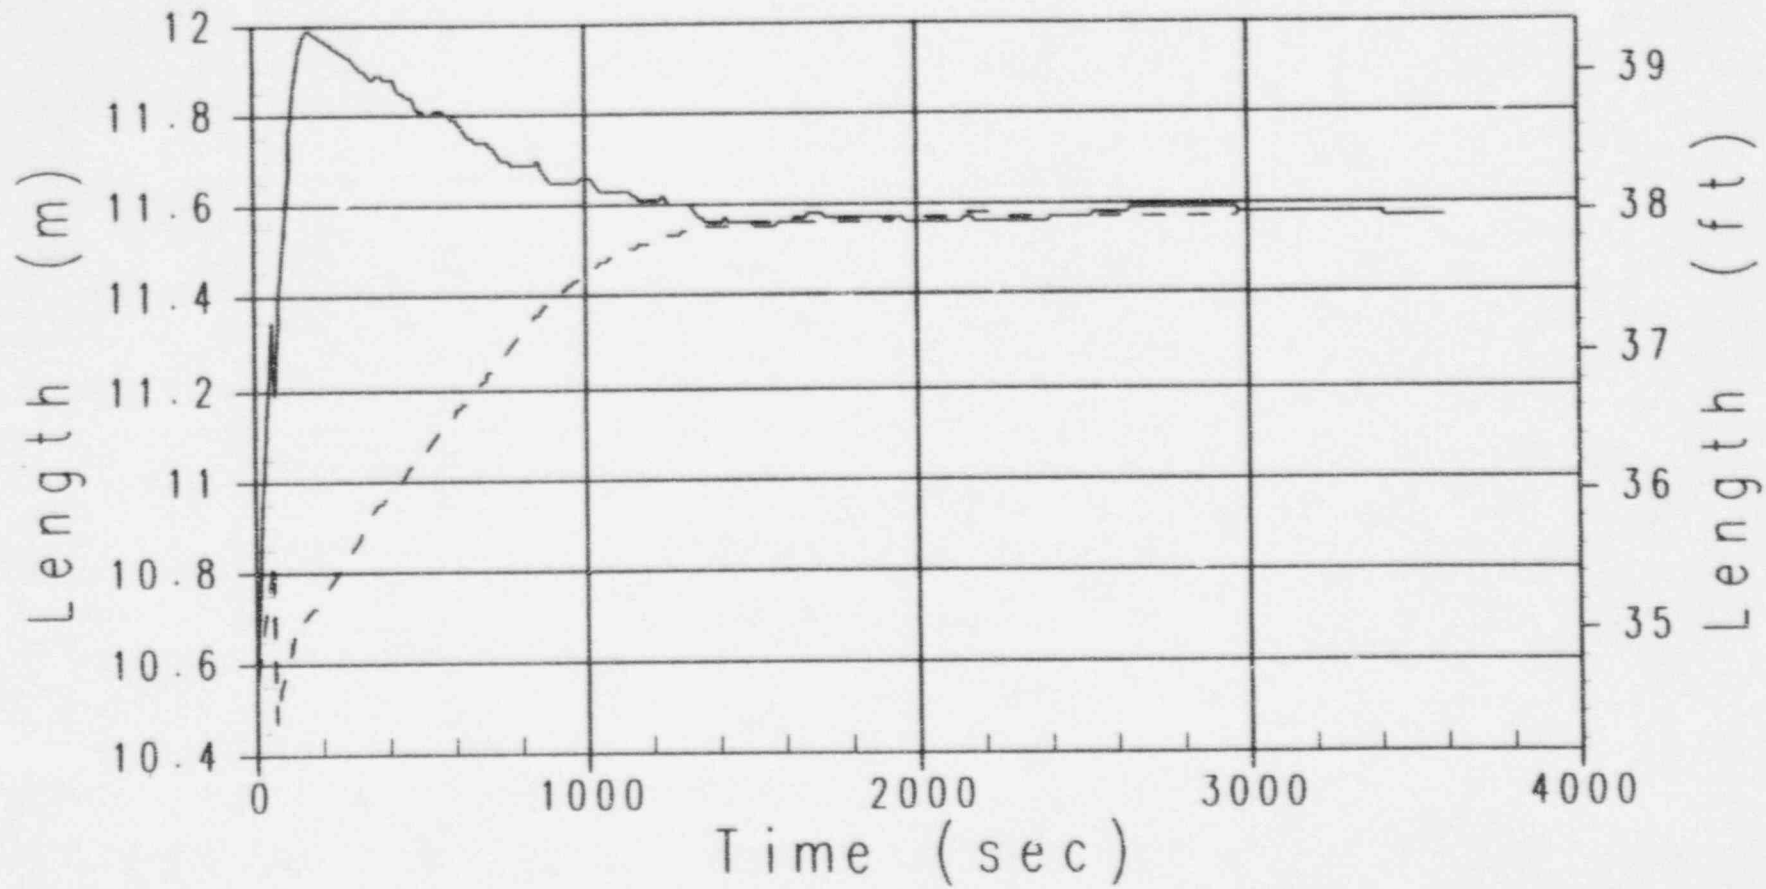
Figure 121

AP600 5 Tube Multiple SGTR with PORV Failure
Steam Generator Downcomer Water Level

———— Faulted SG
----- Unfaulted SG

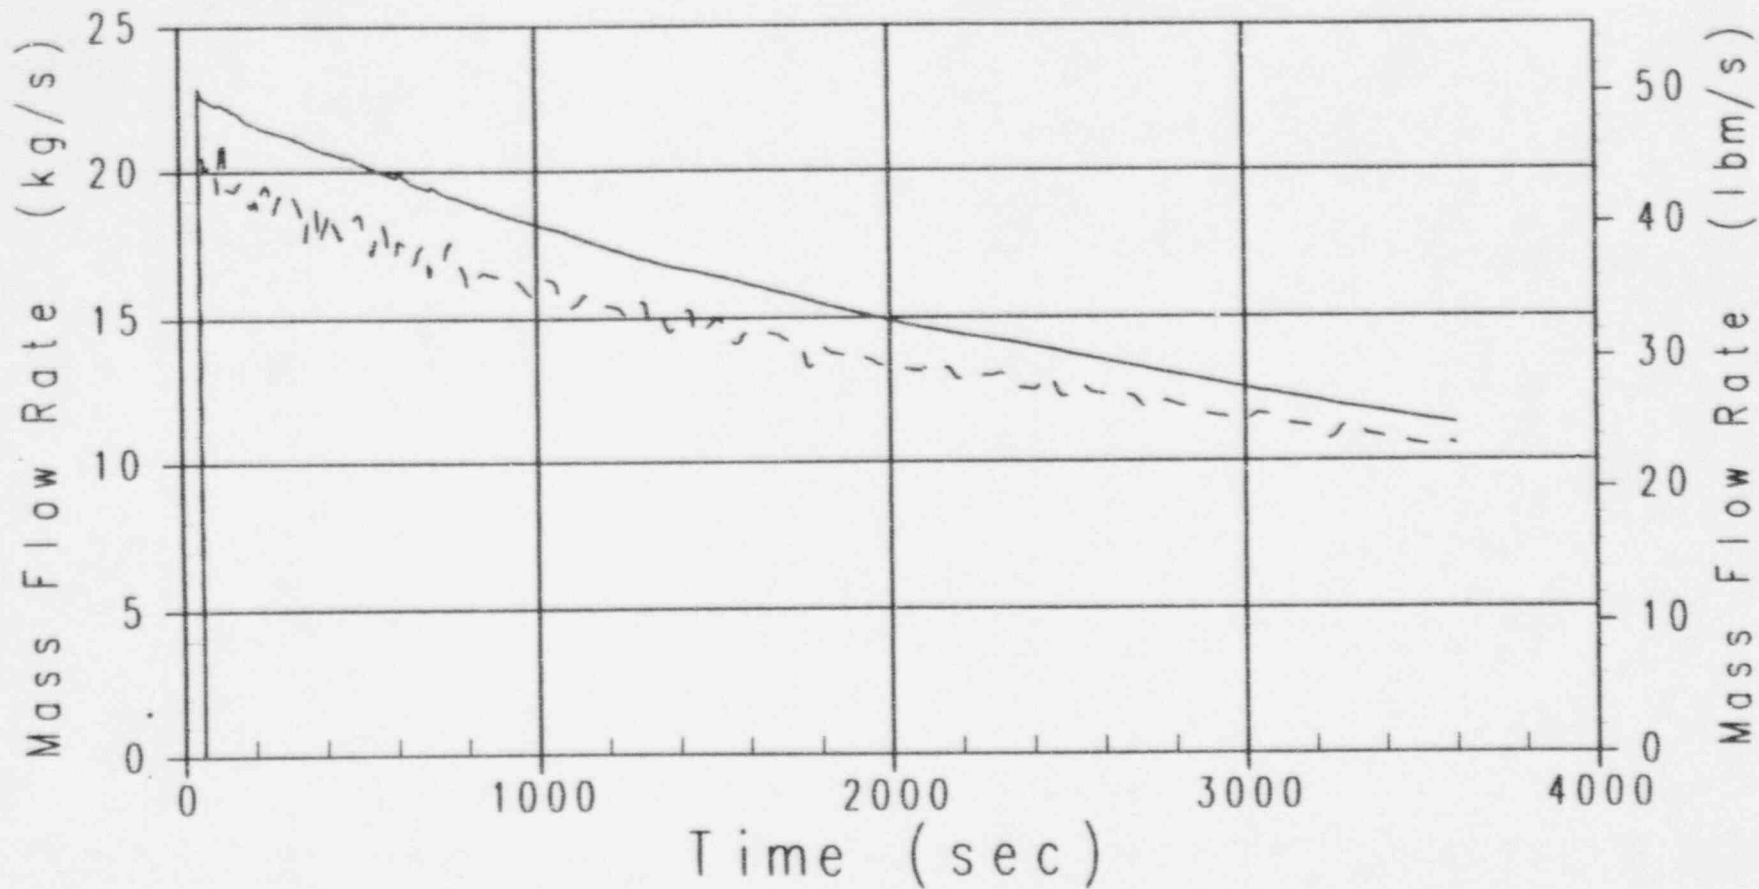
Figure 122

AP600 5 Tube Multiple SGTR with PORV Failure
CMT Water Mass Flowrates

— Dischage Line
- - - Balance Line
