Westinghouse
Electric Corporation

SUBJECT: AP600 MULTIPLE STEAM GENERATOR TUBE RUPTURE ANALYSIS IN
SUPPORT OF RAIS 440.27 AND 440.170 (Revision 2)

AP600 Multiple Steam Generator Tube Rupture Analysis

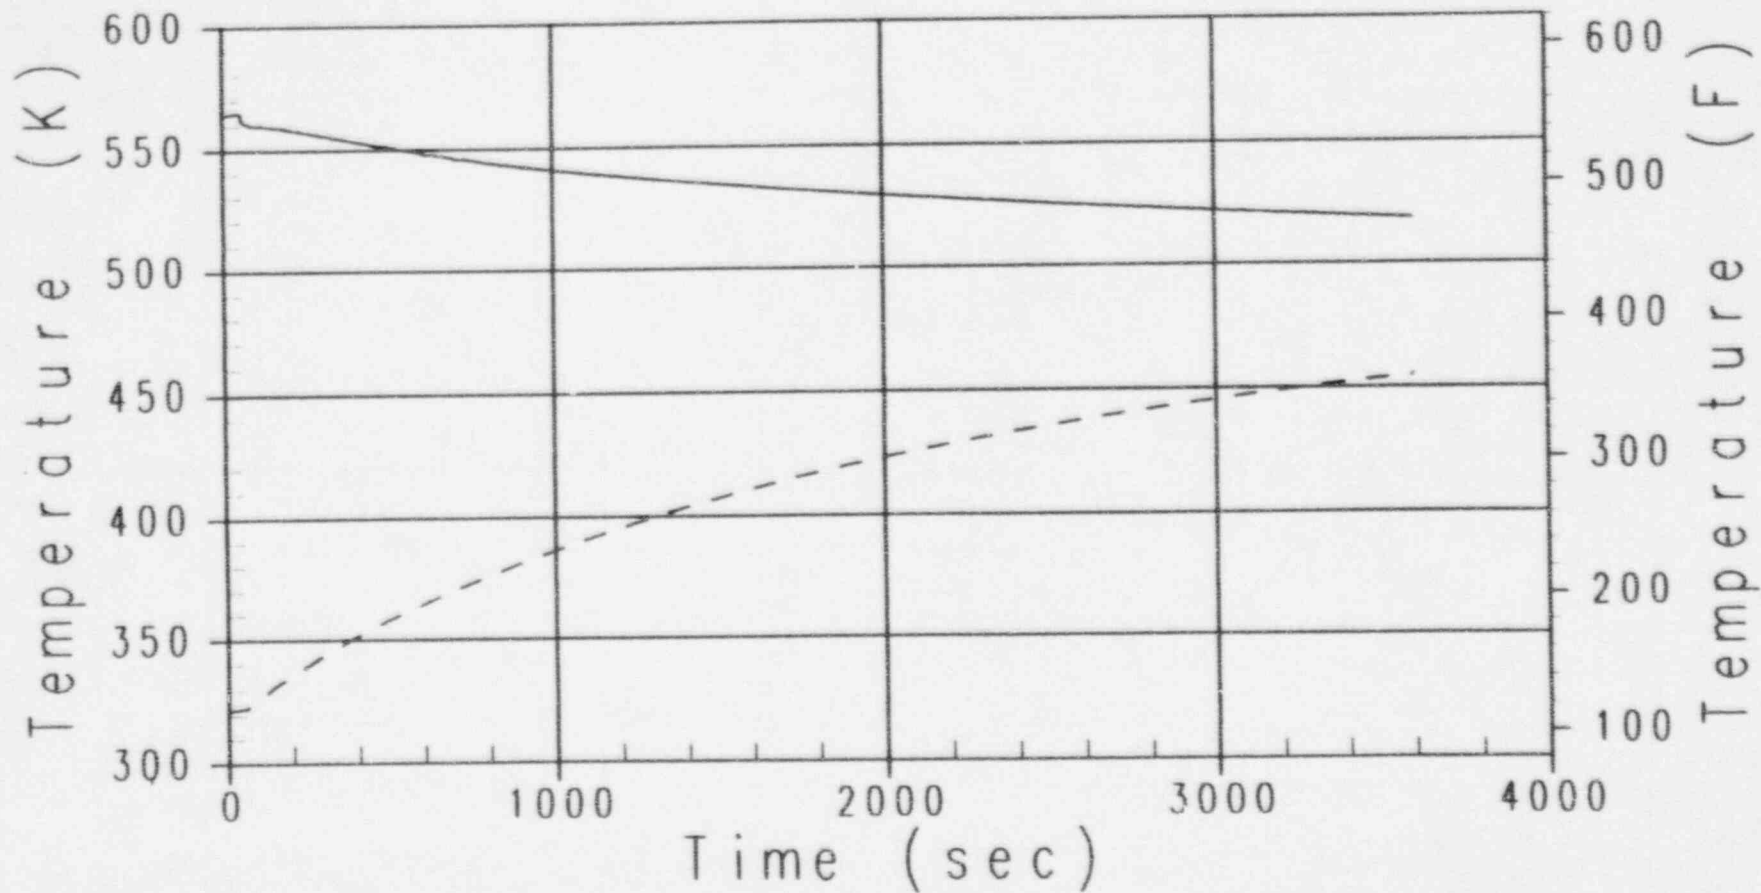
Figure 123

**AP600 5 Tube Multiple SGTR with PORV Failure
RCS and CMT Water Temperatures**

— RCS Core Water
- - - CMT Water

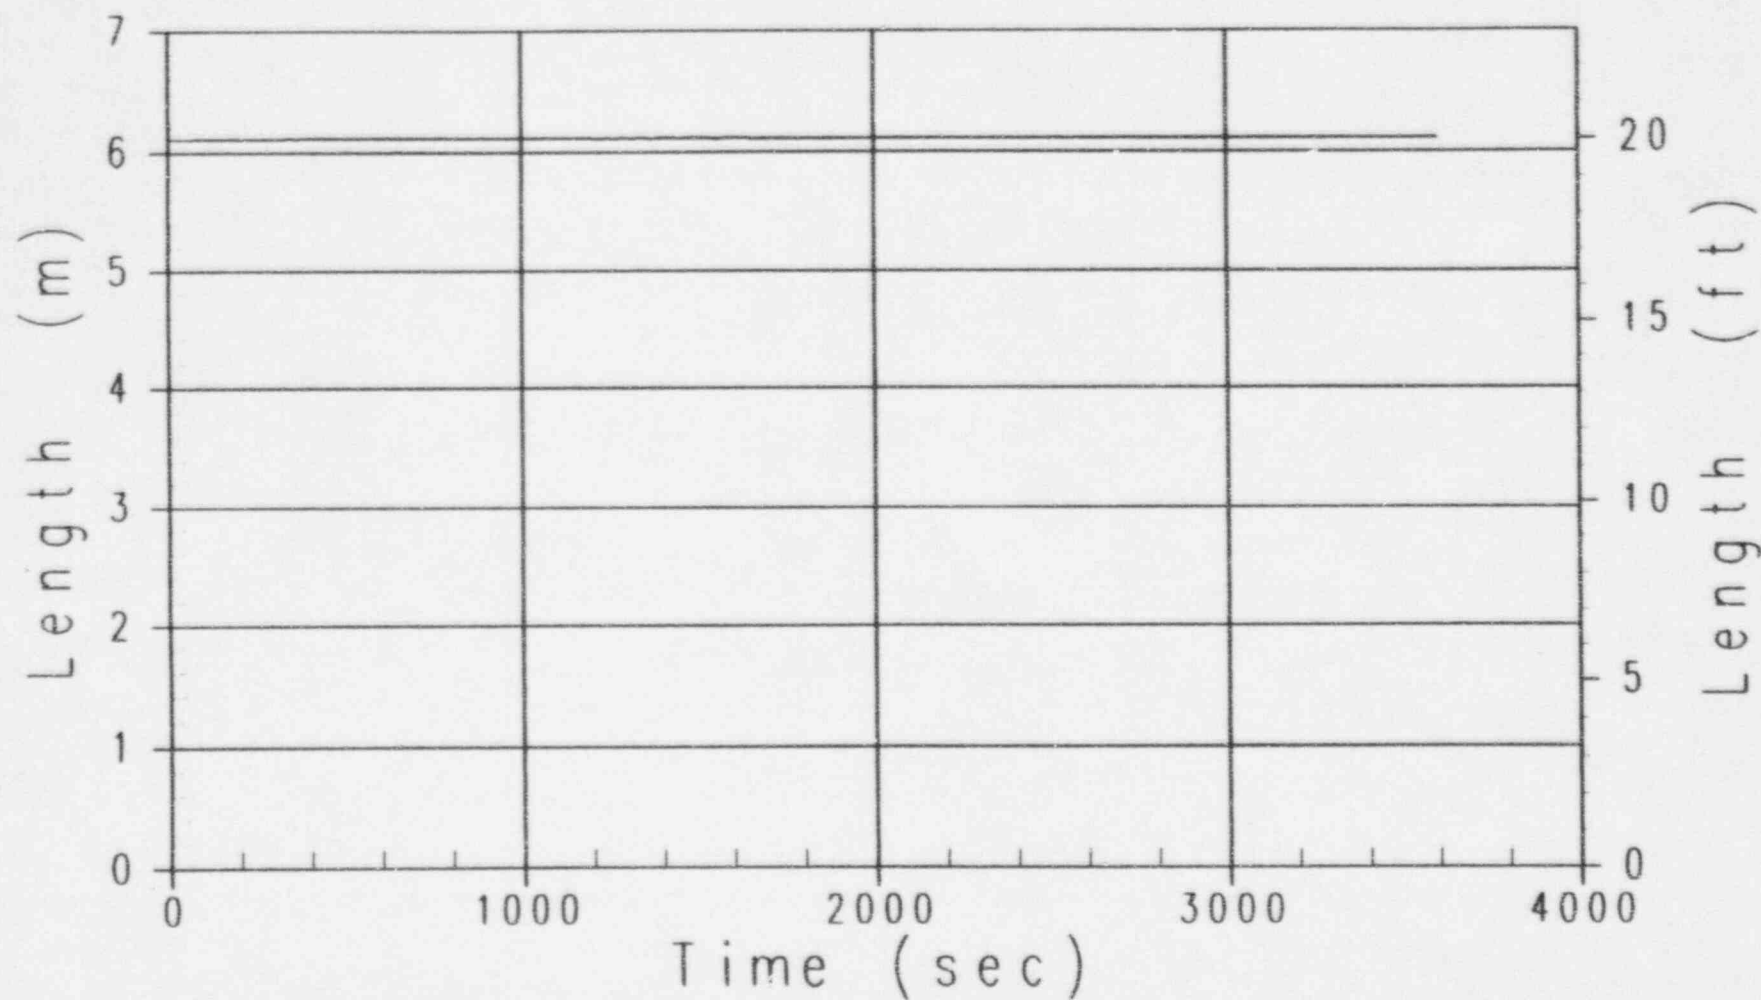
Figure 124

AP600 5 Tube Multiple SGTR with PORV Failure
CMT Water Level

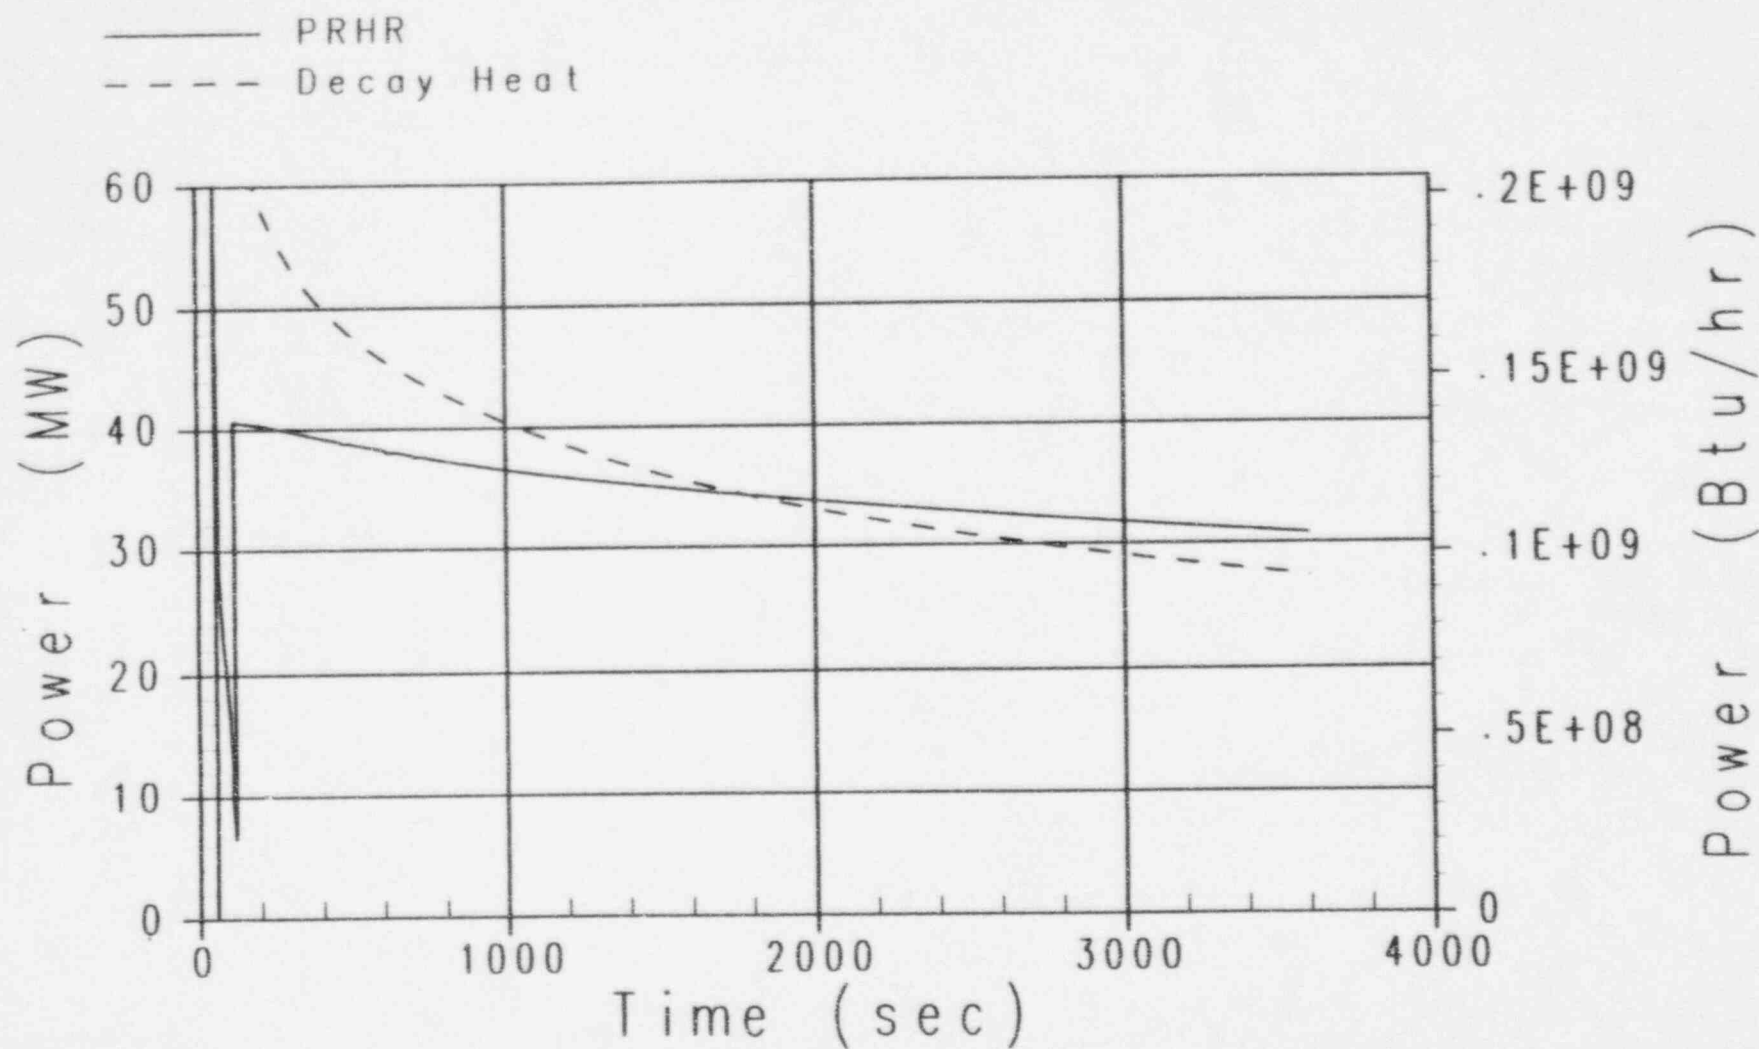
Figure 125

AP600 5 Tube Multiple SGTR with PORV Failure
PRHR Heat Removal

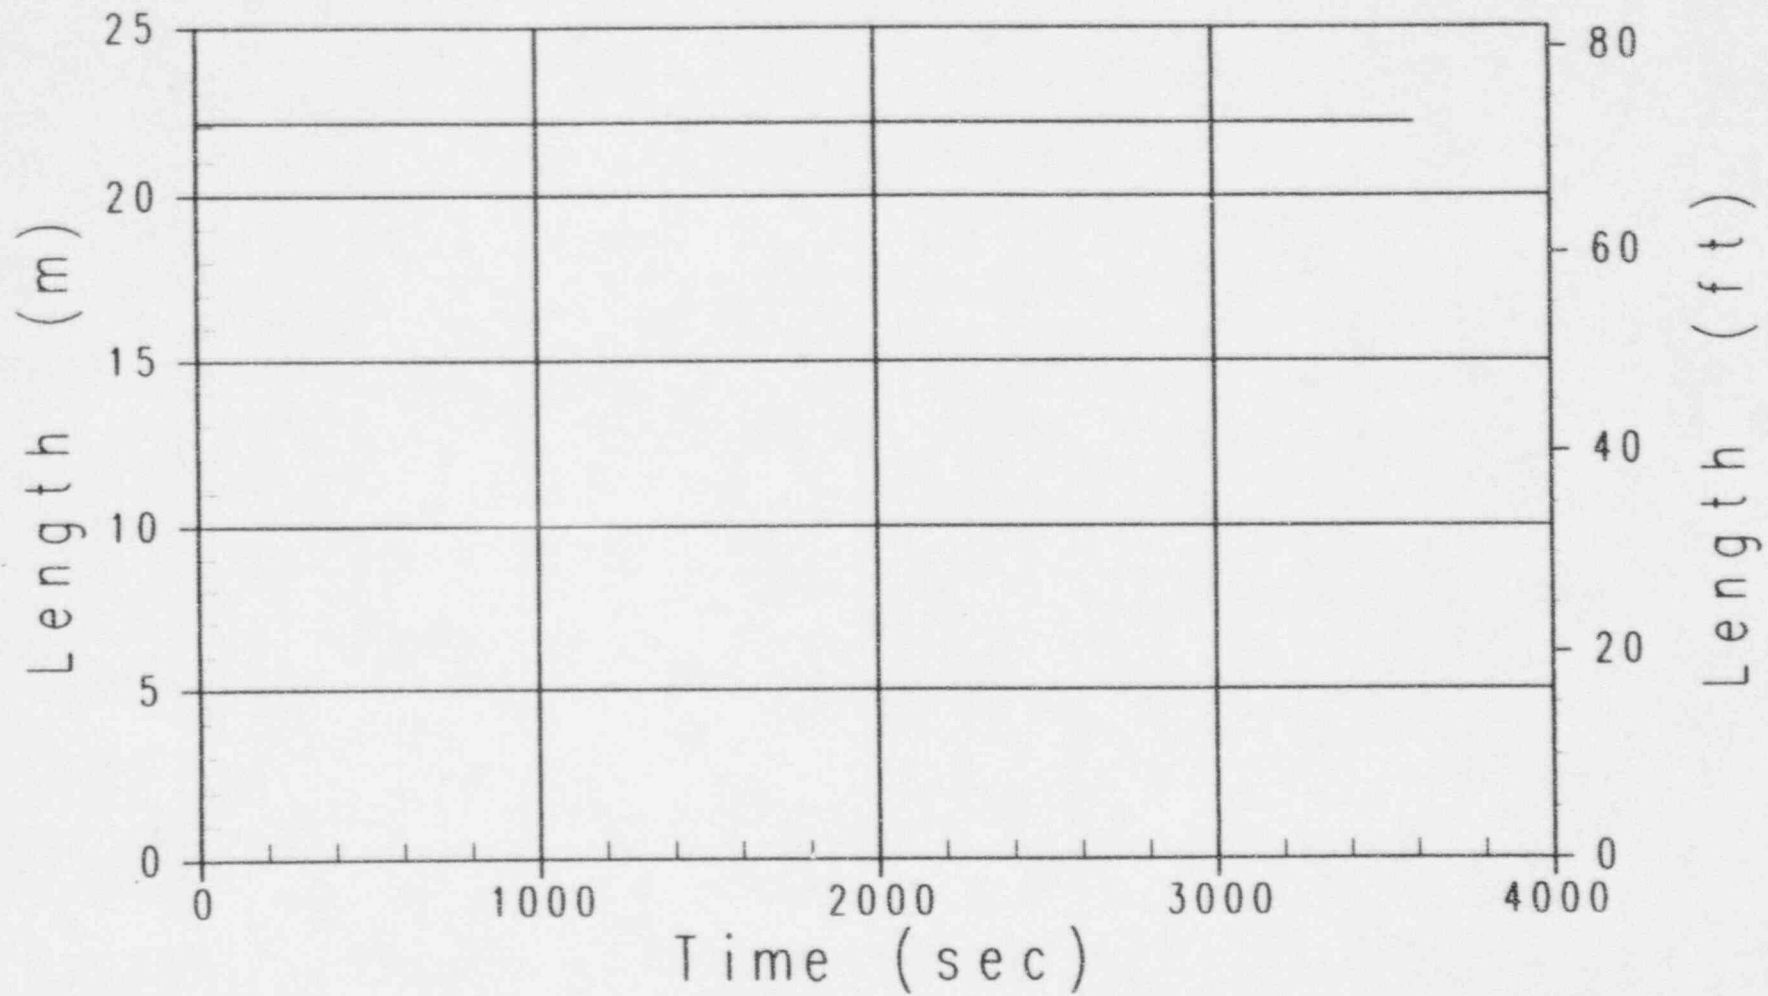
Figure 126

AP600 5 Tube Multiple SGTR with PORV Failure
RCS Water Level
