I.T.L. REPORT NO. 82-11-80

ONE-HOUR FIRE ENDURANCE TESTS CONDUCTED ON

TEST ARTICLES CONTAINING "GENERIC" CABLES

THERMO-LAG 330-1 SUBLIMING COATING ENVELOPE SYSTEM

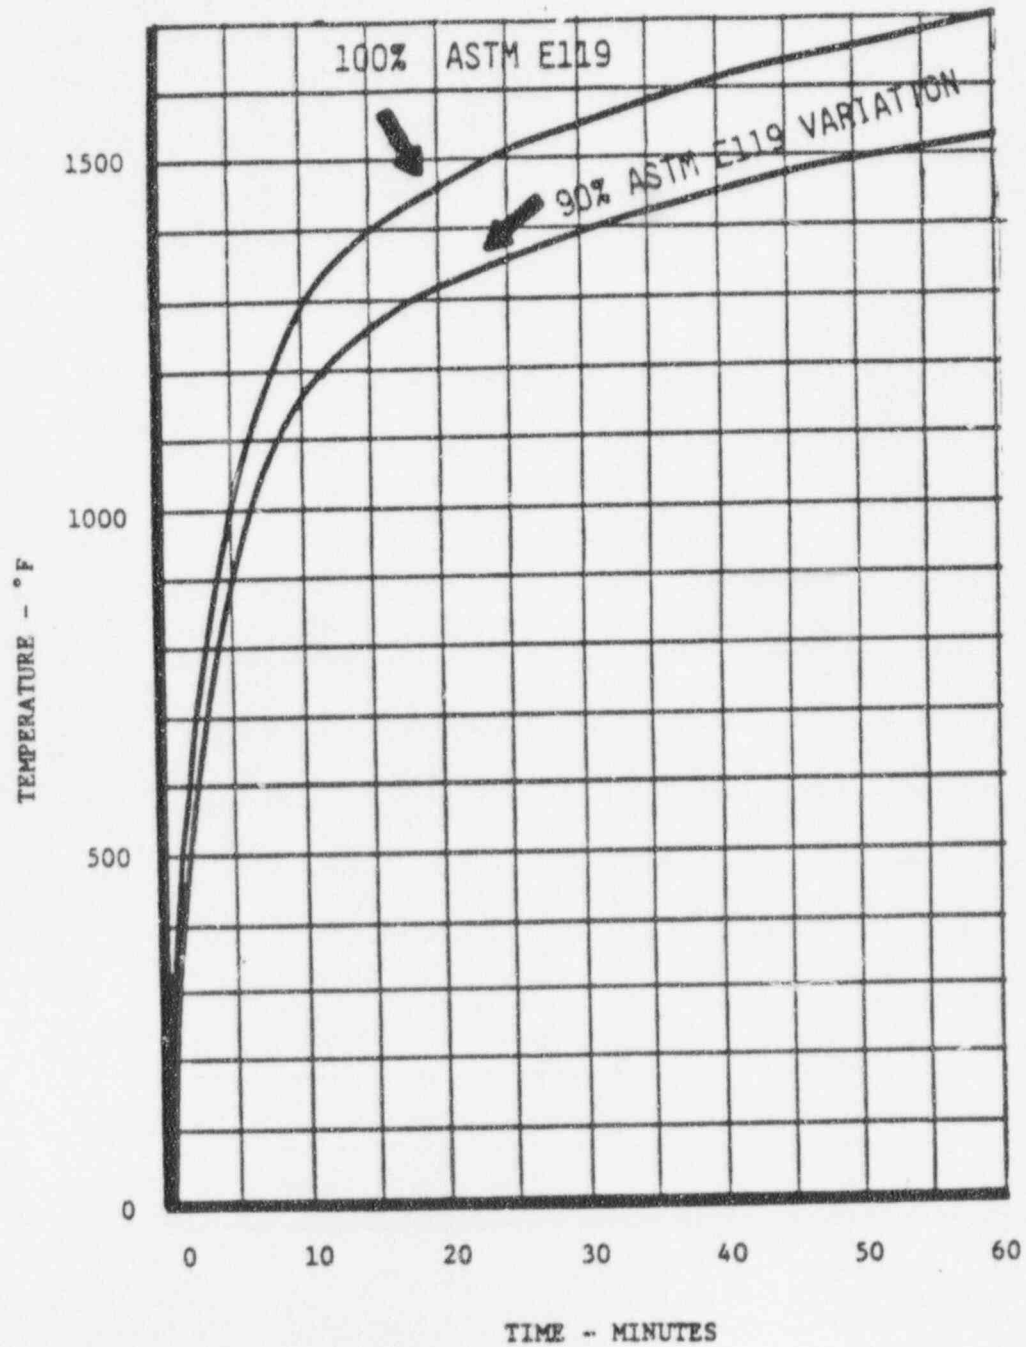
FIGURE 1
TSI'S ASTM E119 FIRE SIMULATION TEST FACILITY
PERFORMANCE PARAMETERS

Paragraph 3.4.1 of ANI's Bulletin #5(79) states that the protective envelope shall be exposed to the standard time/temperature curve found in ASTM E119-76 (revised to E119-81) for a minimum of one hour. In this test, test articles were exposed to the standard time/temperature curve presented in ASTM E119-76 (ANSI A2.1) for a minimum period of one (1) hour. The standard time/temperature curve is presented herein as Figure 1.

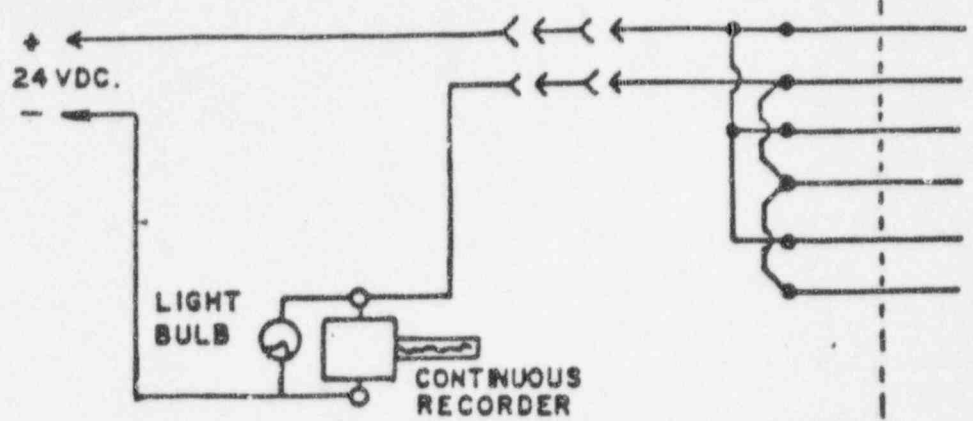
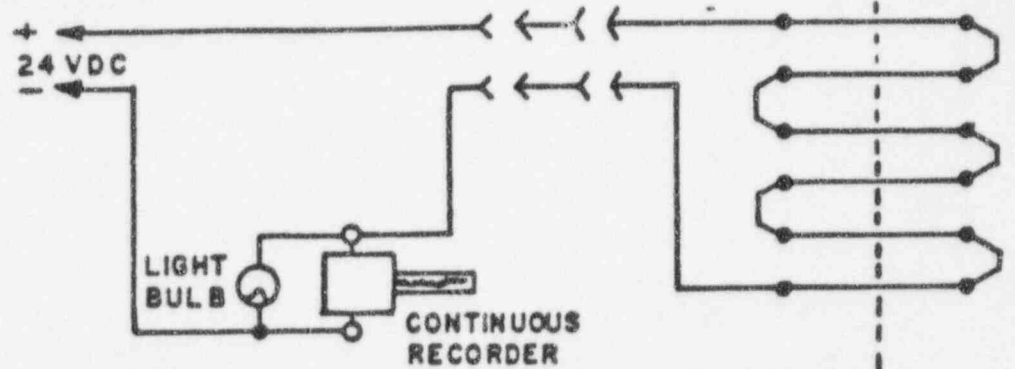
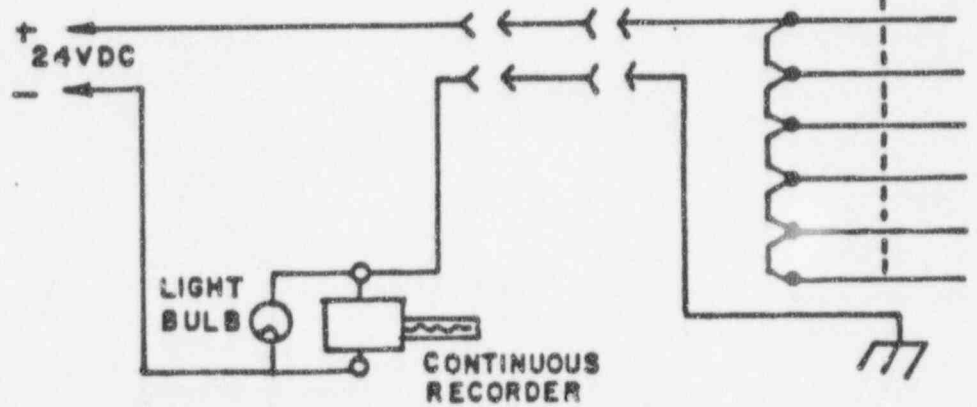
FIGURE 2: CABLE INTEGRITY MONITORING CIRCUITS

1. Power, control and/or instrumentation cables in each assembly were connected as a short circuit detection circuit as shown in Figure 2A;
2. Power, control and/or instrumentation cables in each assembly were connected as a continuity monitoring circuit as shown in Figure 2B;
3. Power, control and/or instrumentation cables in each assembly were connected as a ground detection circuit as shown in Figure 2C.

A-TYPICAL CIRCUIT TO CIRCUIT MONITORING CHANNEL

B-TYPICAL CIRCUIT TO SYSTEM MONITORING CHANNEL

C-TYPICAL CIRCUIT TO GROUND MONITORING CHANNEL

Paragraph 3.5 of ANI's Bulletin #5(79) requires that circuits contained in a test article do not de-energize during exposure to the fire endurance and water hose stream tests. A required test condition is to continuously monitor a sufficient number of electrical circuits in each test specimen to detect failure; circuit to circuit (conductor to conductor short circuits), circuit to system (conductor continuity), and circuit to ground (conductor to ground). Schematic diagrams of the three monitoring channels utilized in this test program are shown in Figure 2.

The Multi-light Display Panel and Event Recorder were wired in such a manner that the monitored circuits were energized, and in the event of a test article cable failure:

1. Circuit-to-Circuit: Light would come on and event recorder indicate the condition. a.
2. Circuit-to-System: Light would go out and event recorder indicate the condition. b.
3. Circuit-to-Ground: Light would come on and event recorder indicate the condition. c.
4. Following the water hose stream test, the circuit to circuit and circuit to ground circuits were manually checked with a test lead to assure the monitoring circuits had been functioning during the fire and water hose stream tests.

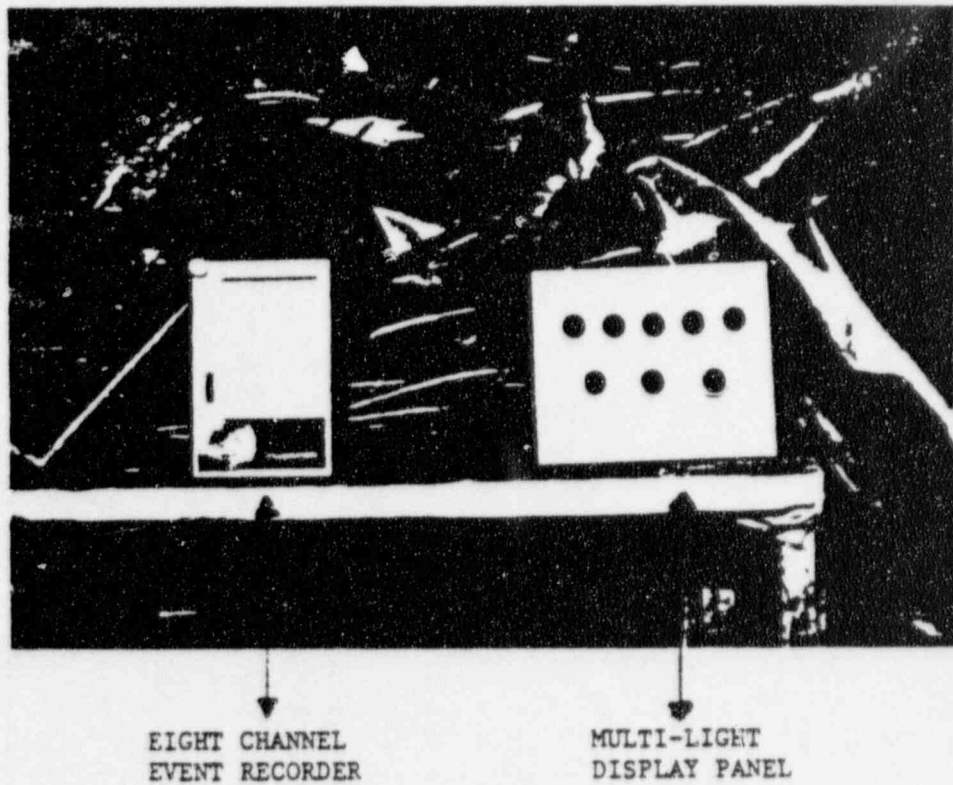
FIGURE 3

PHOTOGRAPH OF THE EIGHT-CHANNEL EVENT RECORDER
AND
THE MULTI-LIGHT DISPLAY PANEL

Figure 3 shows the Multi-light Display Panel and the Eight-Channel Event Recorder.

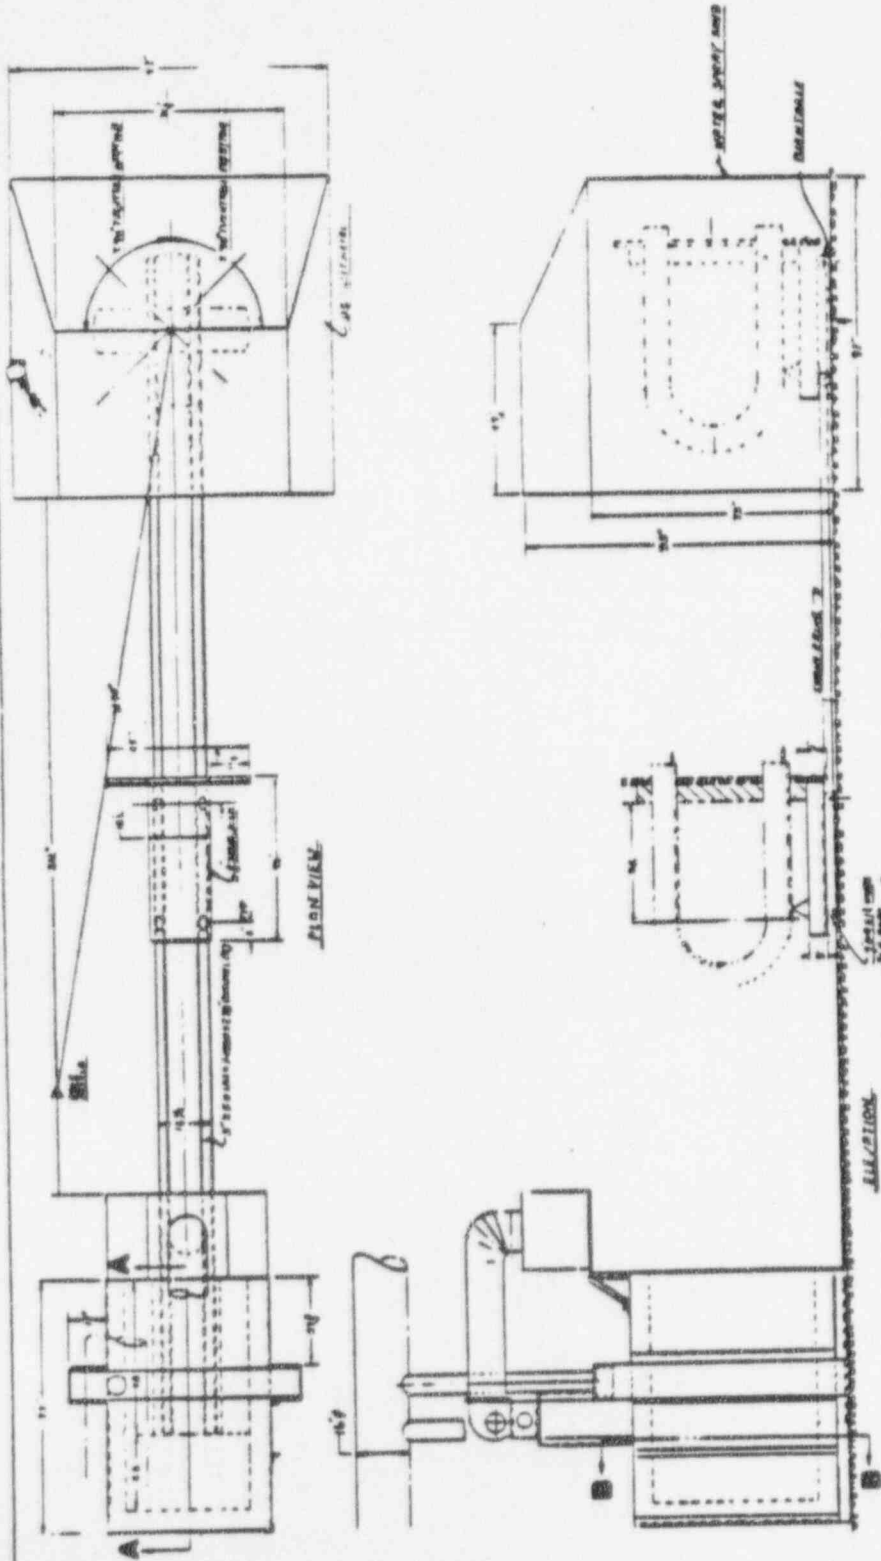
DESCRIPTION	
INC. 3269 BRANNON ST. LOUIS, MO. 63139	
DATE: 1/16/82	DESIGNED BY: <i>Richard A. Johnson</i>
NO. T-10 1982	DRAWN BY: <i>Richard A. Johnson</i>
FIGURE #1 TSI'S ASTH E119 FIRE SIMULATION FACILITY

TSI's ASTM E119 Fire Simulation Facility consists of a high temperature test furnace, a water hose spray booth, equipped with a multi-positioning table, and a transfer cart with connecting rail system. The facility is a self contained test unit with the ASTM E119 fire endurance tests being conducted in the high temperature test furnace. Upon completion of the fire test, the test article is moved on the transfer cart to the water spray booth where it is transferred using an electric hoist to the multi-positioning table. This table rotates 180° and moves both vertically and horizontally during the water hose stream test, permitting the hose stream to be applied over all accessible surfaces of the test article. The water hose stream is provided by a Mack 800 gpm water pumper fire truck which is located outside the building. A schematic of TSI's ASTM E119 Fire Simulation Facility is shown in Figure 4.

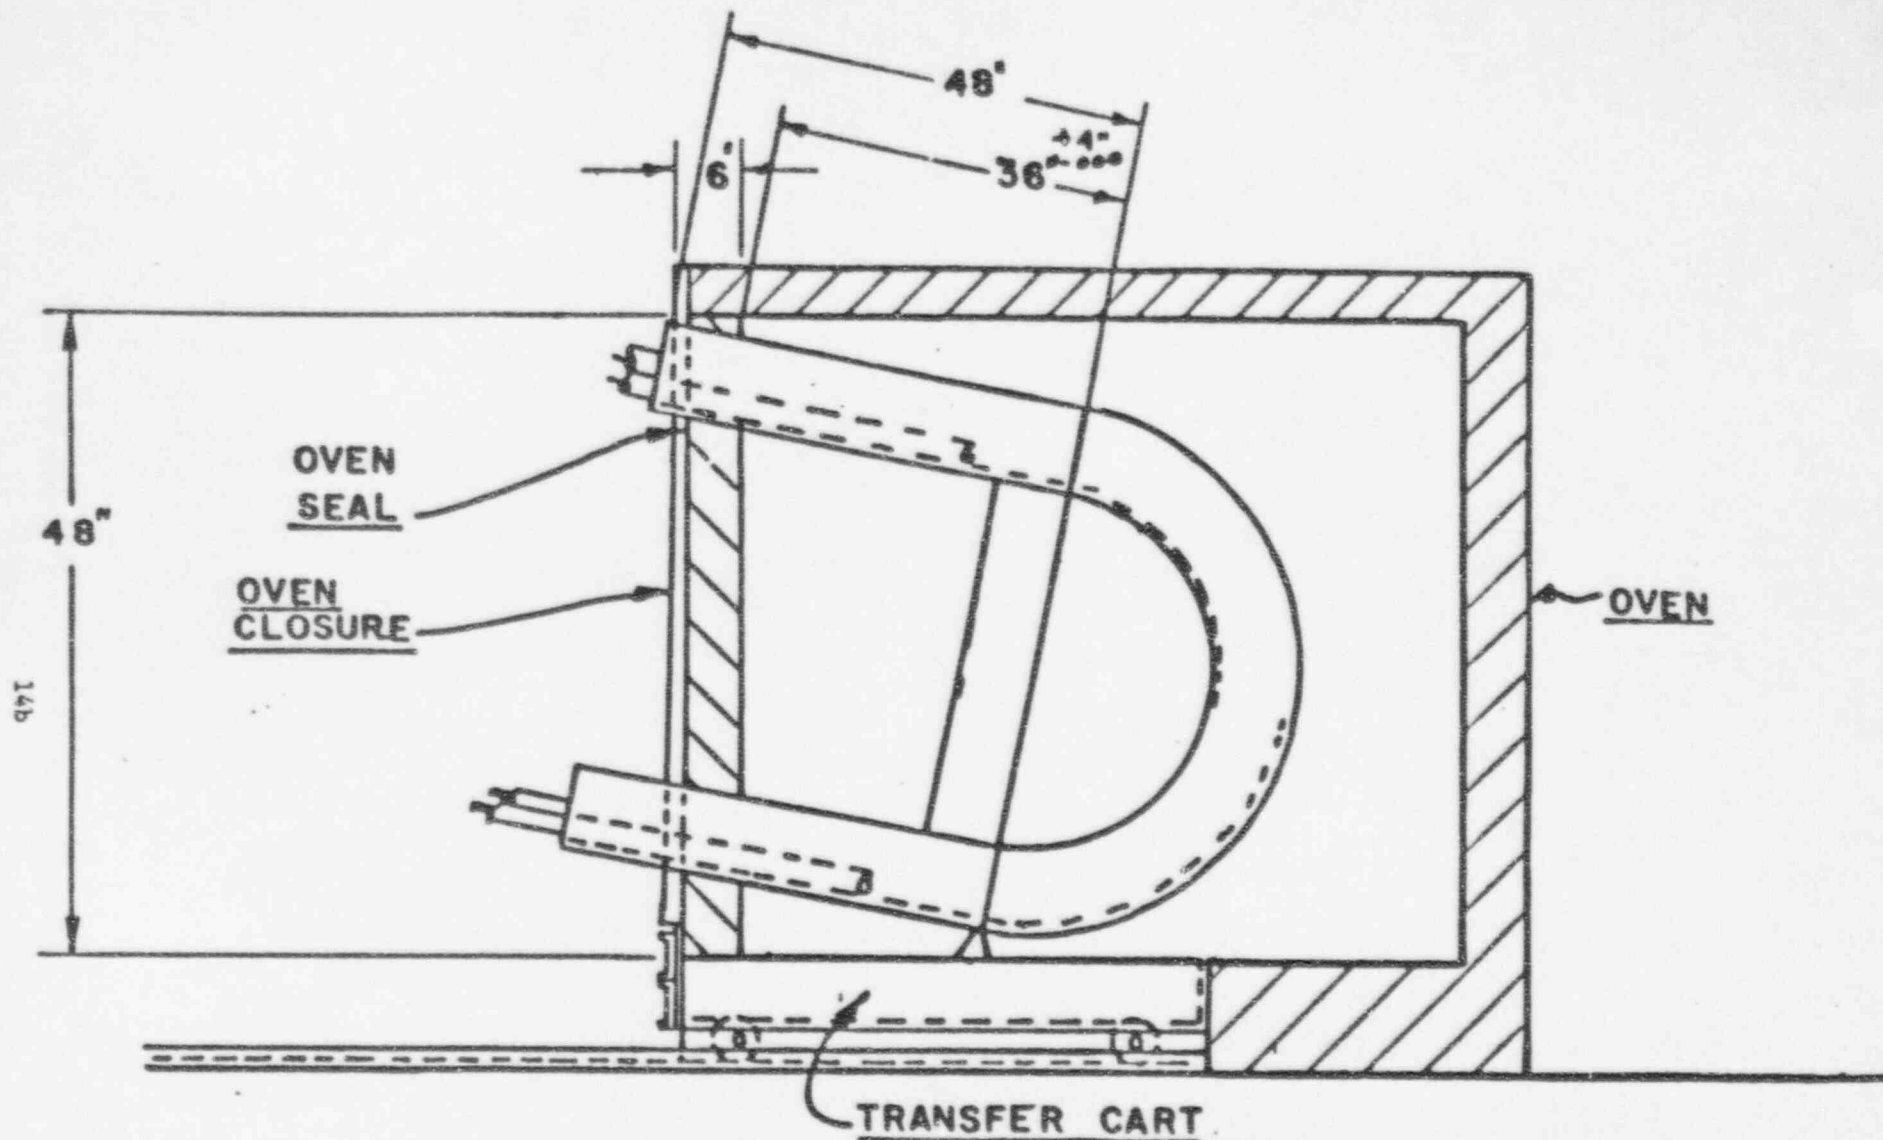
FIGURE 5B: TYPICAL ARRANGEMENT OF TEST ARTICLE IN TSI'S TEST FURNACE FOR TEST ARTICLES 1, 3&5 COMBINED, 4 AND 6

TSI, INC. 3260 BRANNON. ST. LOUIS. MO. 63139.		
SCALE: NONE	APPROVED BY: <i>Edwards</i>	DRAWN BY J. DUMFRIES
DATE: 10-8-1982		DESIGNED
GENERAL ARRANGEMENT - FIRE ENDURANCE TESTS

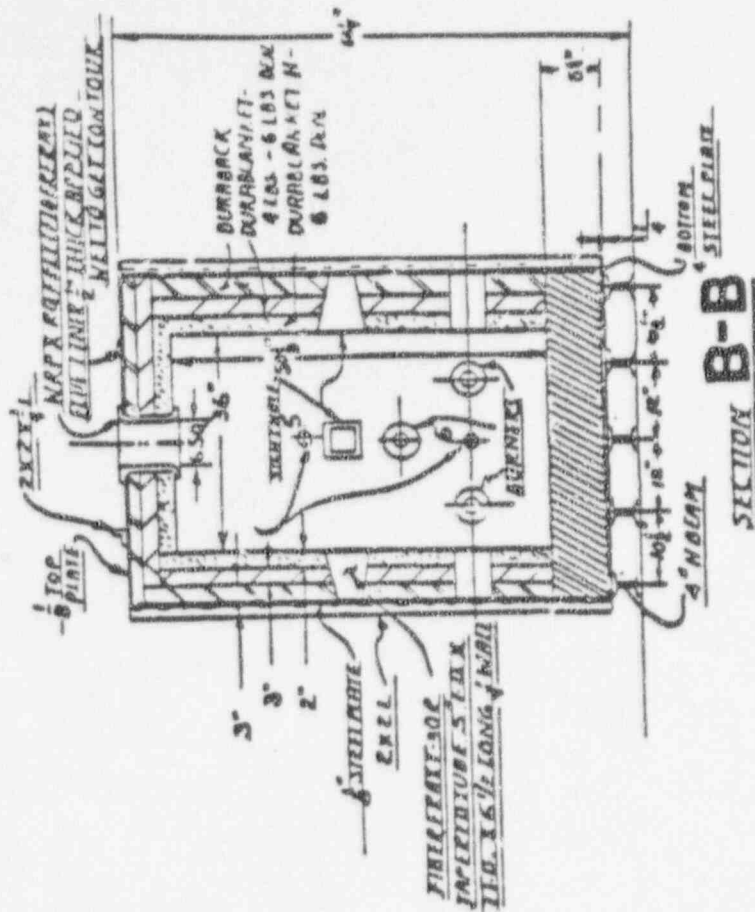
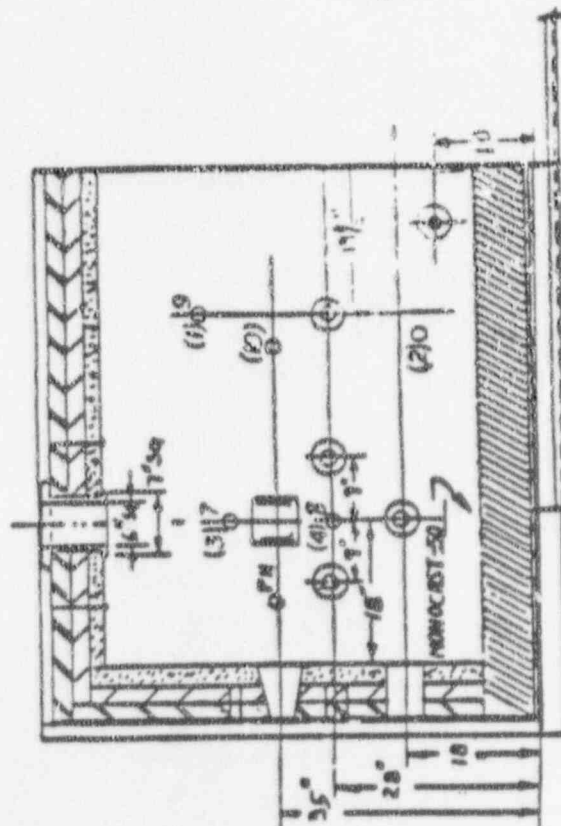
SECTION A-A

LOCATION OF THERMOCOUPLES

W/C #	LOCATION
(1)	Section A-C - East
(2)	Section A-A - East
(3)	Section A-A - West
(4)	Section A-A - West
(5)	Section B-B - South
(6)	Section B-B - South
(7)	Section A-A - West
(8)	Section A-A - West
(9)	Section A-A - West
(10)	Section A-A - West

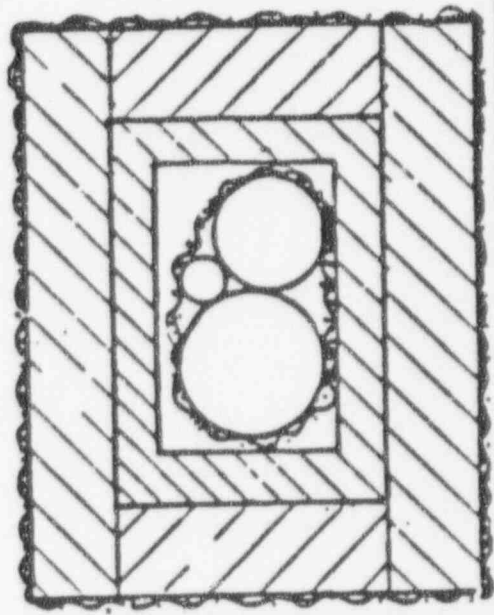
TSI, INC. 3260 BRANNON. ST. LOUIS. MO. 63139.	
SCALE: NONE	APPROVED BY: <i>[Signature]</i>
DATE: 10-15-1982	DRAWN BY: J. DUMM
CROSS-SECTIONAL VIEW OF TEST ARTICLE NO. 385 COMBINED 12"x4" TRAY - 40% FILL WITH AIR DROP	
DRAWING NUMBER 7c

The location of each of these cables, identified by cable item number within each of the test articles, is shown in Figure 7C and 7D.

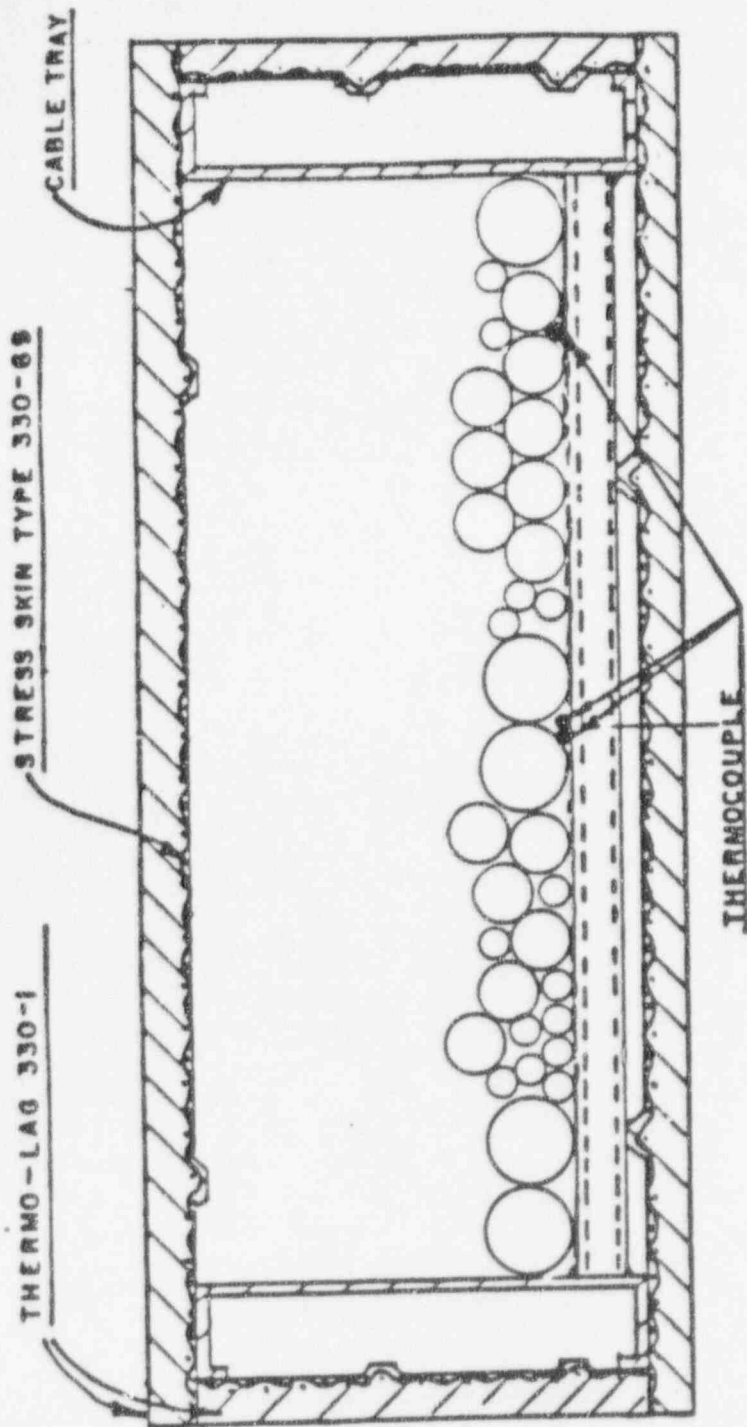
T51, INC. 3260 BRANNON. ST. LOUIS. MO. 63139.	
SCALE: NONE	APPROVED BY: <i>[Signature]</i>
DATE: 10-10-1982	DRAWN BY J. DUMPS
CROSS-SECTIONAL VIEW OF TEST ARTICLE NO. 4	
12" X 4" TRAY - ONE LAYER	
DRAWING NUMBER	
7D

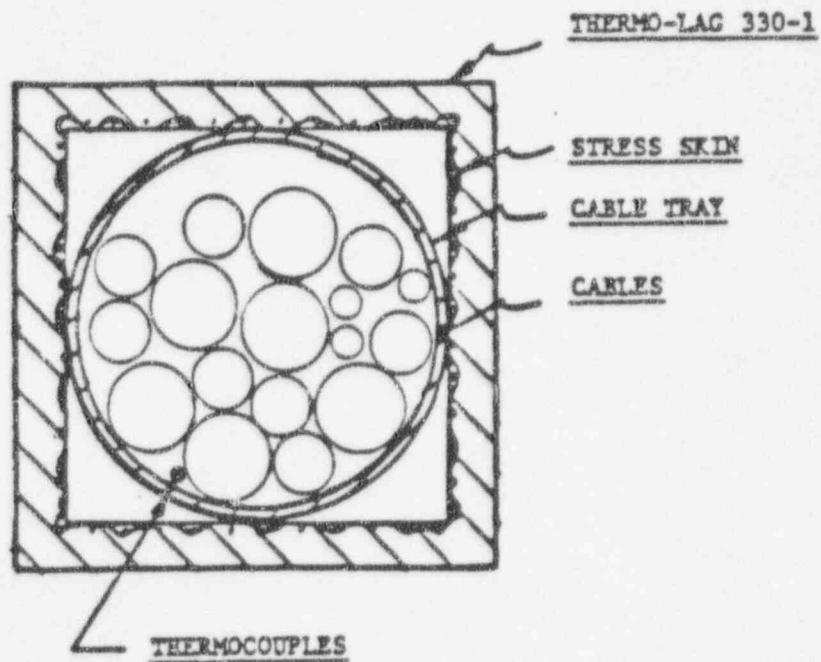
TST. INC. 3260 BRANNON. ST. LOUIS, MO. 63139.		
SCALE: NONE	APPROVED BY: <i>Bliss</i>	DRAWN BY: LDUMPS
DATE: 10-15-1982		DESIGN:
CROSS-SECTIONAL VIEW OF TEST ARTICLE NO. 6 4 INCH DIAMETER STANDARD ELECTRICAL CONDUIT		
25		DRAWING NUMBER 7E

The location of each of these cables, identified by cable item number within the test article, is shown in Figure 7E.

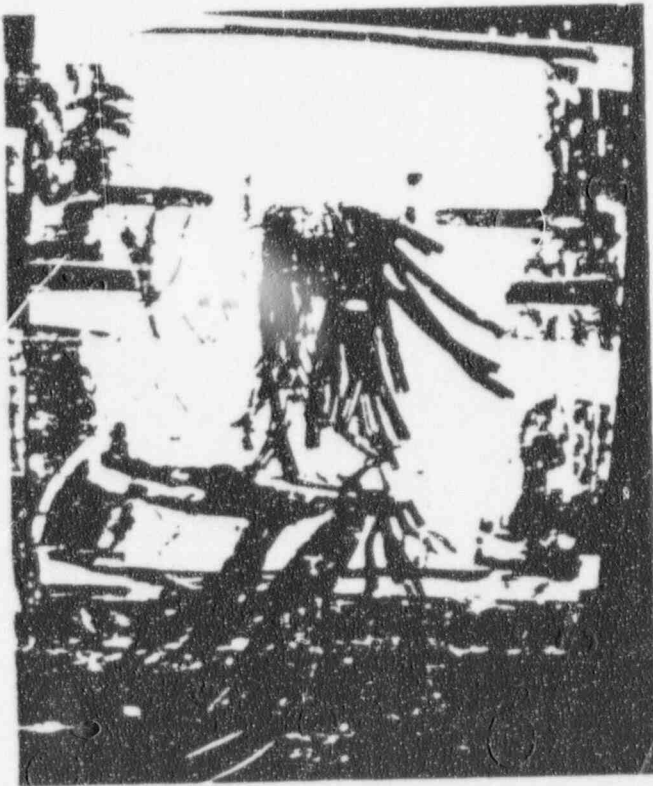
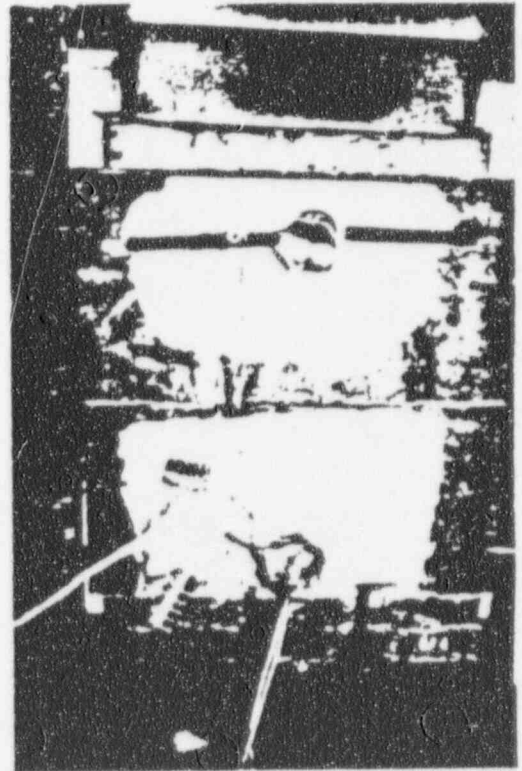
TYPICAL PHOTOGRAPHS OF
TEST ARTICLE ENTRIES AND EXITS SEALED
WITH THERMO-LAG 330-70 CONFORMABLE CERAMIC BLANKET
TO PREVENT AIR FROM CIRCULATING WITHIN EACH TEST ARTICLE
DURING EXPOSURE TO THE ASTM E119 FIRE ENDURANCE TEST

All entries and exits of test articles, utilized in the above subject test programs, were sealed air tight with THERMO-LAG 330-70 Conformable Ceramic Blanket in order to prevent air from circulating within each test article.

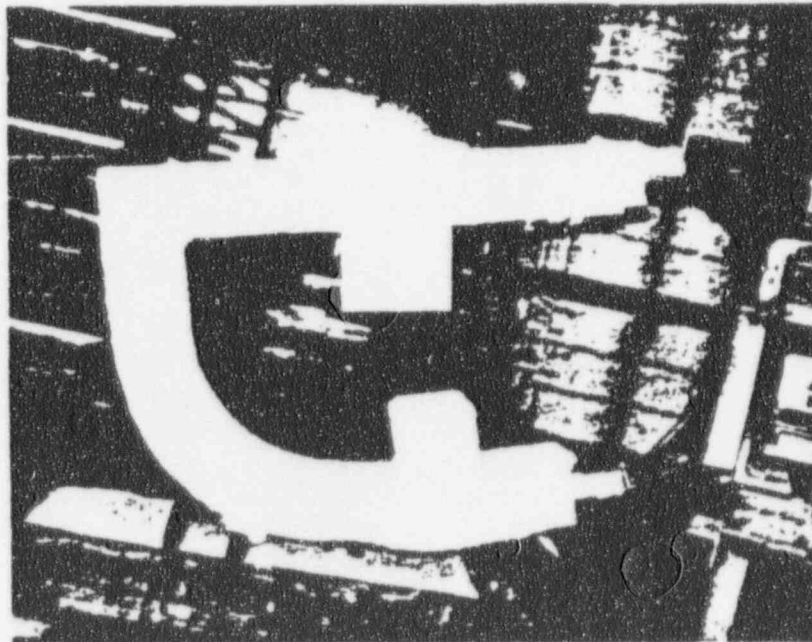
FIGURE 12

PHOTOGRAPH OF TEST ARTICLE NO. 6

PRIOR TO BEING EXPOSED TO THE
ONE-HOUR ASTM E119 FIRE ENDURANCE AND
WATER HOSE STREAM TESTS

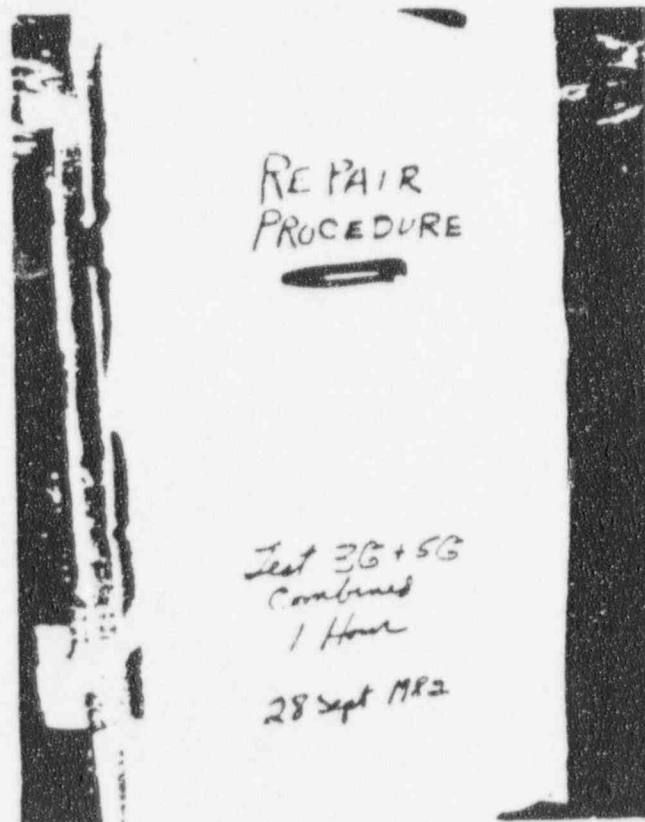
Figure 13A: "Repair" Patch Area Being
Scored For Cutting

A tapered circular section, approximately 4-inches in diameter, was cut through the fully cured protective envelope of Test Article No. 4, to effect a "simulated" repair. This patch was then removed and installed in the cut out section by attaching it to the test article with wire fasteners. The open areas around the repair patch were filled in with the THERMO-LAC 330-1/Cure Accelerator mixture using troweling and caulking methods.

Photographs illustrating the simulated repair process are shown in Figures 13A through 13E.

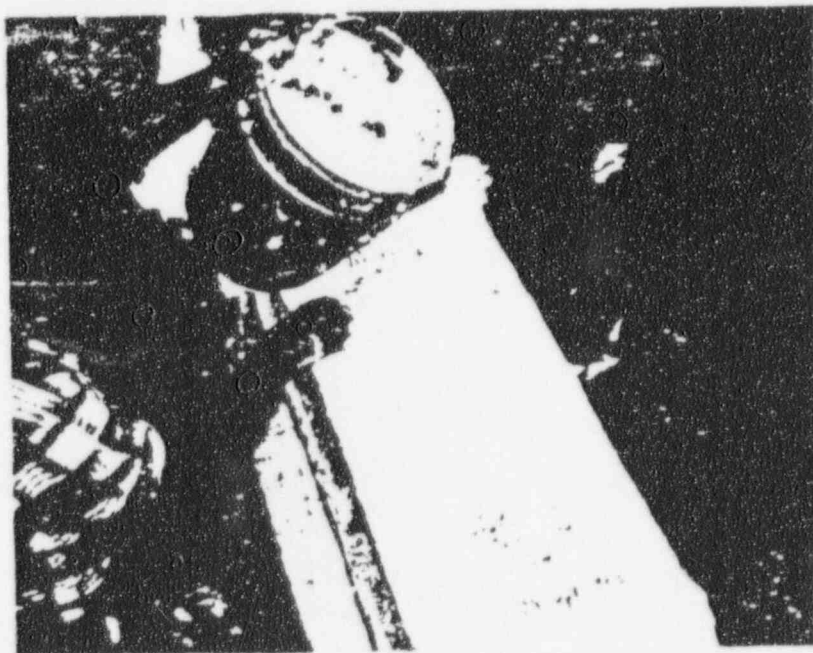
Figure 13E: Simulated "Insitu Repair Procedure" Completed

4. The "repair" patch on Test Article No. 3&5 Combined showed no evidence of damage after the fire exposure and water hose stream tests. This indicates that the THERMO-LAG 330-1 Subliming Coating Envelope System will provide the same degree of fire resistance with no adverse effects to a repaired area when compared to an unrepaired area.

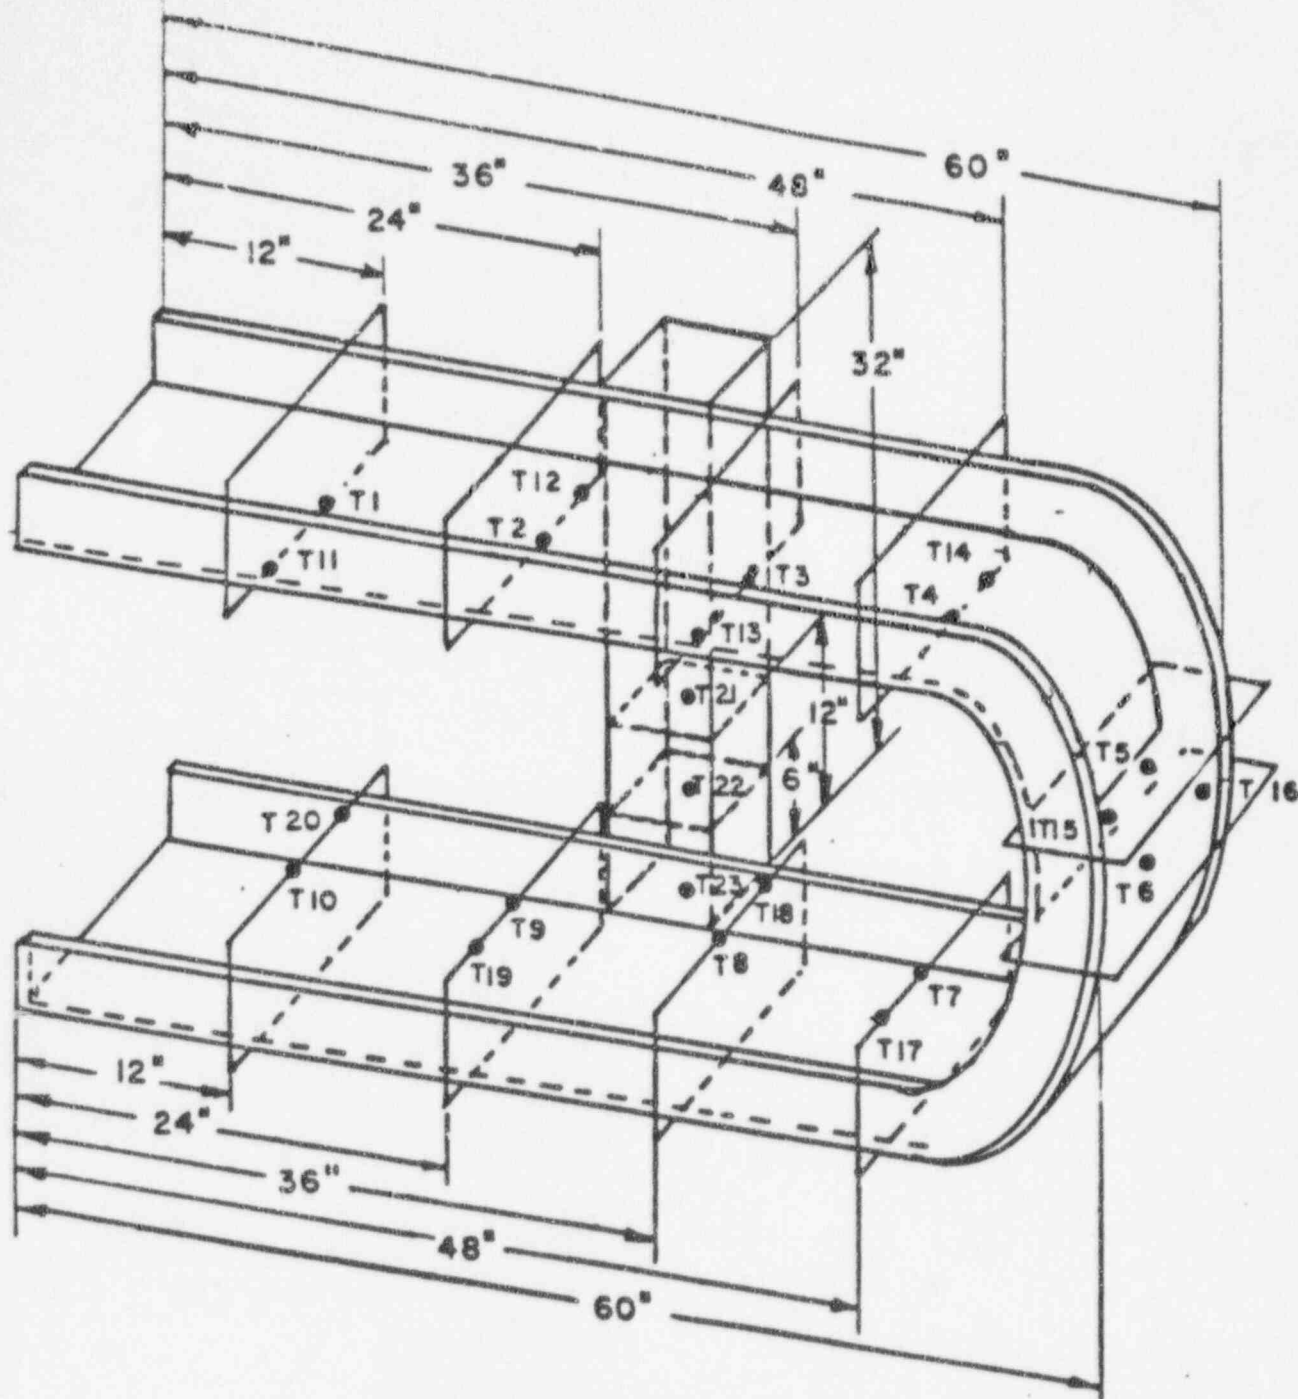
LOCATION OF THERMOCOUPLES WITHIN TEST ARTICLE NO. 1

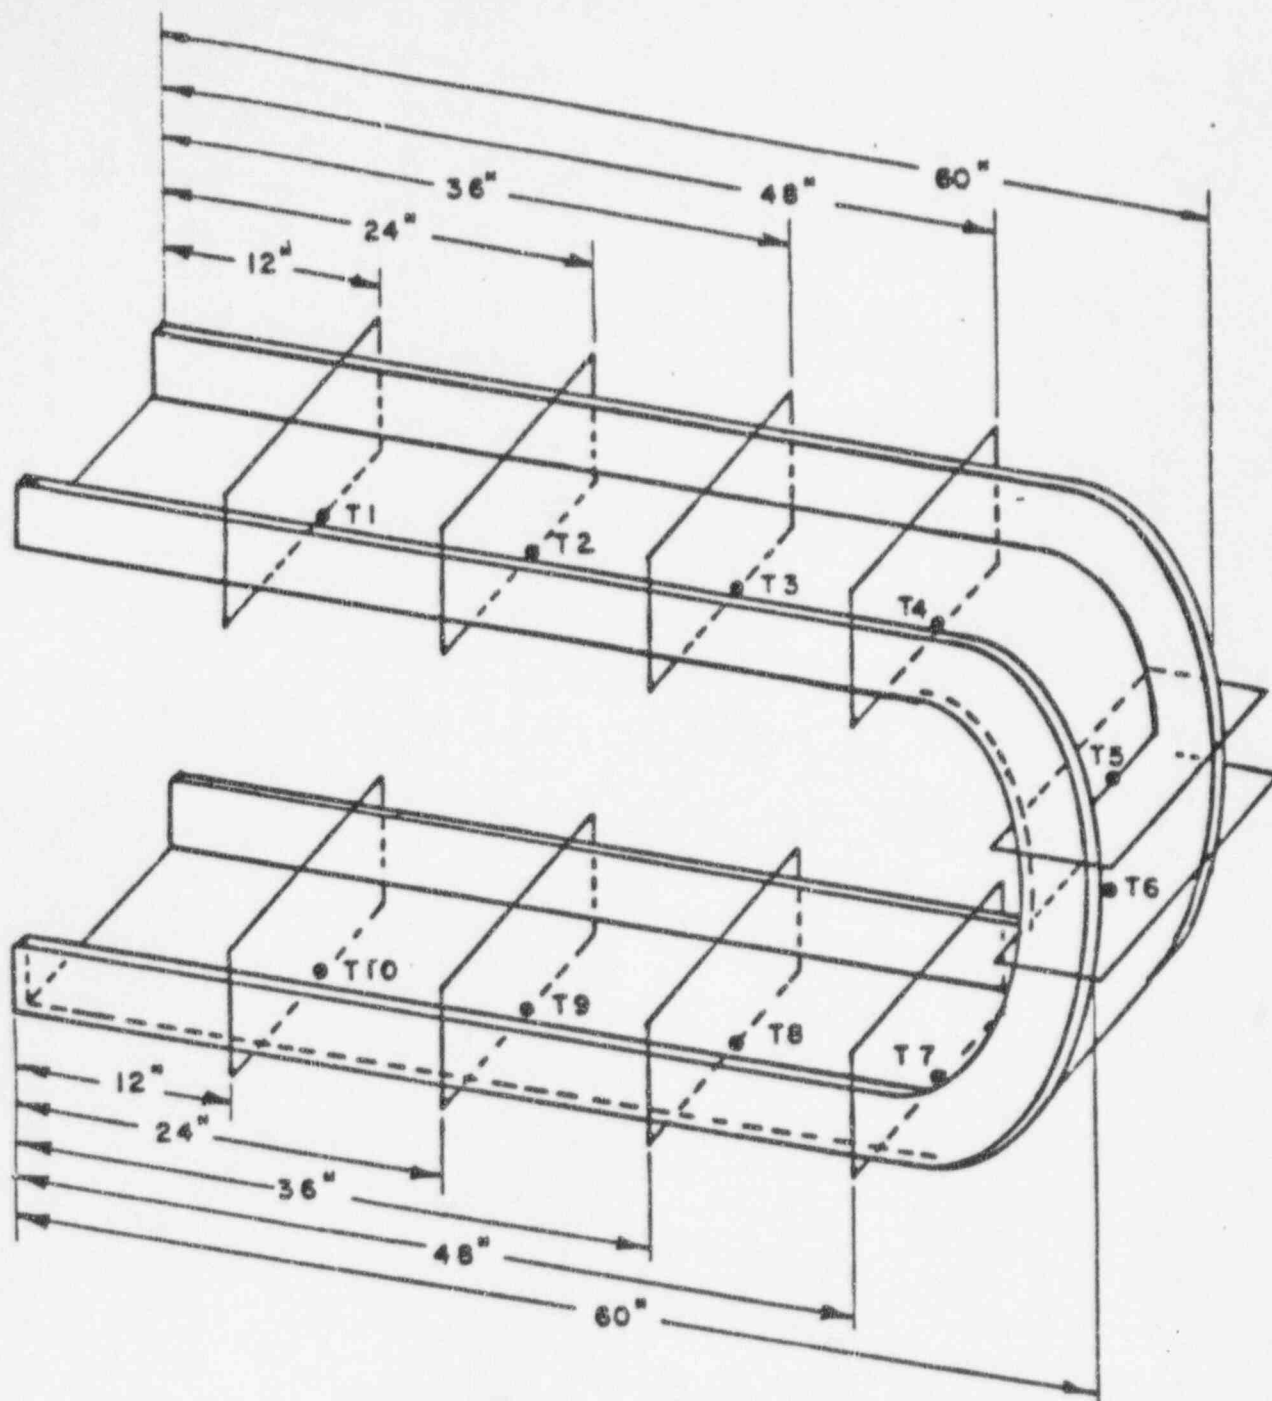
LOCATION OF THERMOCOUPLES WITHIN TEST ARTICLE NO. 2

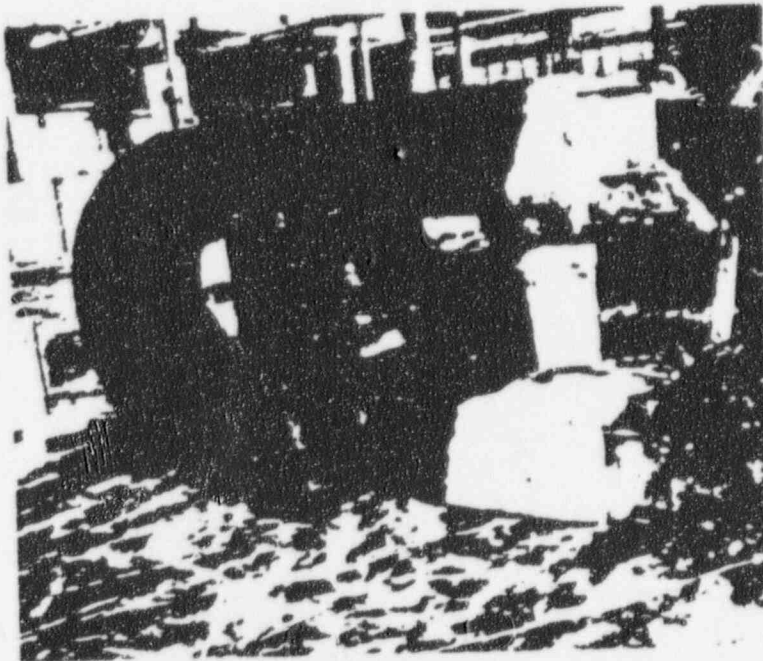
FIGURE 15A

PHOTOGRAPH OF TEST ARTICLE NO. 1
AFTER BEING EXPOSED TO THE
ONE-HOUR ASTM E119 FIRE ENDURANCE AND
WATER HOSE STREAM TESTS

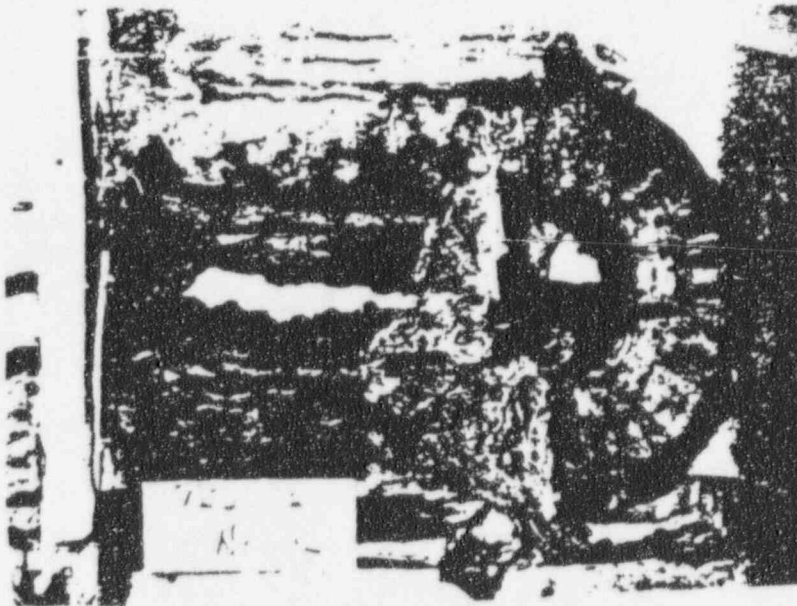
FIGURE 13B

PHOTOGRAPH OF TEST ARTICLE NO. 2

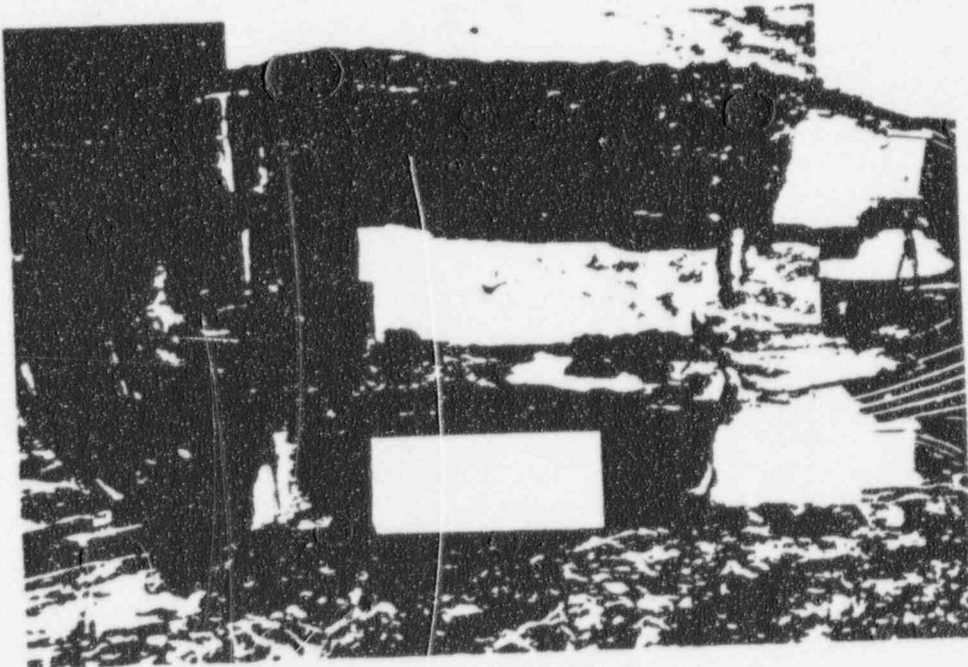
FIGURE 130

REPAIRS ON TEST ARTICLE NO. 343 COMBINED

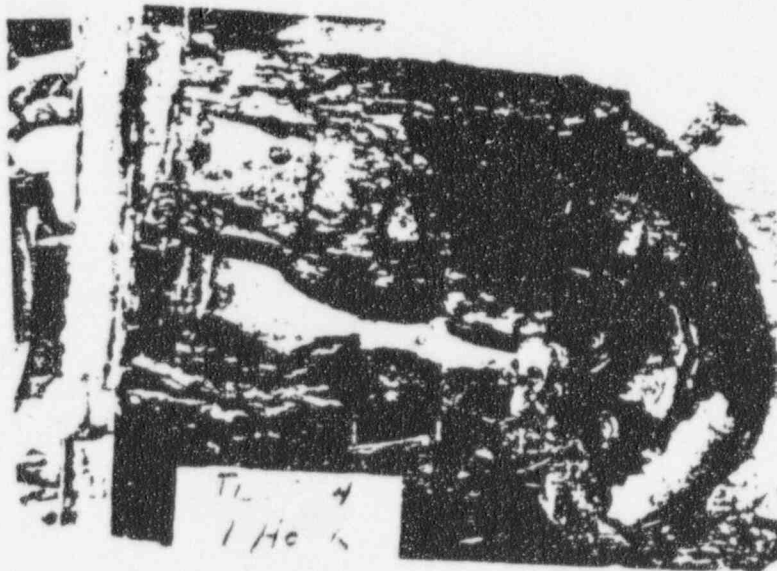
FIGURE 13D

PHOTOGRAPH OF TEST ARTICLE NO. 4

AFTER BEING EXPOSED TO THE
ONE-HOUR ASTM E119 FIRE ENDURANCE AND
WATER HOSE STREAM TESTS

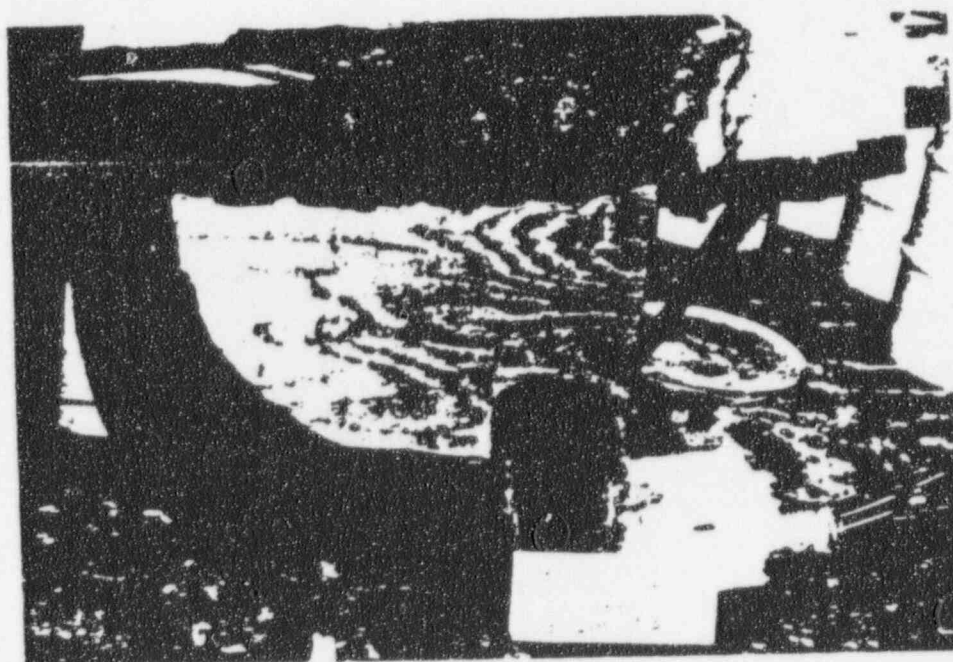
FIGURE 15E

PHOTOGRAPH OF TEST ARTICLE NO. 6

AFTER BEING EXPOSED TO THE
ONE-HOUR ASTM E119 FIRE ENDURANCE AND
WATER HOSE STREAM TESTS

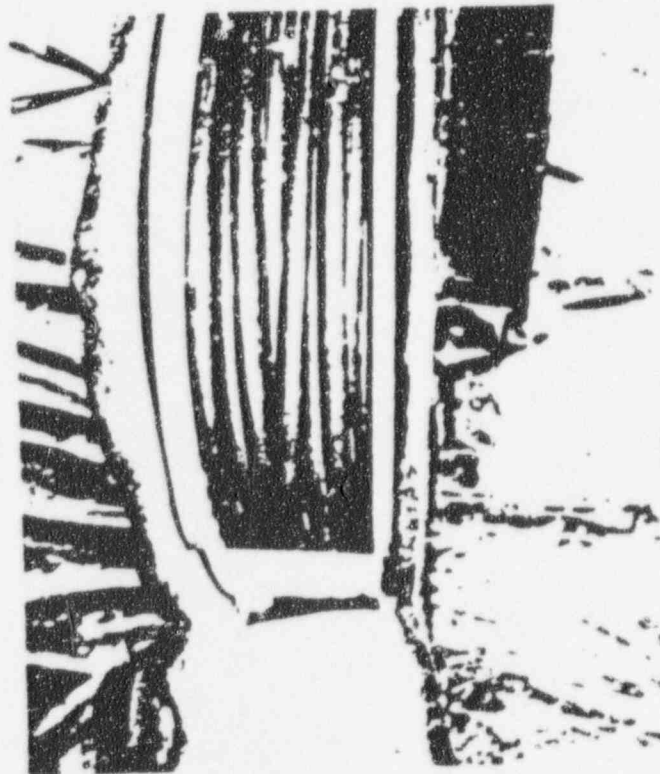
VIEW OF THE CABLES WITHIN TEST ARTICLE NO. 1

AFTER BEING EXPOSED TO THE
ONE-HOUR ASTM E119 FIRE ENDURANCE AND
WATER HOSE STREAM TESTS

3. Examination of the cables after the completion of the tests, as shown in Figures 16A through 16E indicated that none of the electrical insulation of the cables were damaged. Further examination of the nylon tie wires used in retaining the cables within each test article showed no evidence of damage.

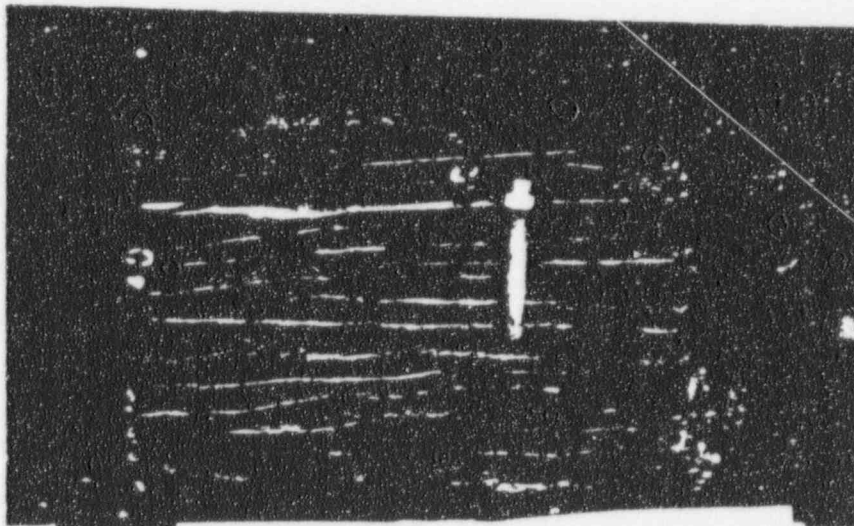
FIGURE 16B

VIEW OF THE CABLES WITHIN TEST ARTICLE NO. 2

AFTER BEING EXPOSED TO THE
ONE-HOUR ASTM E119 FIRE ENDURANCE AND
WATER HOSE STREAM TESTS

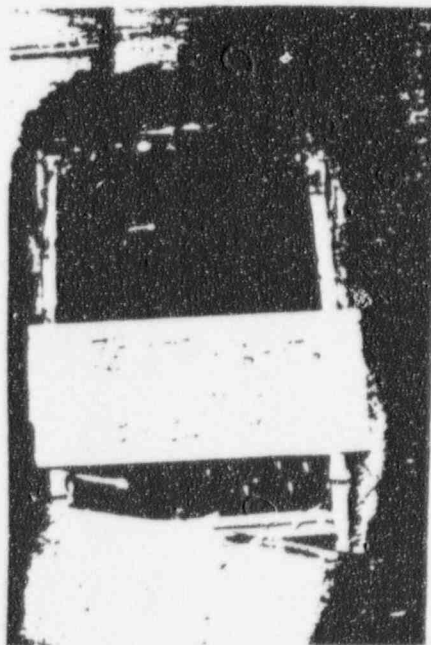
FIGURE 16.

VIEW OF THE CABLES WITHIN
TEST ARTICLE NO. 165 COMBINED
AFTER BEING EXPOSED TO THE
ONE-HOUR ASTM E119 FIRE ENDURANCE AND
WATER HOSE STREAM TESTS

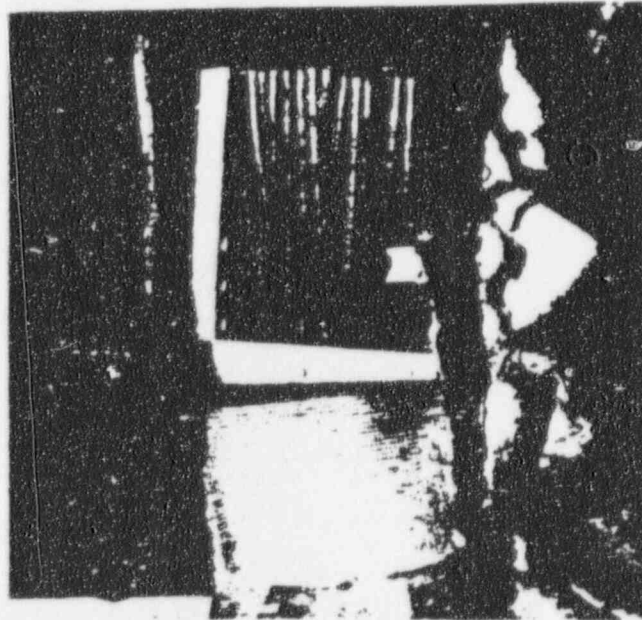
FIGURE 16D

VIEW OF THE CABLES WITHIN TEST ARTICLE NO. 4

AFTER BEING EXPOSED TO THE
ONE-HOUR ASTM E119 FIRE ENDURANCE AND
WATER HOSE STREAM TESTS
