I.T.L. REPORT NO. 82-11-80

ONE-HOUR FIRE ENDURANCE TESTS CONDUCTED ON

TEST ARTICLES CONTAINING "GENERIC" CABLES

THERMO-LAG 330-1 SUBLIMING COATING ENVELOPE SYSTEM

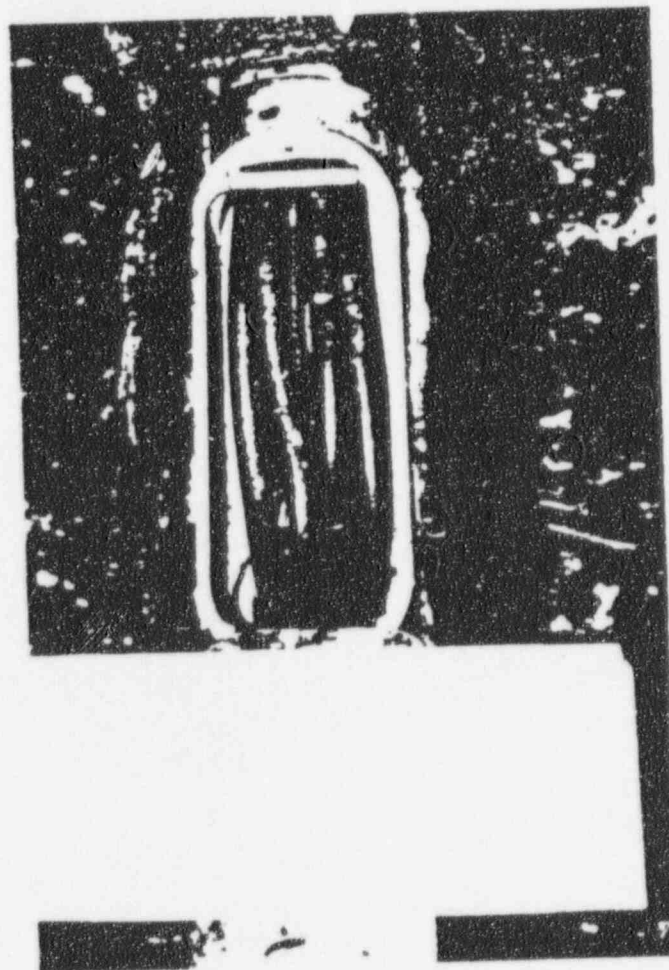
FIGURE 16E

VIEW OF THE CABLES WITHIN TEST ARTICLE NO. 6
AFTER BEING EXPOSED TO THE
ONE-HOUR ASTM E119 FIRE ENDURANCE AND
WATER HOSE STREAM TESTS

3. Examination of the cables after the completion of the tests, as shown in Figures 16A through 16E indicated that none of the electrical insulation of the cables were damaged. Further examination of the nylon tie wires used in retaining the cables within each test article showed no evidence of damage.

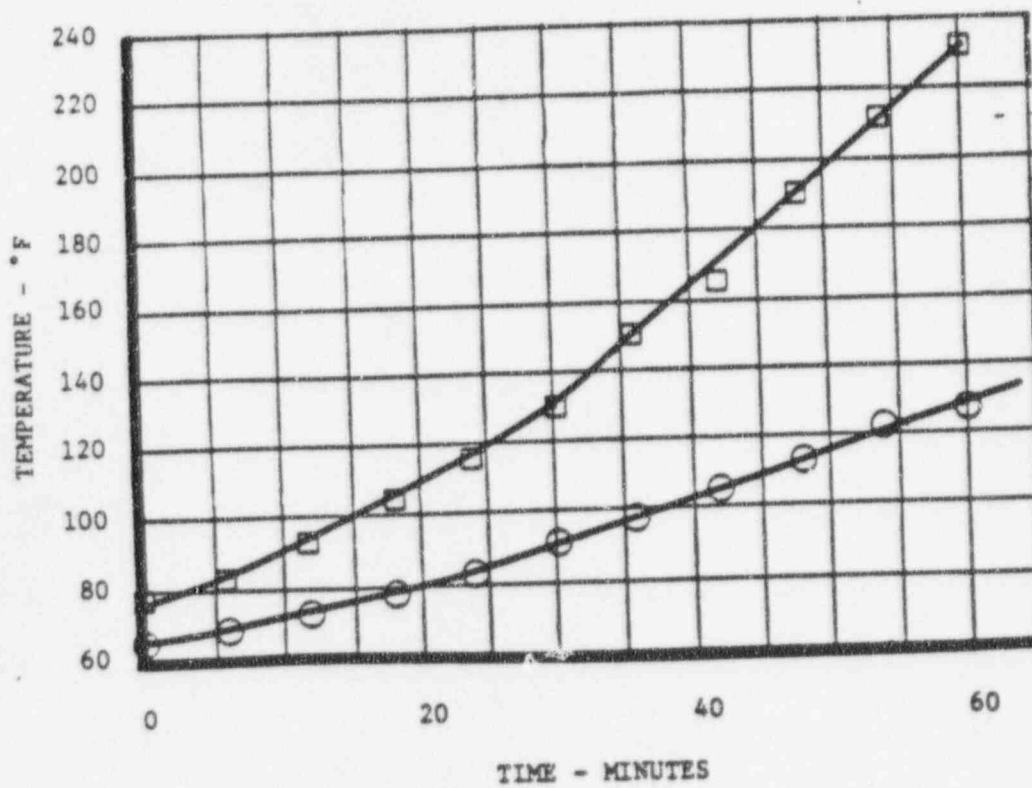
FIGURE 17
AVERAGE AND MAXIMUM OF
ALL CABLE SURFACE TEMPERATURES
RECORDED DURING FIRE ENDURANCE TEST NO. 1
(MINIMUM - ONE HOUR EXPOSURE)

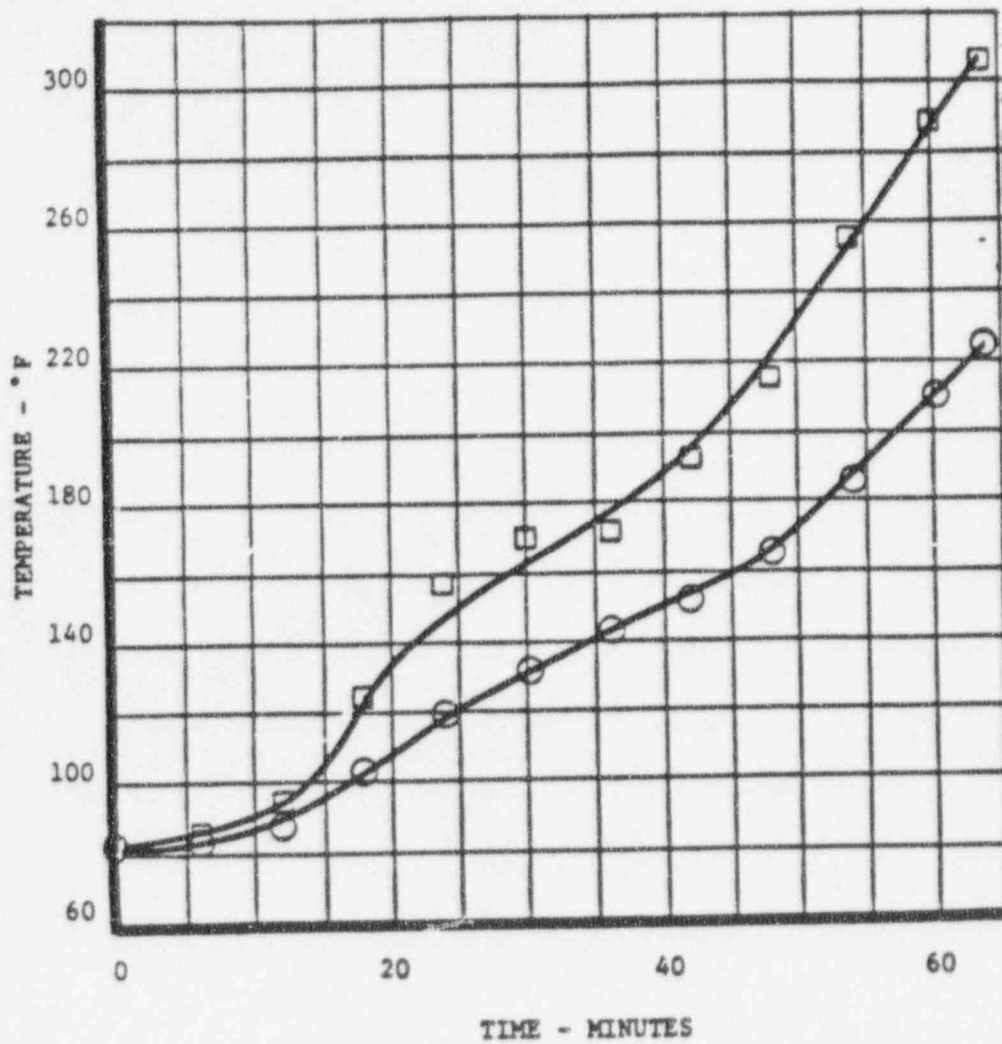
FIGURE 18

AVERAGE AND MAXIMUM OF
ALL CABLE SURFACE TEMPERATURES
RECORDED DURING FIRE ENDURANCE TEST NO. 2
(MINIMUM - ONE HOUR EXPOSURE)

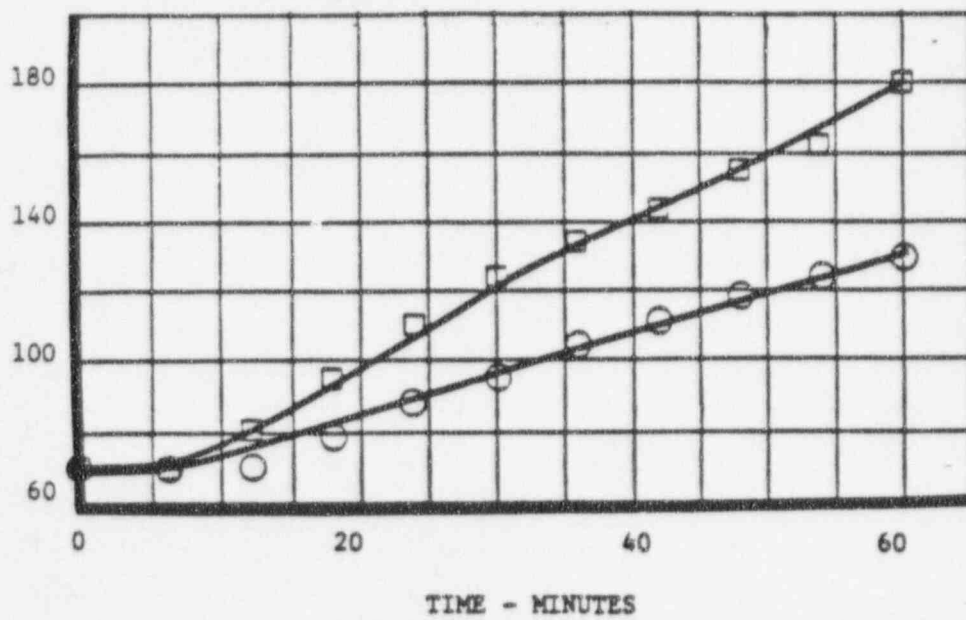
FIGURE 19

AVERAGE AND MAXIMUM OF
ALL CABLE SURFACE TEMPERATURES
RECORDED DURING FIRE ENDURANCE
TEST NO. 3&5 COMBINED
(MINIMUM - ONE HOUR EXPOSURE)

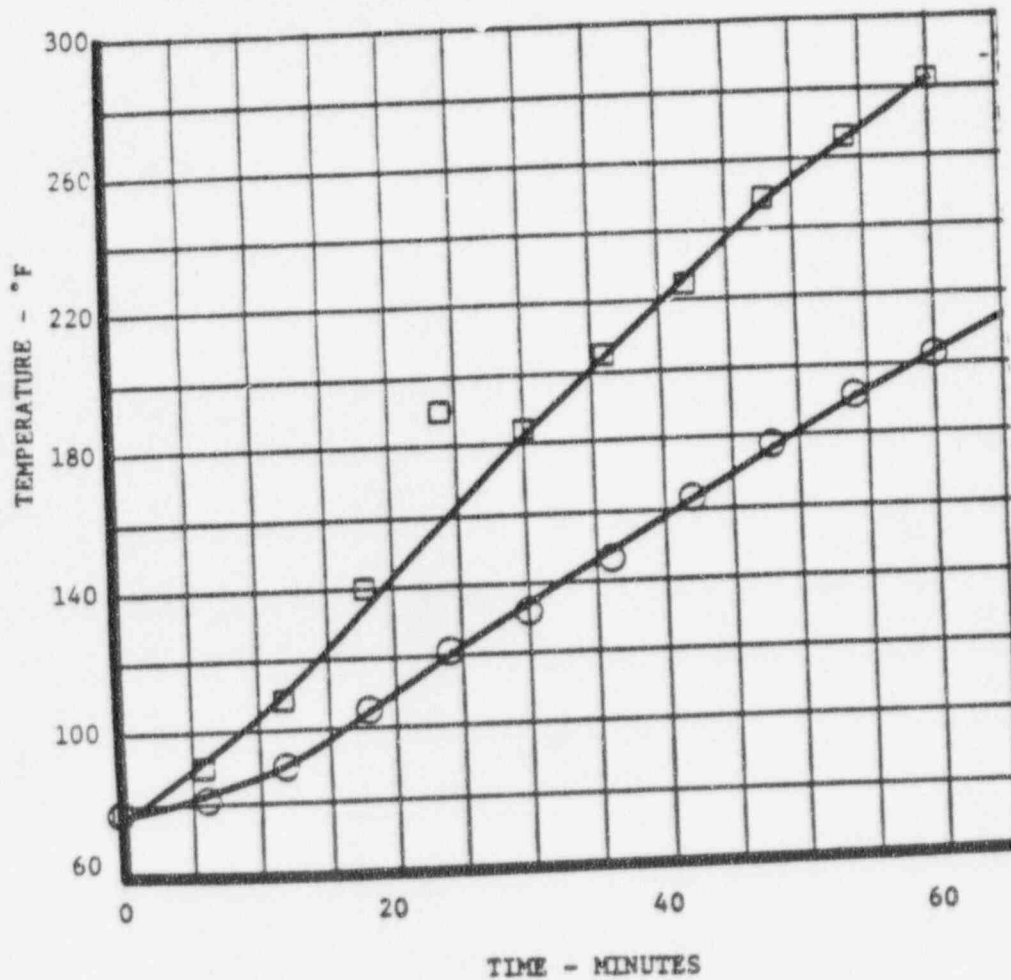
FIGURE 20

AVERAGE AND MAXIMUM OF
ALL CABLE SURFACE TEMPERATURES
RECORDED DURING FIRE ENDURANCE TEST NO. 4
(MINIMUM - ONE HOUR EXPOSURE)

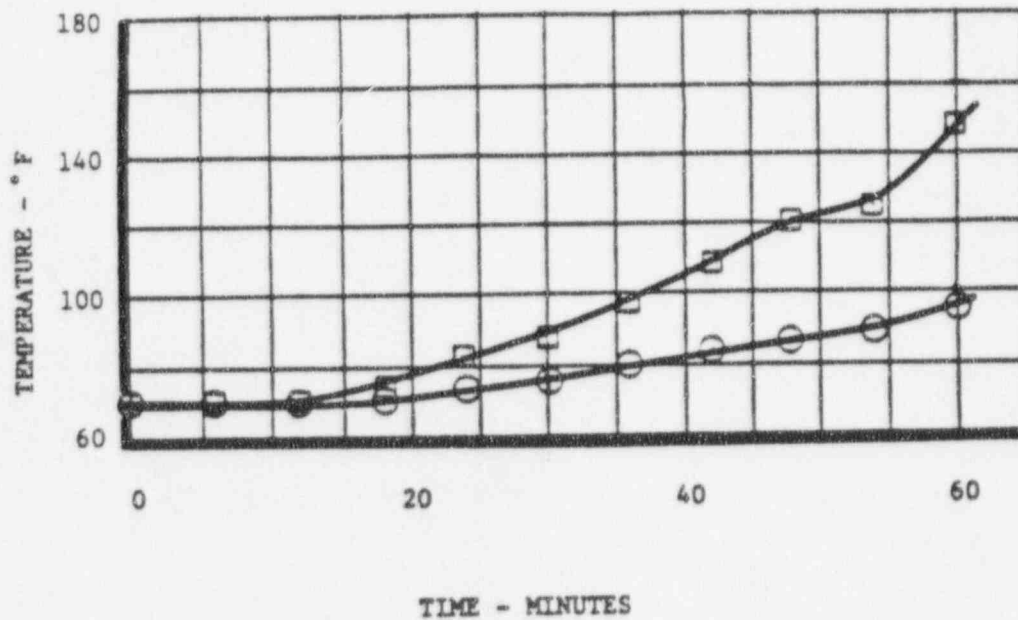
FIGURE 21

AVERAGE AND MAXIMUM OF
ALL CABLE SURFACE TEMPERATURES
RECORDED DURING FIRE ENDURANCE TEST NO. 6
(MINIMUM - ONE HOUR EXPOSURE)

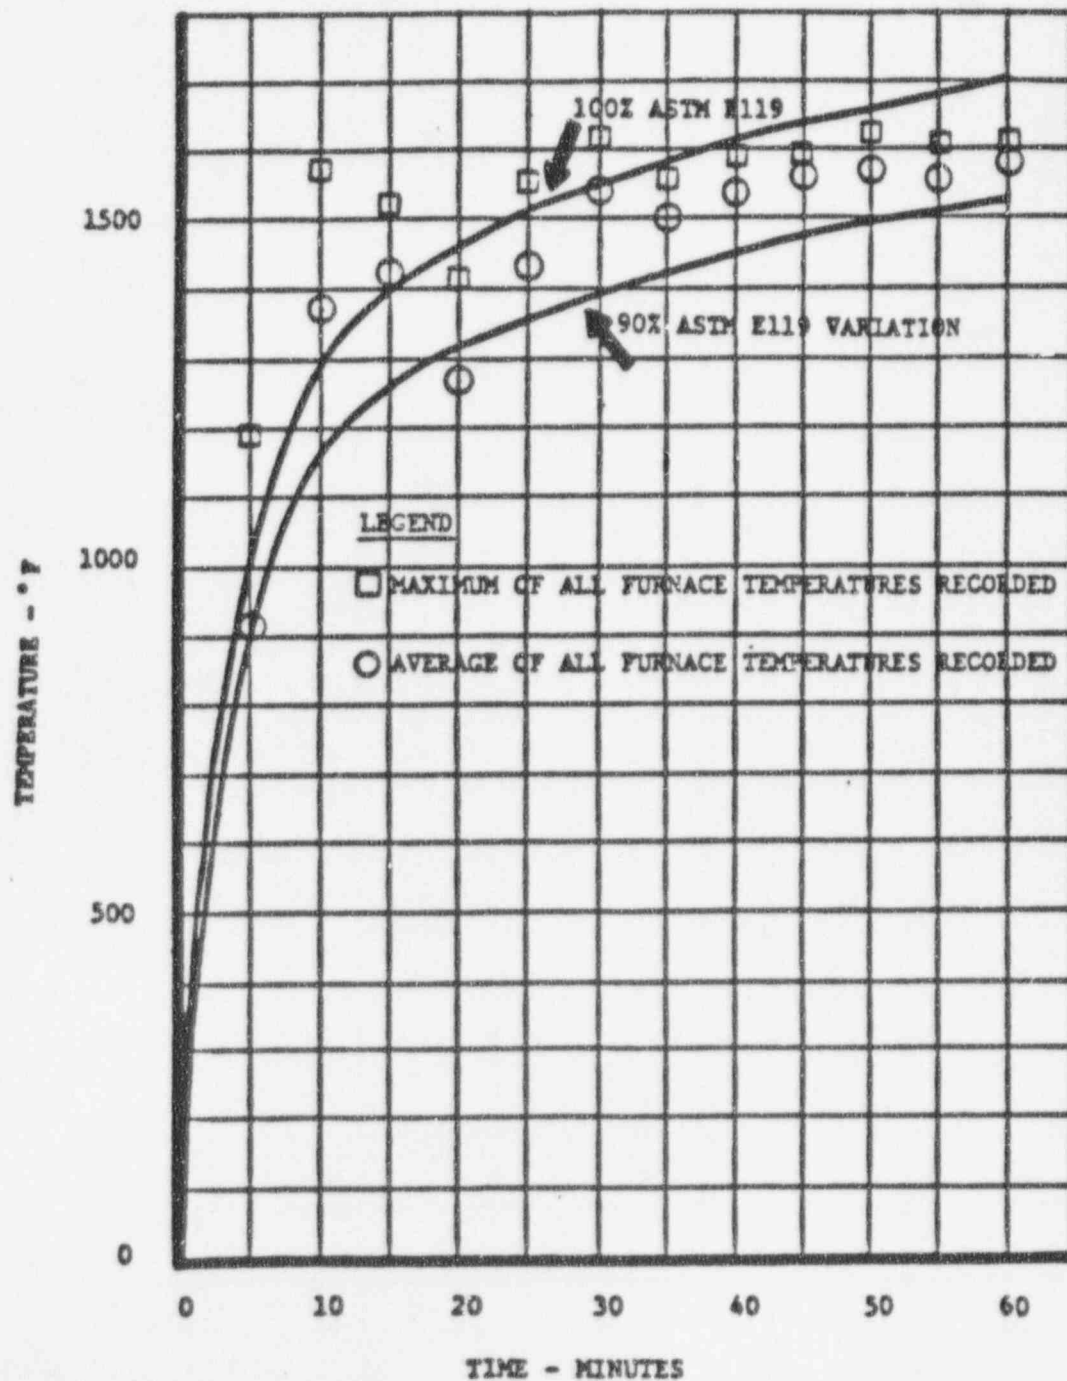
WITH THE ACTUAL RANGE OF TEMPERATURES RECORDED

DURING FIRE ENDURANCE TEST NO. 1

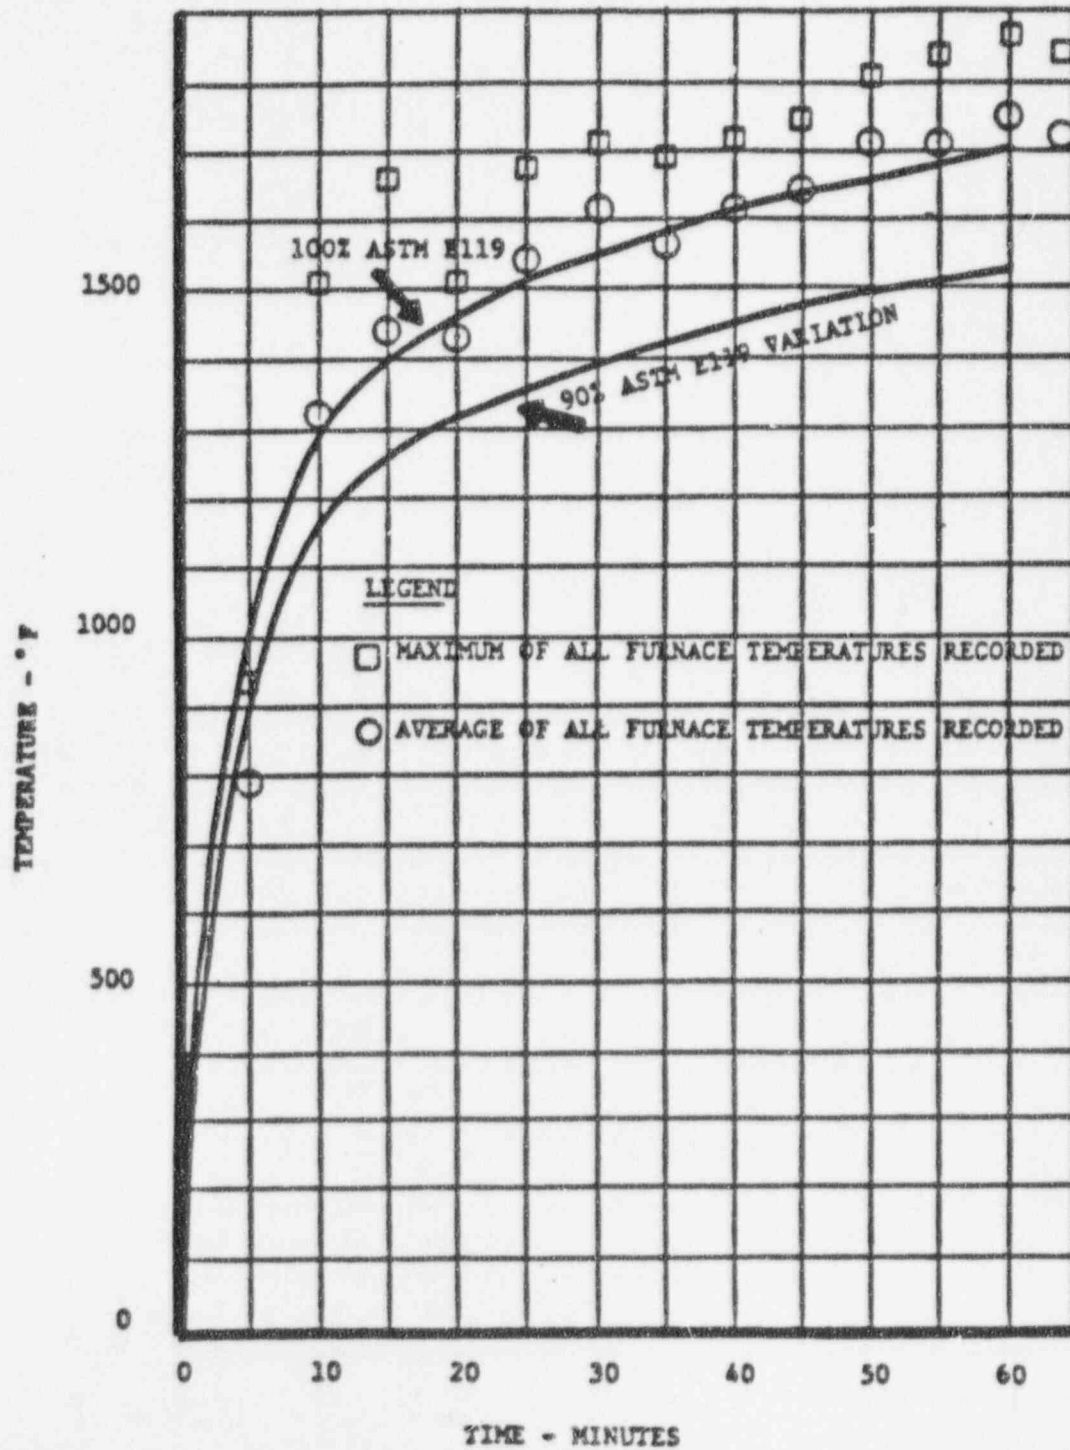
FIGURE 23

WITH THE ACTUAL RANGE OF TEMPERATURES RECORDED

DURING FIRE ENDURANCE TEST NO. 2

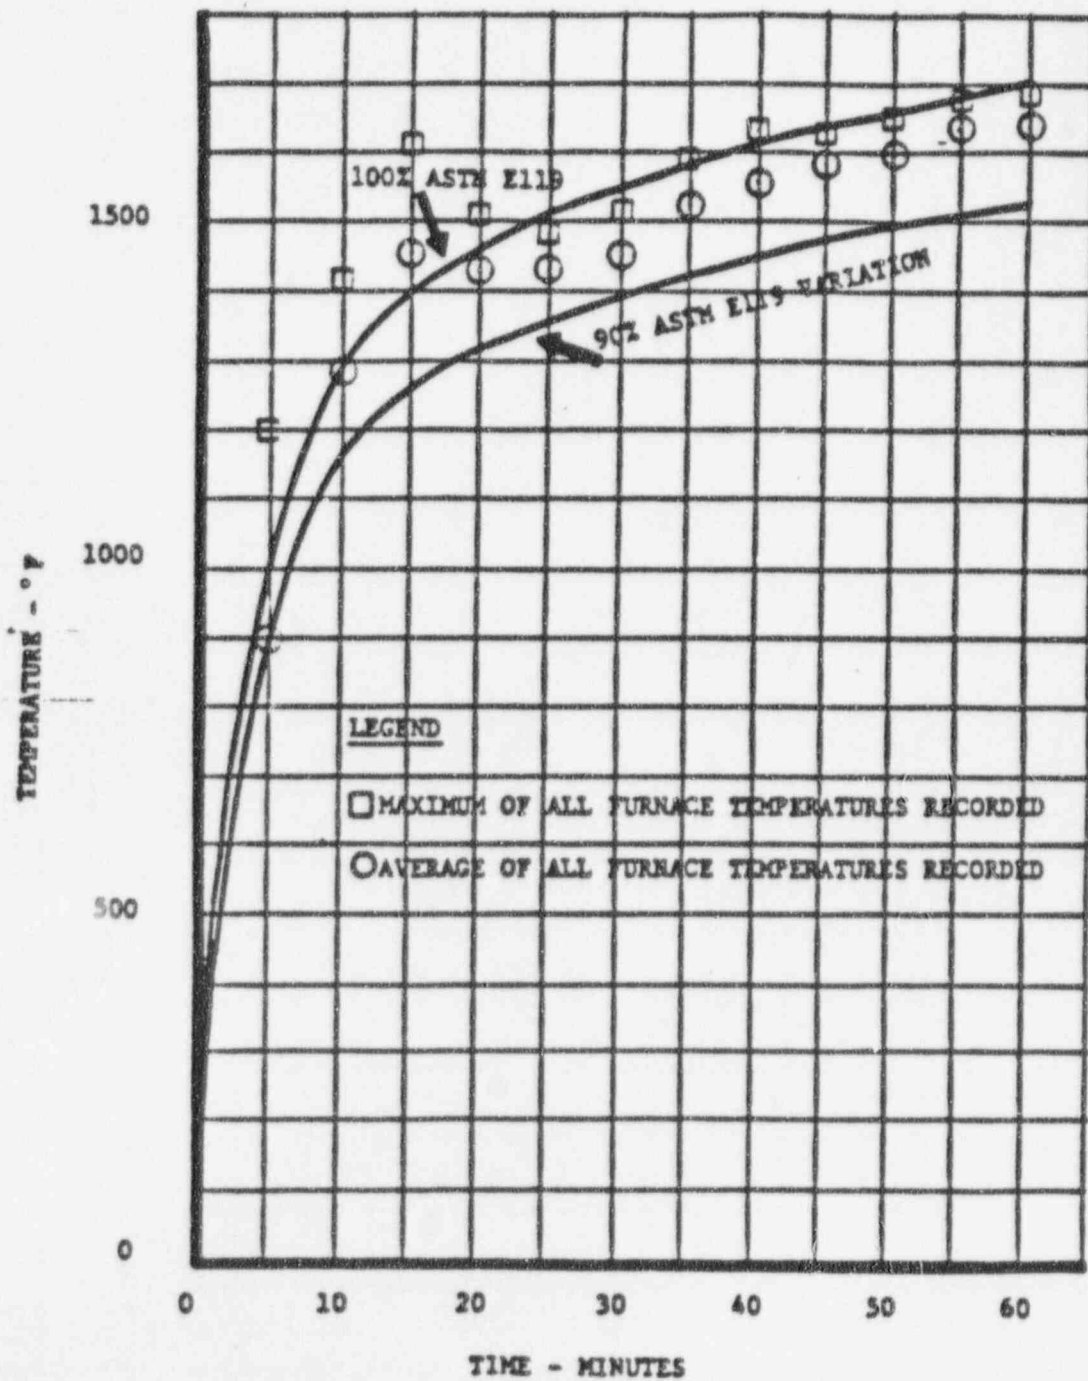
FIGURE 24

DURING FIRE ENDURANCE TEST NO. 345 COMBINED

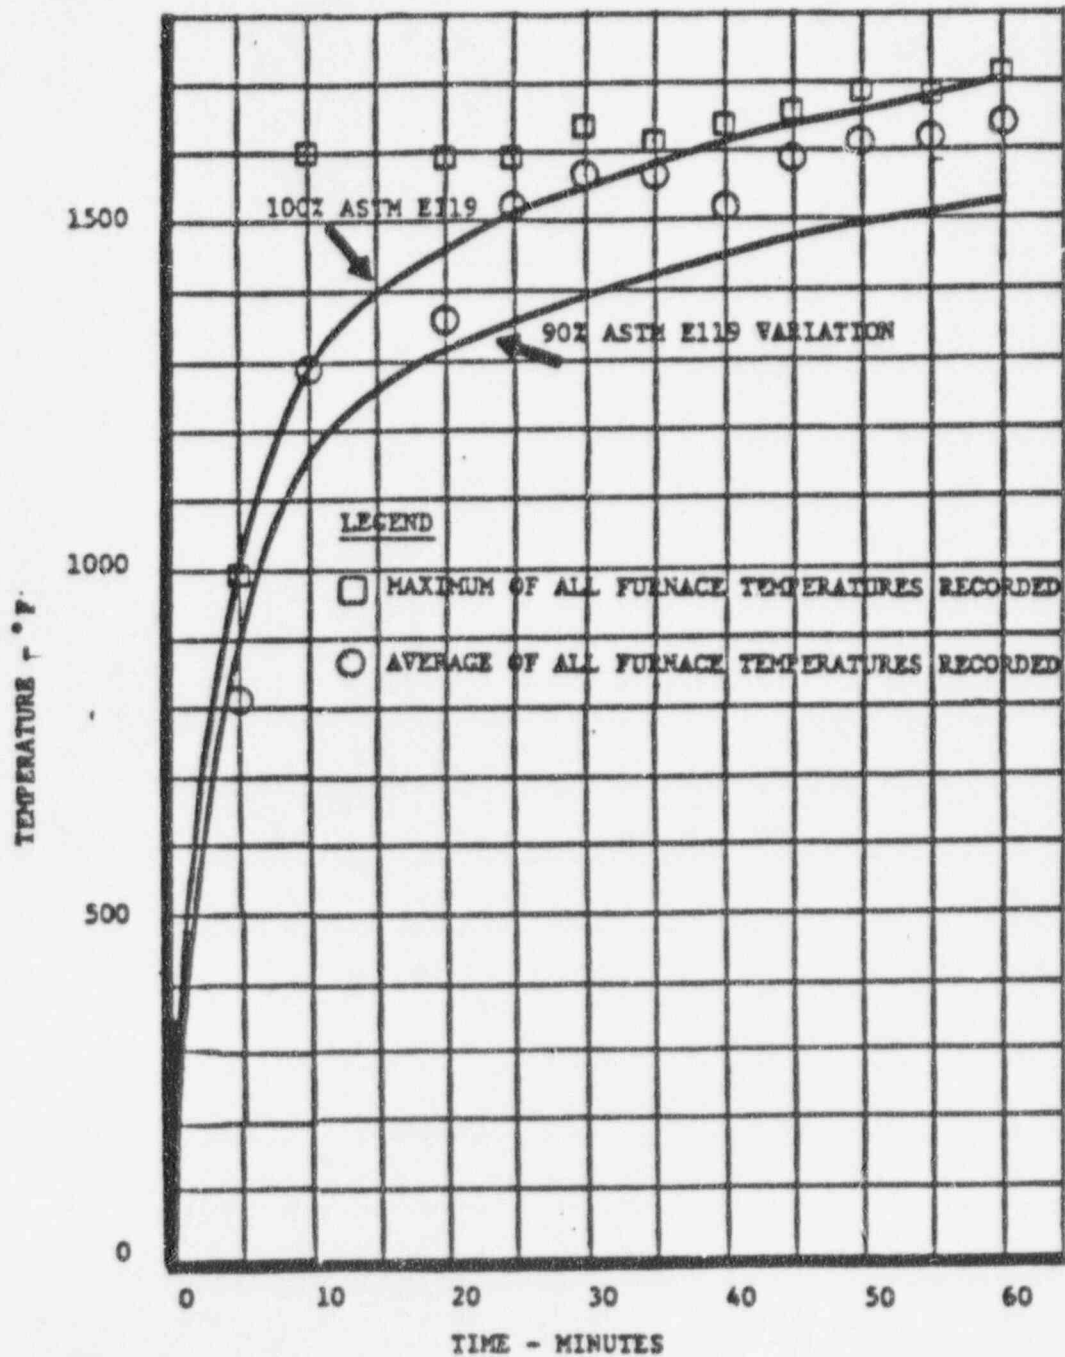
FIGURE 25

DURING FIRE ENDURANCE TEST NO. 4

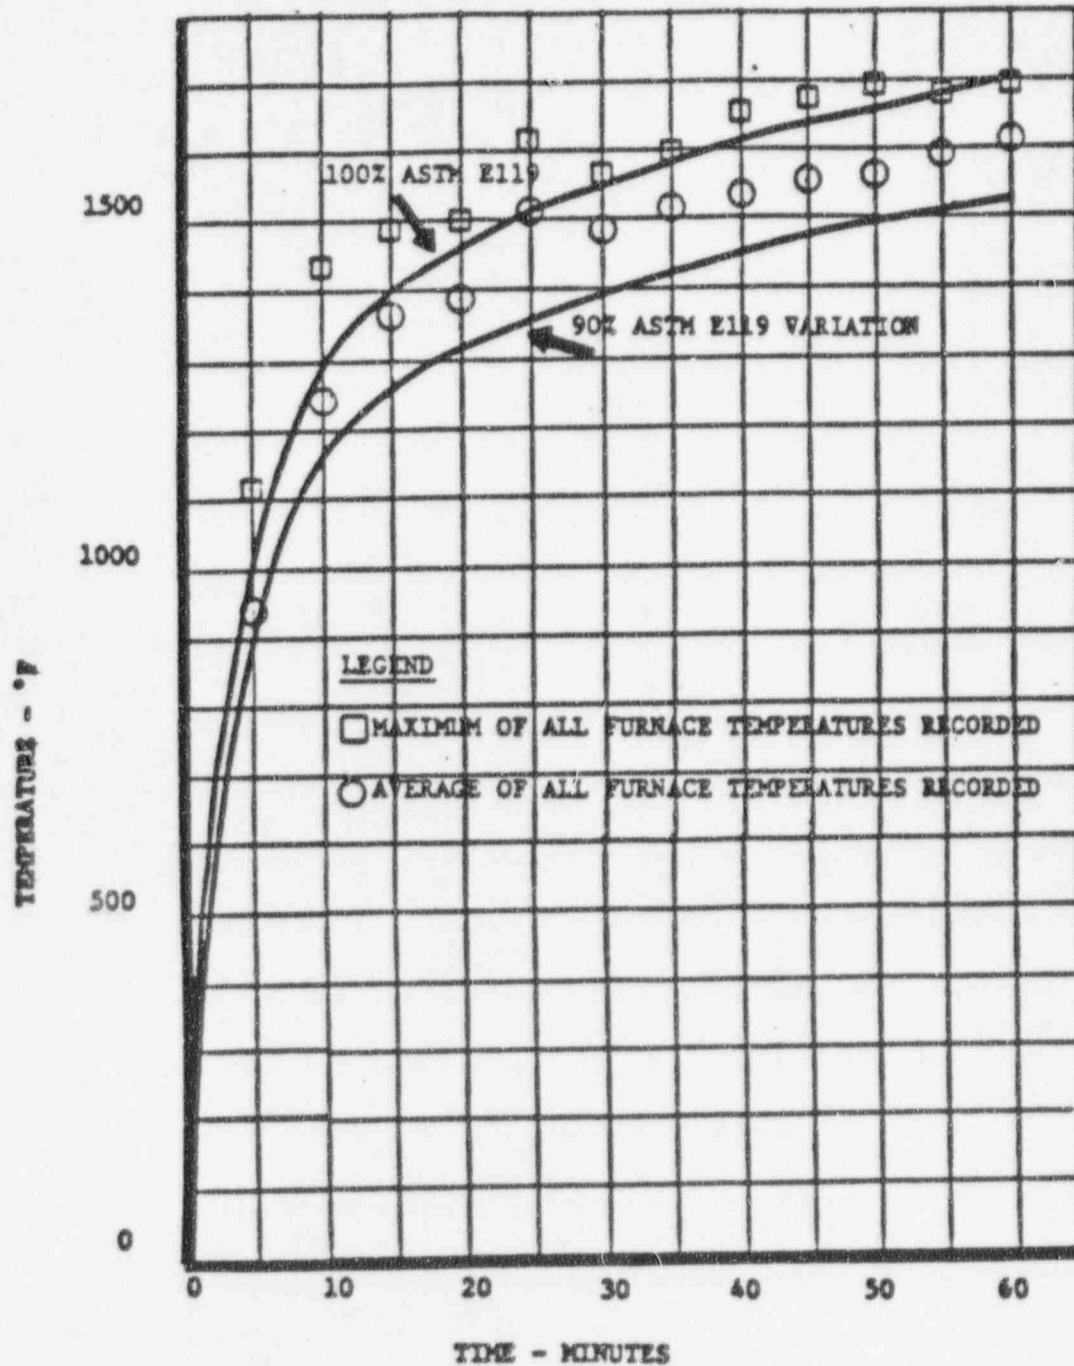
FIGURE 26

DURING FIRE ENDURANCE TEST NO. 6
