## Bechtel Eastern Power Company

Joseph M. Farley Nuclear Plant Units 1 and 2  
Bechtel Job 7597-011/021  
Electric Hydrogen Recombiner Splices -  
Justification for Continued Operation  
(PCR 87-0-4441)  
Bechtel File A-78, E-91  
AP-13541

SUBJECT: Evaluation of splices used on Hydrogen Recombiner  
heater leads to field cables

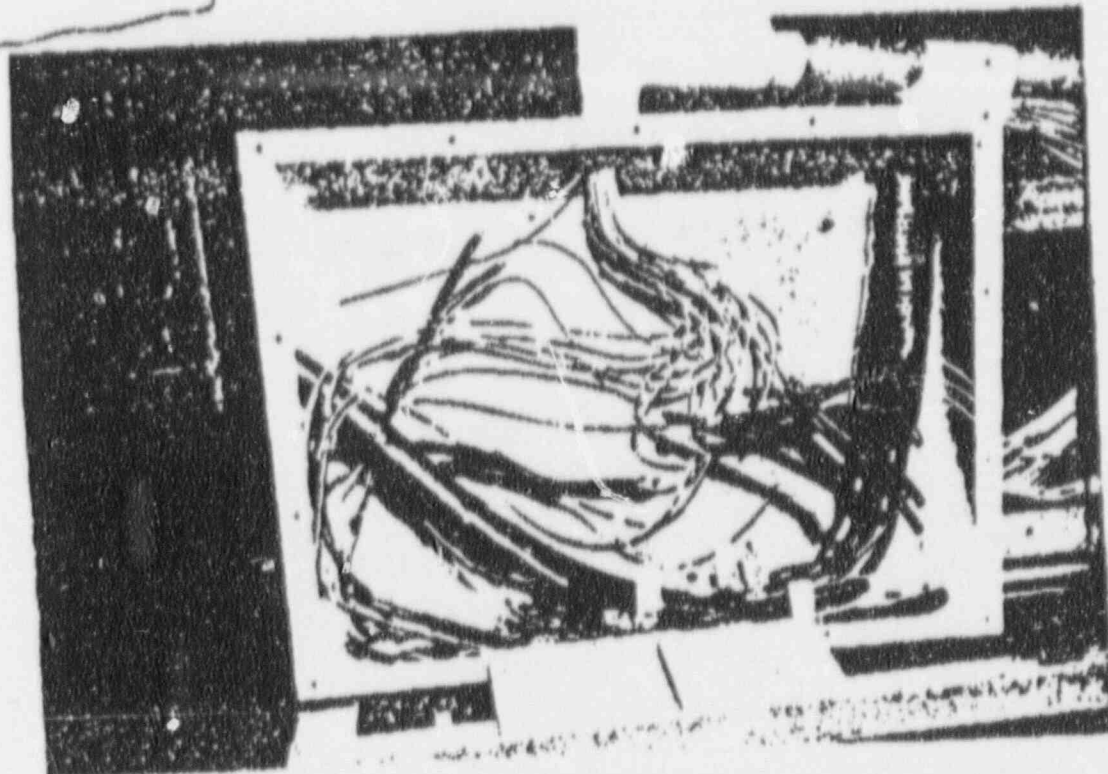
PHOTOGRAPH NO. VIII-3

INTERNAL VIEW OF NEMA 12 ENCLOSURE WITH SPECIMENS B1-B6,  
Z12 AND Z13 MOUNTED ON LOWER LEDGE. B7 WAS MOUNTED  
WITH THE SPLICE END VERTICAL IN THE ENCLOSURE
