SUBJECT: COMANCHE PEAK STEAM ELECTRIC STATION
DOCKET NOs. 50-445 and 50-446
RESPONSE TO IE BULLETIN 84-03

The following information is given in response to IE Bulletin 84-03, "Refueling Cavity Water Seal". Our response is based on Section No. 2's Action request that an evaluation be performed to determine the potential for and consequences of a refueling cavity water seal failure.

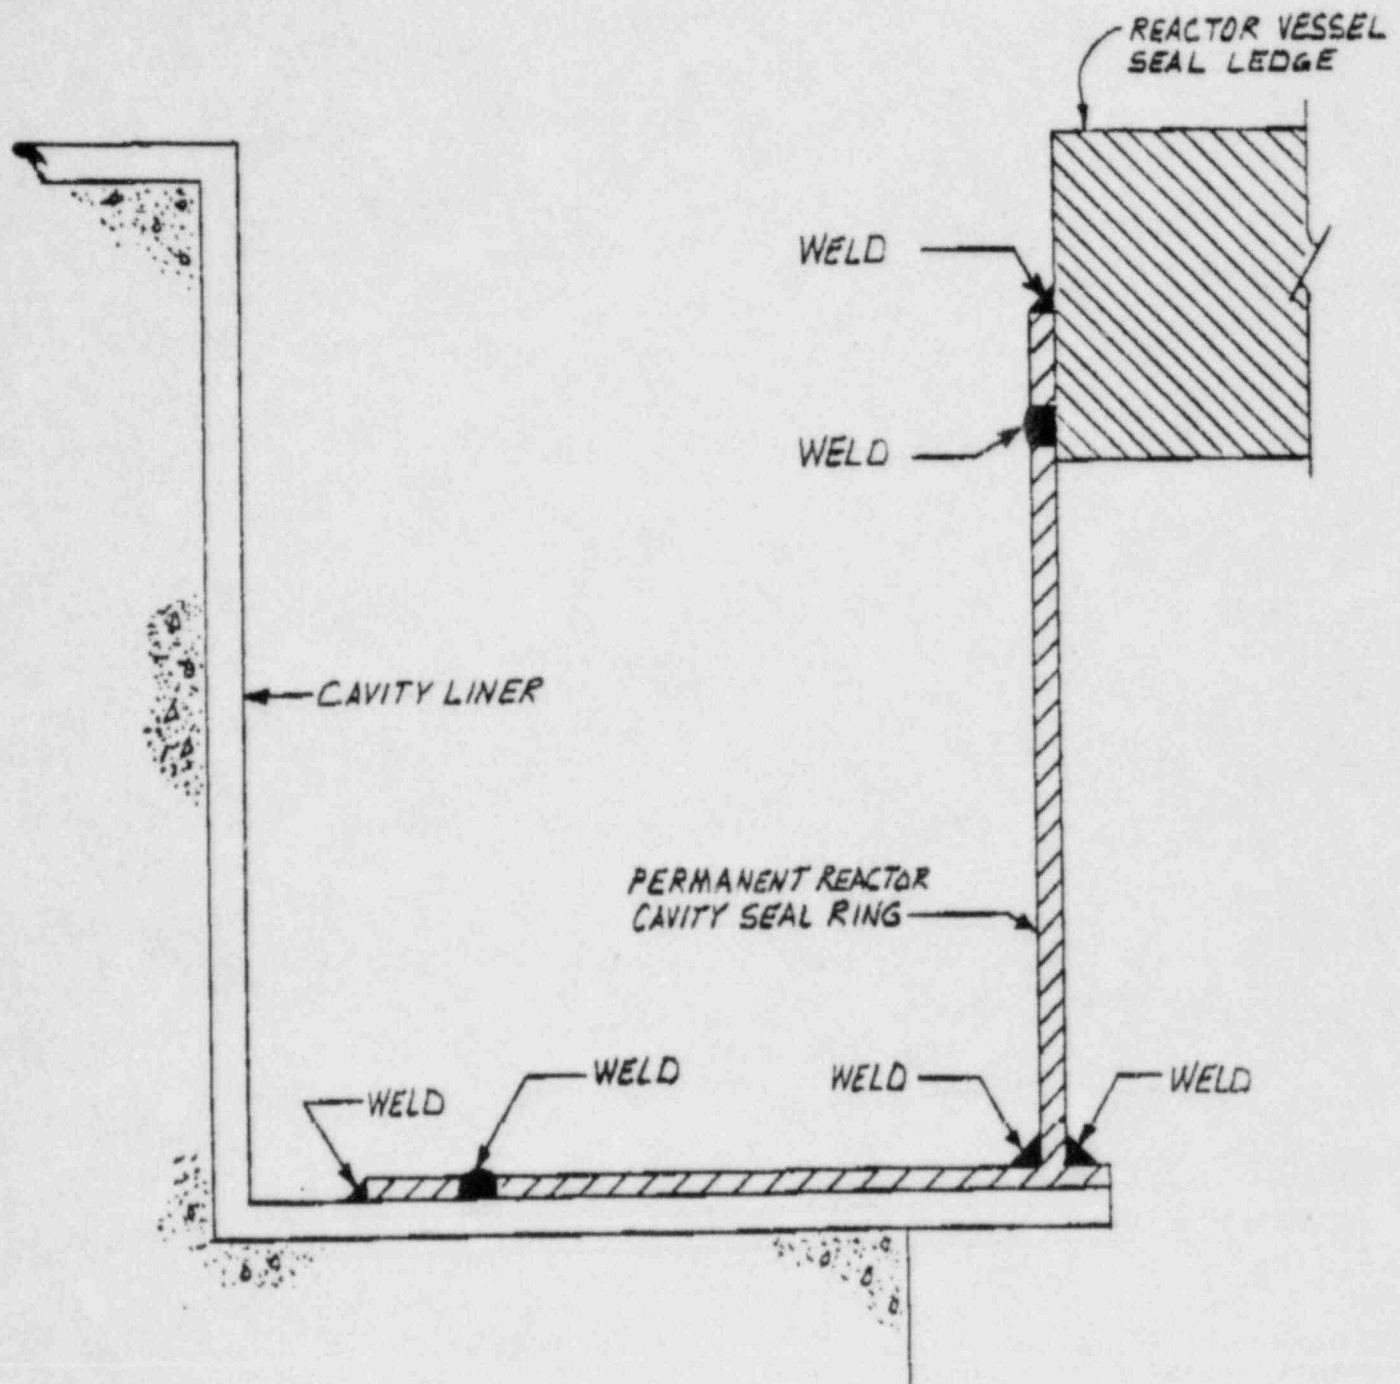
COMANCHE PEAK SEAL RING

The Comanche Peak refueling cavity water seal design (Attachment 1) is much different from that of the Haddam Neck plant. The Comanche Peak design consists of two permanently welded components. One component is a horizontally installed stainless steel ring. The horizontal ring is welded at one end to

the cavity liner and welded at the other end to the bottom of the second component. The second component is a vertically installed stainless steel ring. The vertical ring is welded at the top to the reactor vessel seal ledge. The result of this design is a permanently installed seal, welded to both the cavity liner and the reactor vessel seal ledge. This design does not utilize any active components. Due to the design described above, it is not expected that the Comanche Peak seal will fail in the manner of the Haddam Neck seal but would exhibit leak before break characteristics.

In summary, a gross seal failure as described by IEB 84-03 is highly unlikely to occur at CPSES. The CPSES refueling cavity water seal is a permanently installed stainless steel ring, welded to the cavity liner on one side and welded to the reactor vessel seal ledge on the other side. This type of seal is expected to leak before break. Sufficient alarms and visual checks are provided to detect significant leakage and initiate mitigating actions long before fuel cladding damage could occur. Applicable alarm procedures will be revised to explicitly address the possibility of a seal leak during refueling. In addition, the reactor cavity will be visually checked for seal leakage after filling the refueling cavity.
