COALITION FOR RESPONSIBLE  
ENERGY EDUCATION  
315 W. Riviera Drive  
Tempe, AZ 85282  
May 6, 1985

RE: Show Cause Petition Pursuant to 10 CFR 2.206(a) In the Matter of Arizona Public Service, et al. (Palo Verde Nuclear Generating Station Nos. 1 and 2) Requesting Suspension of PVNGS No. 1 Operating License Pending Completion of Specified Corrective Actions and Institution of Proceeding on Corrective Actions at PVNGS Nos. 1 and 2. Docket Nos. 50-528, 50-529 (License No. NPF-34 and Construction Permit No. 142).

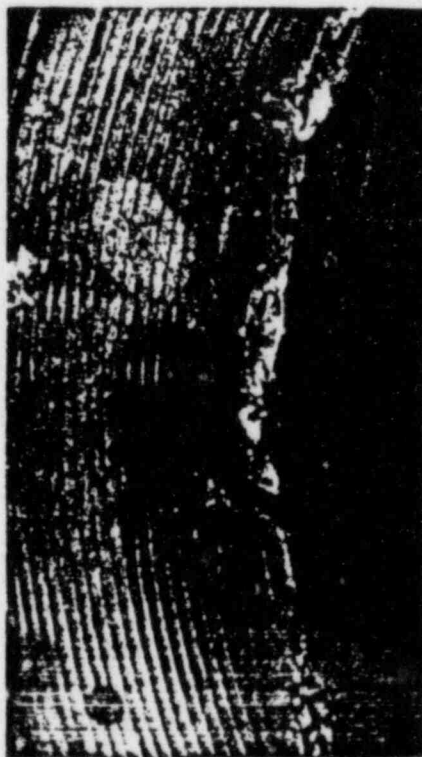
Fig. 2 - Open "gouging" type corrosion of 304 stainless steel flange. This occurred under slime deposits harboring *Desulfovibrio* sulfate reducing bacteria.

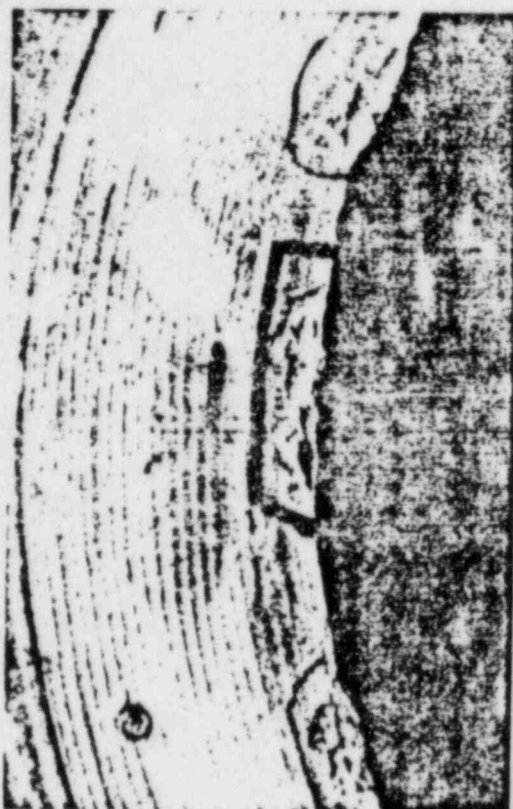
**Figure 2**

Open "gouging"-type corrosion of 304 stainless steel flange.  
This occurred under slime deposits harboring Desulfovibrio  
sulfate reducing bacteria.

Two examples of MIC are shown in Figures 1 and 2 along with a brief description of the cases to give the reader a better idea of what will be discussed in the following chapters.
