U.S. NUCLEAR REGULATORY COMMISSION

Report No.: 040-06264/96001(DNMS)

Licensee: Michigan Chemical (now Velsicol Chemical Corporation)

Facilities: Breckenridge Disposal Site (Closed)

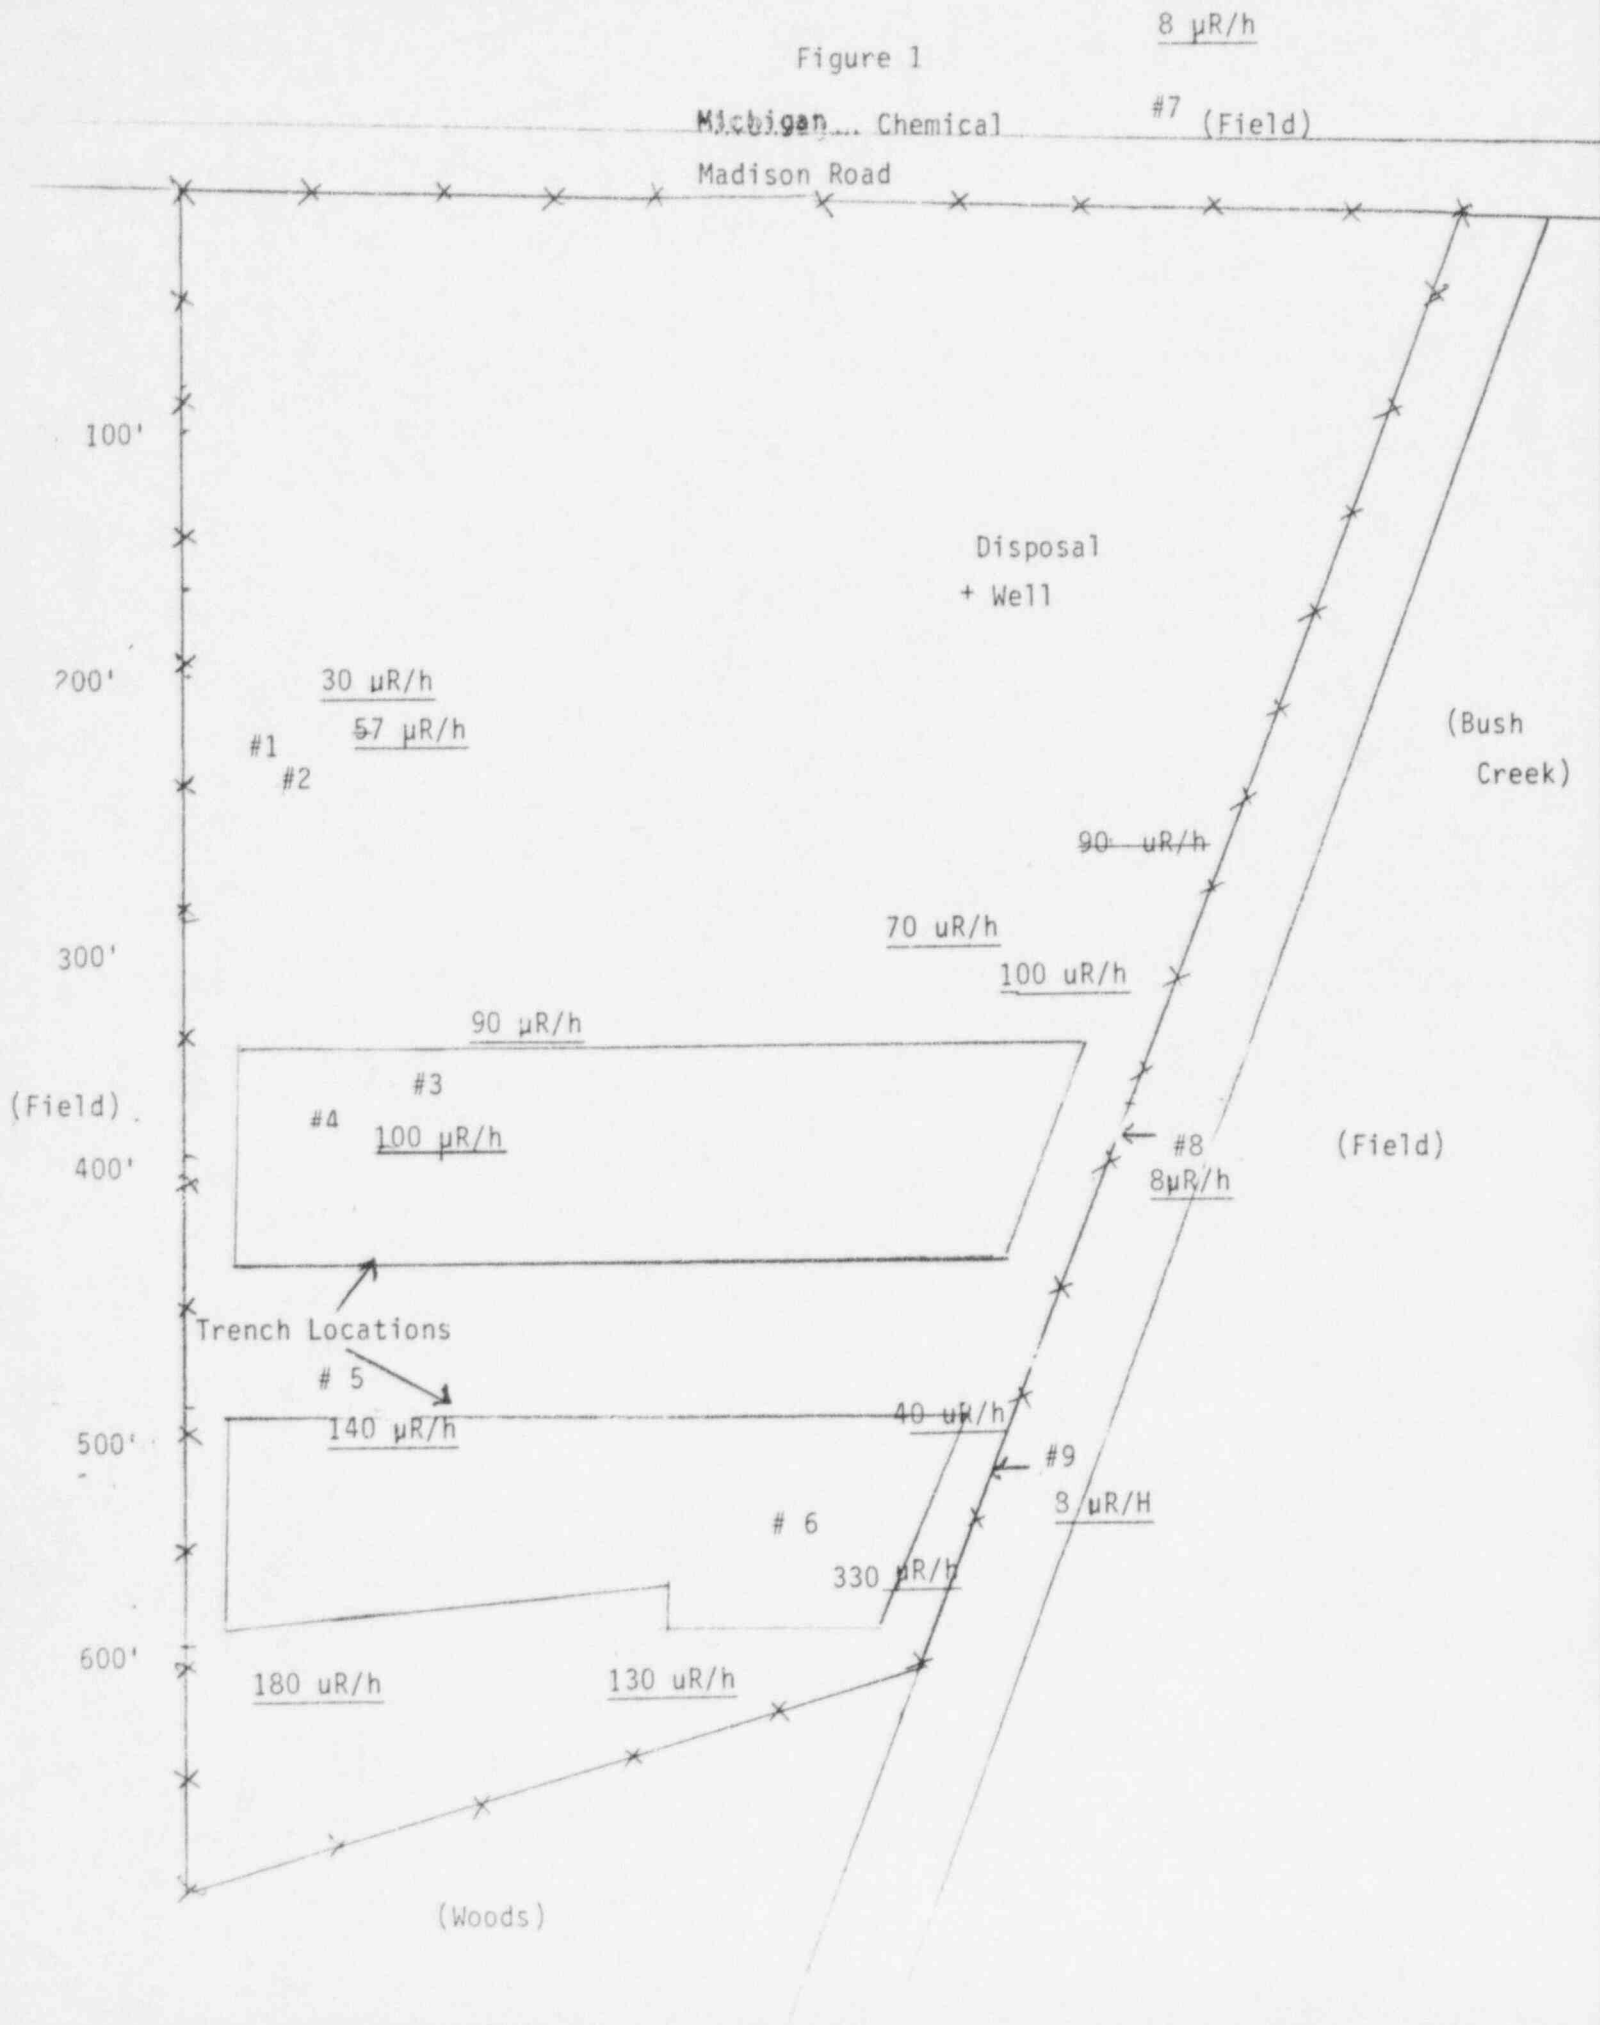
2.2 acres. The parcel is bounded on the north by Madison Road and on the east by Bush Creek. The land is basically level. The southern tip of the property is covered with tall trees and brush. A chain-link security fence was being constructed at the time of the NRC survey, and surrounds the section containing the burial trenches. At the northern end is a deep chemical disposal well, which is capped and no longer used. The reported approximate depth of the well is 600-800 m. Two drain tiles were located on the side of the site bordering Bush Creek. The surrounding land is primarily agricultural; the nearest residence is approximately 0.2 km east of the site. Figure 1 is a diagram of the Breckenridge Disposal Site.

The inspectors collected six surface soil samples from the disposal site from areas with elevated gamma readings ("biased" samples). Additionally, three other soil samples were collected, one from a farm field across the road (north) from the disposal site, and two from the area below two drain tiles which empty into the stream adjoining the disposal site. The soil sample collection locations are identified on Figure 1.
