Edwin I. Hatch Nuclear Plant  
Third 10-Year Interval Inservice Inspection Program  
Request for Relief

**GEORGIA POWER COMPANY  
HATCH NUCLEAR PLANT, UNITS 1 & 2  
THIRD 10-YEAR INTERVAL  
REQUEST FOR RELIEF NO. RR-18**

**GEORGIA POWER COMPANY  
HATCH NUCLEAR PLANT, UNIT 1  
THIRD 10-YEAR INTERVAL  
REQUEST FOR RELIEF NO. RR-19**

**GEORGIA POWER COMPANY  
HATCH NUCLEAR PLANT, UNITS 1 AND 2  
THIRD 10-YEAR INTERVAL  
REQUEST FOR RELIEF NO. RR-20**

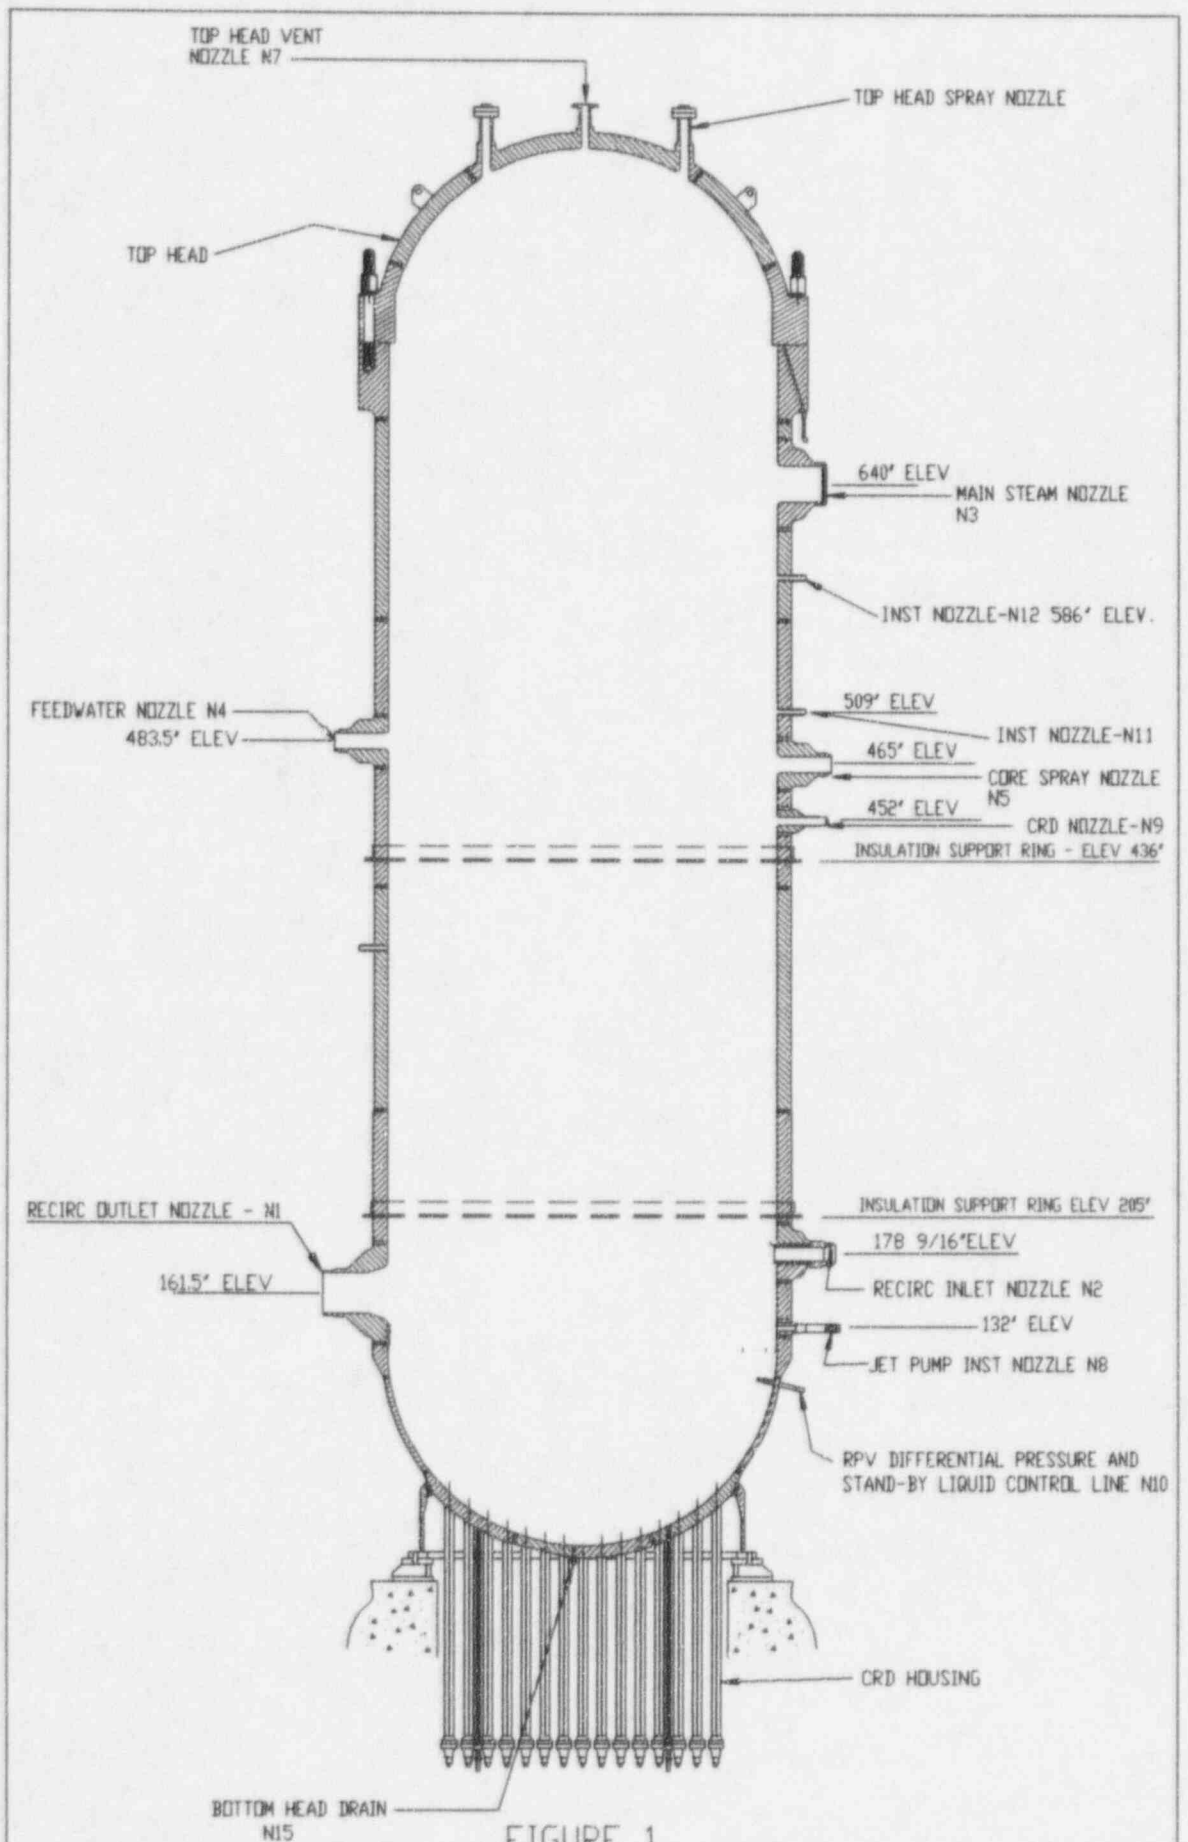
FIGURE 1

E.I. HATCH UNIT 1- RPV NOZZLE LOCATIONS  
AND INTERFERENCES

**N1A, B - Recirculation Outlet Nozzle-To-Vessel Welds** - For this nozzle configuration, the weld is located in the curved, blend radius of the nozzle; therefore, ultrasonic scanning can only be performed on the RPV vessel up to the point where the curvature begins. For this configuration, approximately 60% of the required examination volume is scanned from the one side. (See Figures 1 and 3).

**N2A-H, J-K - Recirculation Inlet Nozzle-To-Vessel Welds** - For this nozzle configuration, the weld is located in the curved, blend radius of the nozzle; therefore, ultrasonic scanning can only be performed on the RPV vessel up to the point where the curvature begins. For this configuration approximately 50% of the required examination volume for 95% of the weld length is scanned from the one side. The 5% limitation exists due to a welded insulation ring that is located just above the nozzles. (See Figures 1, 2, and 4).

**N3A, B, C - Main Steam Nozzle-To-Vessel Welds** - For this nozzle configuration, the weld is located in the curved, blend radius of the nozzle; therefore, ultrasonic scanning can only be performed on the RPV vessel up to the point where the curvature begins. For this configuration, approximately 40 to 50 % of the required examination volume is scanned from the one side. (See Figures 1 and 5).

**N4A-D - Feedwater Nozzle-To-Vessel Welds** - For this nozzle configuration, the weld is located in the curved, blend radius of the nozzle; therefore, ultrasonic scanning can only be performed on the RPV vessel up to the point where the curvature begins. For this configuration, approximately 40 to 50% of the required examination volume is scanned from the one side. (See Figures 1 and 6).

**N5A, B - Core Spray Nozzle-To-Vessel Welds** - For this nozzle configuration, the weld is located in the curved, blend radius of the nozzle; therefore, ultrasonic scanning can only be performed on the RPV vessel up to the point where the curvature begins. For this configuration, approximately 40 to 50% of the required examination volume is scanned from the one side. (See Figures 1 and 7).

**N6A, B and N7 - RPV Head Nozzles** - These small nozzles located on the RPV head have a configuration such that coverage from one side is only approximately 40 to 50% for the N6A, B nozzles and 50% for the N7 nozzle. An evaluation of the configuration shows that these small nozzles have a very short radius. With this configuration, scanning can only be performed on the head and possibly a portion of the weld. (See Figures 1, 13 and 14).

**N8A-B - Jet Pump Instrument Nozzles** - These small nozzles have a configuration such that coverage from one side is in the range of 50 to 60%. An evaluation of the configuration shows that these small nozzles have a very sharp radius. With this configuration, scanning can only be performed on the shell and possibly a portion of the weld. (See Figures 1 and 15).

**N9 - CRD Nozzle-To-Vessel** - For this nozzle configuration, the weld is located in the curved blend radius, such that, ultrasonic scanning can only be performed on the RPV up to the point where the curvature begins. For this configuration, approximately 50 to 60% of the required examination volume is scanned from the one side. (See Figures 1 and 16).

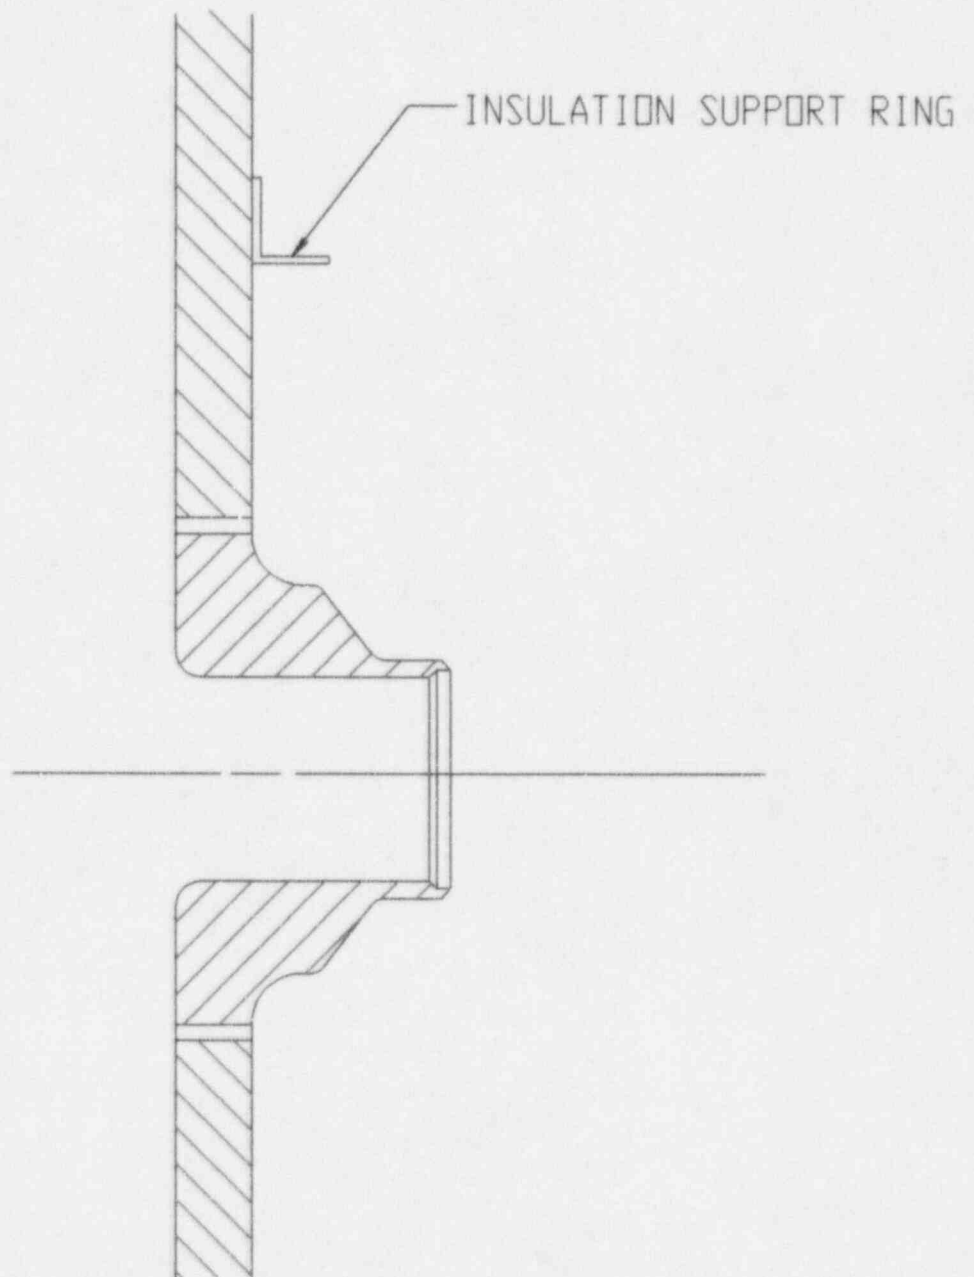
FIGURE 2

E.I. HATCH UNIT 1-RECIRCULATION INLET NOZZLE N2A-H, J-K  
AND INSULATION RING

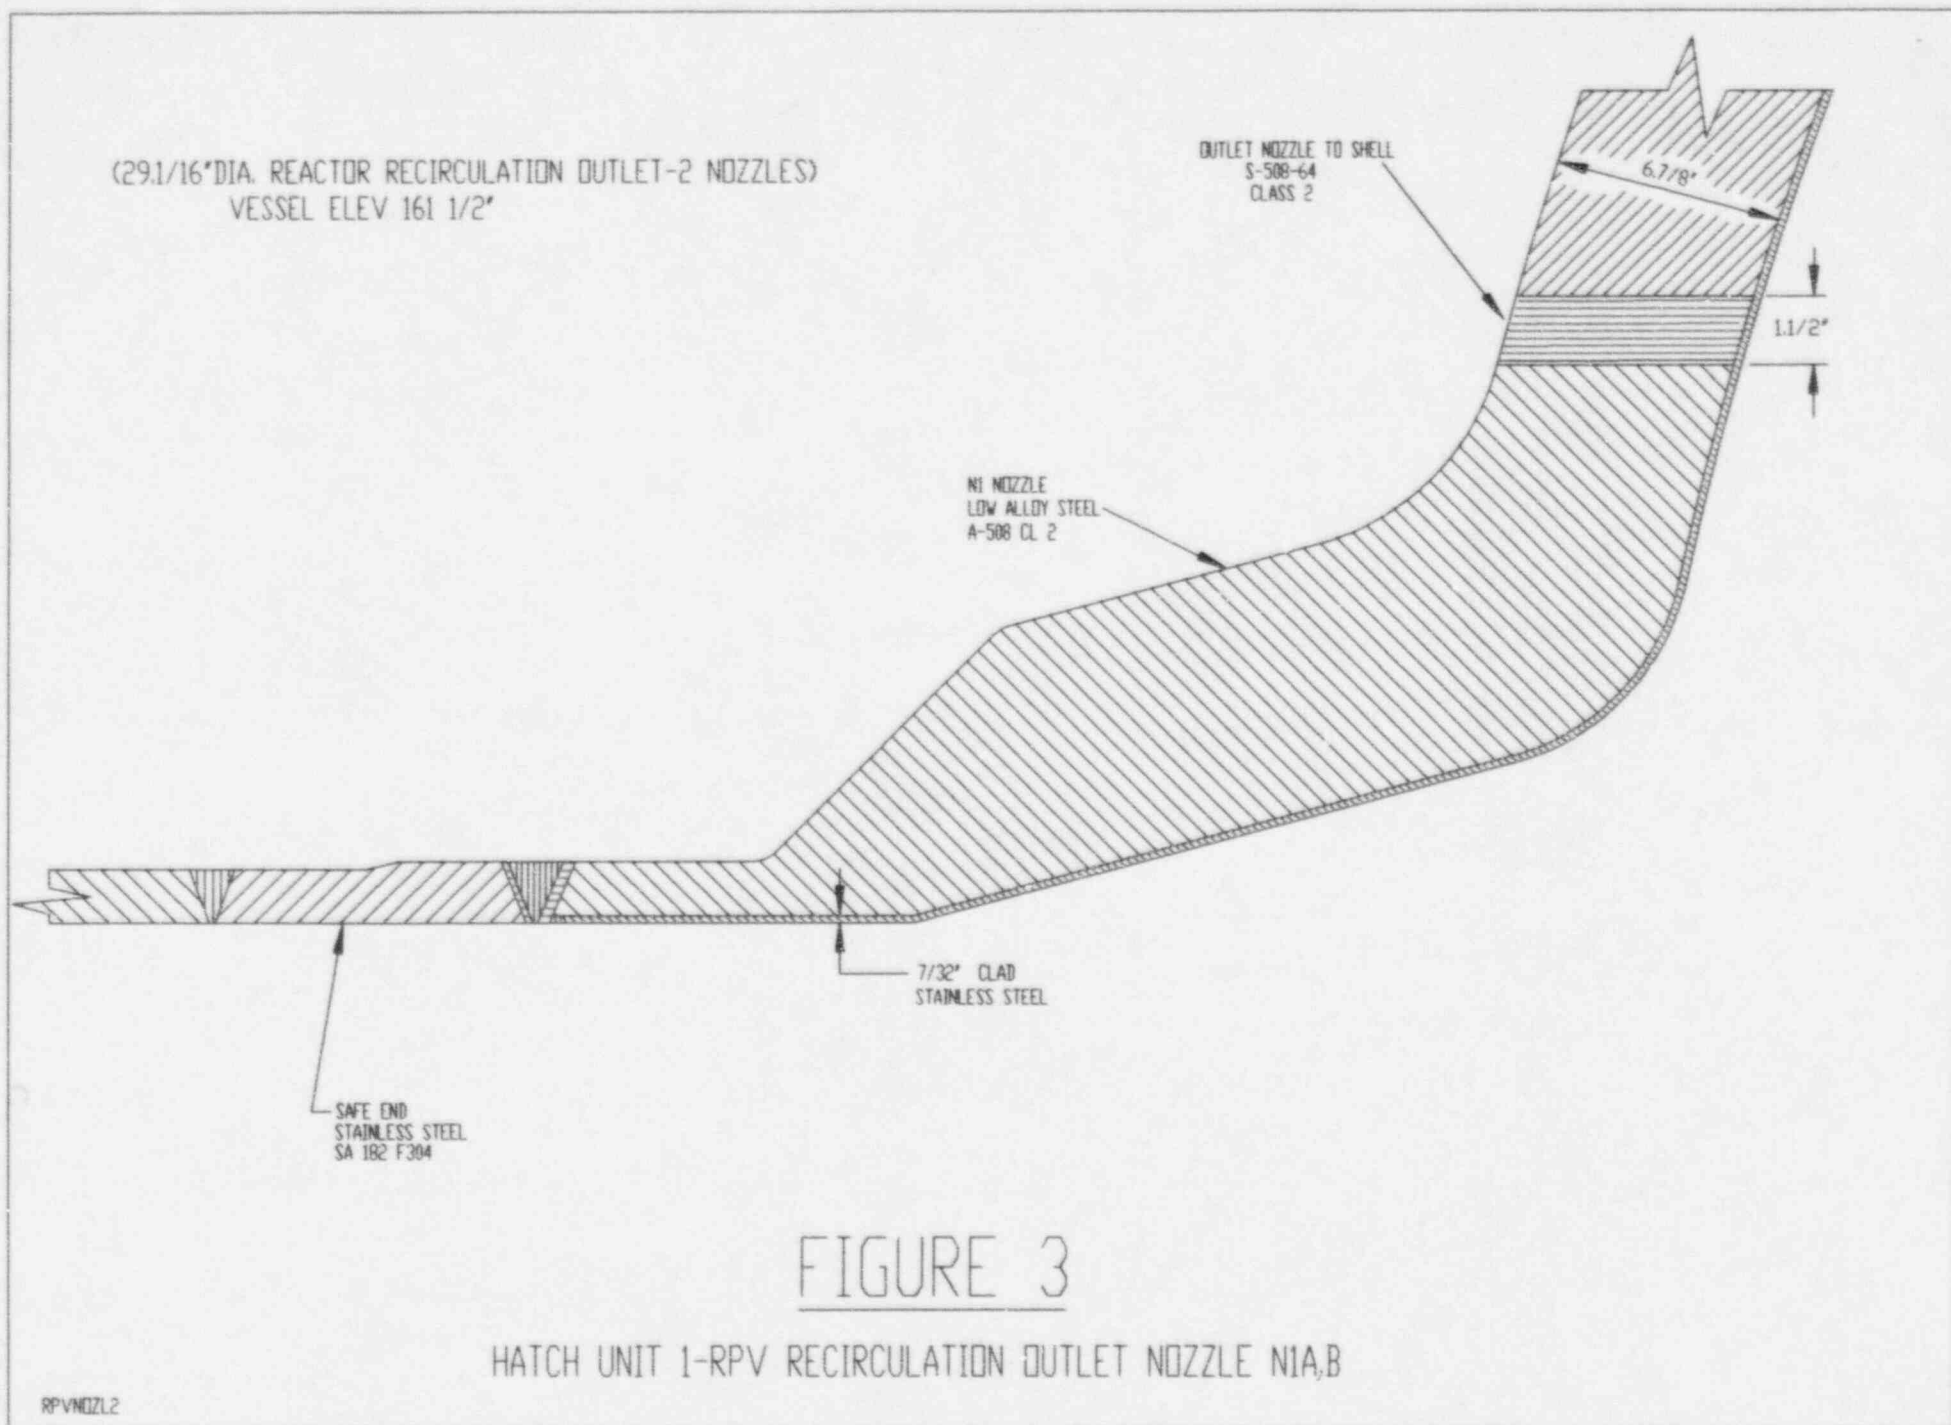
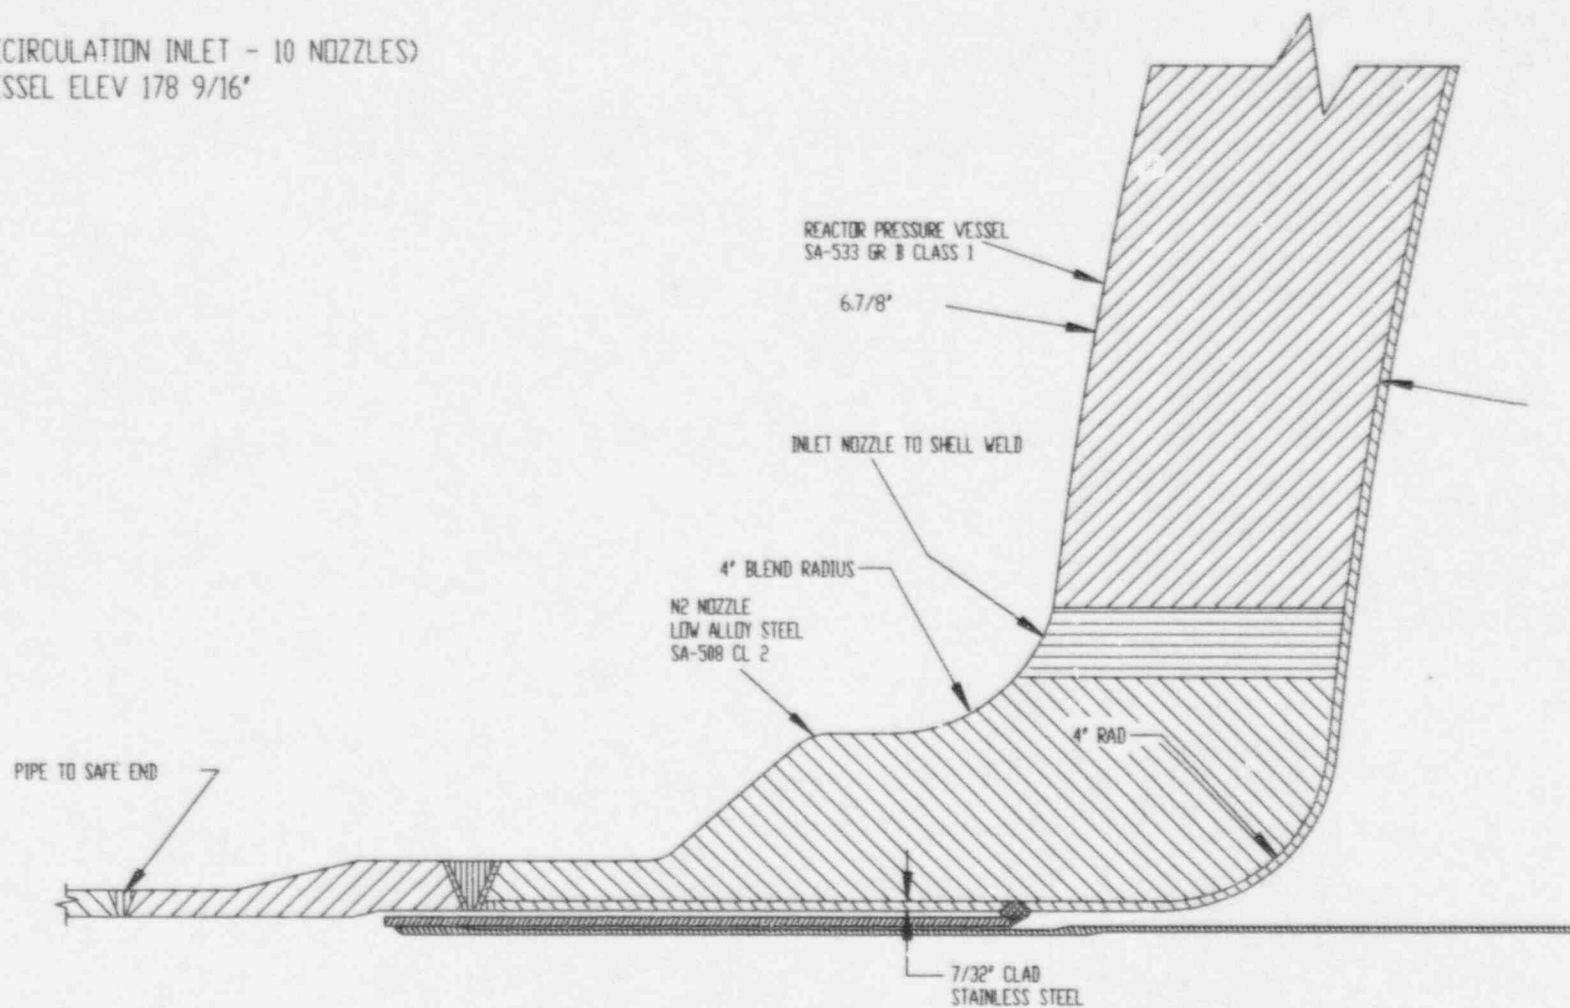
FIGURE 4

(12" REACTOR RECIRCULATION INLET - 10 NOZZLES)  
VESSEL ELEV 178 9/16"

HATCH UNIT 1-RPV RECIRCULATION INLET NOZZLE N2A,B,C,D,E,F,G,H,J,K.

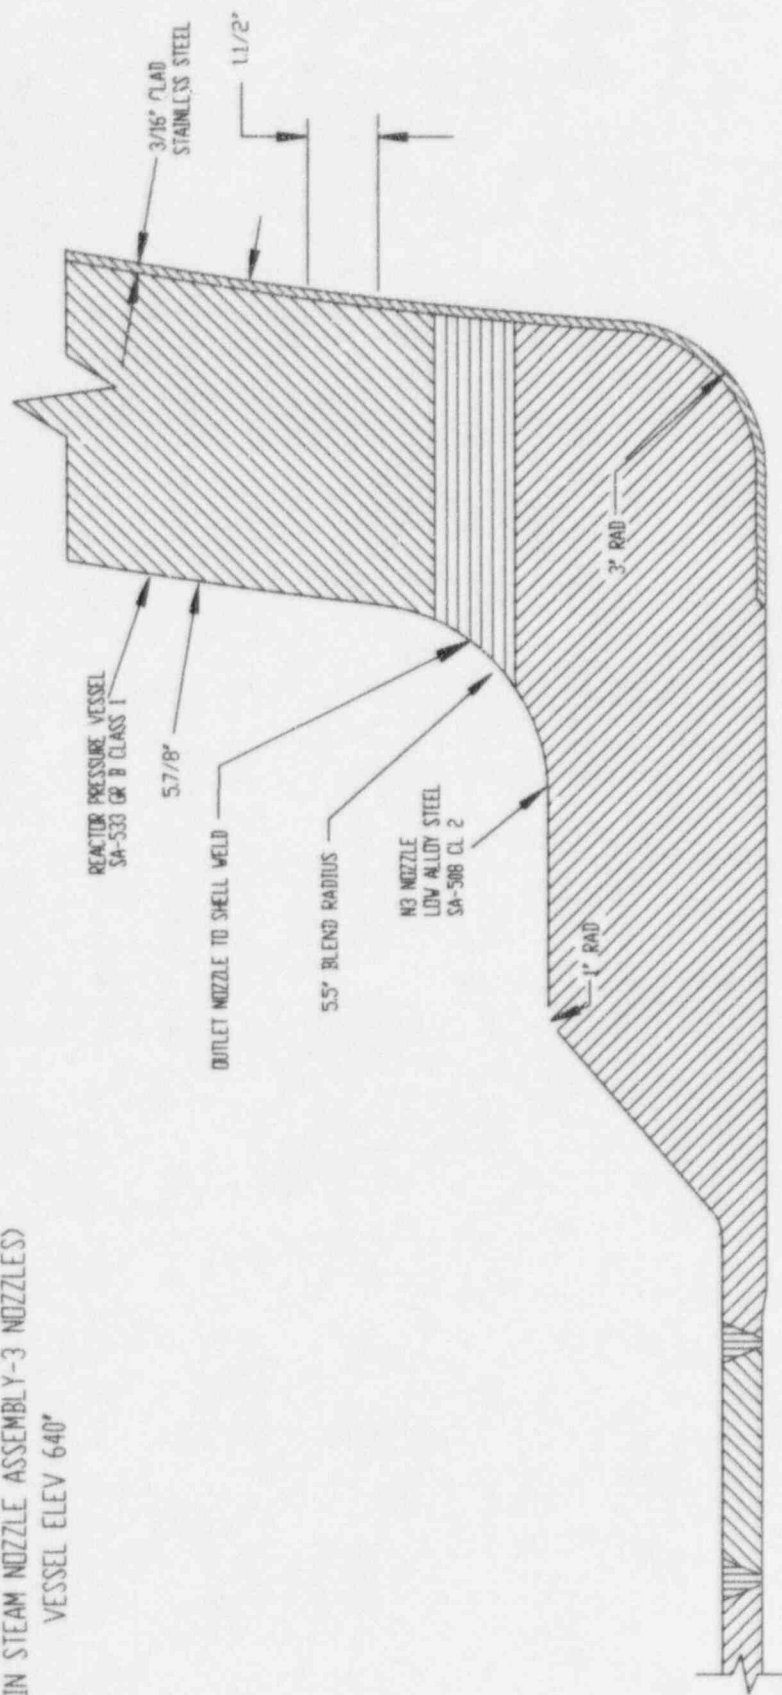
FIGURE 5

(24" MAIN STEAM NOZZLE ASSEMBLY-3 NOZZLES)  
VESSEL ELEV 640"

HATCH UNIT 1-RPV MAIN STEAM NOZZLE N3A,B,C.

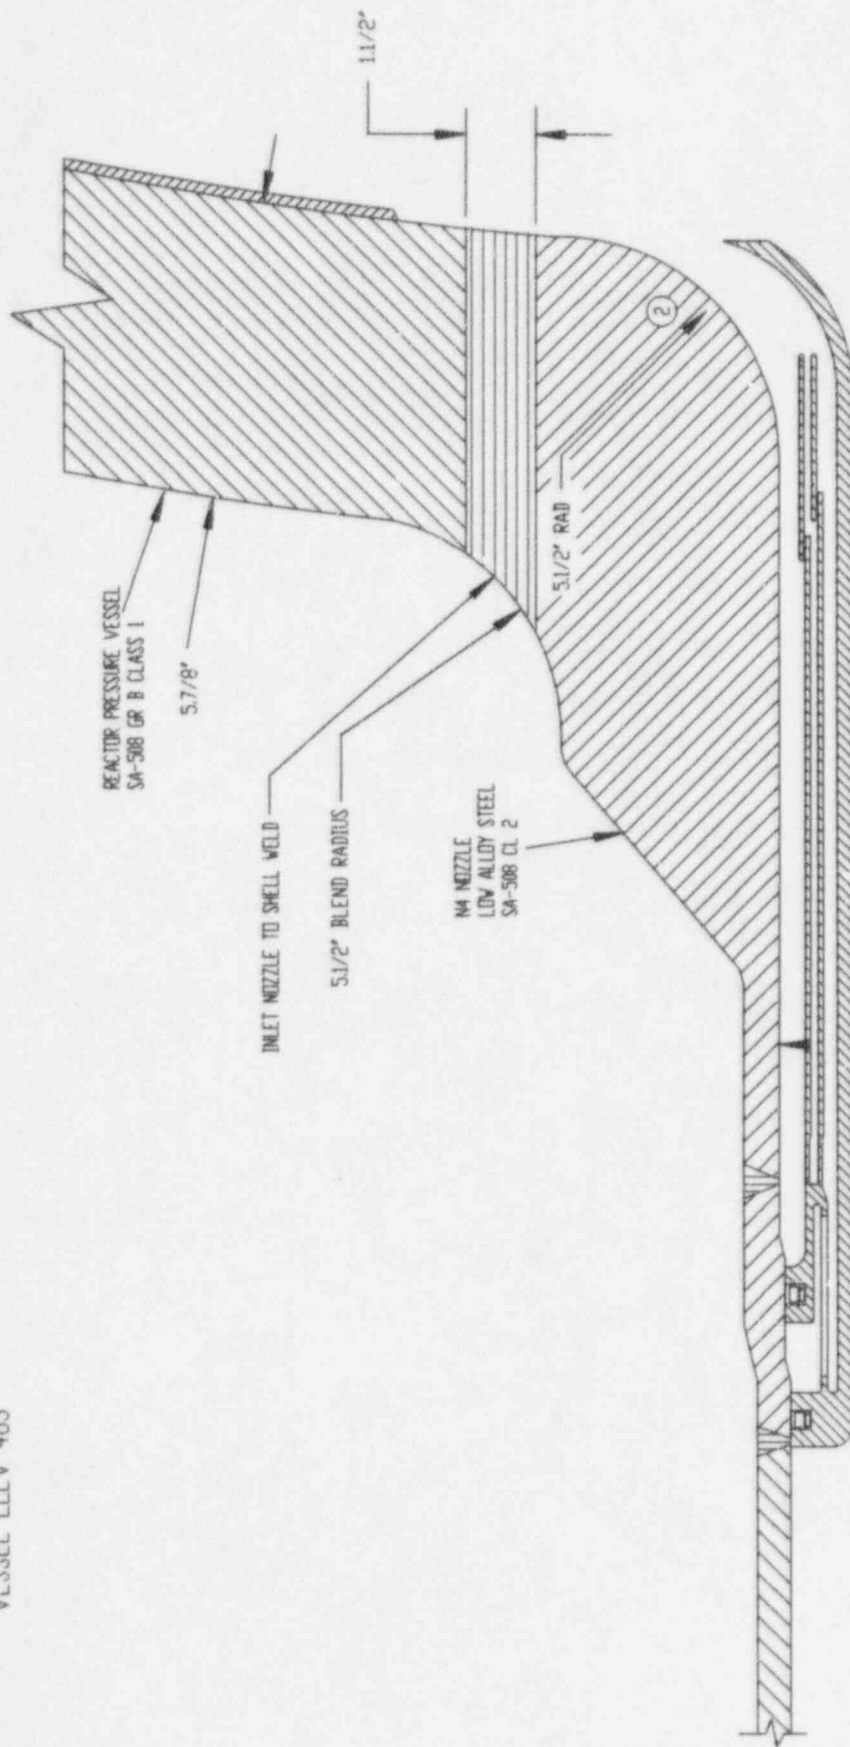
FIGURE 6  
HATCH UNIT 1-RPV FEEDWATER INLET NOZZLE N4A,B,C,D

(12" FEEDWATER NOZZLE ASSEMBLY-4 NOZZLES)  
VESSEL ELEV 483"

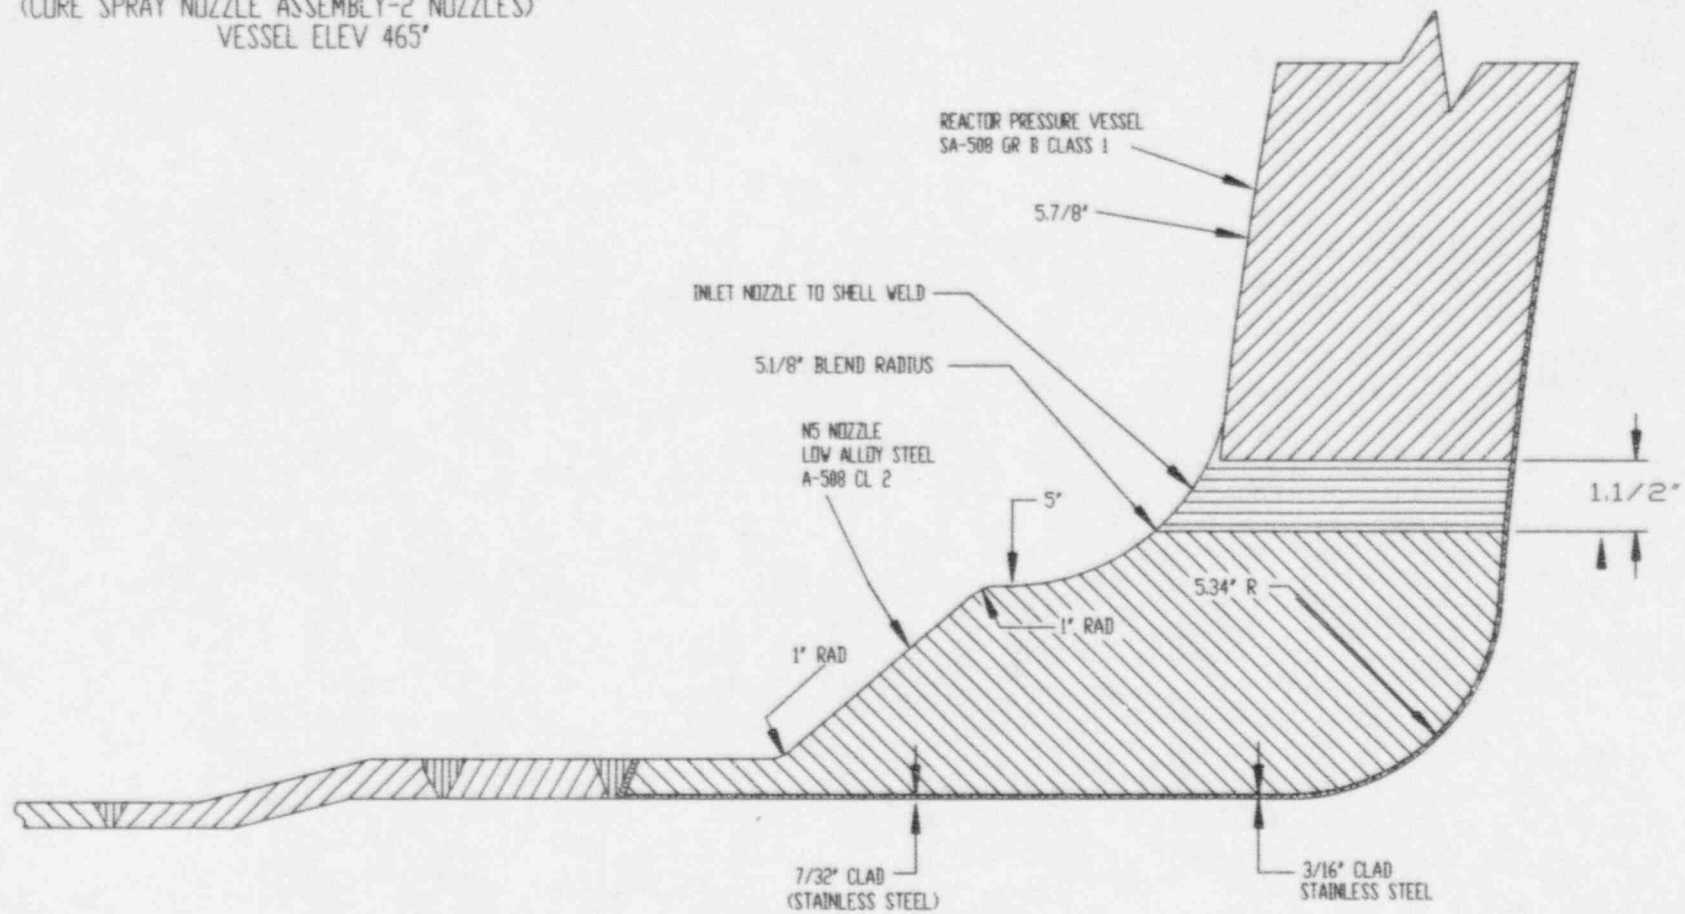
FIGURE 7

(CORE SPRAY NOZZLE ASSEMBLY-2 NOZZLES)  
VESSEL ELEV 465'

HATCH UNIT 1-RPV CORE SPRAY NOZZLE N5A,B

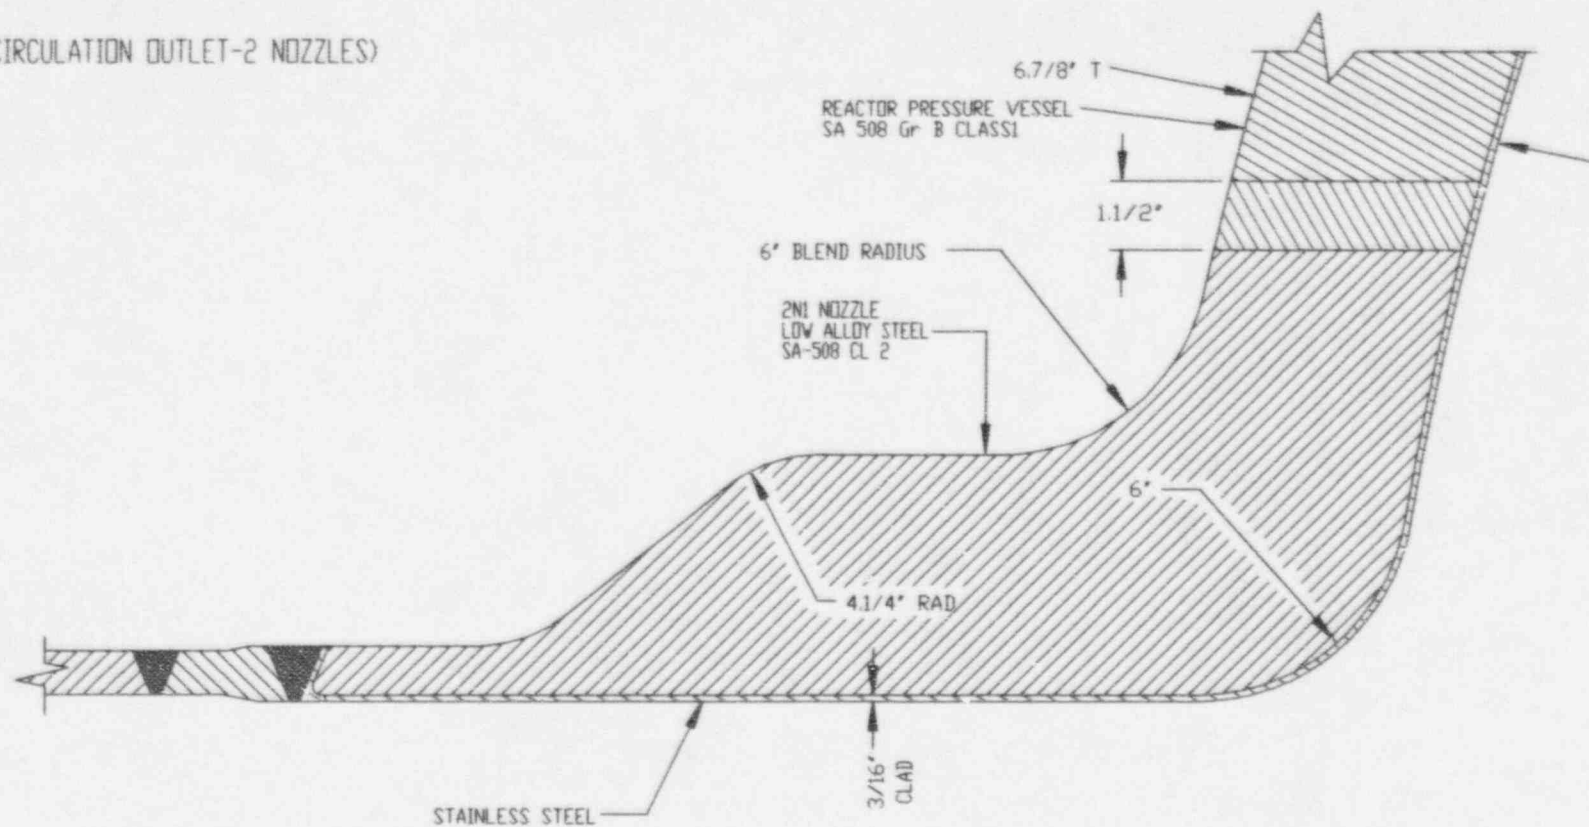
FIGURE 8

(28" REACTOR RECIRCULATION OUTLET-2 NOZZLES)

HATCH UNIT 2-RPV RECIRCULATION OUTLET NOZZLE 2N1A,B

**2N1A, B - Recirculation Outlet Nozzle-To-Vessel Welds** - For this nozzle configuration, the weld is located such that ultrasonic scanning can be performed on the RPV vessel, on the weld, and on a small portion of the nozzle. For this configuration, approximately 80% of the required examination volume is scanned from the one side. (See Figure 8)

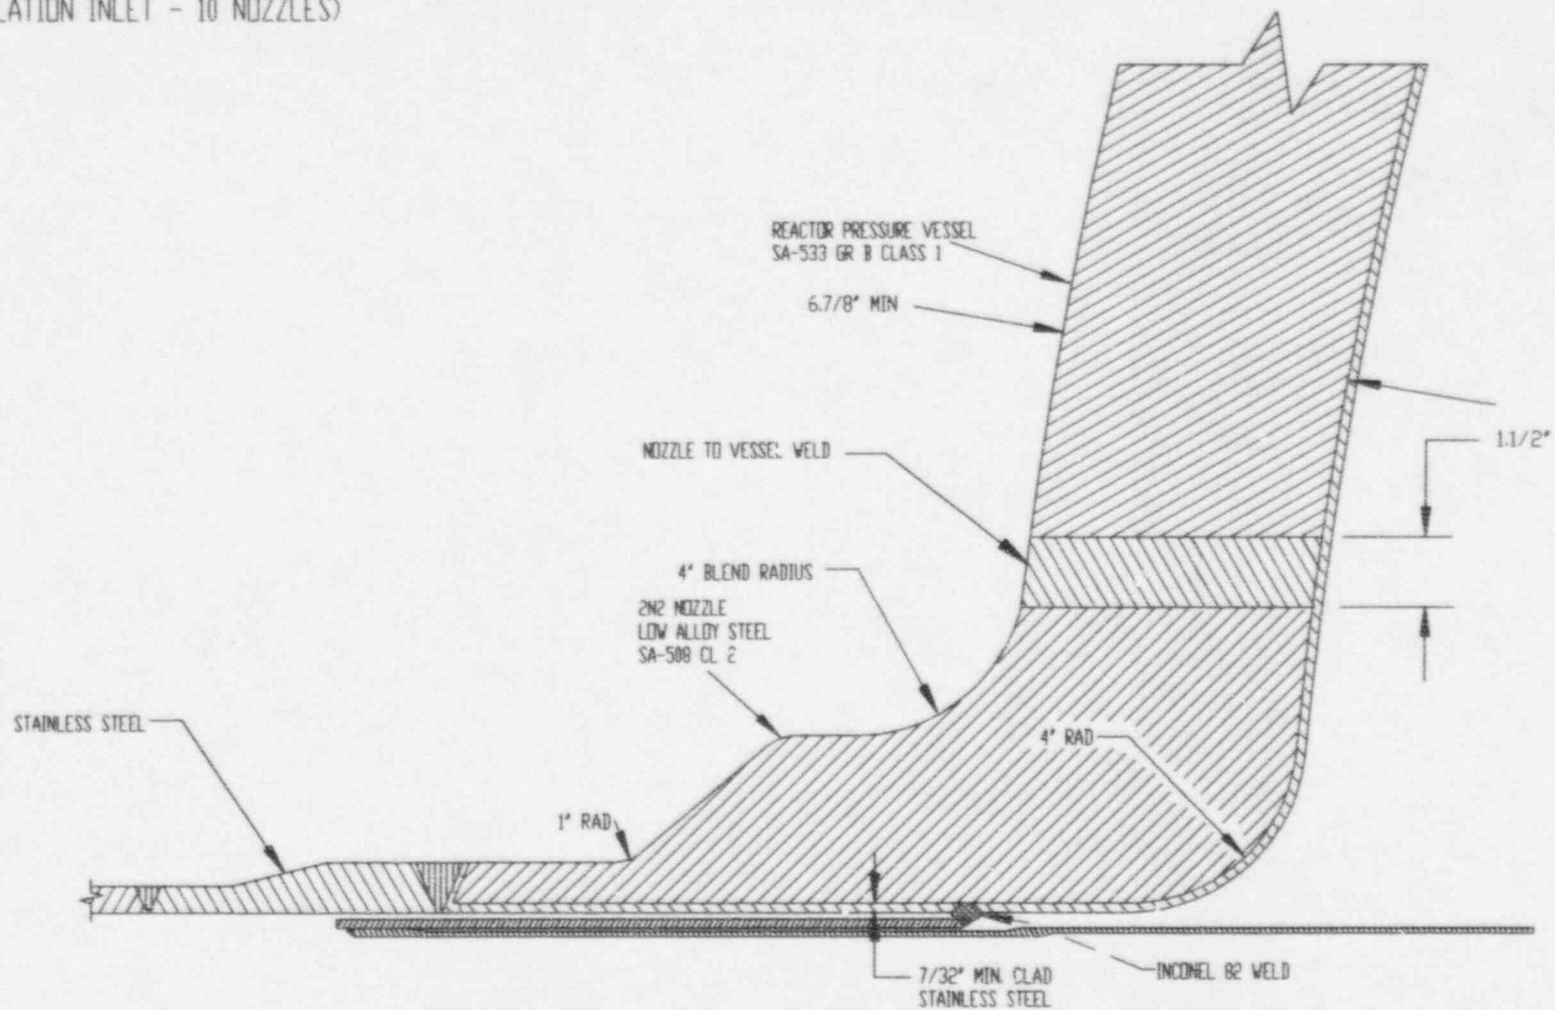
FIGURE 9

(12" REACTOR RECIRCULATION INLET - 10 NOZZLES)

HATCH UNIT 2-RPV RECIRCULATION INLET 2N2A,B,C,D,E,F,G,H,J,K

**2N2A-H, J-K - Recirculation Inlet Nozzle-To-Vessel Welds** -. For this nozzle configuration, the weld is located such that ultrasonic scanning can be performed on the RPV vessel, on the weld, and on a small portion of the nozzle. For this configuration, approximately 75% of the required examination volume is scanned from the one side. (See Figure 9 ). (Note: The welded insulation ring is not present on Unit 2).

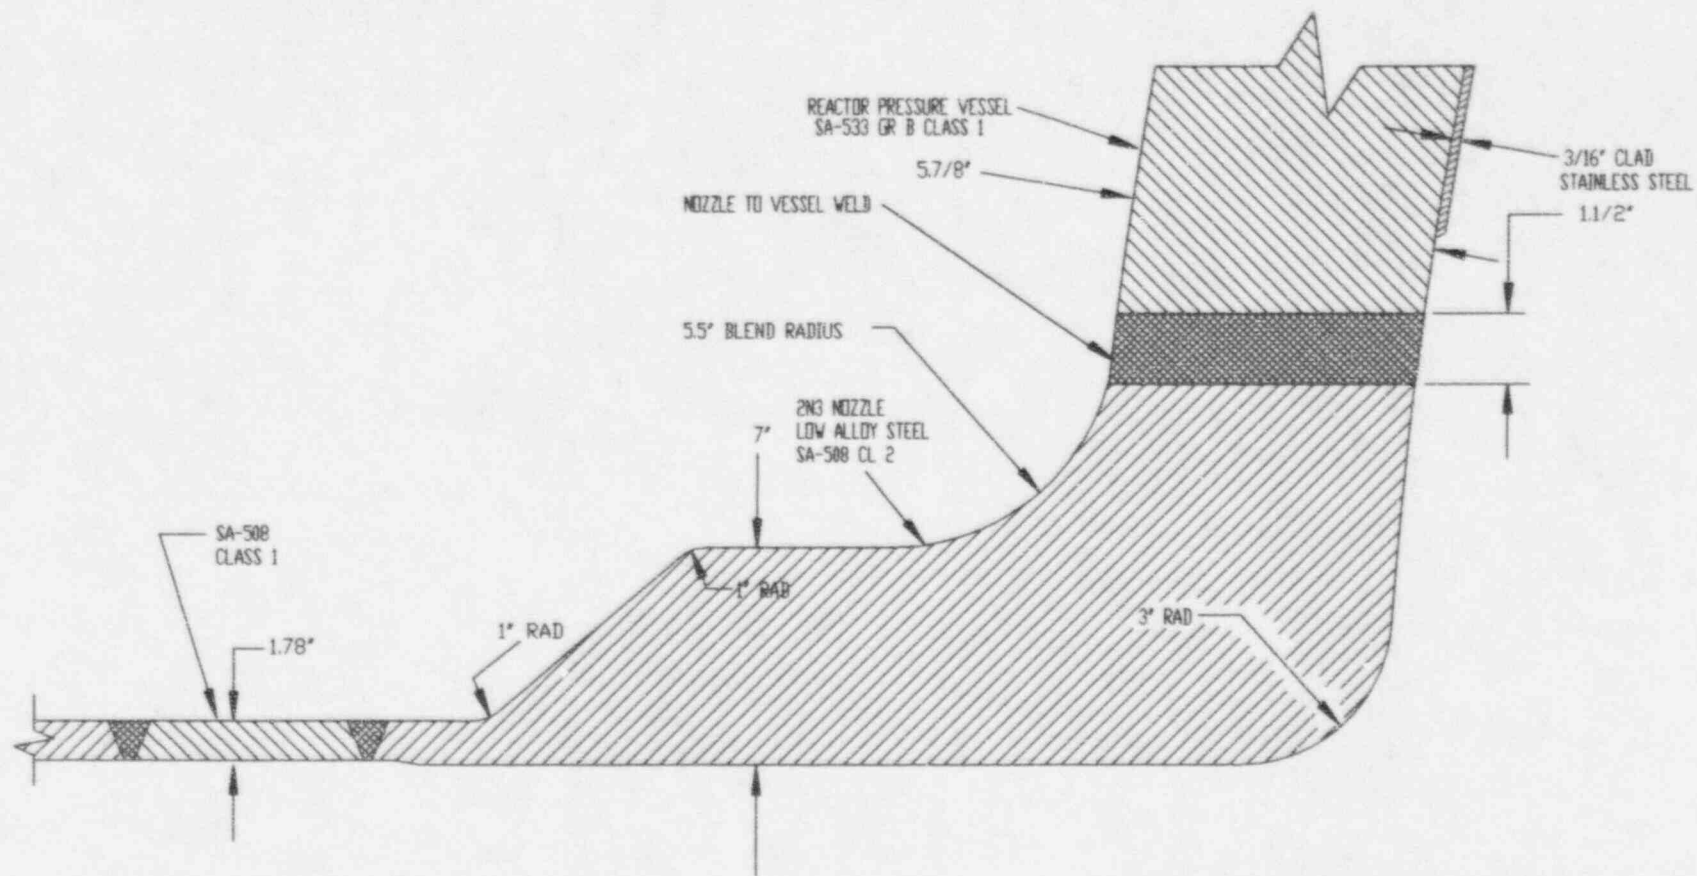
FIGURE 10

(24" MAIN STEAM NOZZLE ASSEMBLY-4 NOZZLES)

HATCH UNIT 2-RPV MAIN STEAM NOZZLE 2N3A,B,C,D (AND HATCH UNIT 1 N3D)

**N3D - Main Steam Nozzle-To-Vessel Welds** - For this one nozzle, the geometry is similar to that of the main steam nozzles for Unit 2, in that, the weld is located such that ultrasonic scanning can be performed on the RPV vessel, on the weld, and on a small portion of the nozzle. For this configuration, approximately 75% of the required examination volume is scanned from the one side. Note: Even though there are differences (e.g., extent of cladding), Figure 10 which depicts the Unit 2 nozzles can also be used to adequately depict the geometry for this nozzle. (Also see Figure 1).

**2N3A-D - Main Steam Nozzle-To-Vessel Welds** - For this nozzle configuration, the weld is located such that ultrasonic scanning can be performed on the RPV vessel, on the weld, and on a small portion of the nozzle. For this configuration, approximately 75% of the required examination volume is scanned from the one side. (See Figure 10).

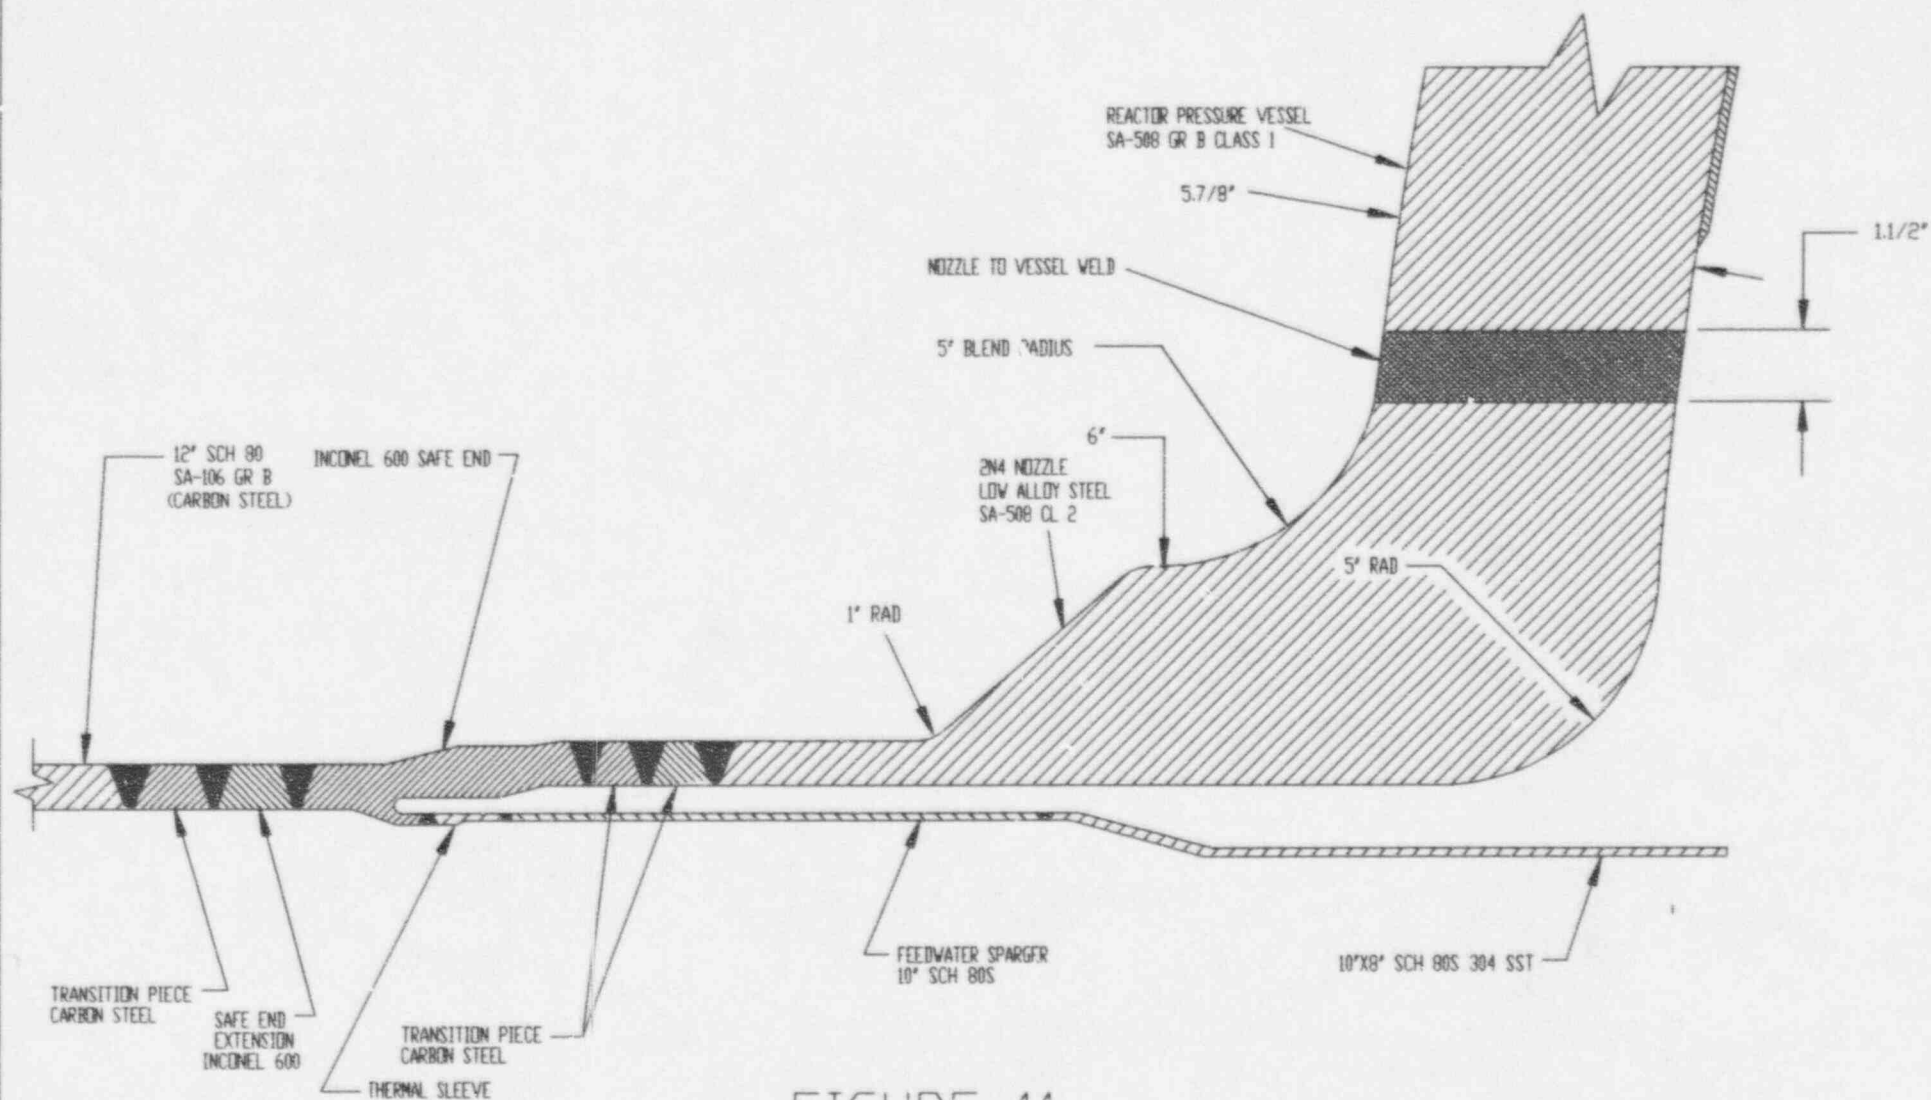
FIGURE 11

(12" FEEDWATER NOZZLE ASSEMBLY-4 NOZZLES)

HATCH UNIT 2-RPV FEEDWATER NOZZLE 2N4A,B,C,D

**2N4A-D - Feedwater Nozzle-To-Vessel Welds** - For this nozzle configuration, the weld is located such that ultrasonic scanning can be performed on the RPV vessel, on the weld, and on a small portion of the nozzle. For this configuration, approximately 80% of the required examination volume is scanned from the one side. (See Figure 11).

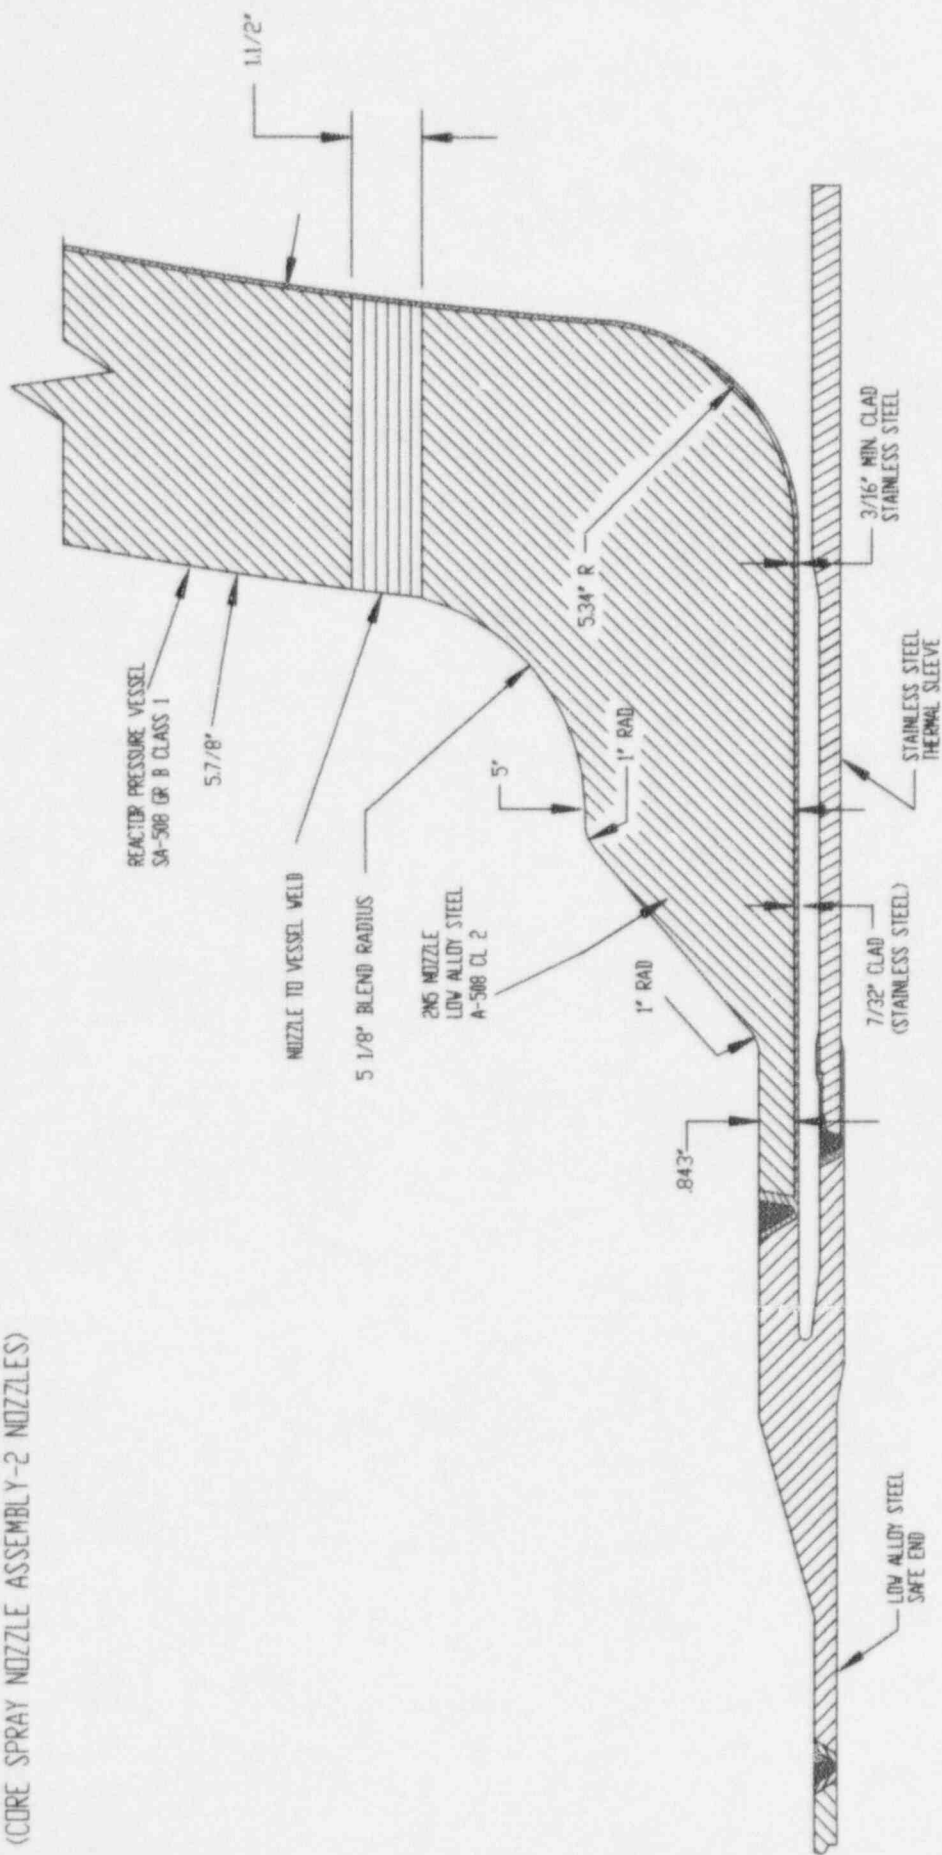
FIGURE 12

(CORE SPRAY NOZZLE ASSEMBLY Y-2 NOZZLES)

HATCH UNIT 2-RPV CORE SPRAY NOZZLE 2N5A,B

**2N5A, B - Core Spray Nozzle-To-Vessel Welds** - For this nozzle configuration, the weld is located such that ultrasonic scanning can be performed on the RPV vessel, on the weld, and on a small portion of the nozzle. For this configuration, approximately 80% of the required examination volume is scanned from the one side. (See Figure 12).
