Edwin I. Hatch Nuclear Plant  
Third 10-Year Interval Inservice Inspection Program  
Request for Relief

**GEORGIA POWER COMPANY  
HATCH NUCLEAR PLANT, UNITS 1 & 2  
THIRD 10-YEAR INTERVAL  
REQUEST FOR RELIEF NO. RR-18**

**GEORGIA POWER COMPANY  
HATCH NUCLEAR PLANT, UNIT 1  
THIRD 10-YEAR INTERVAL  
REQUEST FOR RELIEF NO. RR-19**

**GEORGIA POWER COMPANY  
HATCH NUCLEAR PLANT, UNITS 1 AND 2  
THIRD 10-YEAR INTERVAL  
REQUEST FOR RELIEF NO. RR-20**

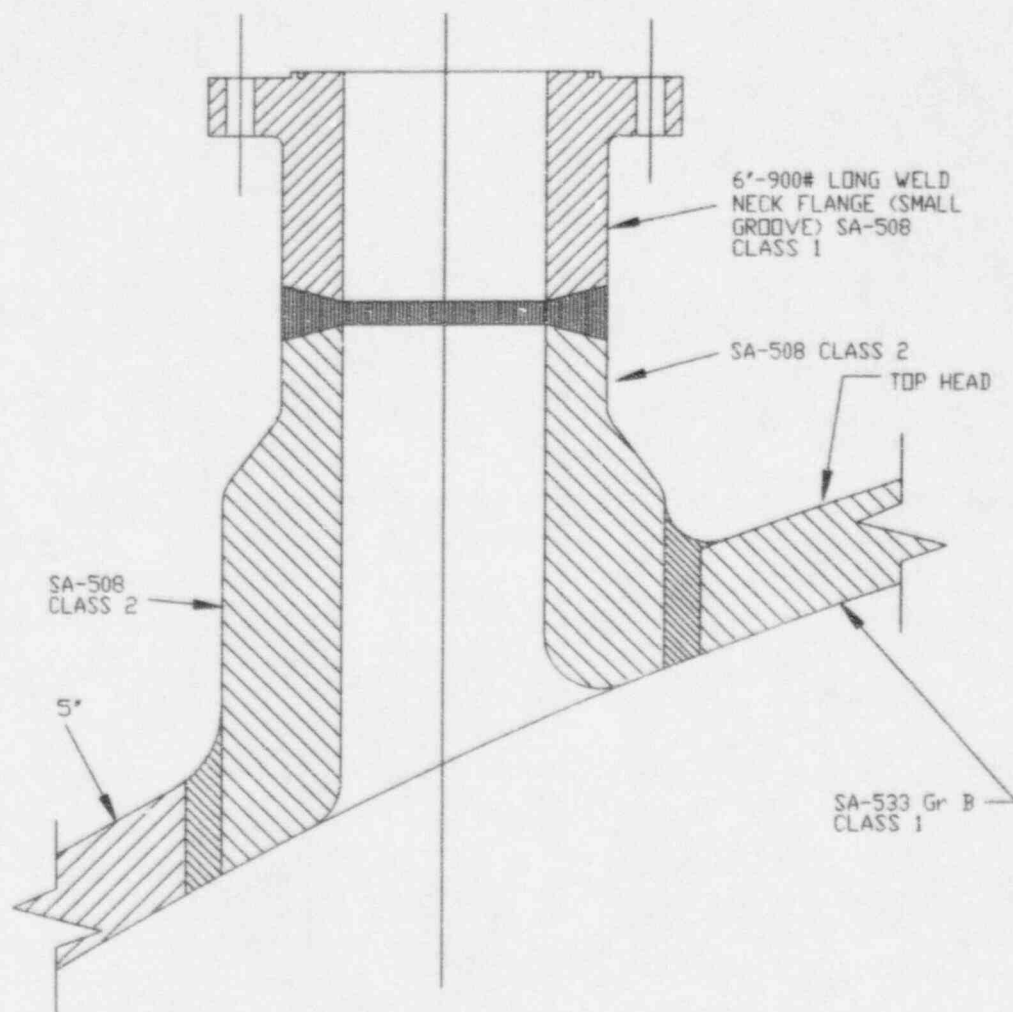
FIGURE 13

(6" TOP HEAD SPRAY NOZZLE ASSEMBLY - 2 NOZZLES)

HATCH UNIT 1-TOP HEAD SPRAY NOZZLE N6A,B

**N6A, B and N7 - RPV Head Nozzles** - These small nozzles located on the RPV head have a configuration such that coverage from one side is only approximately 40 to 50% for the N6A, B nozzles and 50% for the N7 nozzle. An evaluation of the configuration shows that these small nozzles have a very short radius. With this configuration, scanning can only be performed on the head and possibly a portion of the weld. (See Figures 1, 13 and 14).

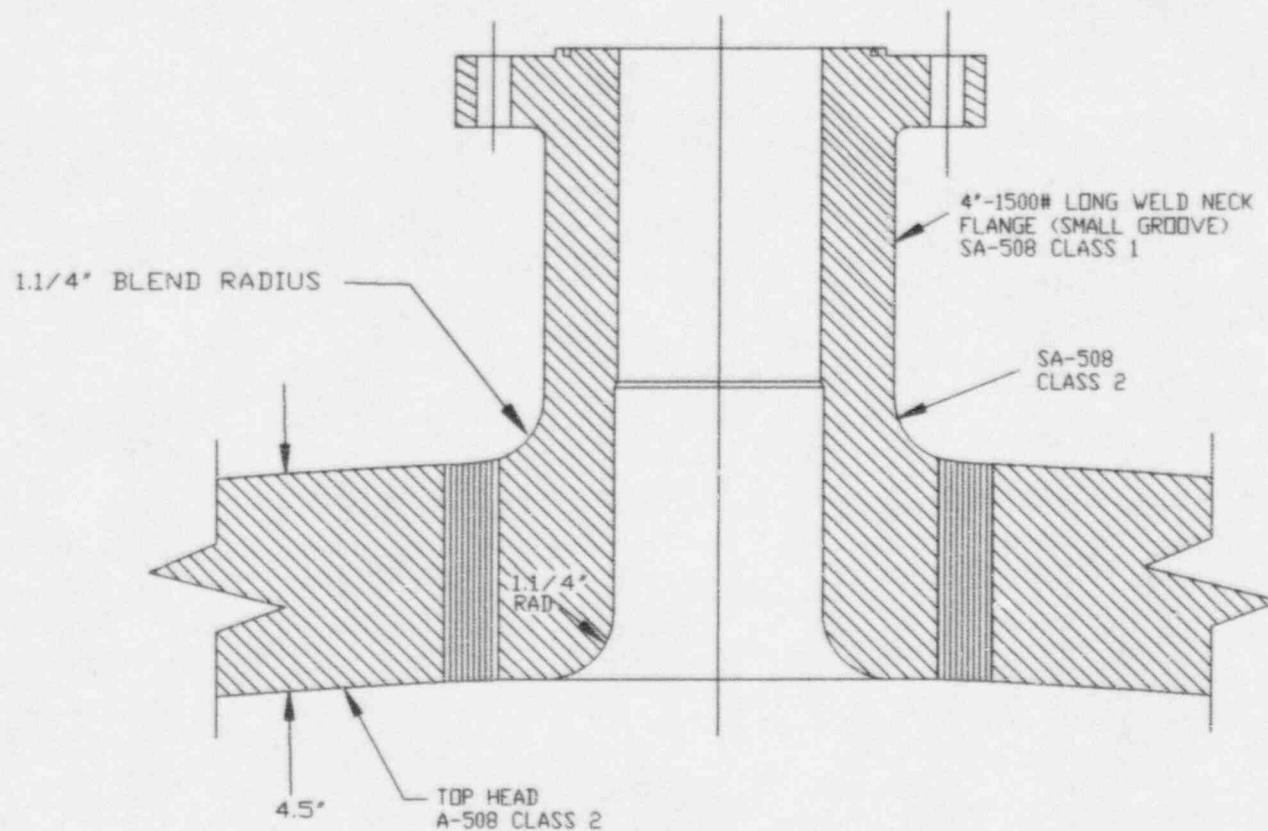
FIGURE 14

(6" TOP HEAD VENT NOZZLE ASSEMBLY - 1 NOZZLE)

HATCH UNIT 1-TOP HEAD VENT NOZZLE N7

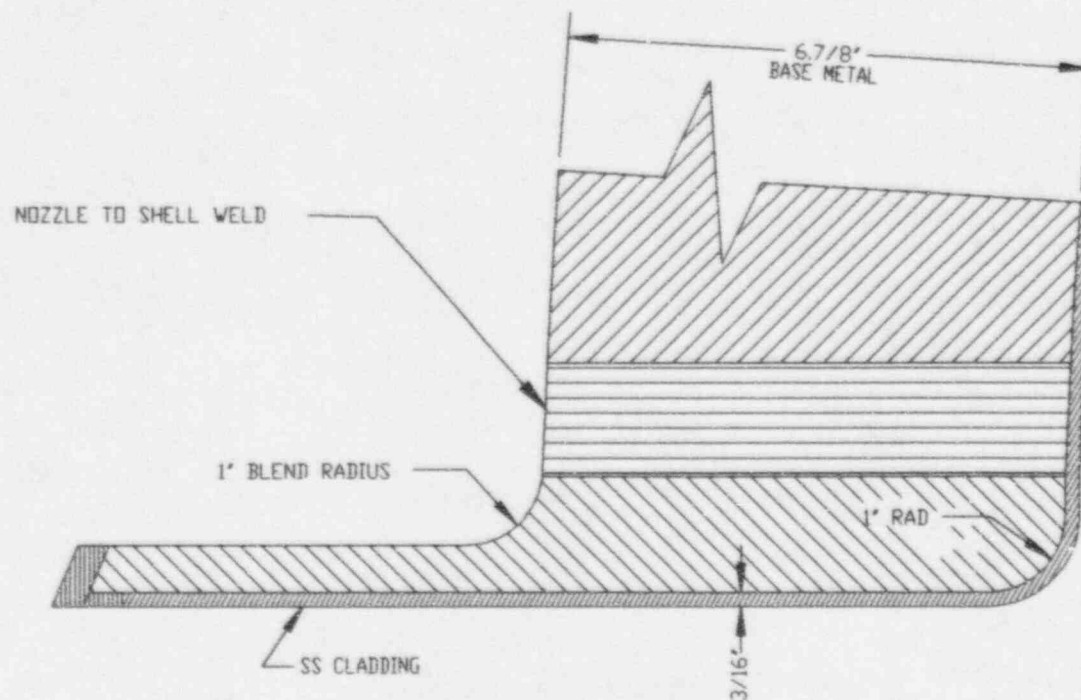
FIGURE 15

(4" JET PUMP INSTRUMENTATION - 2 NOZZLES)

HATCH UNIT 1-JET PUMP INSTRUMENTATION NOZZLE N8A,B

**N8A-B - Jet Pump Instrument Nozzles** - These small nozzles have a configuration such that coverage from one side is in the range of 50 to 60%. An evaluation of the configuration shows that these small nozzles have a very sharp radius. With this configuration, scanning can only be performed on the shell and possibly a portion of the weld. (See Figures 1 and 15).

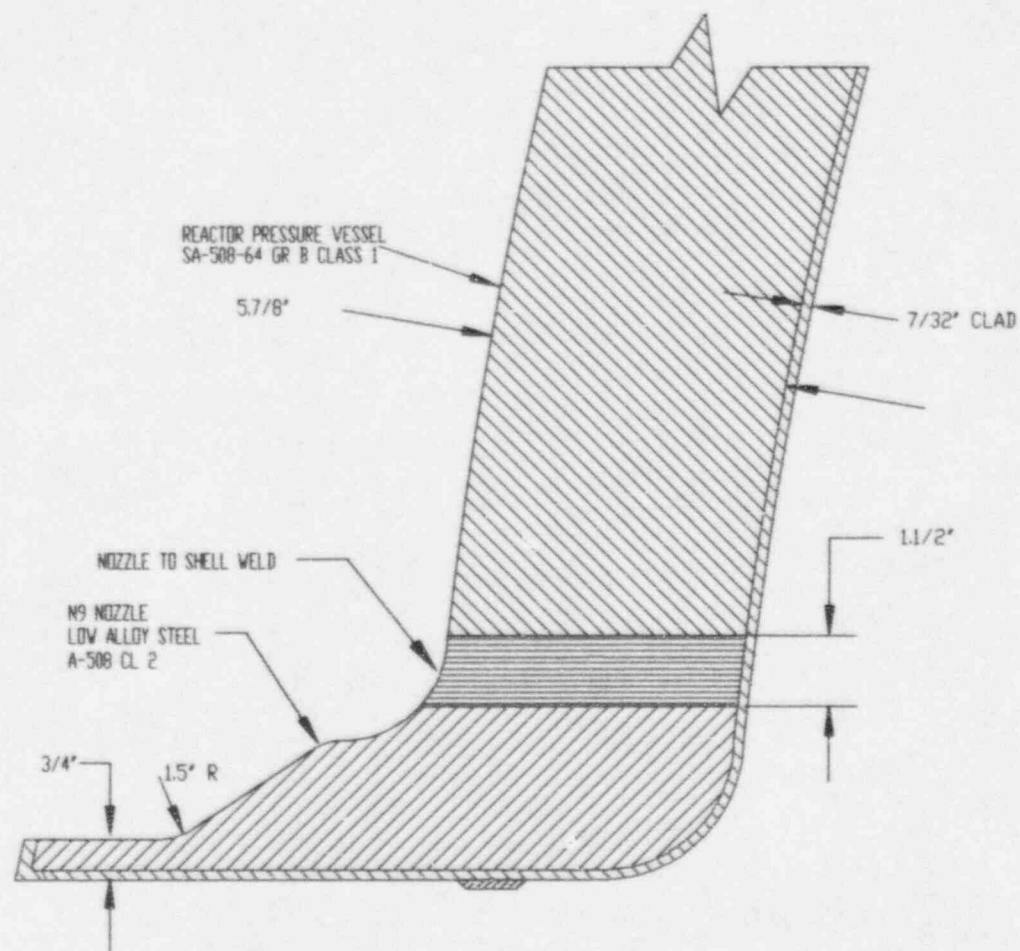
FIGURE 16

(3' CRD HYD SYSTEM RETURN NOZZLE ASSEMBLY-1 NOZZLE)

HATCH UNIT 1-RPV CRD HYD SYSTEM RETURN NOZZLE N9

**N9 - CRD Nozzle-To-Vessel** - For this nozzle configuration, the weld is located in the curved blend radius, such that, ultrasonic scanning can only be performed on the RPV up to the point where the curvature begins. For this configuration, approximately 50 to 60% of the required examination volume is scanned from the one side. (See Figures 1 and 16).

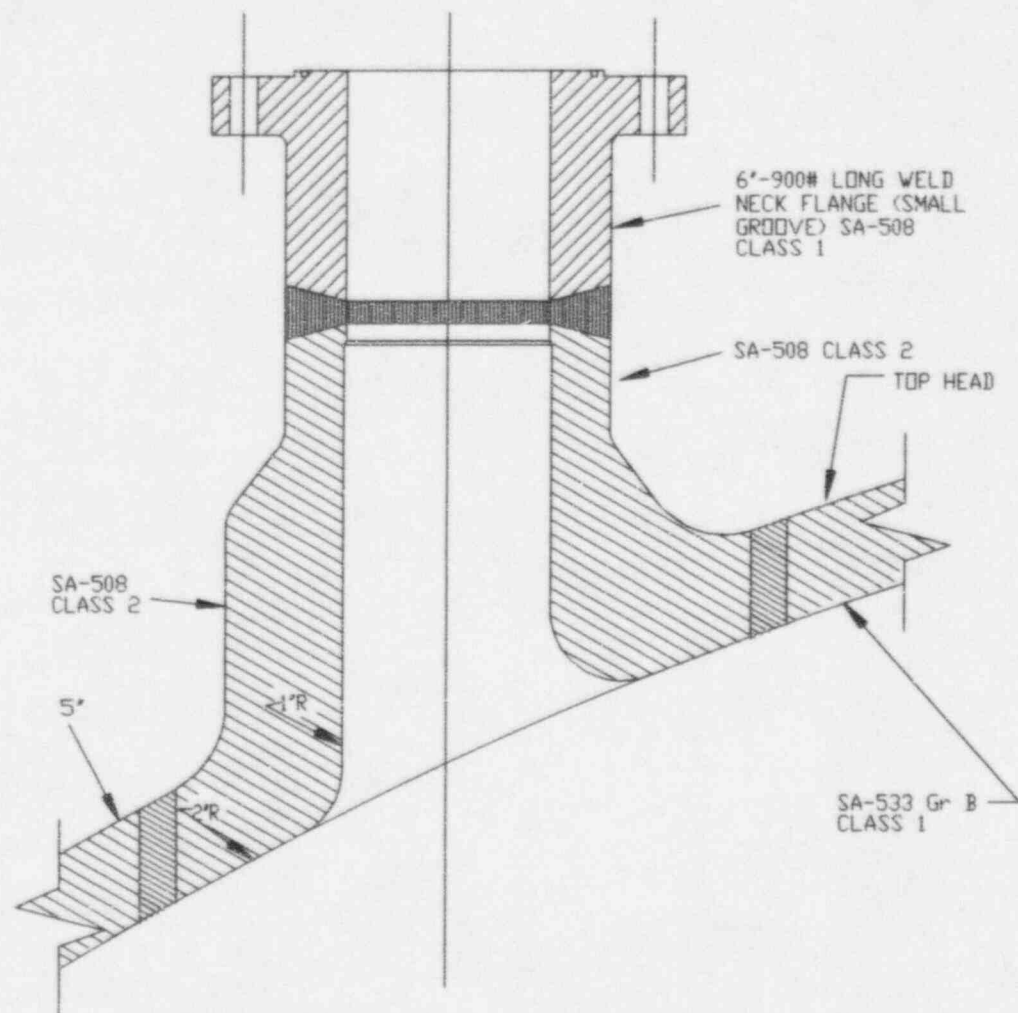
FIGURE 17

(6" TOP HEAD SPRAY NOZZLE ASSEMBLY - 2 NOZZLES)

HATCH UNIT 2- TOP HEAD SPRAY NOZZLE 2N6A,B

**2N6A, B and 2N7 - RPV Head Nozzles** - These small nozzles located on the RPV head have a configuration such that coverage from one side is only approximately 40 to 50% for the N6A, B nozzles and 50% for the 2N7 nozzle. An evaluation of the configuration shows that these small nozzles have a very short radius. With this configuration, scanning can only be performed on the head and possibly a portion of the weld. (See Figures 17 and 18).

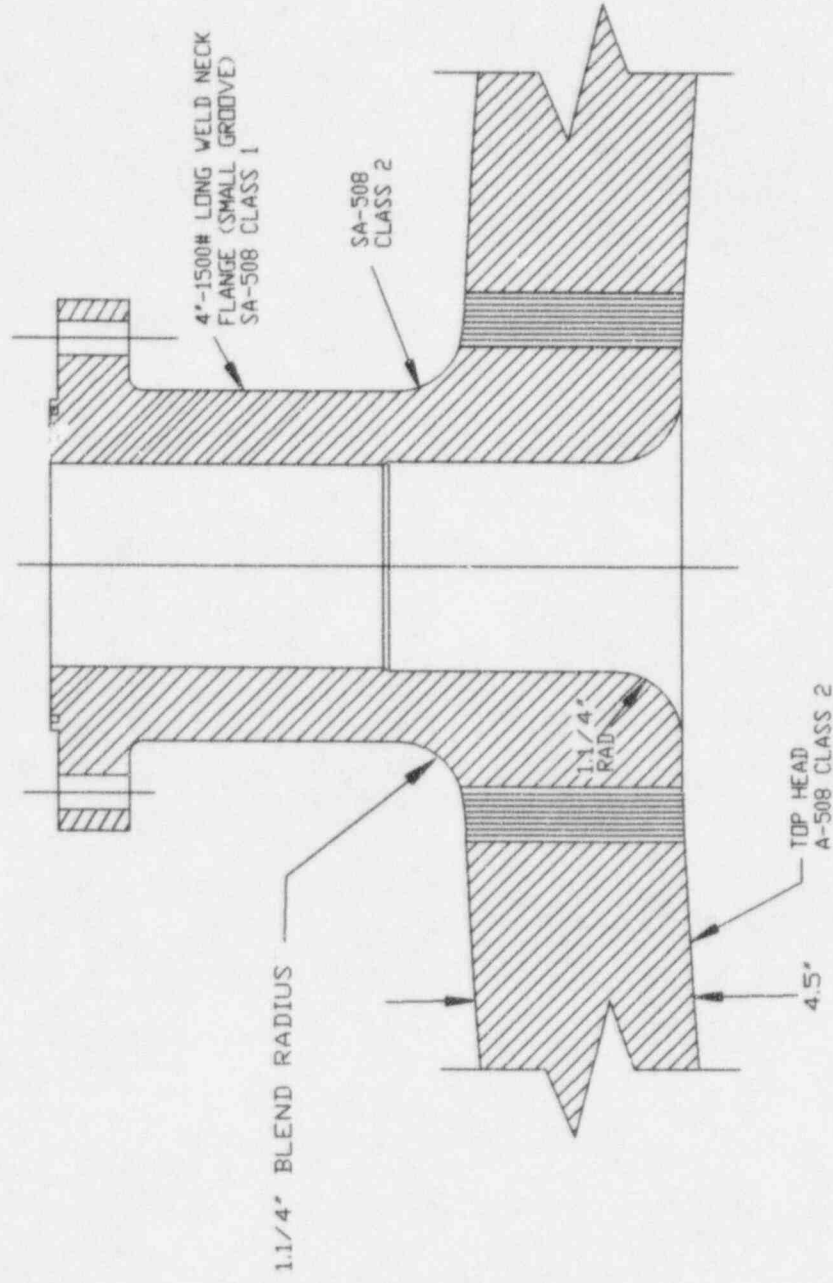
FIGURE 18

(6" TOP HEAD VENT NOZZLE ASSEMBLY - 1 NOZZLE)

HATCH UNIT 2-TOP HEAD VENT NOZZLE 2N7

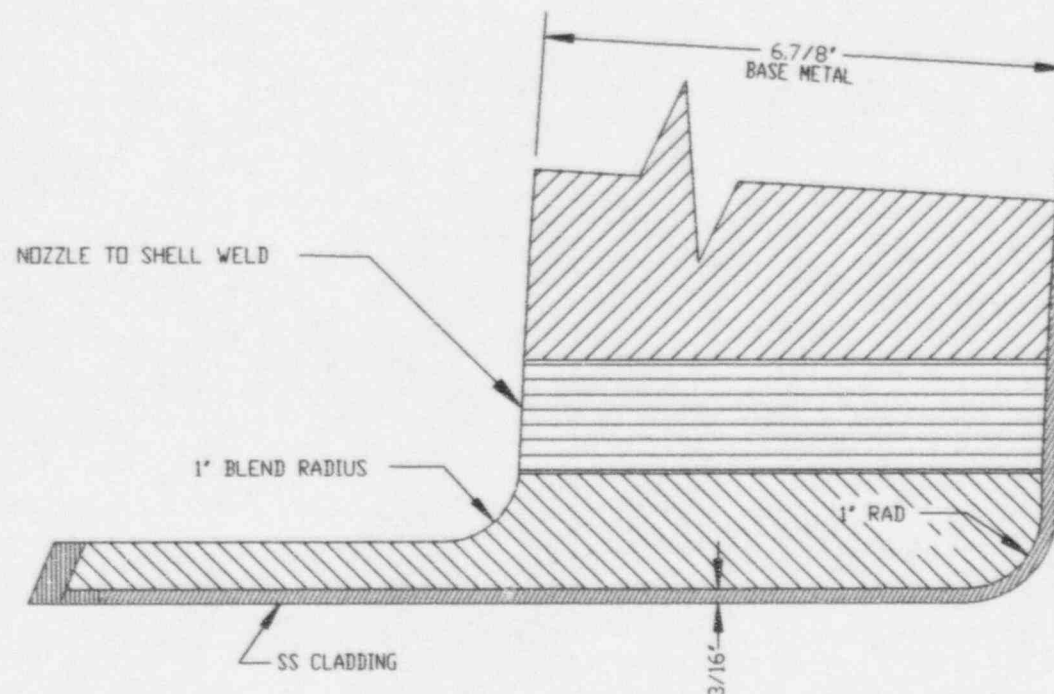
FIGURE 19

(4" JET PUMP INSTRUMENTATION - 2 NOZZLES)

HATCH UNIT 2-JET PUMP INSTRUMENTATION NOZZLE 2N8A,B

**2N8A, B - Jet Pump Instrument Nozzles** - These small nozzles have a configuration such that coverage from one side is the range of 50 to 60%. An evaluation of the configuration shows that these small nozzles have a very sharp radius. With this configuration, scanning can only be performed on the shell and possibly a portion of the weld. (See Figure 19).

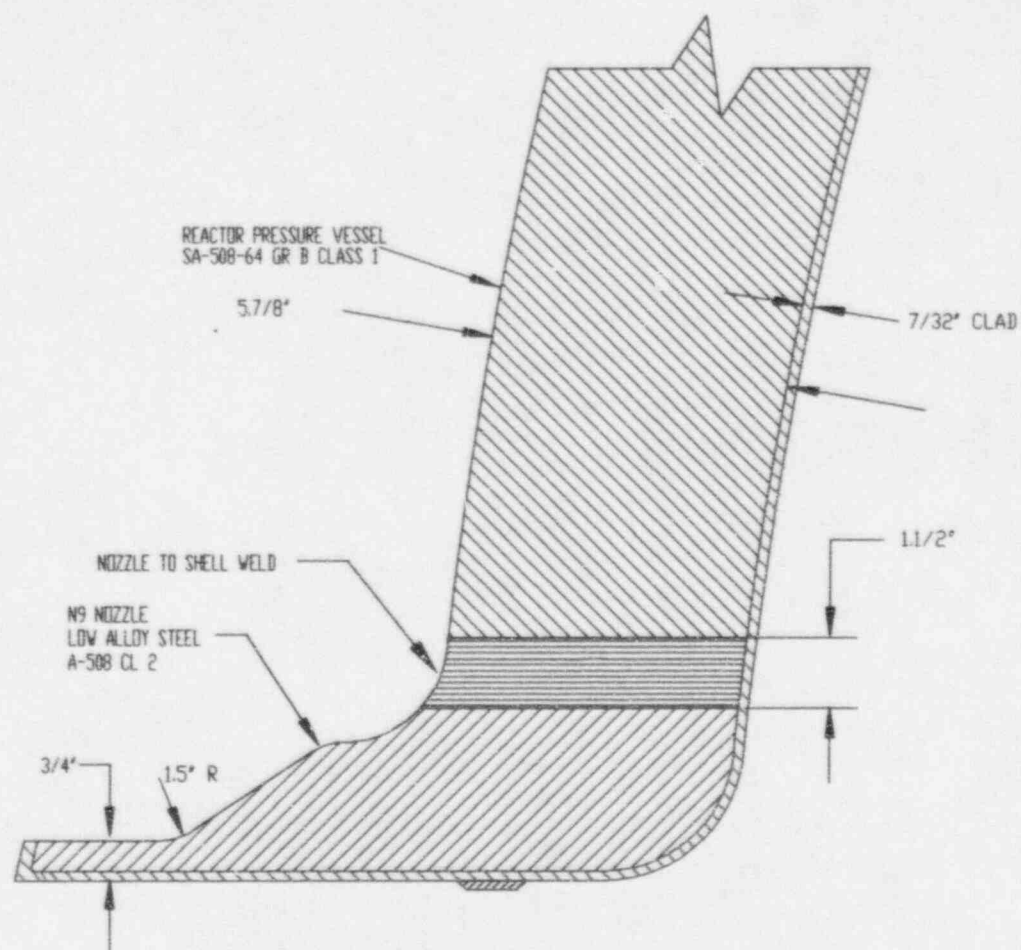
FIGURE 20

(3' CRD HYD SYSTEM RETURN NOZZLE ASSEMBLY-1 NOZZLE)

HATCH UNIT 2-RPV CRD HYD SYSTEM RETURN NOZZLE 2N9

**2N9 - CRD Nozzle-To-Vessel** - For this nozzle configuration, the weld is located in the curved blend radius, such that, ultrasonic scanning can only be performed on the RPV up to the point where the curvature begins. For this configuration, approximately 50% of the required examination volume is scanned from the one side. (See Figure 20).

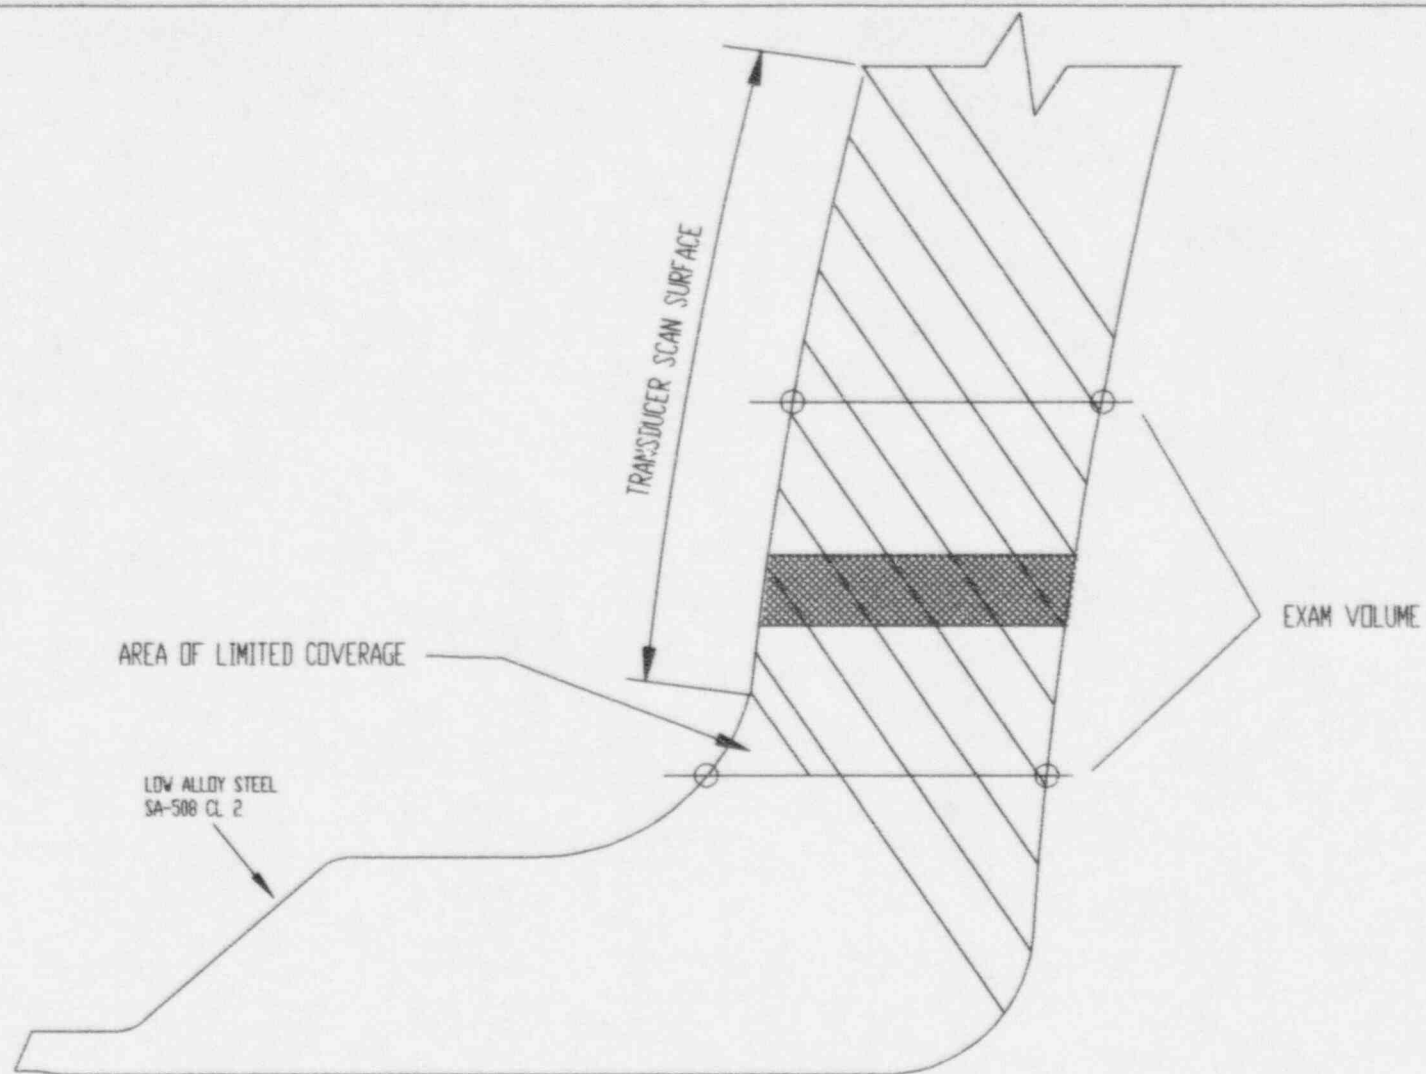
FIGURE 21

TYPICAL HATCH RPV NOZZLE 45 DEG. SCAN COVERAGE  
FOR FLANGE TYPE NOZZLE.

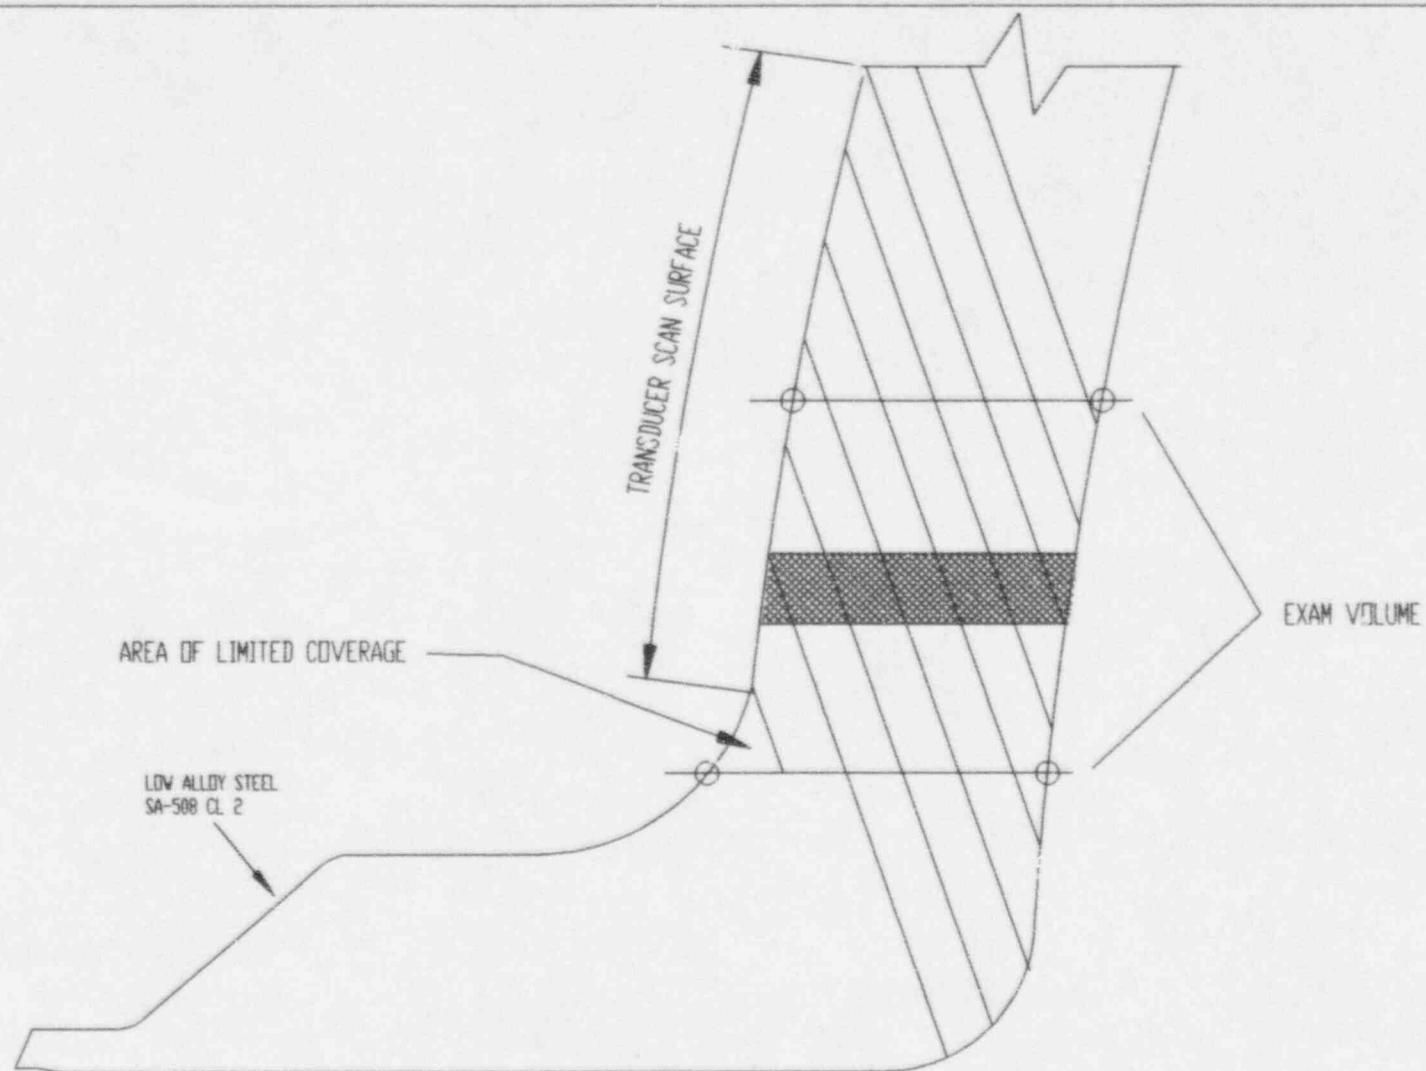
FIGURE 22

TYPICAL HATCH RPV NOZZLE 60 DEG. SCAN COVERAGE  
FOR FLANGE TYPE NOZZLE.

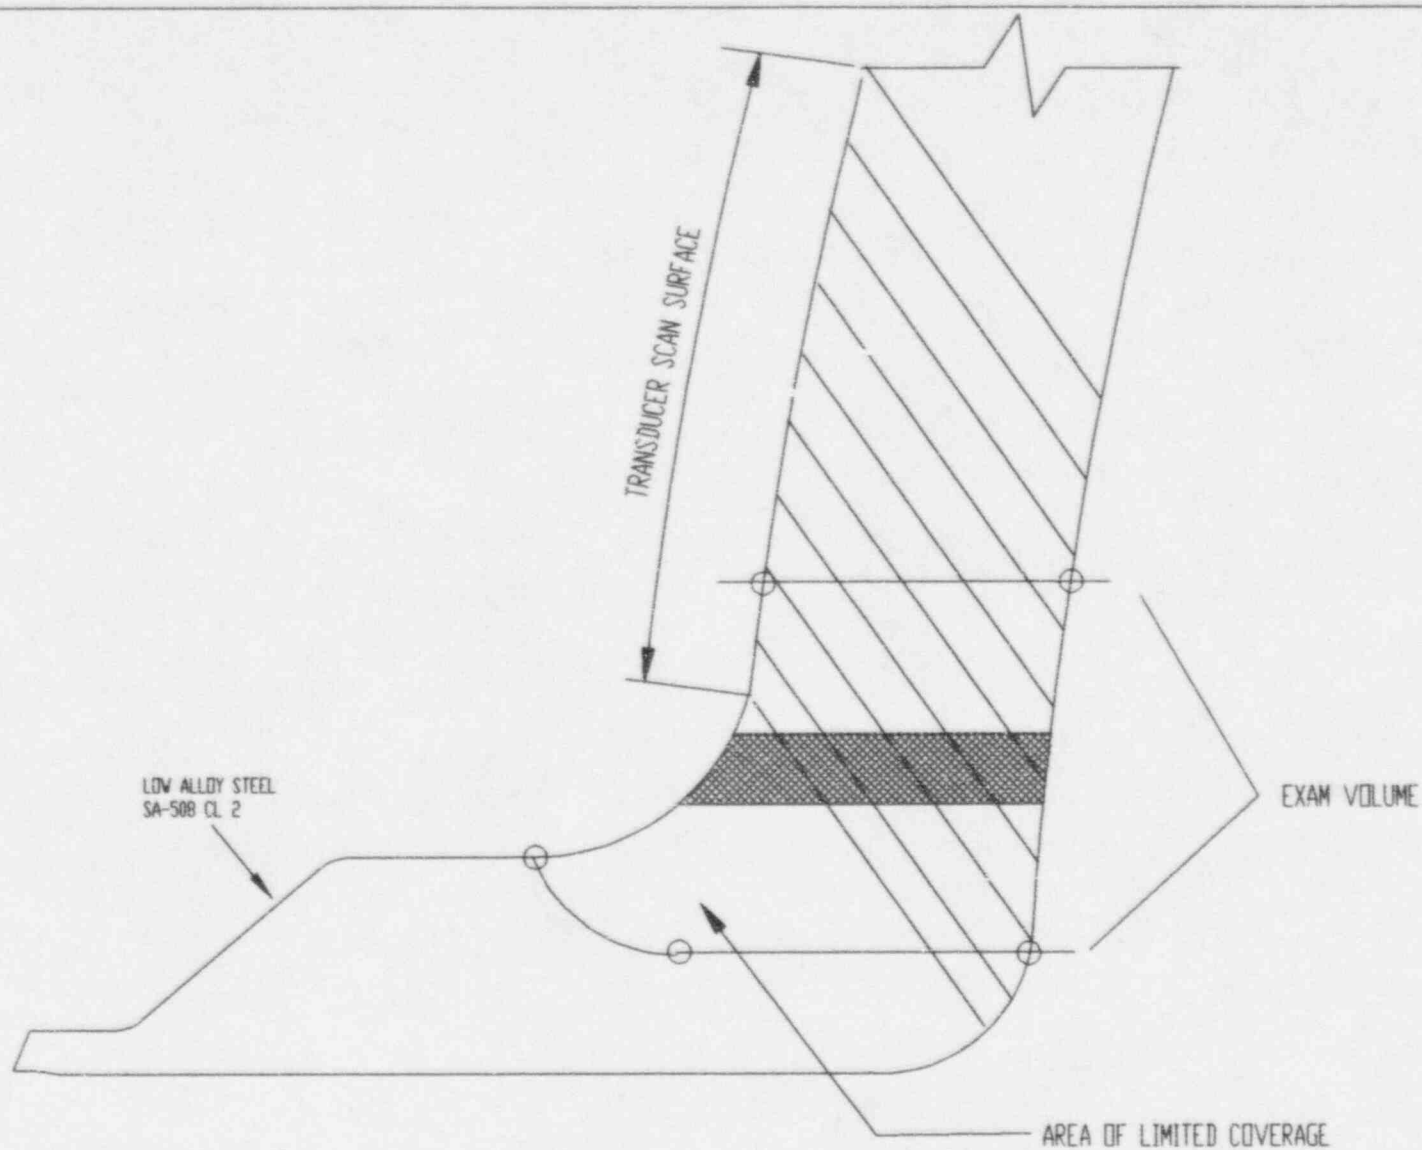
FIGURE 23

TYPICAL HATCH RPV NOZZLE 45 DEG. SCAN COVERAGE  
FOR BARREL TYPE NOZZLE

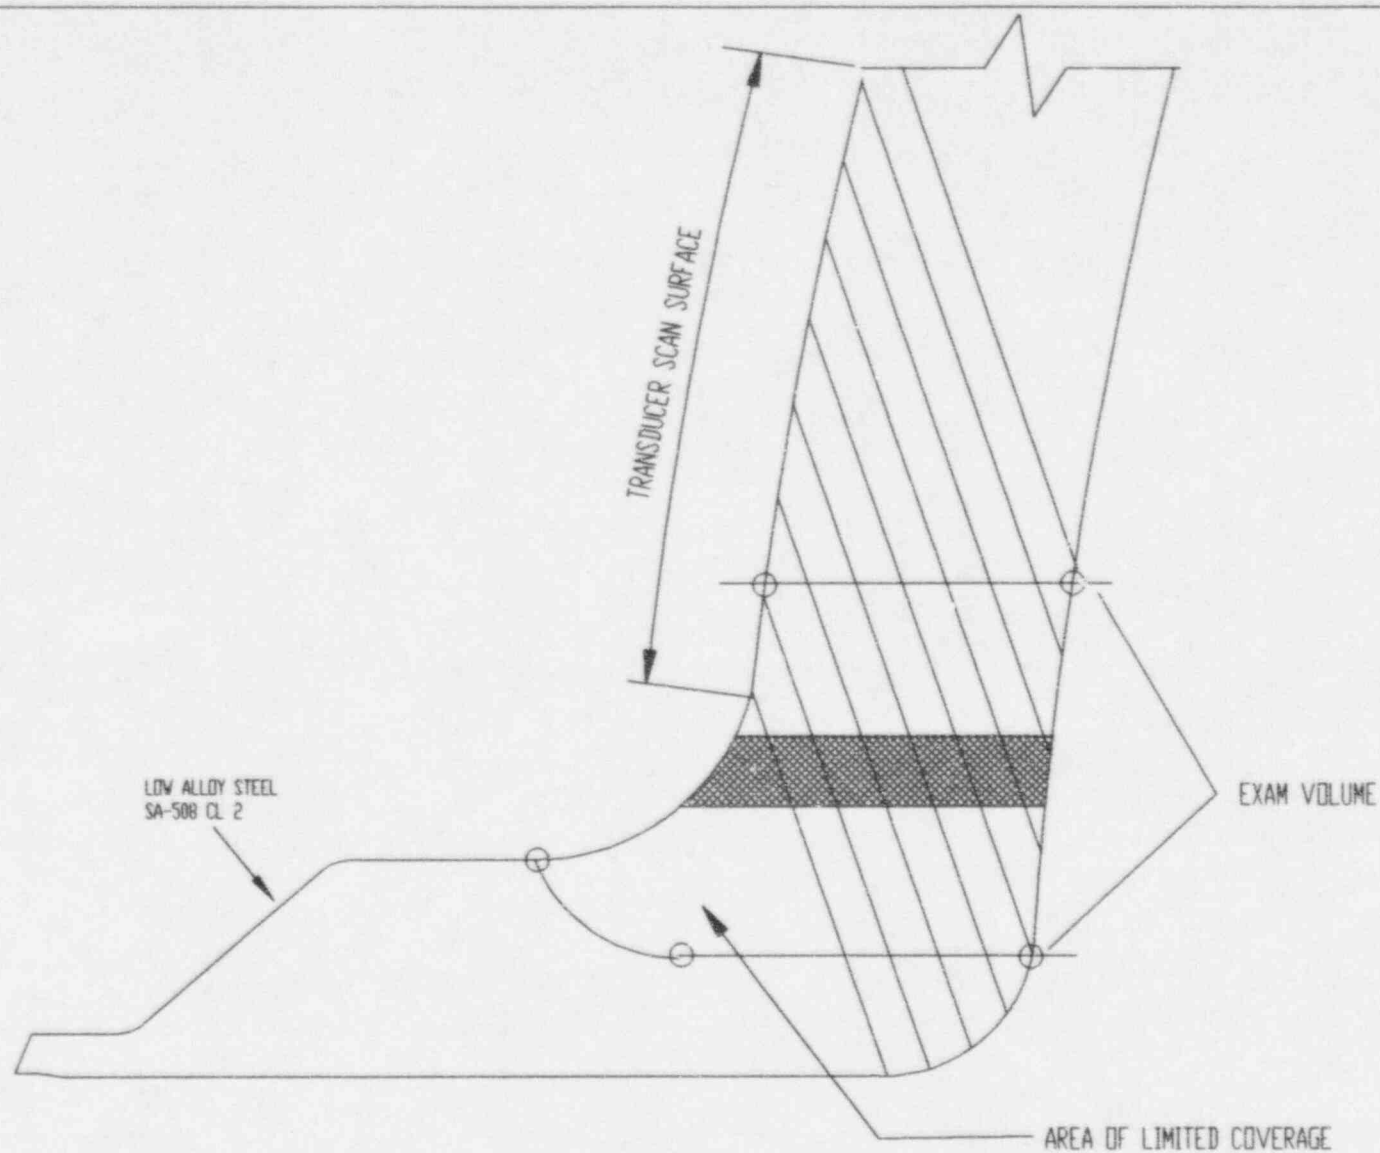
FIGURE 24

TYPICAL HATCH RPV NOZZLE 60 DEG. SCAN COVERAGE  
FOR BARREL TYPE NOZZLE

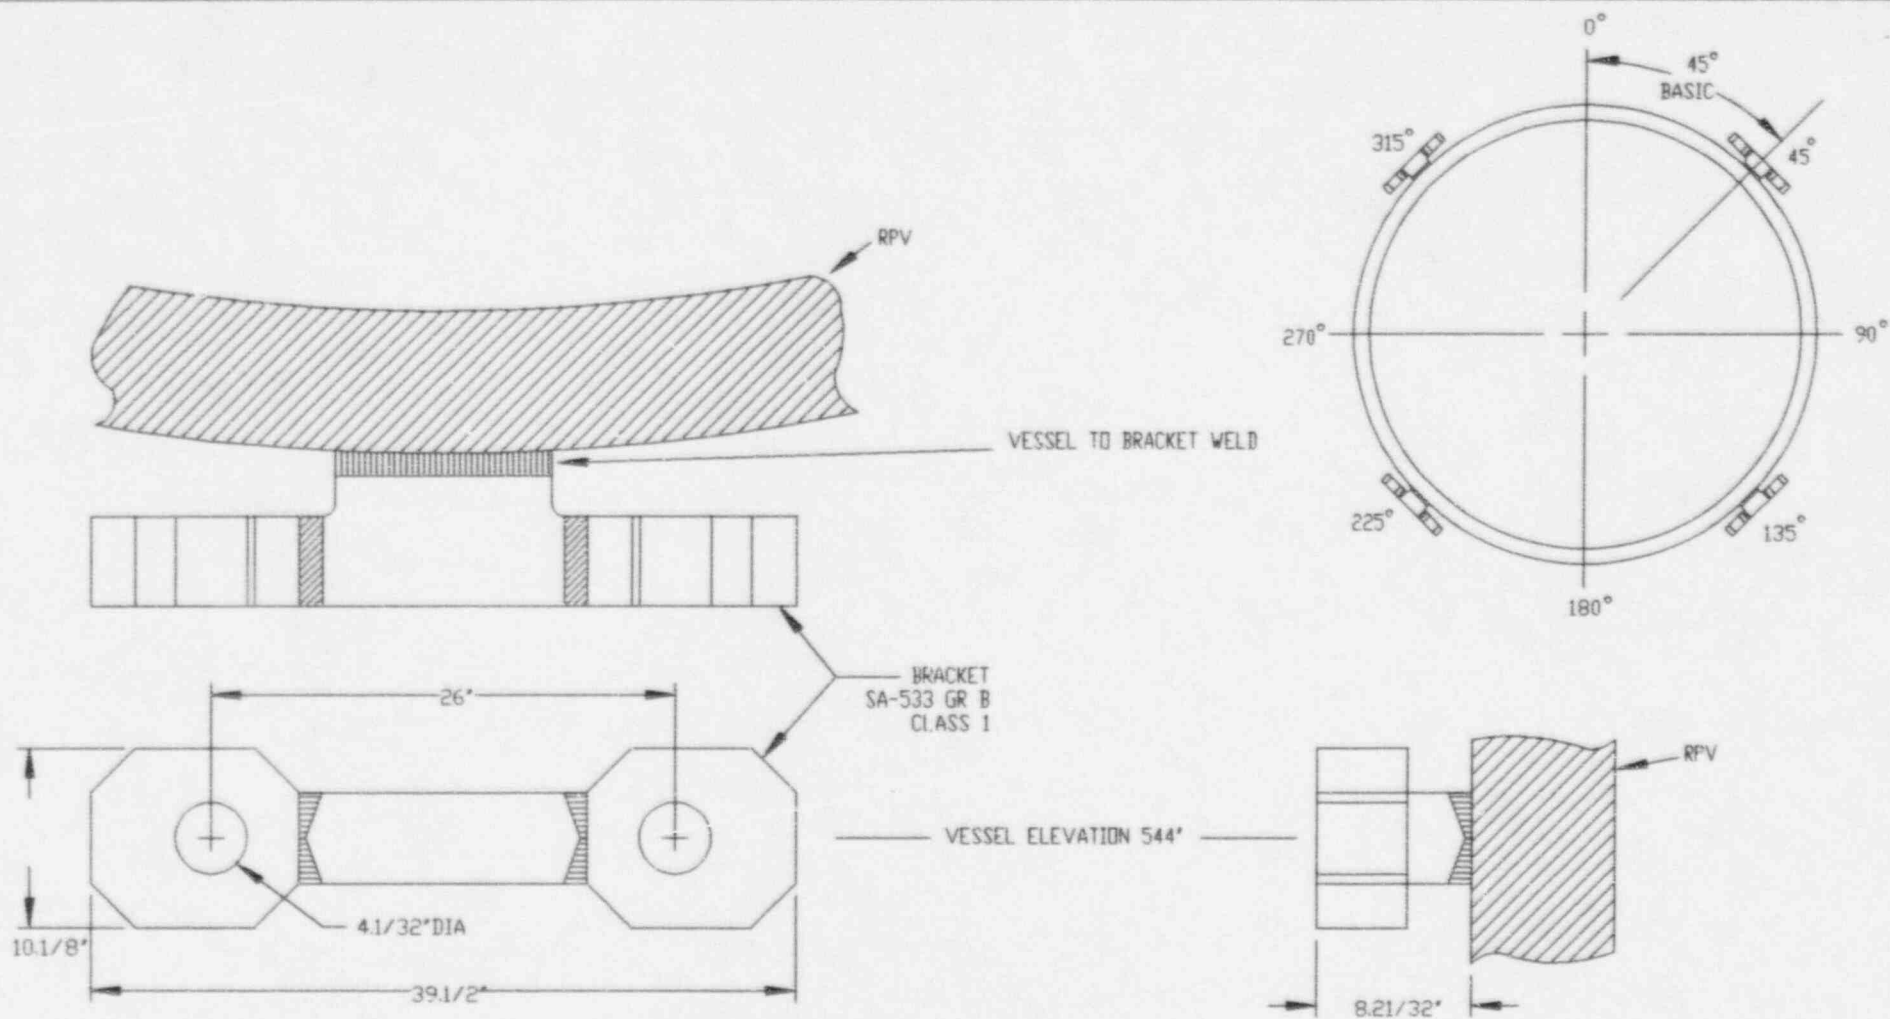
FIGURE 1

Hatch Unit 1 has a "Tee" shaped bracket stabilizer bracket welded to the RPV as shown in Figure 1. This design prevents examination of the weld located on the ends of the bracket between the "ears" of the tee and the RPV wall. Additionally, the bottom of the bracket cannot be examined due to the limited distance between the bracket and the shield wall. With such a small opening, especially considering the additional interference from other components of the stabilizer assembly and vessel insulation, insufficient space exists to perform the required examinations. Approximately 30 to 35% of the weld can be examined on each Unit 1 bracket.

HATCH UNIT 1-RPV STABILIZER BRACKET

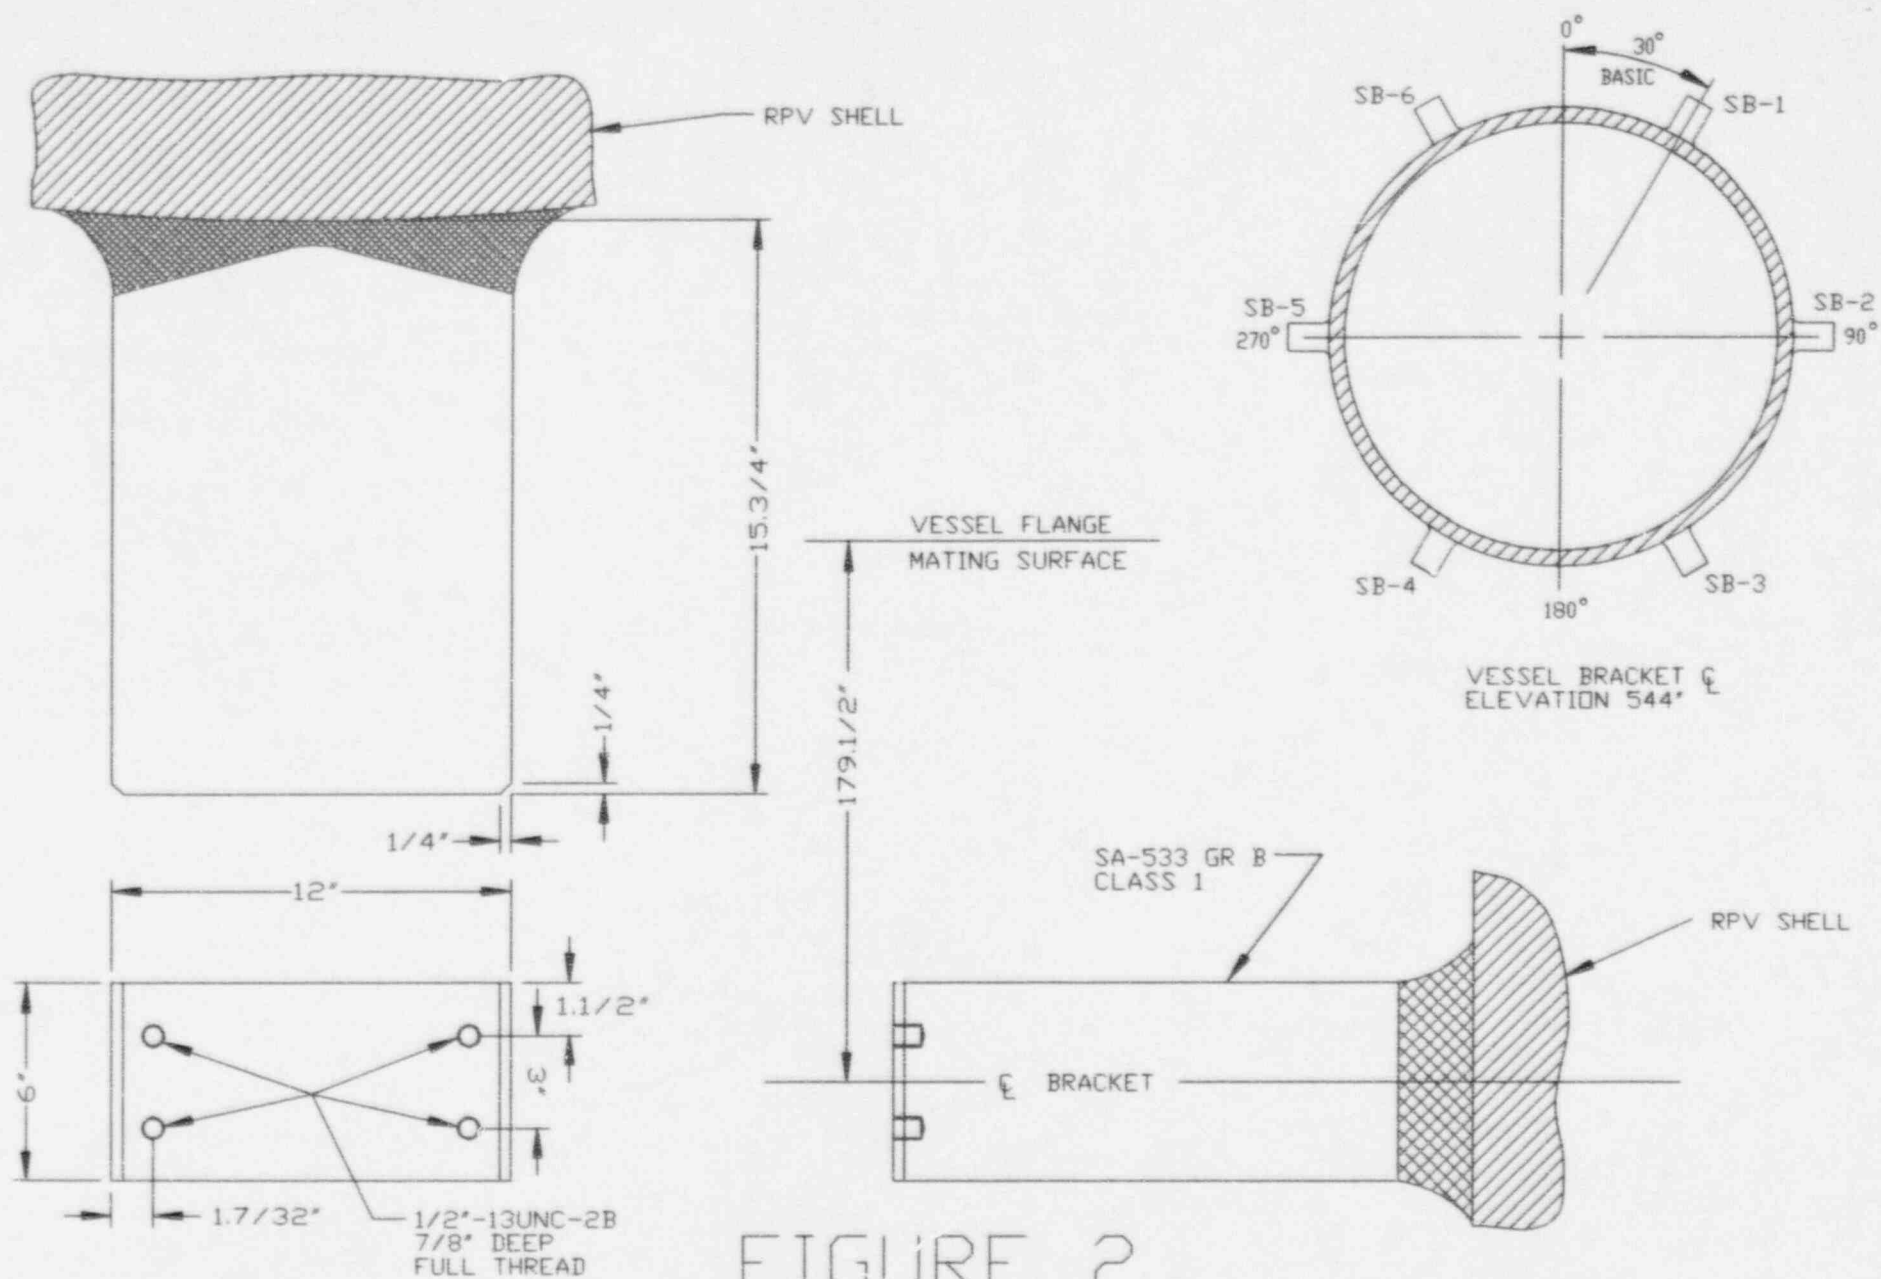
FIGURE 2

Hatch Unit 2 has a more conventional "lug type" design, as shown in Figure 2, that extends approximately 15" from the RPV surface. With this extension and the above described interference, the bottom portion of the weld cannot be accessed for examination. The top of the weld and both sides of the weld can be examined, resulting in a coverage of approximately 65 to 70%.

HATCH UNIT 2-RPV STABILIZER BRACKET

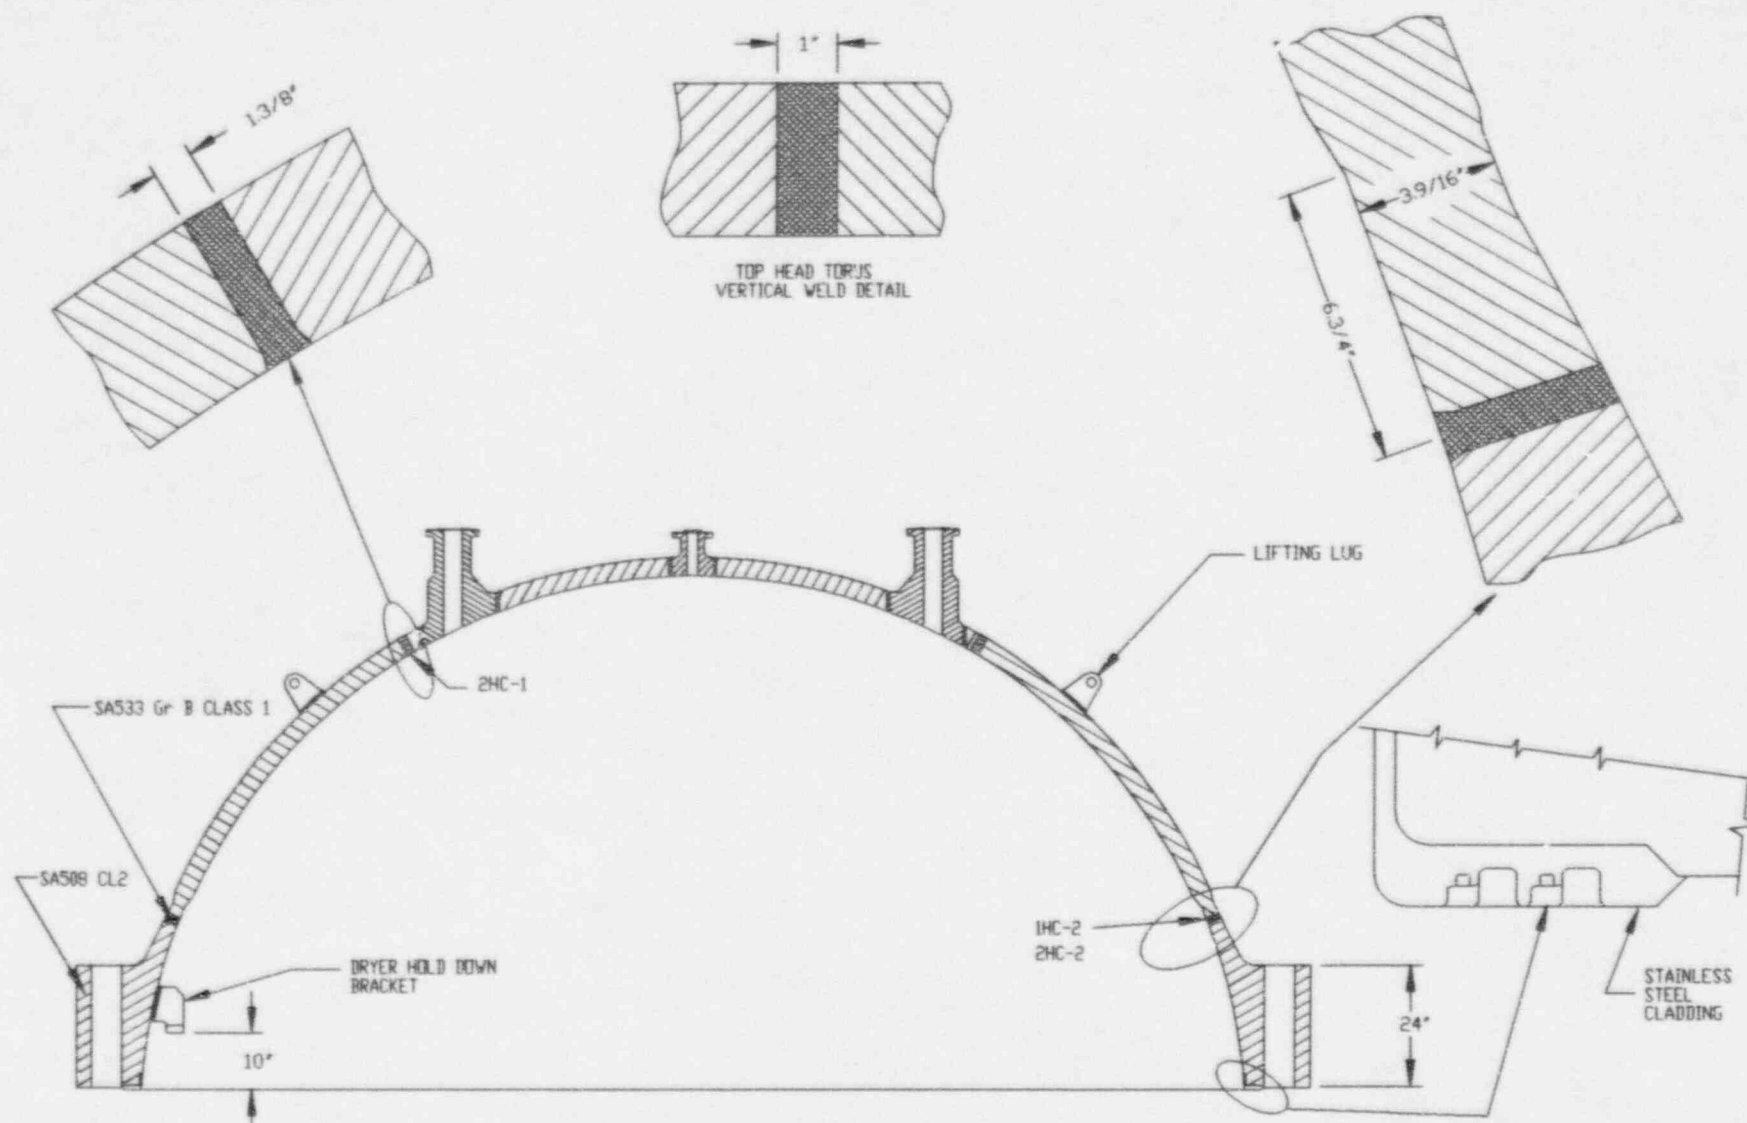
FIGURE 1

- III. Code Requirement for Which Relief is Requested: Limitations exist that preclude complete volumetric examination of the head-to-flange welds.
- IV. Basis for Relief: As shown in Figure 1, head-to-flange welds 1HC-2 and 2HC-2 are located such that ultrasonic scanning can be performed for about six inches on either side of the respective weld. Past the six inches, on the dome side, there is a taper that joins two different thicknesses together, while on the flange side there is a strong curvature. Outside the six-inch scanning area, on each side of these welds, meaningful examination is not possible due to the configuration.

With the existing accessibility, the 0-degree scan can be performed over the entire examination volume. Using a 45-degree scan, approximately 85% of the examination volume can be scanned from both sides of the weld with all of the volume scanned from at least one direction. The 60-degree scan has more significant limitations since a longer distance from the weld centerline is needed to perform the scan. Approximately 25% of the examination volume cannot be scanned from either direction with the 60-degree scan.
- V. Alternate Examination: None.

HATCH UNIT 1 AND 2-RPV TOP HEAD WELD DETAIL
