UNITED STATES OF AMERICA
NUCLEAR REGULATORY COMMISSION

In the Matter of)	
)	Docket Nos. 50-528
ARIZONA PUBLIC SERVICE)	and 50-529
COMPANY, ET AL.)	
(Palo Verde Nuclear Generating)	(10 CFR 2.206)
Station, Units 1 and 2))

DIRECTOR'S DECISION UNDER 10 CFR 2.206

MTI PUBLICATION NO. 13
**MICROBIOLOGICALLY INFLUENCED CORROSION:
A STATE-OF-THE-ART REVIEW**

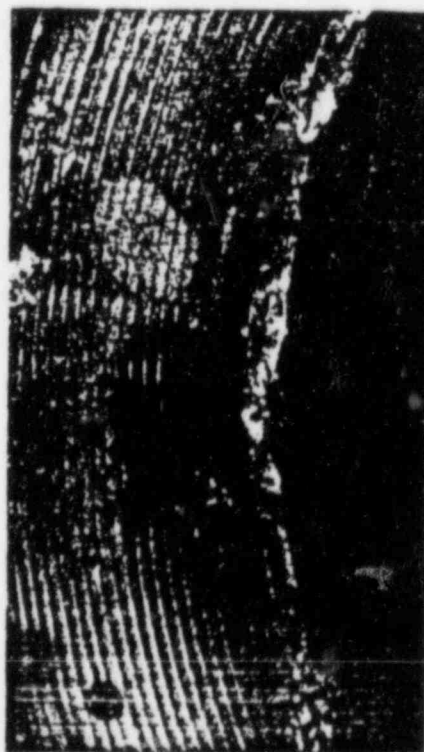
Fig. 2 - Open "gouging" type corrosion of 304 stainless steel flange. This occurred under slime deposits harboring *Desulfovibrio* sulfate reducing bacteria.

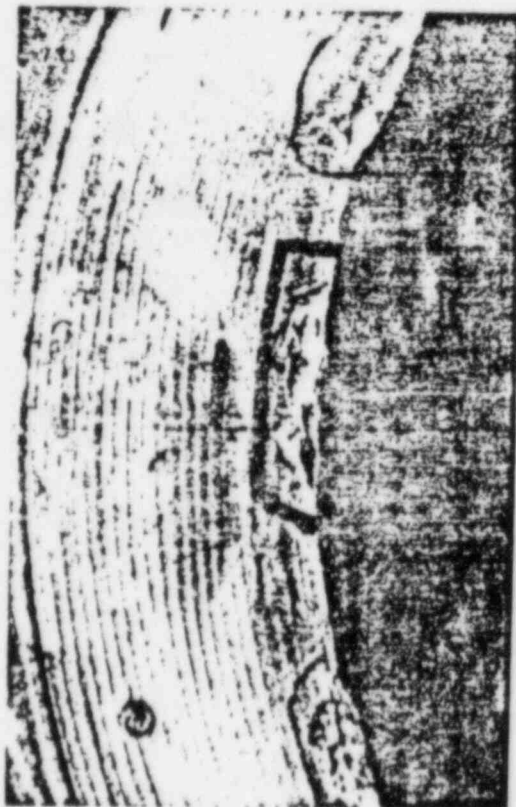
Figure 2

Open "gouging"-type corrosion of 304 stainless steel flange.
This occurred under slime deposits harboring Desulfovibrio
sulfate reducing bacteria.

Two examples of MIC are shown in Figures 1 and 2 along with a brief description of the cases to give the reader a better idea of what will be discussed in the following chapters.

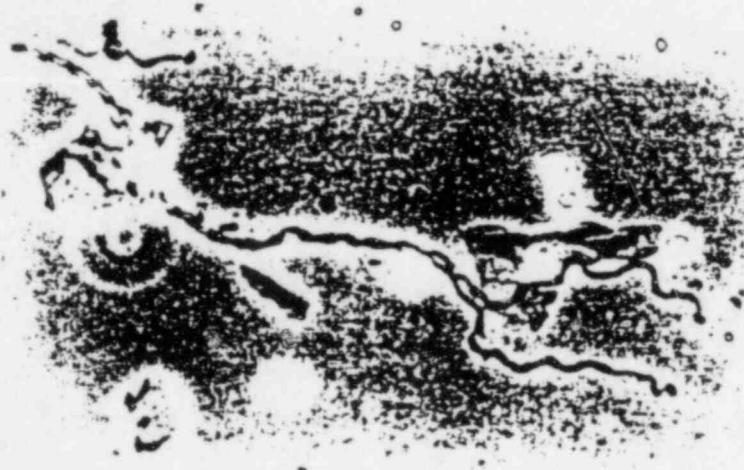
Gallionella. Note the small cell attached laterally at the tip
of each of the twisted stalks.

- (20) Some bacteria can oxidize or reduce metals or metallic ions directly. For example some species (Gallionella, Figure 6 and Sphaerotilus, Figure 7) oxidize Fe^{+2} to Fe^{+3} . These ferric compounds then precipitate in a sheath around the cells, and can accumulate as tubercles in pipes and plug them. Concentration cells are easily formed under such deposits with corrosion resulting. Whether the removal of the Fe^{+2} directly affects the corrosion of the metal or not is unclear. Other organisms (e.g., Pseudomonas spp. from oil wells and bacteria from marine sediments) have been shown to reduce ferric iron to the more soluble ferrous form. It has been suggested that this bacterial action strips off the ferric compounds which normally stabilize the surface of mild steels, leaving it reactive. Corrosion is thus accelerated. Other bacteria can oxidize or reduce manganese which, along with the iron transformations listed above, is the cause of considerable tubercle formation and subsequent fouling or occluding of pipes, and probably deposit-associated corrosion by species such as the sulfate-reducing bacteria. Many organisms which transform iron also transform manganese. It has been suggested that some of these organisms can reduce iron through the mediation of hydrogen peroxide and catalases (enzymes capable of breaking down hydrogen peroxide into oxygen and water). Yet other organisms are reported to mediate changes in the oxidation state of chromium, possibly aiding in the corrosion of stainless steels.
