Asunto/Subject: **REPLY TO A NOTICE OF NONCONFORMANCE REPORT n° 99901379/2019-201**

Attached: ENSA Report: NCR-2PR3/003 Rev.00 Non Conformity Report (35 pages).

Asunto/Subject: **Response to NCR Observation during Liquid Penetrant (PT) inspection in ENSA workshop.**

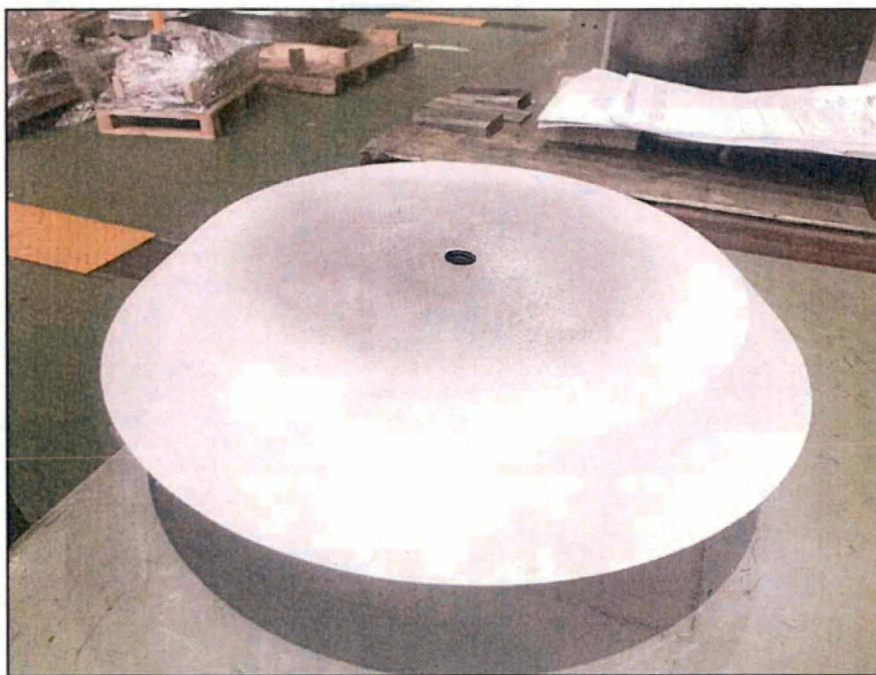
Figure 3, Photo of the Backing plate during PT inspection.

To be conservative with this requirement and in accordance with ENSA NDT inspection good practice, qualified level 2 non-destructive inspector extended the examination area to avoid any misunderstanding about the coverage of the inspection. Therefore it was made the previous cleaning in the surface to be examined and adjacent area (within at least 25mm), and the coverage with the penetrant of all the surface to be welded (upper and lower) plus at least 15mm. (see figure 3). The same requirements are applied to all inspected.

The inspection was performed with the part positioned on a table as shown in the figure 3. There is enough accessibility to perform the complete inspection without perform any movement. It was done with the aid of a mirror to cover the lower area.

The penetrant application was done with a brush, penetration time (20min. minimum) was respected. After penetration time, penetrant removal was performed with cloths according to the applicable OPR3CS401 specification. Verification was done with the aid of a mirror to cover the lower area.

Developer was applied by spraying uniformly, covering all the inspection area after checking the drying of the piece. Verification was done with the aid of a mirror to cover the lower area.
