DOE-EM/GJRAC2040-K

# Moab UMTRA Project Crescent Junction Disposal Cell Interim Completion Report Addendum - K

December 2021

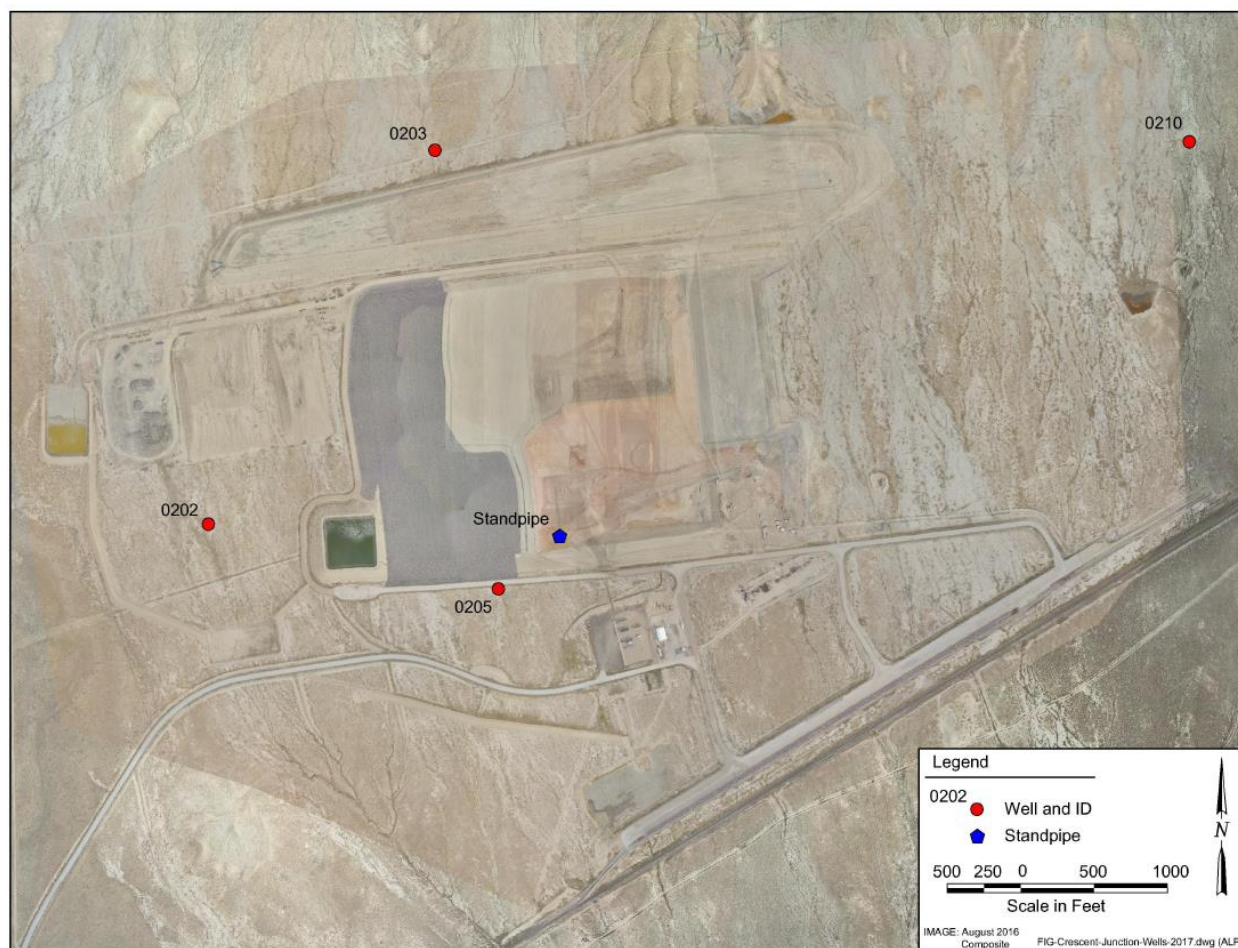
*Figure 6. Locations of Monitoring Wells and Standpipe*

One short-term recovery test (from 0205) was completed to determine the water source and recharge rates. Analysis of the December 2020 recovery data collected indicated the recharge rate was 0.029 gpm, which is within the historical range of recharge rates measured at this location.

Water level, precipitation, recovery test data, along with the analytical results continue to suggest that the groundwater source is surface runoff flowing off the cover, and not associated with leakage from the disposal cell.
