St. Lucie Nuclear Plant Units 1 and 2
Dockets 50-335 and 50-389
Facility Operating Licenses DPR-67 and NPF-16

**SUBSEQUENT LICENSE RENEWAL APPLICATION REVISION 1 – DOCUMENTS WCAP-18623-P/NP
REVISION 1 SUBMITTAL**

**St. Lucie Units 1 & 2 Subsequent License Renewal: Fracture
Mechanics Assessment of Reactor Pressure Vessel Structural
Steel Supports**

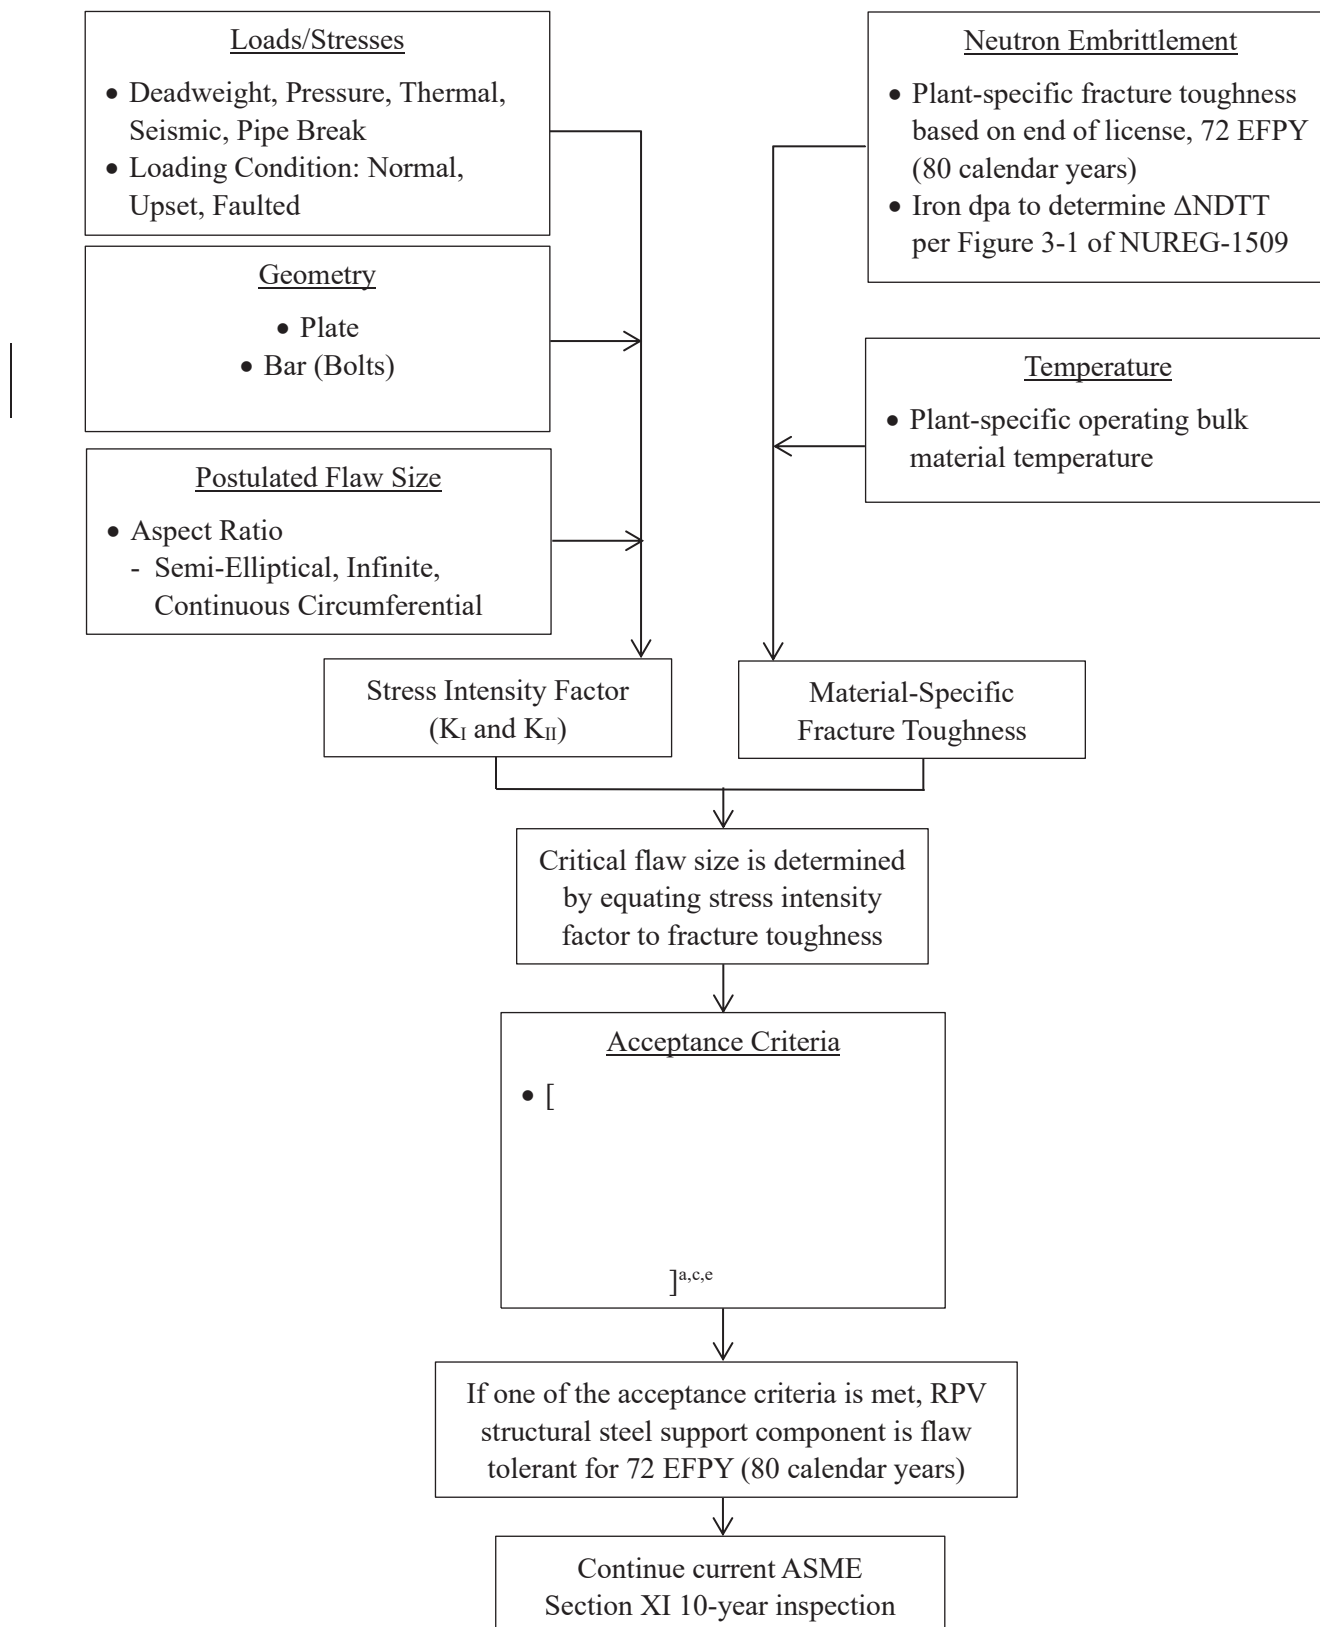
Figure 2-1: Fracture Mechanics Approach Flowchart

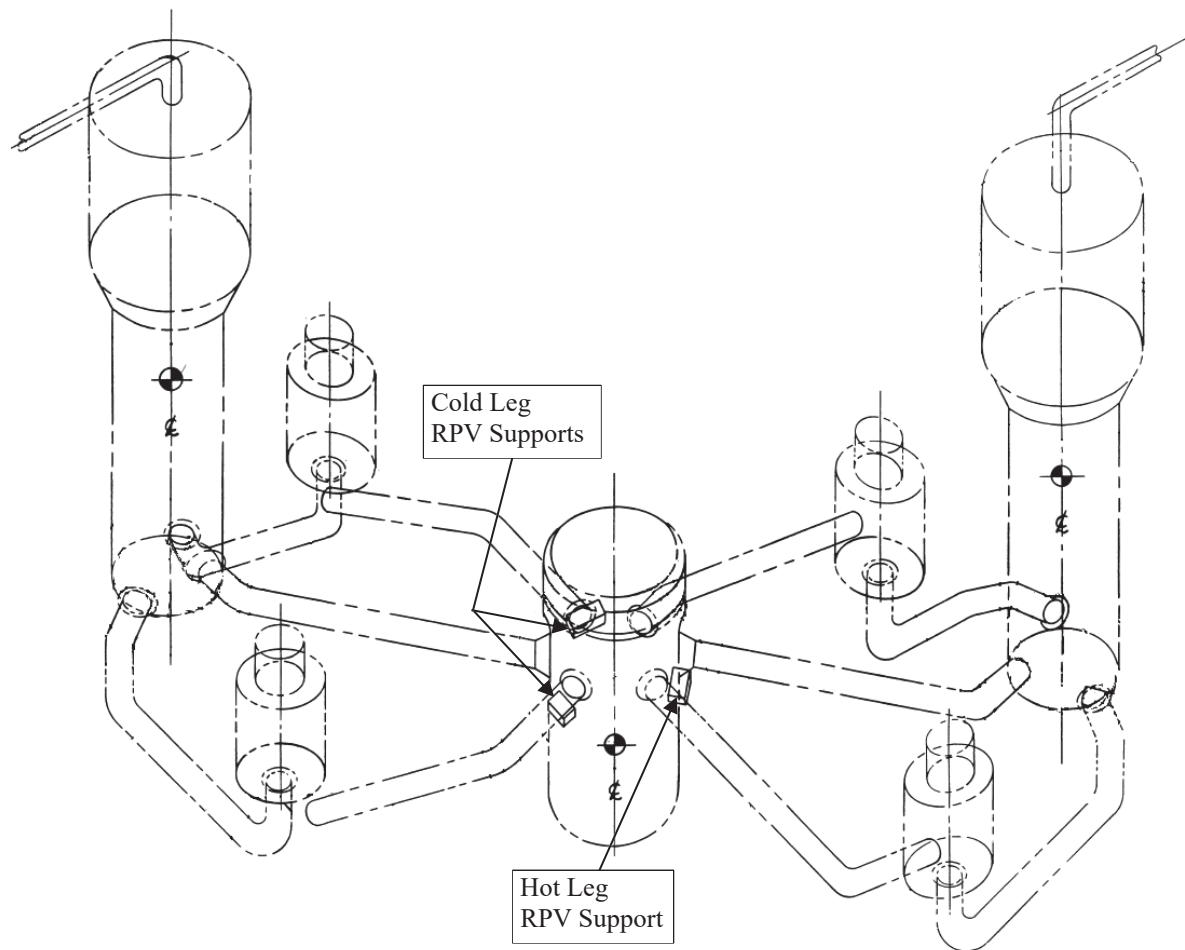
Figure 3-1: Reactor Coolant Loops, Reactor Pressure Vessel, and Location of RPV Supports
Excerpt of References [11.g] and [11.h]

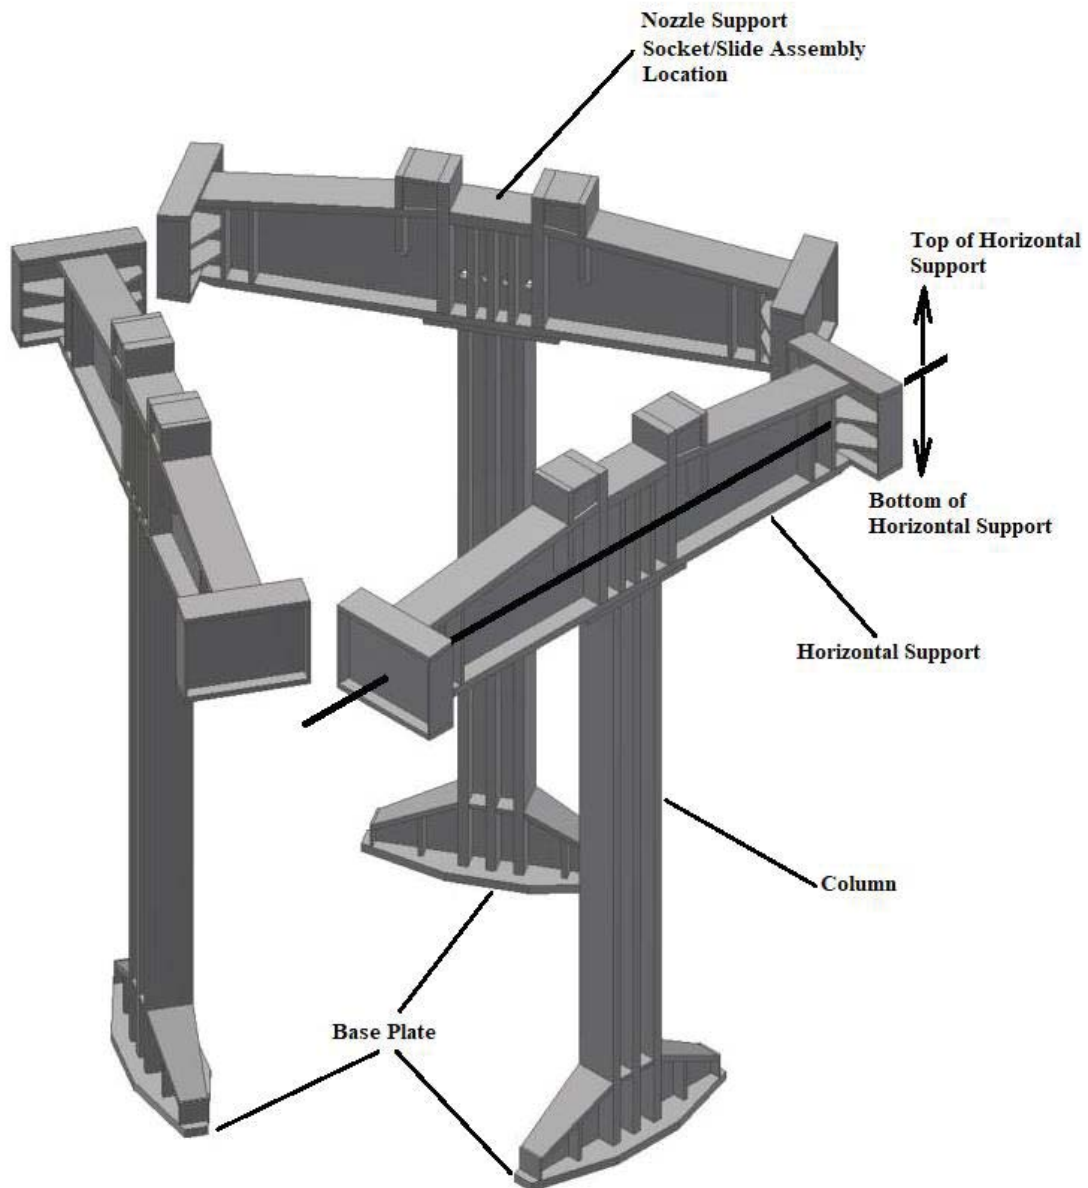
Figure 3-2: St. Lucie RPV Support Arrangement Illustration

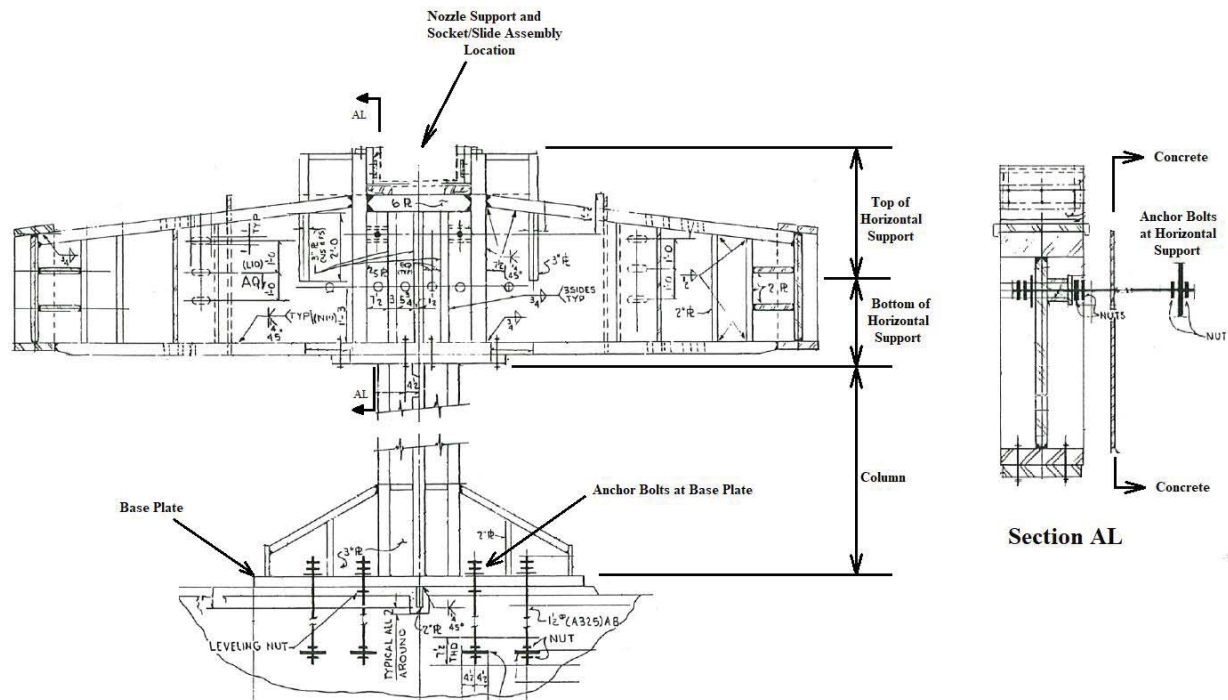
Figure 3-3: St. Lucie RPV Support System
Excerpt of References [11.a] and [11.b]

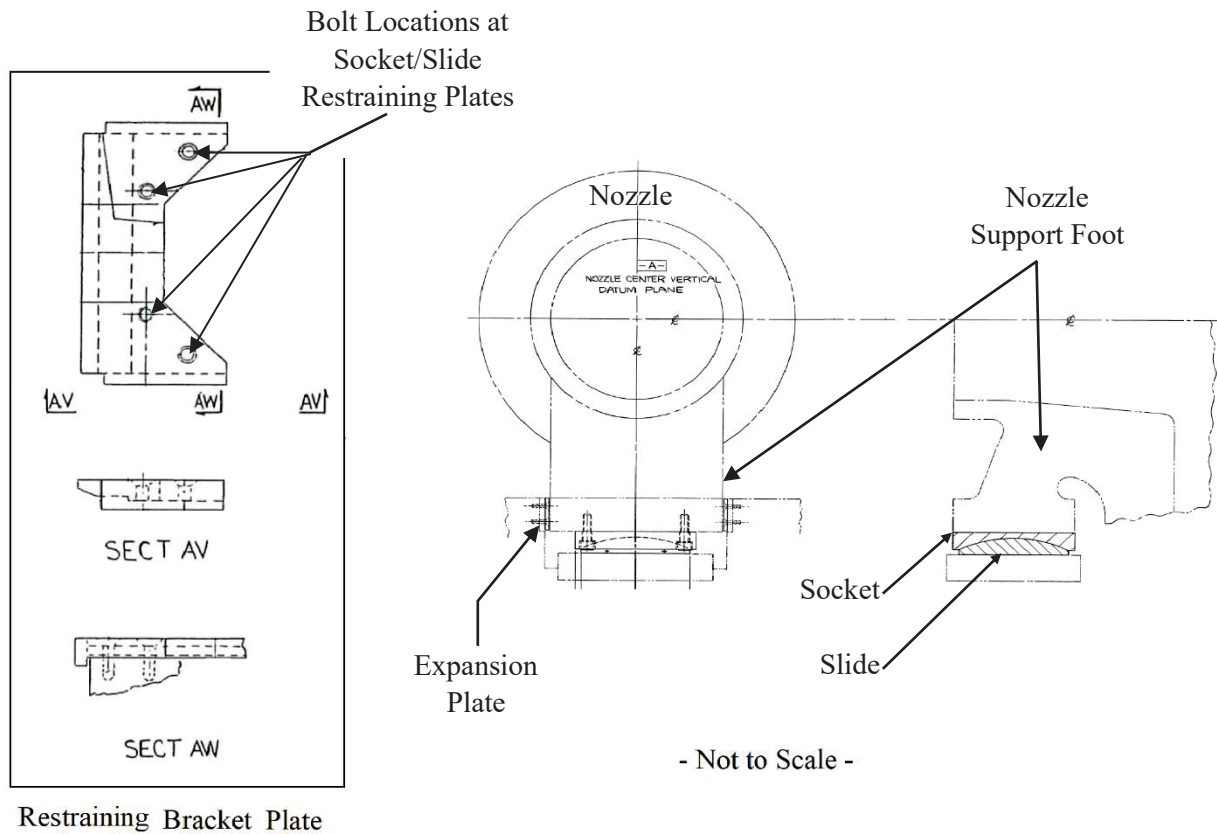
Figure 3-5: St. Lucie RPV Support Shoe Socket and Slide at Nozzle Support
Excerpt of References [11.a] through [11.d]

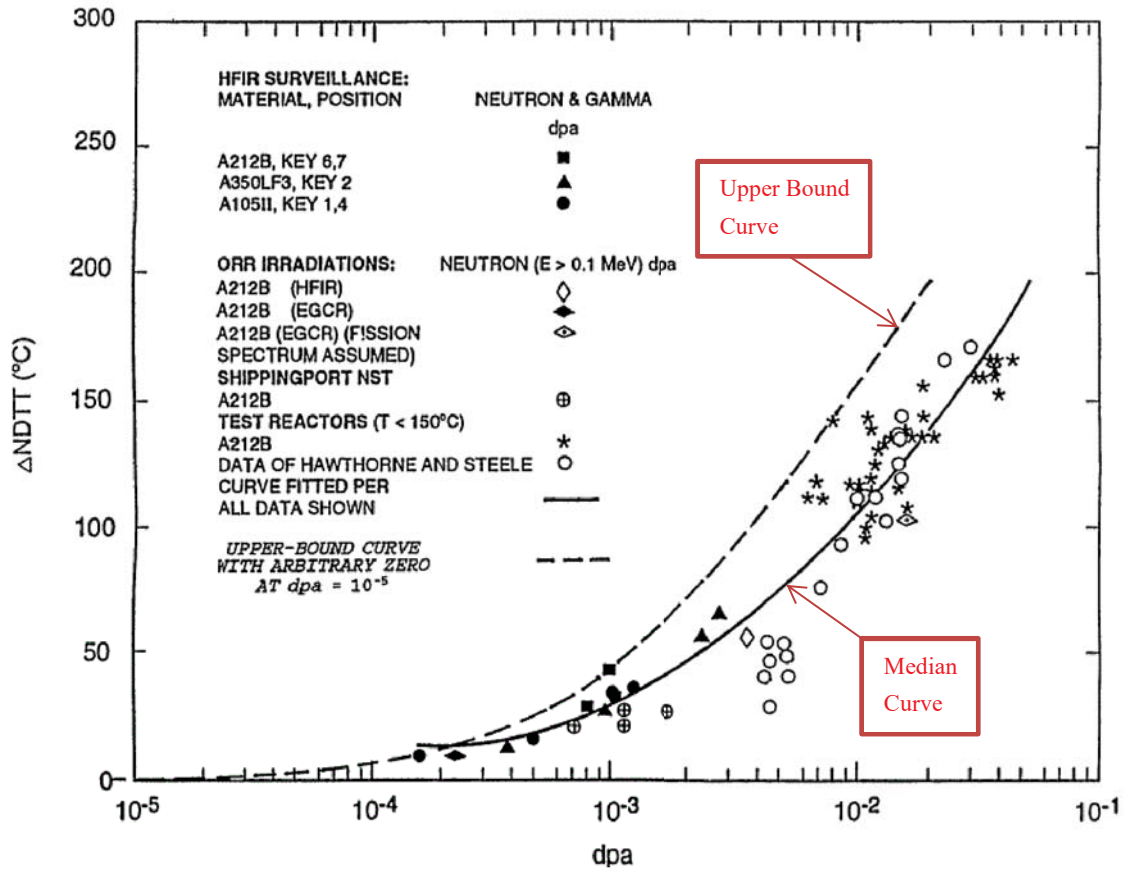
Figure 5-1: Change in Nil-Ductility Transition Temperature, ΔNDTT as a Function of dpa per Figure 3-1 of NUREG-1509 [4]

The iron dpa values from Section 5.1.1 are used to determine the embrittled fracture toughness. The Δ NDTT is based on Figure 3-1 of NUREG-1509 using the conservatively biased full spectrum fluence embrittlement effects resulting from 40 calendar years, 40 calendar years +25% dpa, 72 EFPYs (80 calendar years) and 72 EFPY +25% dpa of radiation. The +25% in iron dpa accounts for analytical uncertainties associated with the methodology used to calculate embrittlement of the St. Lucie RPV support structure. Bounding initial reference temperatures are used with adjustment for dynamic effects on fracture toughness.

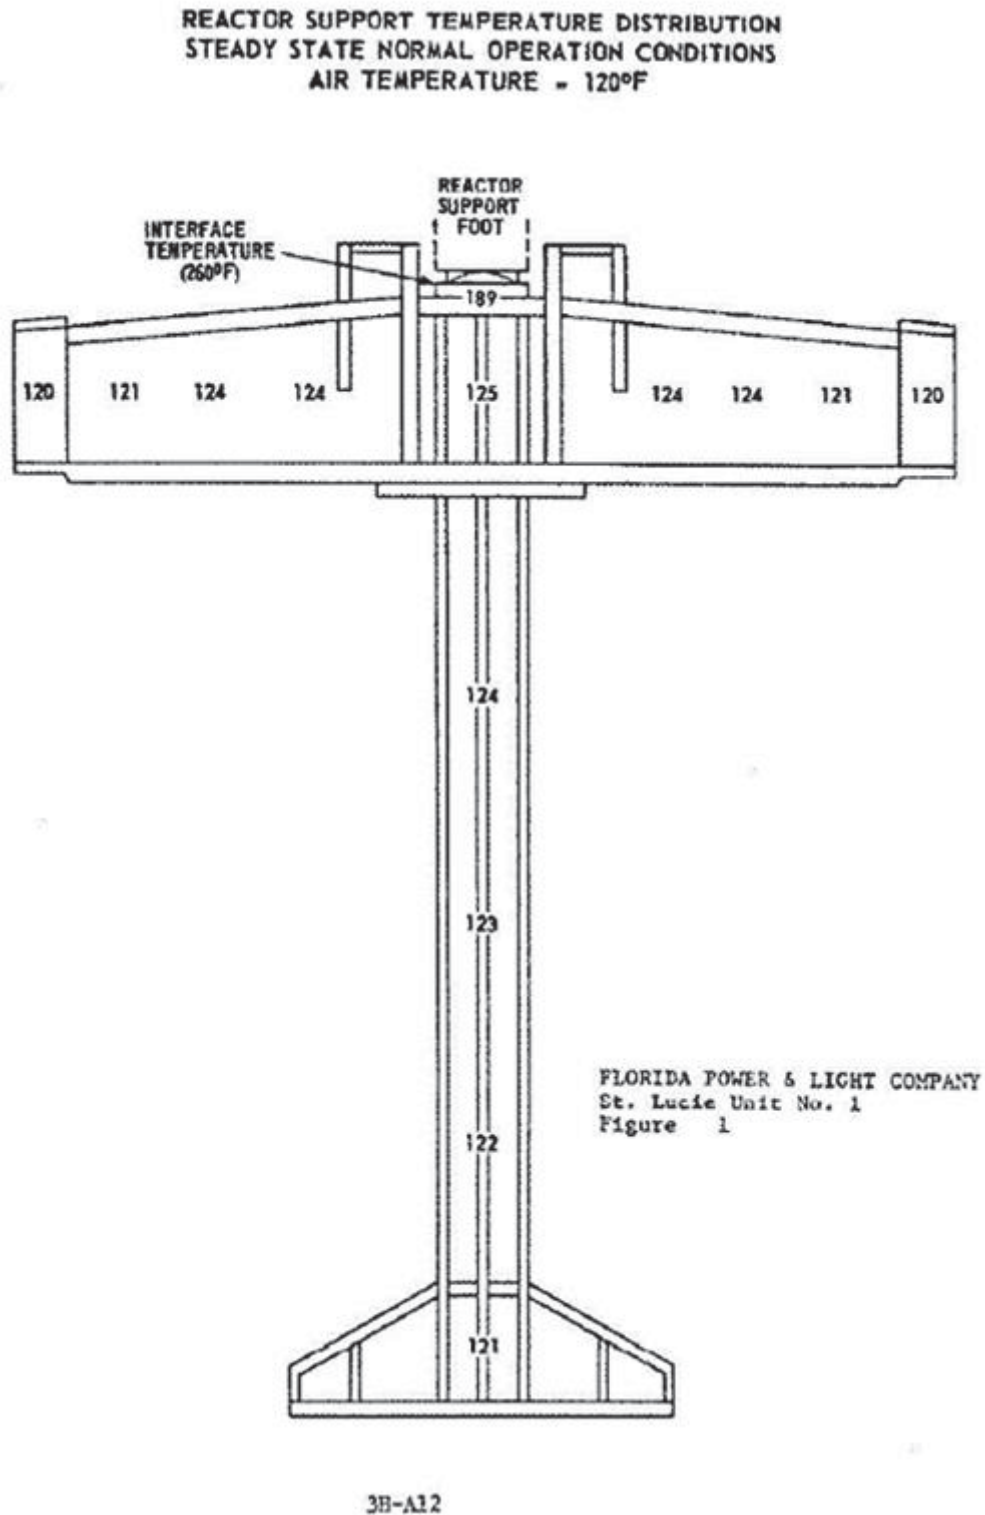
The bulk material temperature or normal operating temperature of the RPV supports is an input for the fracture toughness determination. Figure 1 in the St. Lucie Unit 1 UFSAR, Appendix 3H [26] provides a temperature distribution during steady-state normal operating conditions for the hot leg support. The temperature distribution during steady-state normal operating conditions for the cold leg RPV supports is not available. As illustrated in Figure 5-9, the hot leg reactor support foot location is 189°F. [

Figure 5-9: St. Lucie Unit 1 RPV Support Normal Operation Temperature [26]

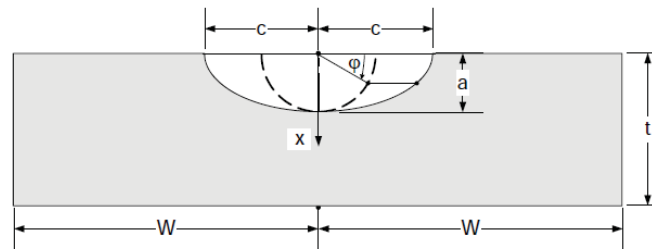
The welded plates within the RPV horizontal support are modeled as a flat plate. The first postulated flaw case in the flat plate model is a semi-elliptical flaw with aspect ratios (flaw length / flaw depth) of 2 and 6 as a parametric study of critical flaw sizes. A graphical representation of a semi-elliptical flaw in a plate model is provided in Figure 5-13.a. The stress intensity factor is calculated at the surface point ($\phi = 0^\circ$, see Figure 5-13.a) and the deepest point ($\phi = 90^\circ$) along the postulated crack front, and the limiting critical flaw sizes are reported in Section 7. The stress provided in Section 4.1, Section 4.2 and Section 4.3 is conservatively applied as constant through the wall thickness (i.e., as a pure membrane stress). The semi-elliptical flaws included welding residual stress since the flaws are postulated near the welds of the plate components. The stress intensity factor correlation for the semi-elliptical flaw with pure membrane stress is provided in API-579 [31] Section 9B.3.4 as follows:

(a) Finite Length Surface Crack

(b) Infinitely Long Surface Crack ($c \gg a$)

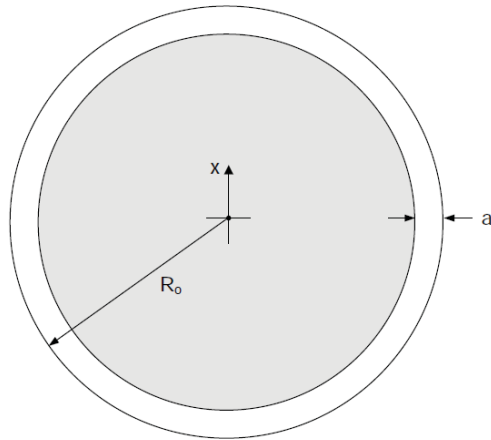
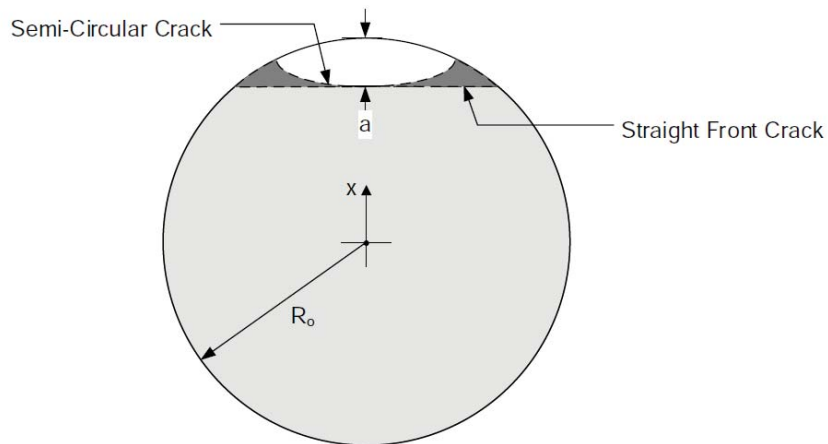
Figure 5-14: Postulated Flaws in a Round Bar Model

The bolts which connect the column to the bottom of the horizontal support were conservatively assumed to have completely 360° circumferential flaws oriented perpendicular to the bolt centerlines and therefore responsive to bolt tensile loading. In addition, the straight front and semi-circular crack models are postulated as a parametric study and for less limiting critical flaw size results. A graphical representation of the three flaw types in a bar model is provided in Figure 5-14. The axial force, shear stress, and moments on the bar components are provided in Section 4.4. The stress intensity factor for the bolts is based on API-579 [31] Sections 9B.11.1, 9B.11.2, and 9B.11.3 for round bar surface circumferential crack – 360°, straight front crack, and semi-circular front crack, respectively, with through-wall membrane stress as follows:

(a) 360° Continuous Surface Flaw

(b) Straight Front and Semi-Circular Surface Crack

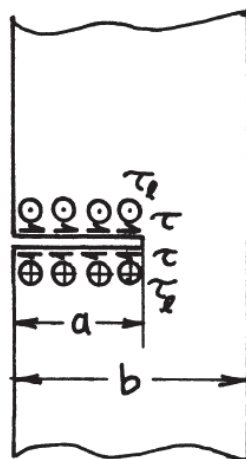
A review of Mode II and Mode III influence coefficients determined that $F_{II(a/b)}$ will provide a more limiting critical flaw size; thus, critical flaw size is only calculated and reported based on the Mode II stress intensity factor. The Mode II stress intensity factor is based on a [

**Figure 5-15: Postulated Single Edge Flaw with Shear Stress in a Plate Model**
