# NRC Feedback on EPRI Integrity Assessment Guideline Appendix G Implementation

NRC Meeting with  
Industry Steam Generator Task Force (SGTF)  
September 8, 2022

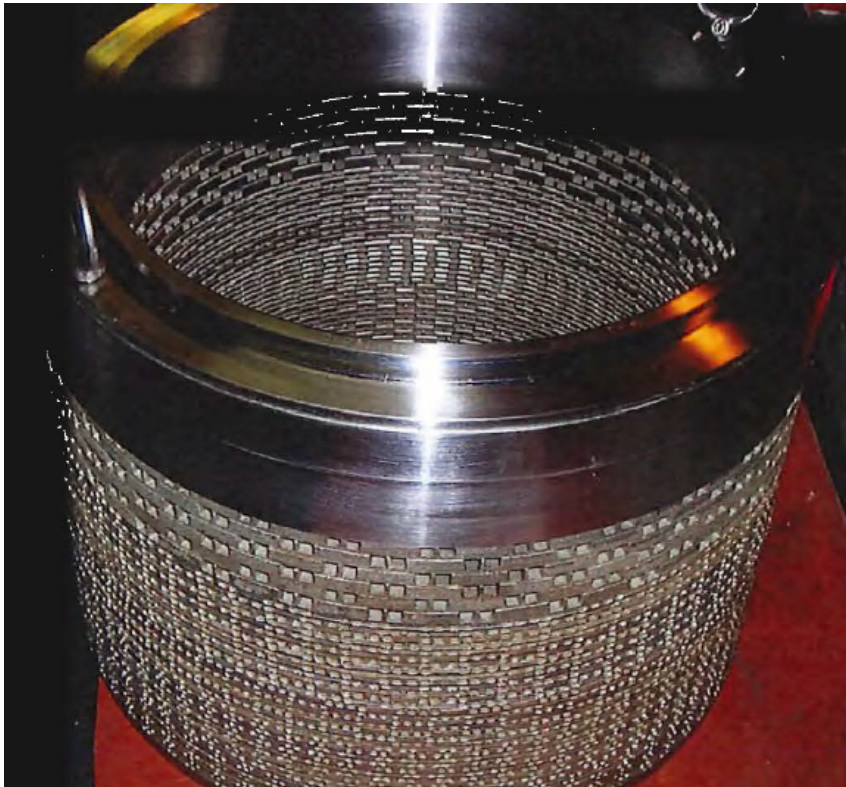
- ML22108A224
  - Detailed explanation about the definitions of dents and dings, in both the historical and current use context
  - Feed regulating valve disc stack photograph
