Palisades Nuclear Plant
NRC Docket 50-255
Renewed Facility Operating License No. DPR-20

Subject: *Revised Relief Request Number RR 5-9, Proposed Alternative to ASME Section XI Code Requirements for Modification of Reactor Pressure Vessel Closure Head, Control Rod Drive Mechanisms and InCore Instrumentation Penetrations*

Revised Relief Request Number RR 5-9

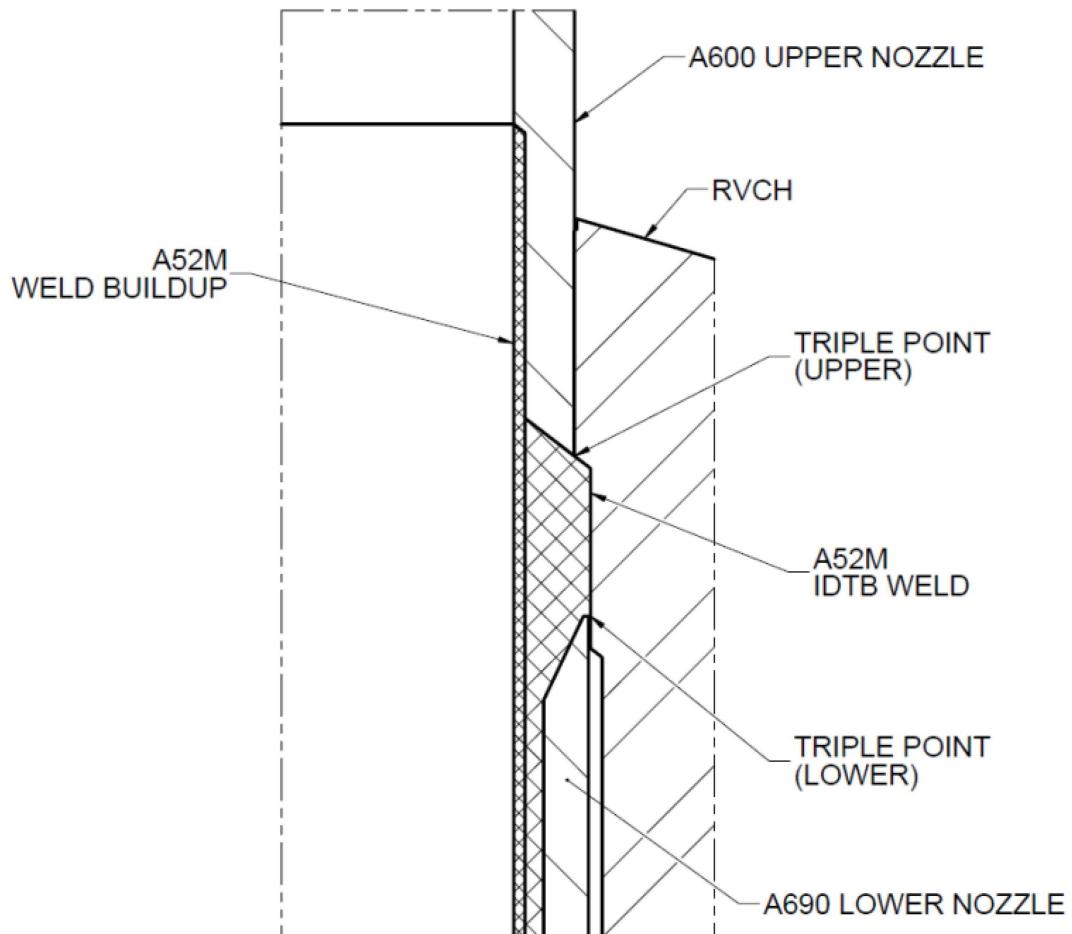
Figure 4-5
Triple Point Locations
