Amersham International plc

Packaging Design Group

Test Report No. 1901

1.1 Package Design No 3750A.

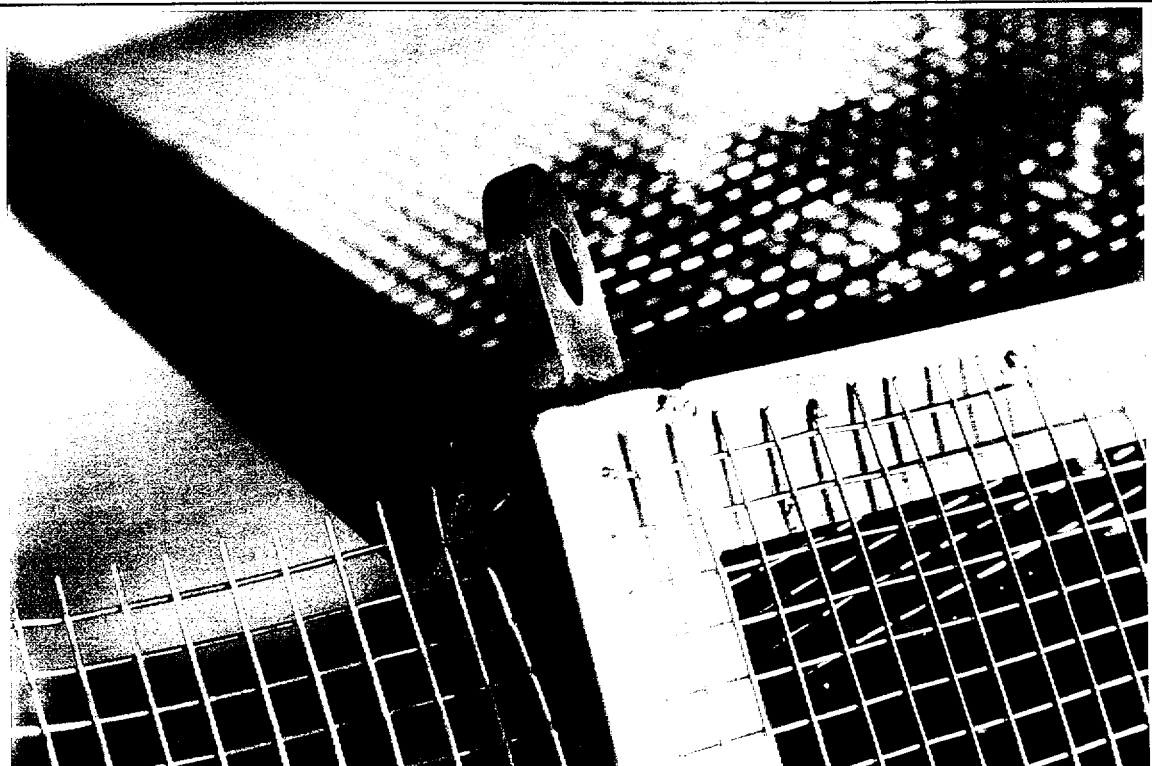
Figure 9: Split near cage weld and lifting point showing bruise

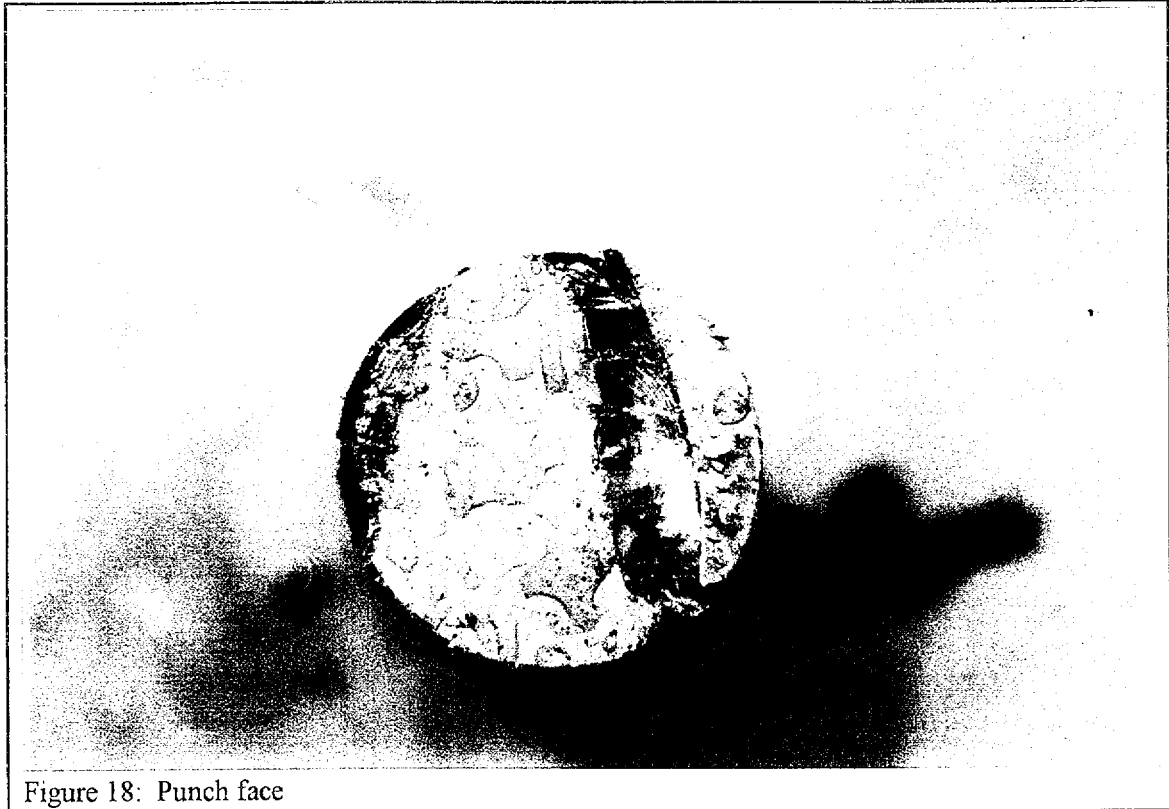
4.4.6 **Punch:** The punch carried two indentations from the cooling fins (figs 17 & 18) indicating a good impact.

Figure 17: Punch after impact

Figure 18: Punch face

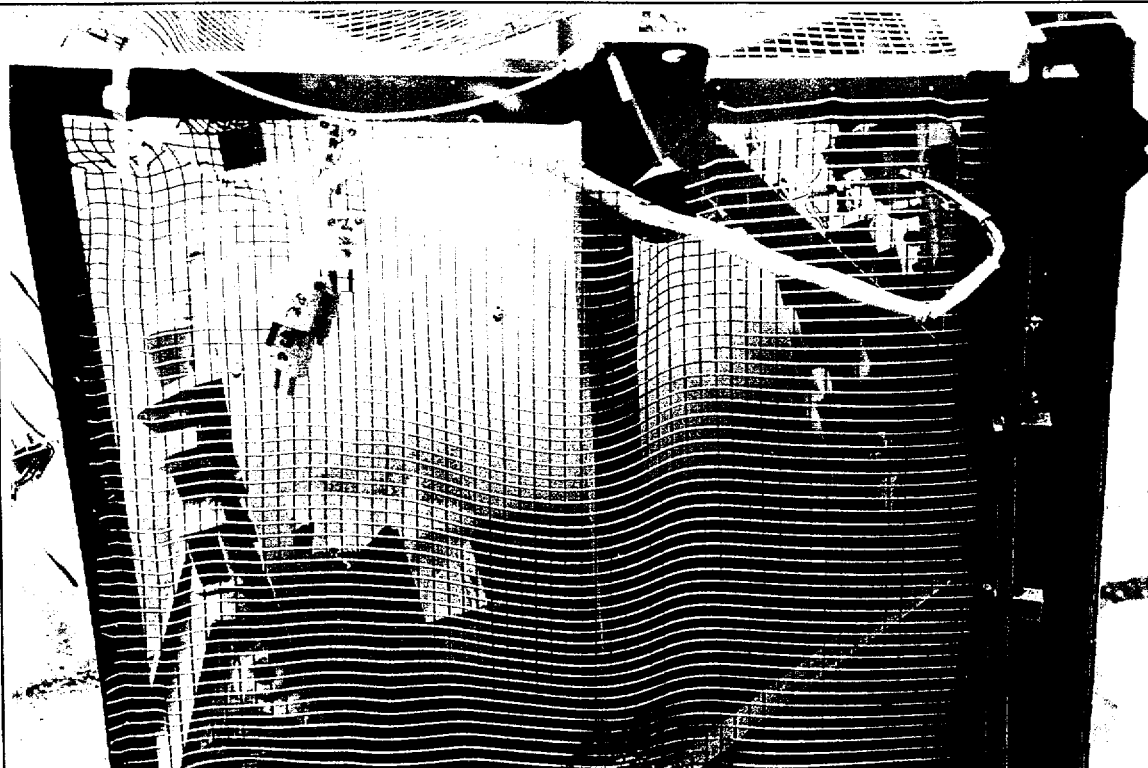
Figure 7: Cage showing yielding around pallet fixings

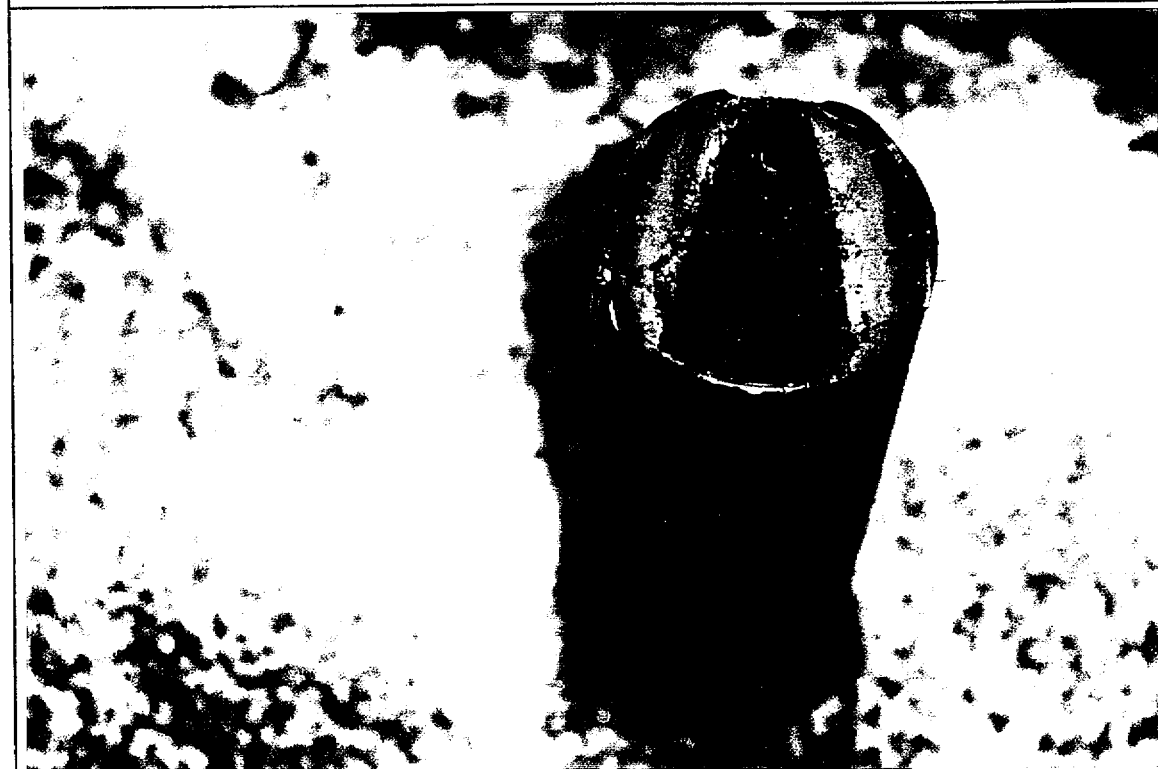
Figure 11: Punch face

- 4.4.6 Punch: The punch carried two indentations from the cooling fins (fig 11) indicating a good impact.
