Dry Cask Storage Characterization Project—Phase 1: CASTOR V/21 Cask Opening and Examination

Idaho National Engineering and Environmental Laboratory

U.S. Nuclear Regulatory Commission
Office of Nuclear Regulatory Research
Washington, DC 20555-0001

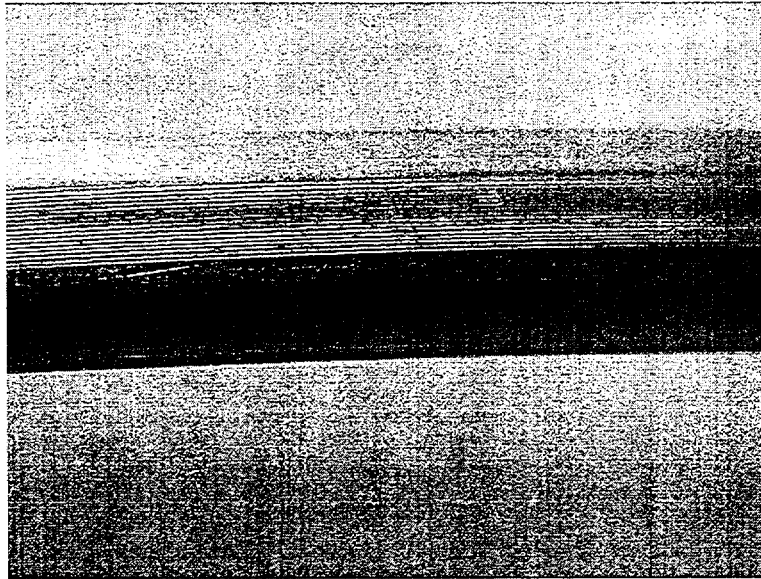
Figures 2-12. Primary lid metal O-ring.

The top surface of the metal O-ring, which was in contact with the seat of the O-ring groove, did not have any defects except for a few fresh (unoxidized) shallow scratches that have been attributed to handling damage during removal from the lid. The bottom surface as shown in Figure 2-12, which was in contact with the seal surface of the cask body, exhibited approximately 20 small pin-point indentations into the surface. The indentations were typically less than 1 mm (0.04 in.) in lateral dimension and did not appear to puncture the thickness of the metal O-ring. Because these were not spotted in the initial remote camera inspection, these features are being attributed to compression damage from environmental grit on the seal surface of the cask body. The grit was probably transfer from the bottom of the seal protector to the seal area during the fuel examination operations.

- Several pinpoint indentations, some on sealing surface; typically <0.5 mm dia, probably <0.5 mm deep

- Several light scratches, a few across the sealing surface; most have metal glint in scratch root, indicating fresh scratches
- No evidence of significant general corrosion, pitting corrosion, stains
- Sealing surface defined by the impression of the machining marks from the seal surface on cask
- No evidence of significant oxidation or spallation of these fine line features
- No deformation of the individual line impressions despite numerous cycles of lid removal/replacement during fuel inspection.

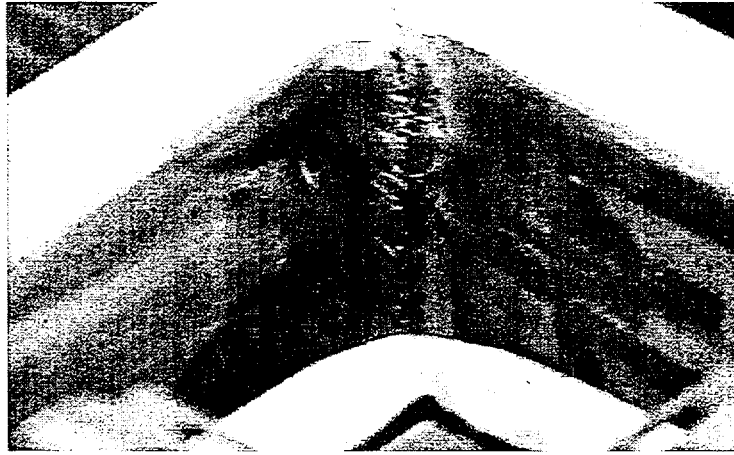
Additional cracks in basket welds (as shown in Figure 2-19.) were associated with stainless/borated steel junctions welds in fuel tubes.

Figure 2-19. Crack in basket weld below weld crack 4 (120 degree side) identified in Figure 2-13.

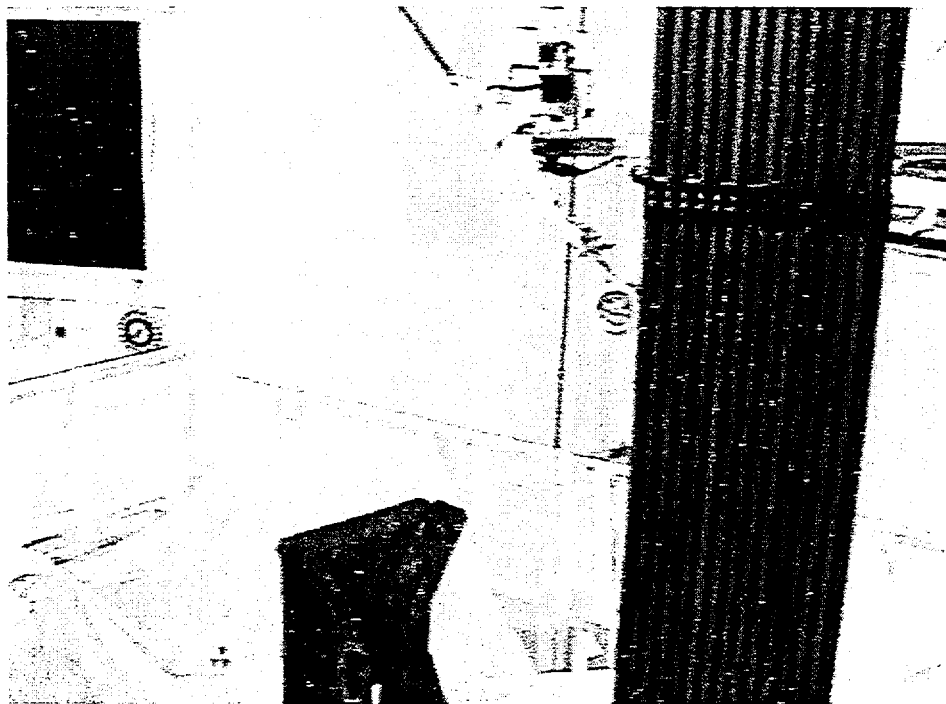
Figure C-64. Fuel assembly T-11 attempt to obtain loose material.

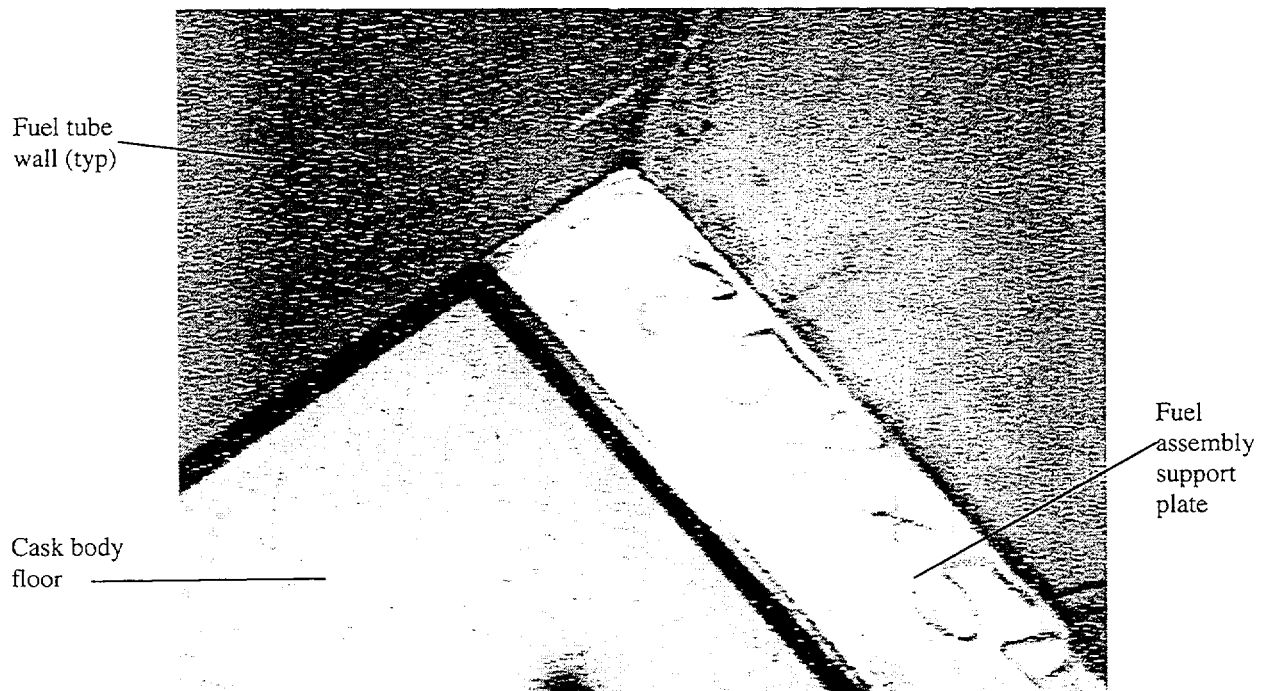
Figure D-20. Fuel tube C-5 reflective surfaces and existence of original fabrication/layout characters.

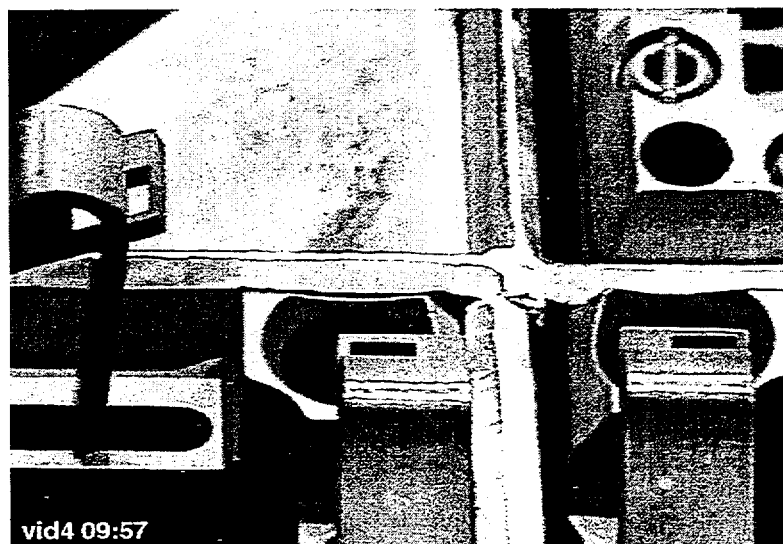
Figure G-2. Existing 1985 weld crack at location No. 2 identified in Figure G-9.
