APPENDIX A

Stream and Sampling Photographs During the Fisheries Survey

APPENDIX B

Stream Photos
During the Habitat Assessment Survey

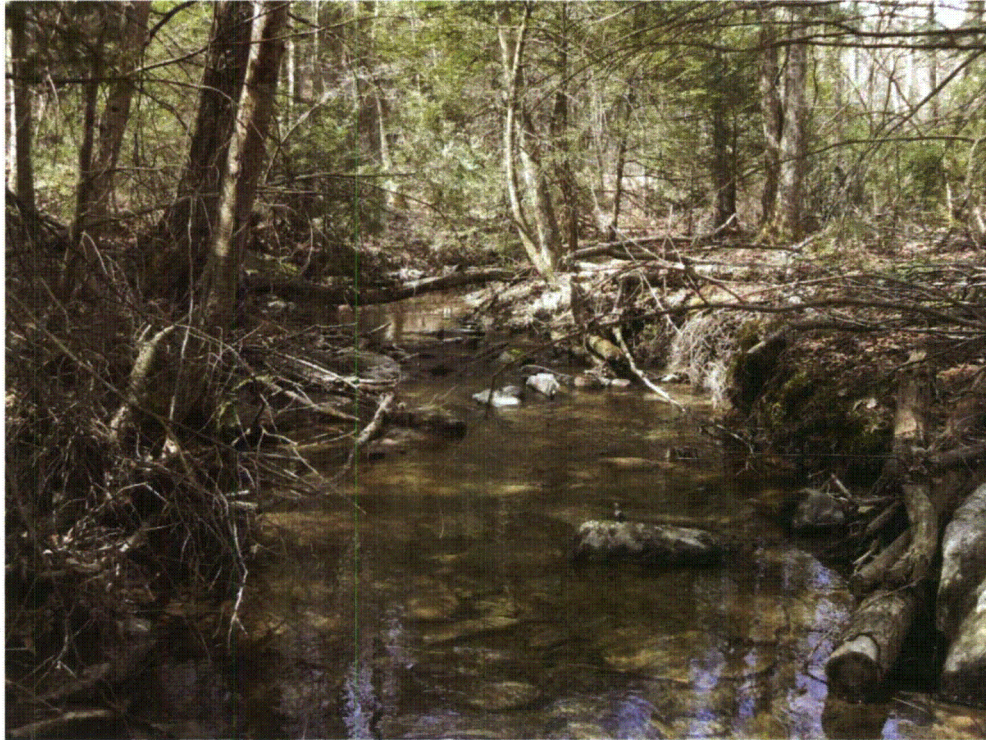
Photo 7. Reach 2 and surrounding forested land.

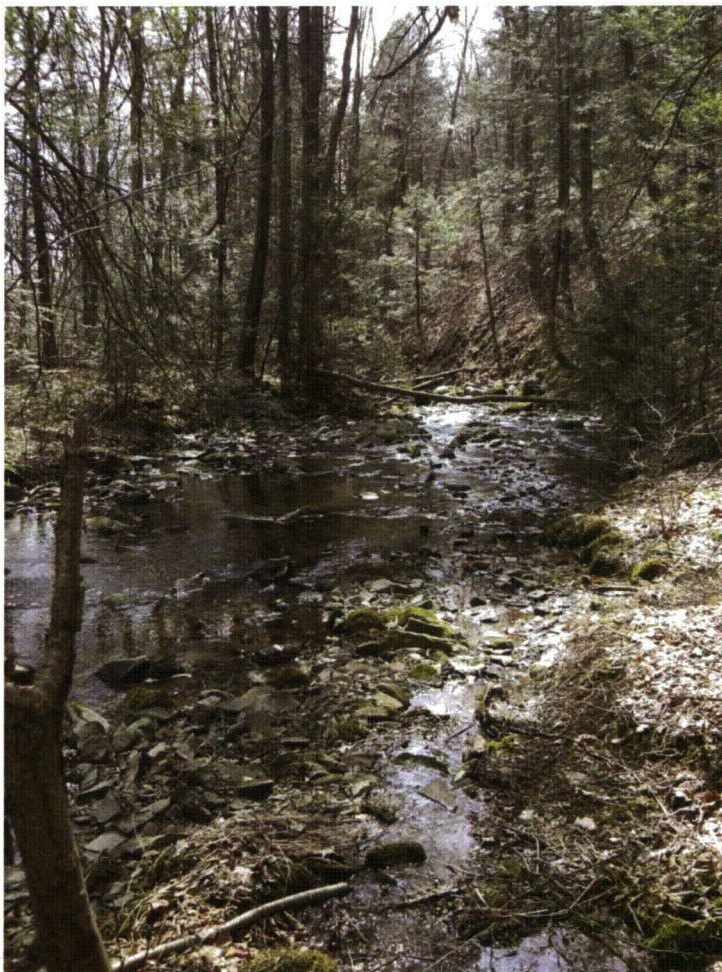
Photo 10. Reach 2 and surrounding forested land.

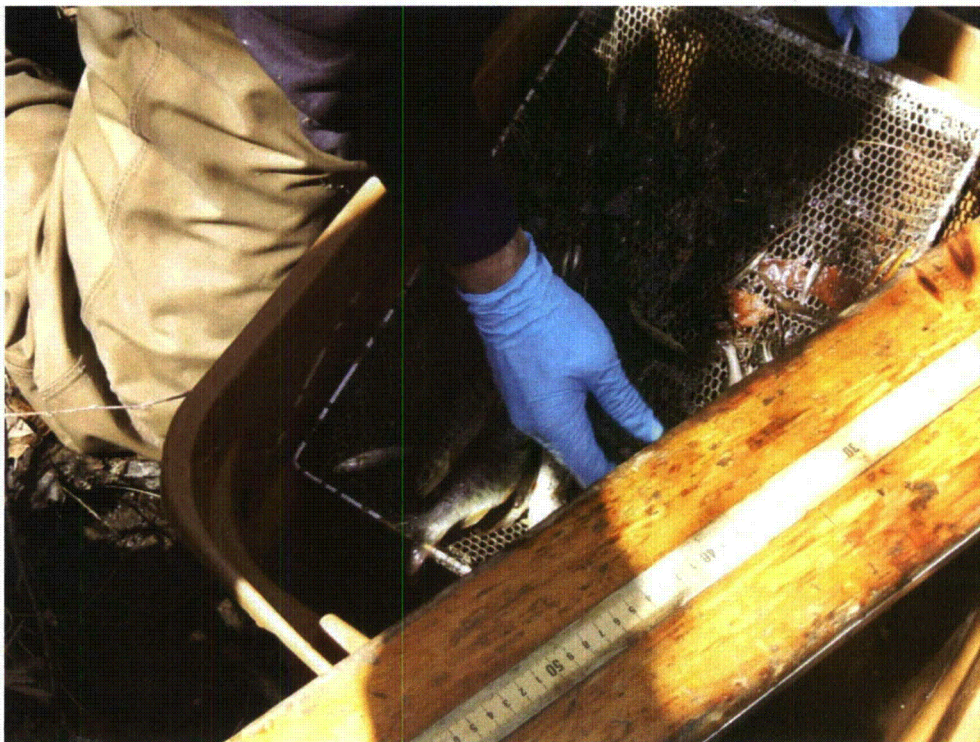
Photo 11. Fish collected at Reach 2 with measuring board.

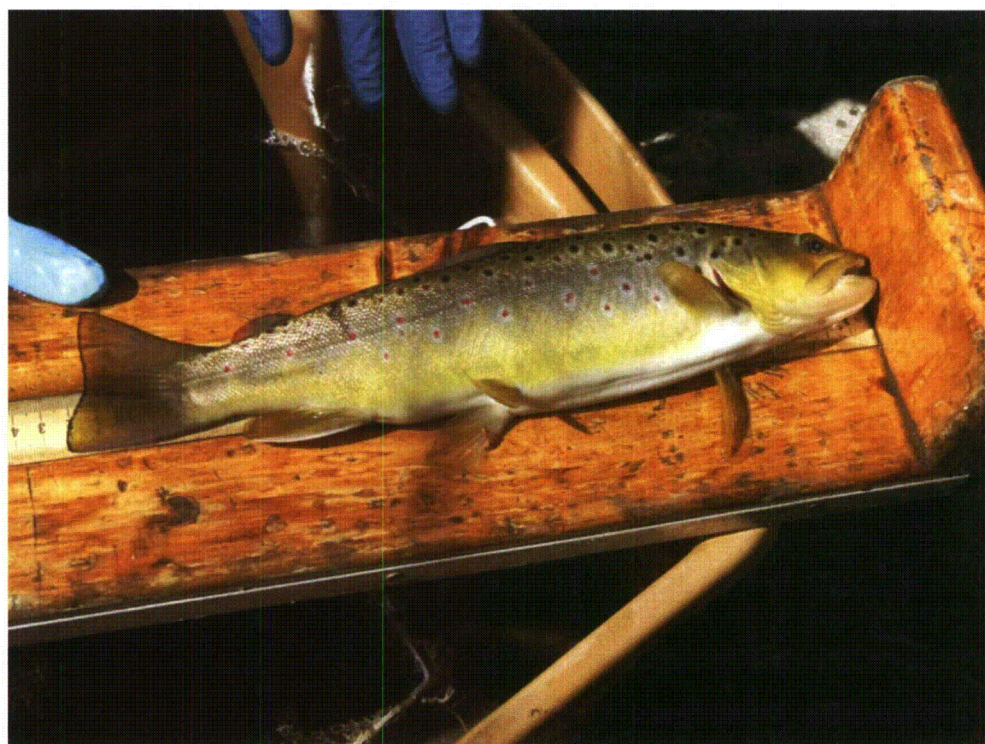
Photo 12. Large brown trout collected at Reach 2.

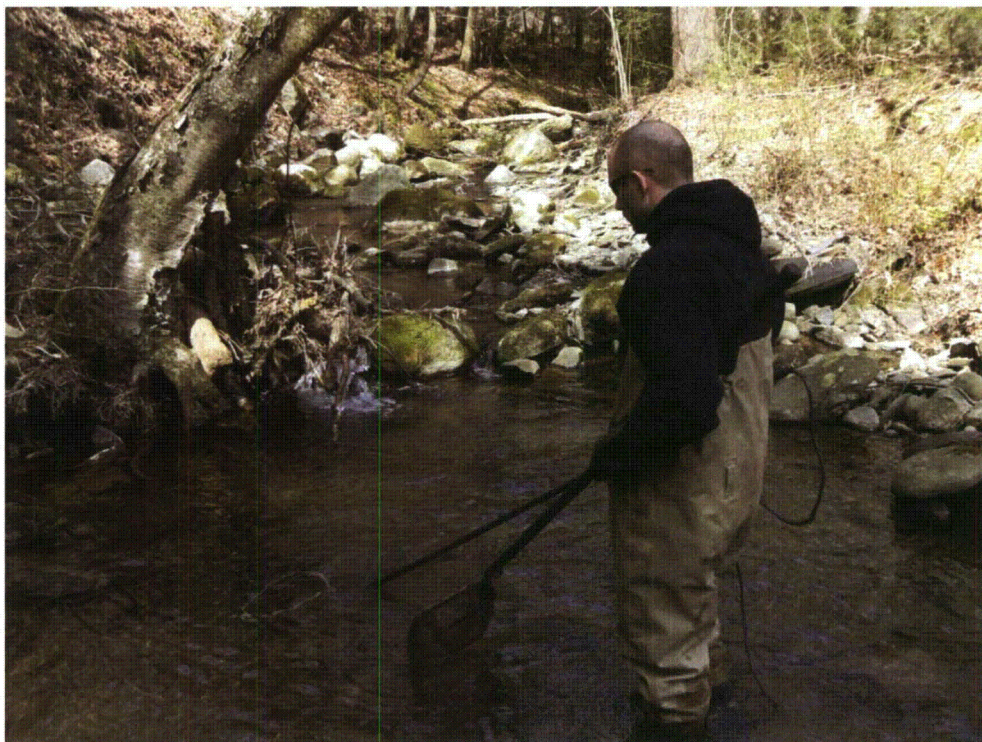
Photo 15. Equipment used to electroshock and collect fish.

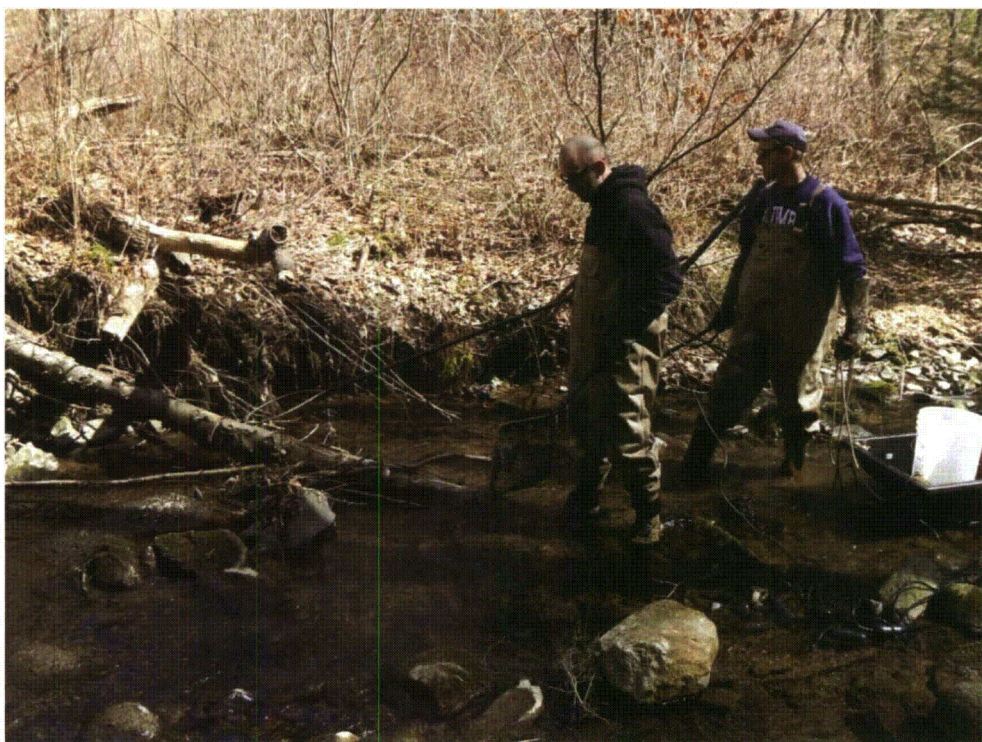
Photo 16. Walker Run at Reach 3.

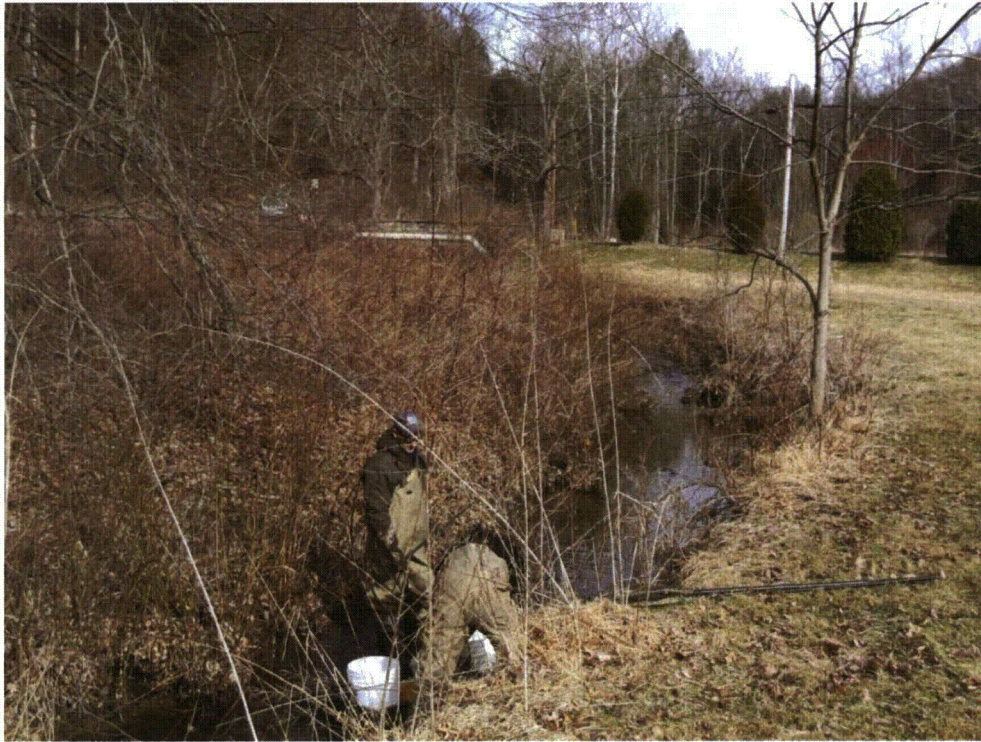
Photo 17. Reach 4 and surround land use.

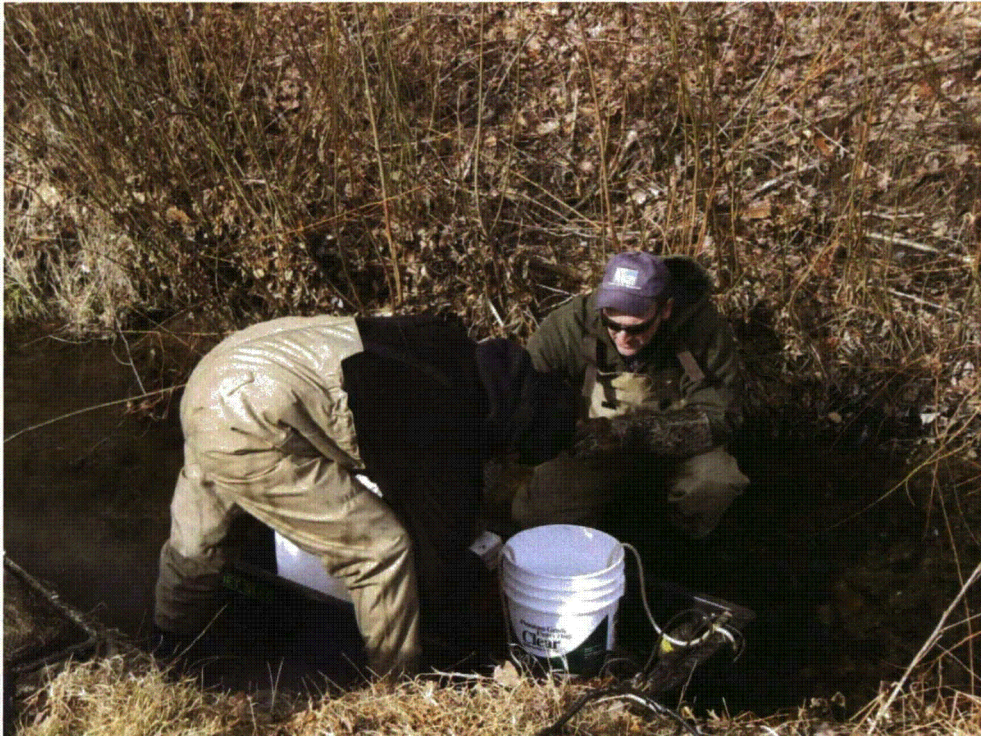
Photo 18. View of equipment used to collect fish at Reach 4.

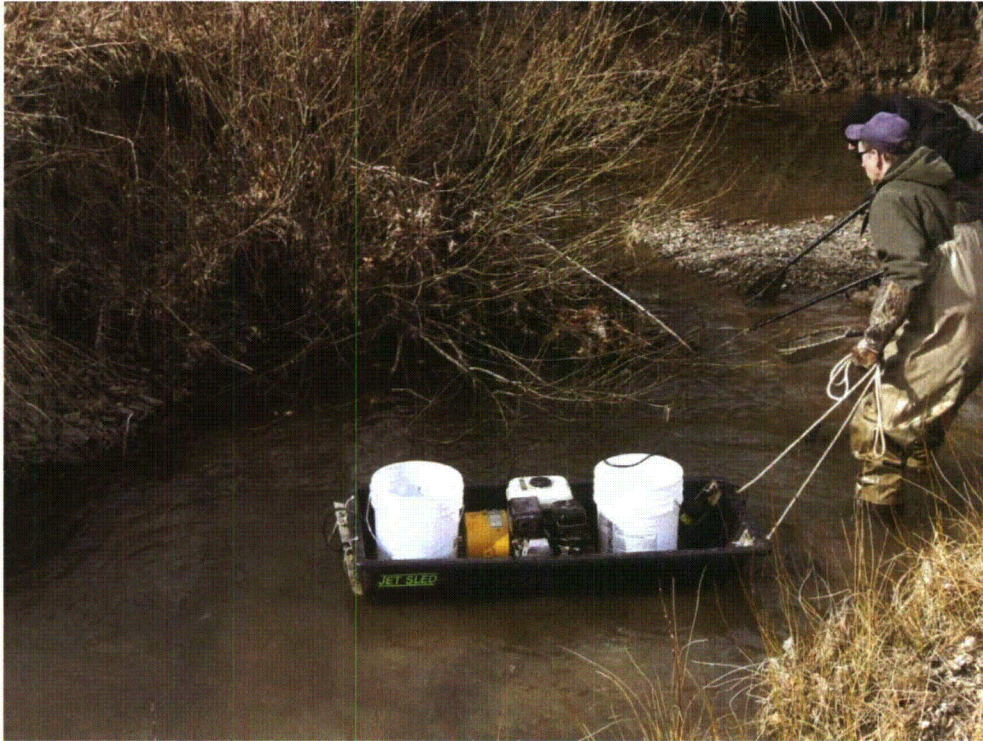
Photo 19. Electroshocking at reach 4.

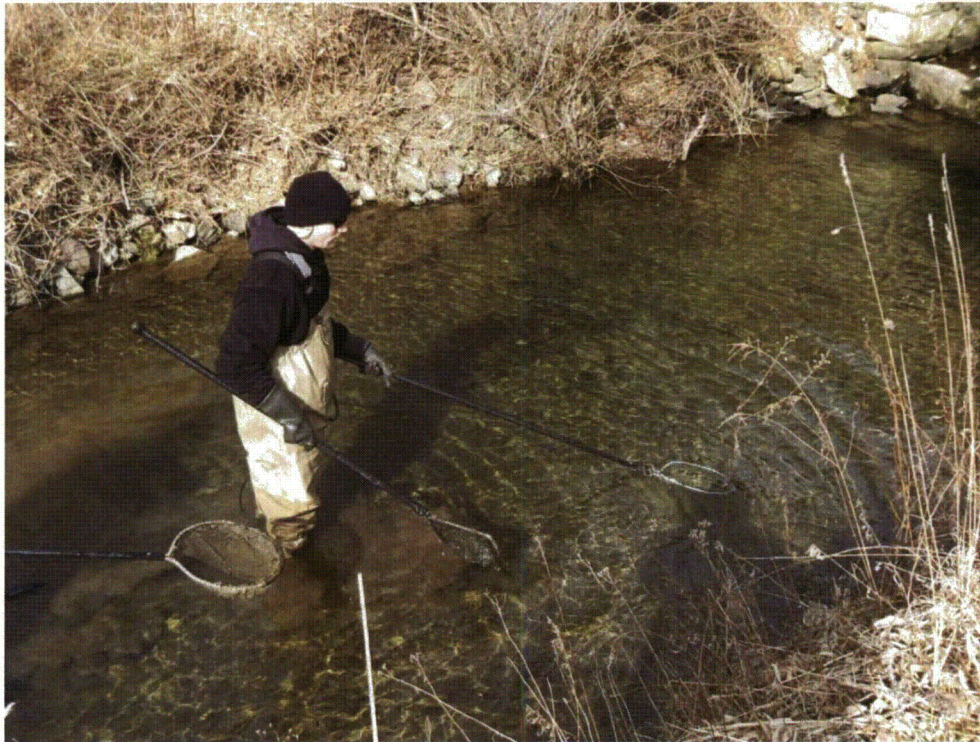
Photo 21. Electroshocking at reach 4 in pool below bridge.

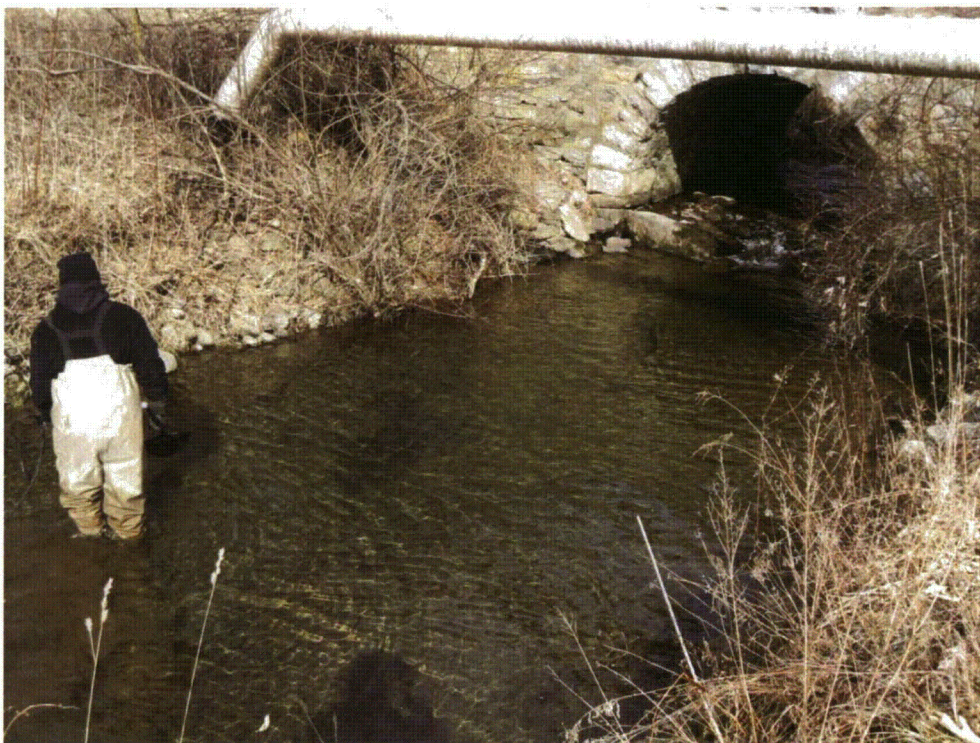
Photo 22. View of road crossing and pool at upstream end of Reach 4.

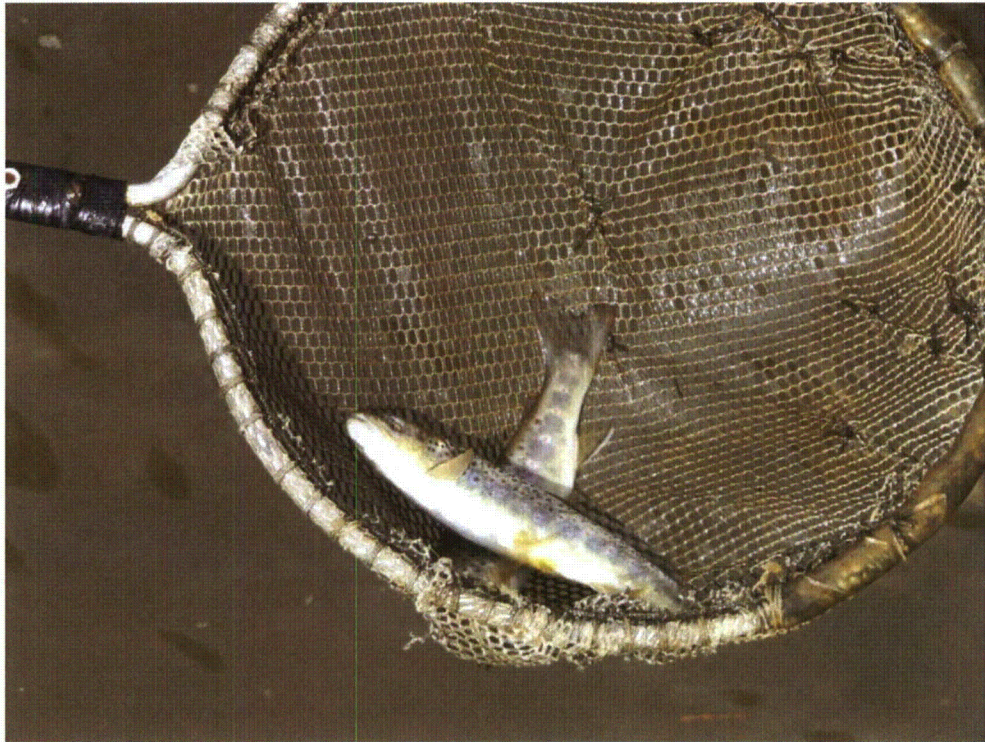
Photo 23. Brown trout collected at Reach 4.

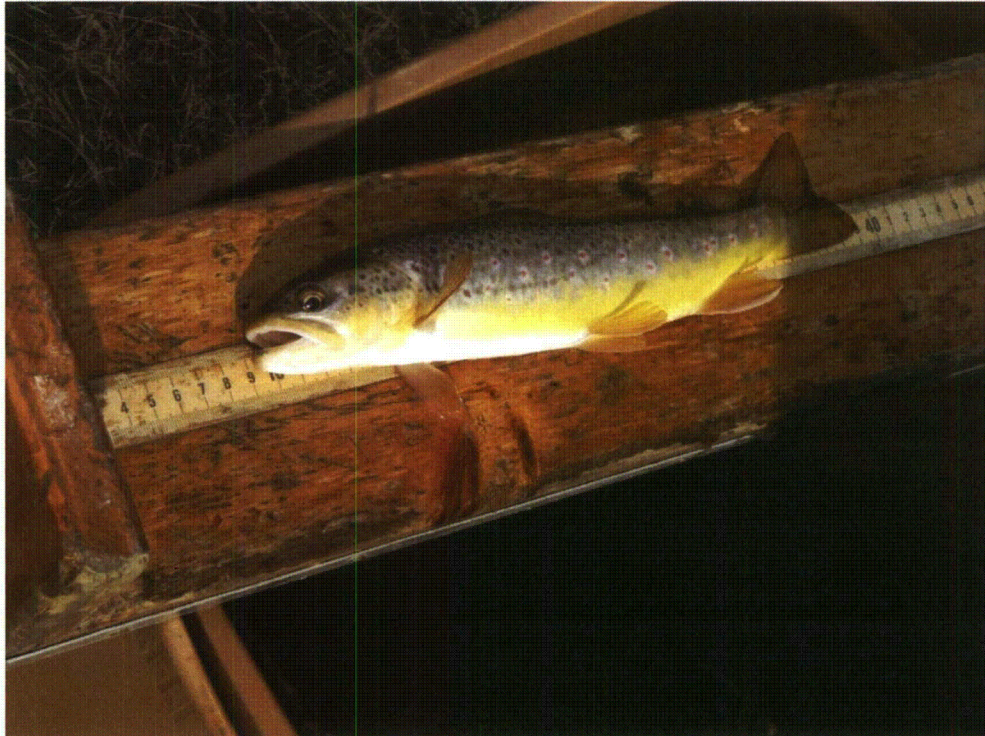
Photo 24. Brown trout on measuring board.

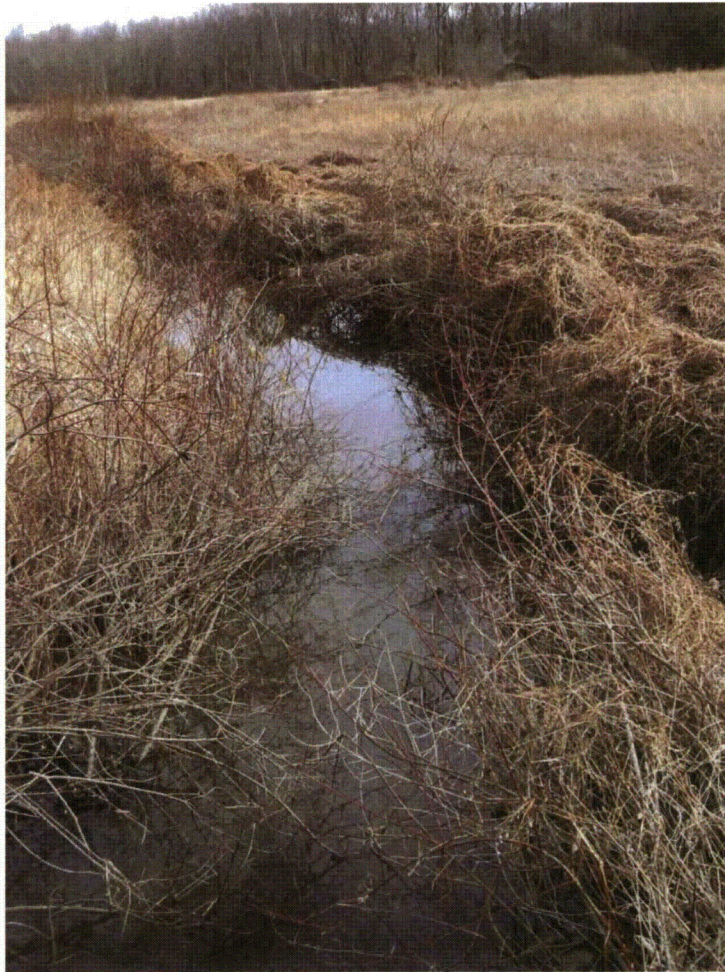
Photo 25. Reach 5 and surrounding land use.

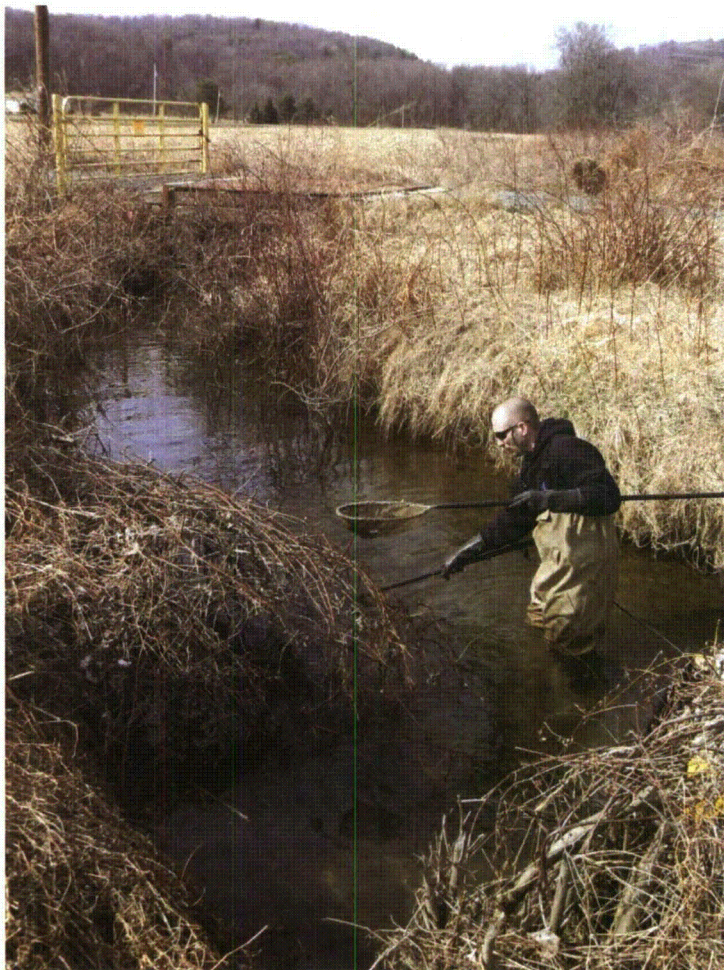
Photo 28. Electroshocking downstream of crossing.

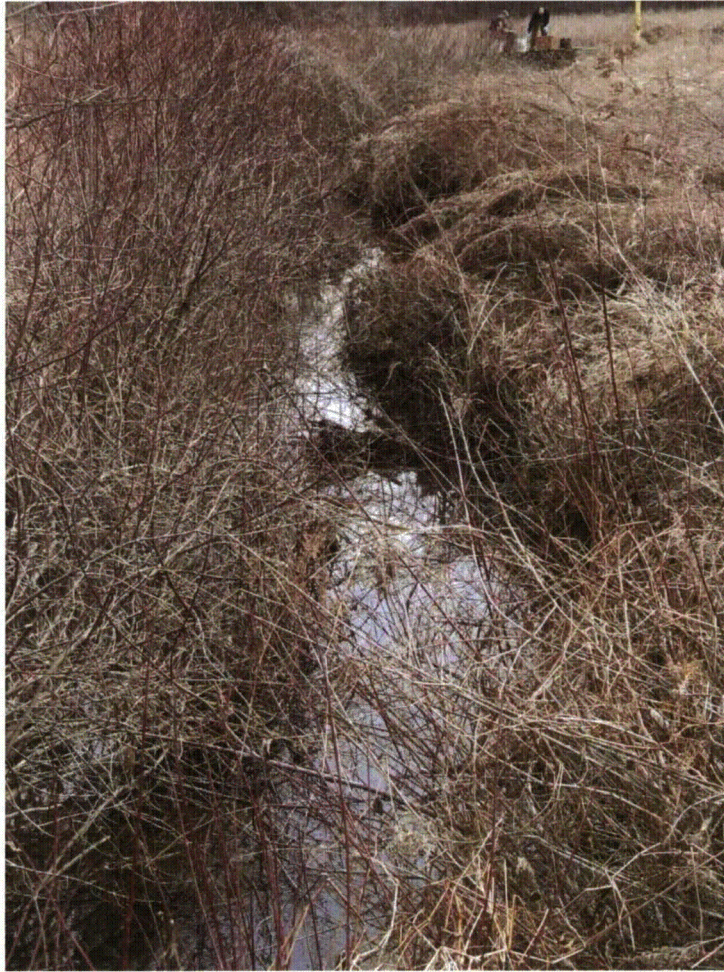
Photo 29. View of Walker Run, Reach 5.

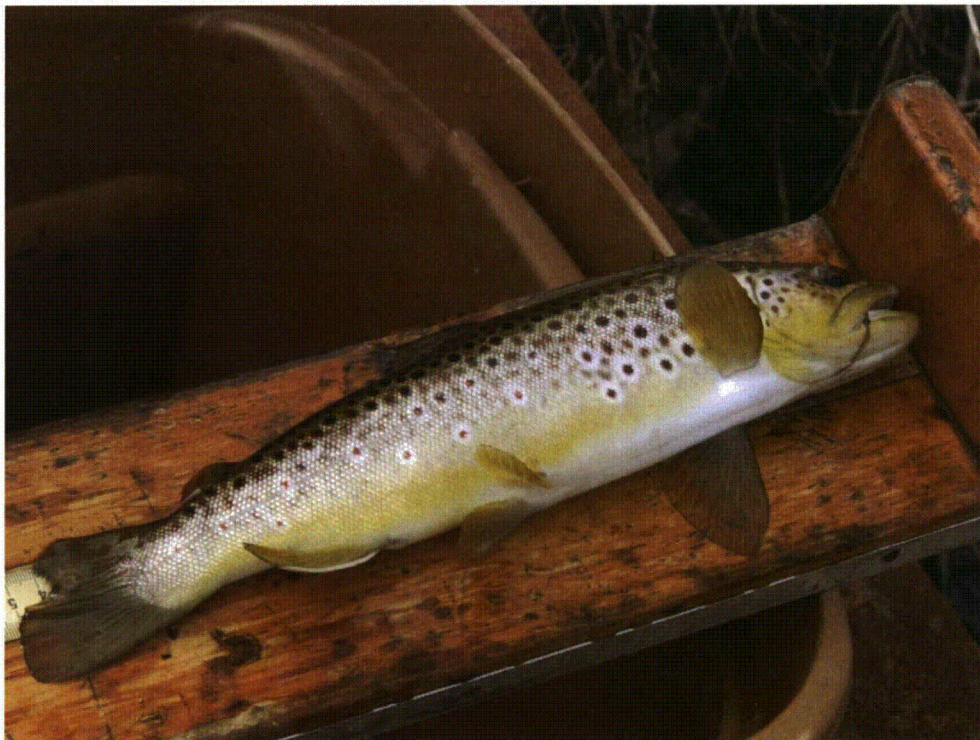
Photo 30. Brown trout collected at Reach 5.

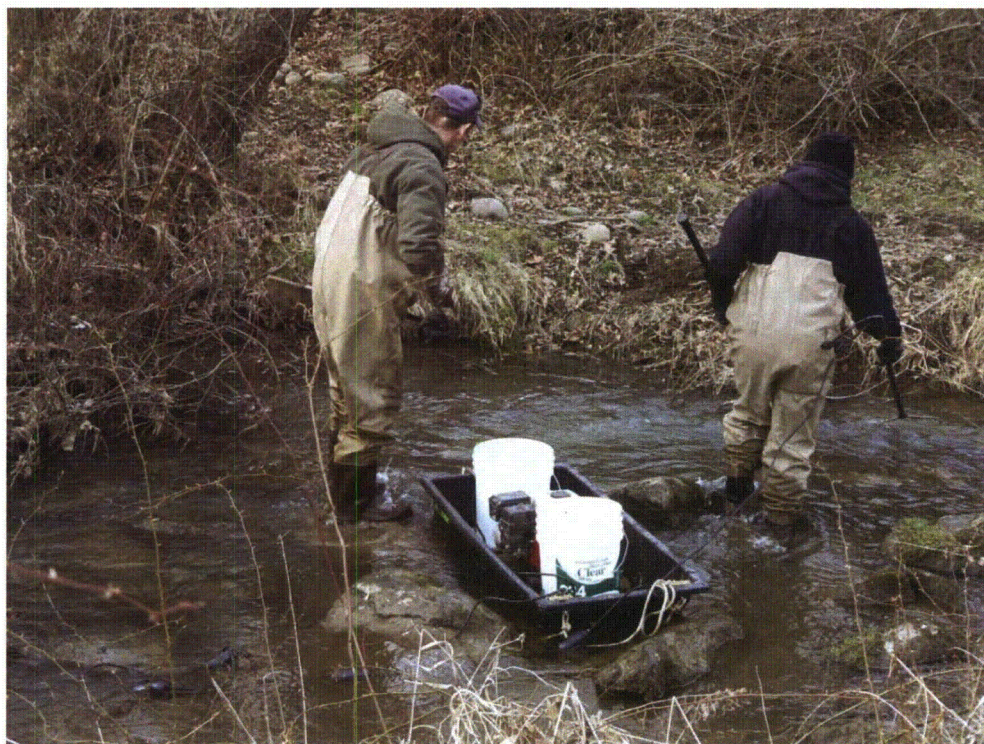
Photo 31. Equipment used to electroshock at Reach 6.

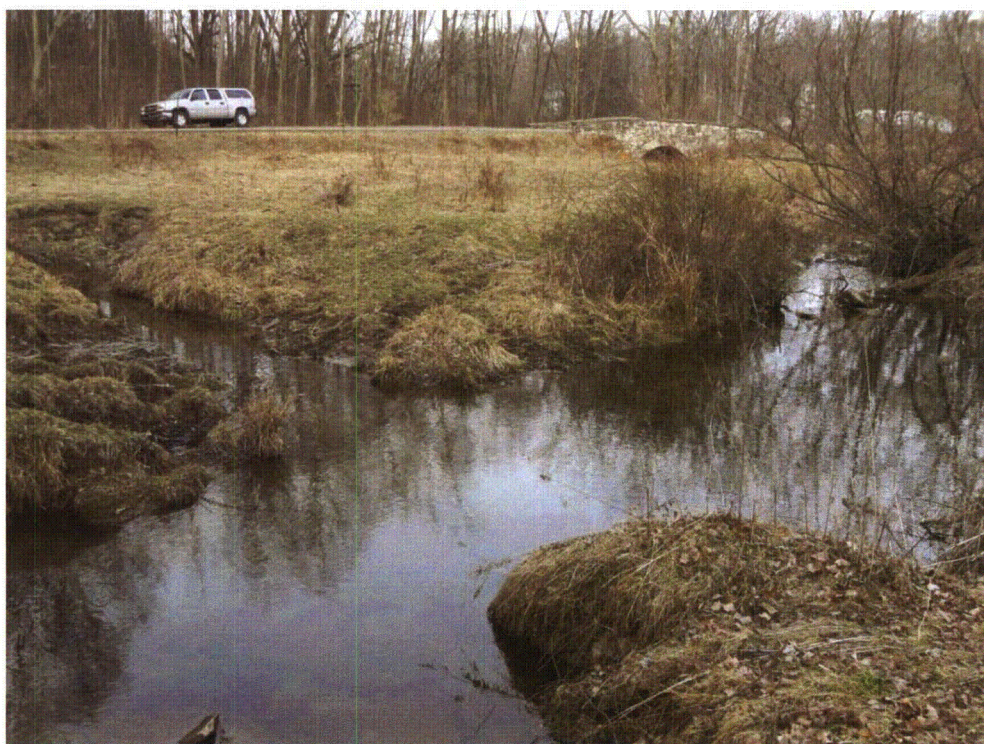
Photo 32. Overview of Reach 6.

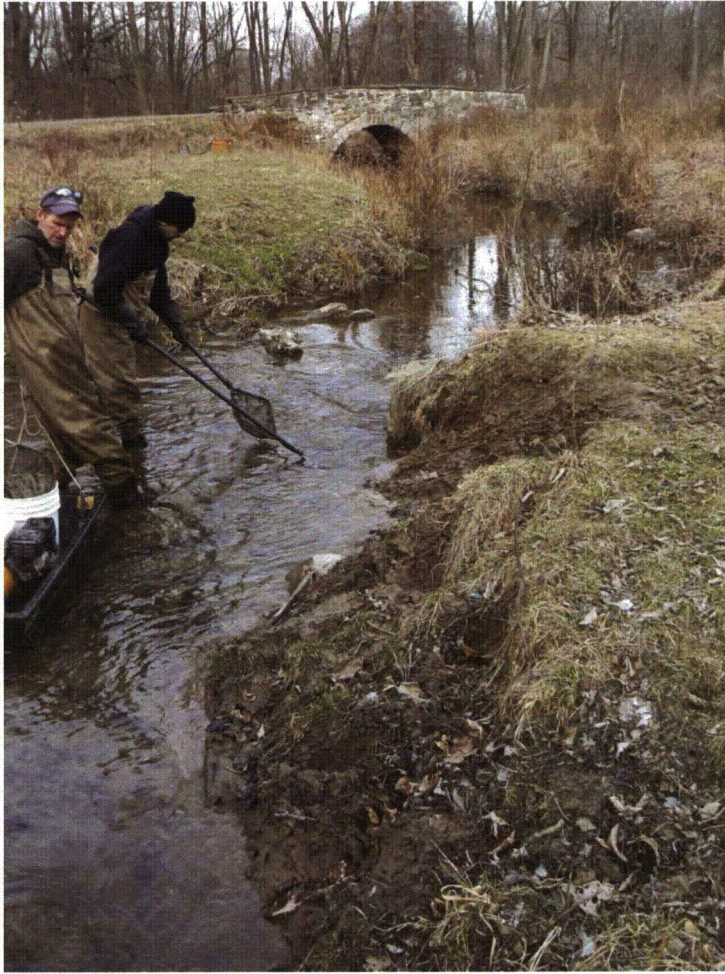
Photo 33. View of Walker Run, Reach 6.

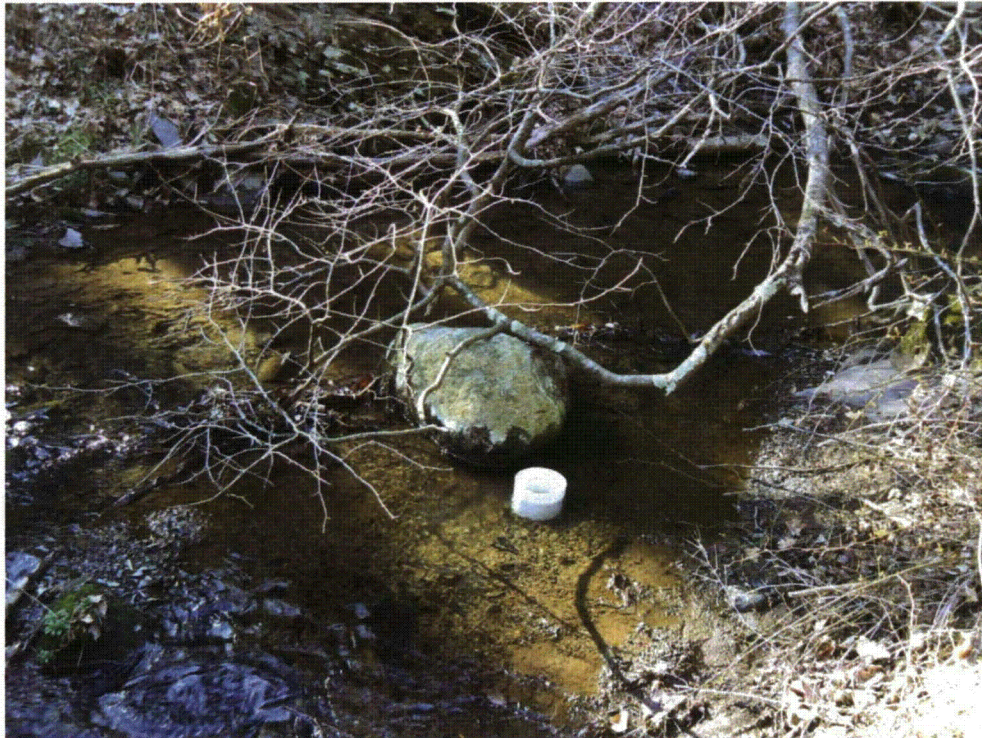
Photo 2. Overview of stream substrate in Reach 1 for trout spawning.

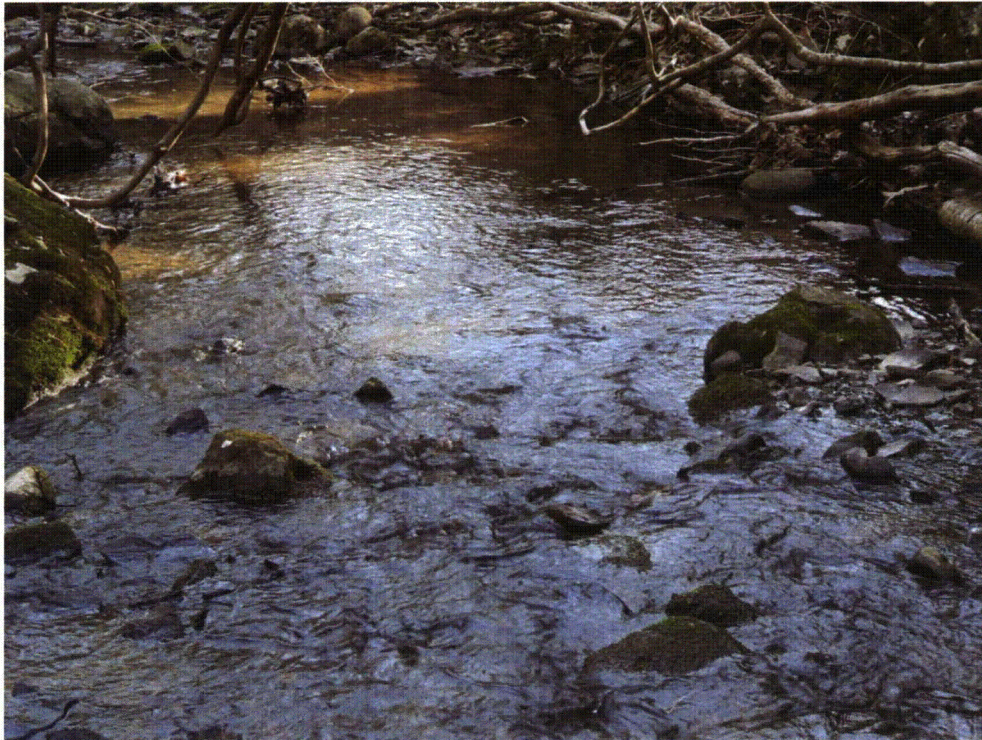
Photo 5. Reach 1 looking downstream.

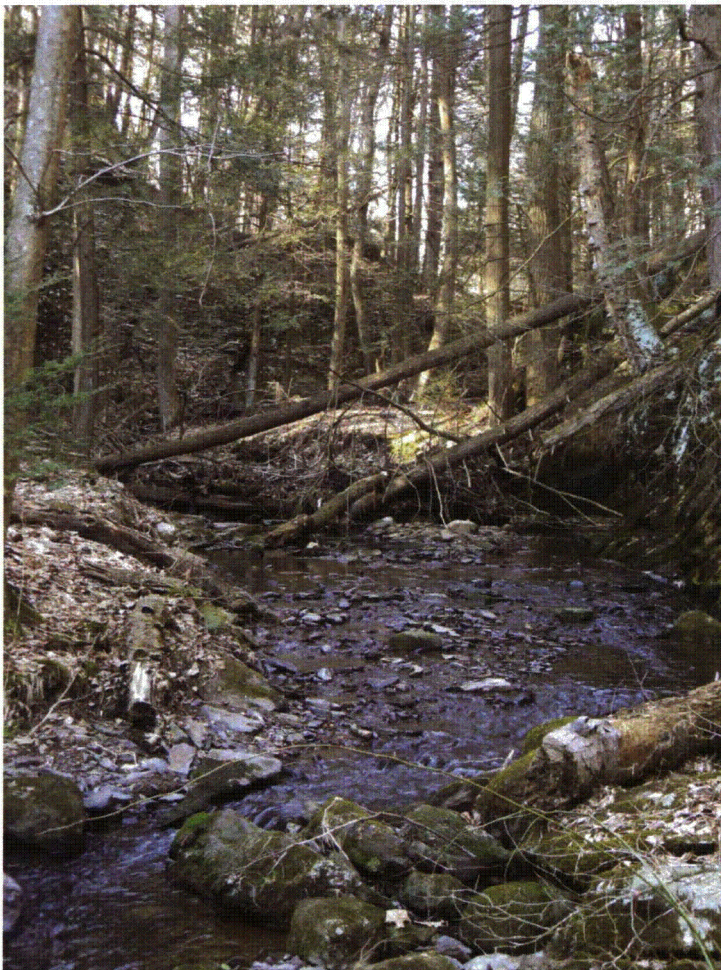
Photo 6. Reach one looking upstream.

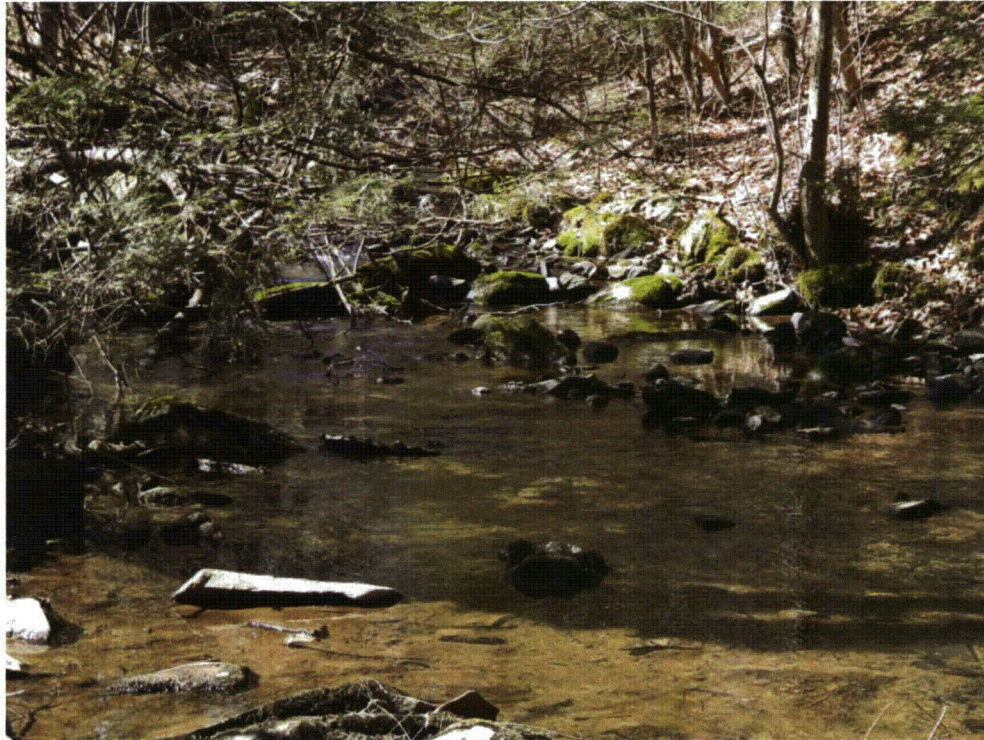
Photo 9. Walker Run, Reach 2.

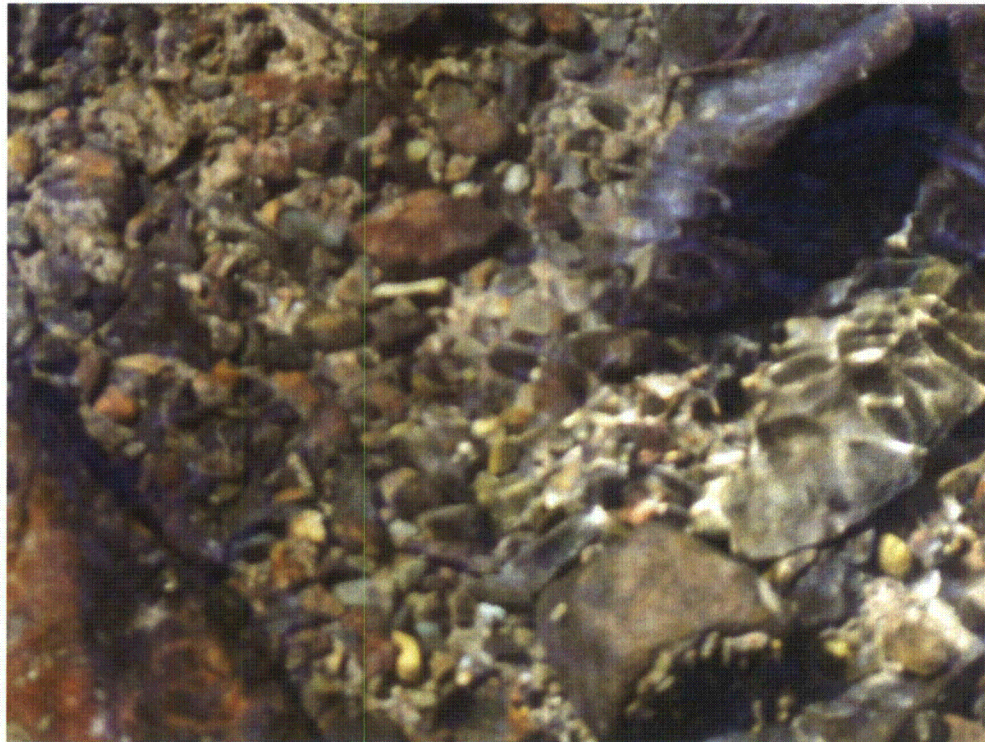
Photo 11. Close-up of substrate at Reach 2.

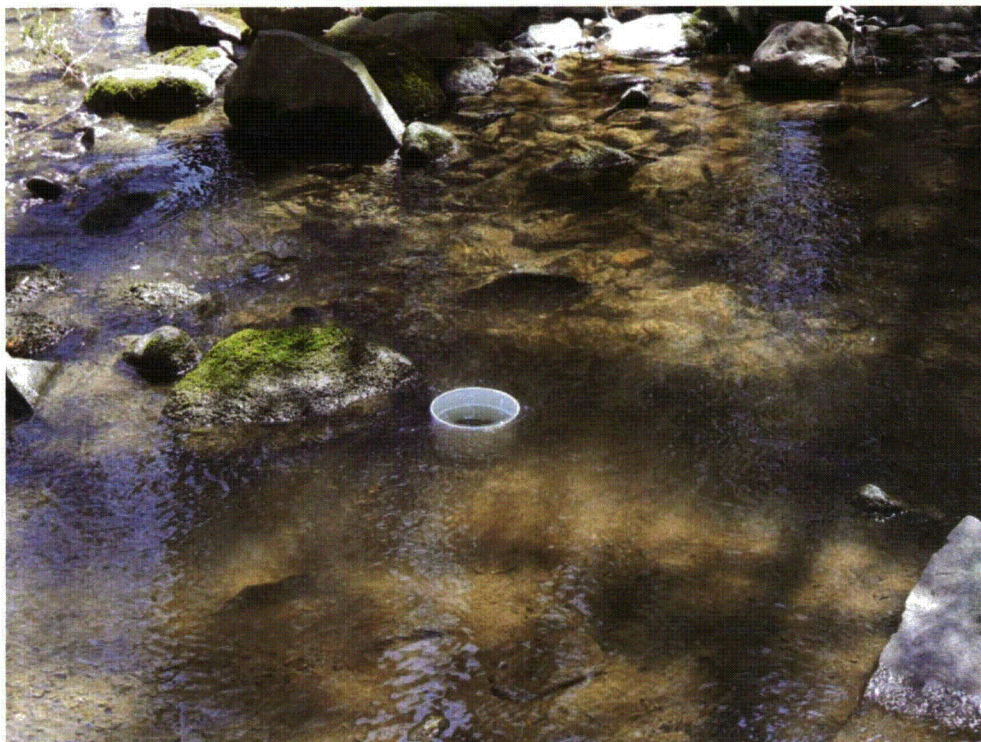
Photo 13. Substrate in Reach 3.

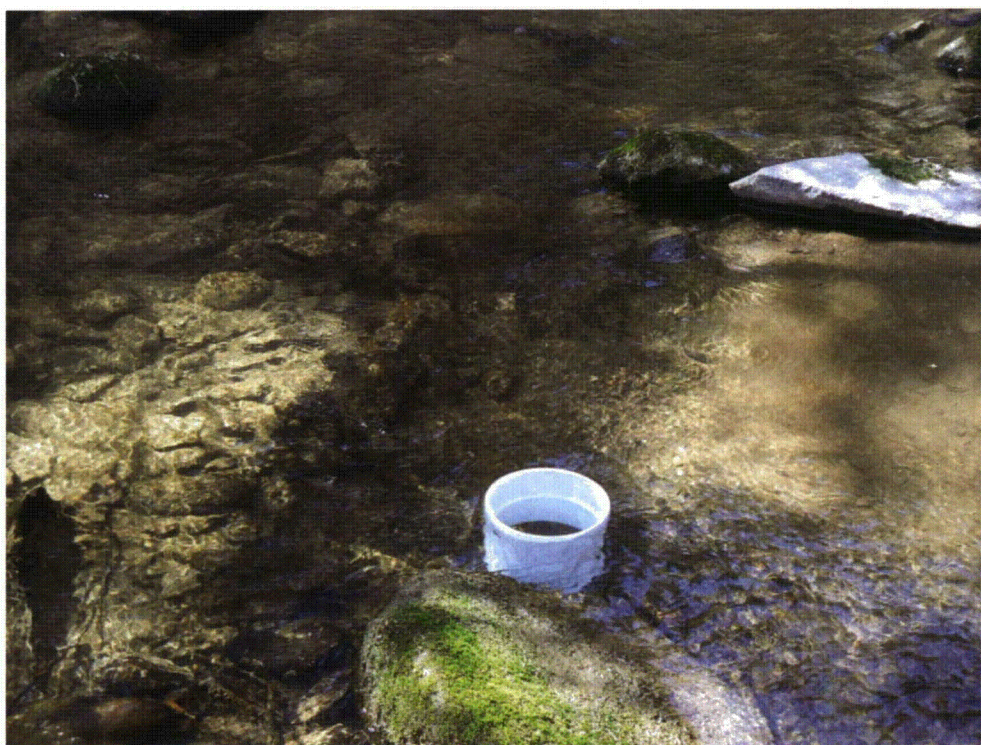
Photo 14. Gravel and cobble in stream at Reach 2.

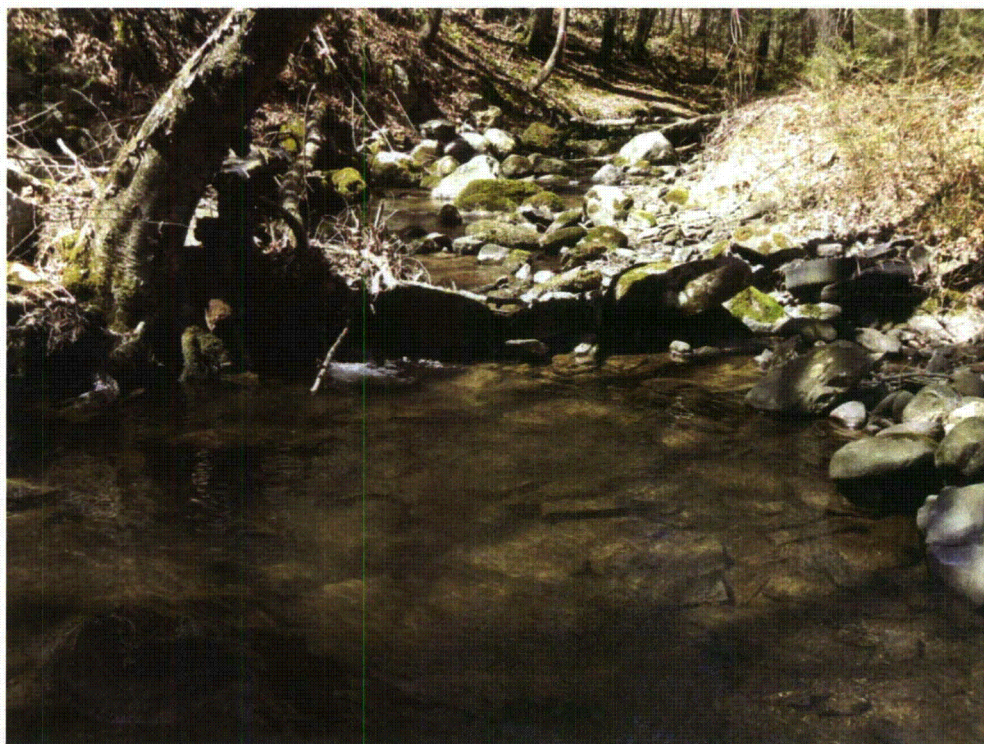
Photo 15. Substrate at Reach 3.

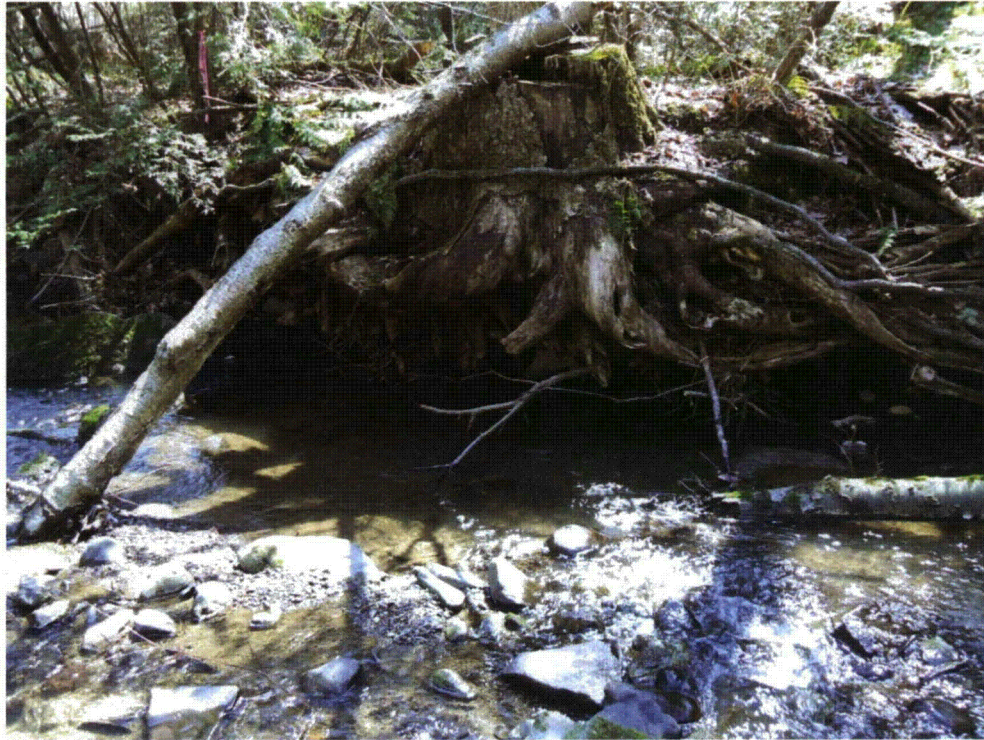
Photo 17. Substrate and habitat at Reach 3.

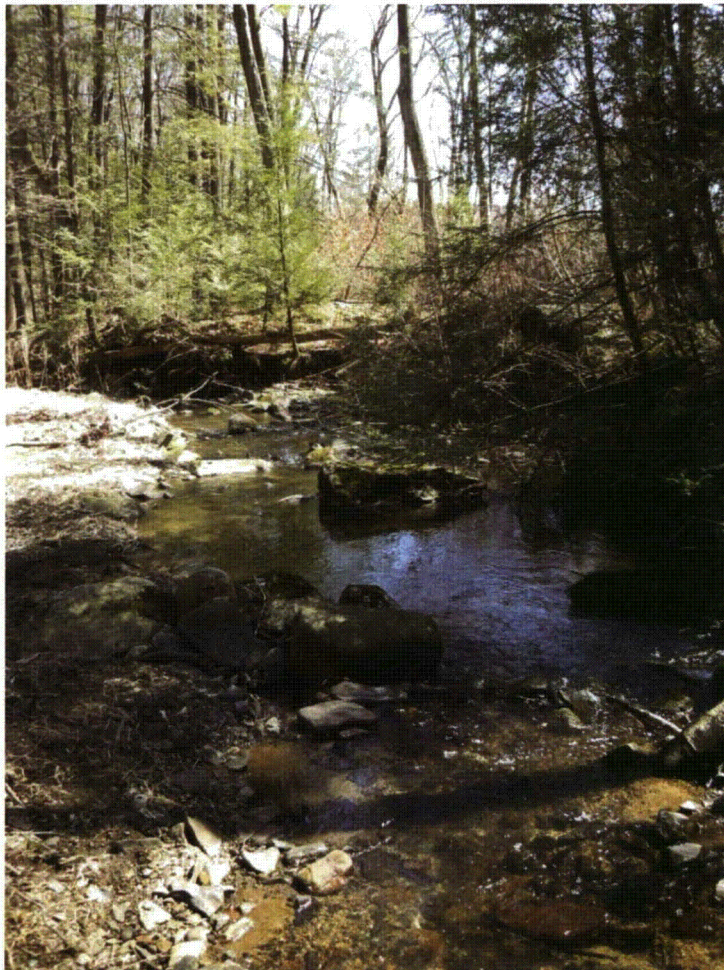
Photo 18. Walker Run, Reach 3.

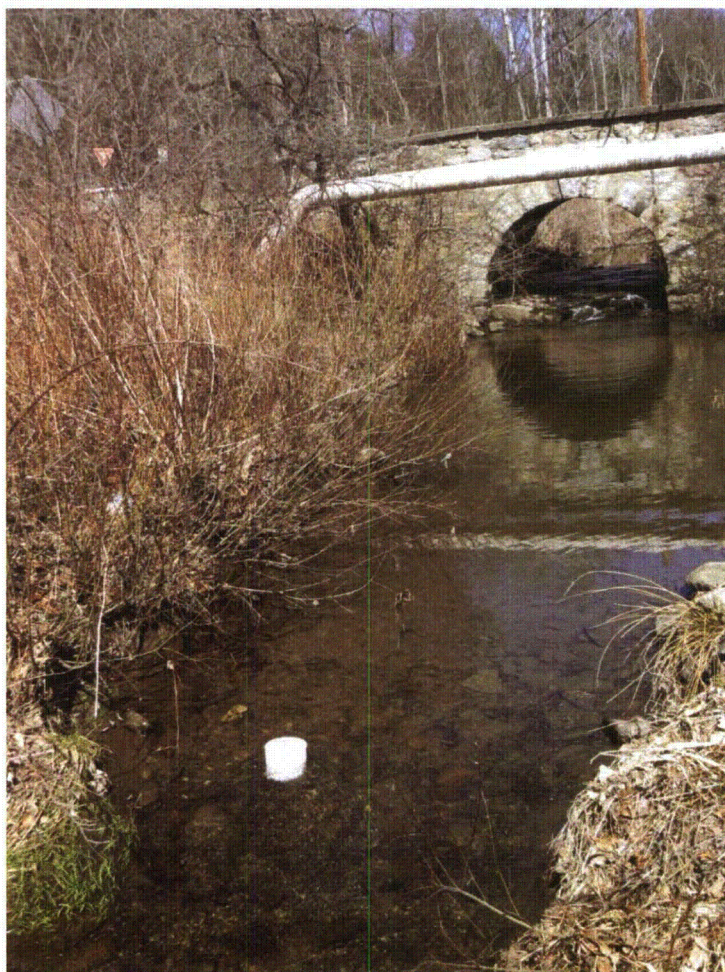
Photo 20. Overview of Reach 4.
