APPENDIX A

Stream and Sampling Photographs During the Fisheries Survey

APPENDIX B

Stream Photos
During the Habitat Assessment Survey

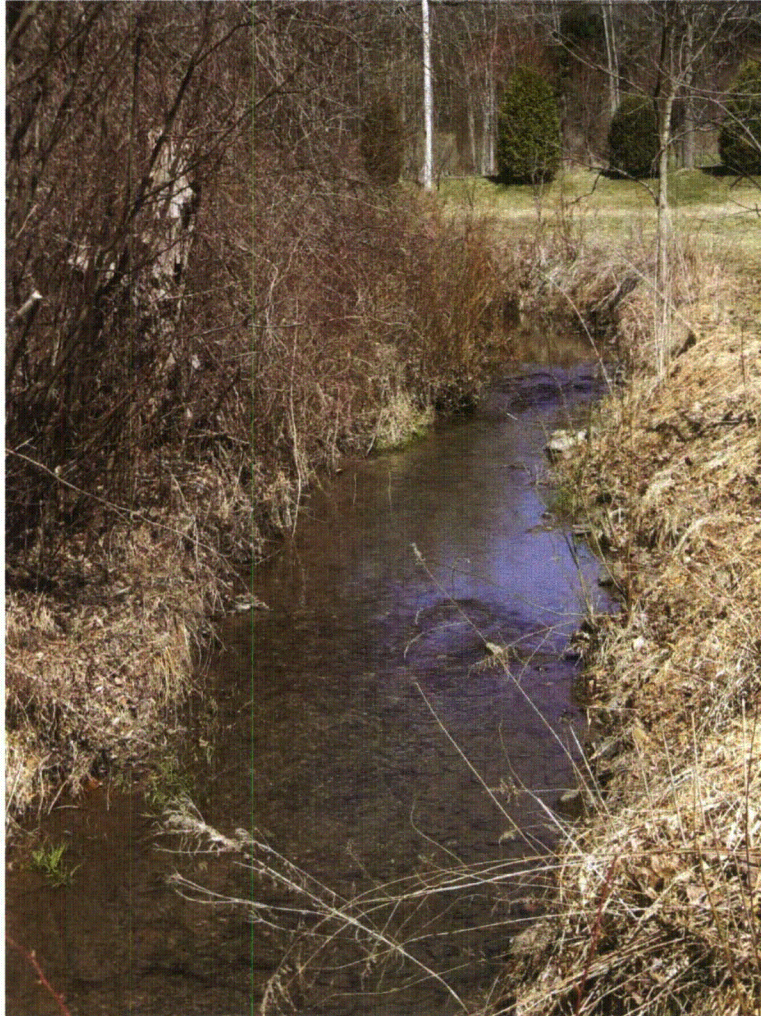
Photo 23. Walker Run, Reach 4.

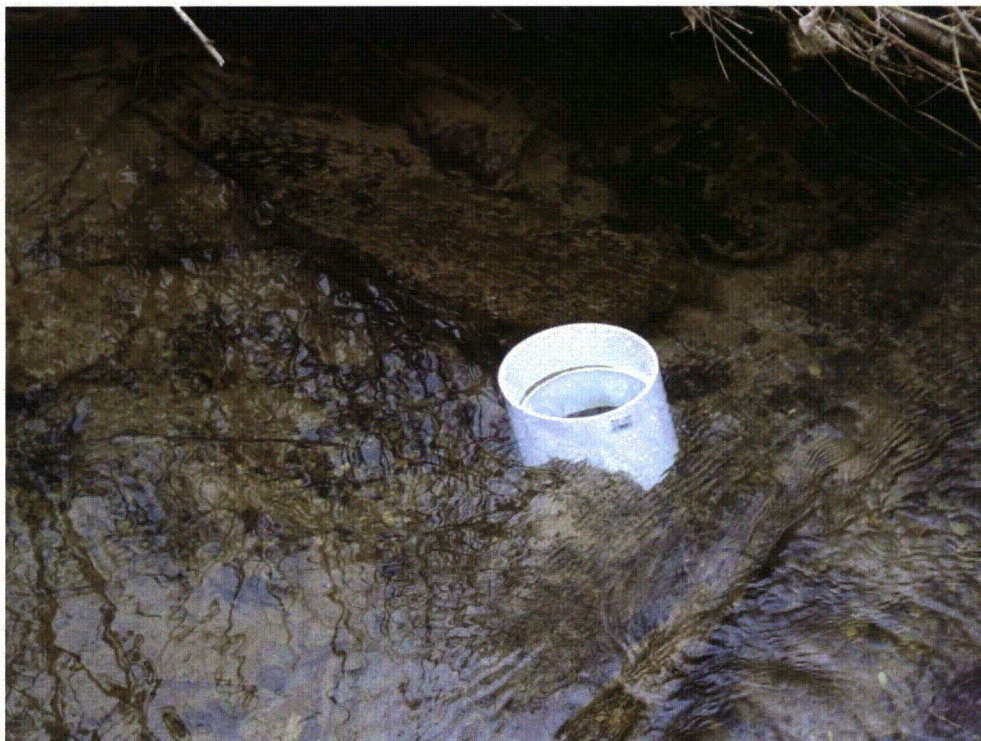
Photo 24. Substrate in Reach 5.

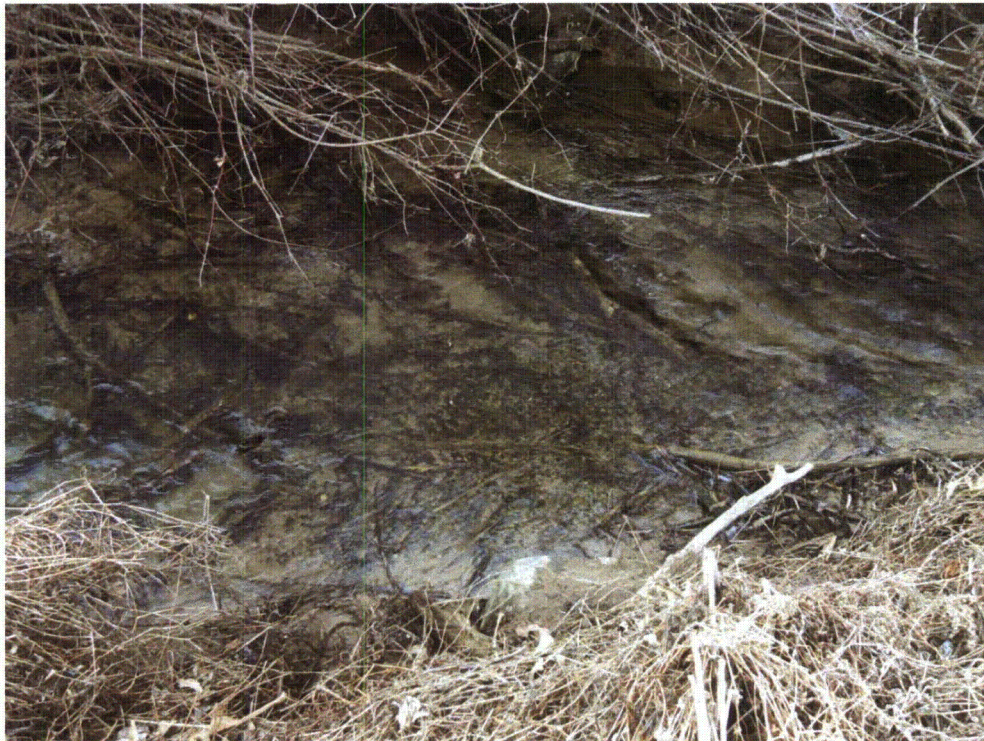
Photo 26. Substrate at Reach 5.

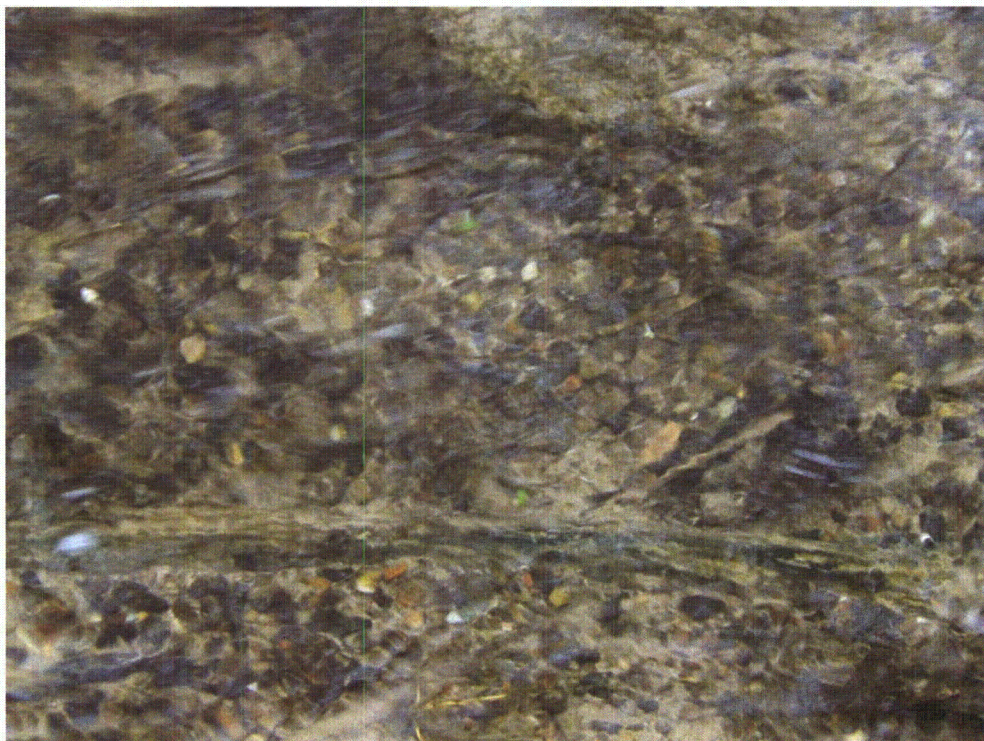
Photo 27. Substrate at Reach 5.

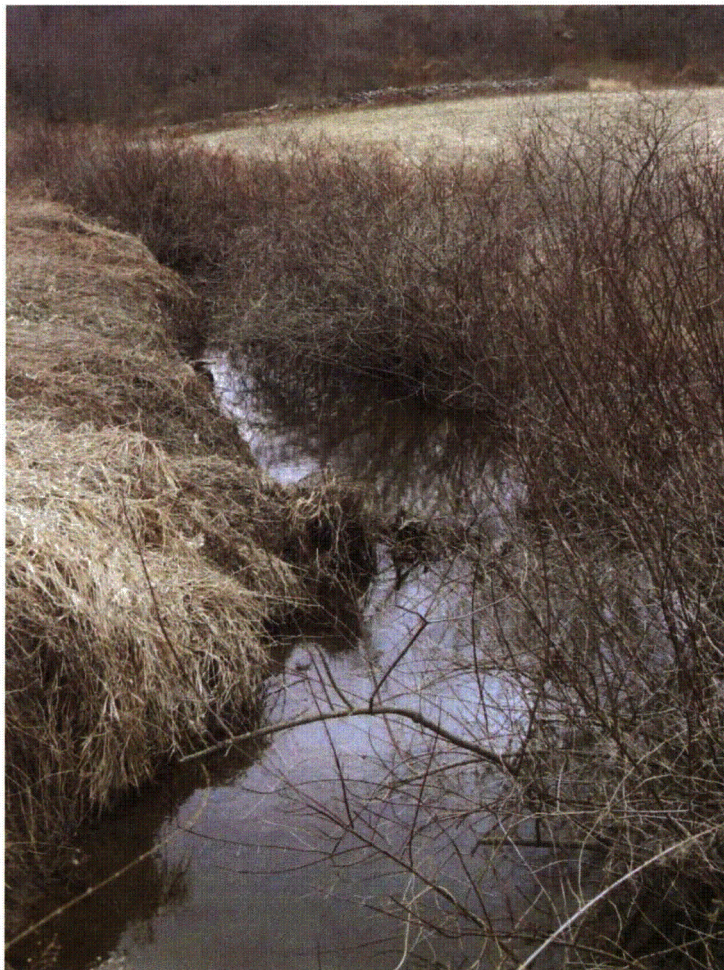
Photo 29. Overview of Walker Run, Reach 5.

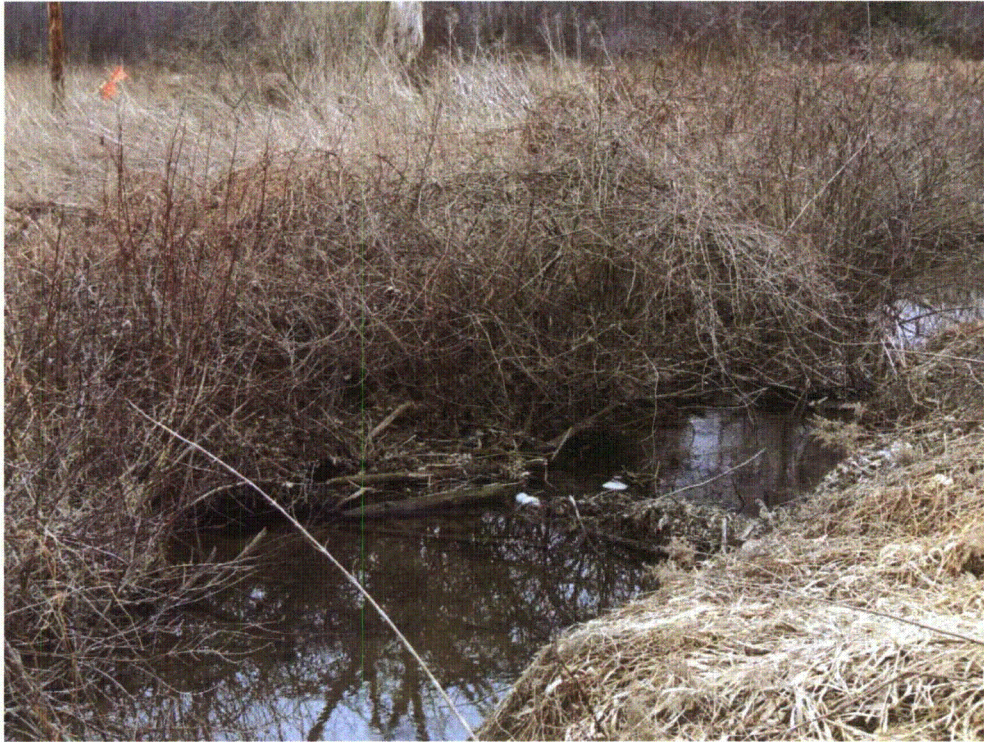
Photo 30. Walker Run, Reach 5 vegetation.

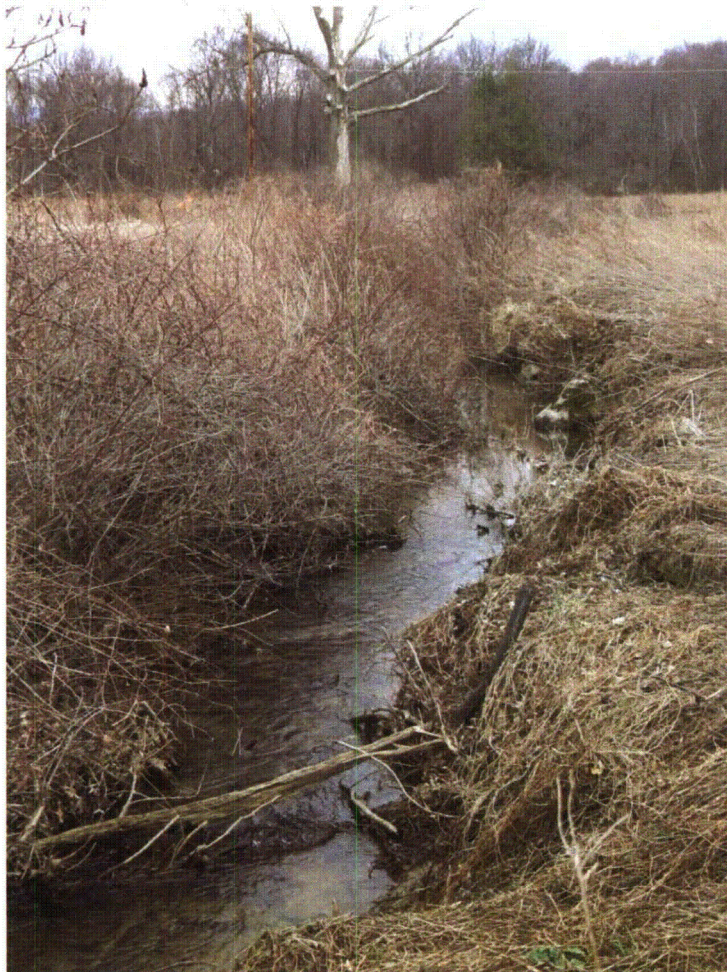
Photo 31. Overview of Walker Run, Reach 5.

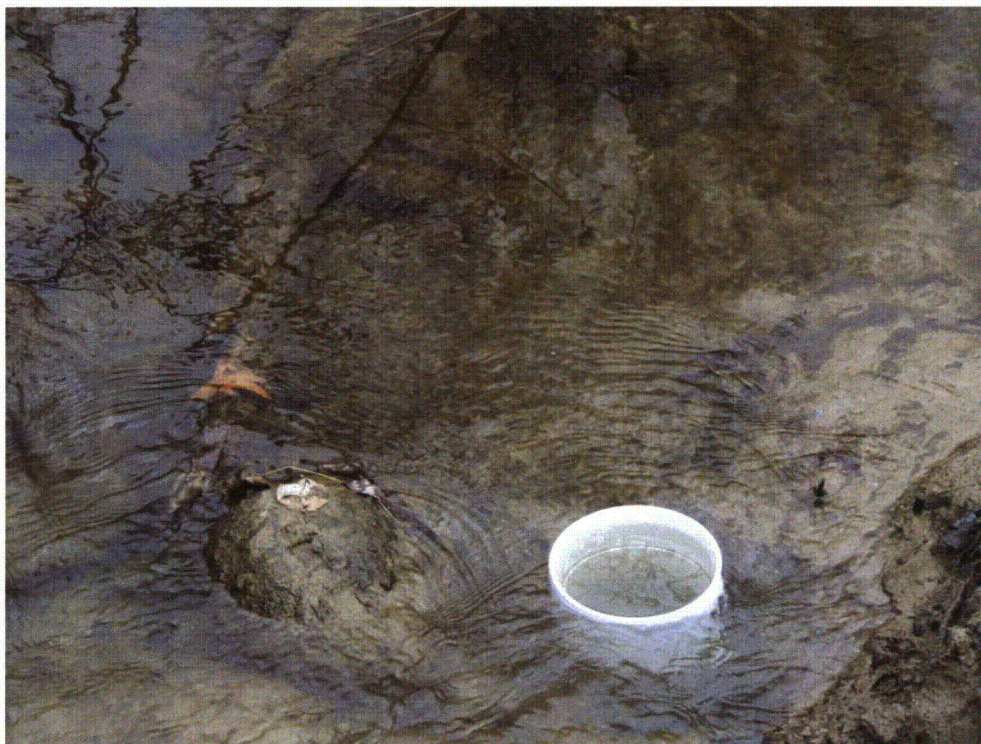
Photo 32. Substrate in Reach 6.

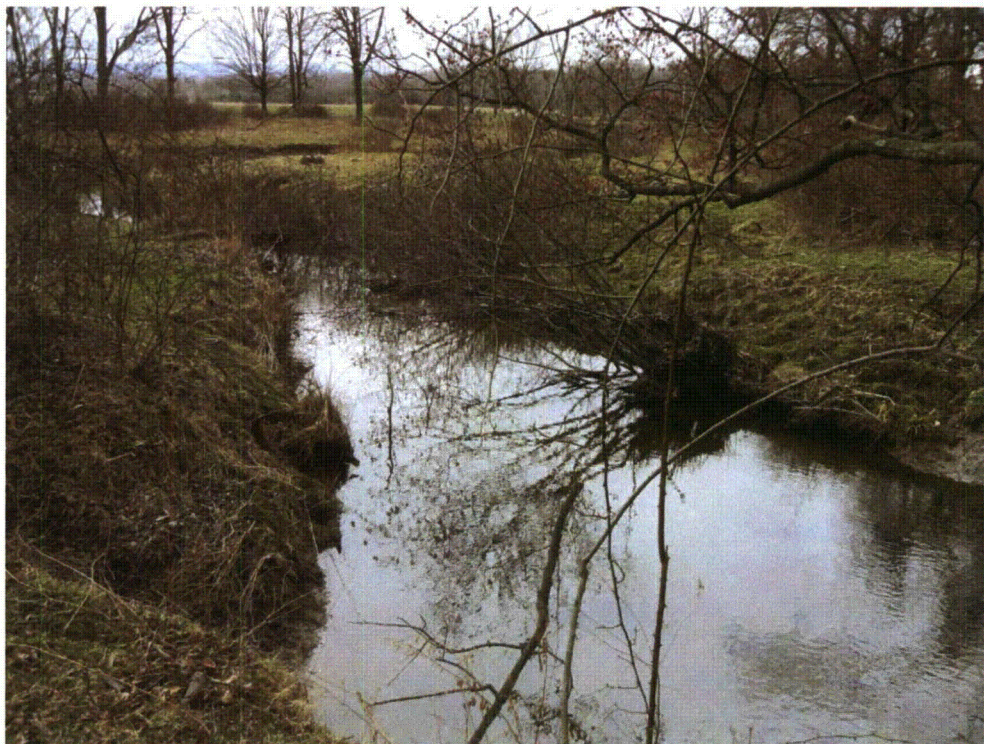
Photo 34. Reach 6 looking downstream.

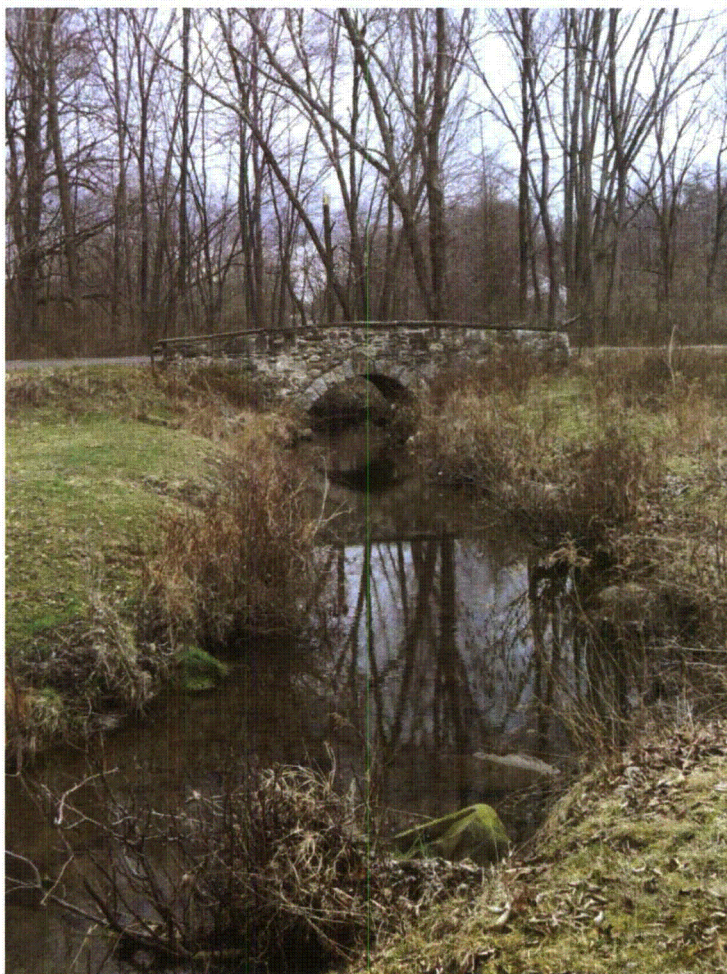
Photo 35. Reach 6 looking upstream towards road crossing.

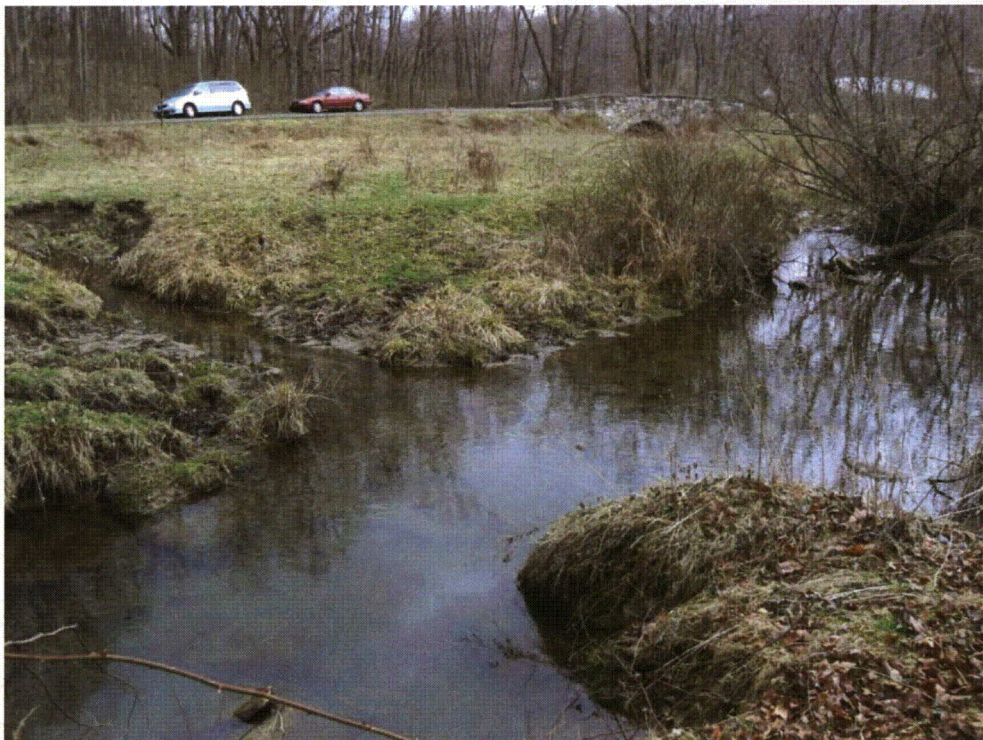
Photo 37. Reach 6 looking upstream towards road crossing.
