ATTACHMENT 9.6

SEISMIC WALKDOWN CHECKLIST FORM

Status: Y ☒ N ☐ U ☐Seismic Walkdown Checklist (SWC) SWEL2-008Equipment ID No. 19P-1A Equip. Class 5. Horizontal pumpsEquipment Description: Fuel pool cooling recirc pump ALocation: Bldg. RB Floor El. 326 Room, Area Col 3 line T

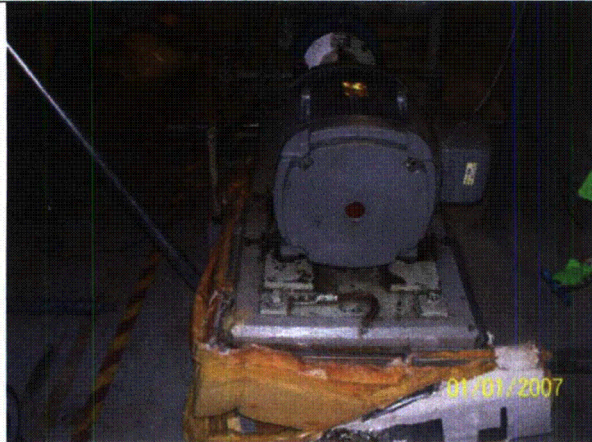
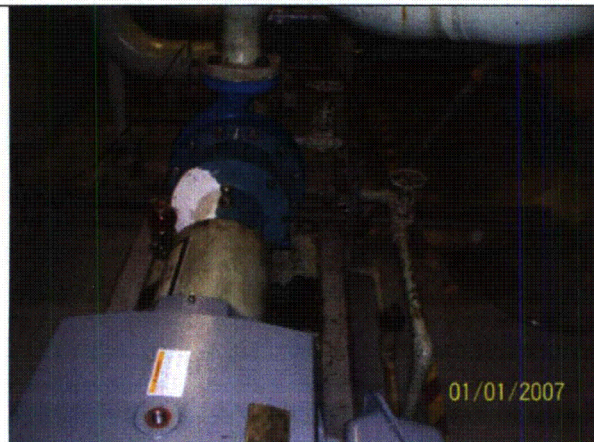
Note: 19P-1A (The date provided on the bottom right corner is not correct the date that the picture was taken. Malfunction with camera setting)

1. Is the anchorage configuration verification required (i.e., is the item one of the 50% of SWEL items requiring such verification)? Y ☒ N ☐
2. Is the anchorage free of bent, broken, missing or loose hardware? Y ☒ N ☐ U ☐ N/A ☐
The anchorage is free of bent, broken, missing or loose hardware.
3. Is the anchorage free of corrosion that is more than mild surface oxidation? Y ☒ N ☐ U ☐ N/A ☐
Mild corrosion where paint is chipped
4. Is the anchorage free of visible cracks in the concrete near the anchors? Y ☐ N ☒ U ☐ N/A ☐
*Single hairline cracks less than 1/16" in foundation near each bolt.
These cracks are judged to have no adverse seismic impact on 19P-1A*

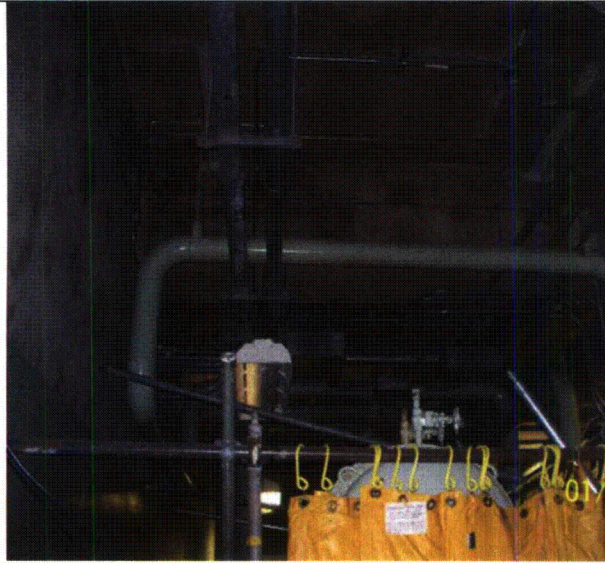
Note: 19E-1A with lead shielding around it.
(The date provided on the bottom right corner
is not correct the date that the picture was
taken. Malfunction with camera setting)

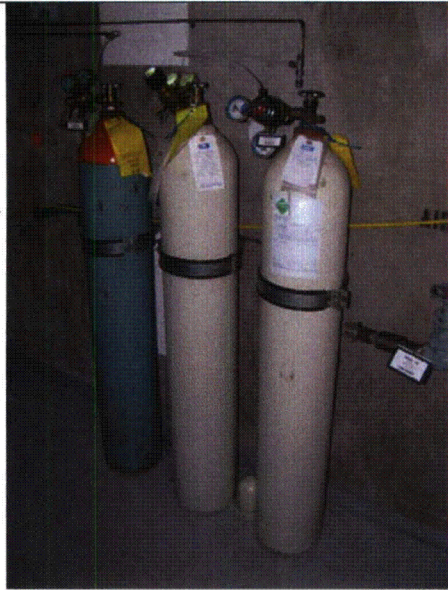
Note: Picture of the compressed gas cylinder tanks.

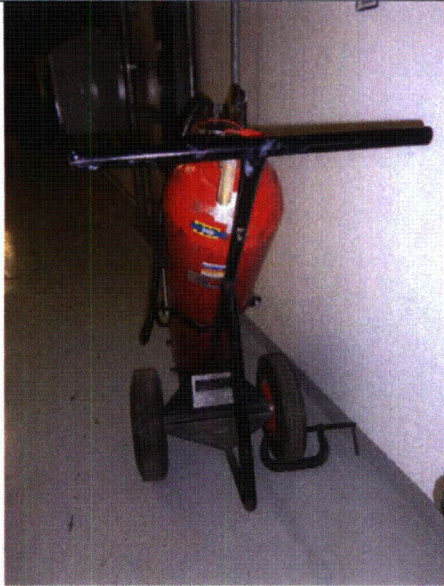
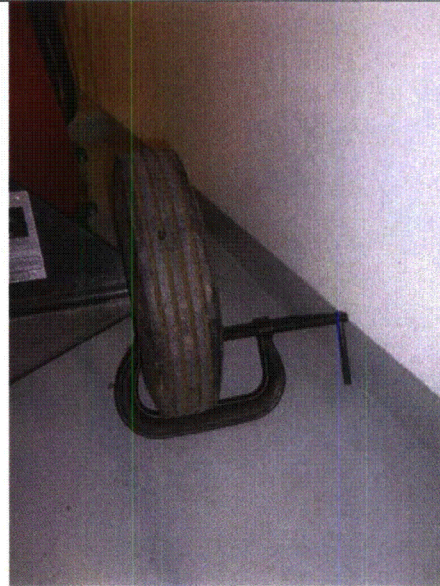
**Note:** CO₂ fire extinguisher 76CX-606

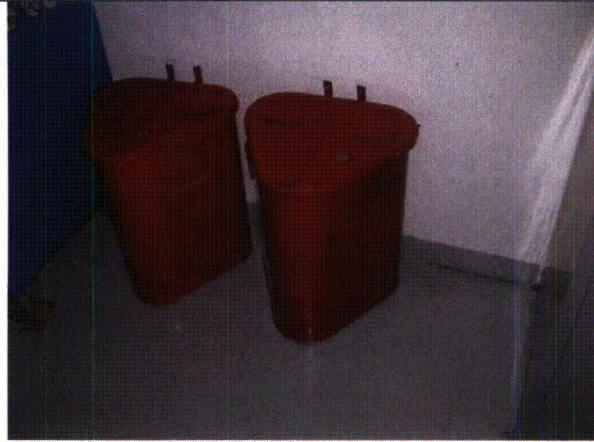
**Note:** *Picture of the clean/dirty rags.*

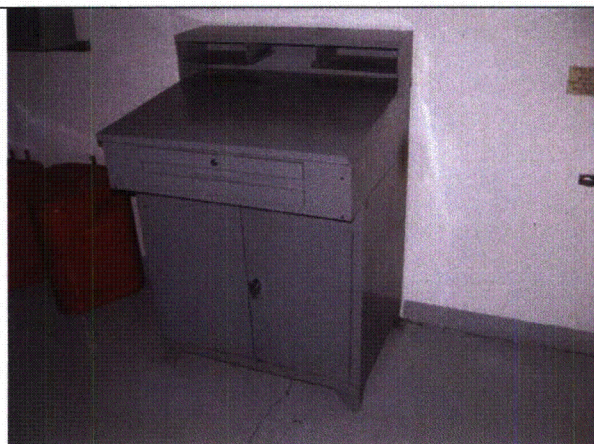
**Note:** *Picture of the work bench.*

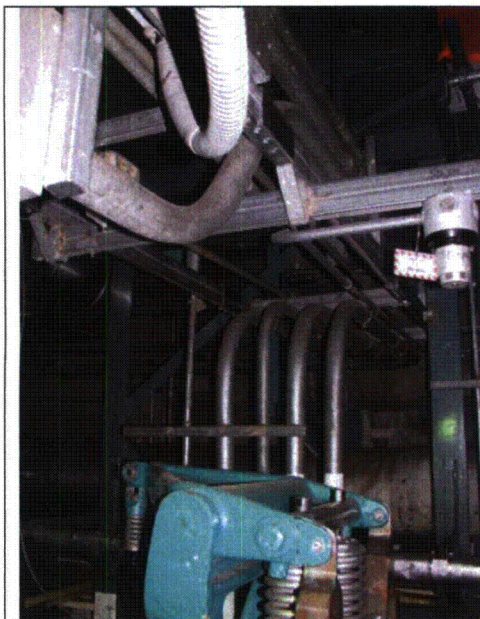
Note: Unistruts providing supporting the conduits and Junction box.

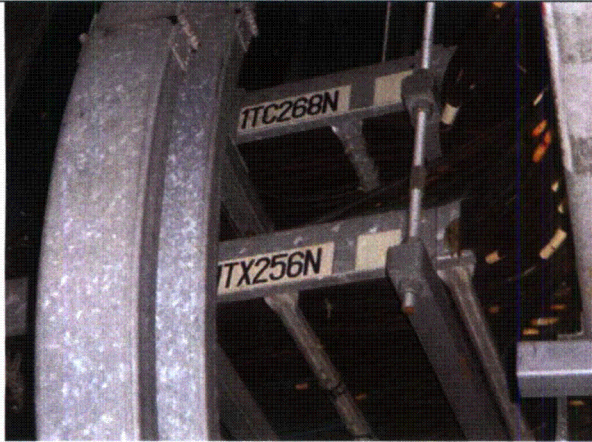
**Note:** Cable trays

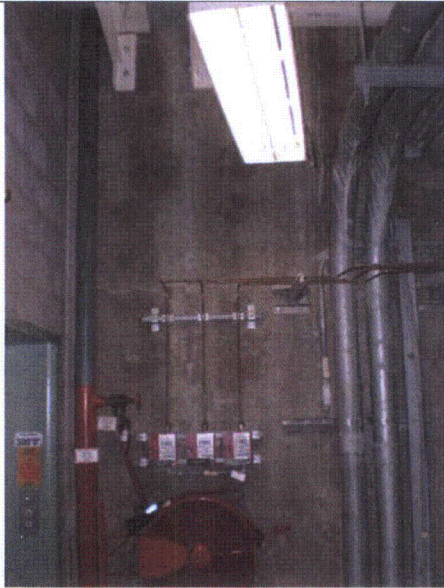
**Note:** *light fixture and copper tubing.***Note:**
