Attachment G

PEER Review Checklist for SWEL

Peer Review Checklist for SWEL

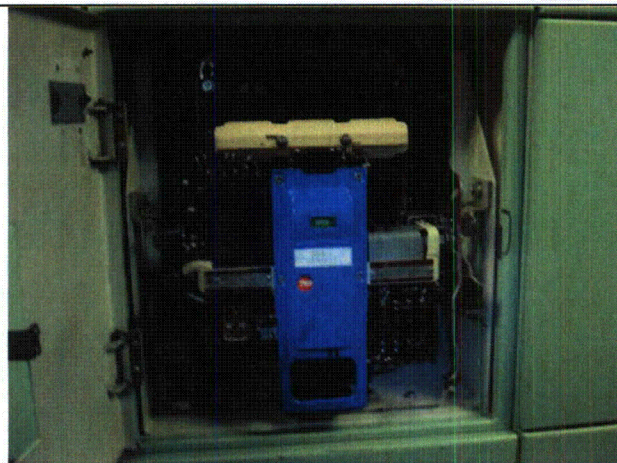
Note: View inside front of breaker cubicle.

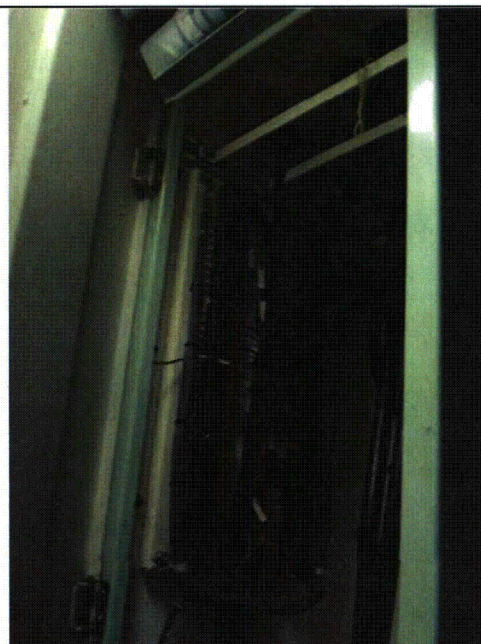
Note: View in rear of full cubicle.

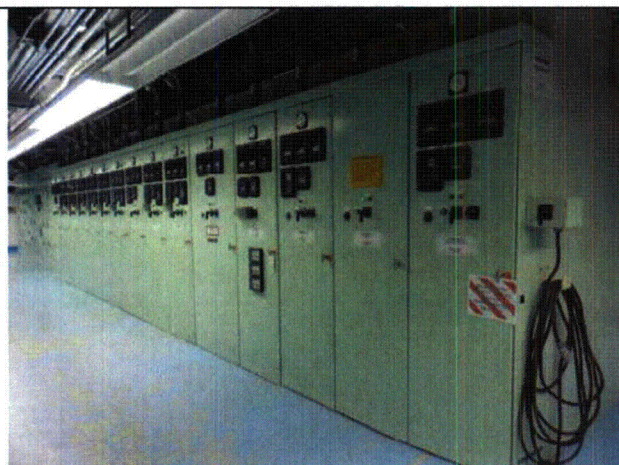
Note: View from front of 4KVESWGR3A panel.

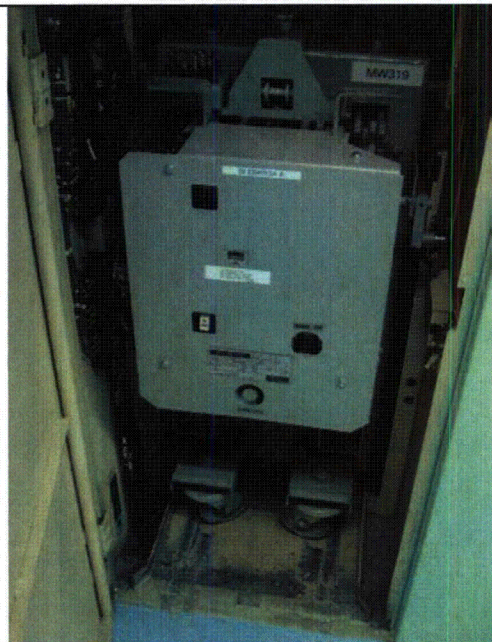
Note: View inside SI EBKR3A 4 cubicle.
Typical of most of the other breaker cubicles.

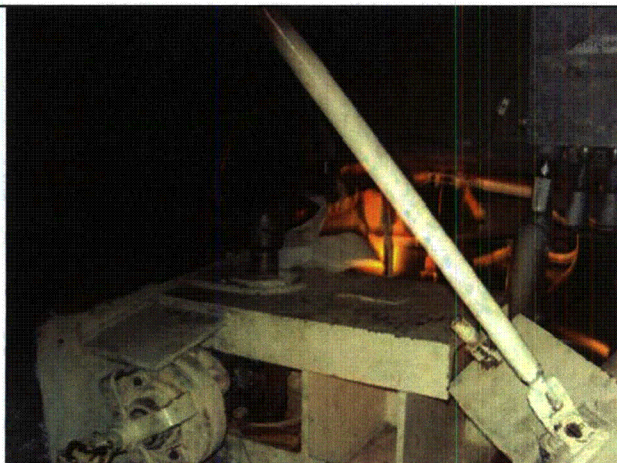
Note: Support strut for CVCMVAAA209

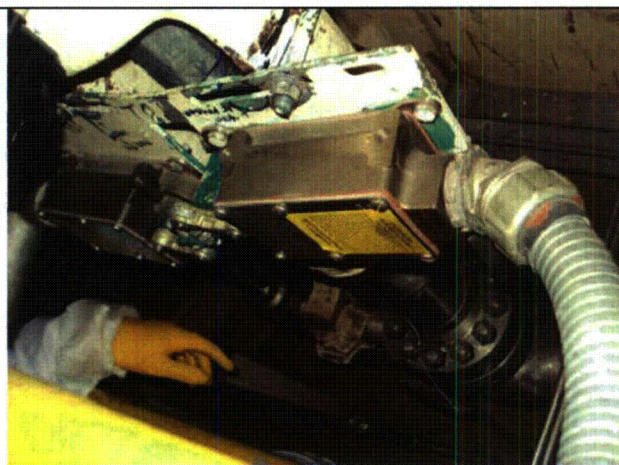
Note: View of limit switch mounting plate on operator.

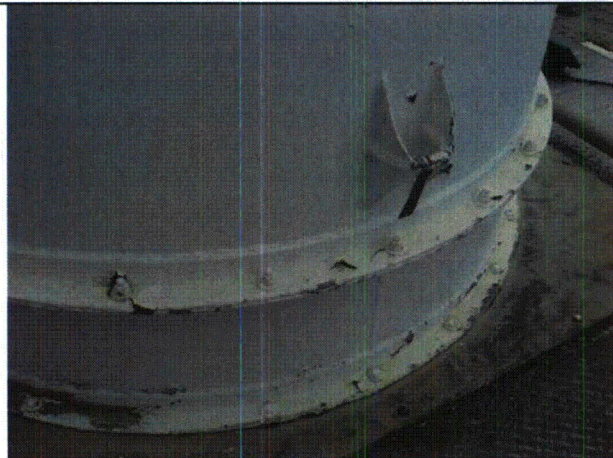
Note: View showing bolts used to mount shroud and fans.

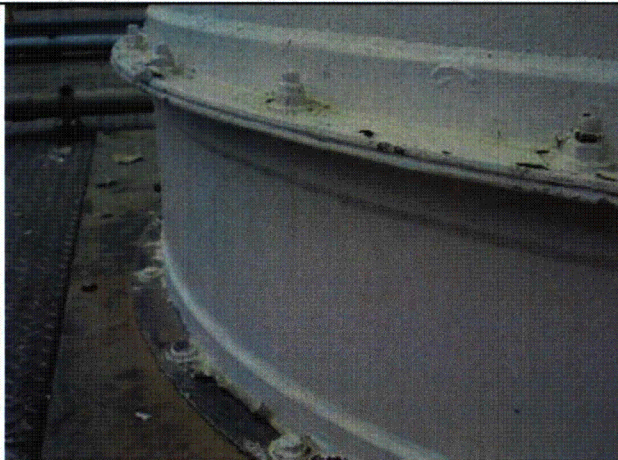
Note: View showing bolts used to mount fan and shroud.

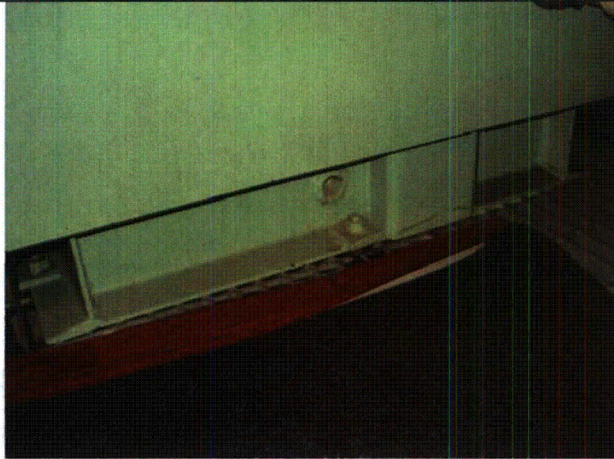
Note: View of right end of panel showing structural bolt. Fabric material is FME material placed over floor grating during the outage. The red tape is used to hold down the material. This is removed during plant operation.

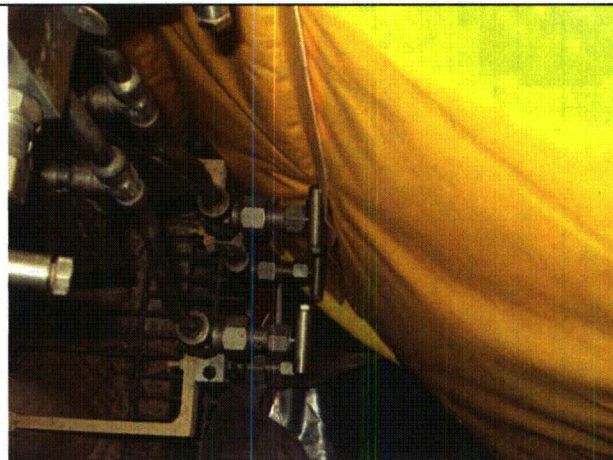
Note: "Smitty Shield" up against instruments on lower part of stand. CR-WF3-2012-07217 was written for the lead shielding up against the instrument.

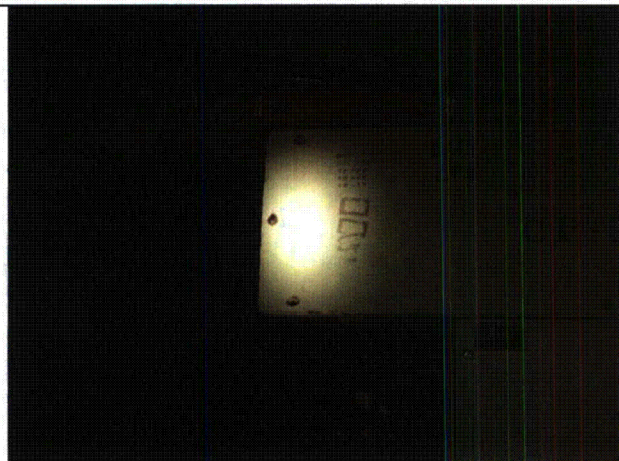
- *A sheet metal cover plate in the upper part of the panel was found with only 3 of 5 screws installed.*
- *Sections of plastic wire tray covers were found loose on the bottom part of the panel.*
- *CR-WF3-2012-06688 was written for these two findings.*

Note: Sheet metal cover plate with 3 of 5 screws installed.

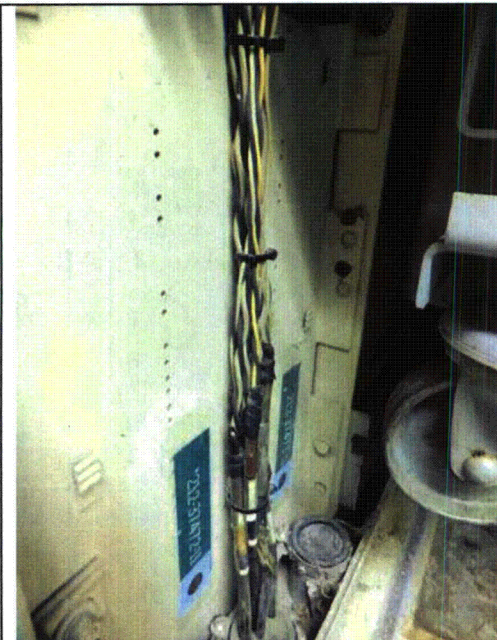
Note: Locations where grommets and cables could be installed.

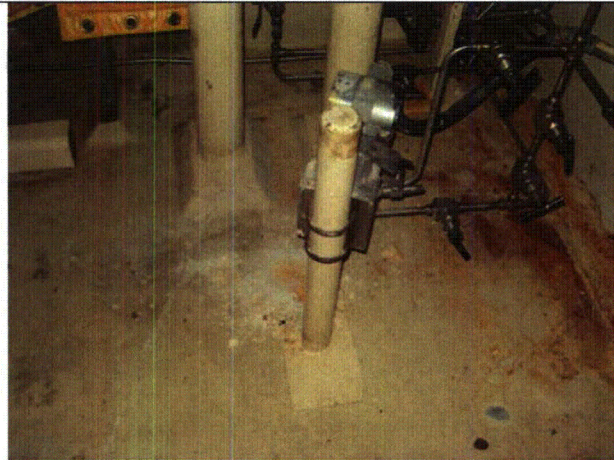
Note: Some boric acid crystals seen on floor in area. Instrument in picture is BM IPT0601 IXMITR. See CR-WF3-2012-07125.

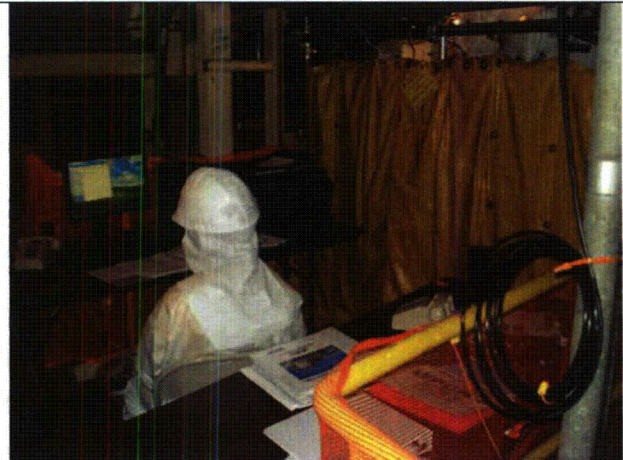
Note: View of work station (plus lead shielding) in area.

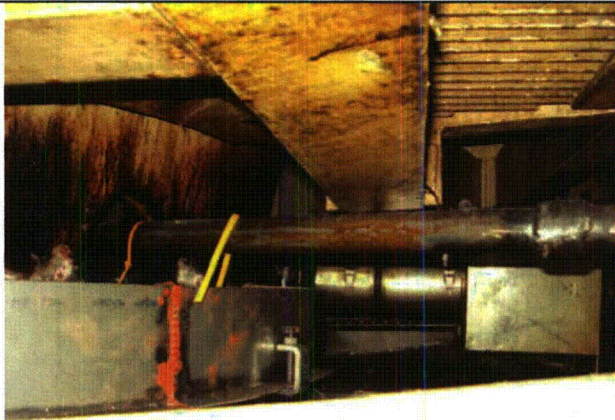
Note: Line 3CC1 1/2-59-B2. No corrosion was found on this line.
