**Seismic Walkdown Checklist (SWC)**

Equipment ID No.   2SIS-MOV867A

Equipment Description   HHSI Isol to Cold Leg Injection

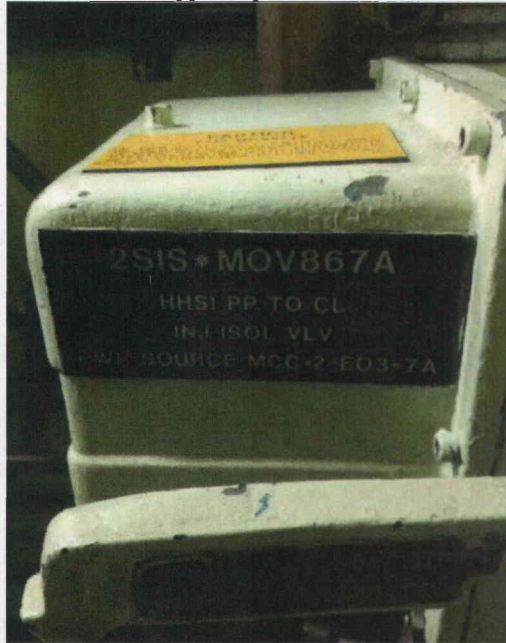
File Name: 2-61-1-2-01.jpeg

Description: Component Plate ID

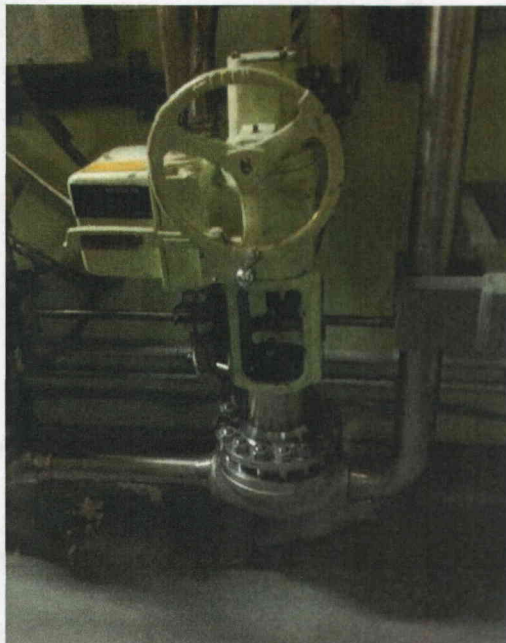
File Name: 2-62-1-2-01.jpeg

*Valve found in very good condition.*

Description: General View of Component

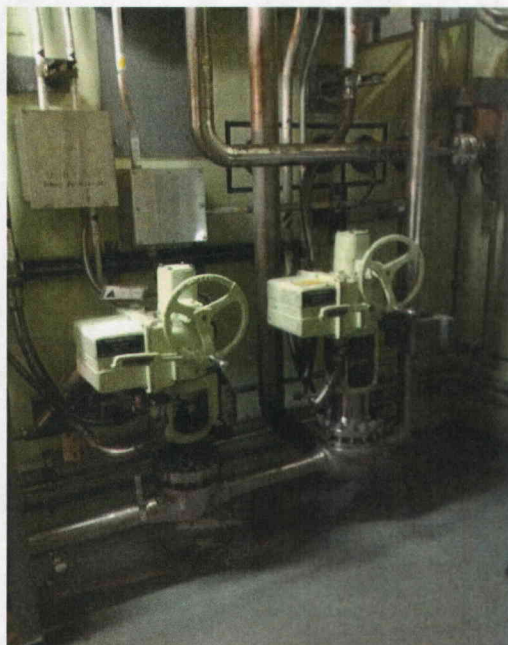
File Name: 2-63-1-2-01.jpeg

Description: General View of Component Area

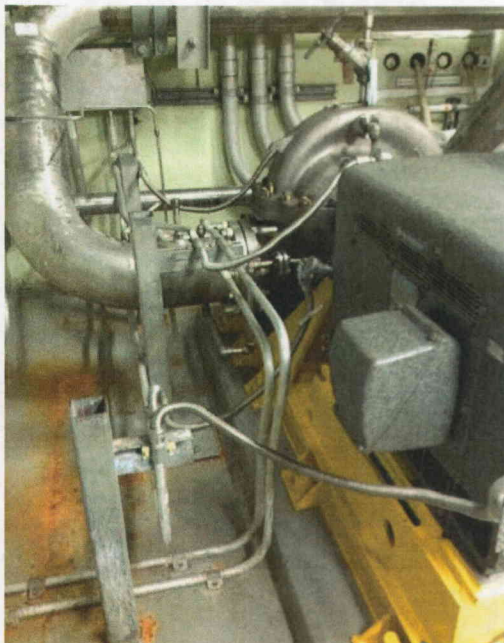
File Name: 2-64-5-2-23.jpeg  
Description: View of Attached Lines

*Attached lines found with adequate flexibility.*

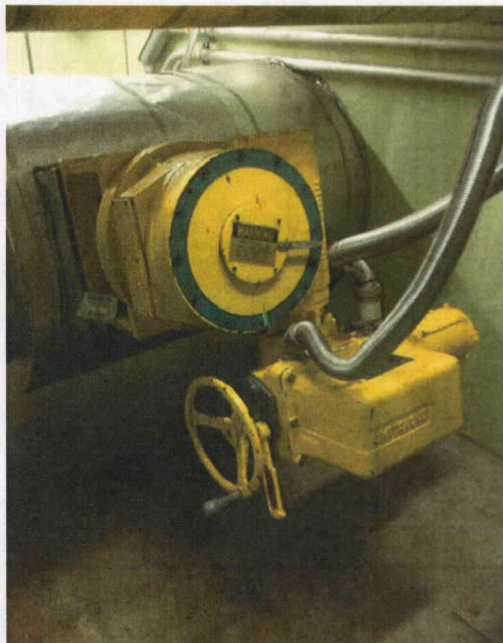
File Name: 2SWS-MOV106A(2).jpg  
Description: General View of Component

*Both packing nuts observed to have moderate corrosion. CR-2012-14409 written to document this condition.*

11. Have you looked for and found no other seismic conditions that could adversely affect the safety functions of the equipment?  
*Deficiency tagged as "packing leak" (Notification no. 600716354).*

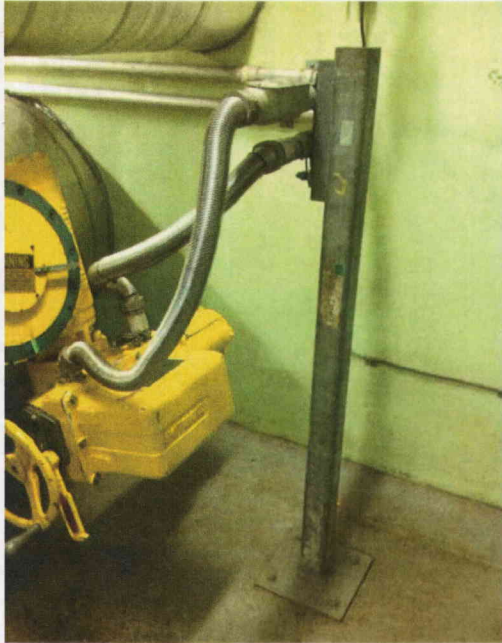
File Name: 2SWS-MOV106A(3).jpg  
Description: View of Attached Lines

9. Do attached lines have adequate flexibility to avoid damage?  
*Attached lines have adequate flexibility.*

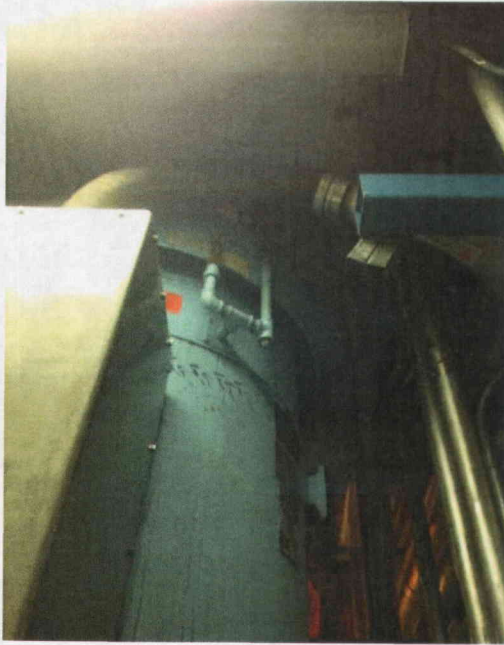
File Name: 2SWS-P21A(5).jpg

Description: View of Attached Line

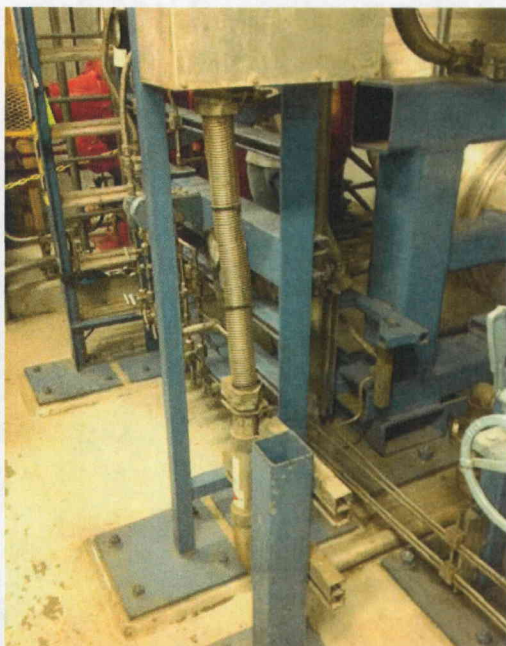
File Name: 2SWS-PT-117A(6).jpg  
Description: General View of Rack

9. Do attached lines have adequate flexibility to avoid damage?  
*Attached top conduit is adequately flexible.*

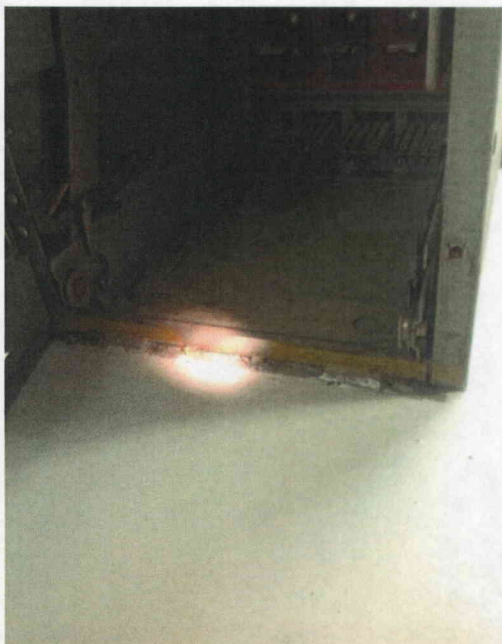
File Name: 2-61-9-2-26.jpeg  
Description: View of Anchor Welds

*Presence of embedded sill channels indicates that the unit is welded to the embed and therefore no missing or broken anchorage is expected.*

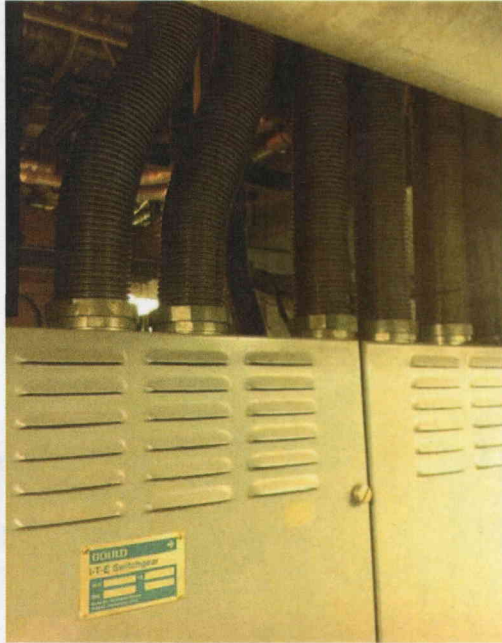
File Name: 480VUS-2-9(3).jpg

Description: View of Flexible Top Conduit

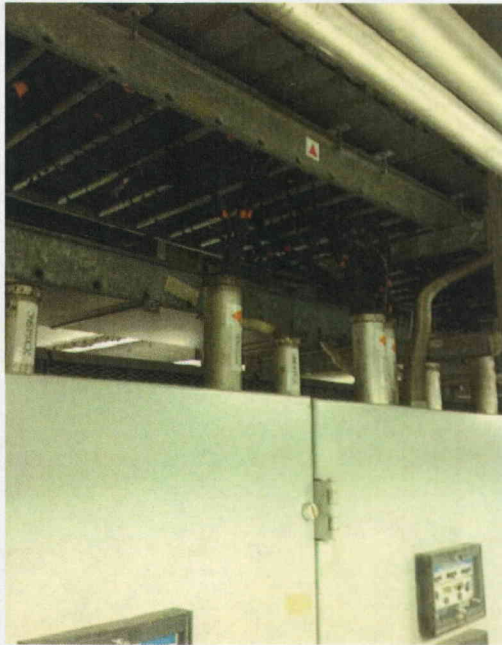
File Name: 4KVS-2AE(3).jpg  
Description: View of Flexible Top Conduit

9. Do attached lines have adequate flexibility to avoid damage?  
*Attached top conduit is adequately flexible.*

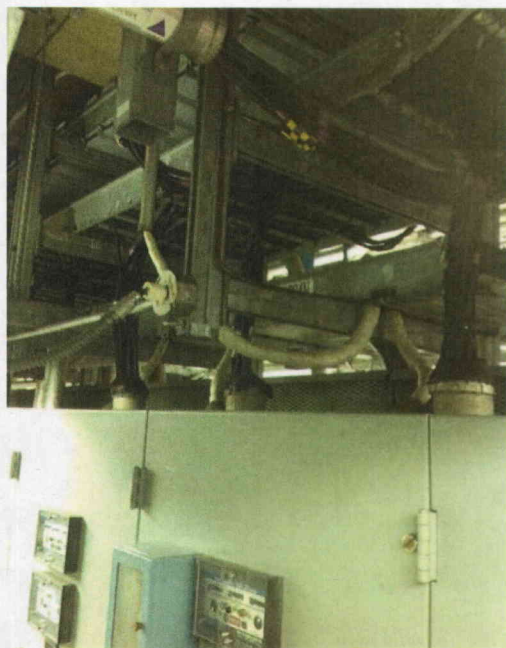
File Name: 4KVS-2-DF(3).jpg

Description: View of Flexible Top Conduit

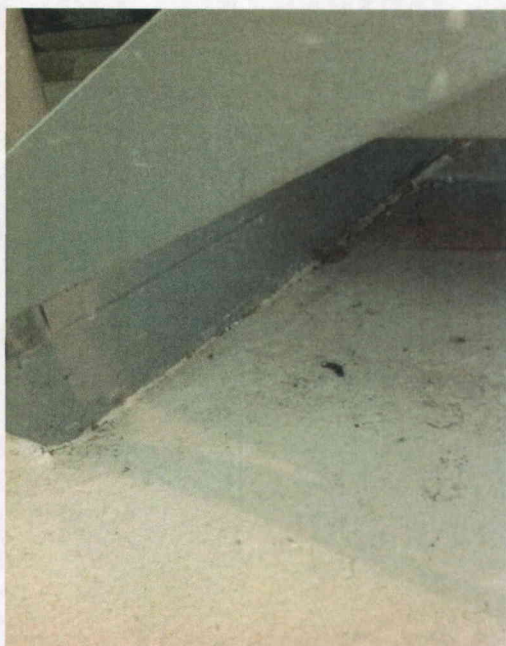
File Name: BAT-2-1(2).jpg

Description: View of Anchor Welds

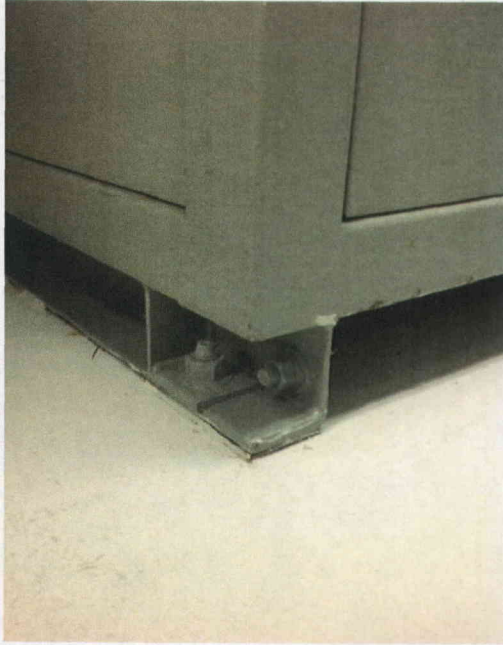
File Name: BAT-CHG2-1(1).jpg  
Description: View of Anchor Bolts in Rear of Component

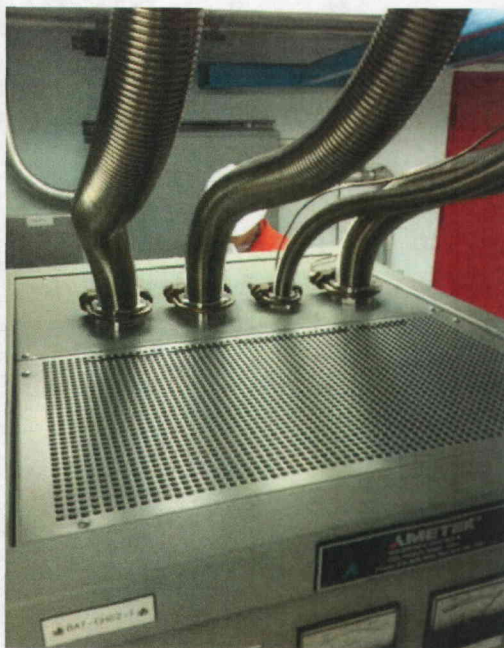
File Name: BAT-CHG2-1(5).jpg  
Description: View of Flexible Top Lines

9. Do attached lines have adequate flexibility to avoid damage?  
*Attached top entry conduit found with adequate flexibility.*

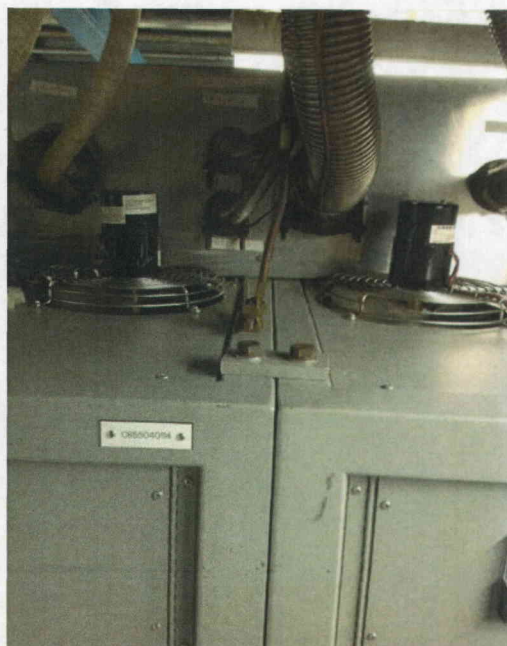
File Name: BAT-CHG2-1(6).jpg  
Description: Adjacent Cabinets Bolted Together

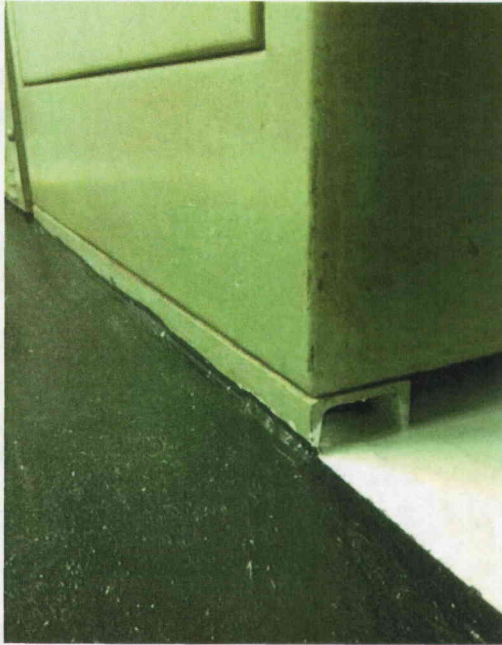
File Name: DC-SWBD2-1(3).jpg  
Description: View of Anchorage

*Calculation NM(B)-468-CZC confirms anchorage configuration as 12-3" long welds at corners of MCC sections for a total of 18" of fillet welds at front and 18" of welds at the back of the MCC. The welds are specified to be placed at each corner of MCC section. The required welds per the referenced calc is 36" vs. 50" observed during walkdown. The configuration is adequate.*

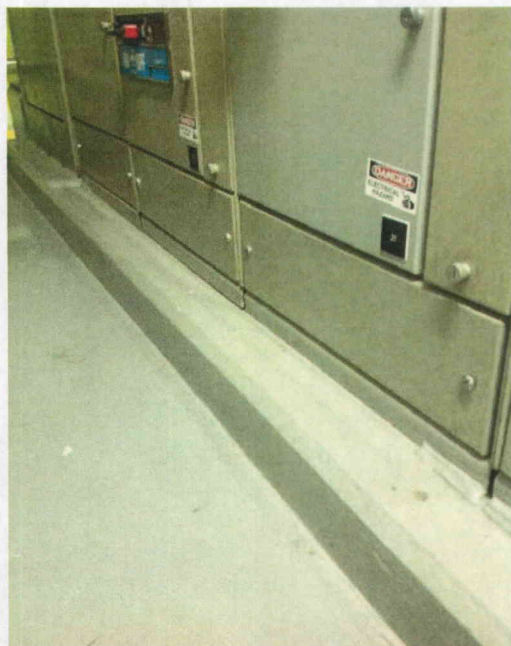
File Name: 2-95-3-2-04.jpeg  
Description: View of Weld Configuration on Left Side

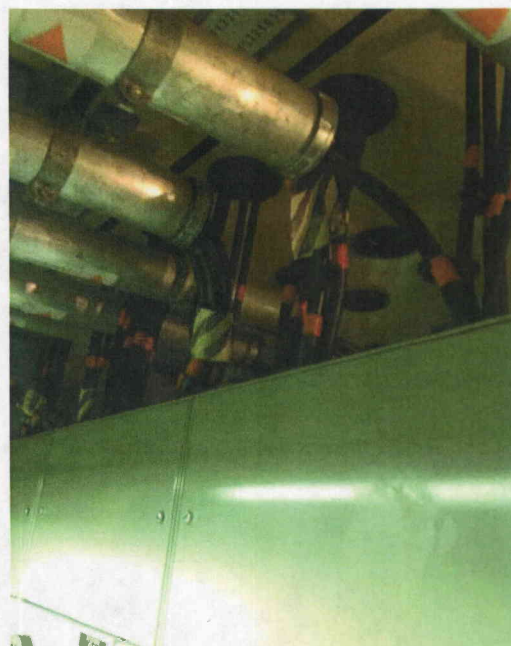
File Name: 2-96-3-2-04.jpeg  
Description: Flexible top lines

*Attached top entry conduit found with adequate flexibility.*

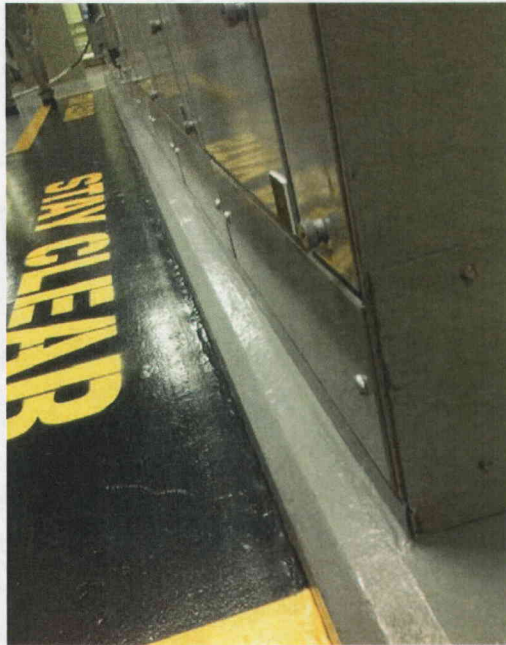
File Name: 2-63-1-2-13.jpeg  
Description: View of Front Anchorage

*Calculation 12241-NM(B)-468-CZC confirms anchorage configuration as total of eight 3" long fillet welds at both front and back of the MCC. The welds are specified to be placed at each corner of MCC sections. The required weld length per the referenced calculation is 48" vs. ~84" observed during walkdown. The configuration is adequate.*

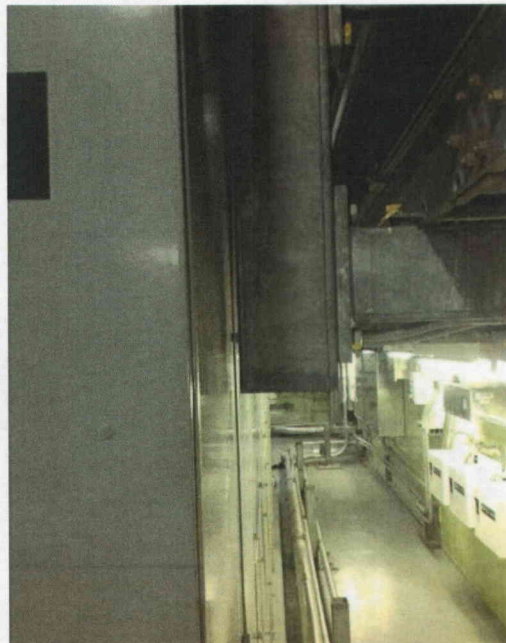
File Name: 2-94-1-2-13.jpeg  
Description: Space Between MCC and Cable Tray Support

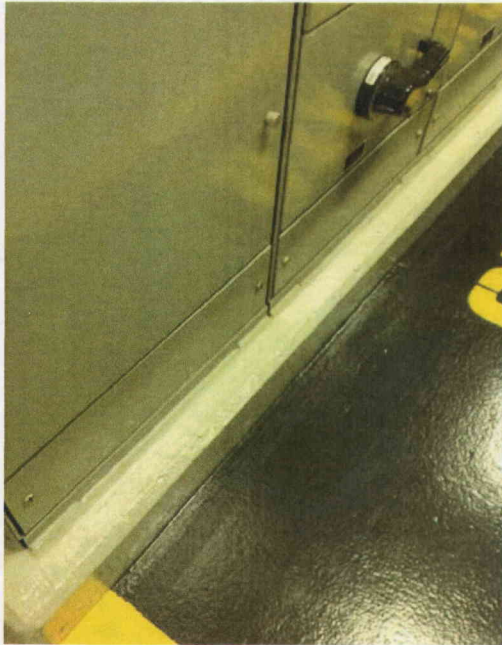
Description: View of Anchor Welds

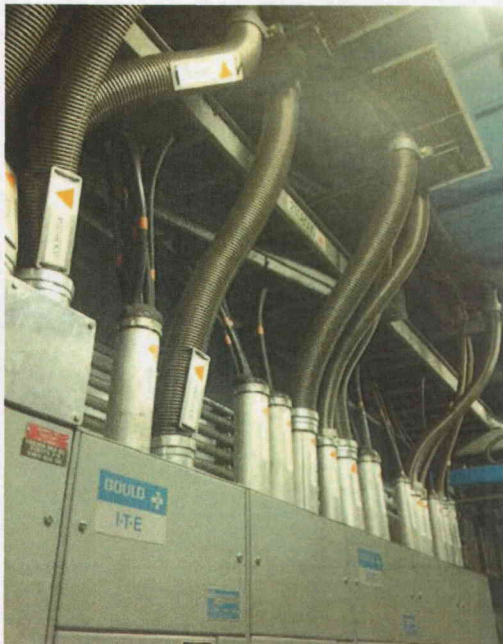
Description: View of Flexible Top Lines

9. Do attached lines have adequate flexibility to avoid damage?  
*Attached top conduit found with adequate flexibility.*

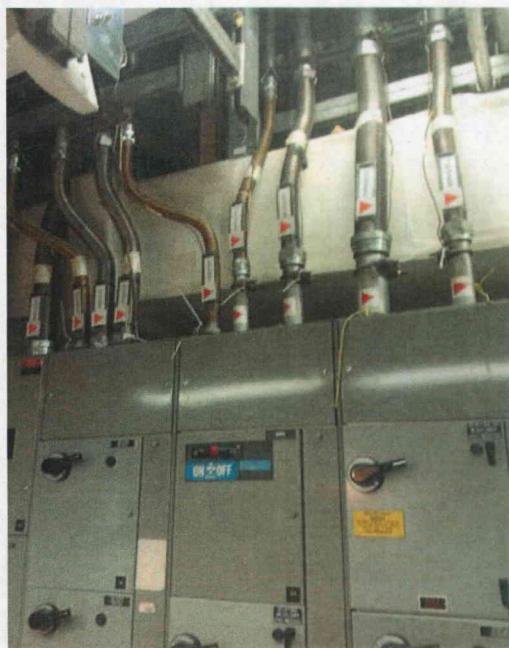
File Name: 2-64-1-2-06.jpeg  
Description: View of Flexible Top Conduit

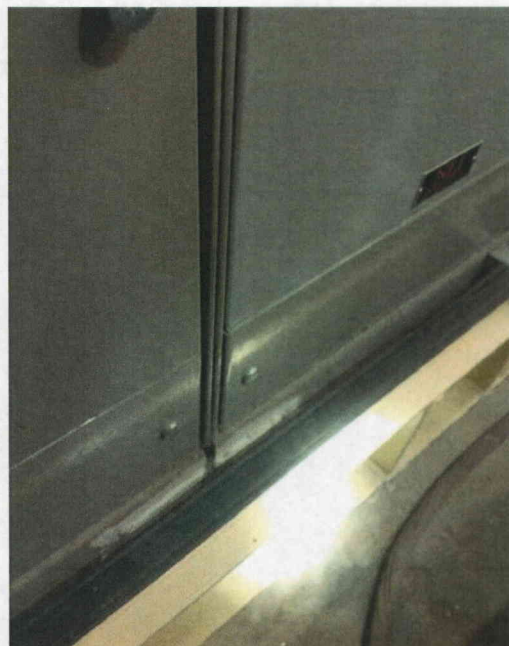
File Name: 2-73-1-2-06.jpeg  
Description: View of Welds at Component Base

*Calculation 12241-NM(B)-468-CZC confirms anchorage configuration as 24- 3" long fillet welds at corners of MCC sections for a total of 36" of weld at front and 36" of weld at the back of the MCC. The required welds at each side of the MCC is 36" vs. the 49.5" observed during walkdown. The configuration is adequate.*

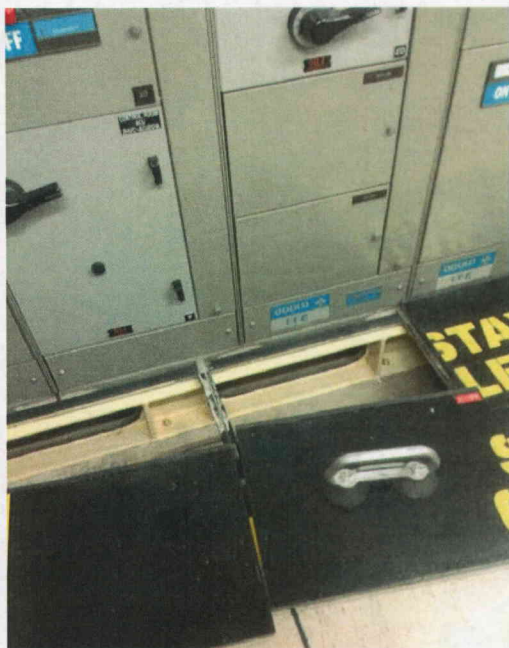
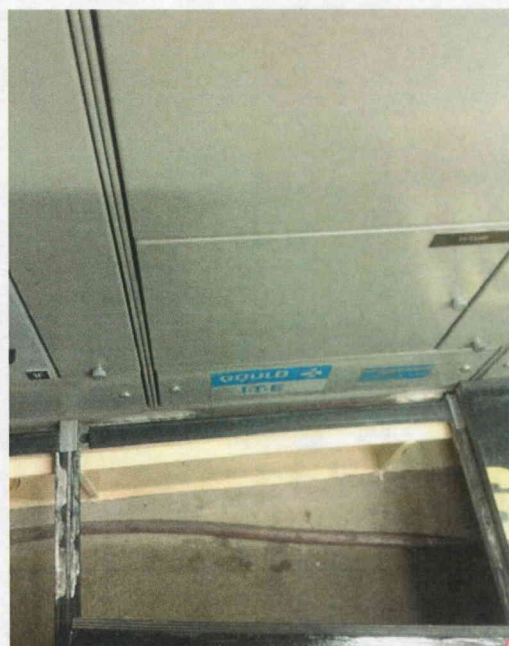
File Name: 2-94-1-2-06.jpeg

Description: View of Welds at Component Base

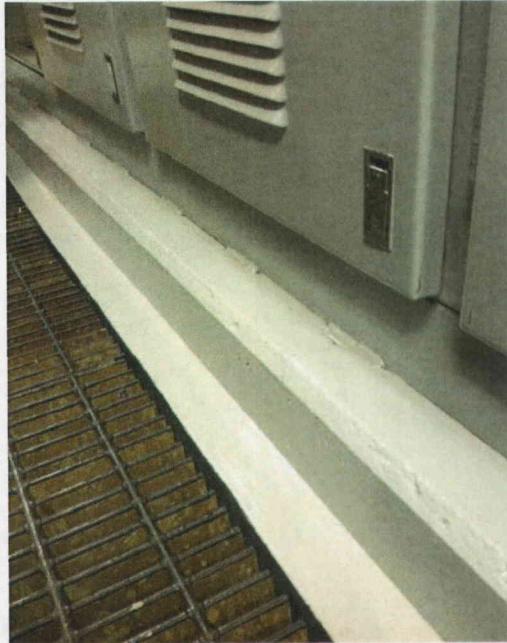
File Name: 2-64-8-2-08.jpeg

Description: Typical Anchor Weld

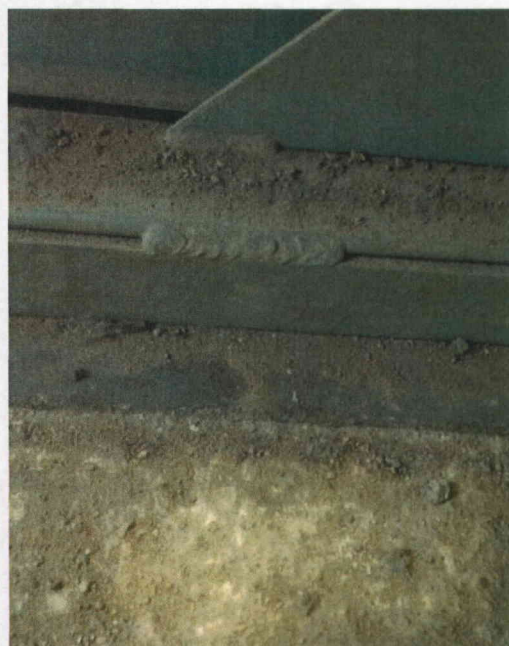
File Name: 2-95-17-2-26.jpeg

Description: View of Internal Welding

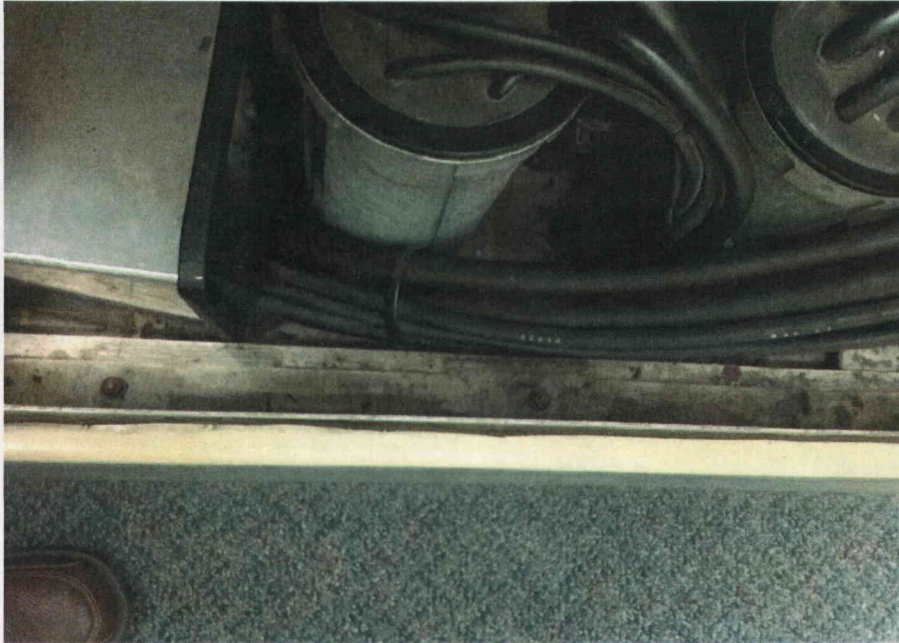
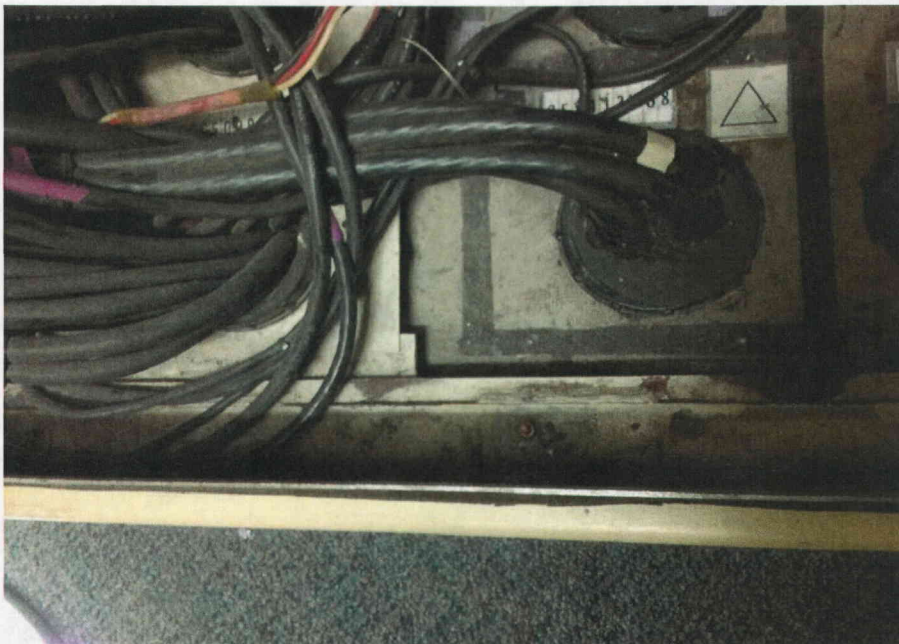
File Name: 2HVR-TI228(1).jpg  
Description: View of Cabinet Anchorage

File Name: 2HVR-TI228-1(3).jpg  
Description: View of Cabinet Anchorage

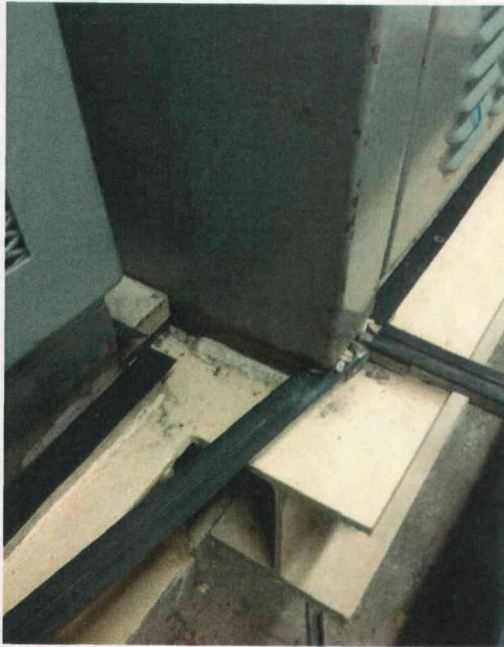
File Name: 2-63-6-2-06.jpeg  
Description: View of Anchor Welds

File Name: 2-64-6-2-06.jpeg  
Description: View of Anchor Welds

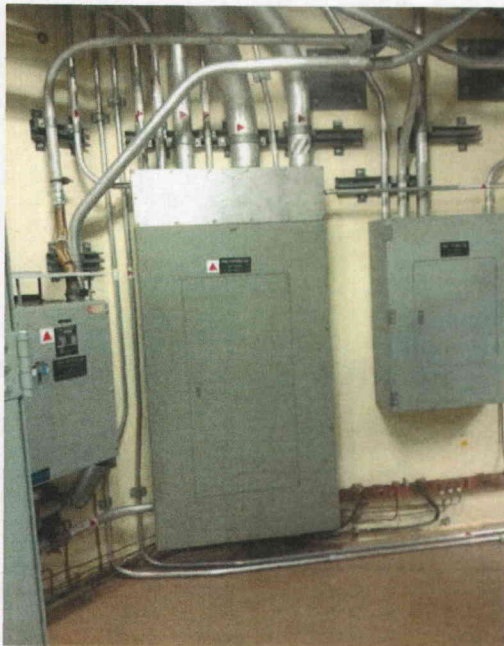
File Name: 2-61-2-2-06.jpeg

Description: Component Plate ID

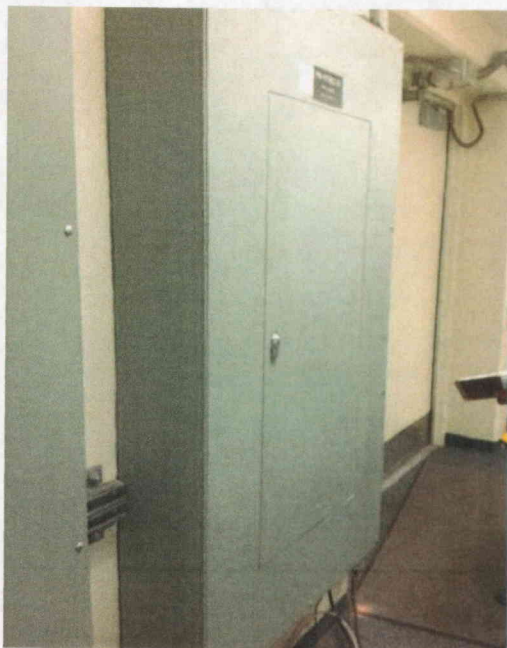
File Name: PNL-VITBS2-2C(2).jpg  
Description: General View of Component

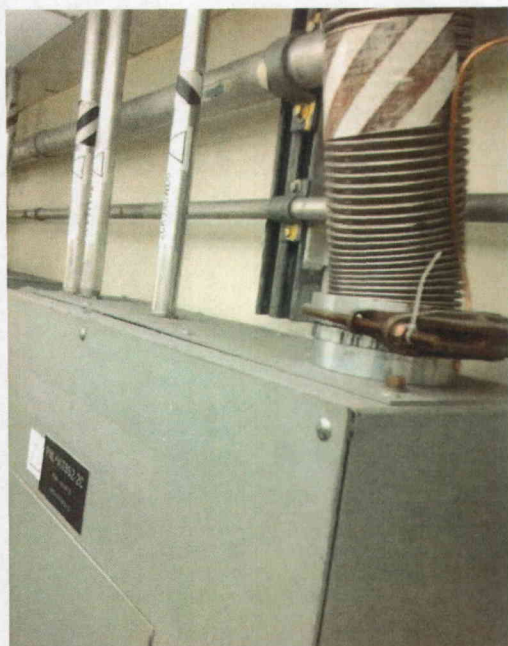
File Name: PNL-VITBS2-2C(3).jpg  
Description: View of Attached Lines

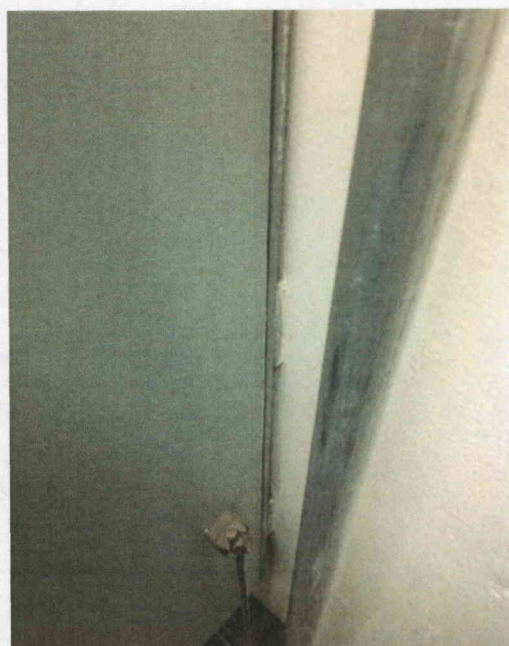
File Name: PNL-VITBS2-2C(4).jpg  
Description: View of Anchorage to Wall

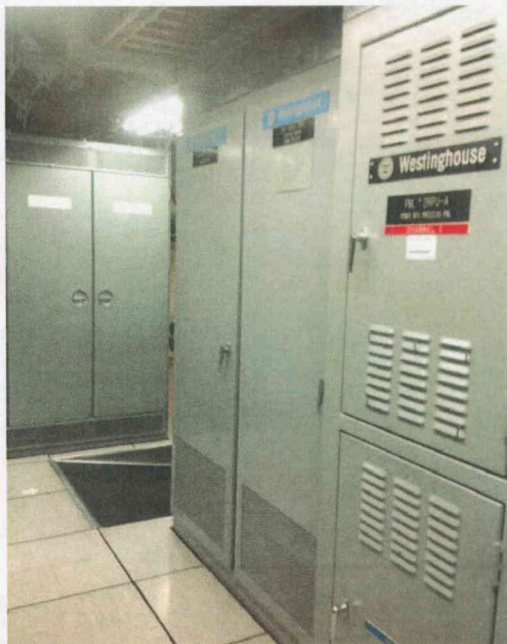
File Name: 2-62-7-2-06.jpeg

Description: General View of Component

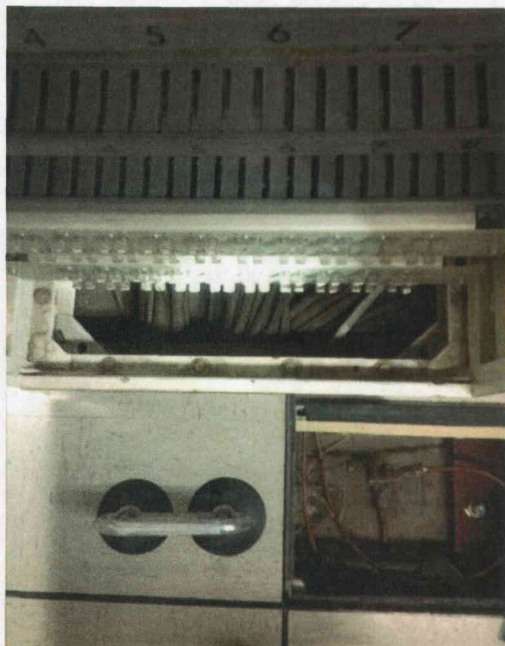
File Name: 2-64-7-2-06.jpeg  
Description: View of Interior at Cabinet Base

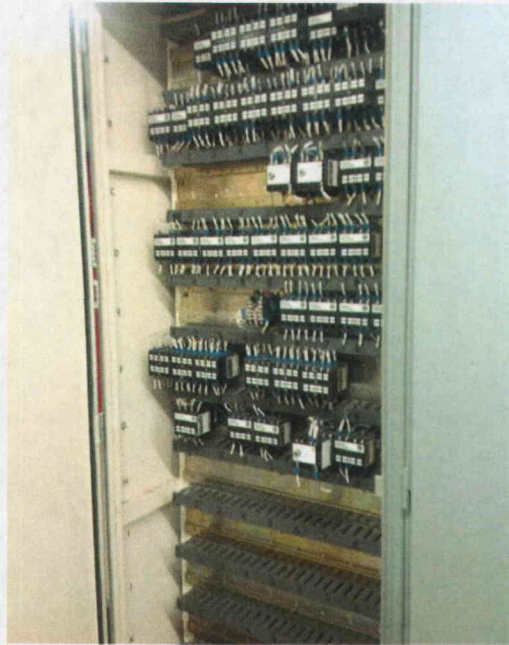
File Name: 2-73-7-2-06.jpeg

Description: View of Interior Components

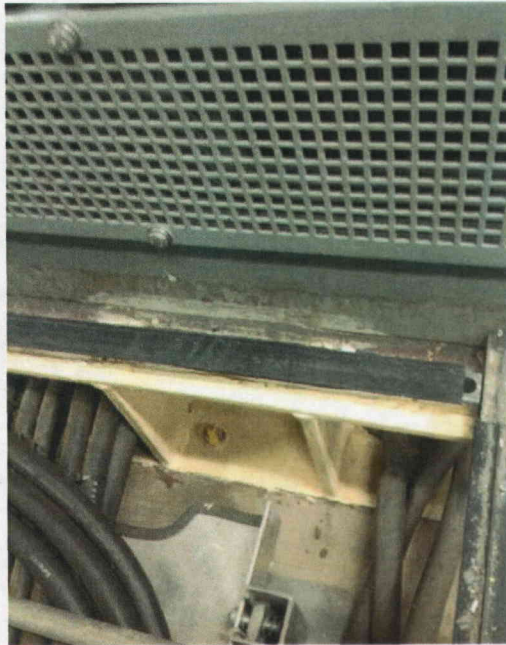
File Name: 2-95-3-2-06.jpeg

Description: View of Anchor Weld and Wide Flange Anchor Bolt

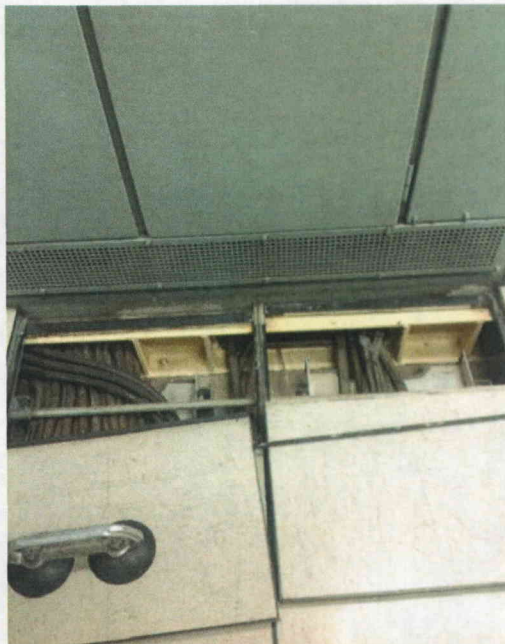
File Name: 2-96-3-2-06.jpeg

Description: View of Anchor Welds

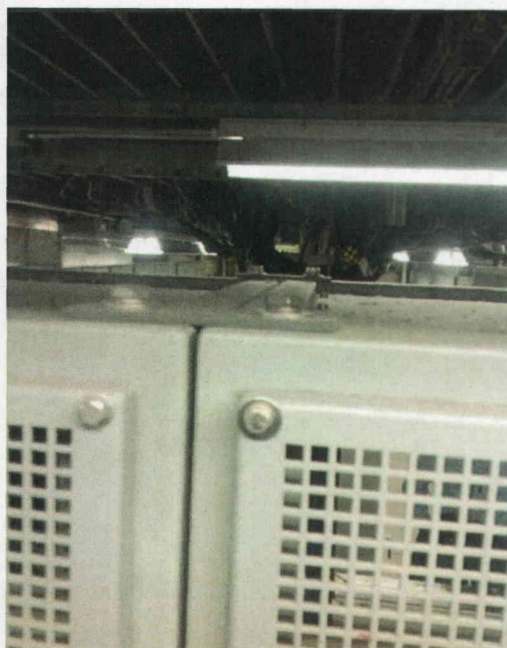
File Name: 2-95-4-2-06.jpeg

Description: Adjacent Cabinets are Bolted Together

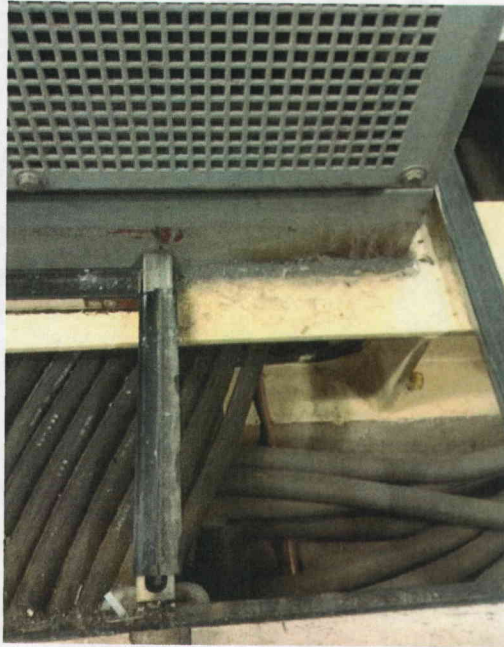
File Name: 2-97-4-2-06.jpeg  
Description: View of Base Weld

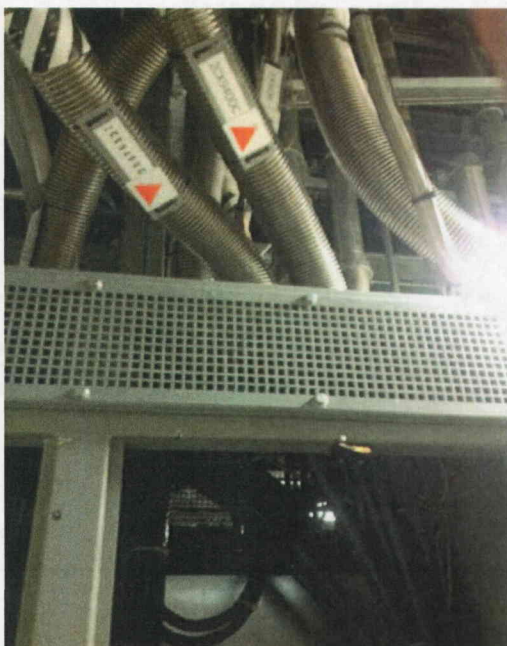
File Name: 2-73-5-2-06.jpeg  
Description: View of Flexible Top Conduit

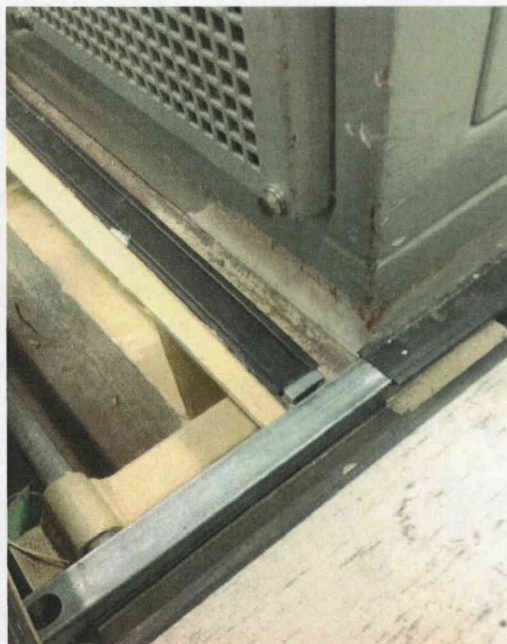
File Name: 2-95-5-2-06.jpeg  
Description: View of Base Weld

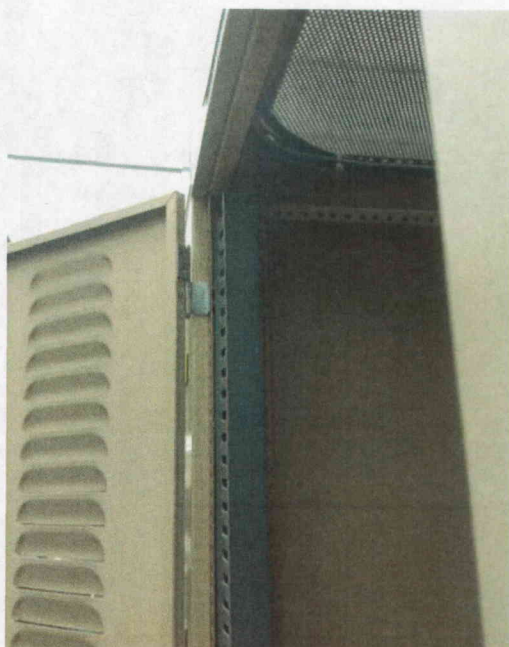
File Name: 2-73-7-2-07.jpeg  
Description: Adjacent Cabinets Bolted Together

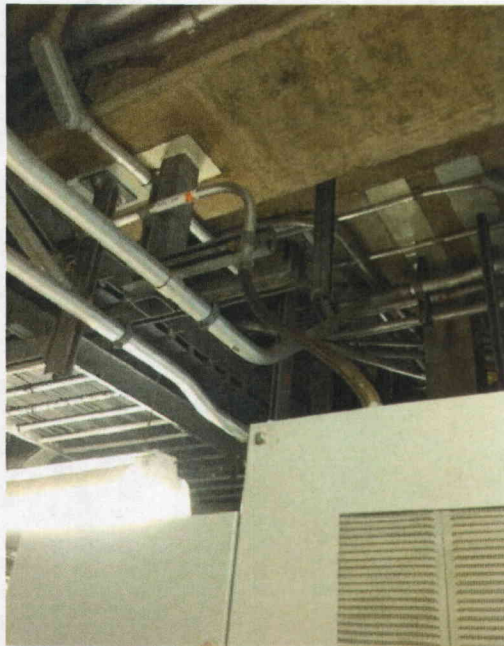
File Name: TRF2-8N(1).jpg  
Description: View of Top Conduits

9. Do attached lines have adequate flexibility to avoid damage?  
*Attached lines have adequate flexibility.*

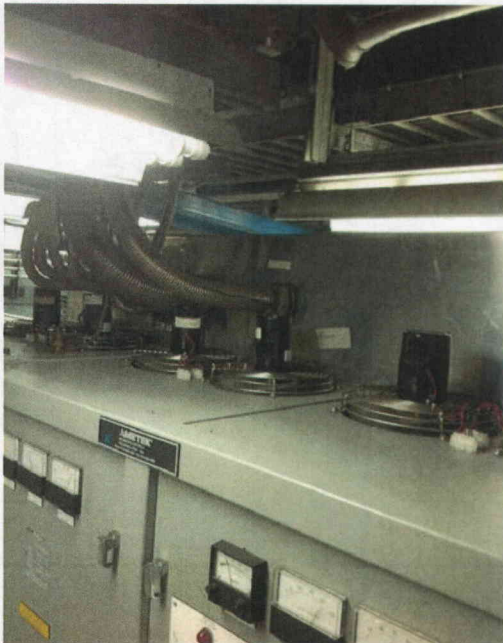
File Name: UPS-VITBS2-1(4).jpg  
Description: View of Flexible Top Lines

9. Do attached lines have adequate flexibility to avoid damage?  
*Attached lines have adequate flexibility.*
