APPENDIX C: AREA WALK-BY CHECKLISTS (AWCs)

Area Walk-By Checklist (AWC)

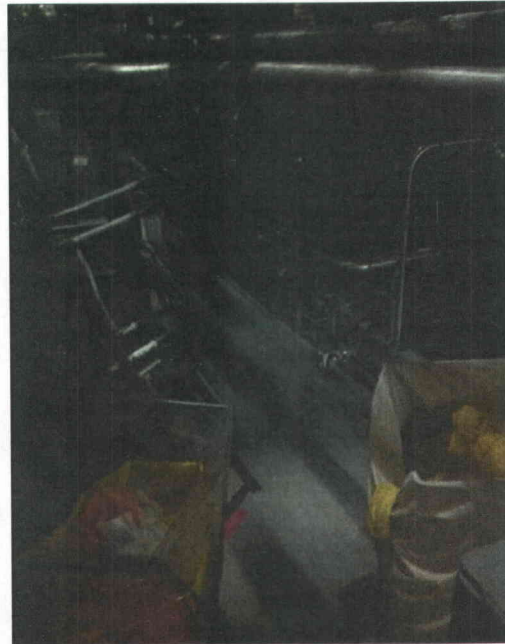
File Name: 1-59-6-3-01.jpeg
Description: Area general view

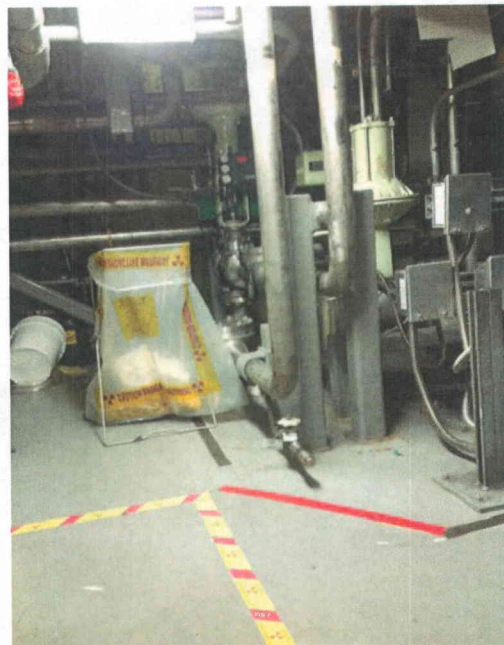
File Name: 1-60-6-3-01.jpeg
Description: Area general view

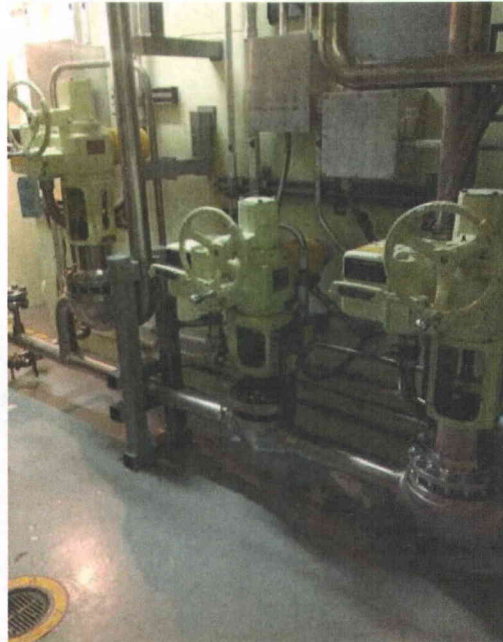
File Name: 1-59-5-3-01.jpeg
Description: General view of valves in the area

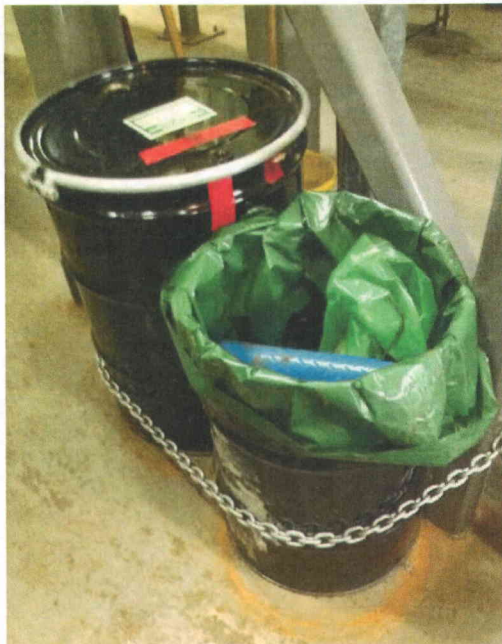
File Name: 1-59-4-3-01.jpeg

Description: Drums in the area identified to be properly restrained

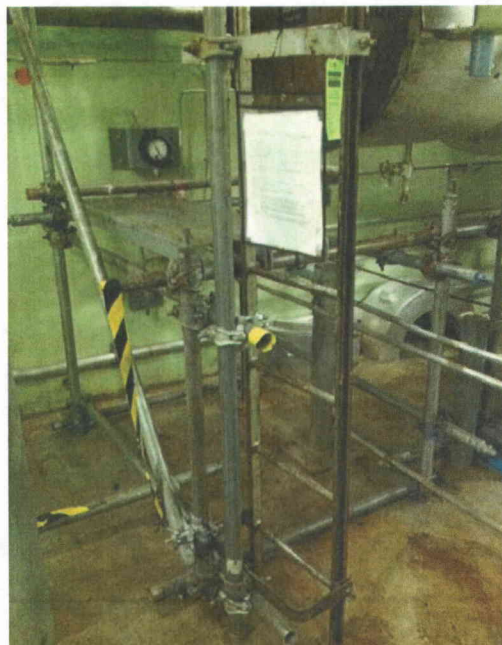
File Name: 1-60-4-3-01.jpeg

Description: Scaffold identified in the area

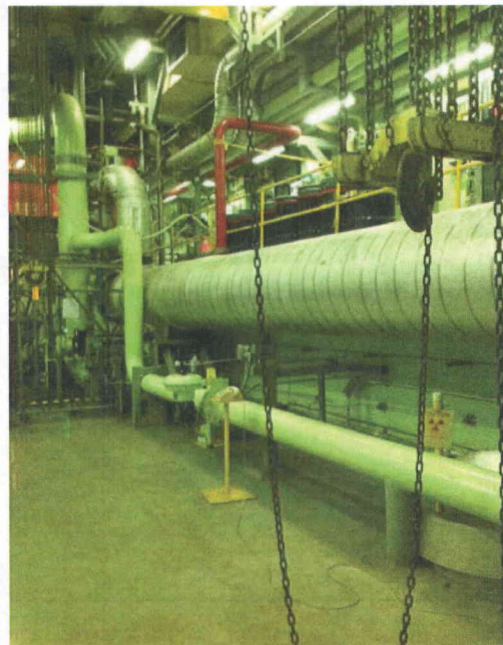
File Name: 1-66-4-3-01.jpeg

Description: General view of Heat Exchanger

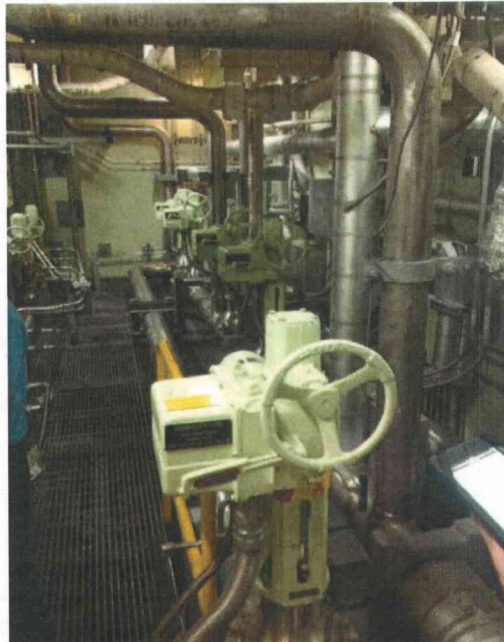
File Name: 1-59-3-3-02.jpeg
Description: General view of area

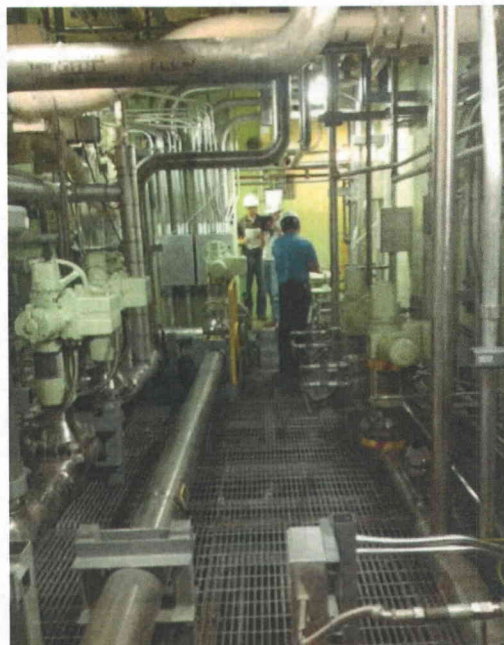
File Name: 1-60-3-3-02.jpeg
Description: General view of area

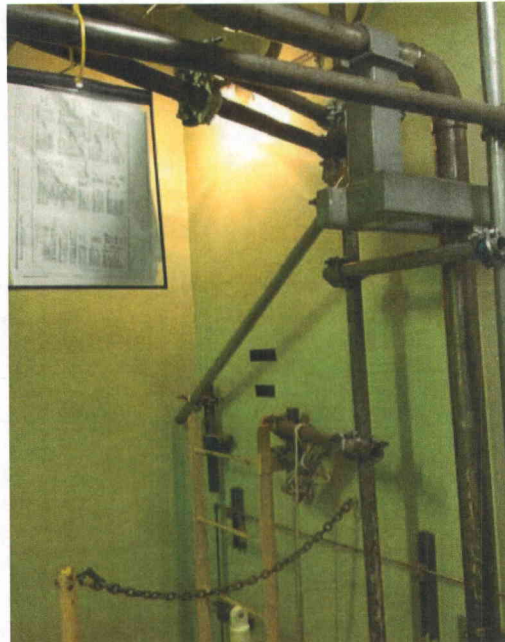
File Name: 1-65-3-3-02.jpeg
Description: View of scaffold in the area

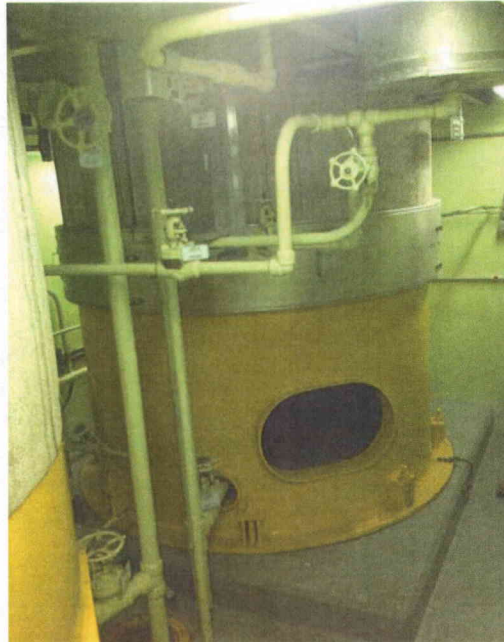
File Name: 1-65-2-3-05.jpeg
Description: General view of Surge Tank

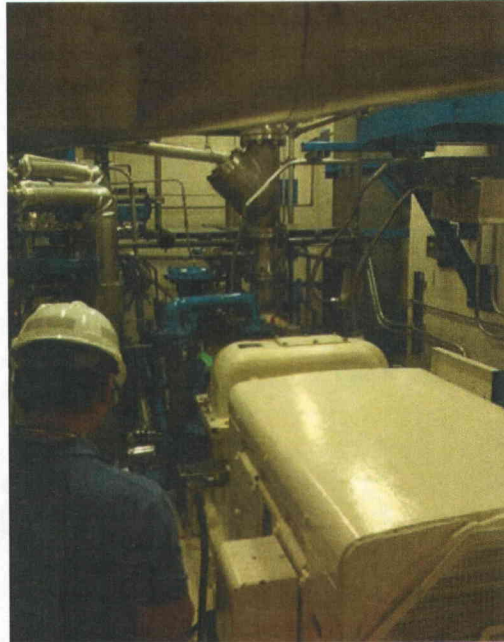
File Name: 1-59-4-3-03.jpeg
Description: General view of area

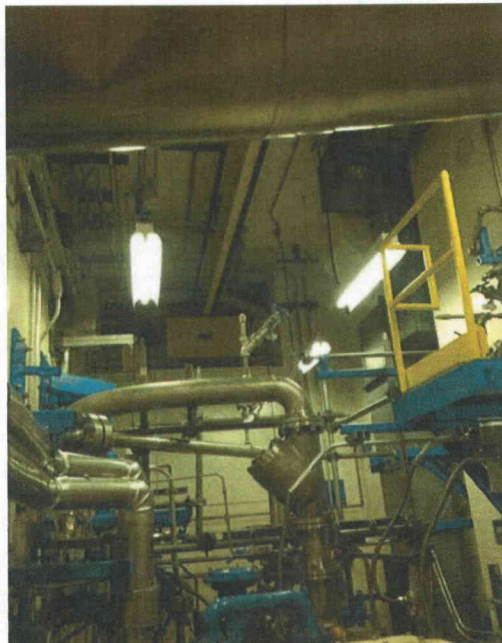
File Name: 1-60-4-3-03.jpeg
Description: View of ceiling and lighting fixtures

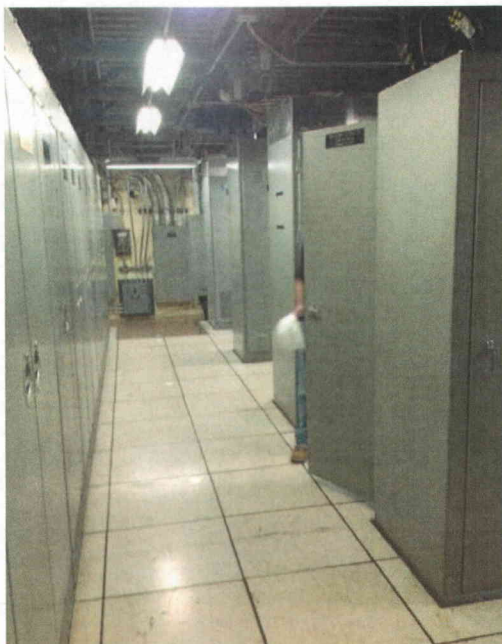
File Name: 1-59-5-3-06.jpeg

Description: View of cabinet arrangement in the area and lighting fixtures

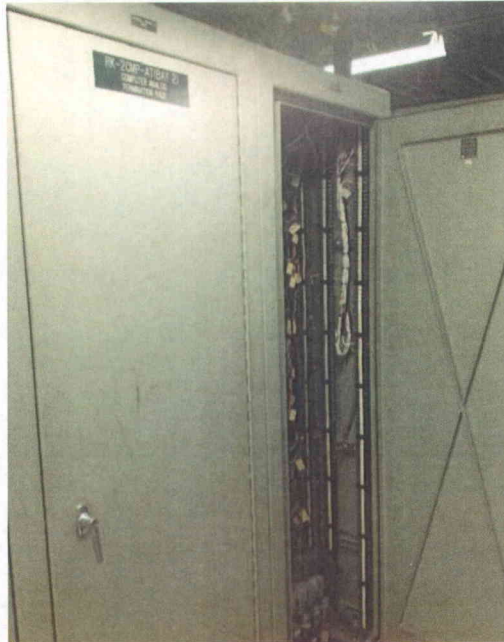
File Name: 1-65-5-3-06.jpeg
Description: General view of opened cabinet

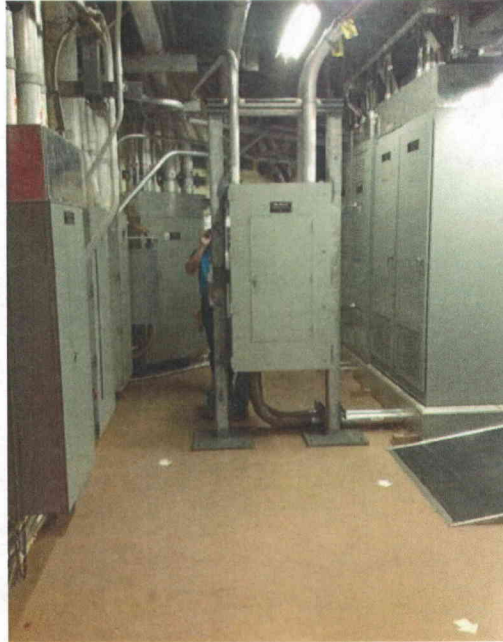
File Name: 1-59-4-3-06.jpeg
Description: South-west area with wall mounted panels

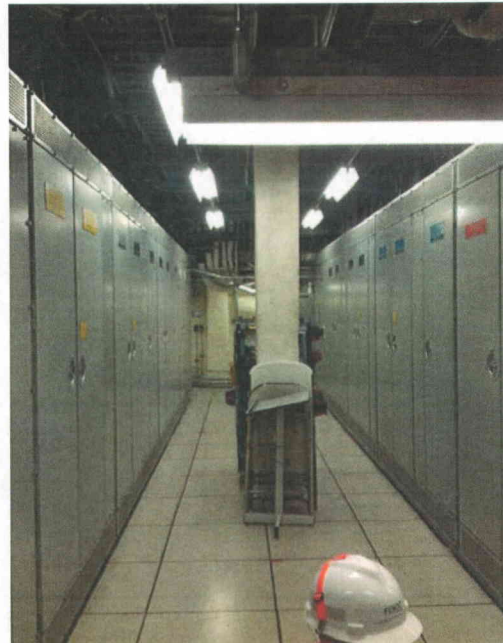
File Name: 1-60-4-3-06.jpeg
Description: View of maintenance equipment properly tight to center column

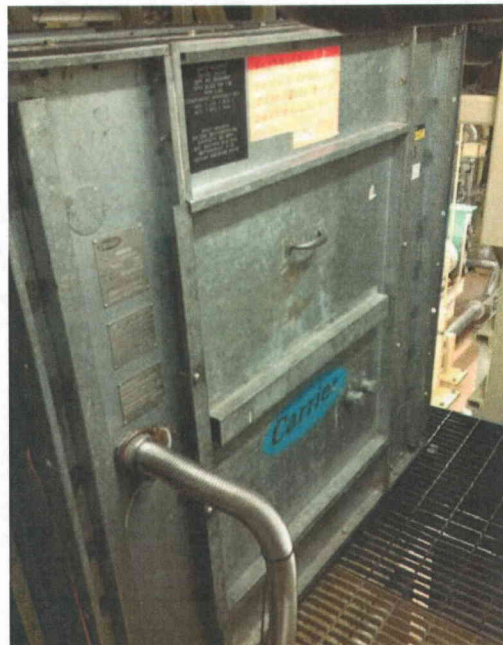
File Name: 1-60-2-3-07.jpeg
Description: General view of component 2HVC-ACU201A

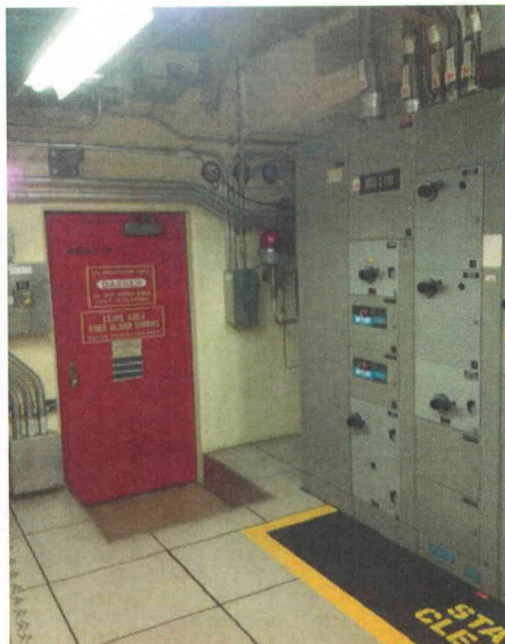
File Name: 1-59-3-3-06.jpeg
Description: General view of area

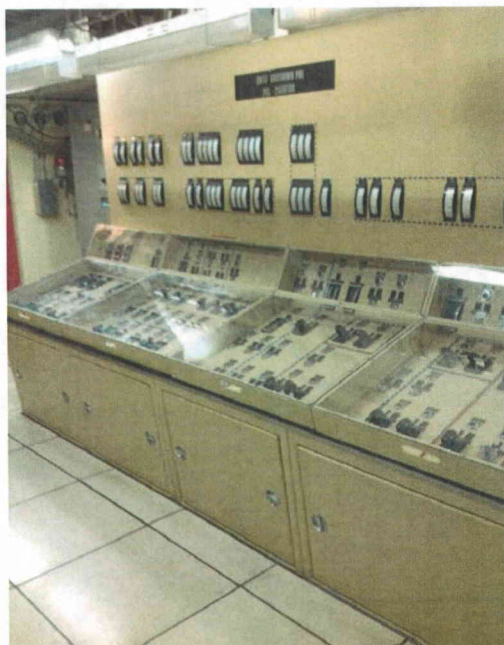
File Name: 1-60-3-3-06.jpeg
Description: View of control panel

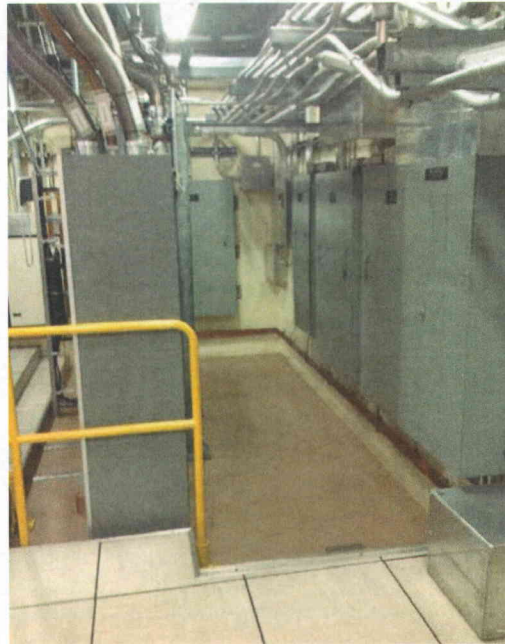
File Name: 1-65-3-3-06.jpeg
Description: View of cabinet arrangement in the area

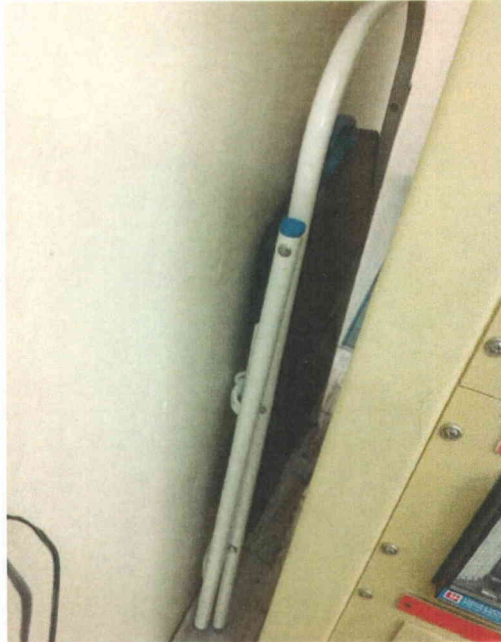
File Name: Control_Rm(3).jpg
Description: Step ladder located next to cabinet

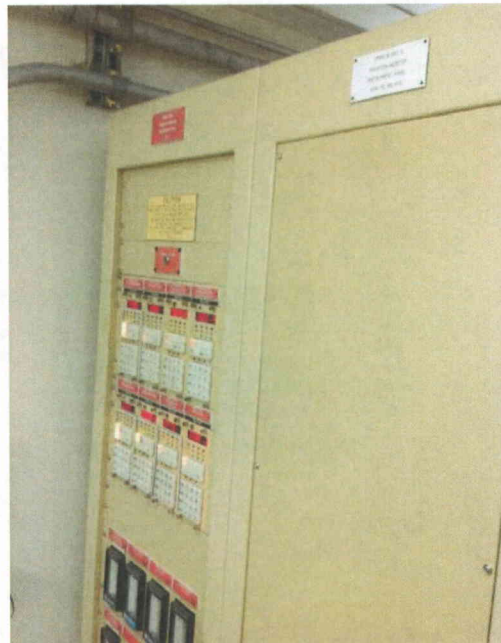
File Name: Control_Rm(4).jpg
Description: View of cabinet in the area

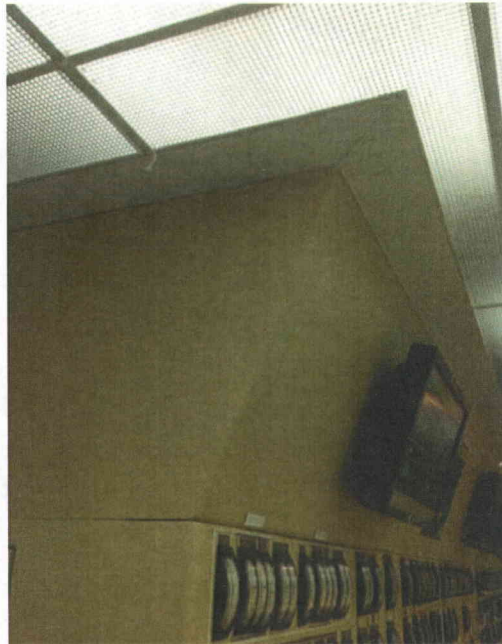
File Name: Control_Rm(5).jpg
Description: View of control room ceiling and the back panels

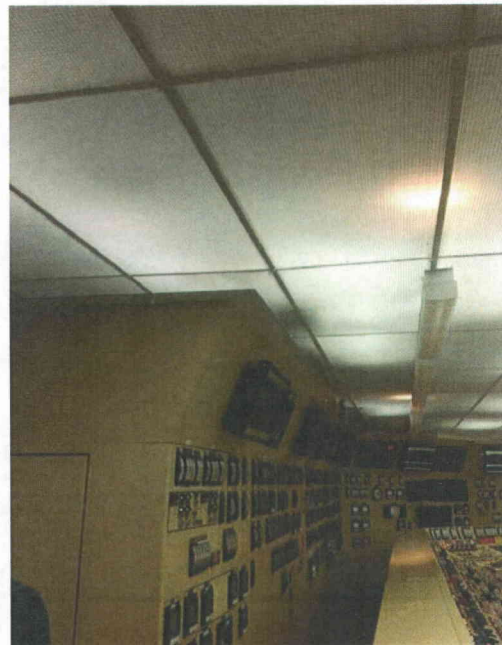
File Name: Control_Rm(6).jpg
Description: General view of ceiling grates.

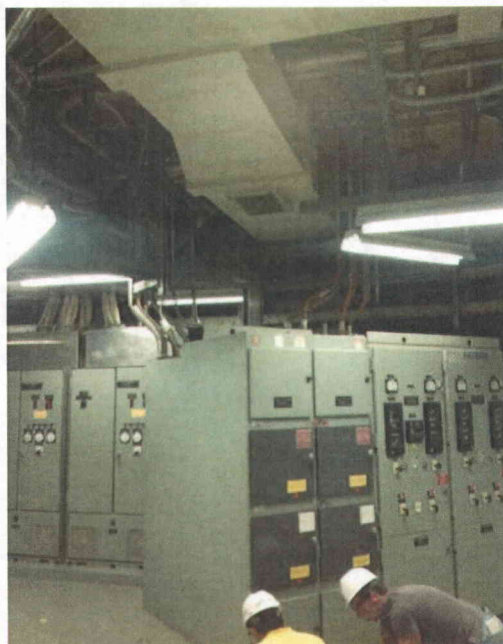
File Name: 1-59-2-3-15.jpeg

Description: General view of cabinets in the area and lighting fixtures

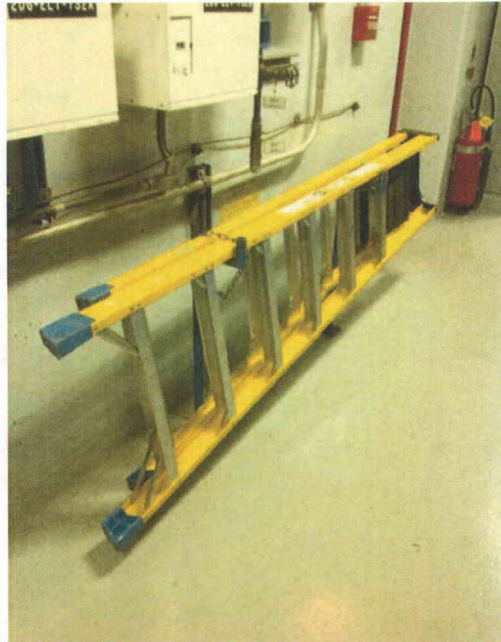
File Name: EDG2-1(5).jpg

Description: Properly restrained ladder identified in the area

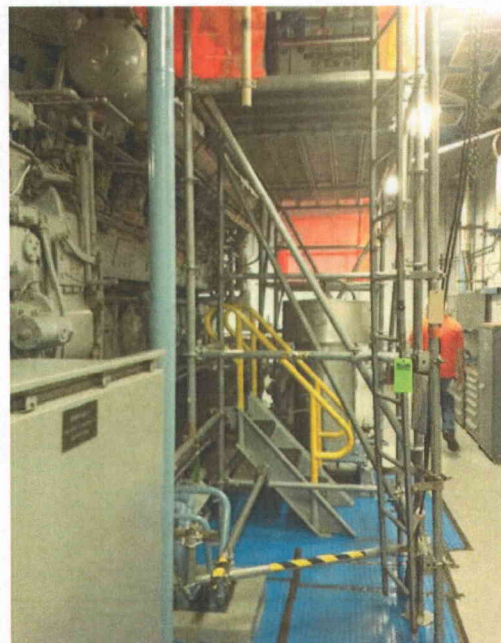
File Name: EDG2-1(6).jpg

Description: View of scaffold located next to Diesel Generator

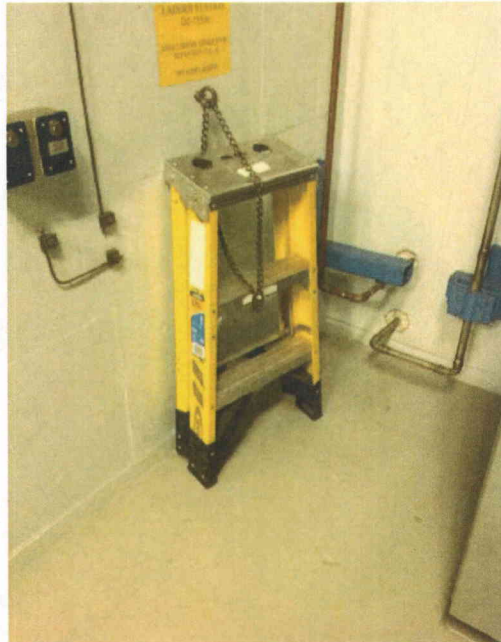
File Name: EDG2-1(7).jpg
Description: View of restrained ladder in the area

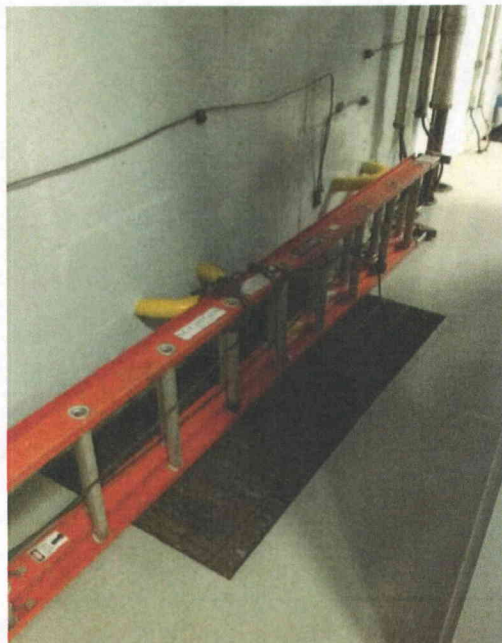
File Name: EDG2-1(8).jpg
Description: View of restrained ladder in the area

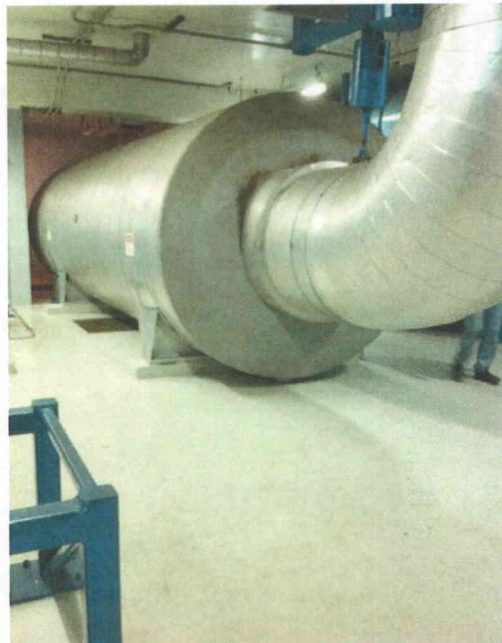
File Name: EDG2-1_Up(2).jpg
Description: General view of DG exhaust muffler

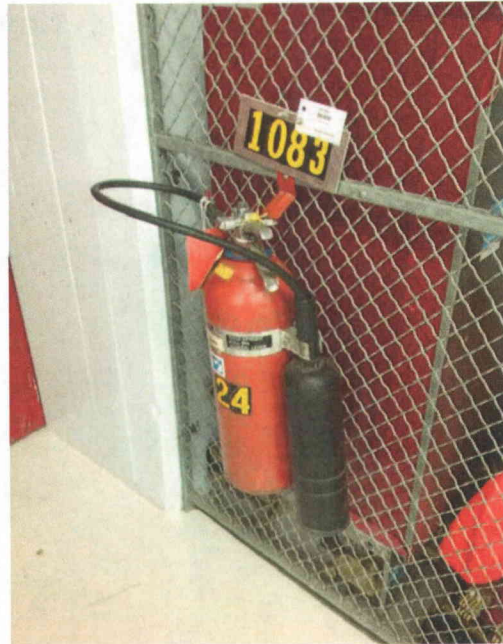
File Name: SWGR AE(3).jpg
Description: Fire extinguisher located in the area

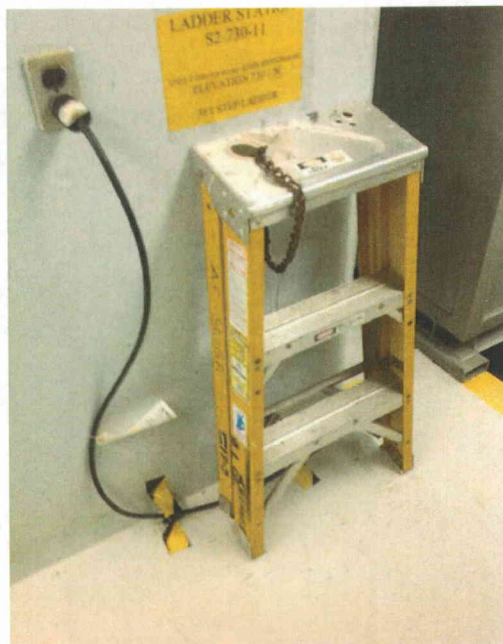
File Name: SWGR AE(5).jpg
Description: Properly restrained ladder identified in the area

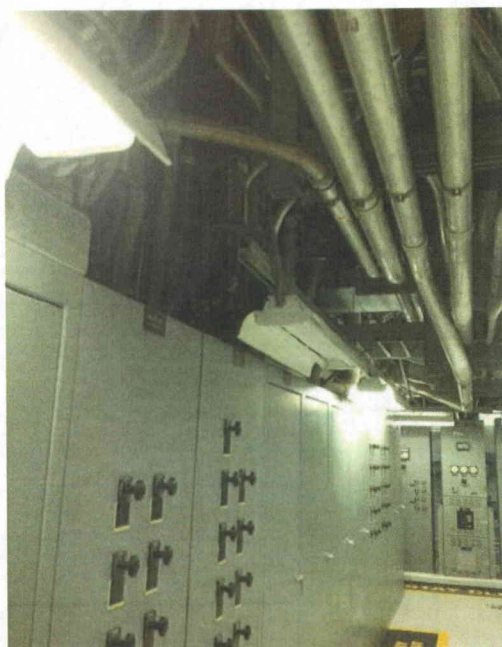
File Name: SWGR AE(6).jpg
Description: View of ceiling conduits and lighting fixtures

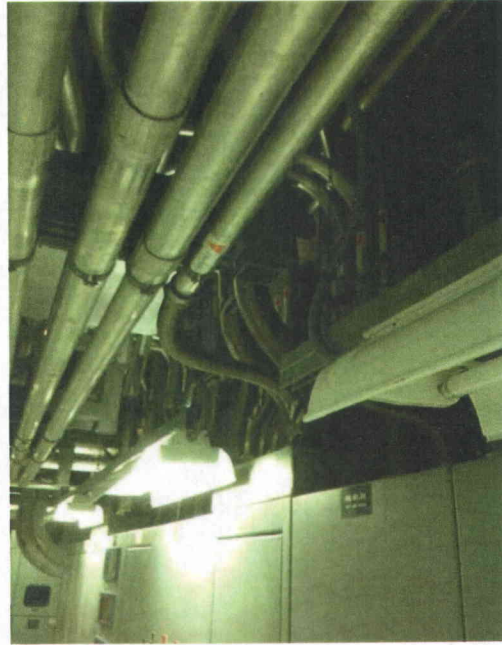
File Name: SWGR AE(7).jpg
Description: Hanging light located close to cabinet.
Interaction addressed in CR-2012-14463

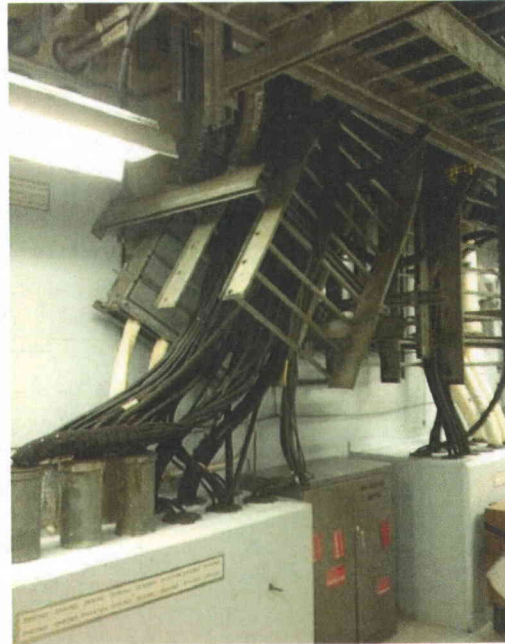
File Name: SWGR_DF(3).jpg
Description: View of cable trays above electrical cabinets

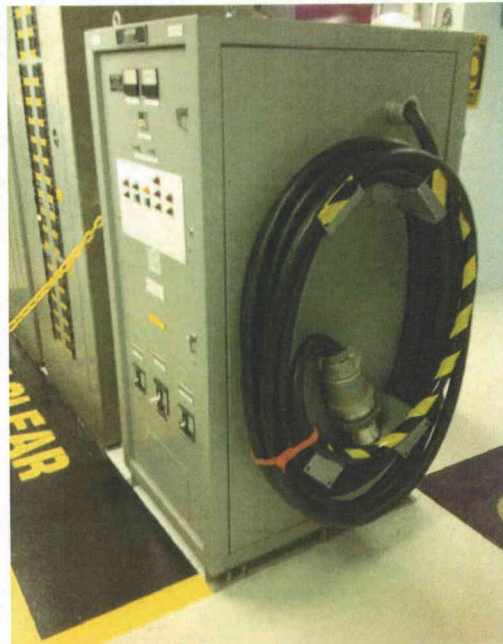
File Name: SWGR_DF(7).jpg
Description: View of 1.5" diameter loops of cable
mounted on the side of BAT-CHG2-9

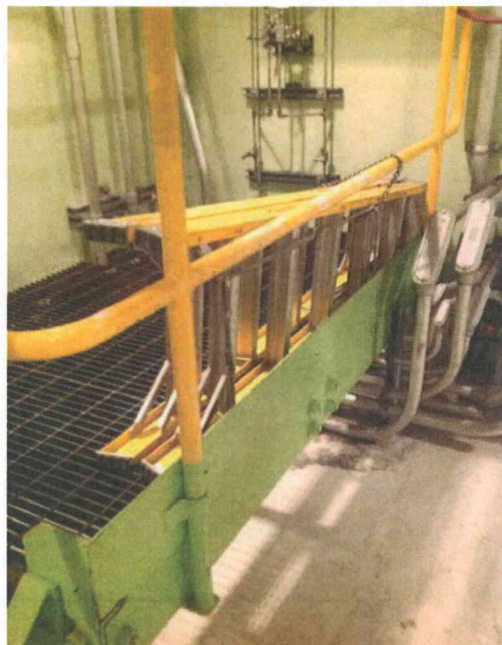
File Name: 1-60-3-3-29.jpeg

Description: Ladder in the area identified to be properly restrained.

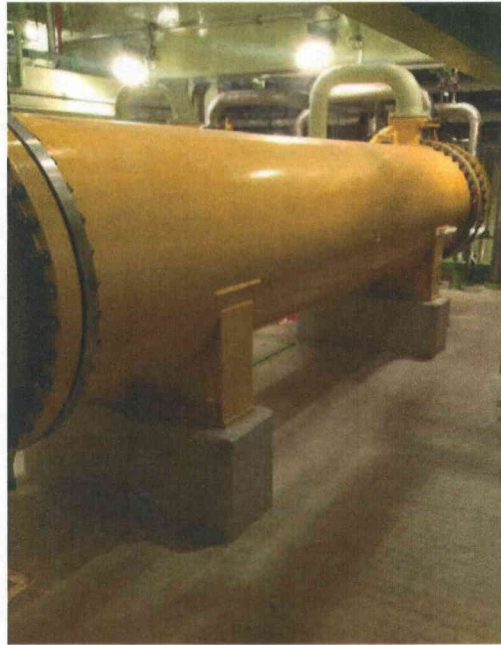
File Name: 1-65-2-3-29.jpeg

Description: View of Heat Exchanger mounted on saddle supports

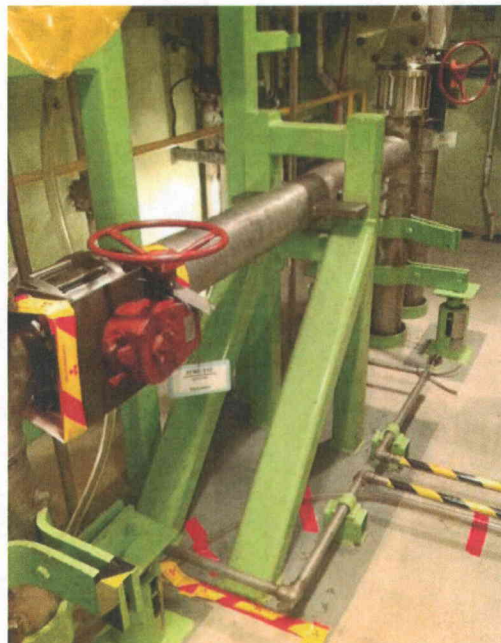
File Name: 1-66-2-3-29.jpeg

Description: Nearby floor mounted pipe supports.

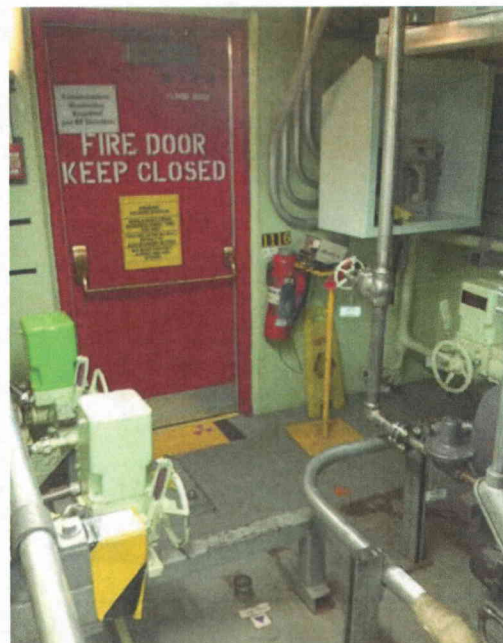
File Name: 1-60-5-3-16.jpeg
Description: Fire extinguisher and floor mounted supports for room pipe lines.

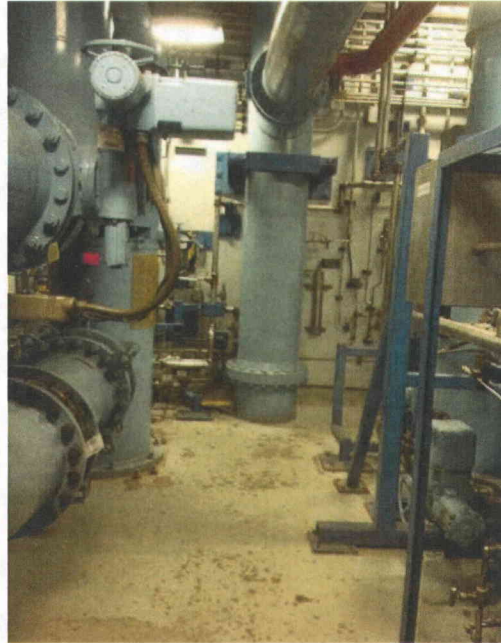
File Name: INTK_CUB_C(3).jpg
Description: General view of area

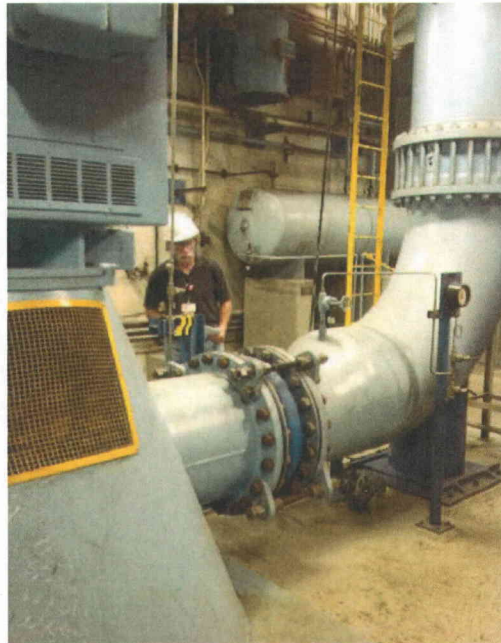
File Name: INTK_CUB_D(1).jpg

Description: View of expansion joint located on pipe attached to vertical Pump 2SWS-P21A.

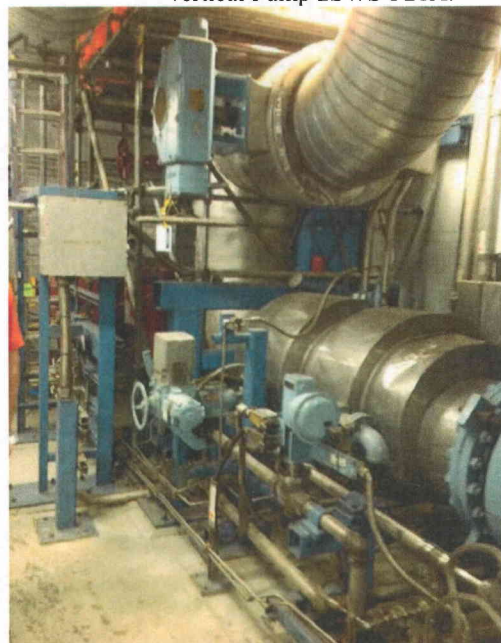
File Name: INTK_CUB_D(2).jpg

Description: General view of instruments in the area

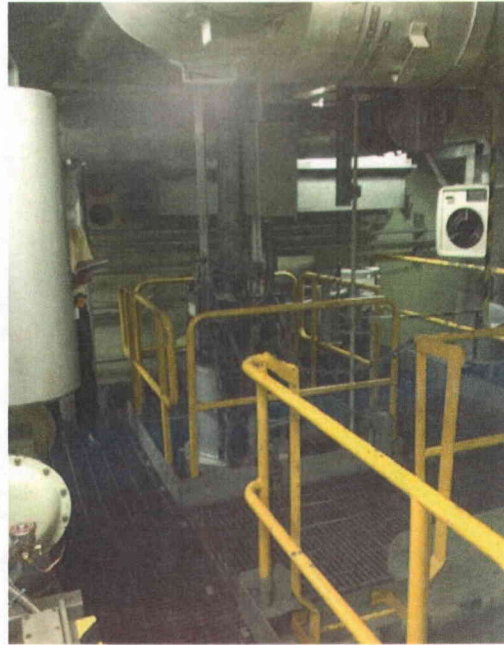
File Name: 1-59-6-3-16.jpeg
Description: General view of area

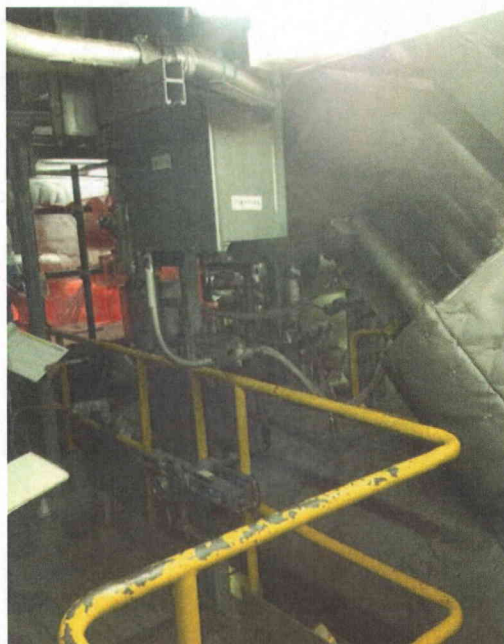
File Name: 1-59-7-3-16.jpeg
Description: General view of area

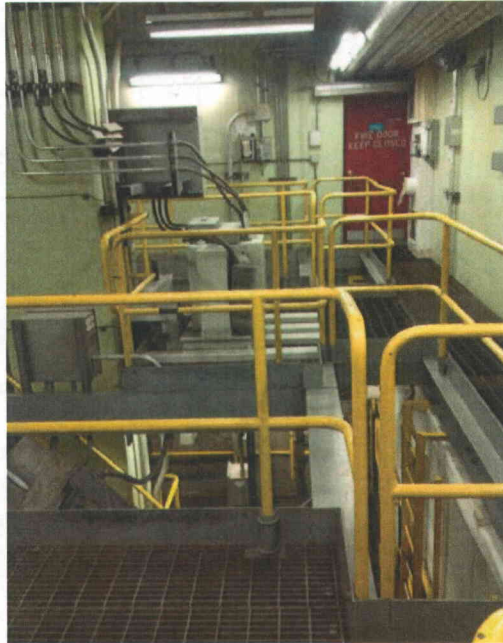
File Name: 1-59-8-3-16.jpeg
Description: General view of area

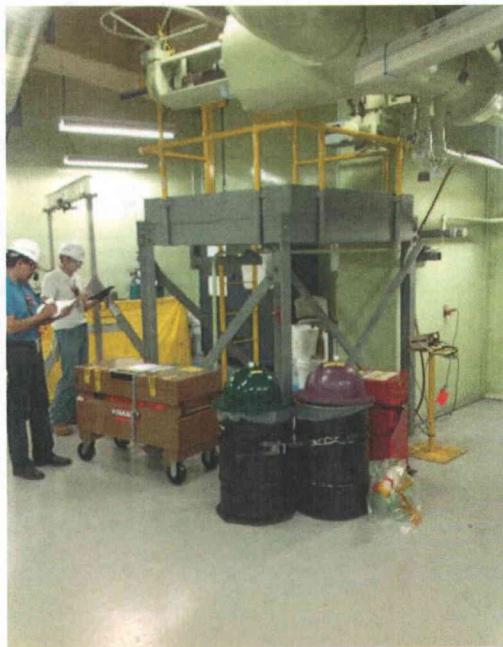
File Name: 1-59-2-3-12.jpeg
Description: General view of area

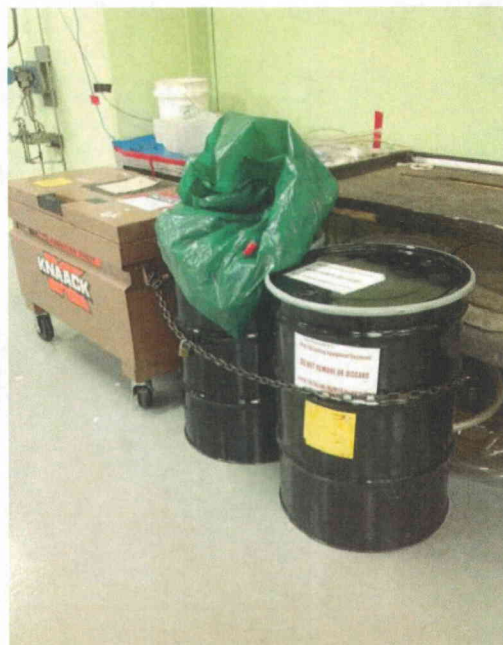
File Name: 1-60-2-3-12.jpeg
Description: View of storage cart and waste drums in the area.
These were identified to be properly secured.

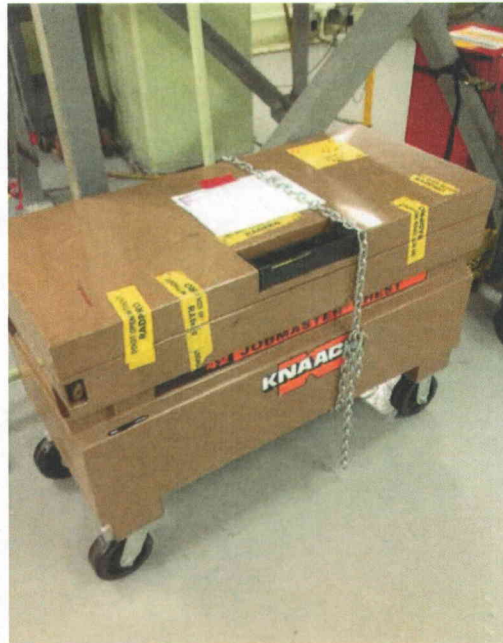
File Name: 1-65-2-3-12.jpeg
Description: View of restrained storage cart

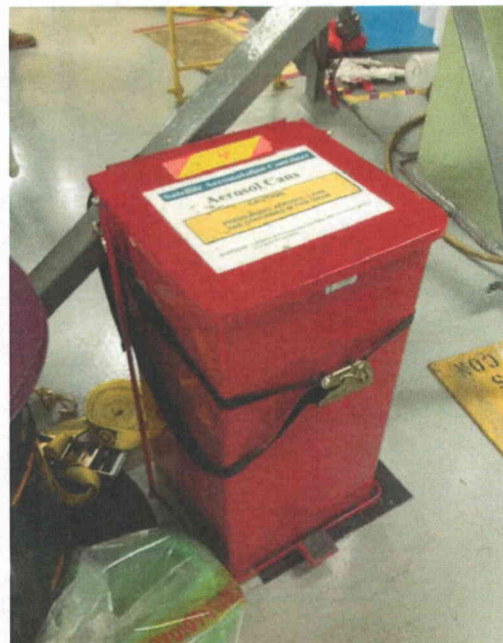
File Name: 1-66-2-3-12.jpeg
Description: View of restrained container

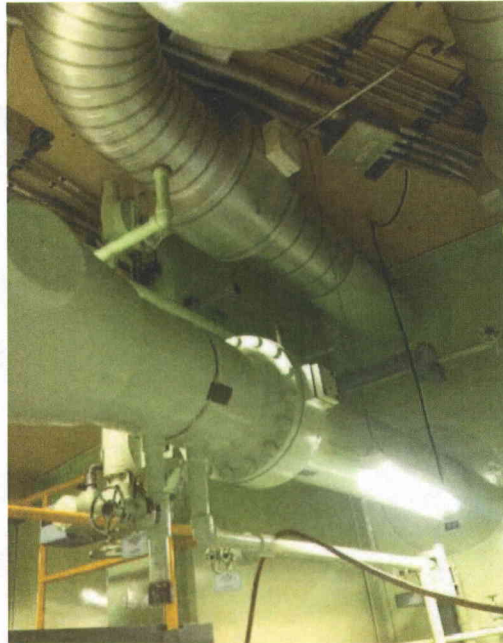
File Name: 1-67-2-3-12.jpeg
Description: View of large diameter pipes

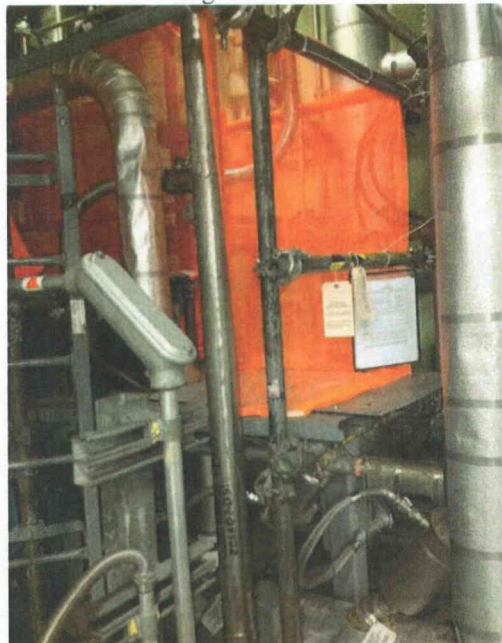
File Name: 1-75-2-3-12.jpeg

Description: Scaffold located in the area

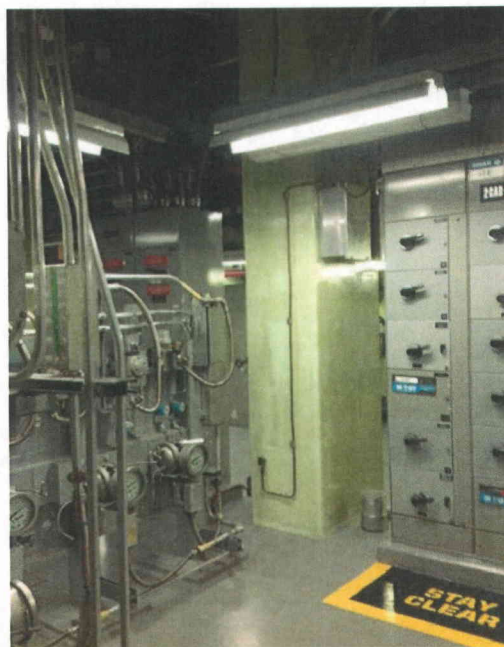
File Name: 1-60-2-3-14.jpeg
Description: General view of area

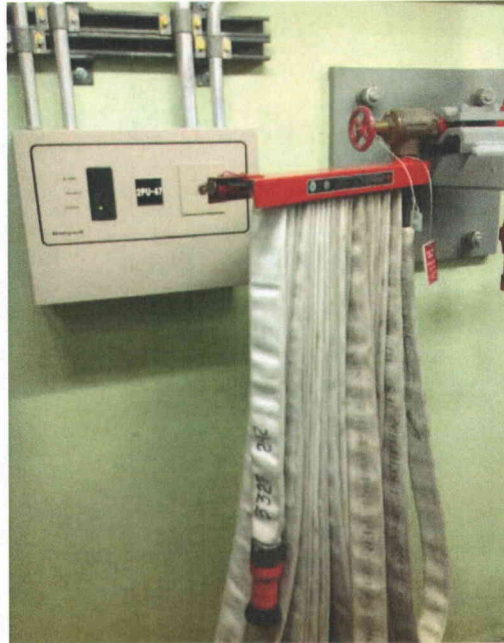
File Name: 1-65-2-3-14.jpeg

Description: Fire hose station located near panel 2PU-47. Judged not a seismic concern

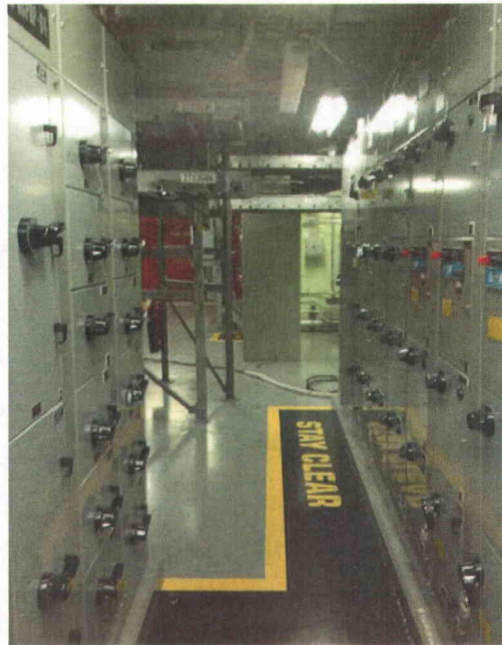
File Name: 1-59-2-3-13.jpeg
Description: General view of area

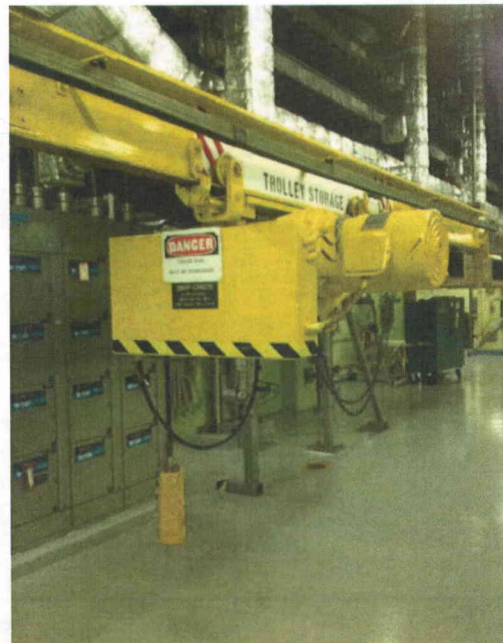
File Name: 1-66-5-3-03.jpeg
Description: Trolley identified in the area to be securely restrained

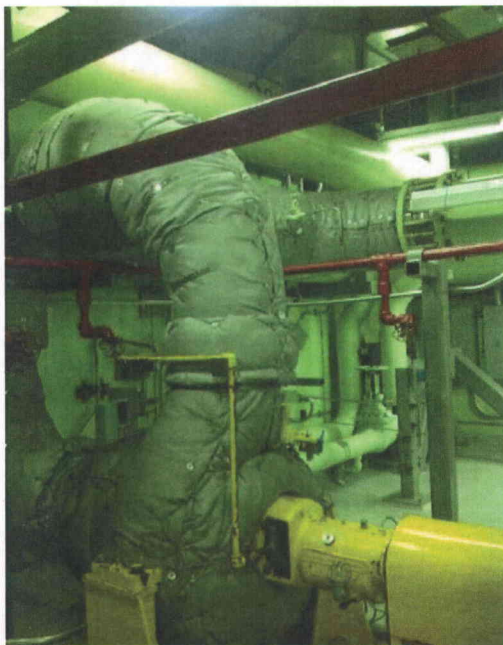
File Name: 1-67-5-3-03.jpeg
Description: General view of insulated pipe lines.

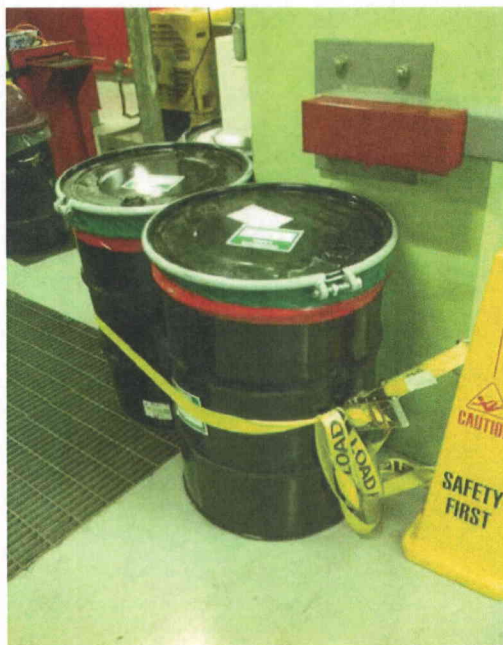
File Name: 1-68-5-3-03.jpeg
Description: Restrained drums located in the area

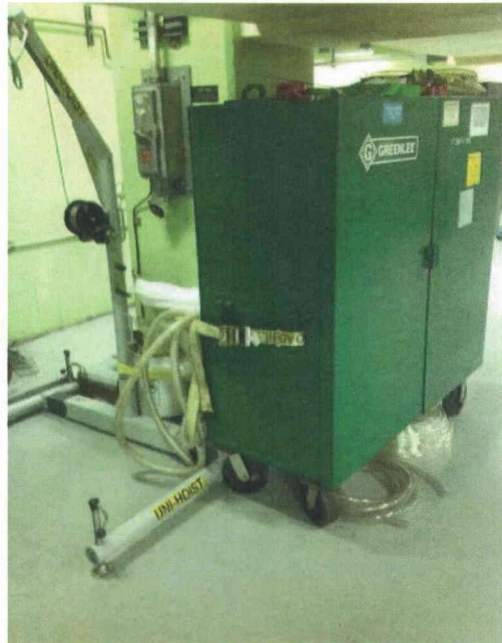
File Name: 1-69-5-3-03.jpeg
Description: Restrained storage cart located in the area

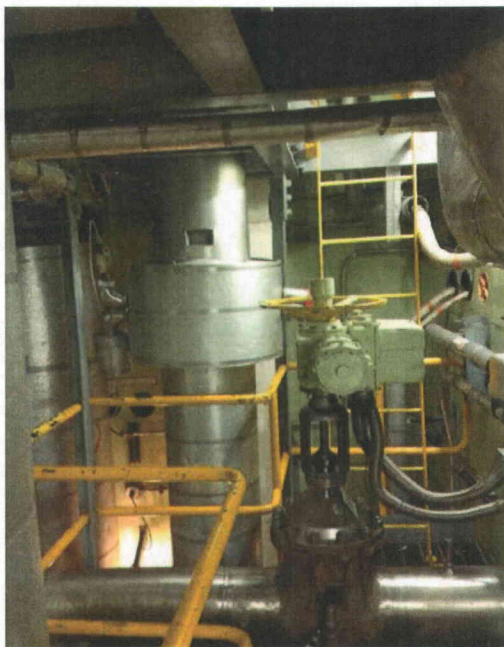
File Name: 1-59-8-3-23.jpeg
Description: General view of area

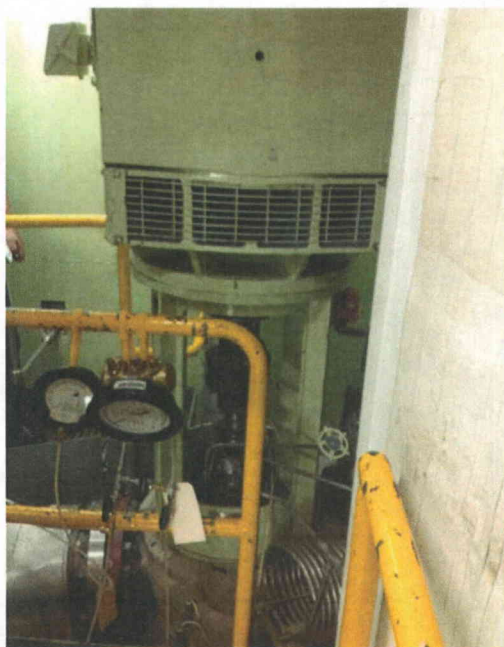
File Name: 1-60-8-3-23.jpeg
Description: View of Recirc Spray Pump 2RSS-P21A.

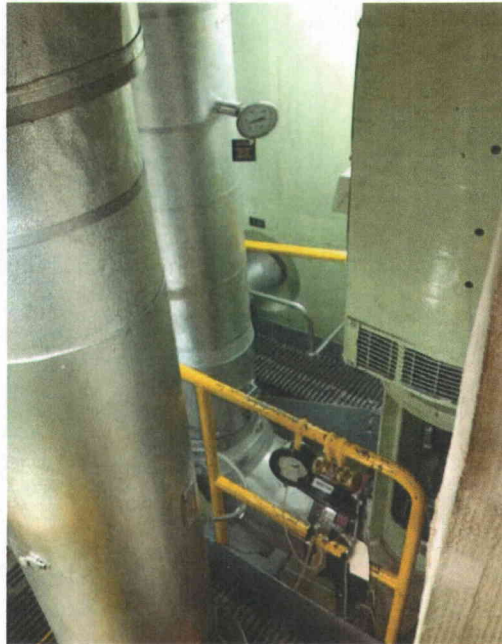
File Name: 1-67-8-3-23.jpeg
Description: Insulated line attached to 2RSS-P21A.

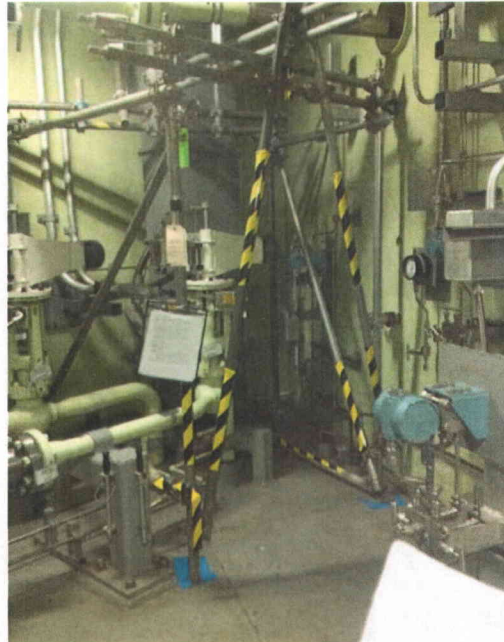
File Name: 1-60-3-3-25.jpeg
Description: Scaffold identified in the area

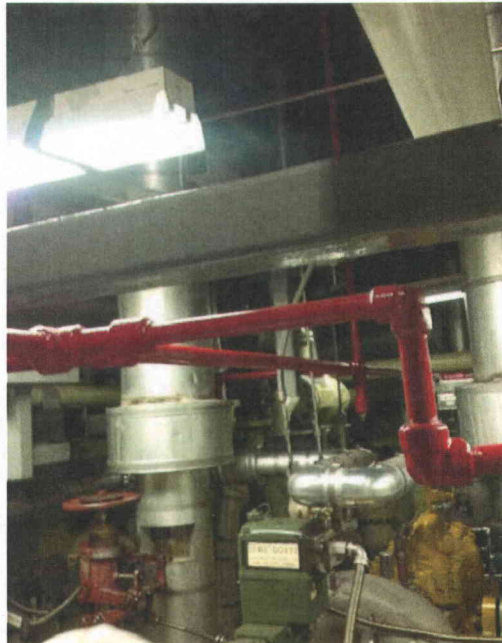
File Name: 1-59-5-3-23.jpeg

Description: General view of fire line located in the area.

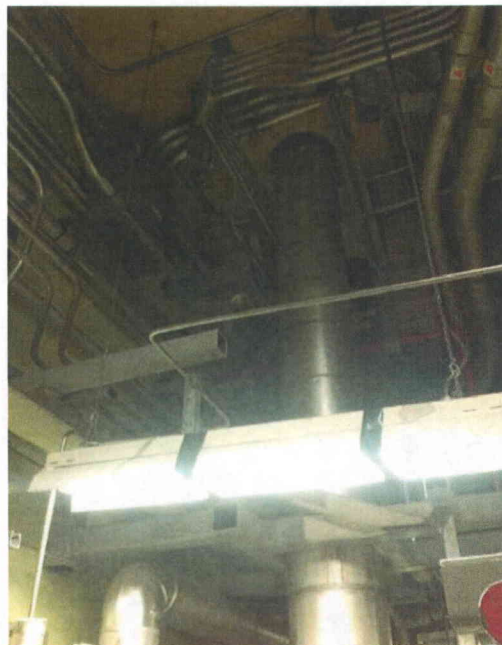
File Name: 1-60-5-3-23.jpeg

Description: General view of room's ceiling

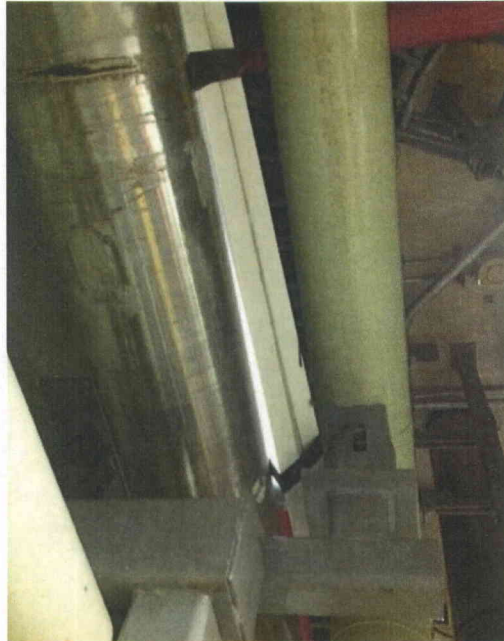
File Name: 1-65-5-3-23.jpeg
Description: Hanging light bearing on top of pipe.

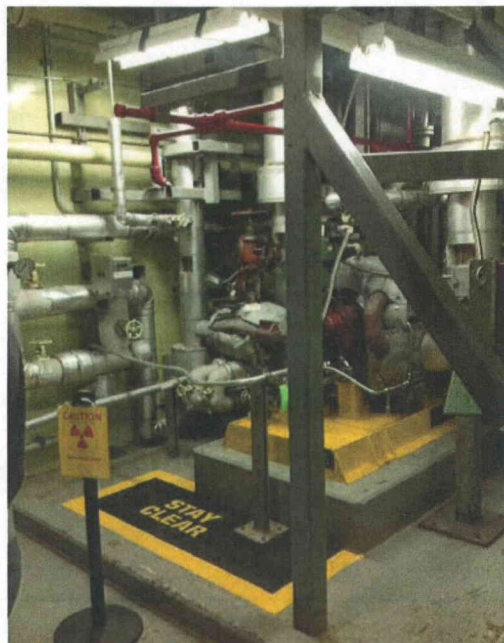
File Name: 1-66-5-3-23.jpeg
Description: General view of area
