APPENDIX C: AREA WALK-BY CHECKLISTS (AWCs)

Area Walk-By Checklist (AWC)

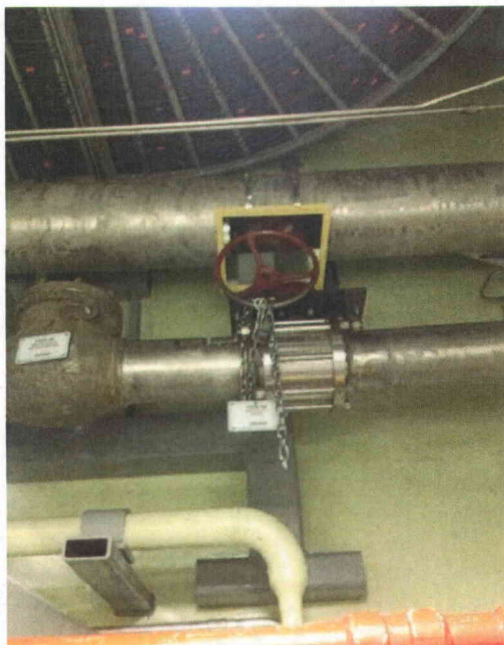
File Name: 1-67-5-3-23.jpeg
Description: Mirror located above 2FWE-P23A

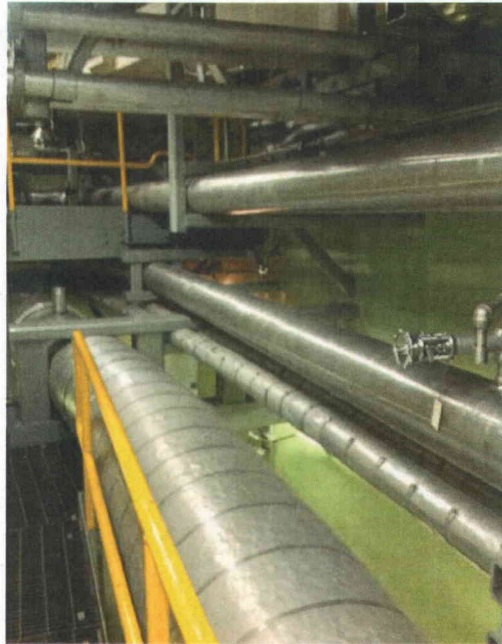
File Name: 1-59-7-3-23.jpeg
Description: View of supports for piping in the area

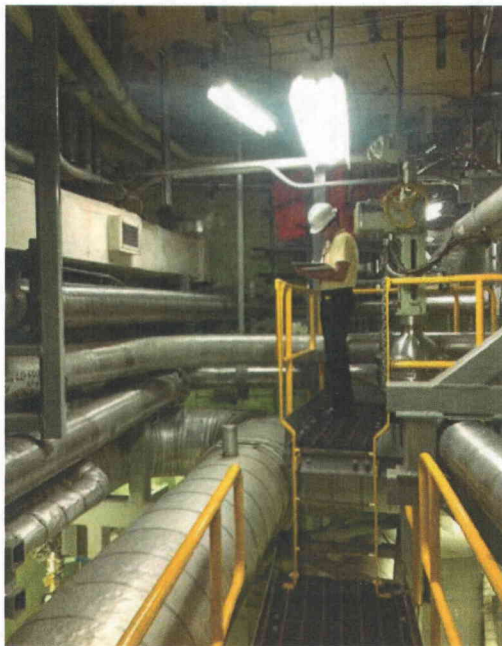
File Name: 1-60-7-3-23.jpeg
Description: General view of area

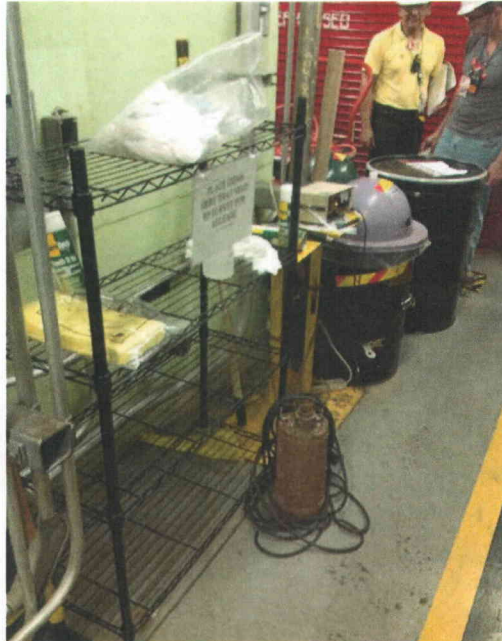
File Name: 1-59-2-3-24.jpeg

Description: Maintenance equipment and unrestrained drums located in the area near MCC. CR-2012-14420 issued to address the situation.

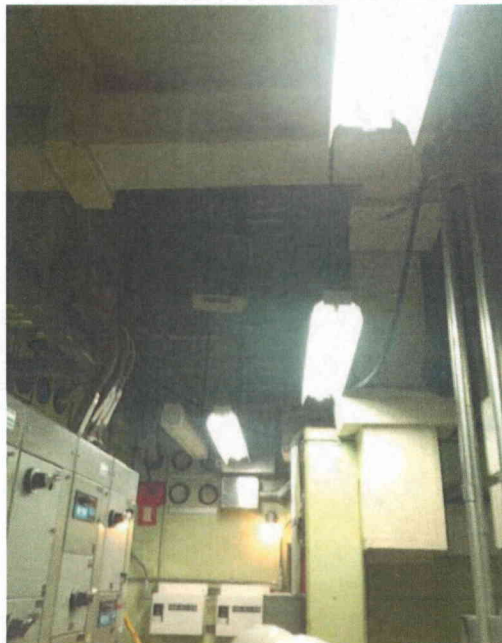
File Name: 1-60-2-3-24.jpeg

Description: View of hanging lights in the area.

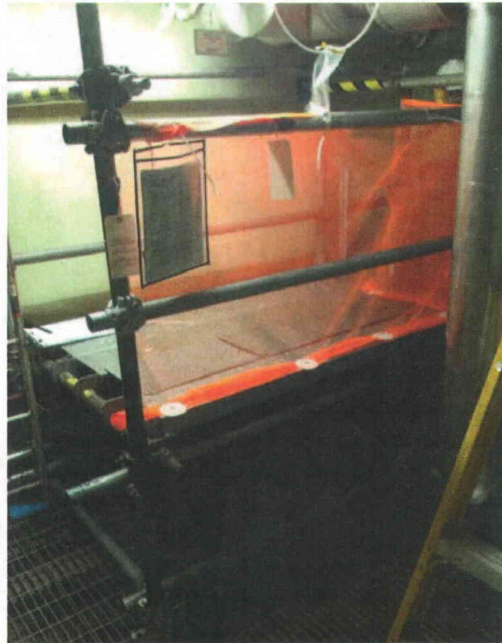
Scaffold in the area is well braced. Temporary unrestrained step ladder found in the area judged not a seismic concern.

File Name: 1-59-2-3-25.jpeg
Description: Scaffold located in the area

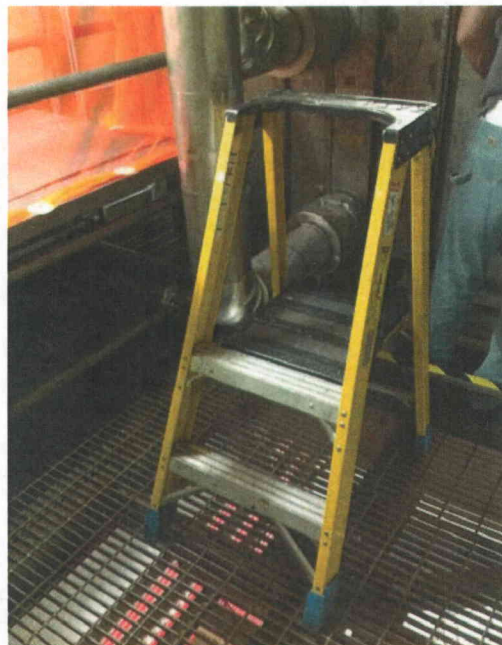
File Name: 1-60-2-3-25.jpeg
Description: Unrestrained ladder identified in the area.
Judged not a seismic concern for nearby equipment.

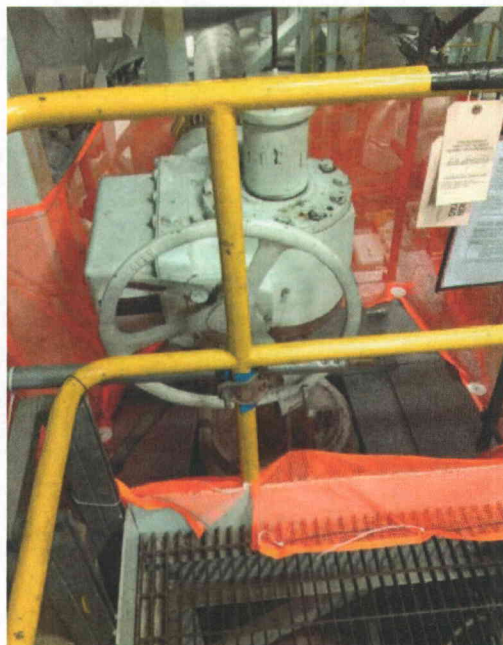
File Name: 1-65-2-3-27.jpeg
Description: Scaffold identified in the area

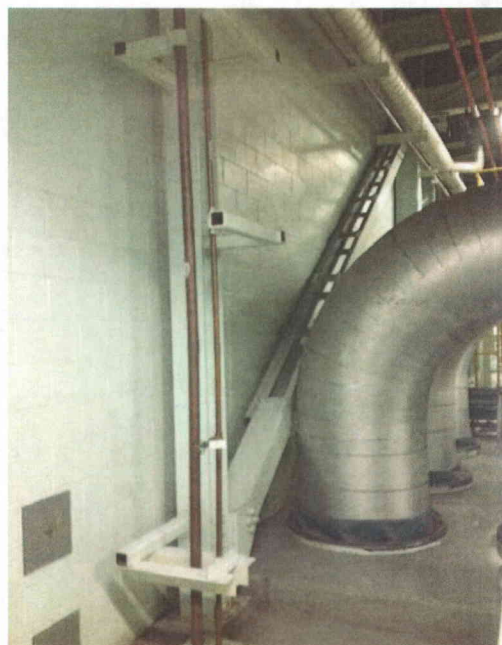
File Name: 1-68-2-3-27.jpeg
Description: Block wall identified in the area

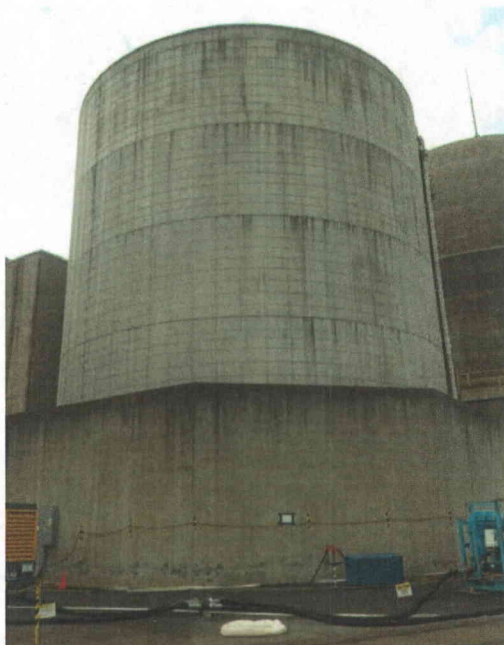
Mild surface corrosion identified on several locations around tank 2QSS-TK21. This is mostly due to humidity in the area. CR-2012-14744 and CR-2012-14749 were issued to address moderate corrosion identified on valves.

File Name: 1-65-4-3-29.jpeg
Description: View of Tank 2QSS-TK21.

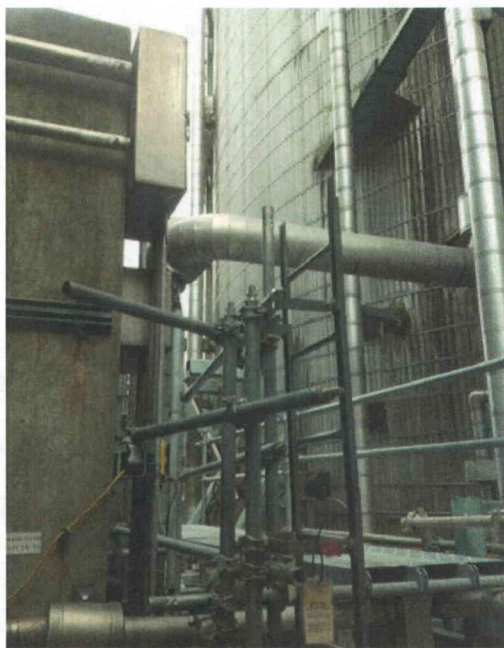
File Name: 1-60-4-3-29.jpeg
Description: Scaffold located in the area.

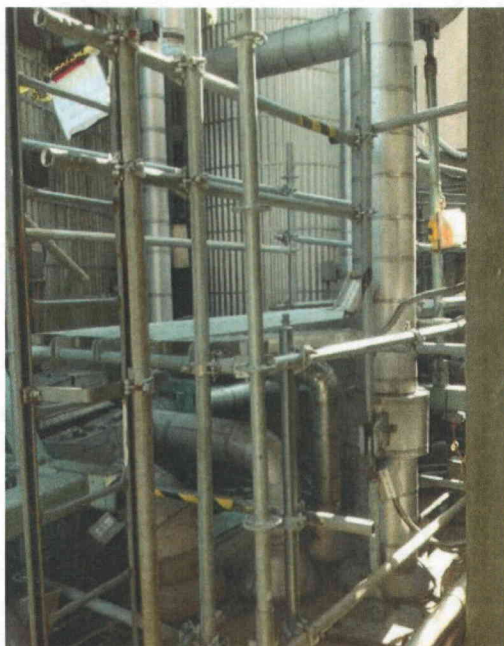
File Name: 1-67-4-3-29.jpeg
Description: Scaffold located in the area.

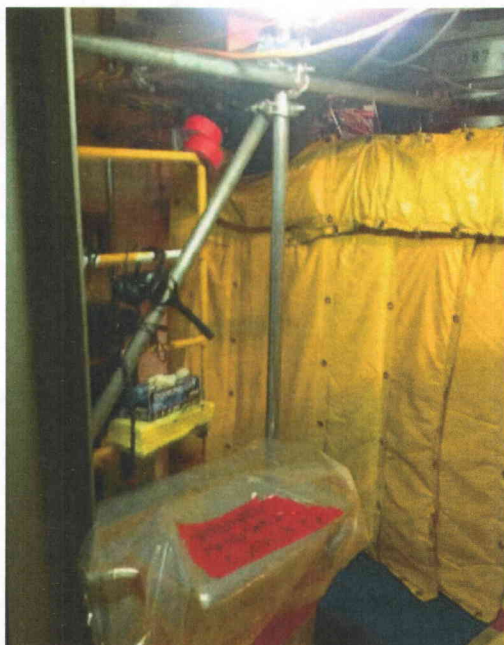
File Name: 1-59-6-3-19.jpeg
Description: View of scaffold in the area

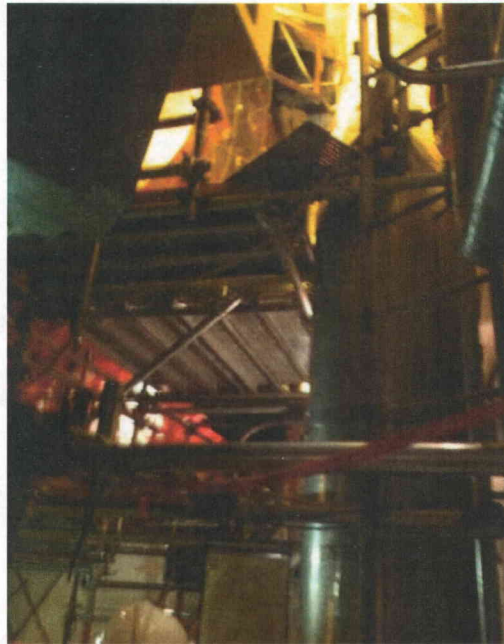
File Name: 1-65-6-3-19.jpeg
Description: View of scaffold in the area

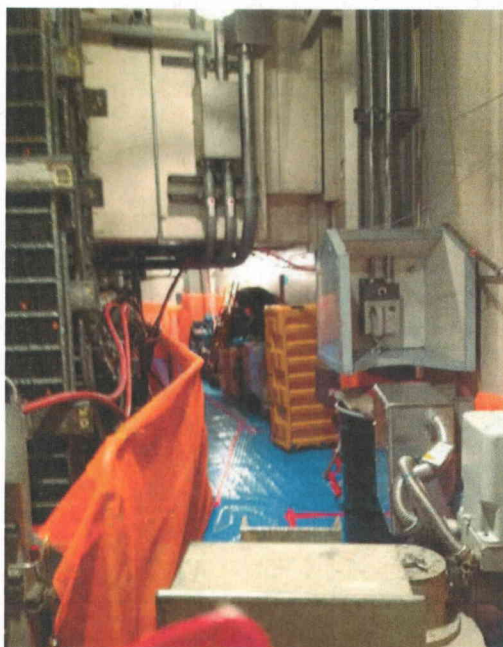
File Name: 1-60-2-3-19.jpeg
Description: View of maintenance equipment in the area

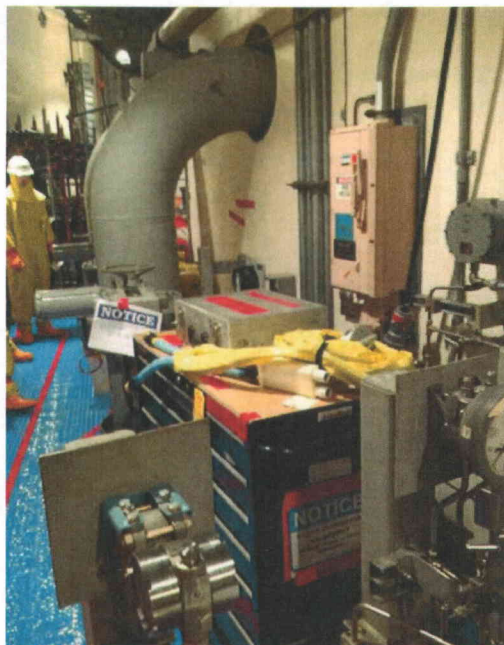
File Name: 1-59-4-3-19.jpeg
Description: Temporary outage related maintenance equipment

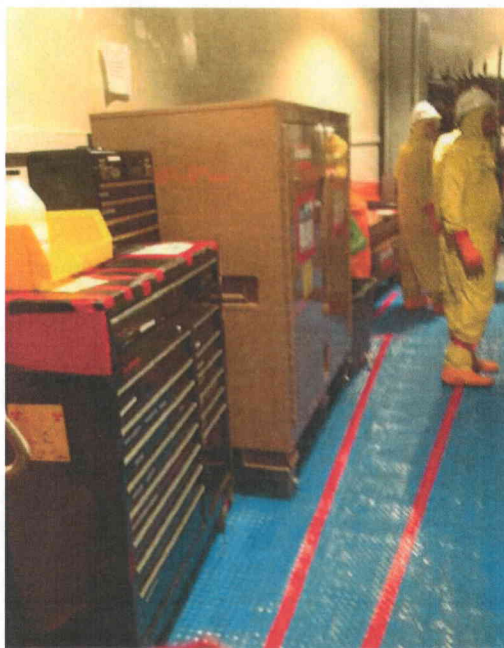
File Name: 1-60-4-3-19.jpeg
Description: Temporary outage related maintenance equipment

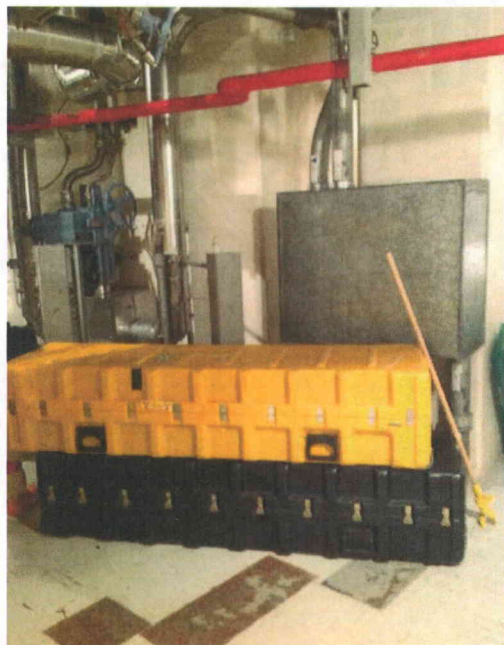
File Name: 1-59-4-3-17.jpeg
Description: View of heavy storage boxes in the area.

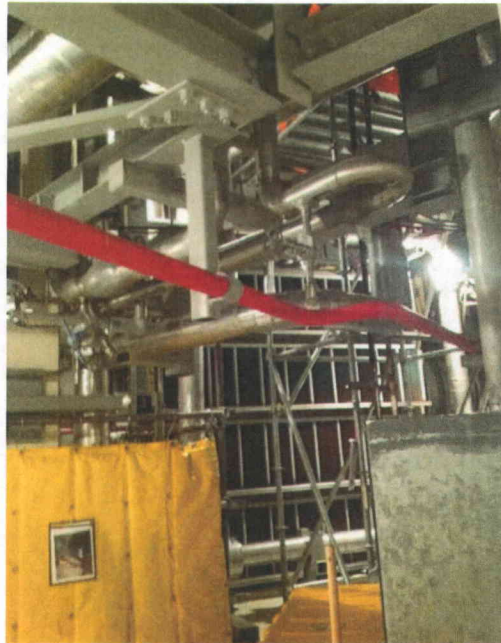
File Name: 1-65-4-3-17.jpeg
Description: View of scaffold in the area

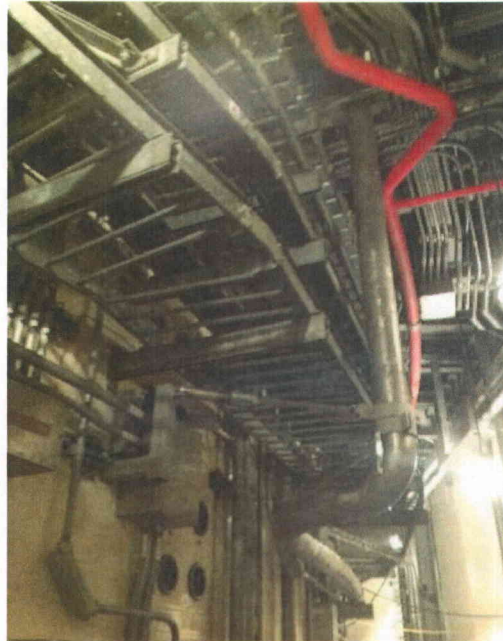
File Name: 1-59-5-3-19.jpeg

Description: General view of cable trays and fire line in the area

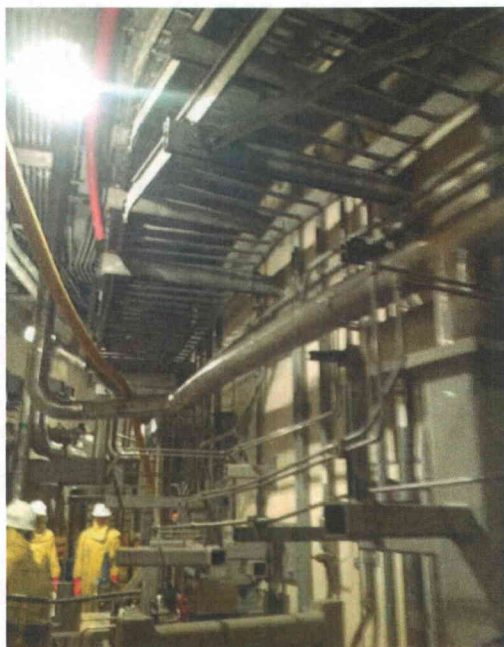
File Name: 1-66-5-3-19.jpeg

2. Does anchorage of equipment in the area appear to be free of significant degraded conditions?
Wall mounted supports for piping and cable trays were identified to be in good condition.

Description: View of wall mounted supports for piping and cable trays.

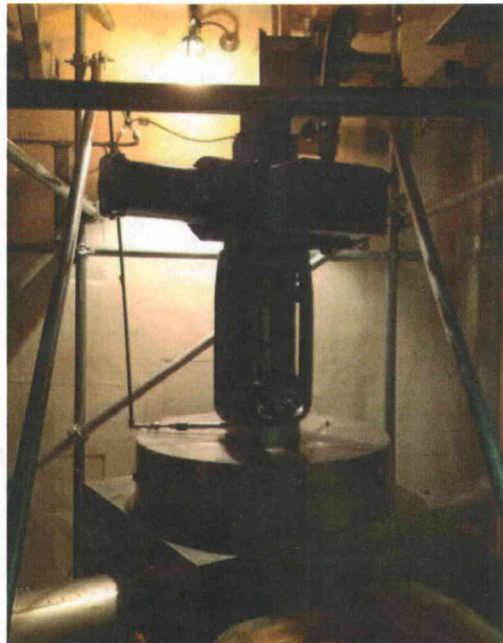
File Name: 2-61-5-2-19.jpeg
Description: General view of 2RHS-MOV720A

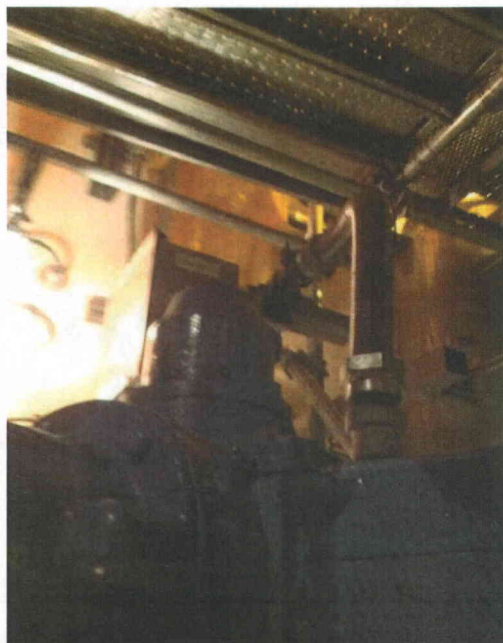
File Name: 2-62-5-2-19.jpeg
Description: View of scaffolding above 2RHS-MOV720A
