APPENDIX C
AREA WALK-BY CHECKLISTS (AWCs)

Area Walk-By Checklist (AWC)

Room 105 Floor El. 545 Bldg. AUXB

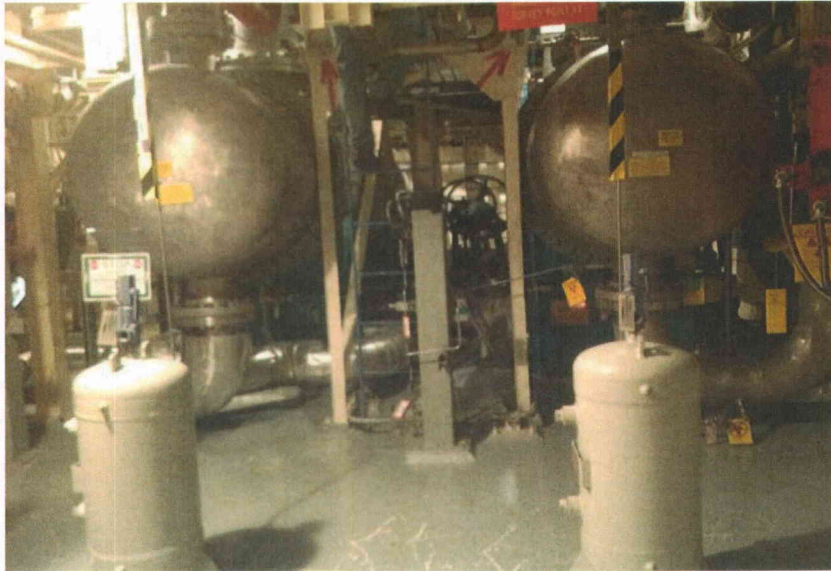
Photo 1
General View of Room 113

Temporary scaffolding installed in area, judged not likely to cause interaction.

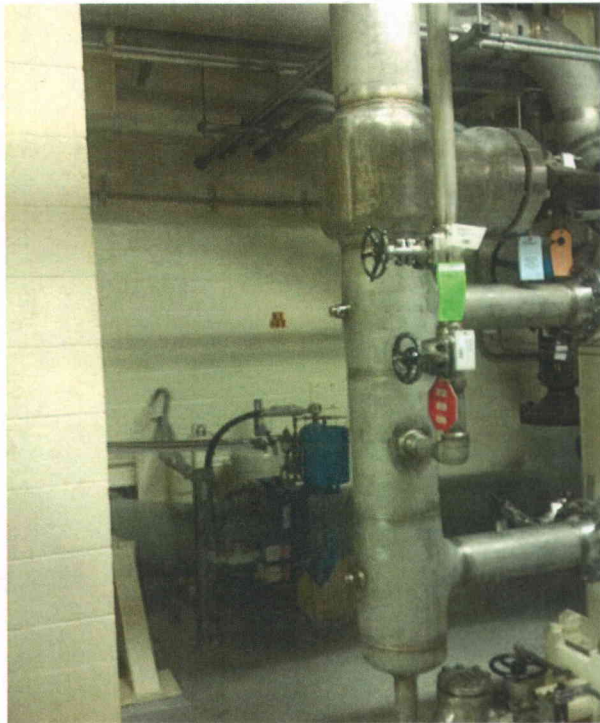
Photo 1
General View of Room 312
Showing Masonry Walls

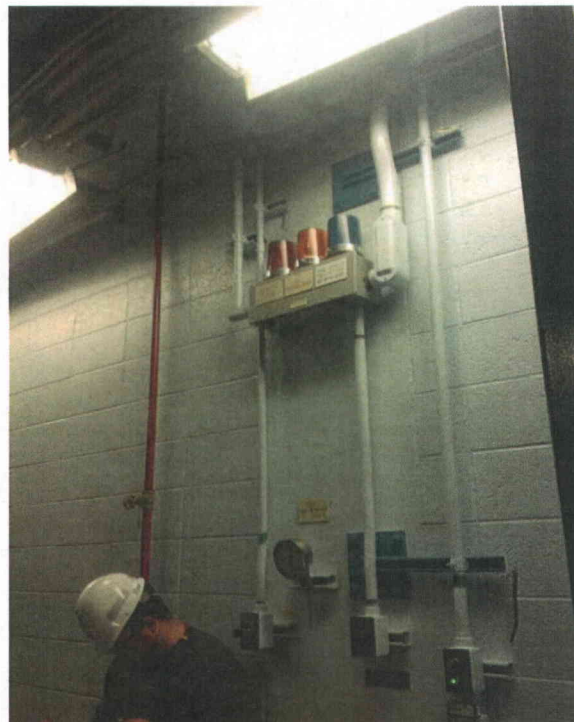
Photo 1
Masonry Wall

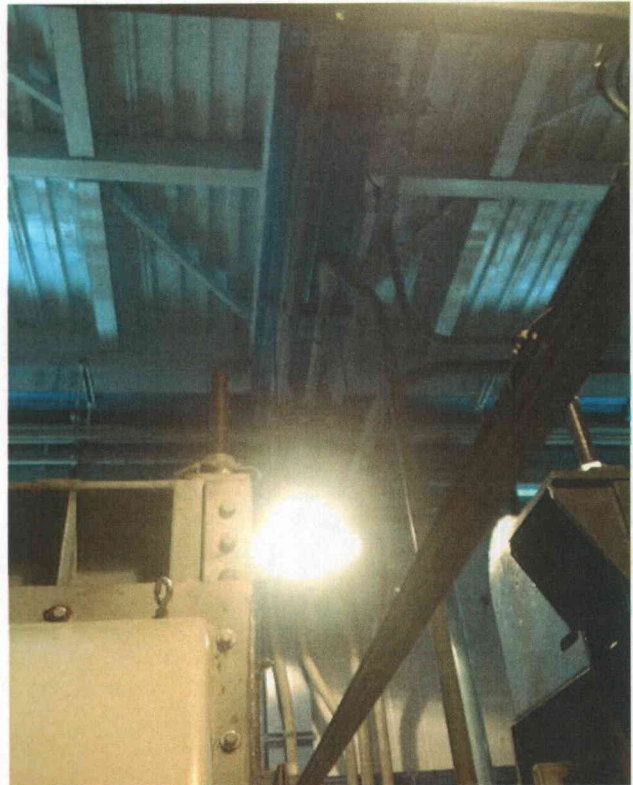
Photo 2
Rod Hung Pipes
