## **APPENDIX B: SEISMIC WALK-DOWN CHECKLISTS (SWCs)**

**Seismic Walkdown Checklist (SWC)**

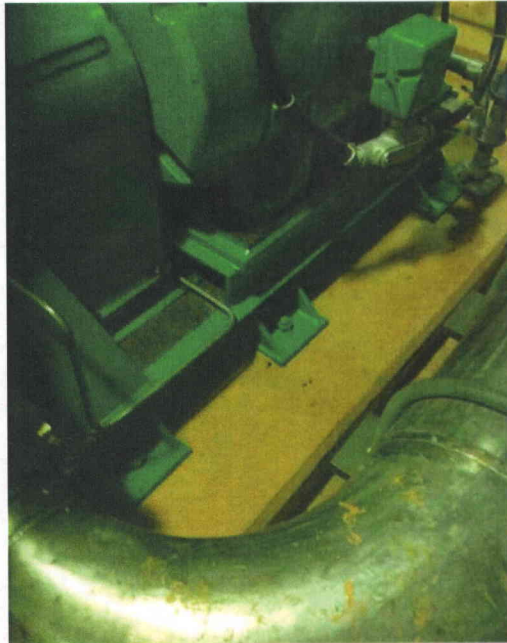
File Name: 2-63-2-4-21.jpeg

Description: View of component anchorage configuration

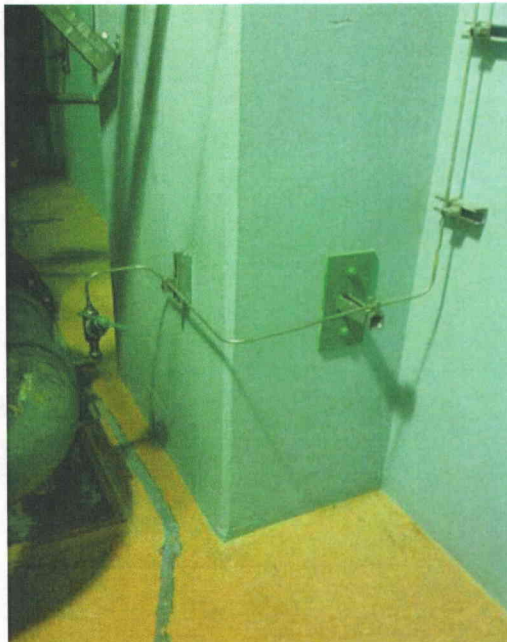
File Name: 2-64-2-4-21.jpeg

Description: View of small tube line supports

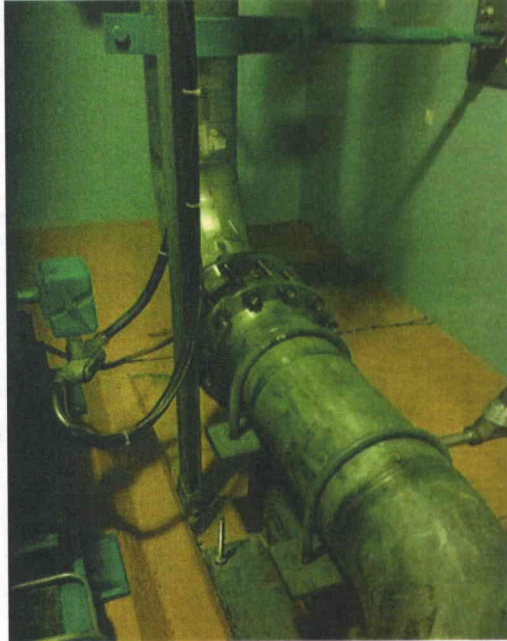
File Name: 2-61-4-4-21.jpeg

Description: View of valve location in main pipe line

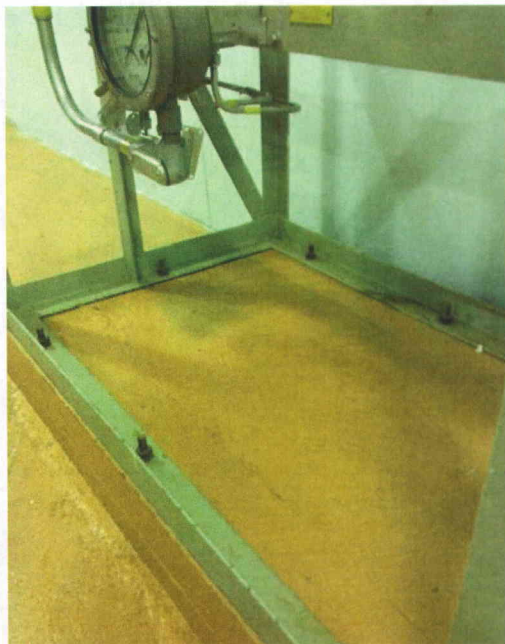
File Name: 2-63-7-4-01.jpeg  
Description: Anchorage view of component

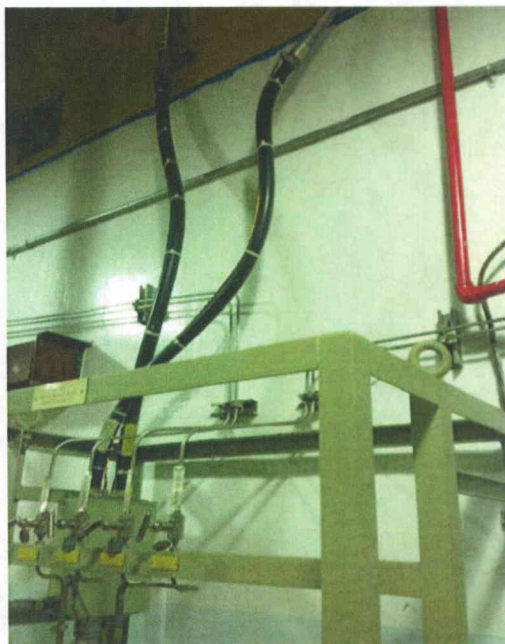
File Name: 2-64-7-4-01.jpeg  
Description: View of attached top lines

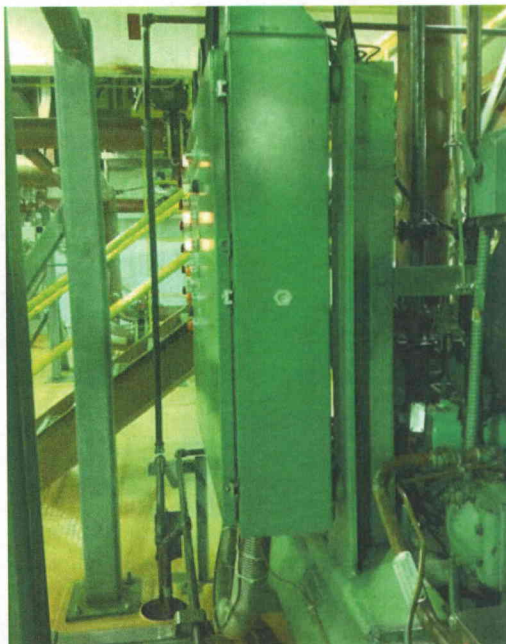
File Name: 2-64-1-1-01.jpeg  
Description: Isolators, plate welded to chiller

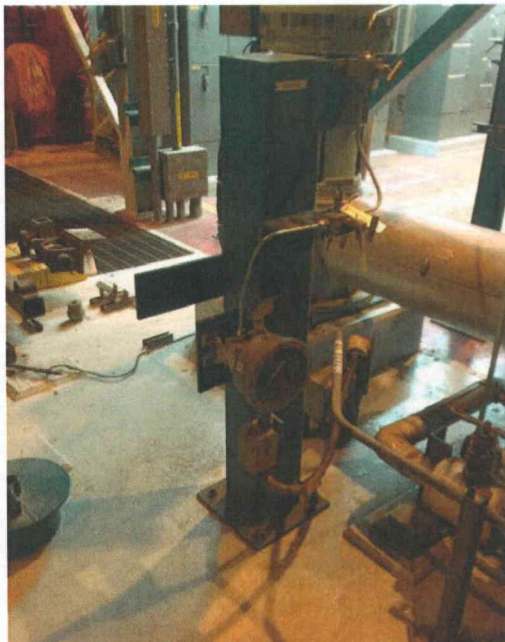
File Name: 2-62-3-1-05.jpeg  
Description: Attached lines with adequate flexibility

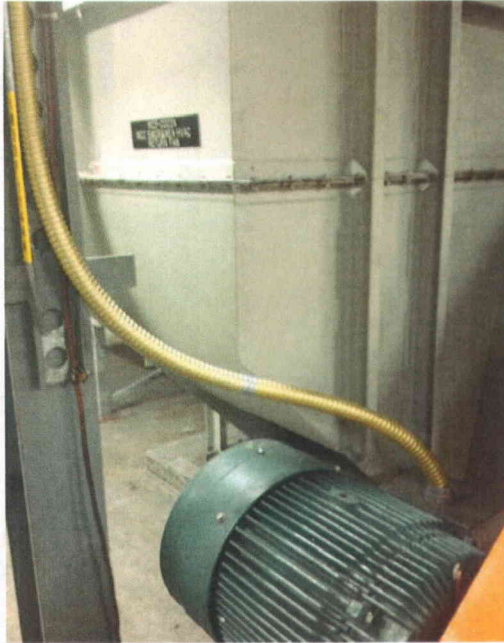
File Name: 2-73-3-4-04.jpeg  
Description: View of attached line

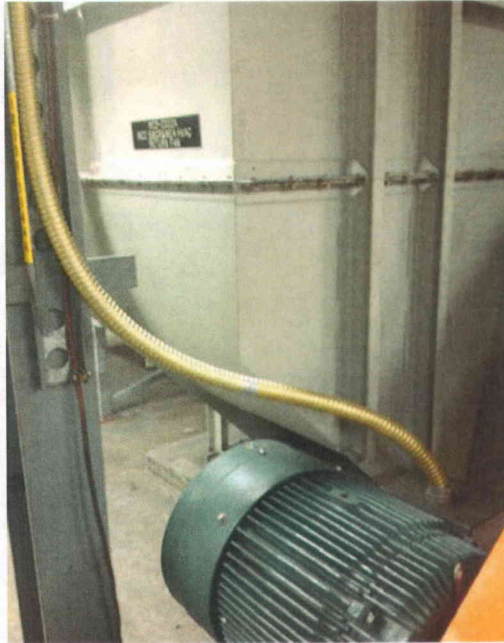
File Name: 2-73-3-4-04.jpeg  
Description: View of attached line

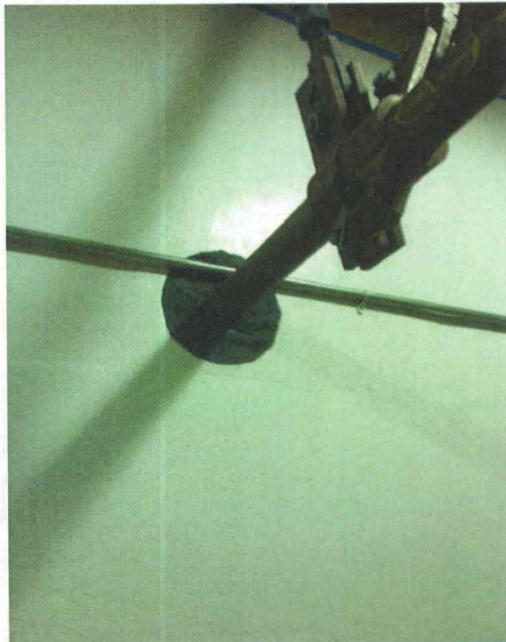
File Name: 2-64-8-4-01.jpeg  
Description: View of insulation material in concrete wall

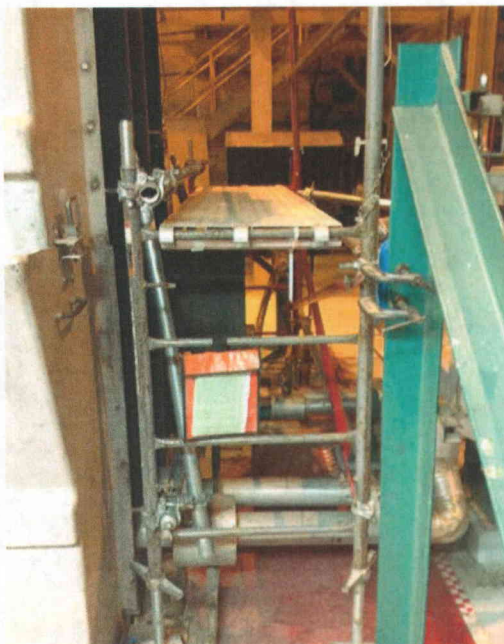
*Scaffolding identified next to screen. Scaffolding properly tied and supported thus no adverse potential condition.*

File Name: 2-94-2-4-05.jpeg  
Description: Scaffold located near component

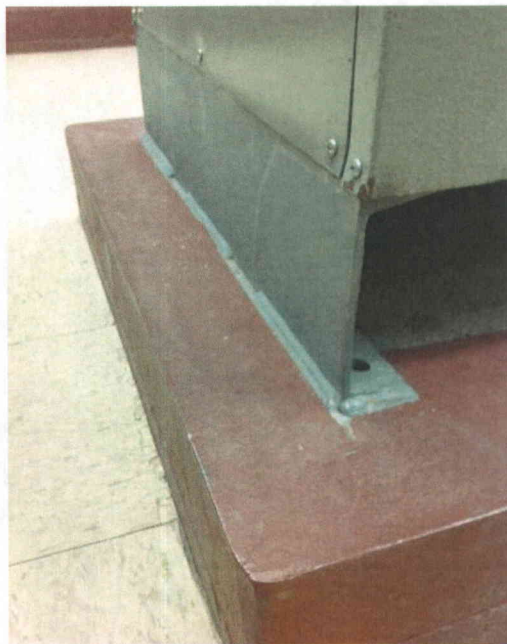
File Name: 2-64-6-1-06.jpeg  
Description: View of base anchorage detail

*Slight surface corrosion identified but judged not a concern.*

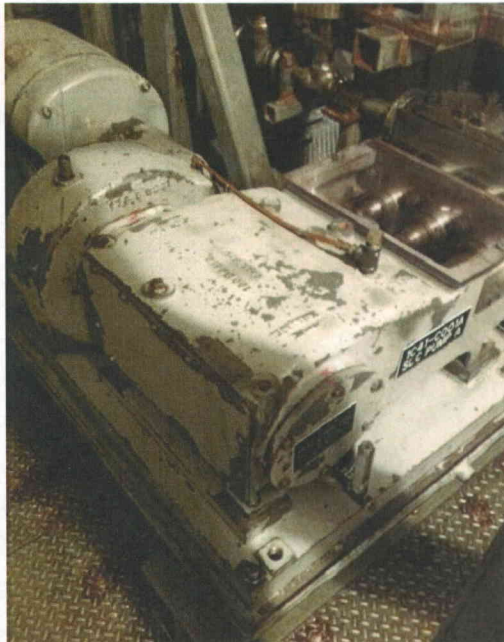
File Name: 2-62-1-4-12.jpeg

Description: General view of Component

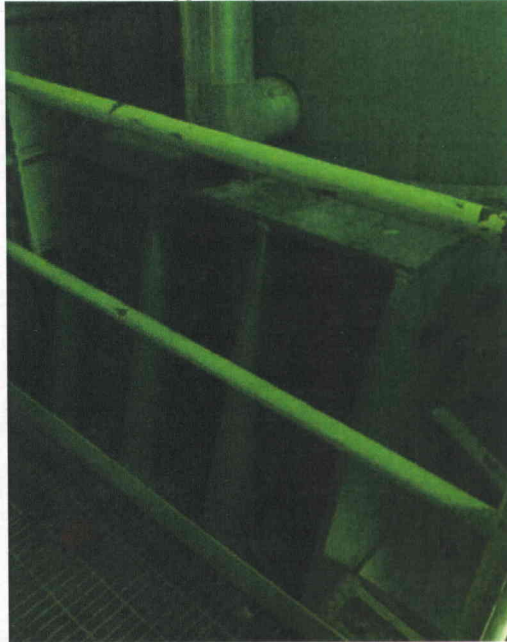
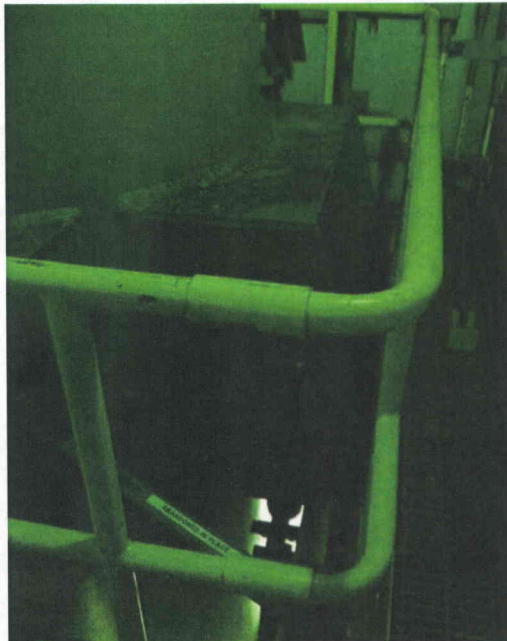
File Name: 2-61-1-4-20.jpeg  
Description: Anchorage view of component

File Name: 2-62-1-4-20.jpeg  
Description: View of anchorage detail of component

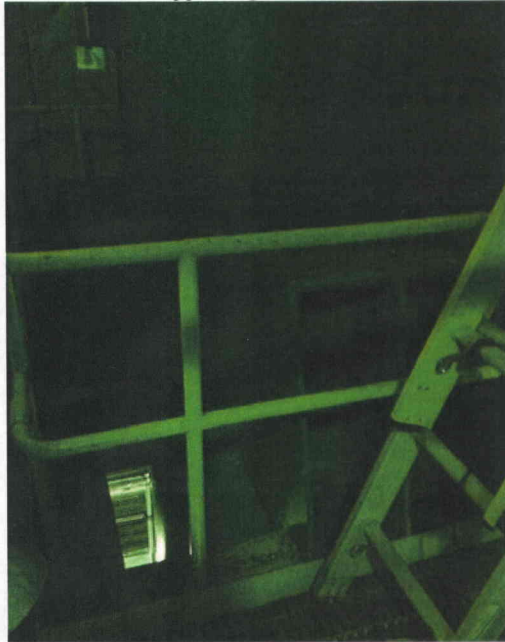
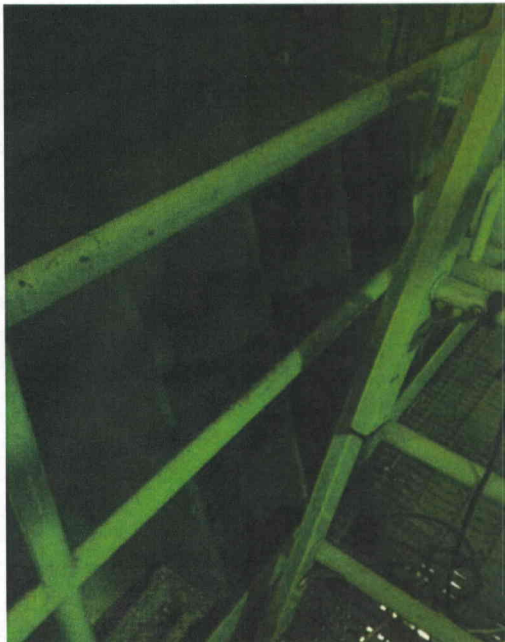
File Name: 2-61-2-4-20.jpeg  
Description: Anchorage view of component

File Name: 2-62-2-4-20.jpeg  
Description: View of anchorage detail of component

*24 total 2" anchors. No degradation identified for anchors and base plate.*

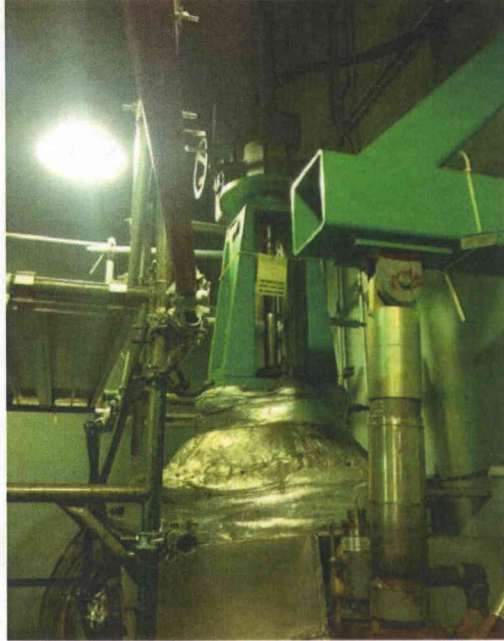
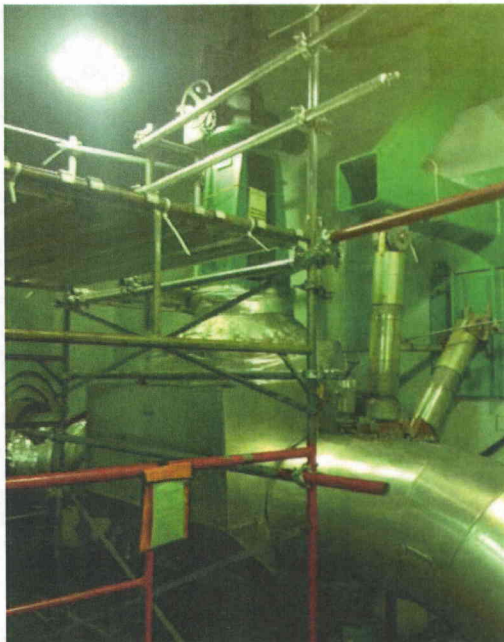
Description: View of valve location in main pipe line

Description: General view of component

*Heavy yoke manual valve identified. No degraded condition and pipe line shows adequate support.*

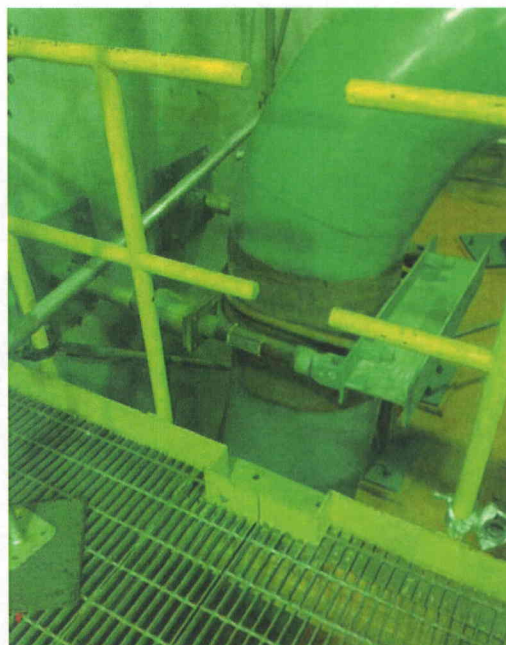
File Name: 2-94-8-4-18.jpeg  
Description: View of main pipe line support configuration

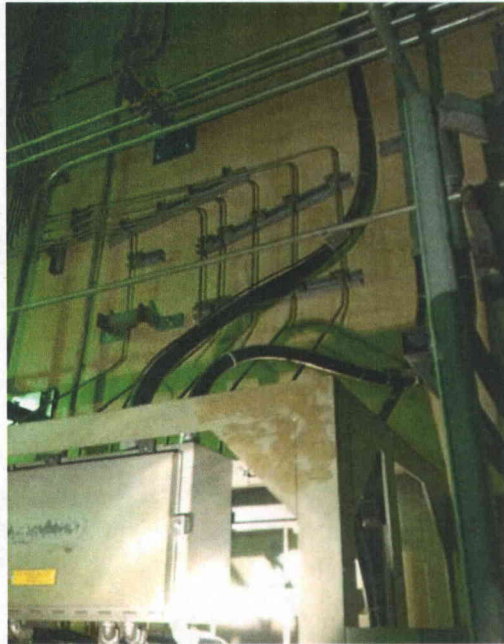
File Name: 2-73-7-4-18.jpeg  
Description: View of top attached lines

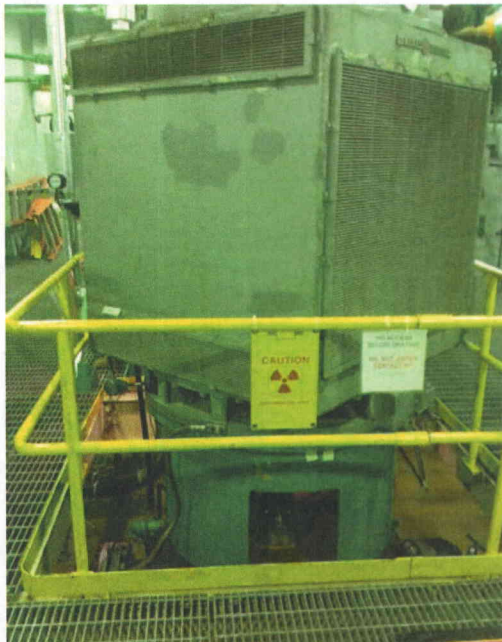
File Name: 2-62-14-4-18.jpeg  
Description: General view of Component

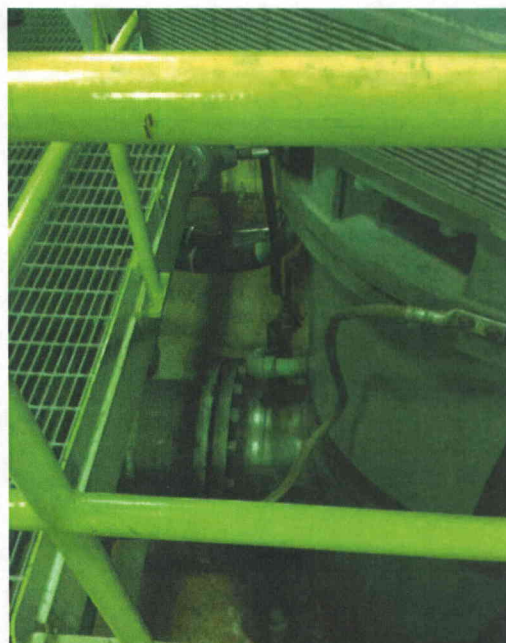
File Name: 2-64-14-4-18.jpeg  
Description: View of attached lines to component

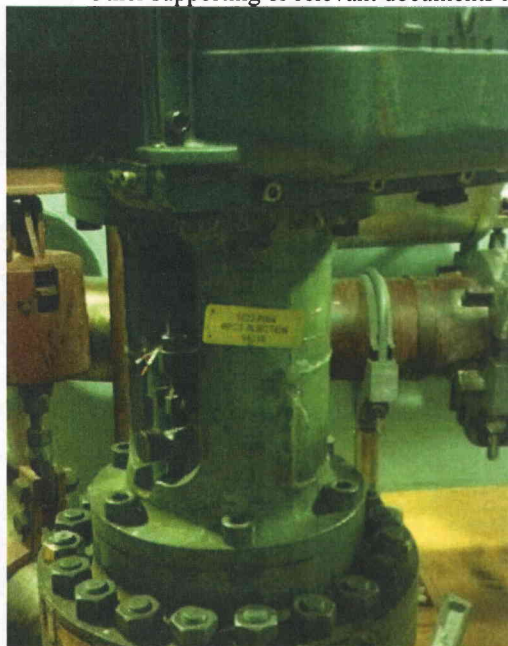
File Name: 2-61-1-4-10.jpeg  
Description: Component Plate ID

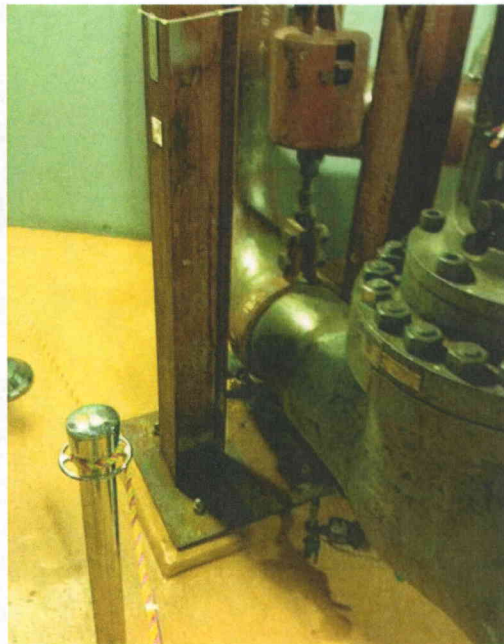
File Name: 2-64-1-4-10.jpeg  
Description: View of main line support configuration

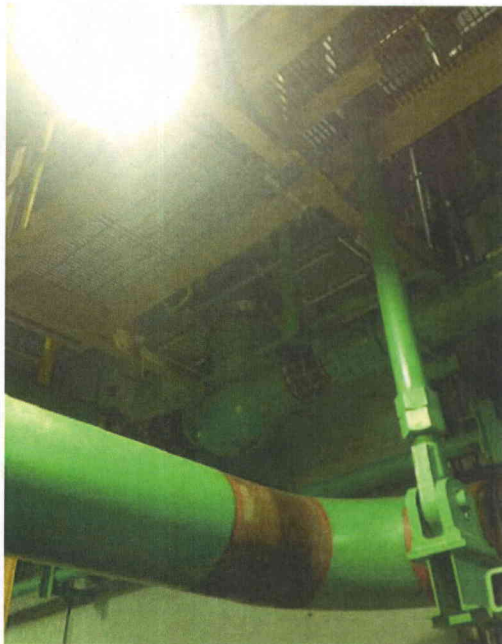
File Name: 2-62-12-4-18.jpeg

Description: General view of Component

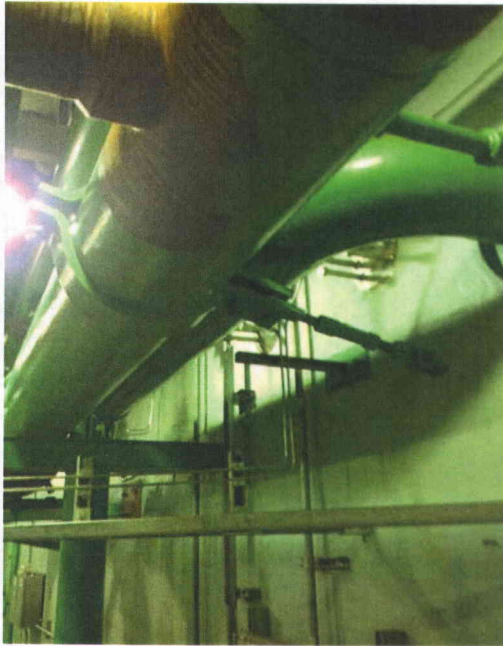
File Name: 2-63-13-4-18.jpeg

Description: View of pipe line lateral supports

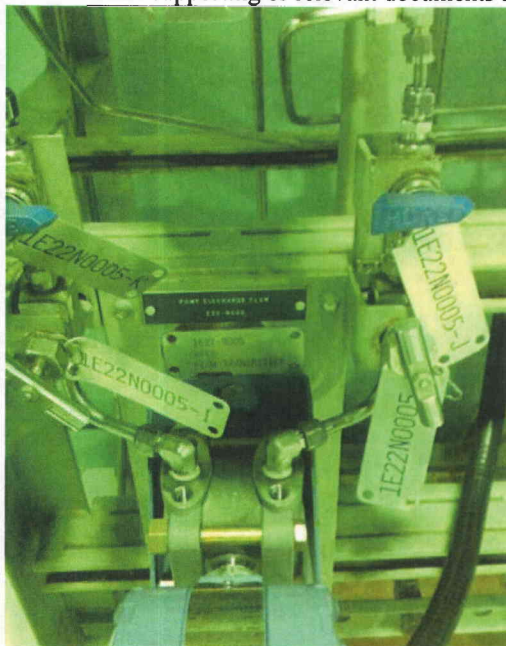
File Name: 2-61-5-4-18.jpeg  
Description: Component Plate ID

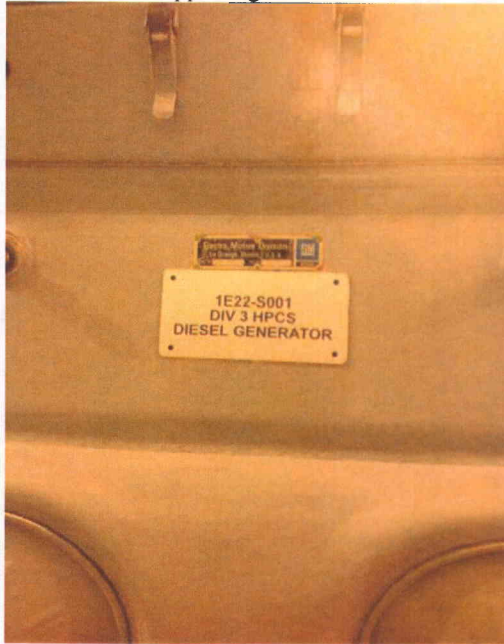
File Name: 2-61-12-4-08.jpeg  
Description: Component Plate ID

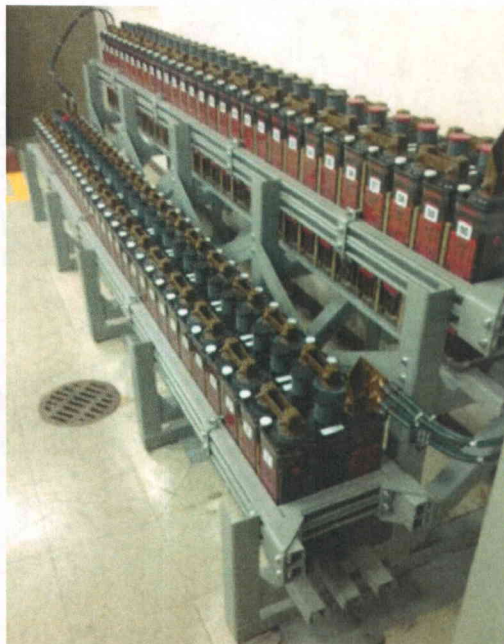
File Name: 2-62-5-4-06.jpeg  
Description: General view of Component

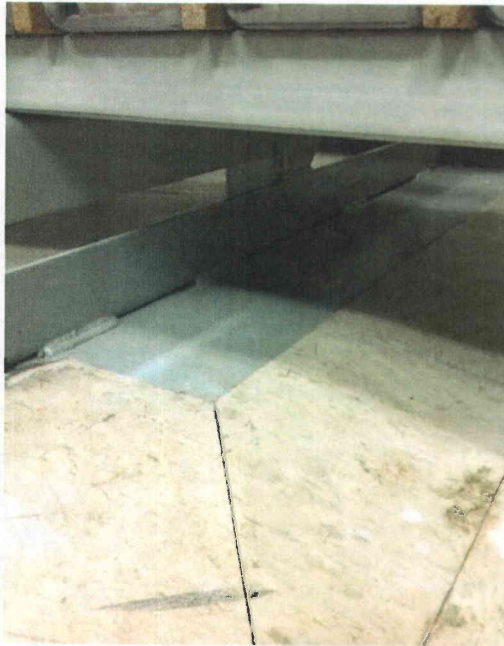
File Name: 2-63-5-4-06.jpeg  
Description: View of component base detail
