appendix B - Lake County Stormwater Management Commission stream inventory photographs

Appendix B includes photographs taken during the Lake County Stormwater Management Commission 2001 stream inventory. Photographs are organized sequentially by reach. The photograph identification numbers correspond to specific Geographic Positioning System coordinates within the watershed, which allows one to review the 2001 conditions in relation to the action plan recommendations (see Appendix H) or to current conditions. Photographs can also be reviewed in relation to the inventory data sheets in Appendix O.

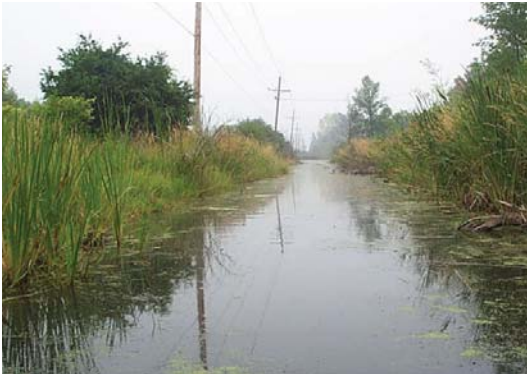
Photo 427 - Representative reach

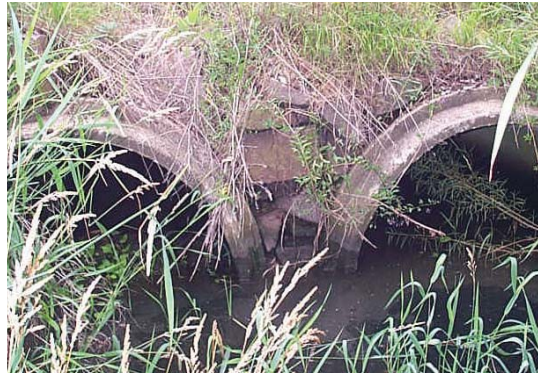
Photo 428 - Culverts

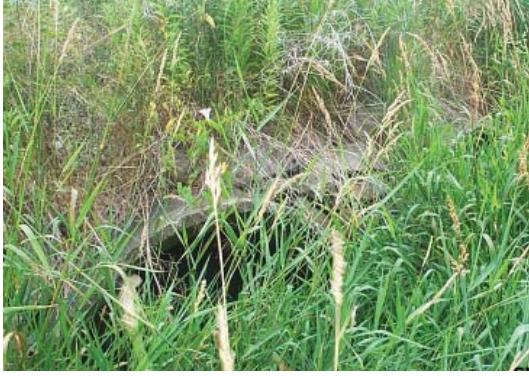
Photo 429 - Culverts at railroad tracks

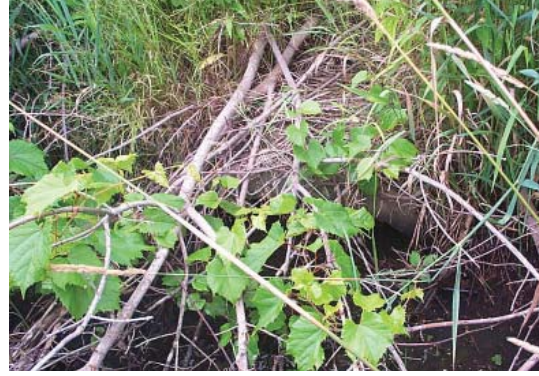
Photo 430 - Culvert

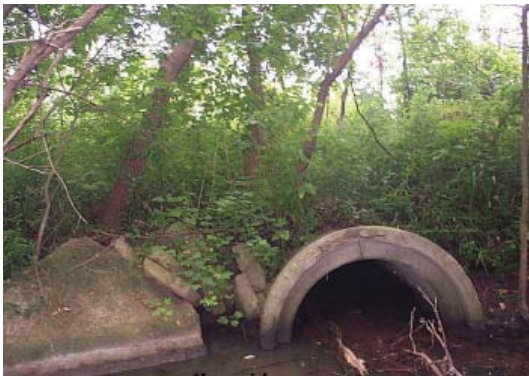
Photo 431 - Other side of culvert

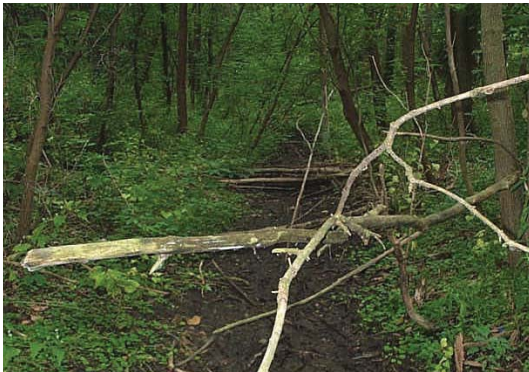
Photo 433 - Open channel

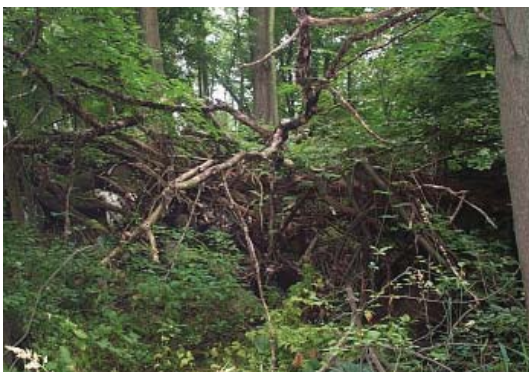
Photo 435 - Debris - left bank

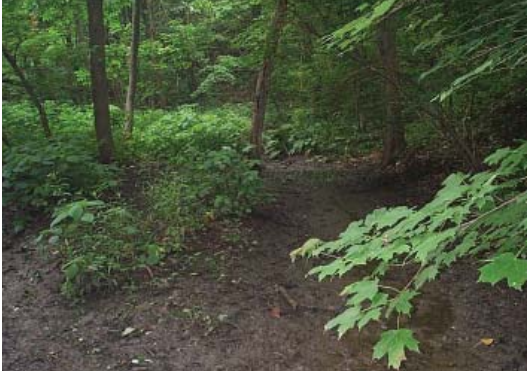
Photo 437 - Open channel

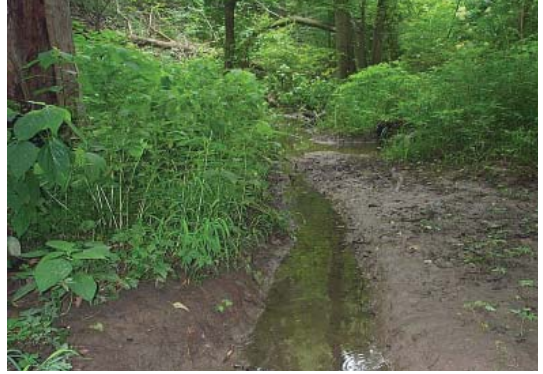
Photo 438 - Open channel

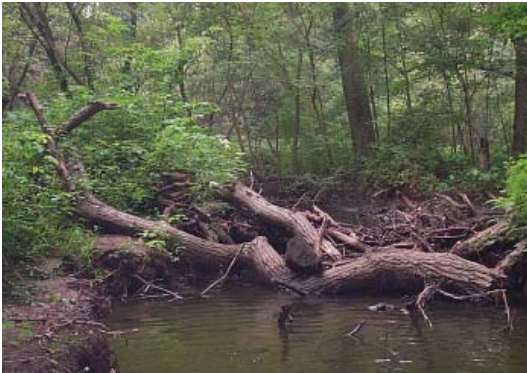
Photo 439 - Debris - log jam

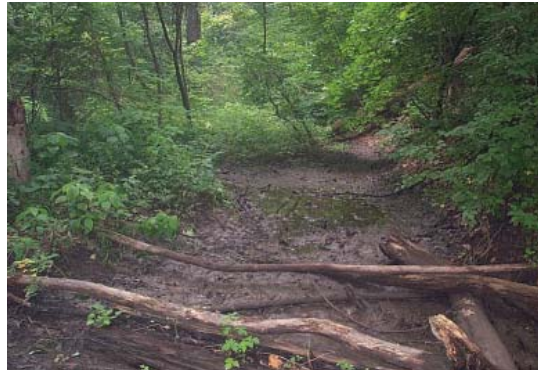
Photo 440- Open channel

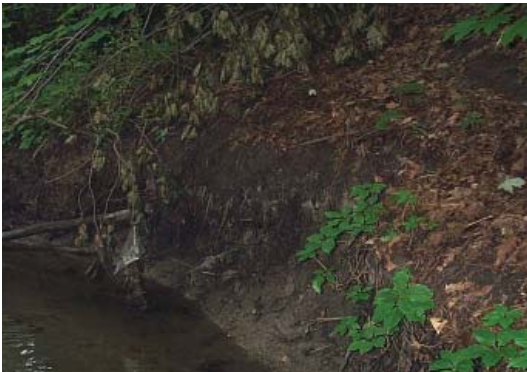
Photo 441 - Erosion

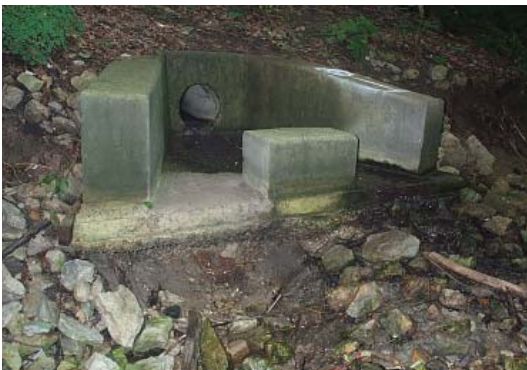
Photo 443 - Drain pipe

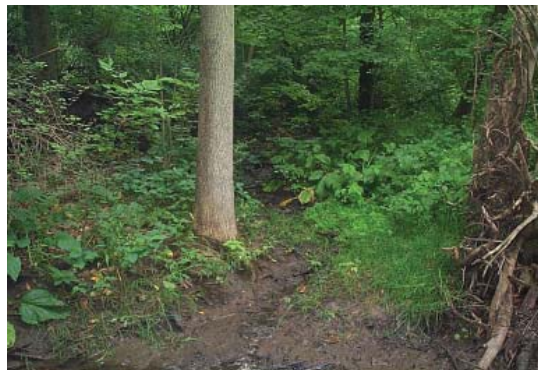
Photo 444 - Open channel

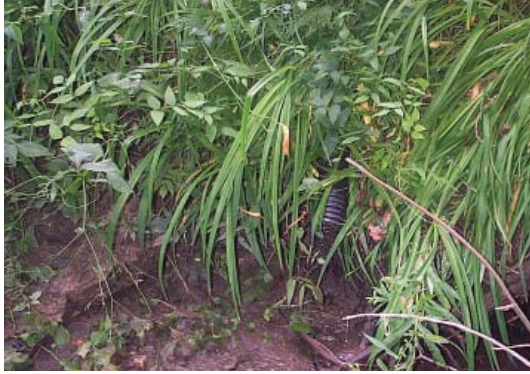
Photo 445 - Drain pipe

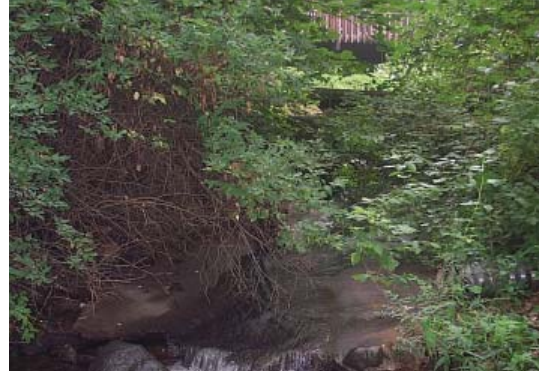
Photo 446 - Concrete/drain pipes

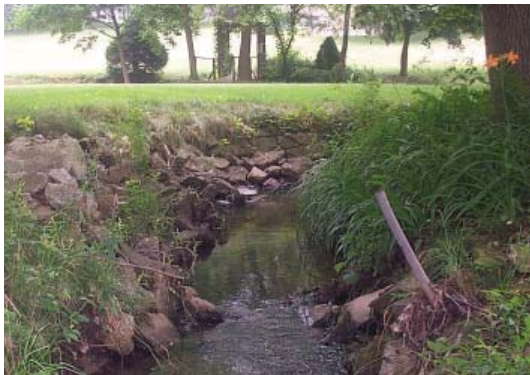
Photo 447 - Armoring

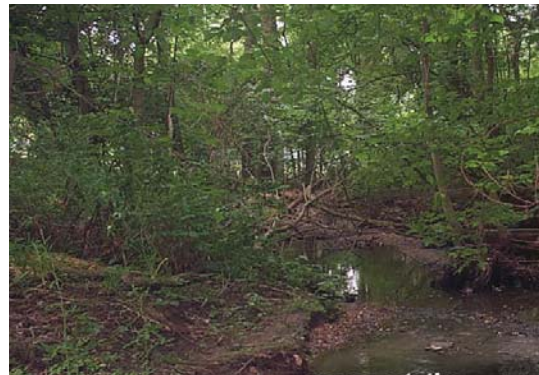
Photo 448 - Representative reach

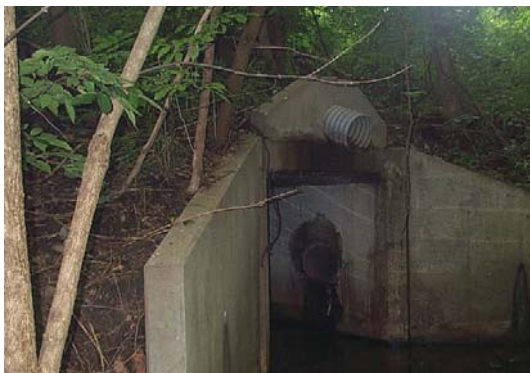
Photo 449 - Culvert/ 2 drain pipes

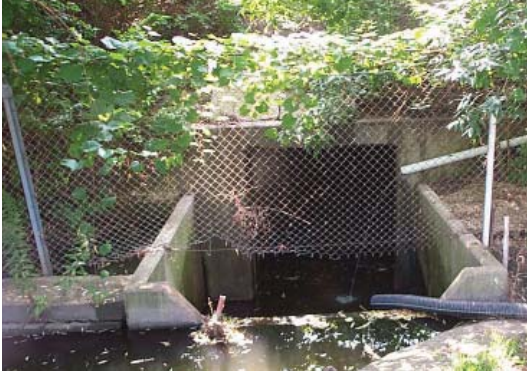
Photo 69 - Culvert/drain pipes/dam

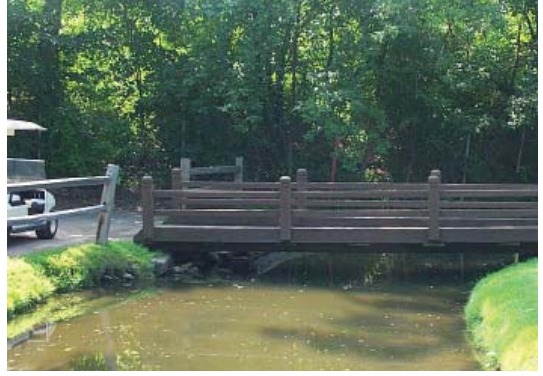
Photo 70 - Bridge

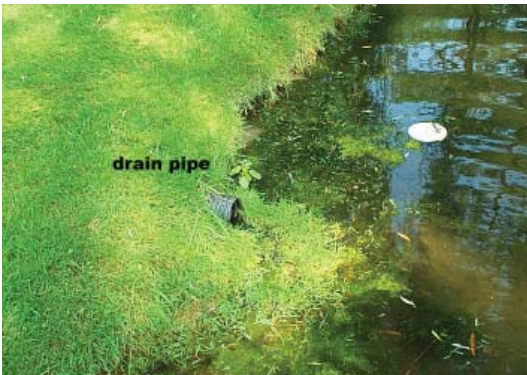
Photo 71 - Drain pipe

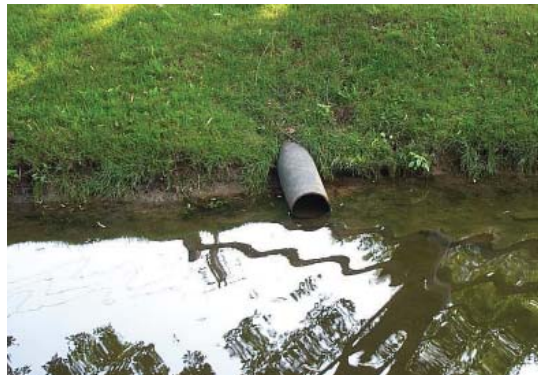
Photo 72 - Drain pipe

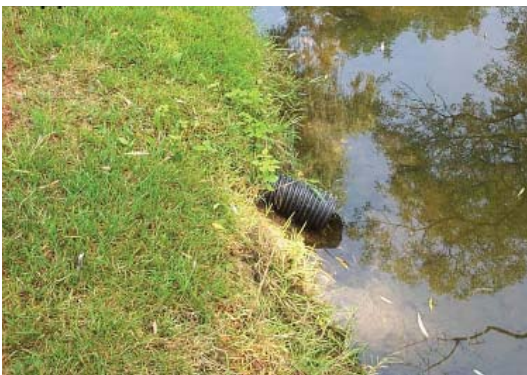
Photo 73 - Drain pipe

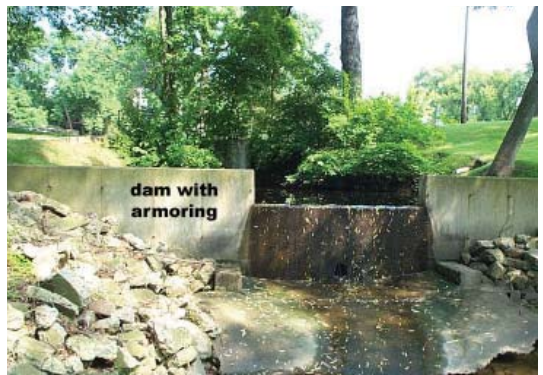
Photo 74 - Dam with armoring

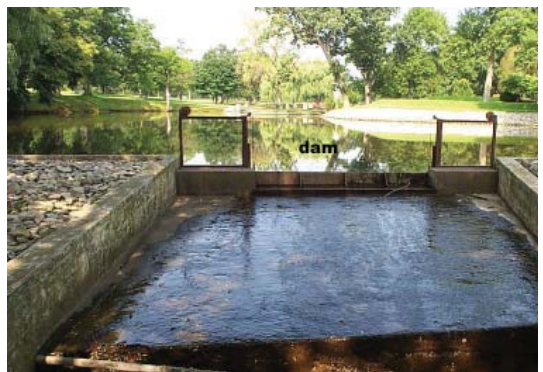
Photo 76 - Dam

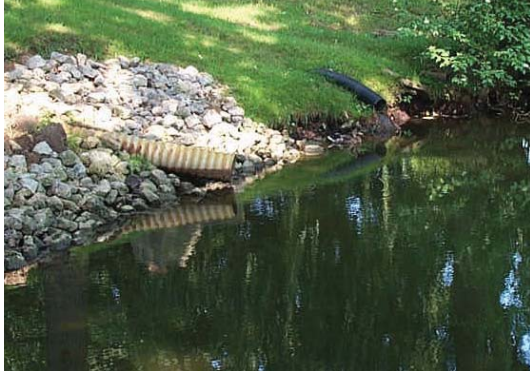
Photo 77 - Drain pipes x2

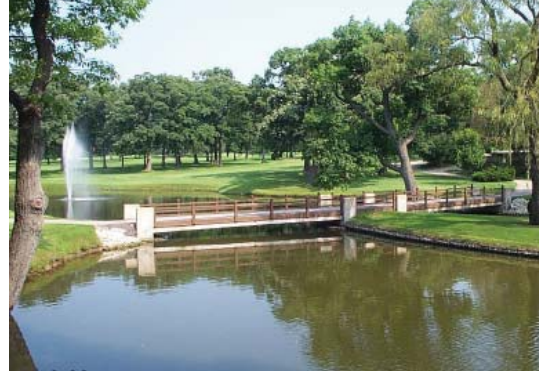
Photo 78 - Bridge

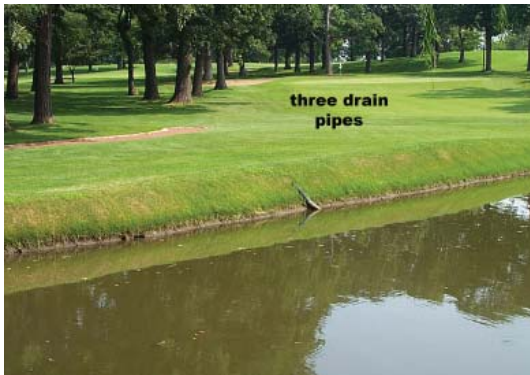
Photo 79 - Drain pipes x3

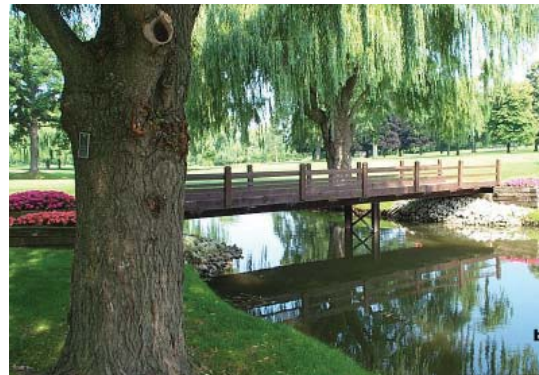
Photo 80 - Bridge

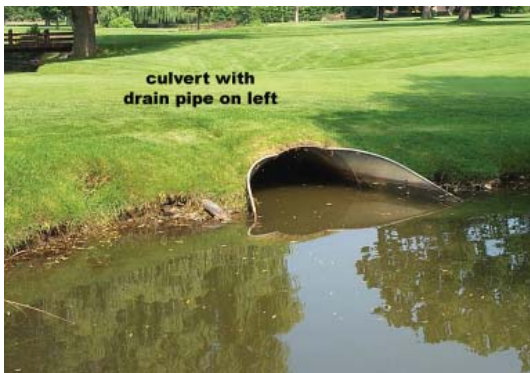
Photo 81 - Culvert with drain pipe

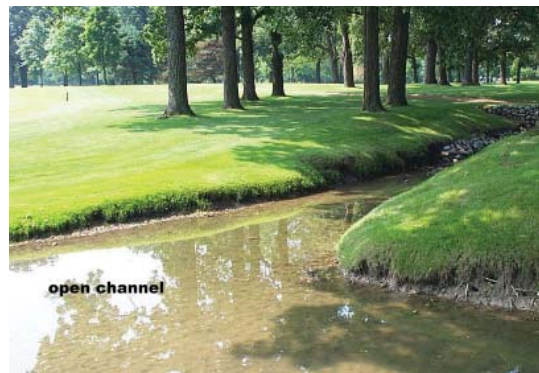
Photo 82 - Open channel

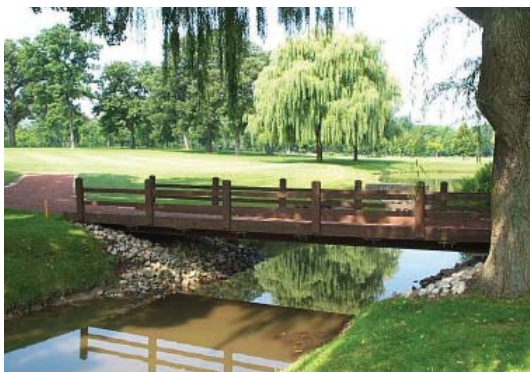
Photo 83 - Bridge

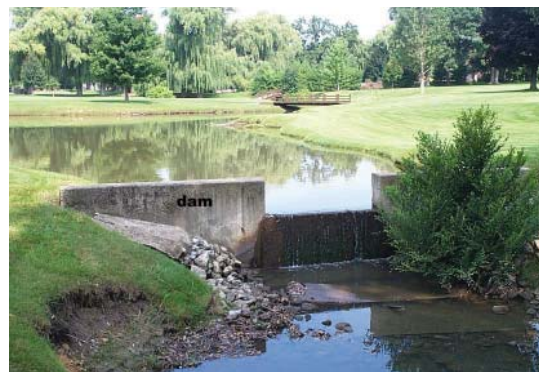
Photo 84 - Dam

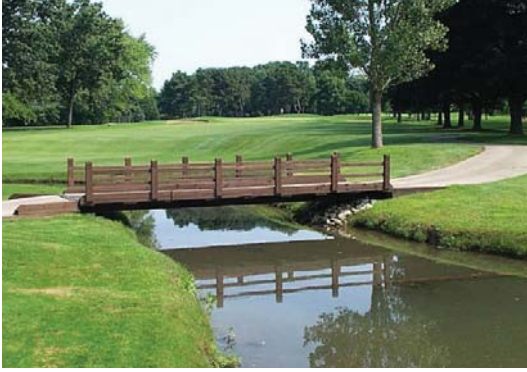
Photo 85 - Bridge

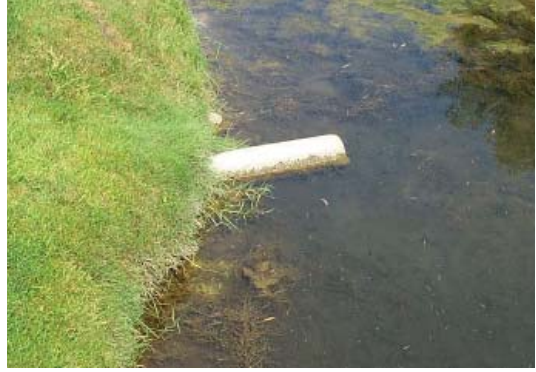
Photo 86 - Drain pipe

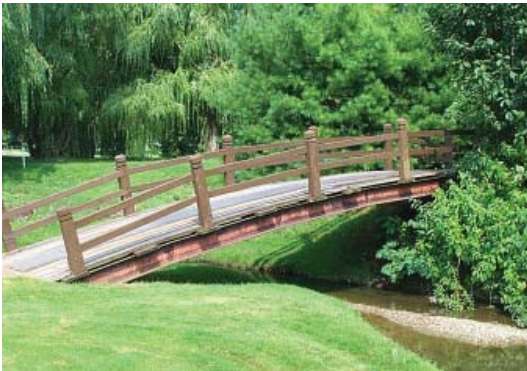
Photo 87 - Bridge

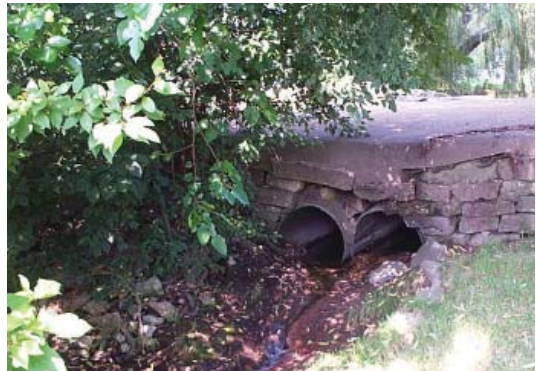
Photo 88 - Culverts x2 with armoring

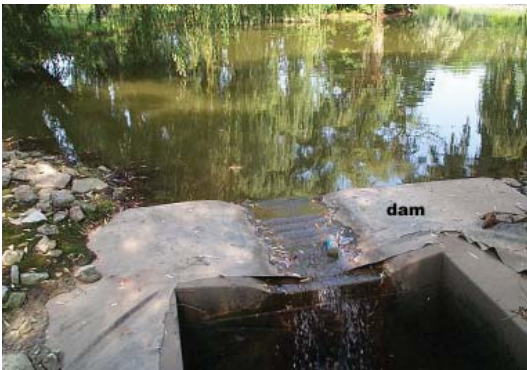
Photo 89 - Dam

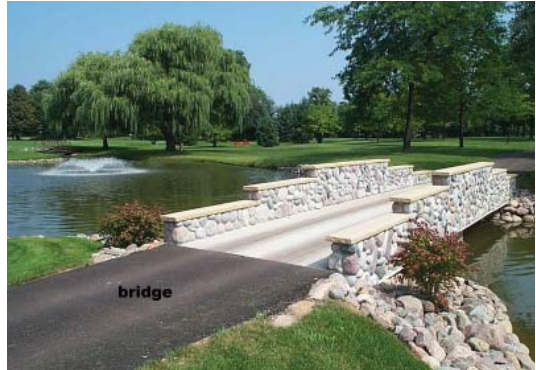
Photo 90 - Bridge

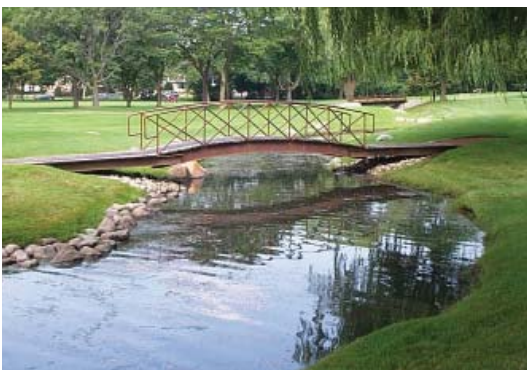
Photo 91 - Bridge

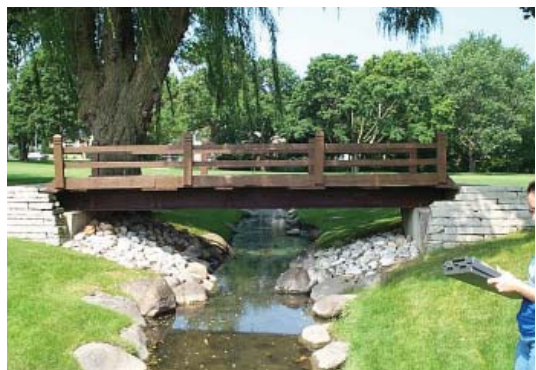
Photo 92 - Bridge

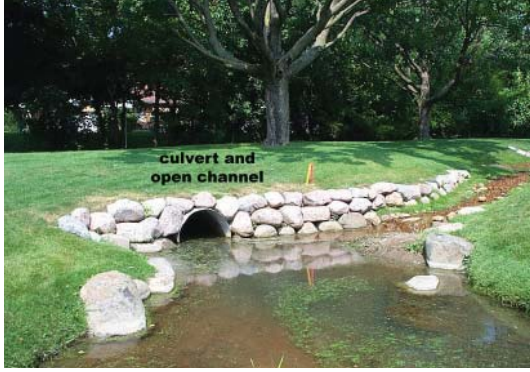
Photo 93 - Culvert and open channel

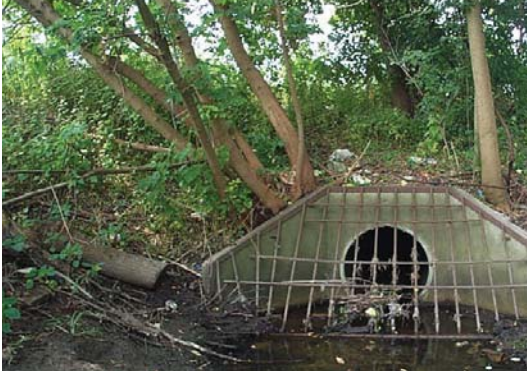
Photo 450 - Culvert - north side of Montesaro

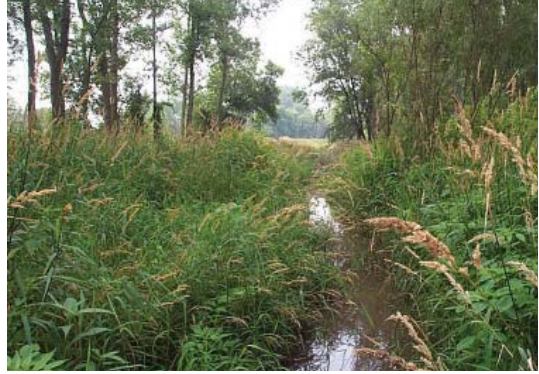
Photo 451 - Representative reach

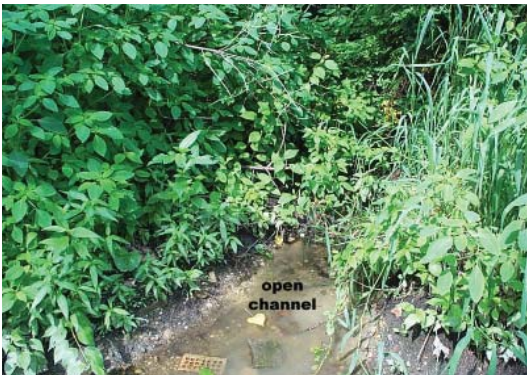
Photo 452 - Open channel

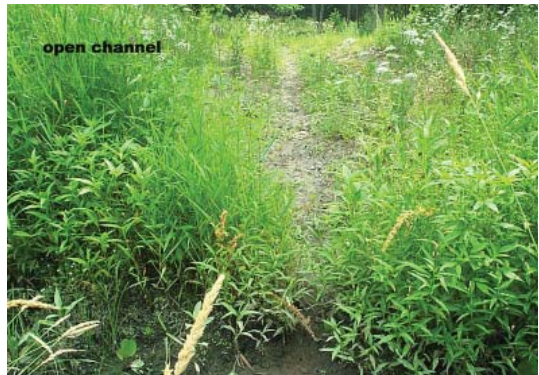
Photo 453 - Open channel

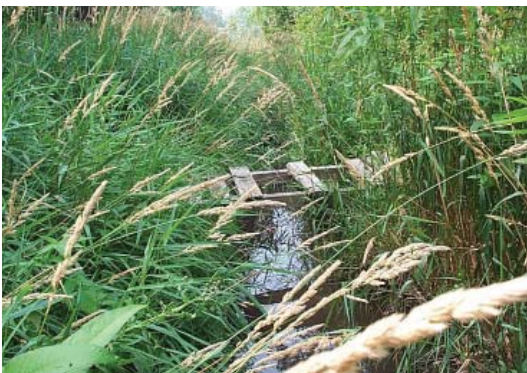
Photo 454 - Bridge (downstream)

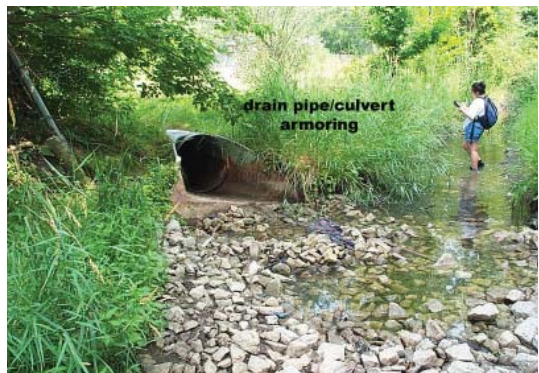
Photo 455 - Drain pipe/ armoring

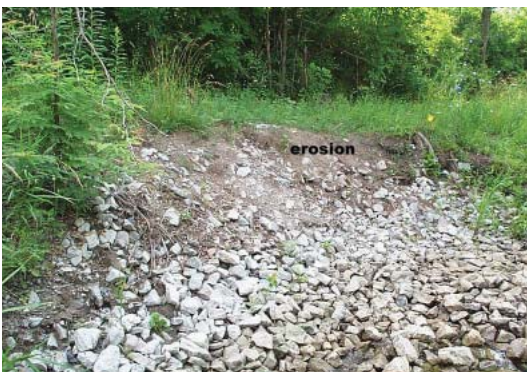
Photo 456 - Erosion

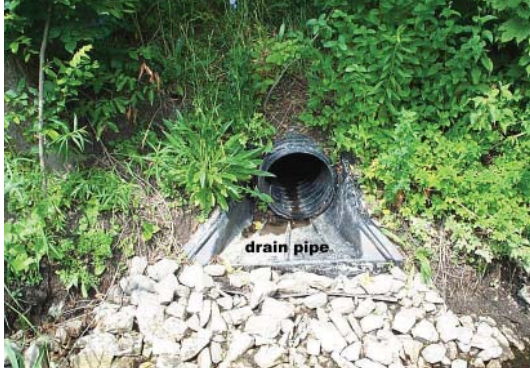
Photo 458 - Drain pipe

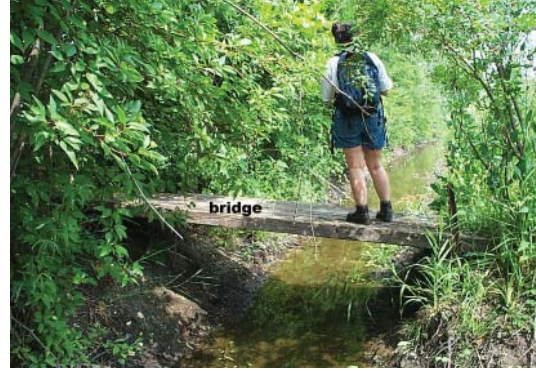
Photo 459 - Bridge

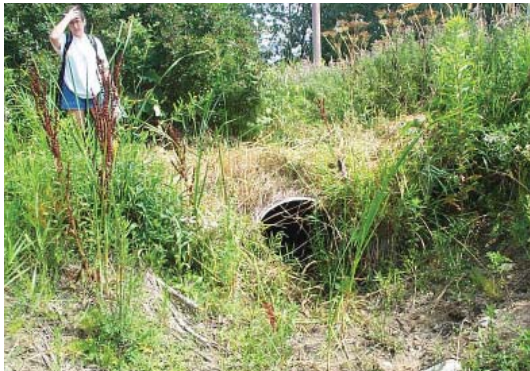
Photo 460 - Culvert

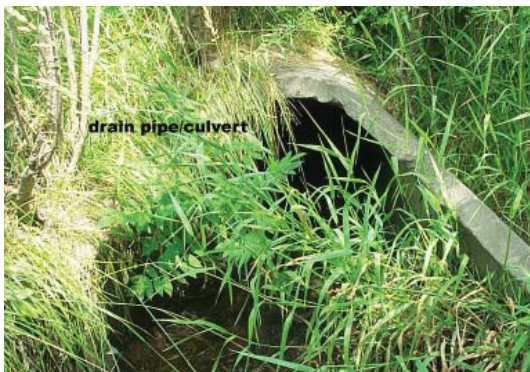
Photo 462 - Drain pipe

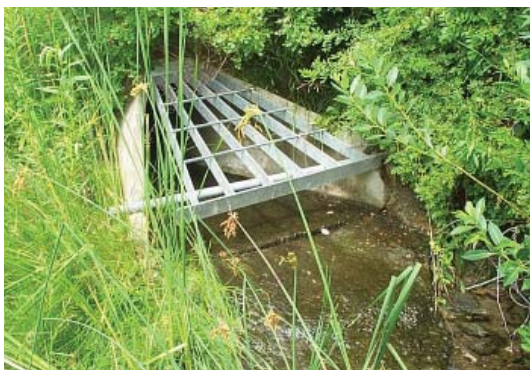
Photo 464 - Culvert at Lewis

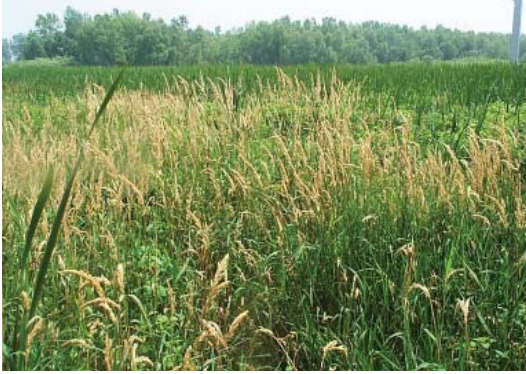
Photo 465 - Wetland

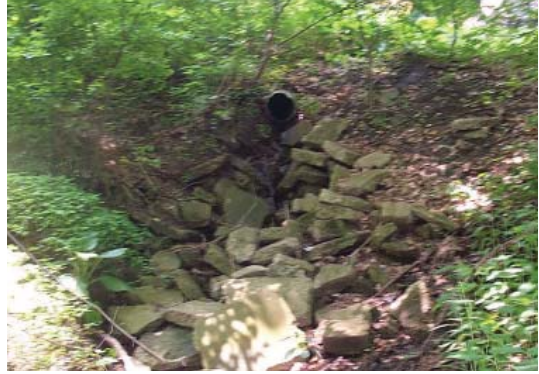
Photo 466 - Drain pipe

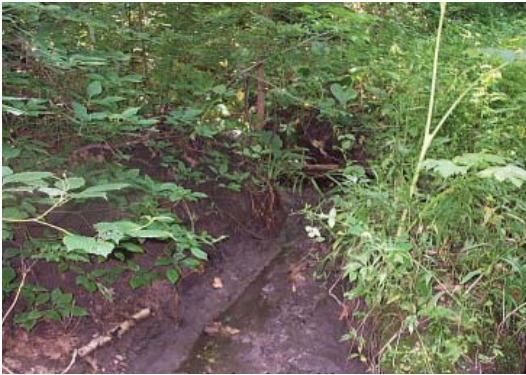
Photo 467 - Drain pipe with open channel

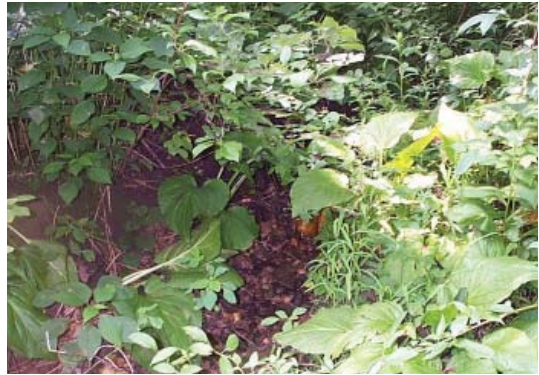
Photo 468 - Open channel

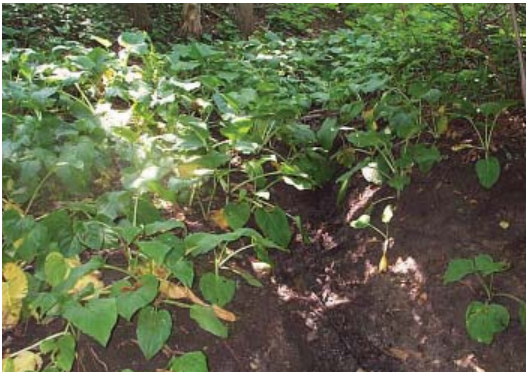
Photo 469 - Open channel

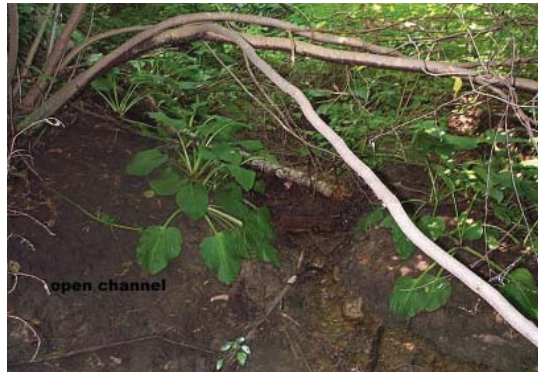
Photo 470 - Open channel

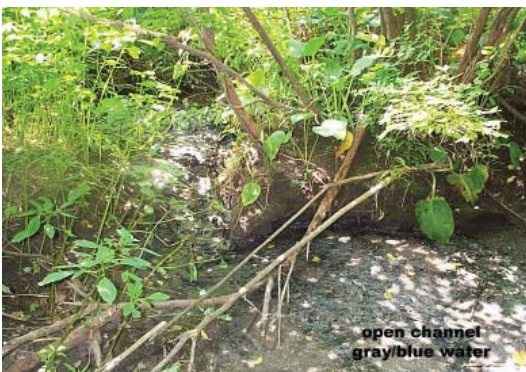
Photo 471 - Open channel - gray/blue water

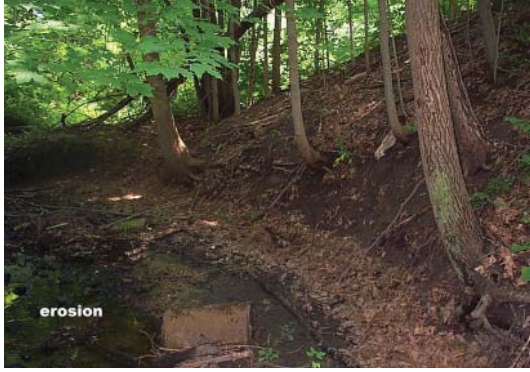
Photo 473 - Erosion

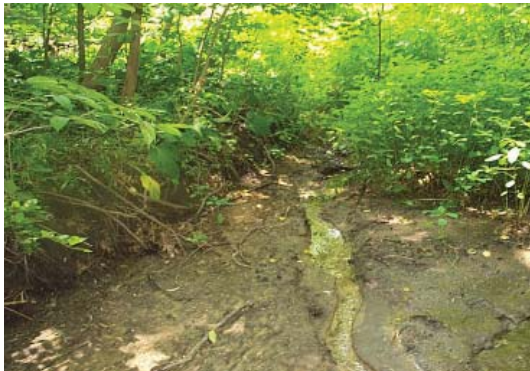
Photo 475 - Open channel

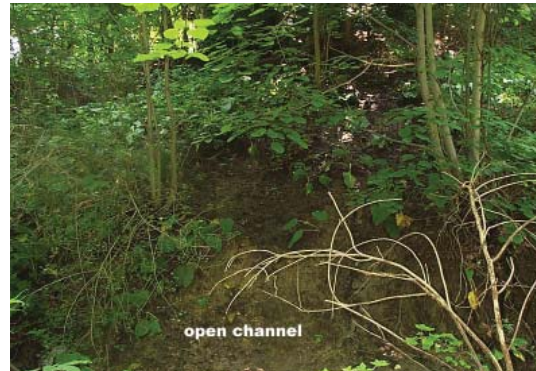
Photo 476 - Open channel

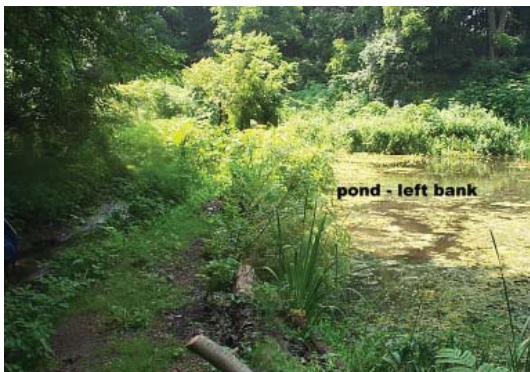
Photo 478 - Pond - left bank

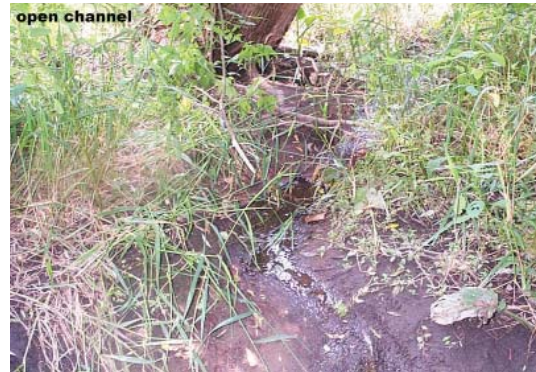
Photo 479 - Open channel

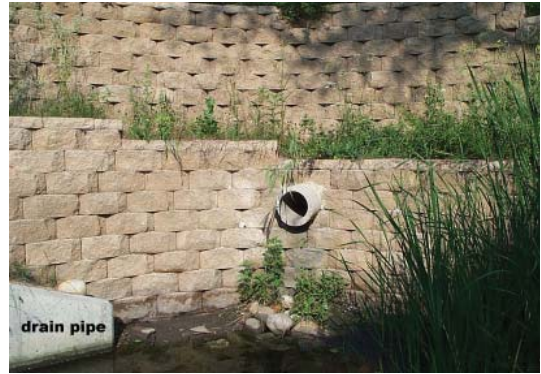
Photo 64 - Drain pipe

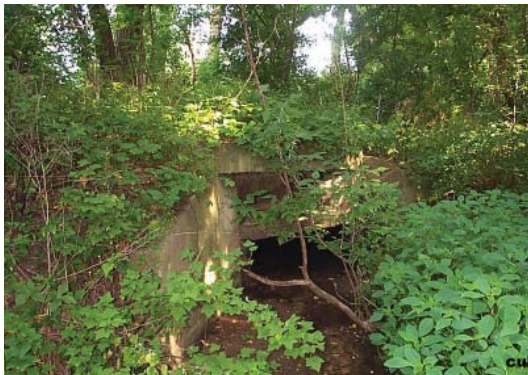
Photo 65 - Culvert

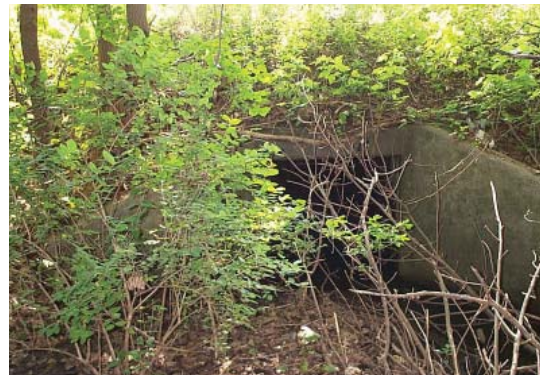
Photo 66 - Culvert

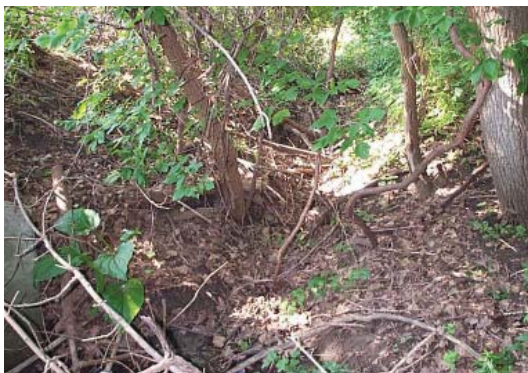
Photo 67 - Open channel

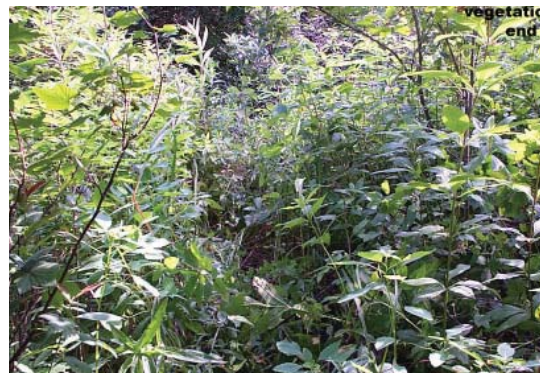
Photo 68 - Vegetation - end

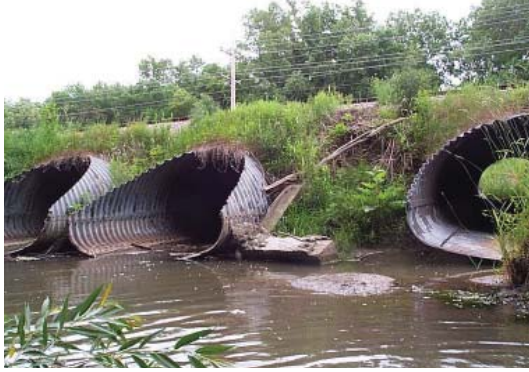
Photo 94 - Culverts under railroad tracks

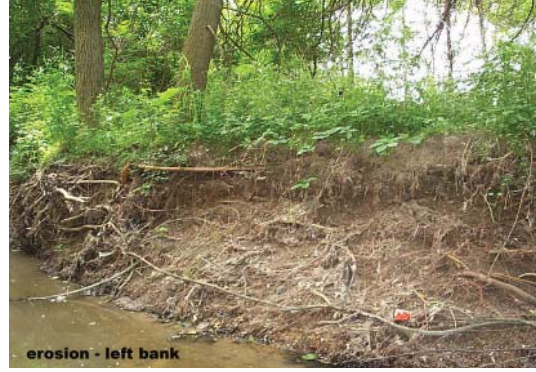
Photo 95 - Erosion - left bank

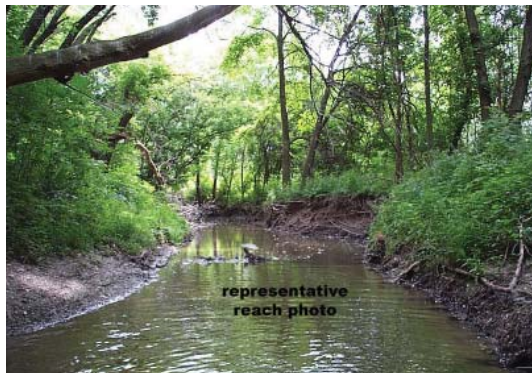
Photo 96 - Representative reach

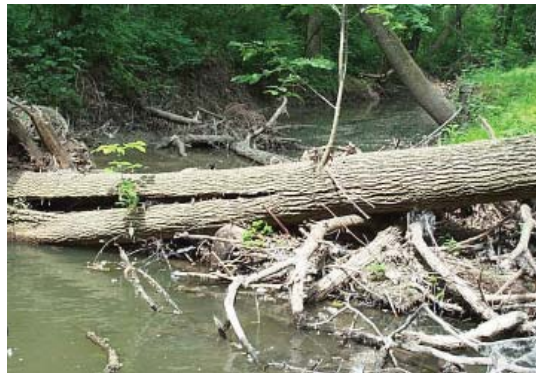
Photo 97 - Debris - log jam

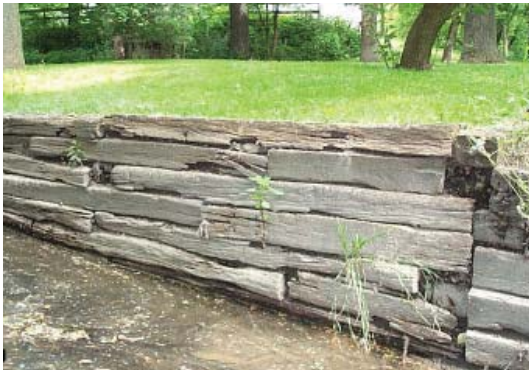
Photo 98 - Armoring

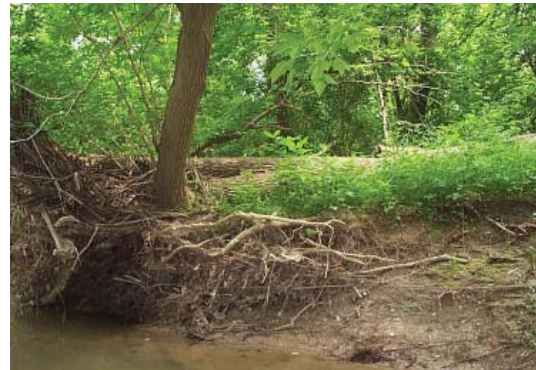
Photo 99 - Erosion - left bank

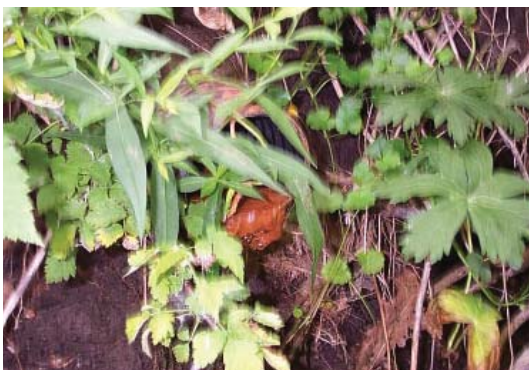
Photo 100 - Drain pipe - left bank

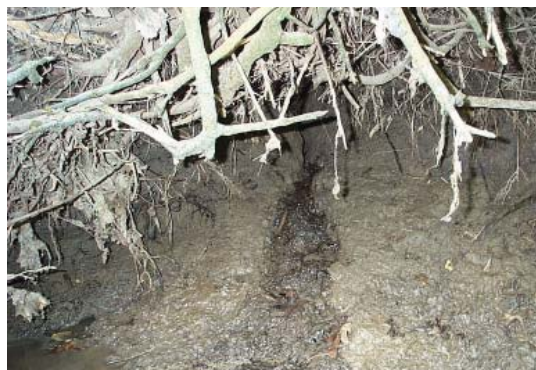
Photo 101 - Open channel - left bank

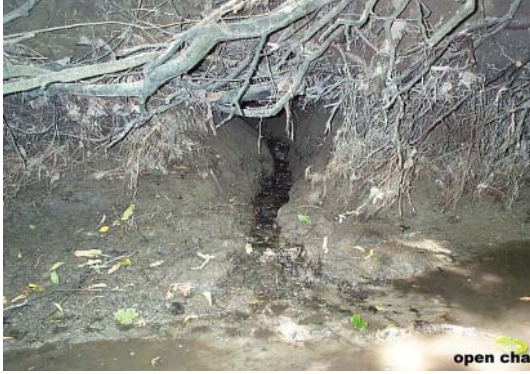
Photo 102 - Open channel

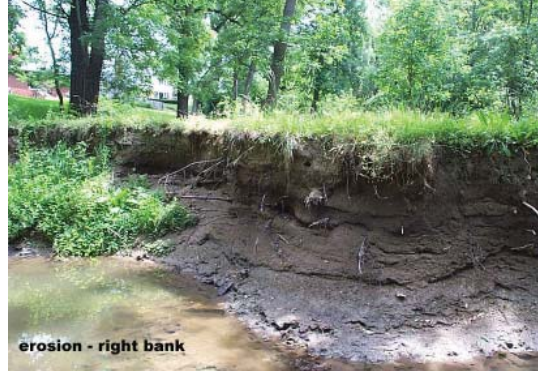
Photo 103 - Erosion - right bank

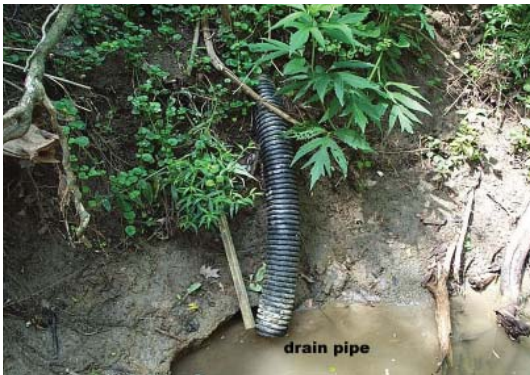
Photo 104 - Drain pipe

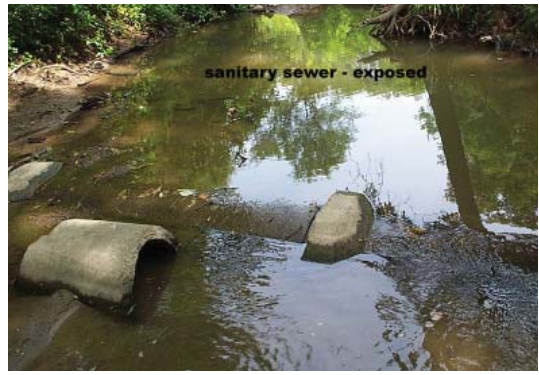
Photo 105 - Sanitary sewer

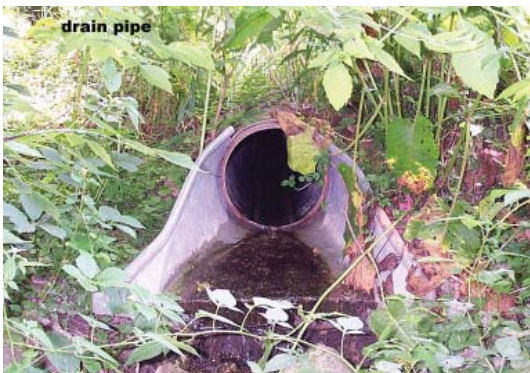
Photo 106 - Drain pipe

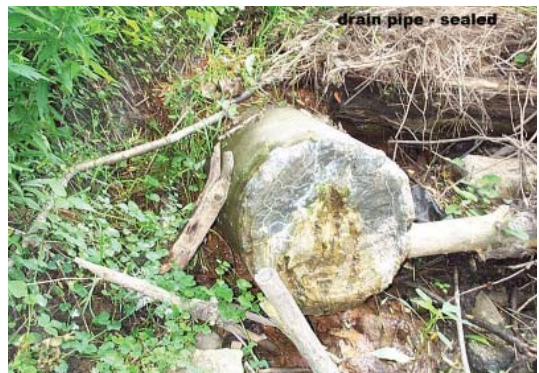
Photo 107 - Drain pipe - sealed

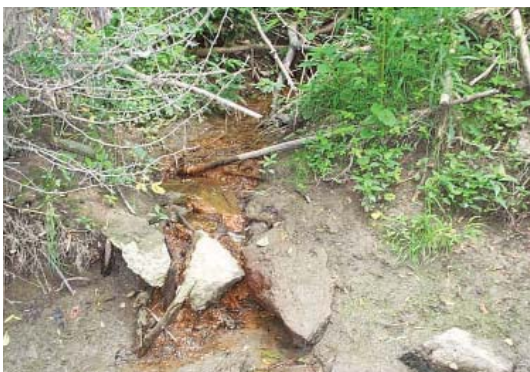
Photo 108 - Open channel

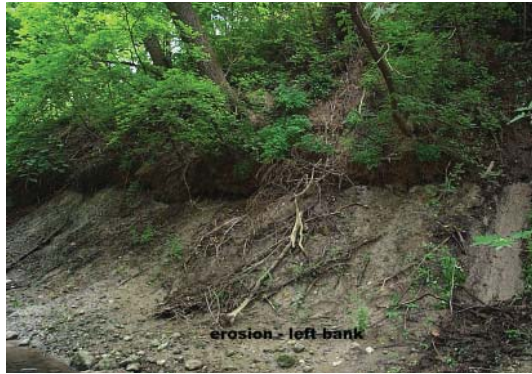
Photo 110 - Erosion - left bank

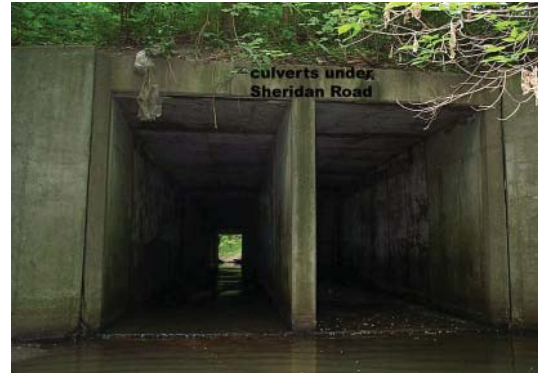
Photo 111 - Box culverts at Sheridan

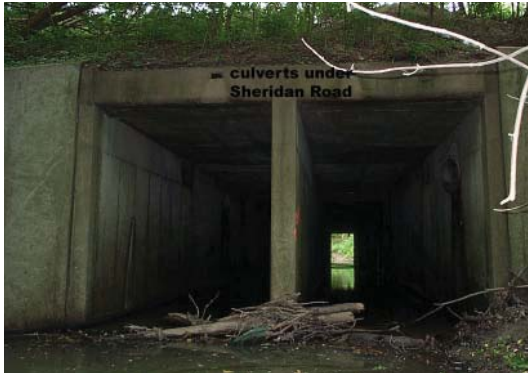
Photo 112 - Culvert

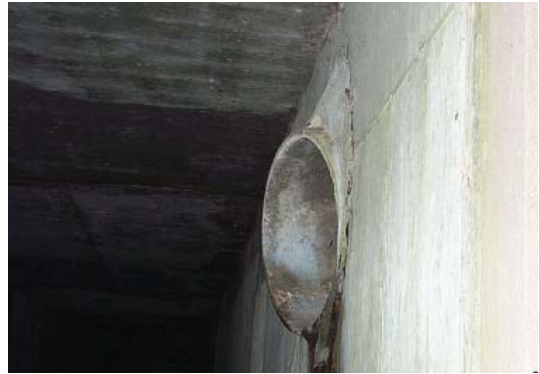
Photo 113 - Drain pipe

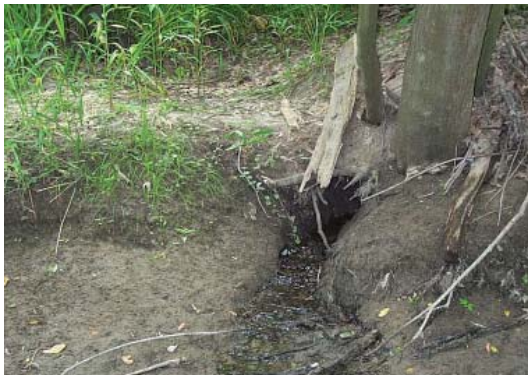
Photo 114 - Open channel - left bank

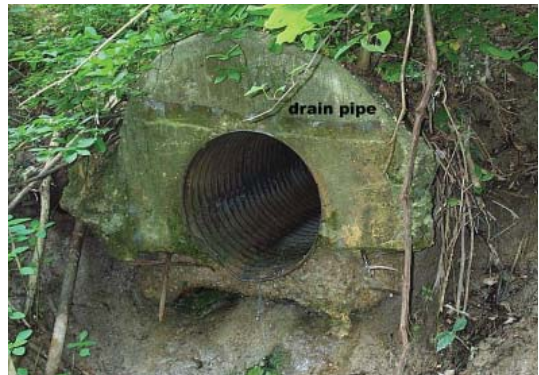
Photo 115 - Drain pipe - creating open channel

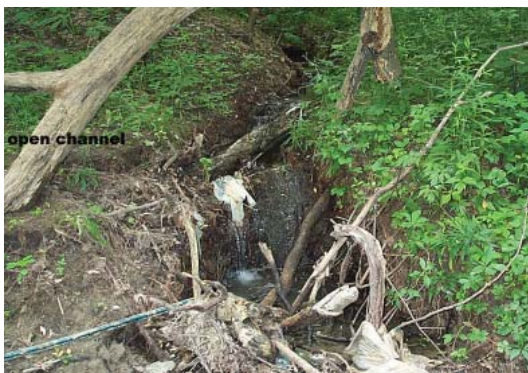
Photo 116 - Open channel

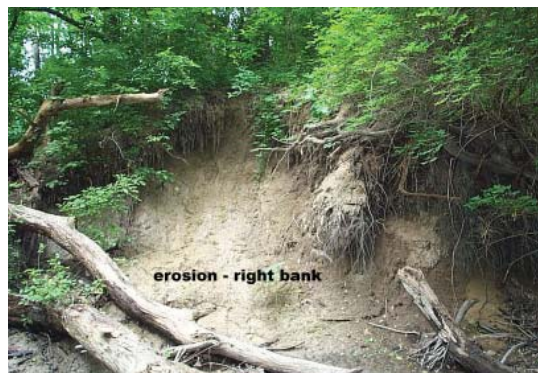
Photo 117 - Erosion - right bank

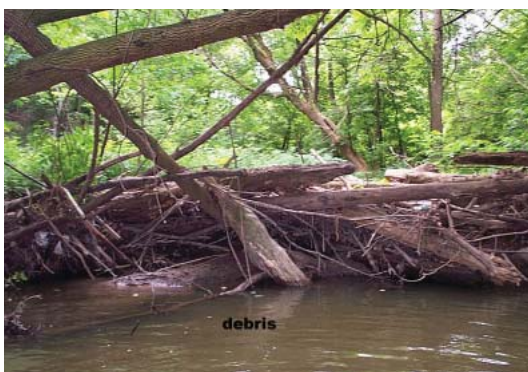
Photo 118 - Debris

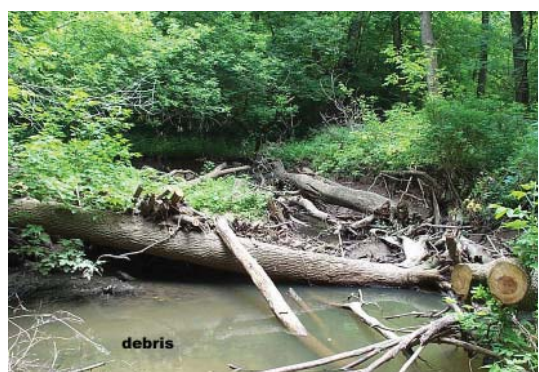
Photo 119 - Debris

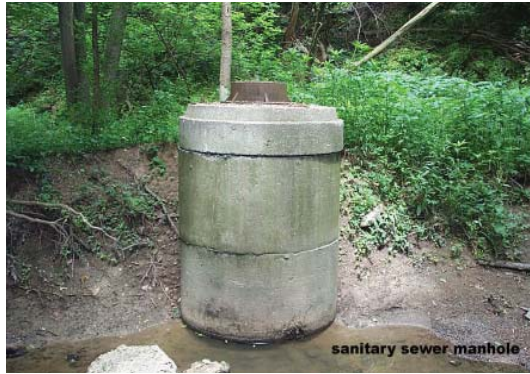
Photo 120 - Sanitary sewer manhole

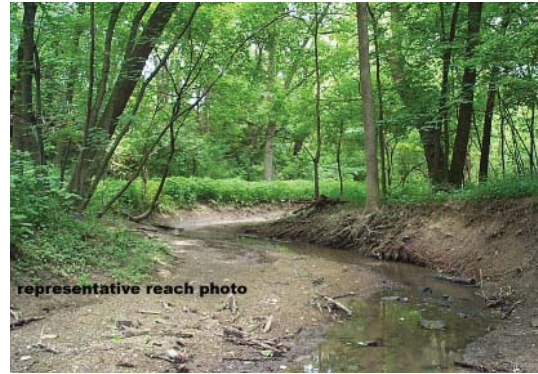
Photo 121 - Representative reach

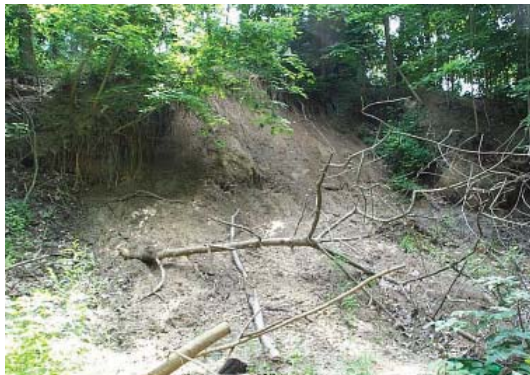
Photo 122 - Erosion/ drain pipe

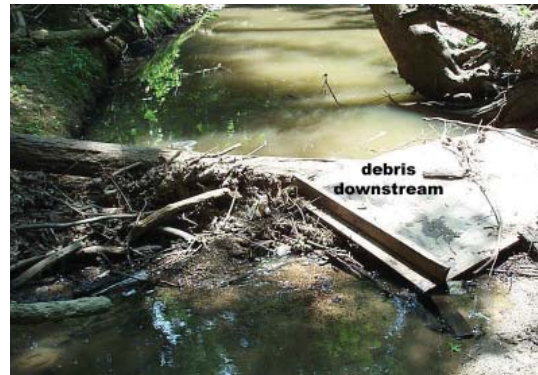
Photo 123 - Debris (downstream)

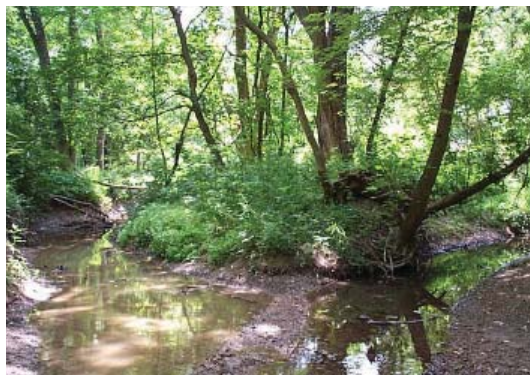
Photo 124 - Main fork - end reach

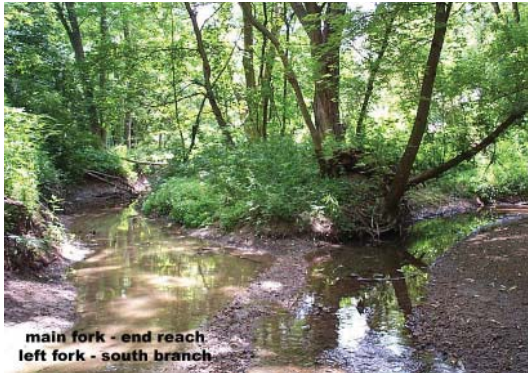
Photo 124 - Left fork - continued south branch

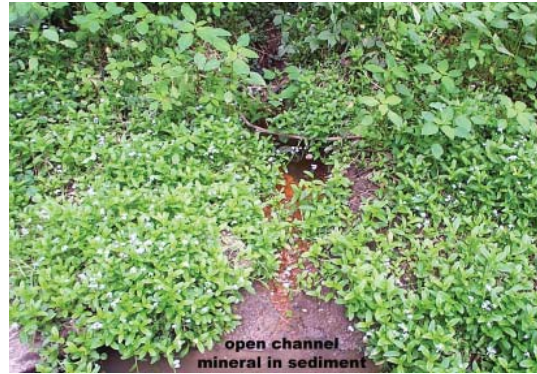
Photo 125 - Open channel - mineral in sediment

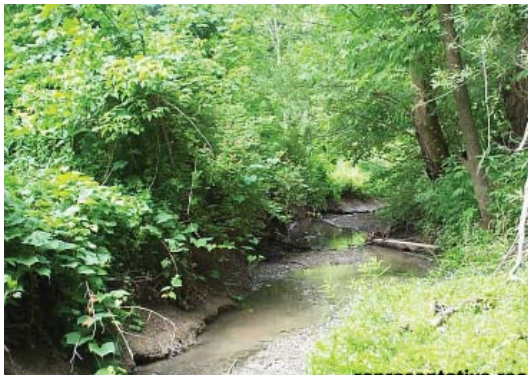
Photo 126 - Representative reach

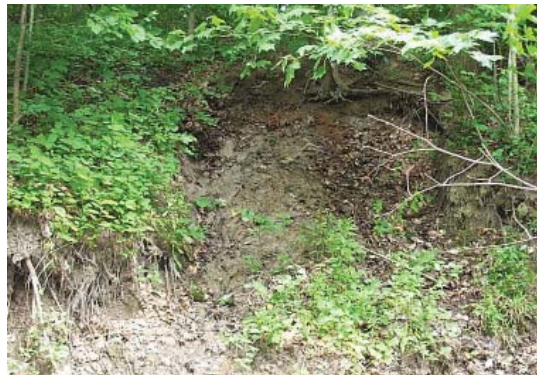
Photo 127 - Erosion - left bank

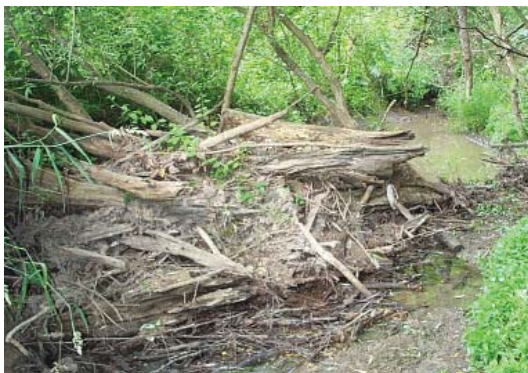
Photo 128 - Debris

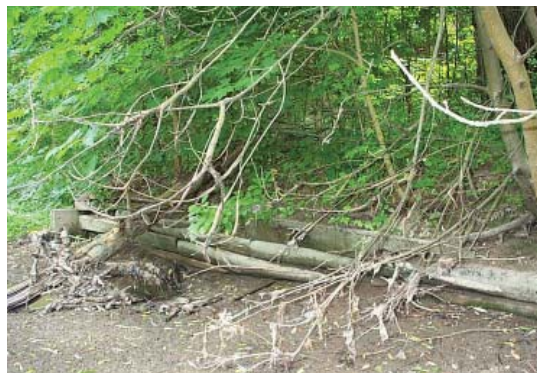
Photo 129 - Armoring - left bank

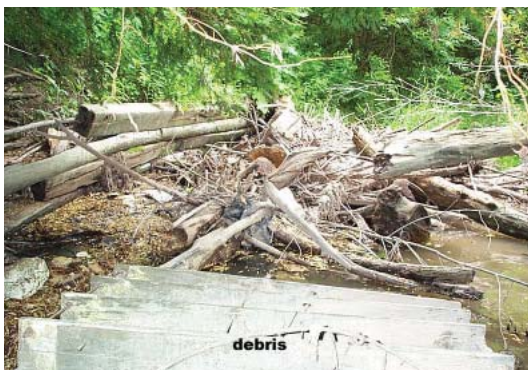
Photo 130 - Debris

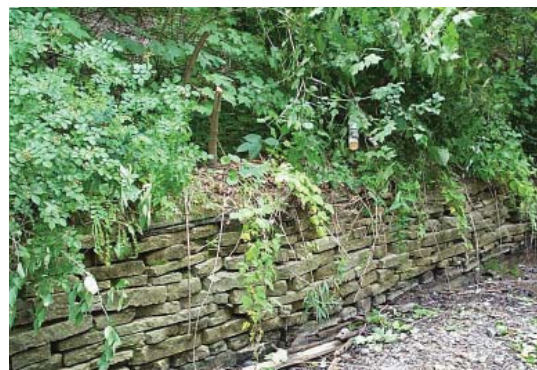
Photo 131 - Armoring - left bank

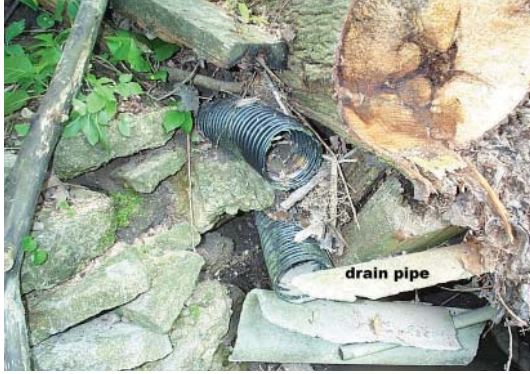
Photo 132 - Drain pipe

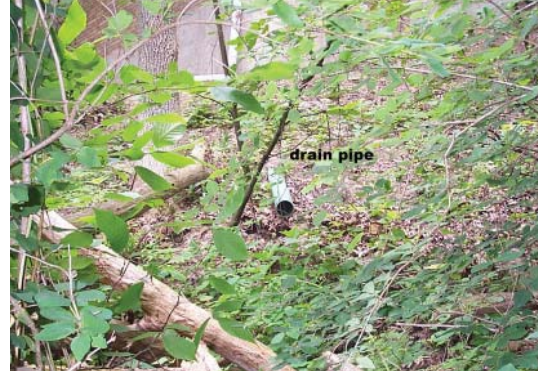
Photo 133 - Drain pipe
