appendix B - Lake County Stormwater Management Commission stream inventory photographs

Appendix B includes photographs taken during the Lake County Stormwater Management Commission 2001 stream inventory. Photographs are organized sequentially by reach. The photograph identification numbers correspond to specific Geographic Positioning System coordinates within the watershed, which allows one to review the 2001 conditions in relation to the action plan recommendations (see Appendix H) or to current conditions. Photographs can also be reviewed in relation to the inventory data sheets in Appendix O.

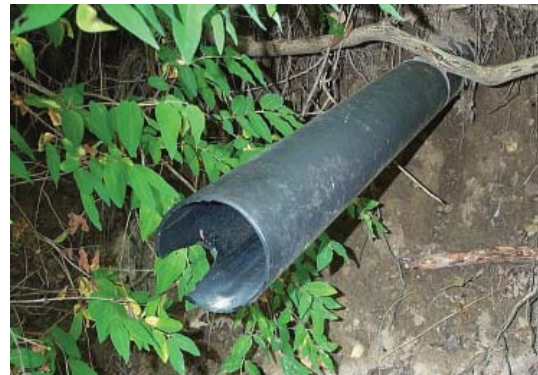
Photo 135 - Drain pipe

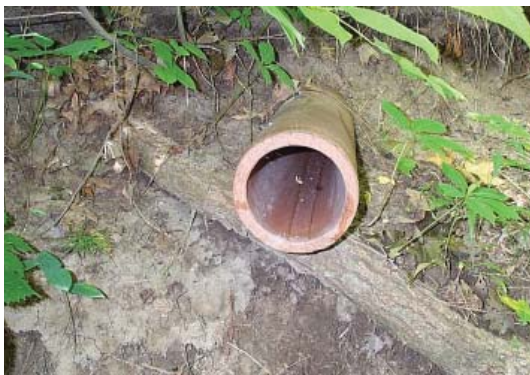
Photo 136 - Drain pipe

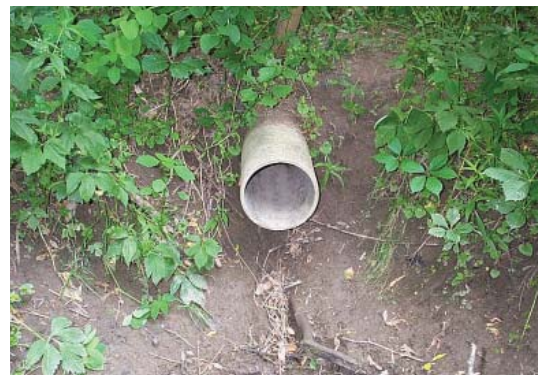
Photo 137 - Drain pipe

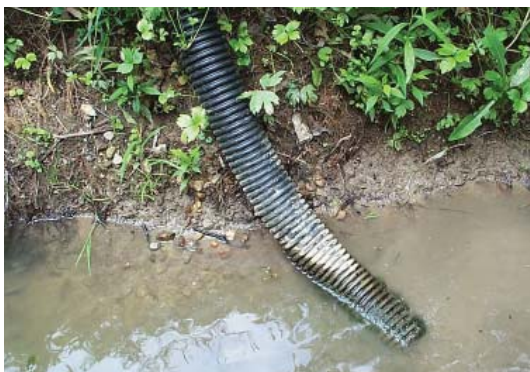
Photo 138 - Drain pipe

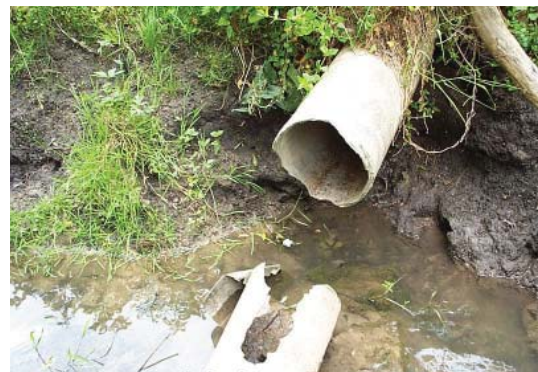
Photo 139 - Drain pipe

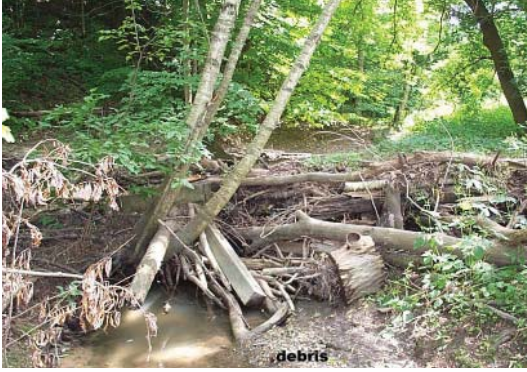
Photo 140 - Debris

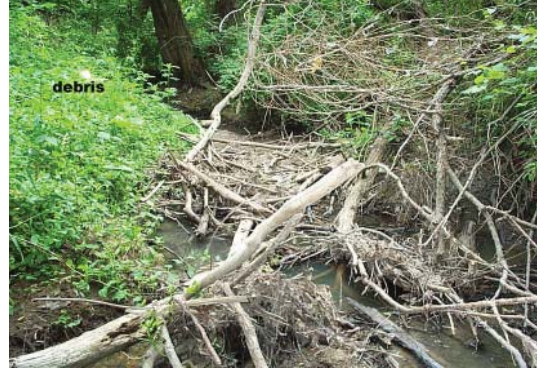
Photo 141 - Debris

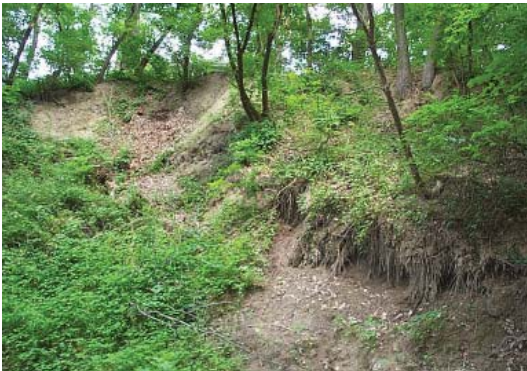
Photo 142 - Erosion - left bank

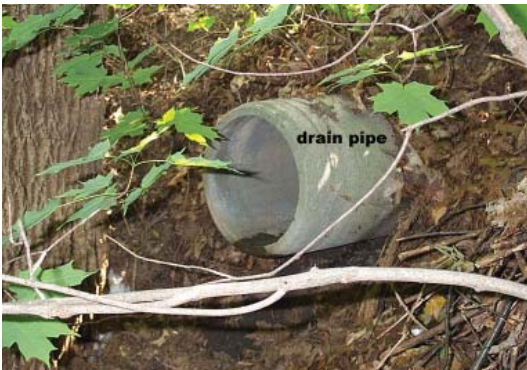
Photo 144 - Drain pipe

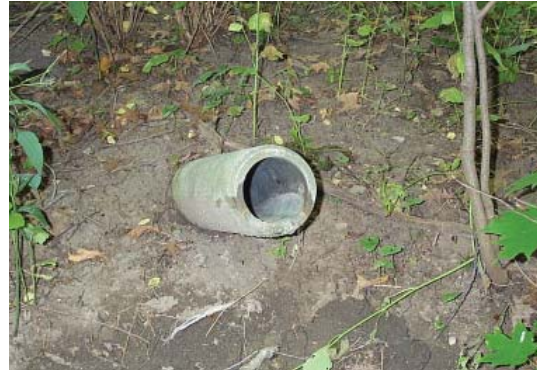
Photo 145 - Drain pipe

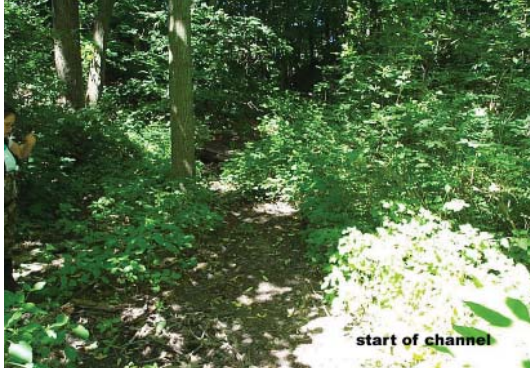
Photo 146 - Start of channel - fork

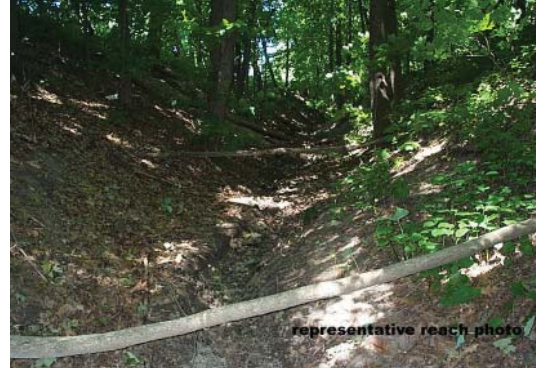
Photo 147 - Representative reach

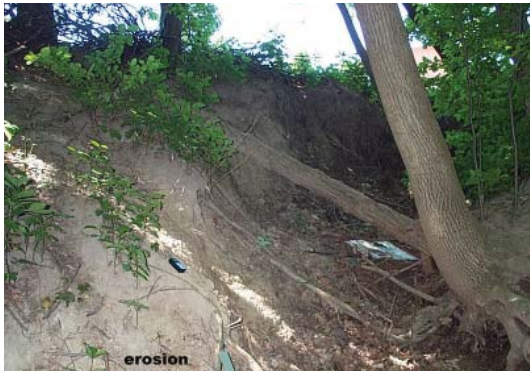
Photo 148 - Erosion

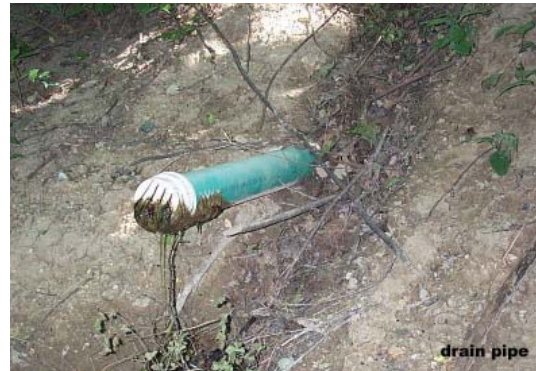
Photo 149 - Drain pipe

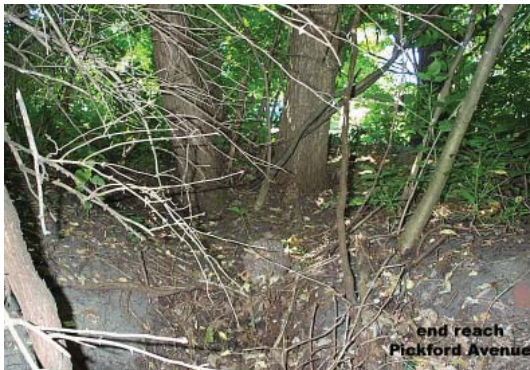
Photo 150 - End reach - Pickford Avenue

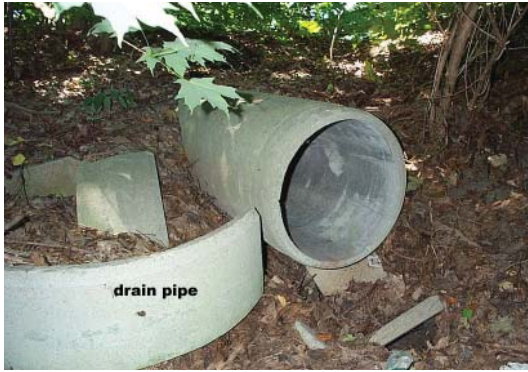
Photo 151 - Drain pipe

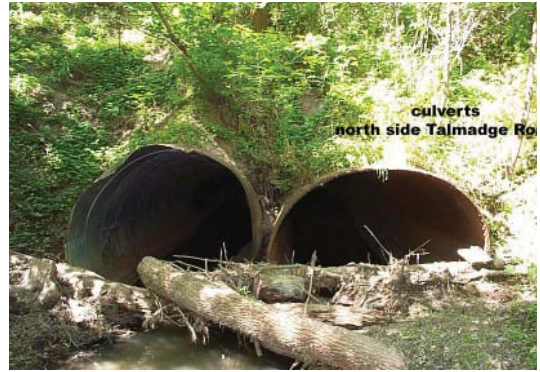
Photo 152 - Culverts

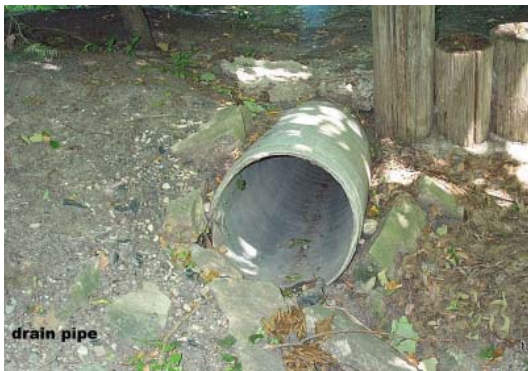
Photo 153 - Drain pipe

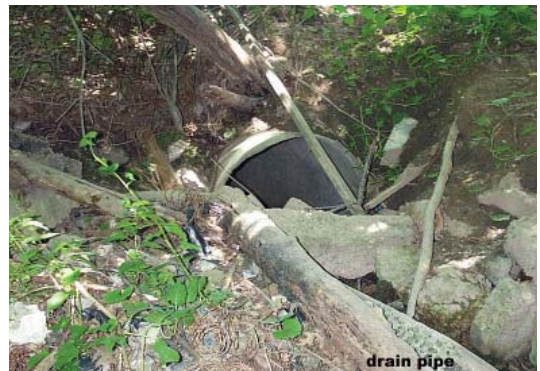
Photo 154 - Drain pipe

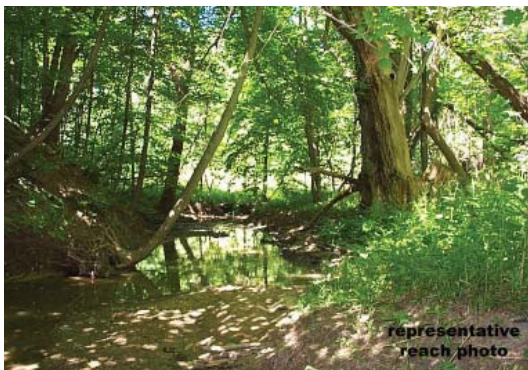
Photo 155 - Representative reach

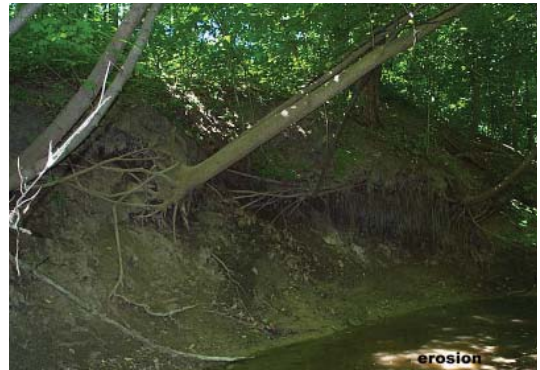
Photo 156 - Erosion

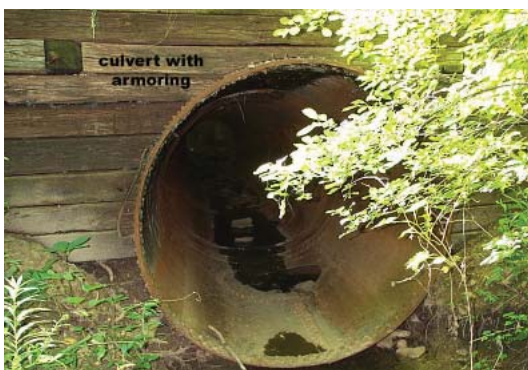
Photo 157 - Culvert with armoring

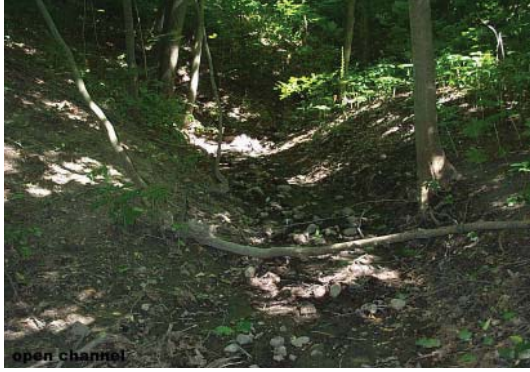
Photo 159 - Open channel

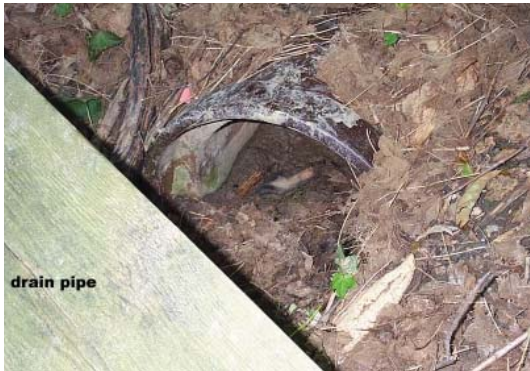
Photo 161 - Drain pipe

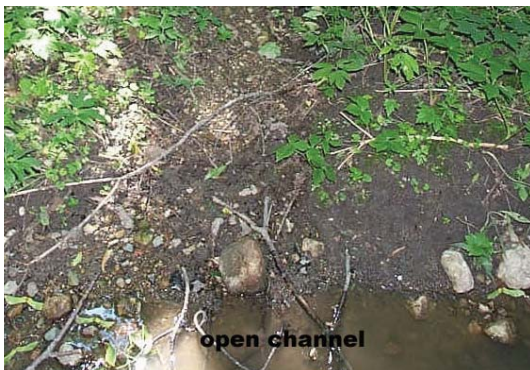
Photo 163 - Open channel

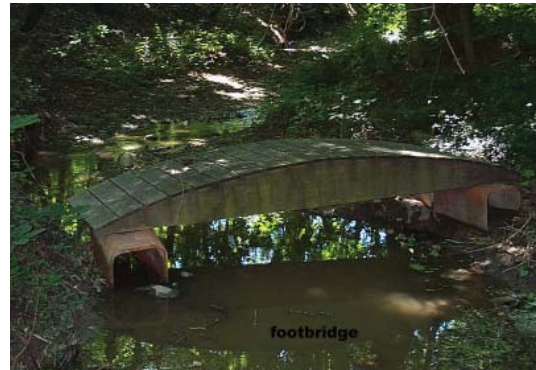
Photo 164 - Bridge

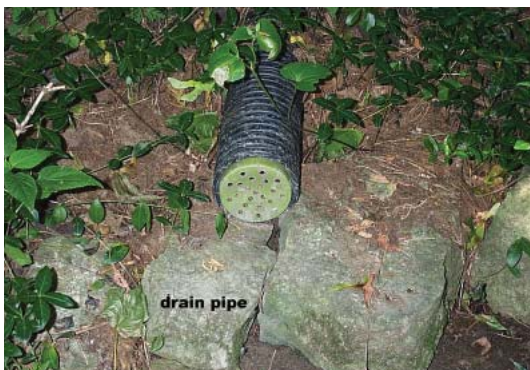
Photo 165 - Drain pipe

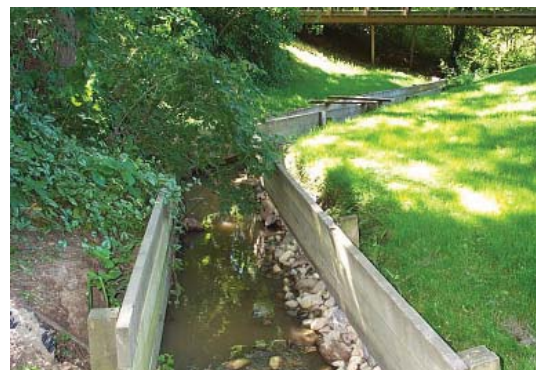
Photo 166 - Armoring

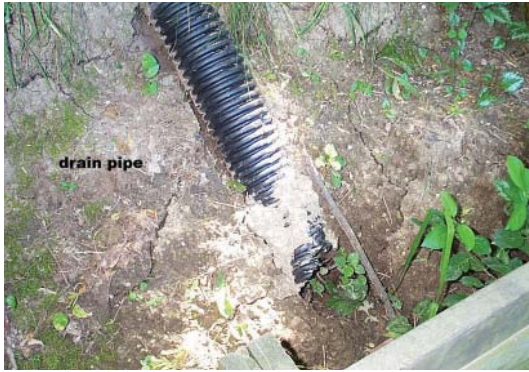
Photo 167 - Drain pipe

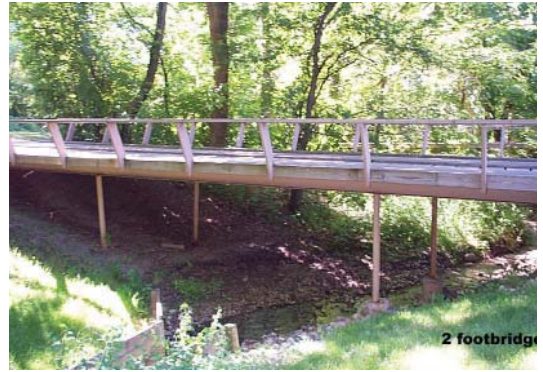
Photo 168 -2 bridges

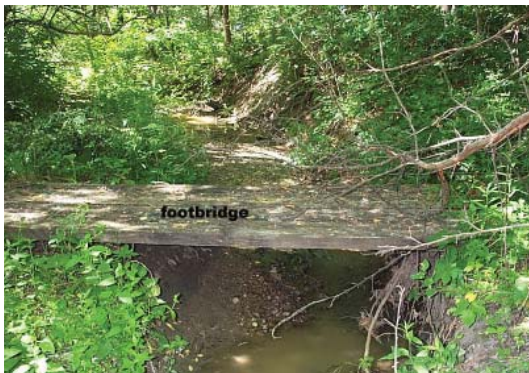
Photo 169 Footbridge

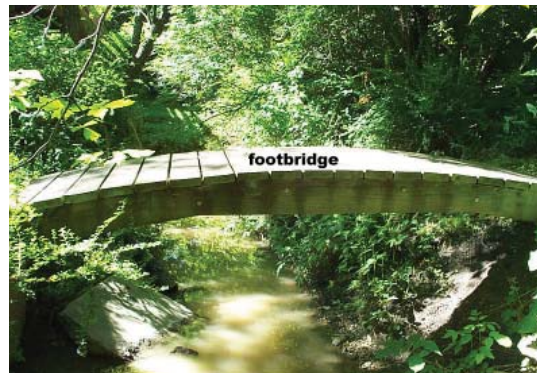
Photo 170 - Footbridge

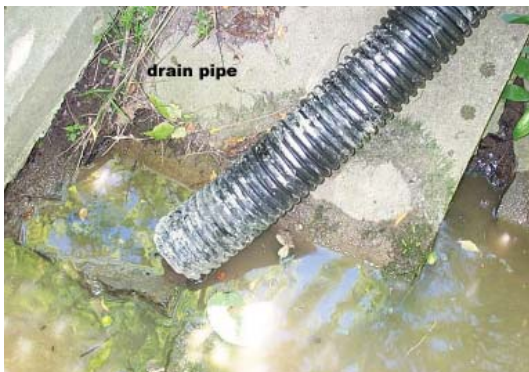
Photo 171 - Drain pipe

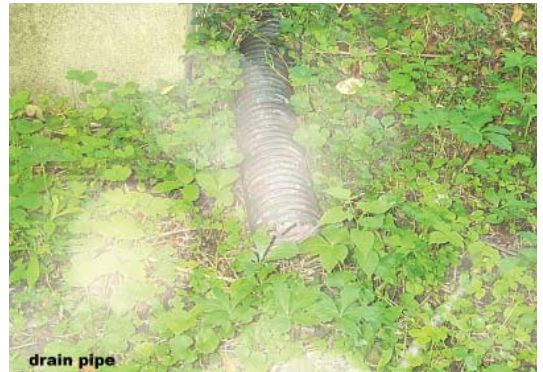
Photo 172 - Drain pipe

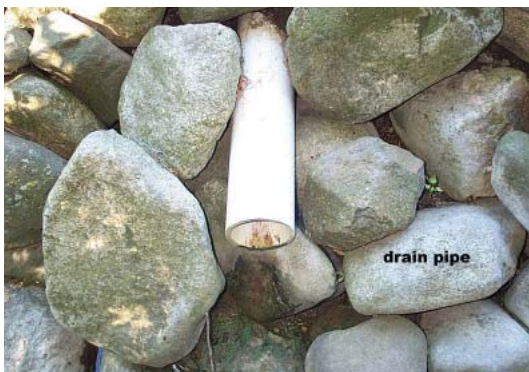
Photo 173 - Drain pipe

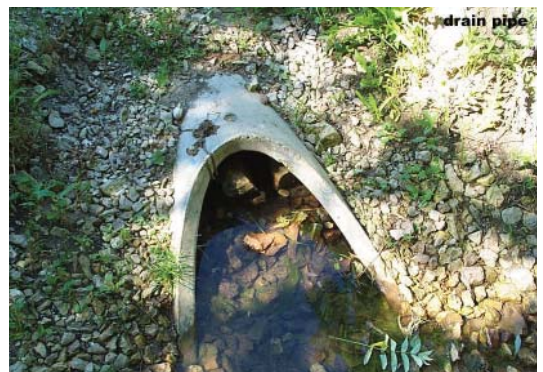
Photo 174 - Drain pipe

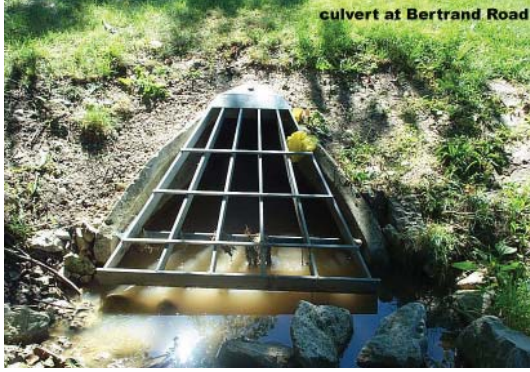
Photo 175 - Culvert at Bertrand

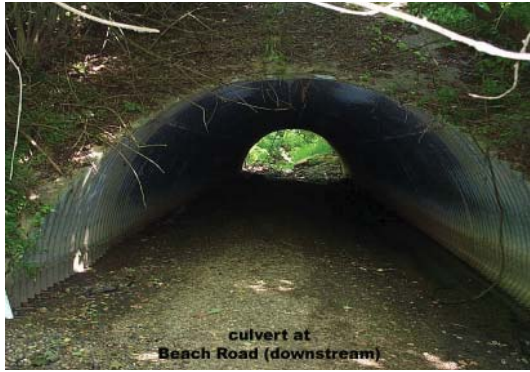
Photo 186 - Culvert at Beach Road (downstream)

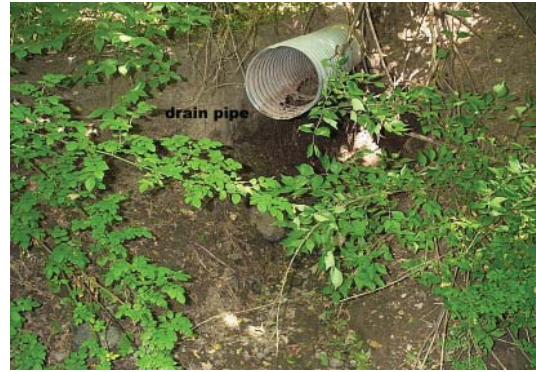
Photo 187 - Drain pipe

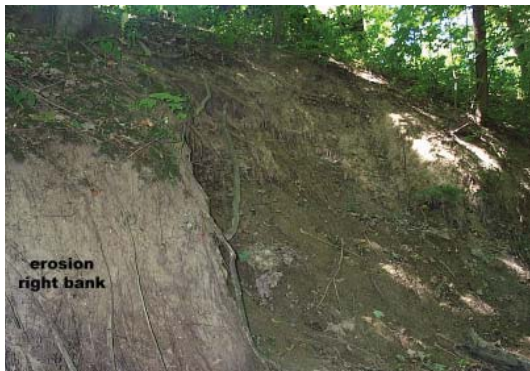
Photo 188 - Erosion - right bank

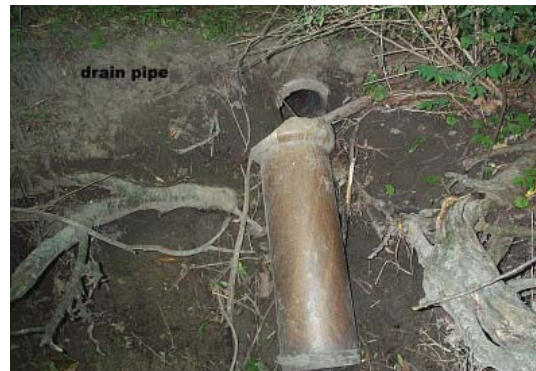
Photo 189 - Drain pipe

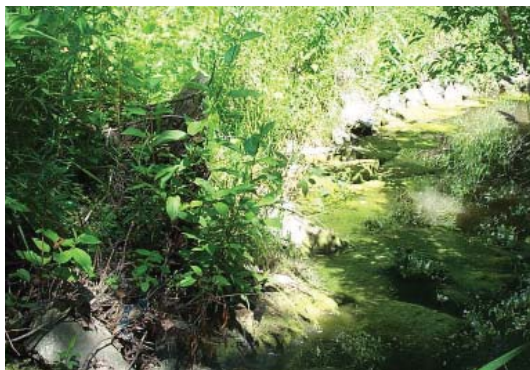
Photo 190 - Armoring - right bank

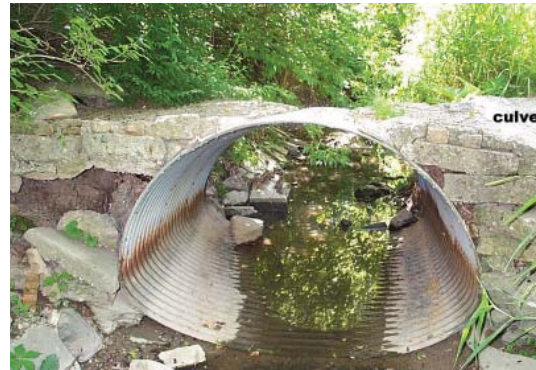
Photo 191 - Culvert

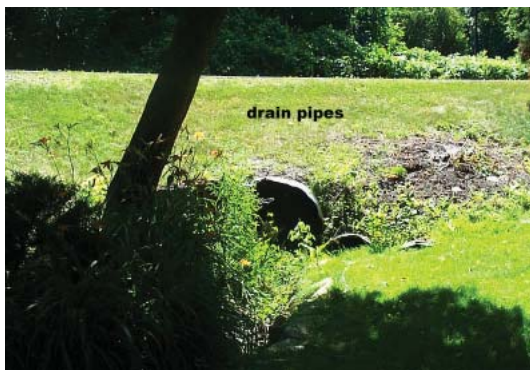
Photo 192 - Drain pipes

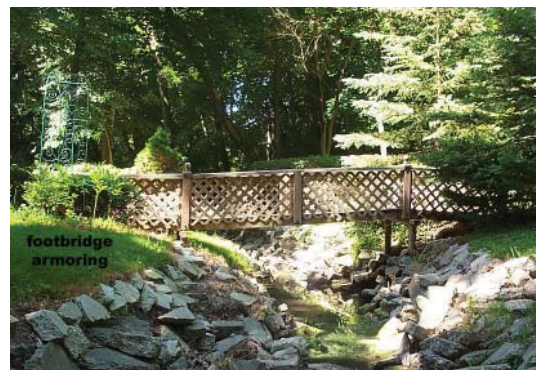
Photo 193 - Footbridge - armoring

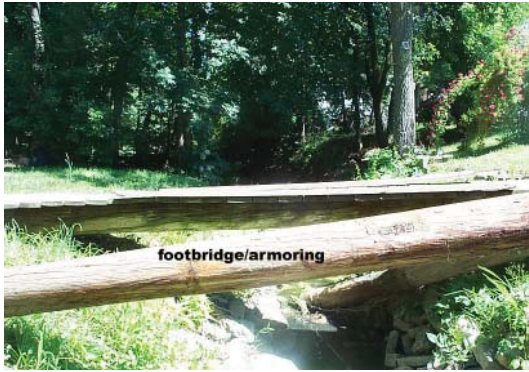
Photo 194 - Footbridge - armor

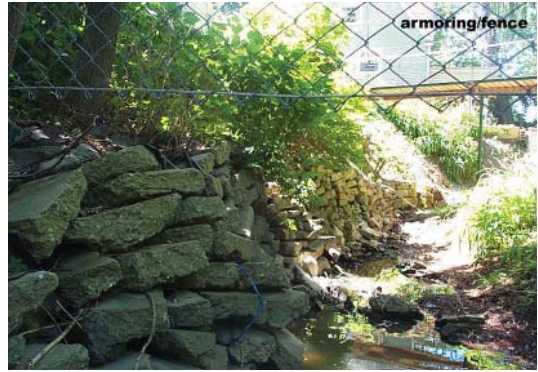
Photo 195 - Armoring/ fence

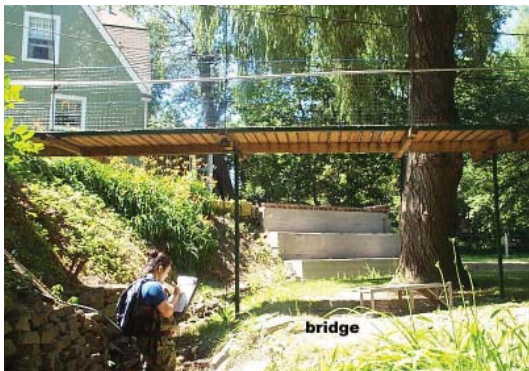
Photo 196 - Bridge

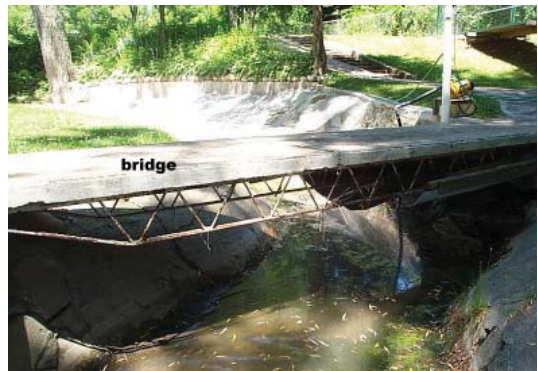
Photo 197 - Bridge

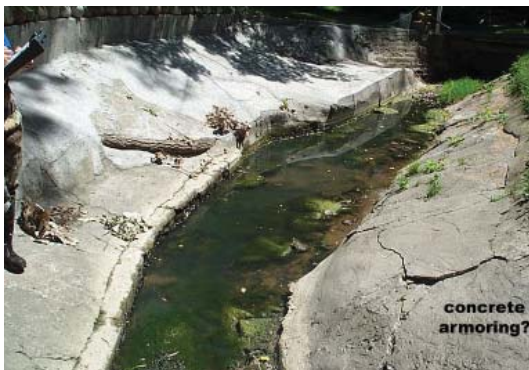
Photo 198 - Concrete - armor

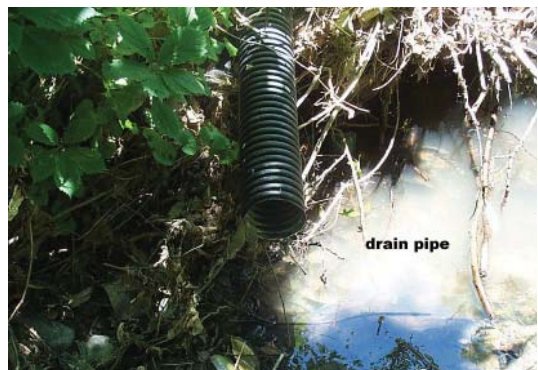
Photo 201 - Drain pipe
