Valley Council of Governments

Connecticut Radium Sites Verification Survey

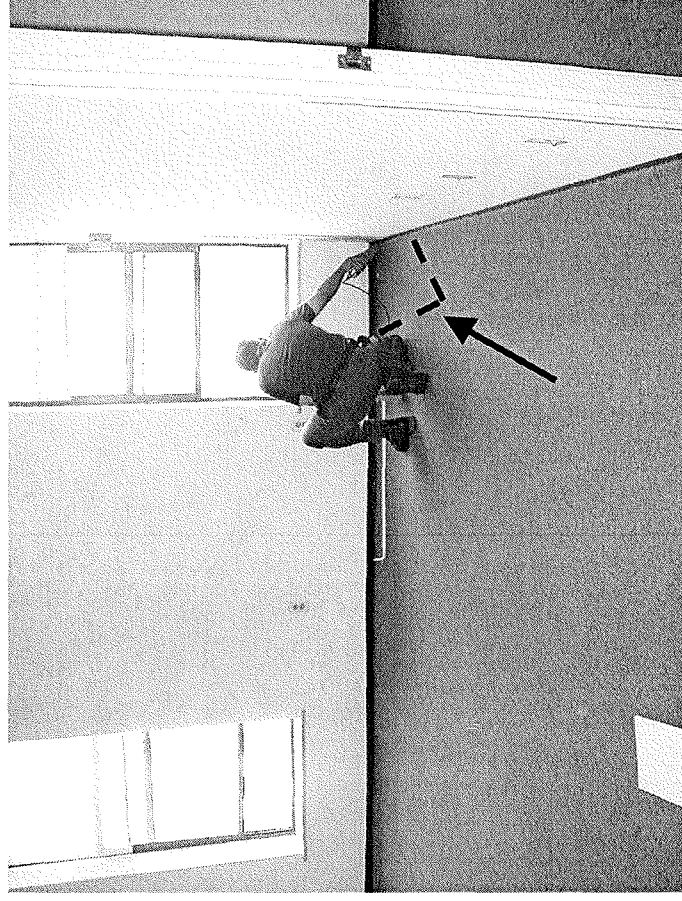
Enterprise Apartments- Apt 507

Contamination found in
living room corner.

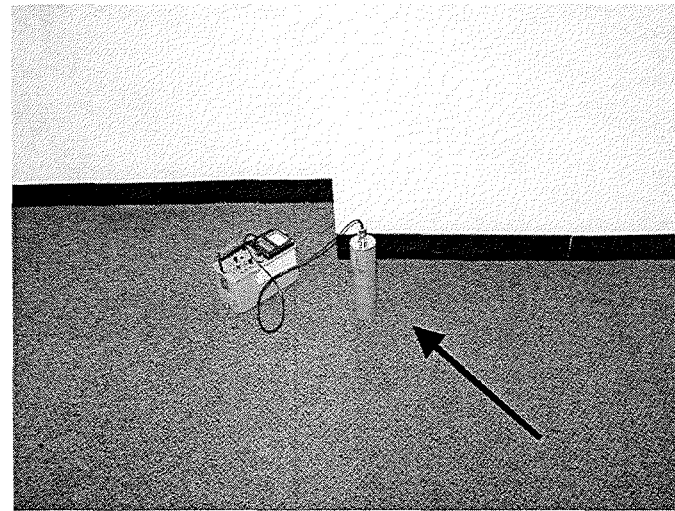
Enterprise Apartments- Hallway 513-515

Contamination found on
floor (as shown by meter)
and tile floor in Waste Room
door.

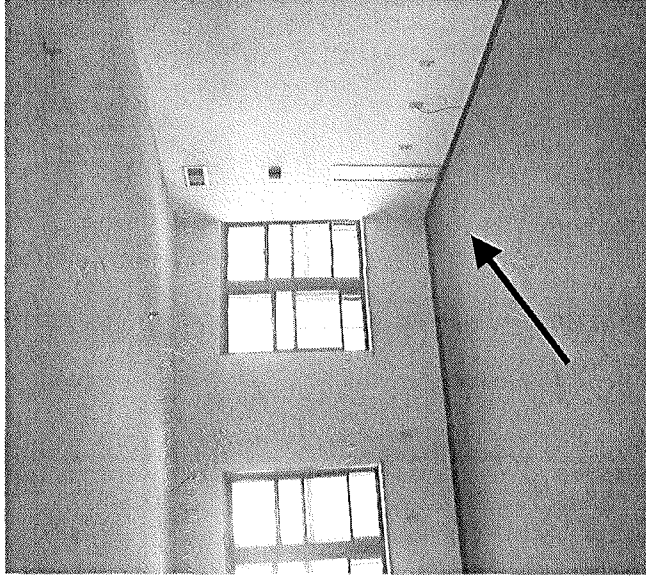
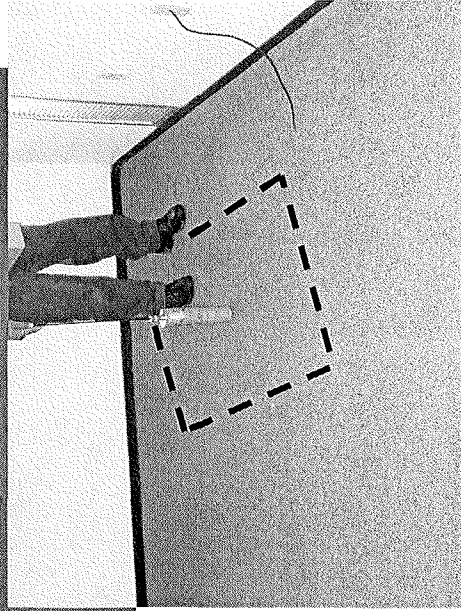
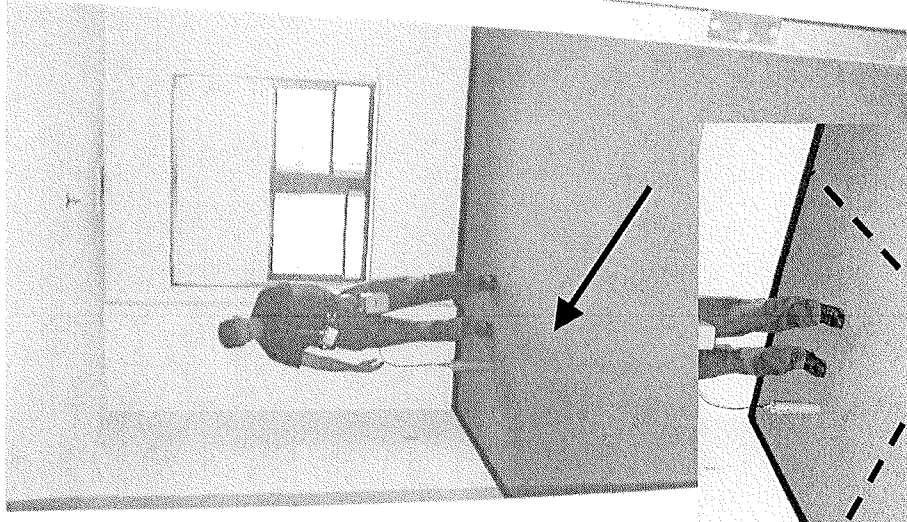
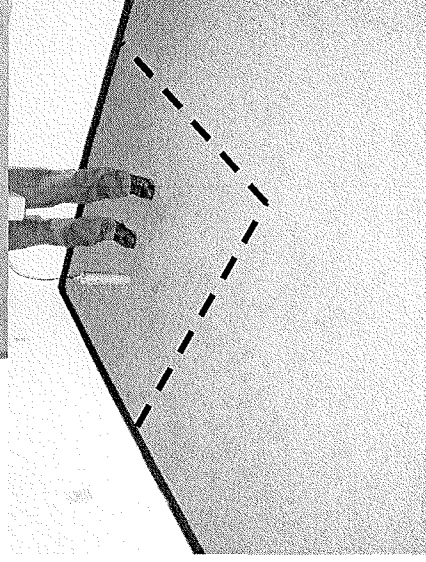
Enterprise Apartments- Apt 514

Contamination
found on Living
Room and
Bedroom 2
floors.

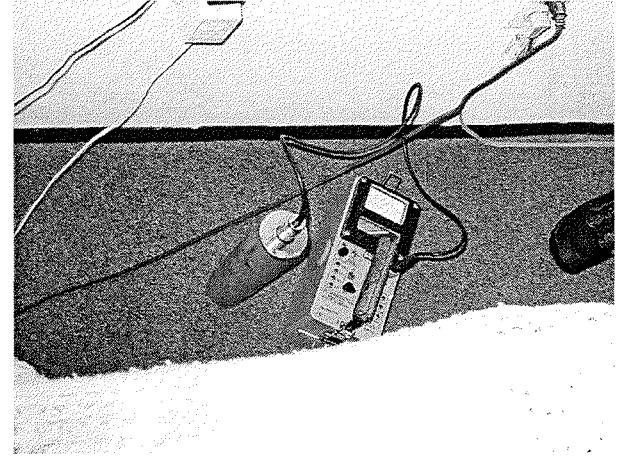
Enterprise Apartments- Apt 515

Contamination found on floor spots in Living Room corner and by window (as shown by meter).

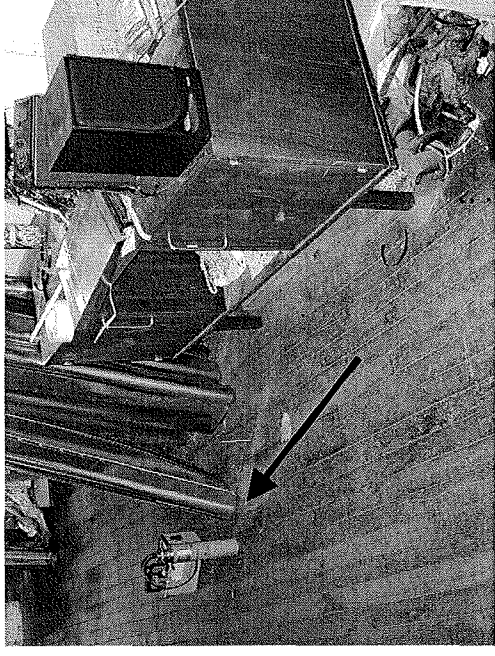
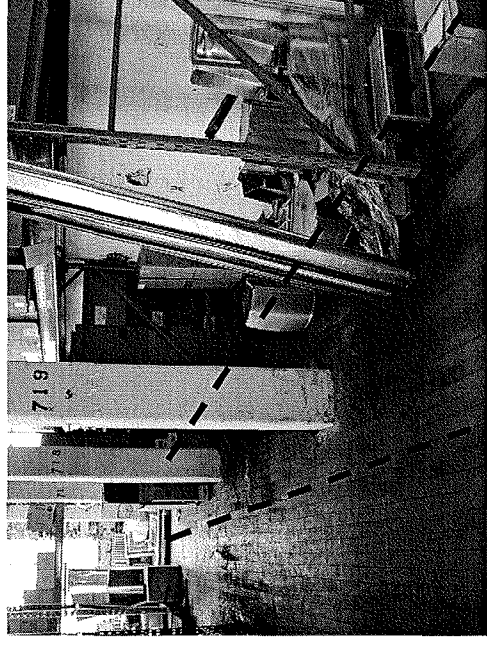
Bender Plumbing- Seventh Floor

Contamination found
throughout the floor.

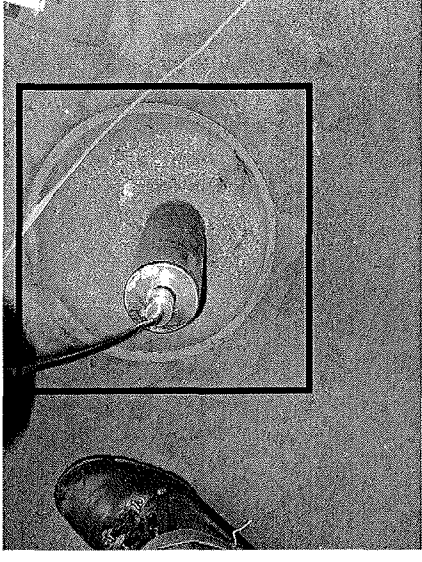
Bender Plumbing- Seventh Floor

Contamination
found along wall
and in hole.

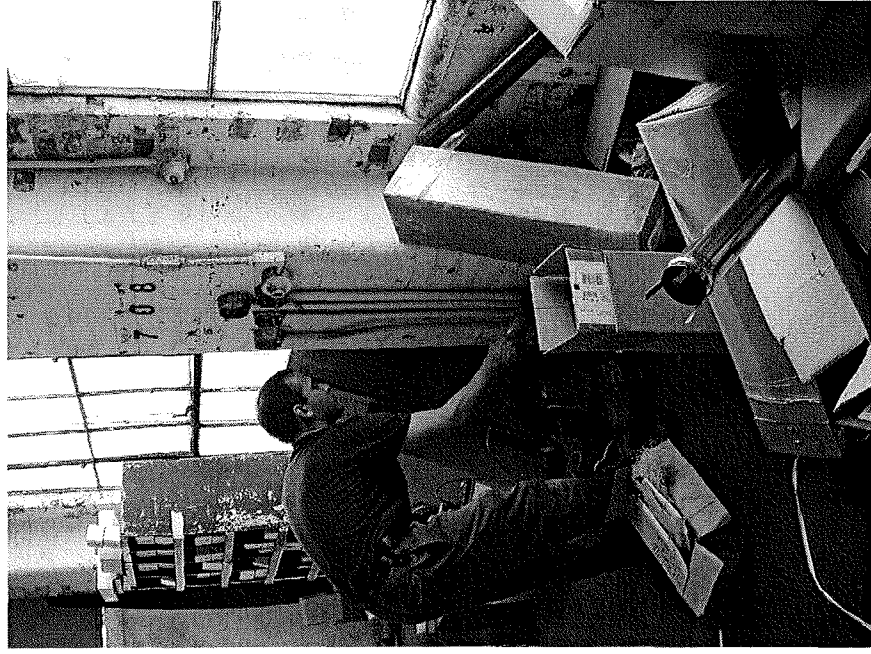
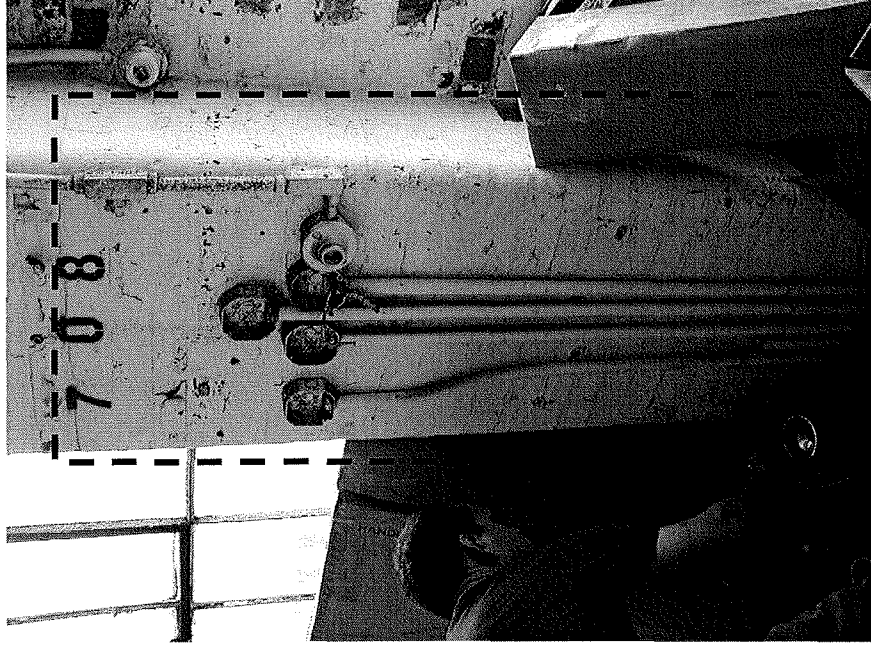
Bender Plumbing- Seventh Floor

Contamination found along wall.

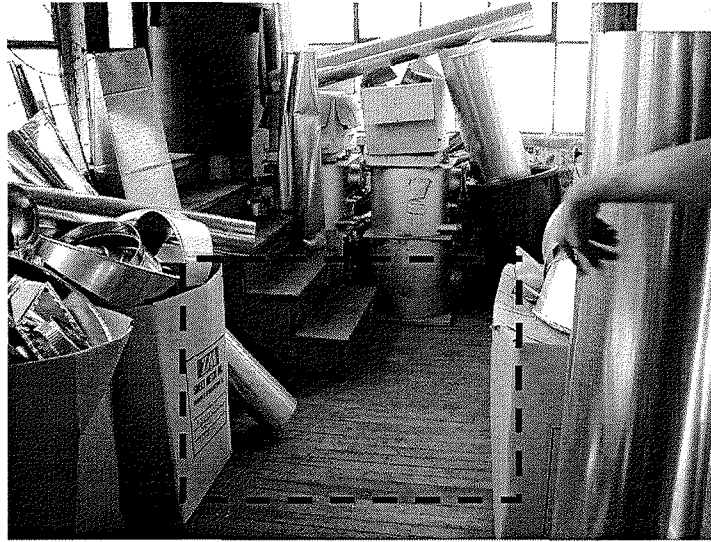
Bender Plumbing- Seventh Floor

Contamination
found in area
near and under
the stairs.

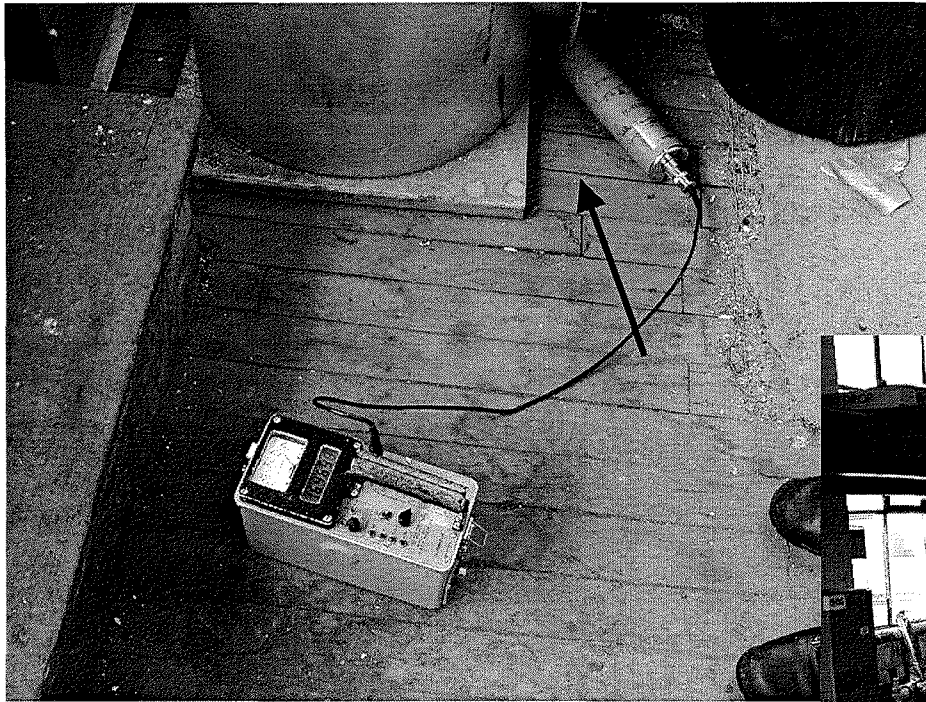
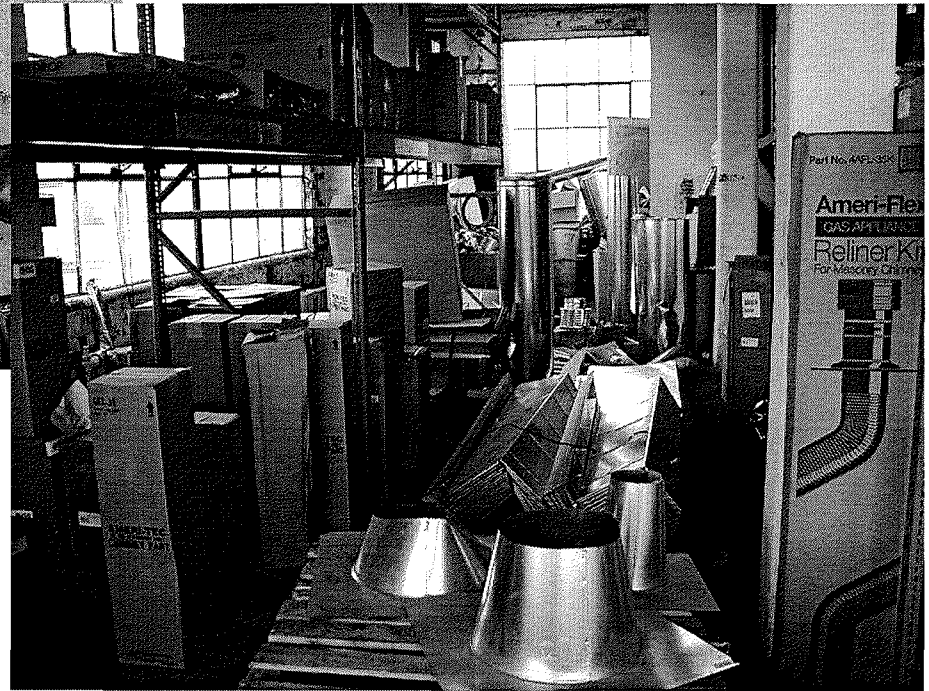
Bender Plumbing- Seventh Floor

Contamination found in the general area and by duct.

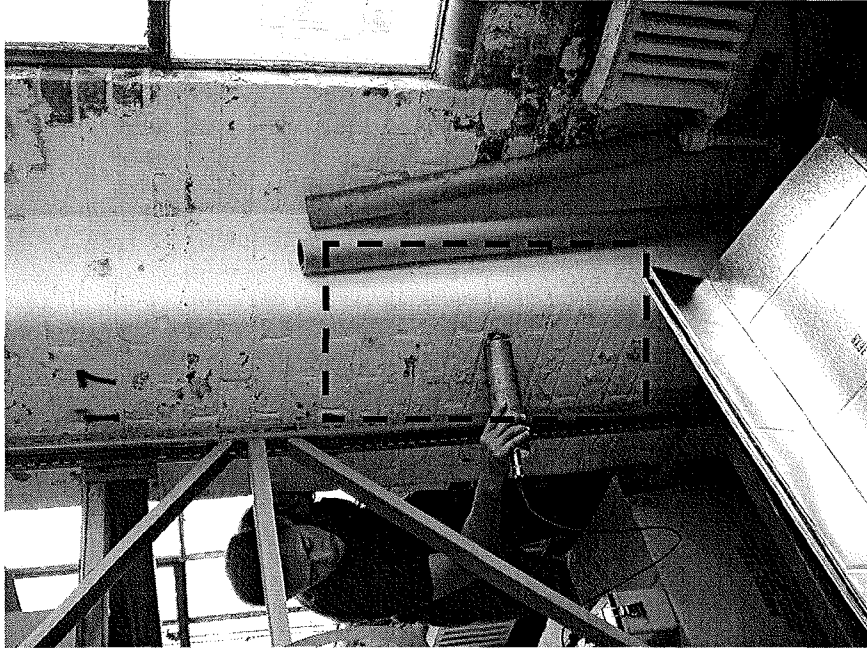
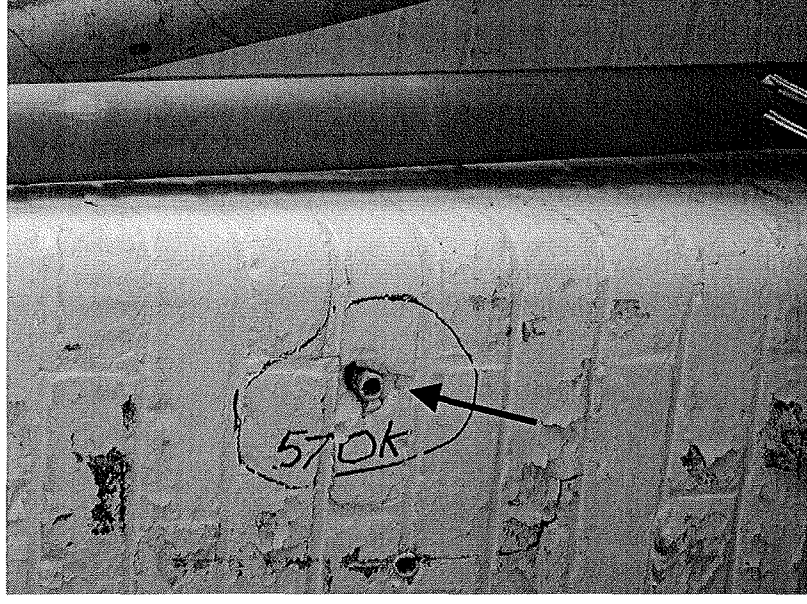
Bender Plumbing- Seventh Floor

Contamination found in pipe.

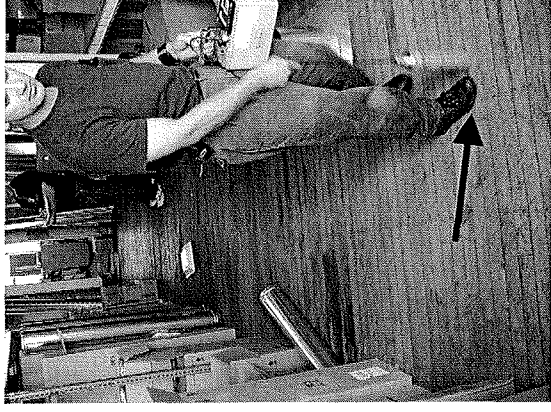
Bender Plumbing- Seventh Floor

Contamination
found on floor in
various spots
and paths.

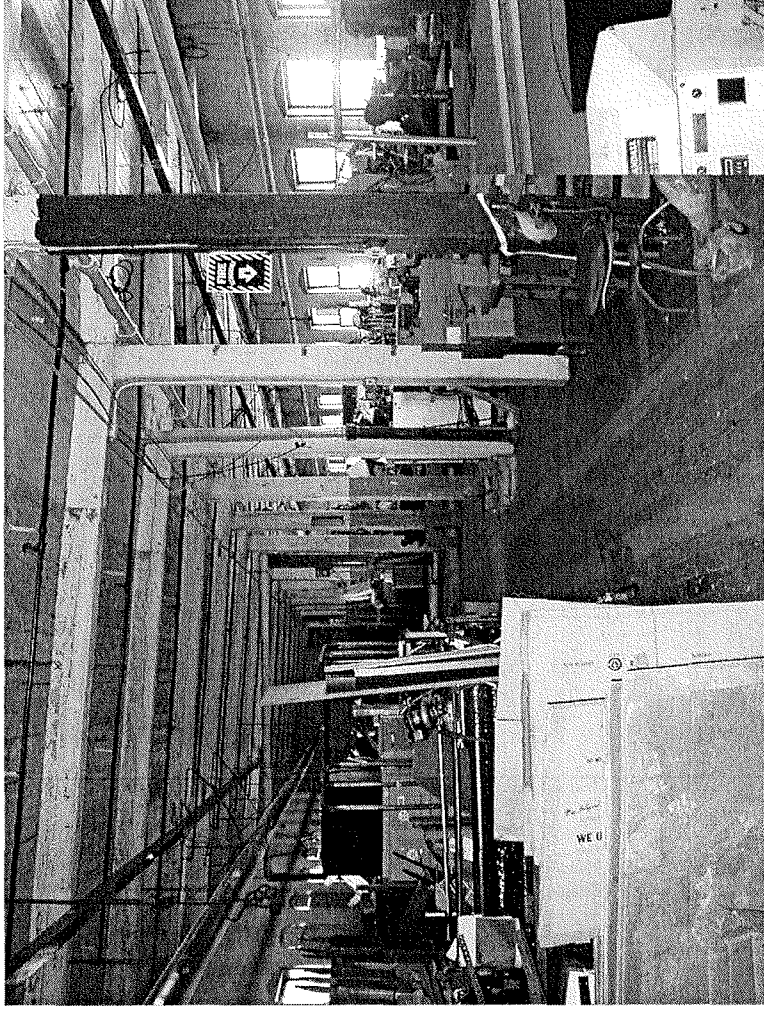
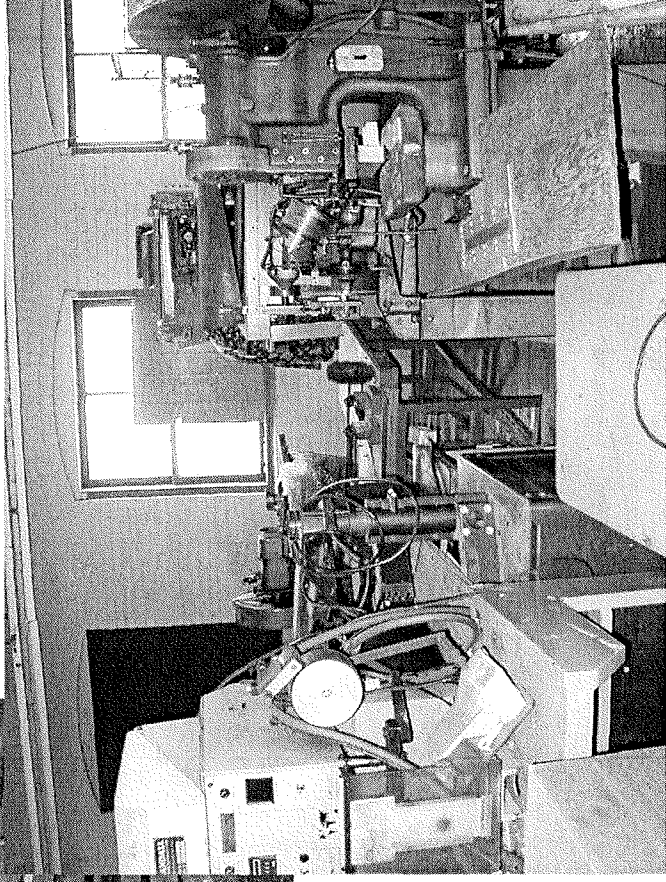
Belco-Sixth Floor

Building 1, Loft
Machines-
contamination
found in 1' x 7'
area by windows

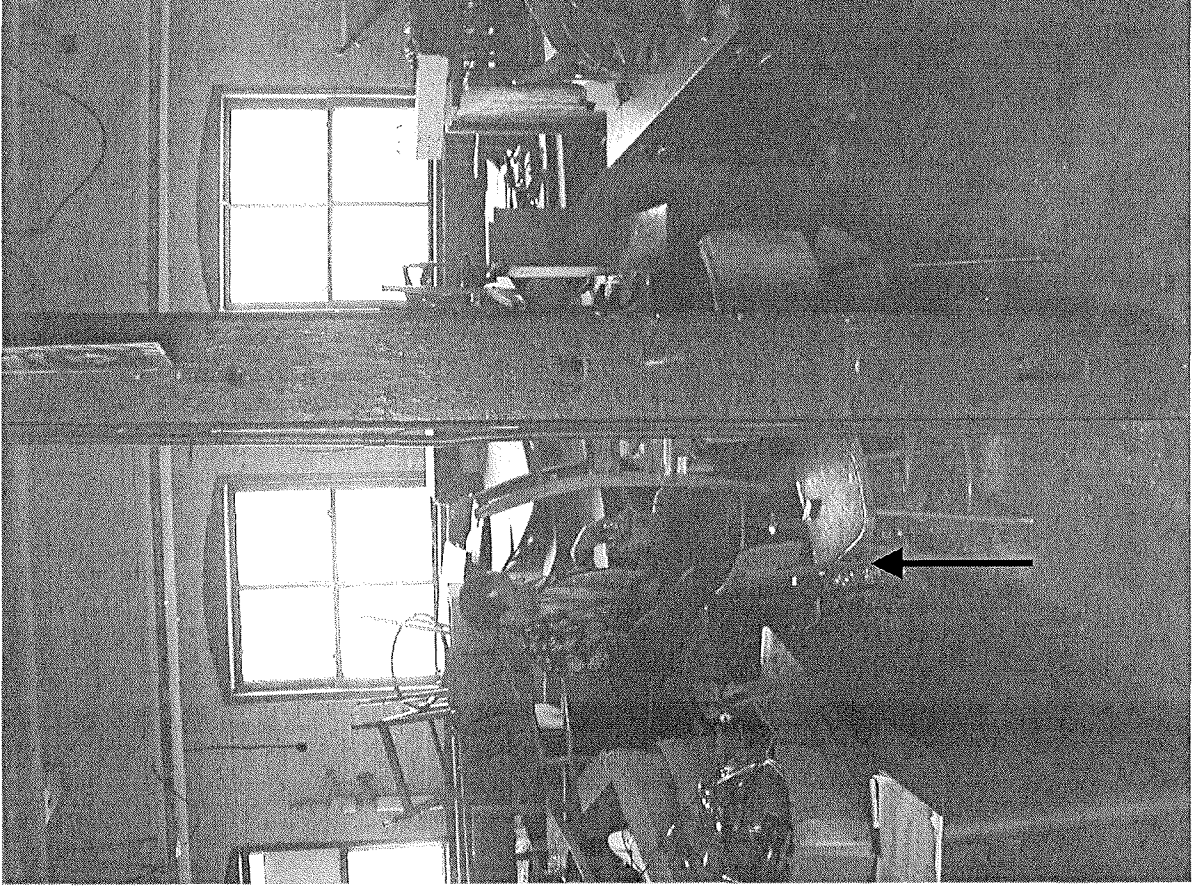
Belco-Sixth Floor

Building 1, Loft
Machines-spot
contamination by
fire extinguisher

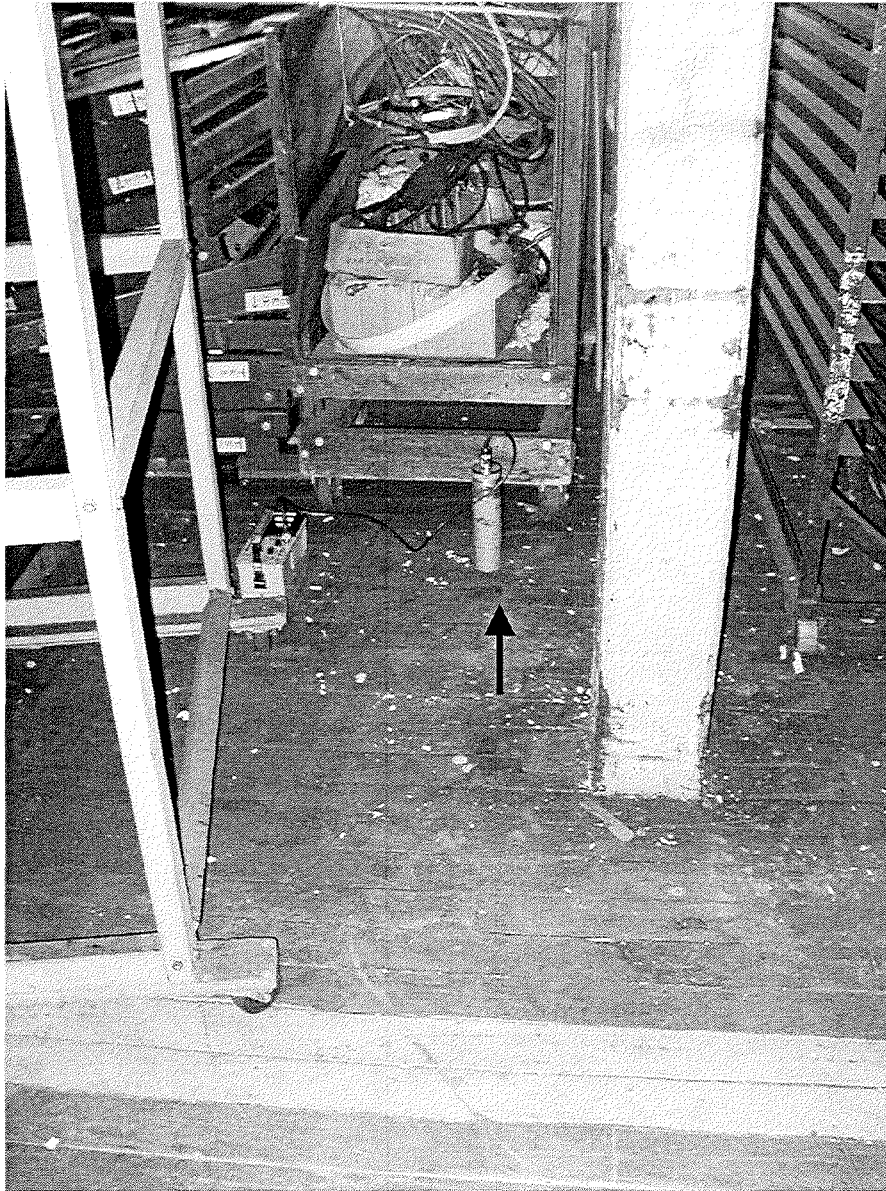
Belco-Sixth Floor

Building 1, Loft
Machines-spot
contamination
(elevated near
tenth pillar- twice
background)

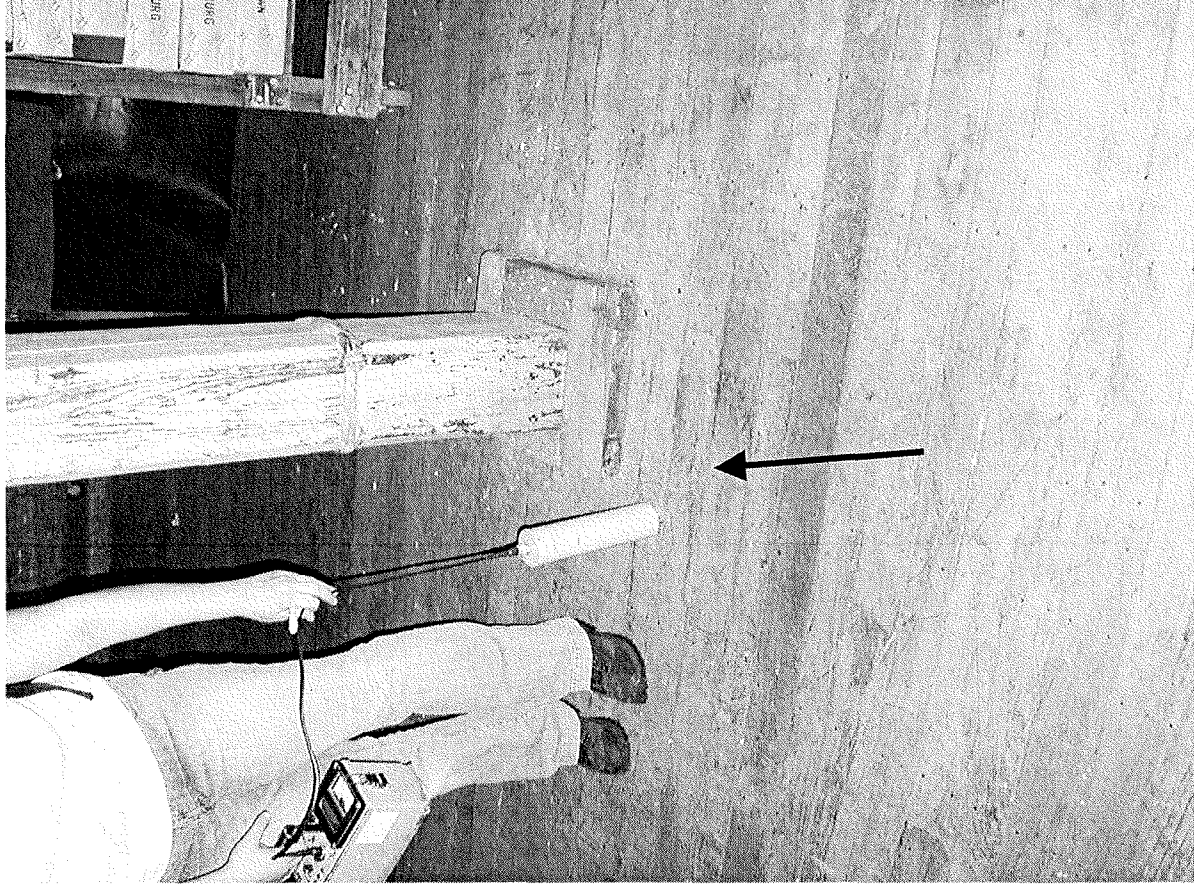
Belco-Sixth Floor

Building 2, NB –
contamination on floor
by pillar

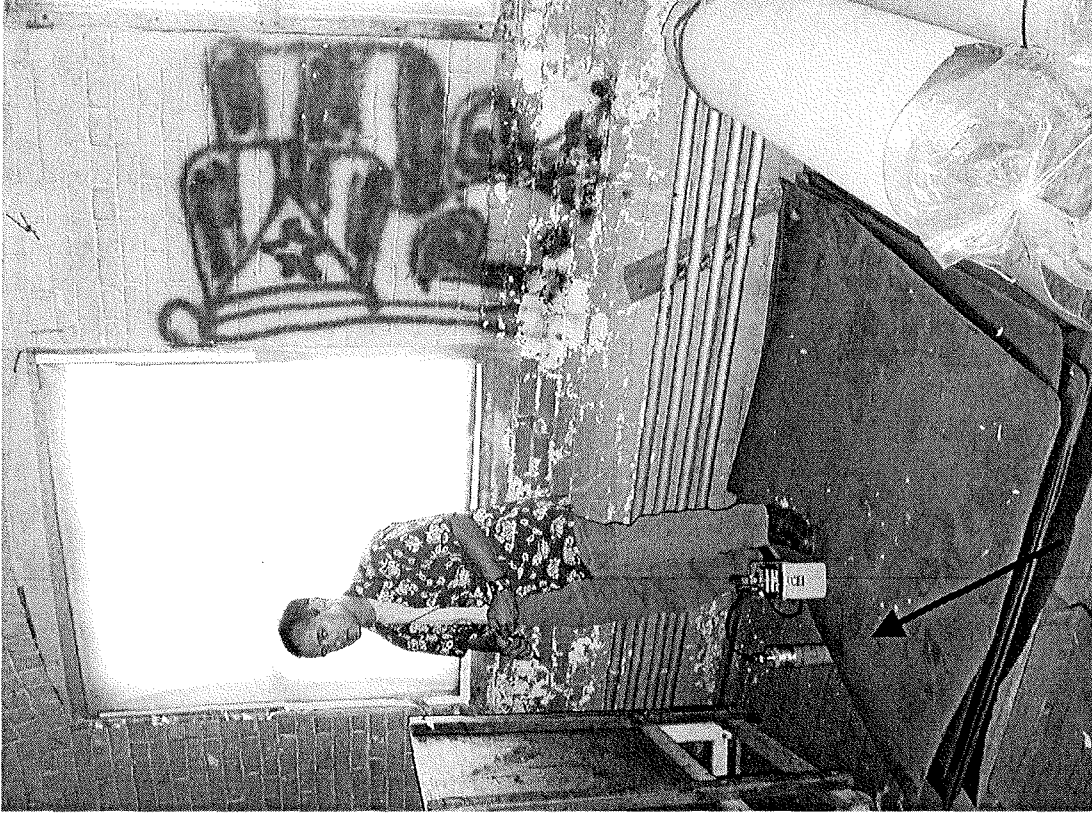
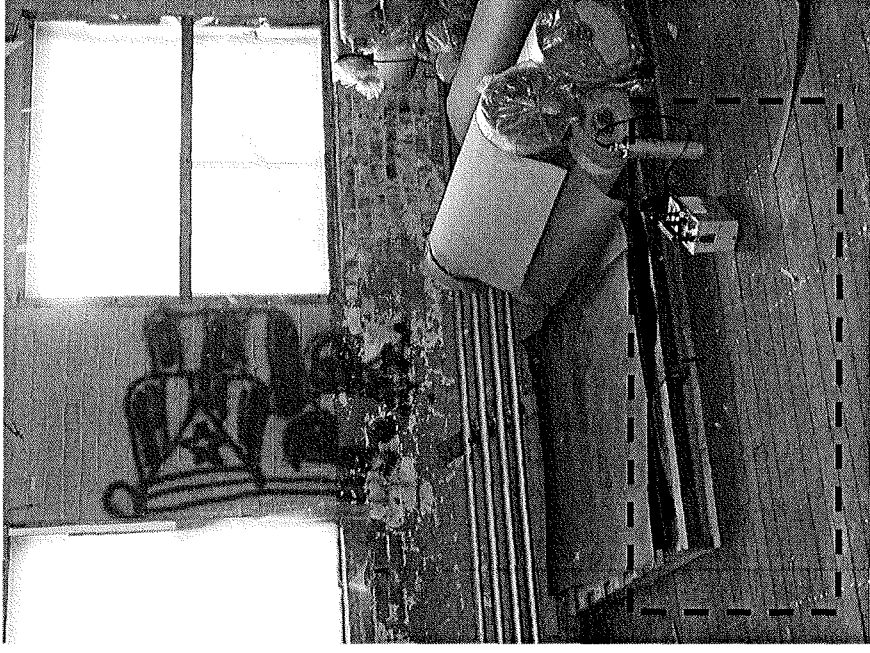
Belco-Sixth Floor

Building 2, NB –
contamination on a
few floor spots by flag.

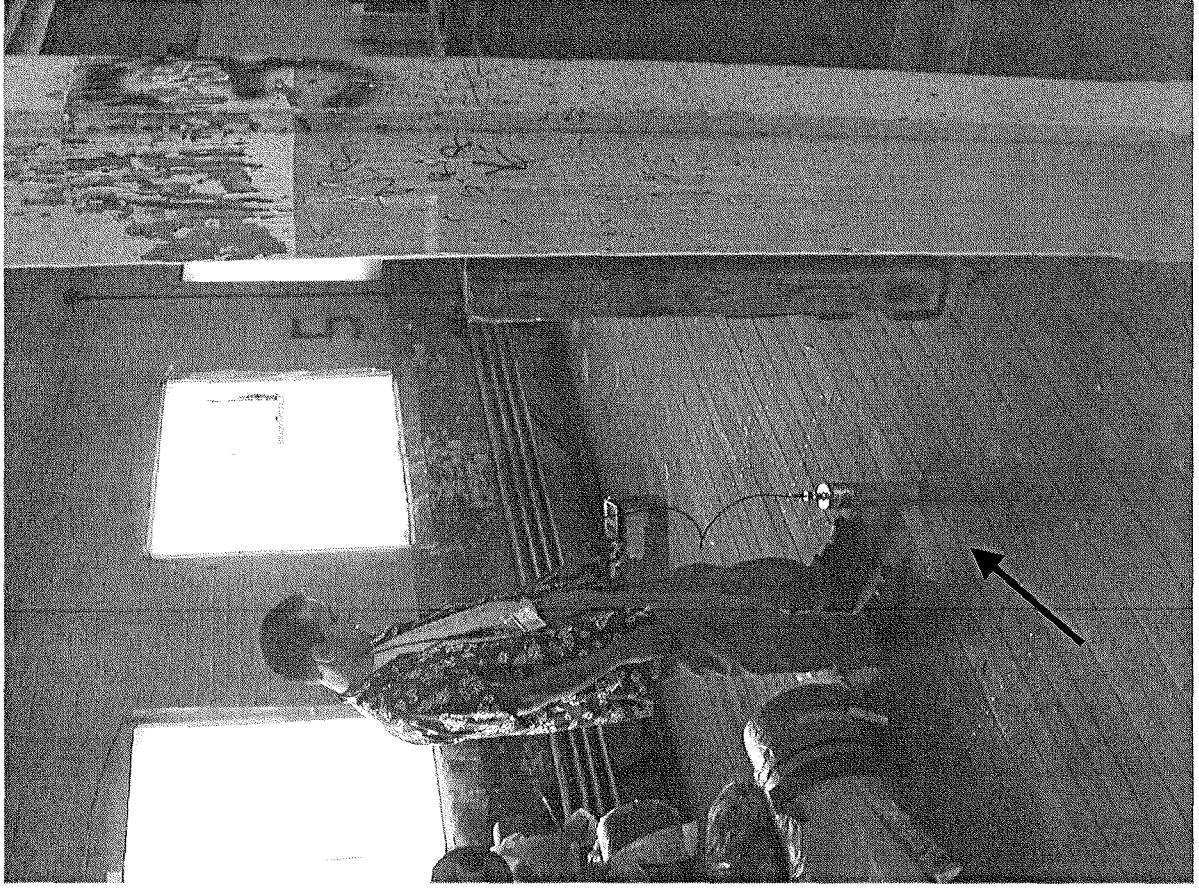
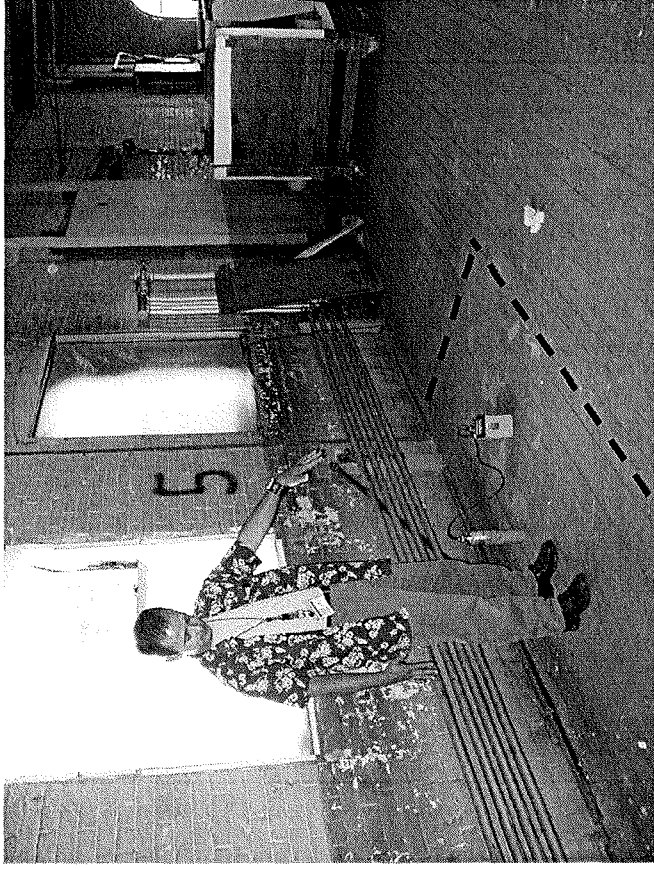
Belco-Sixth Floor

Building 2, NB –
contamination on a
few floor spots and
area by window.

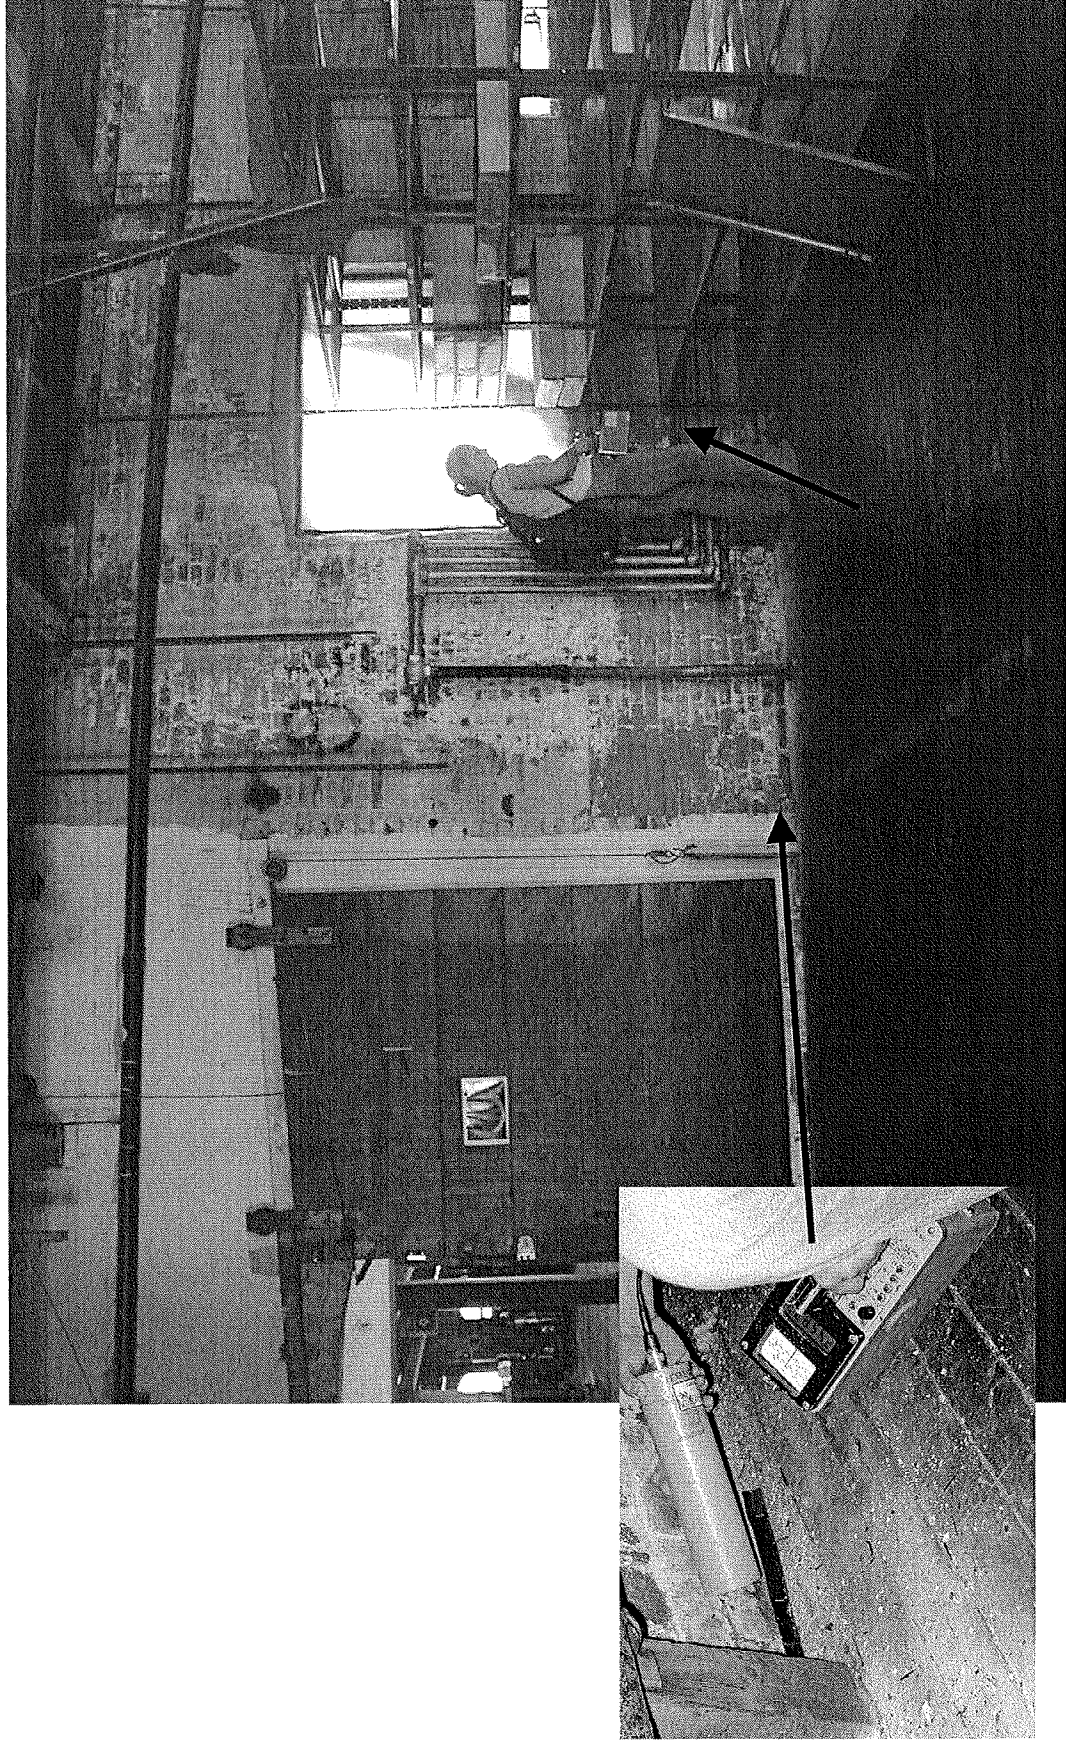
Belco- Sixth Floor

Building 2, NB –contamination on a wall and floor spot by window. B-13

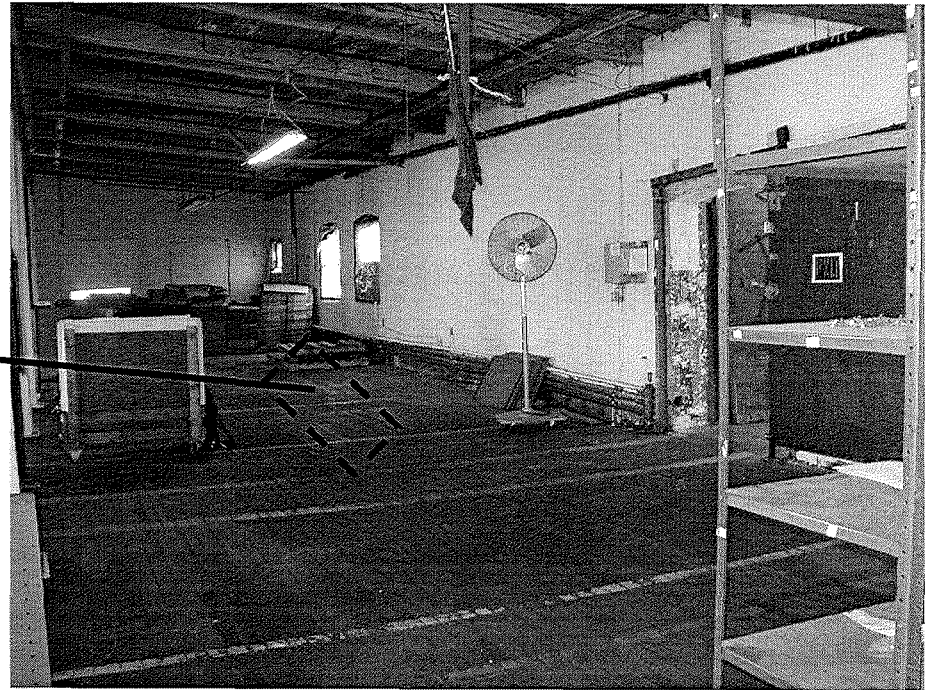
Building 3,
Leatherworks-
Contamination
found on floor
area 5' x 12'.

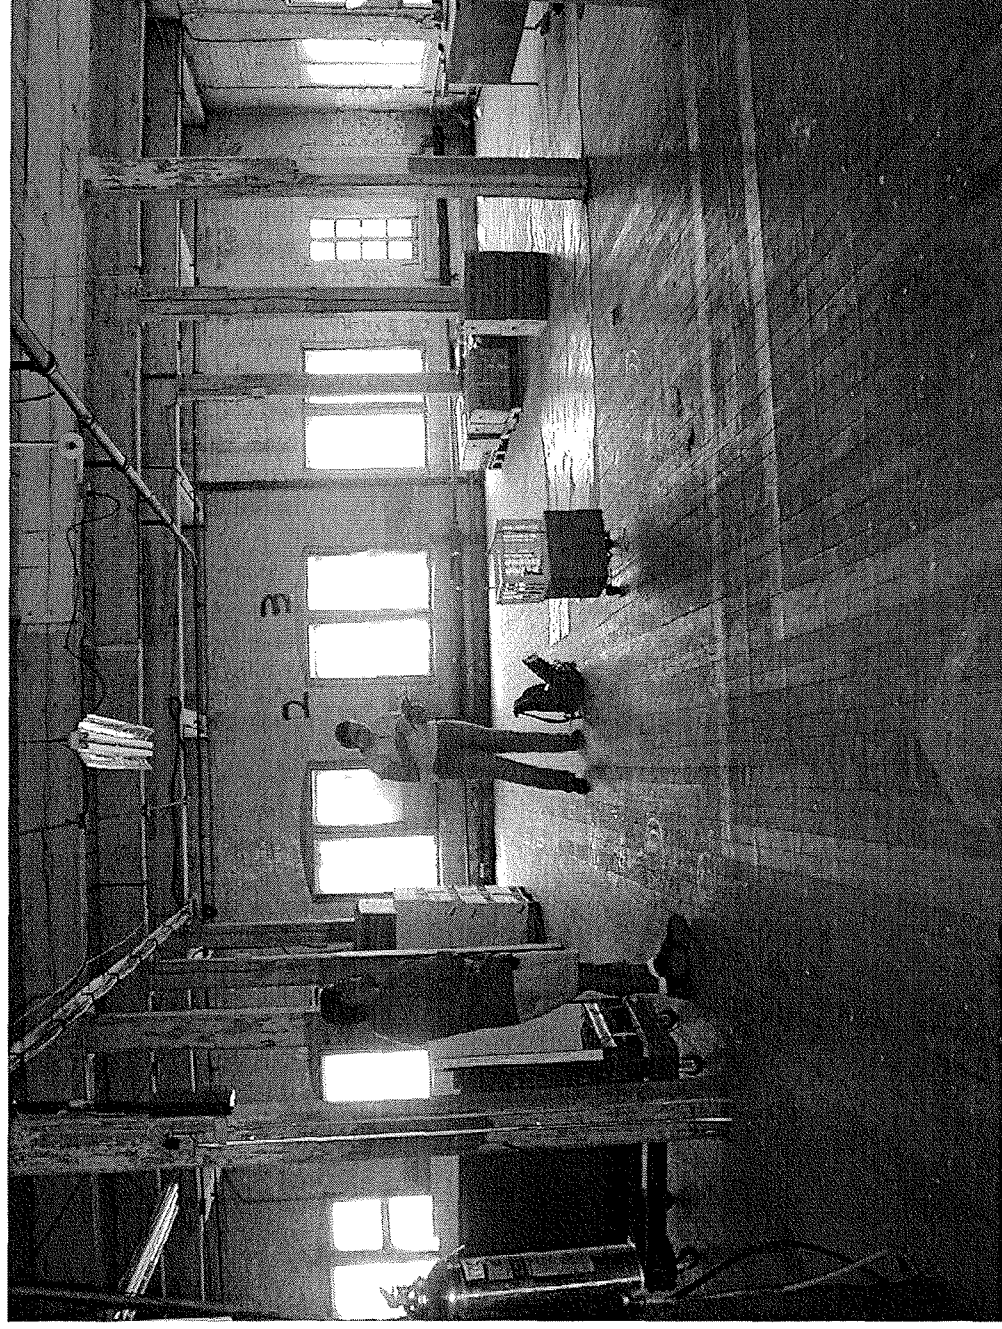
Belco- Fifth Floor

Building 1,
Belt Storage

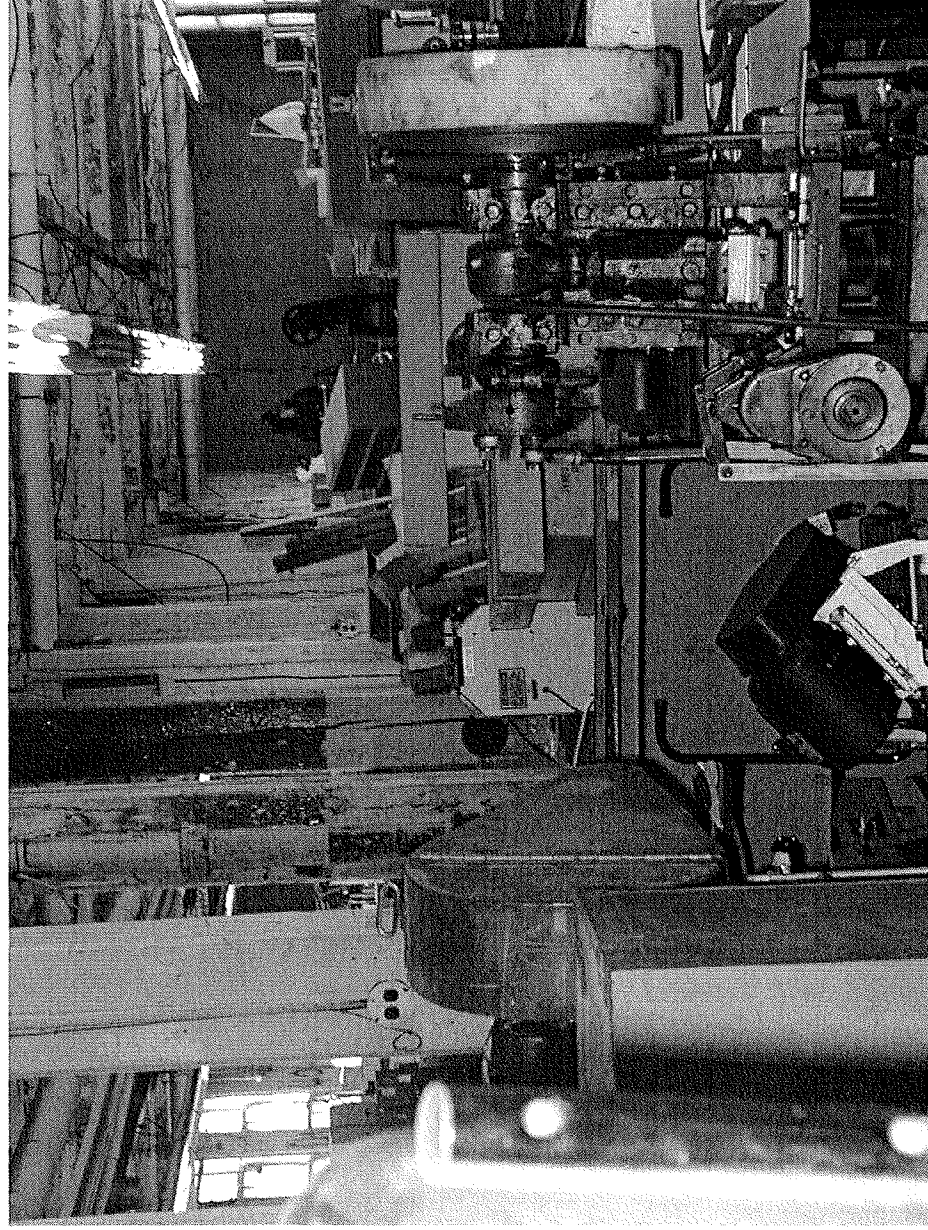
Belco- Fifth Floor

Building 3,
Rental Area

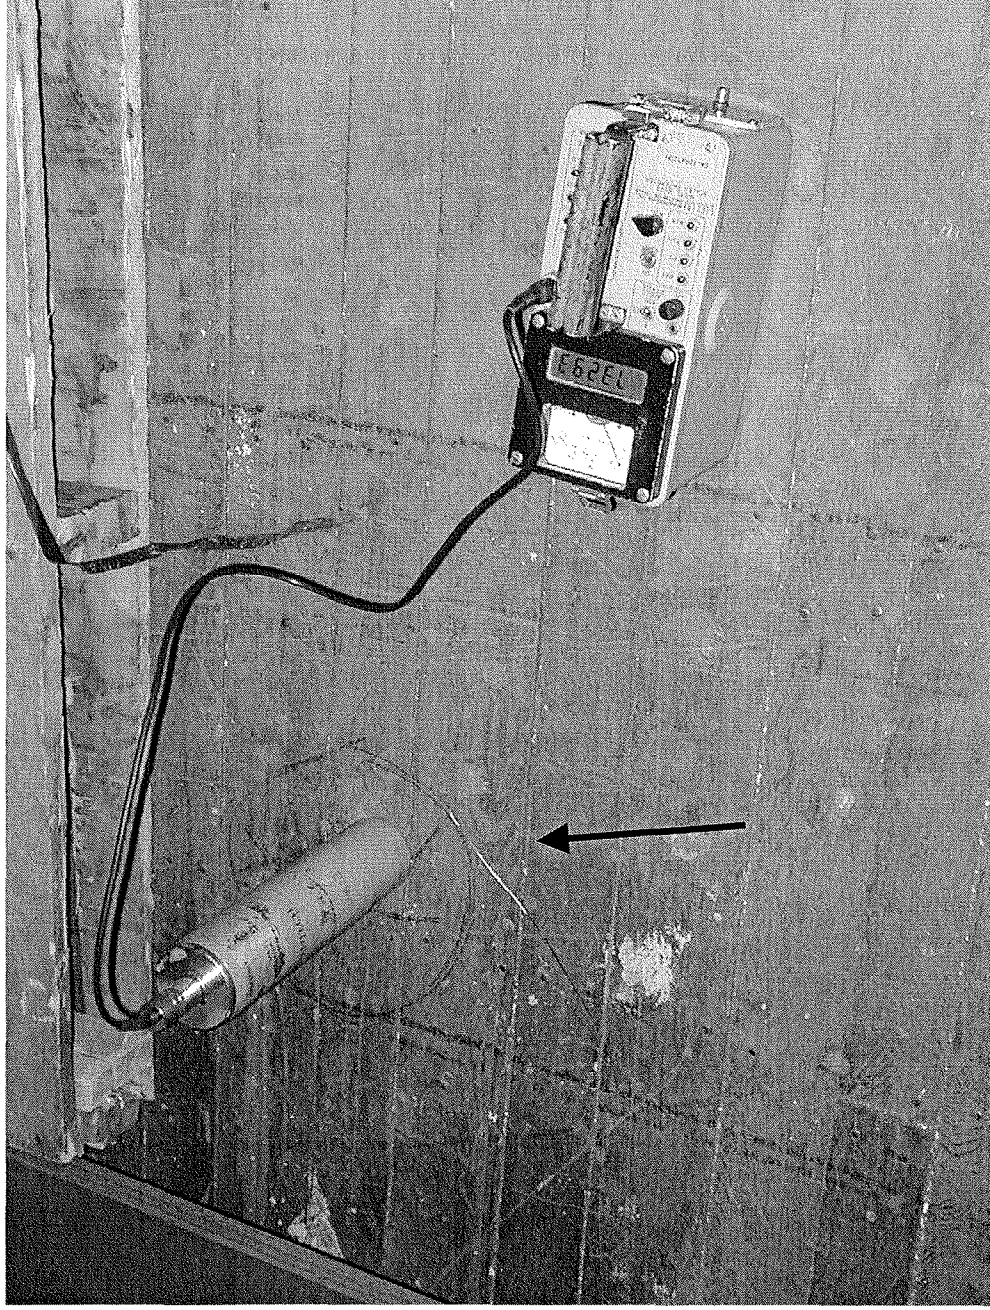
Building 3,
Rental Area-
floor spot
