Valley Council of Governments

Connecticut Radium Sites Verification Survey

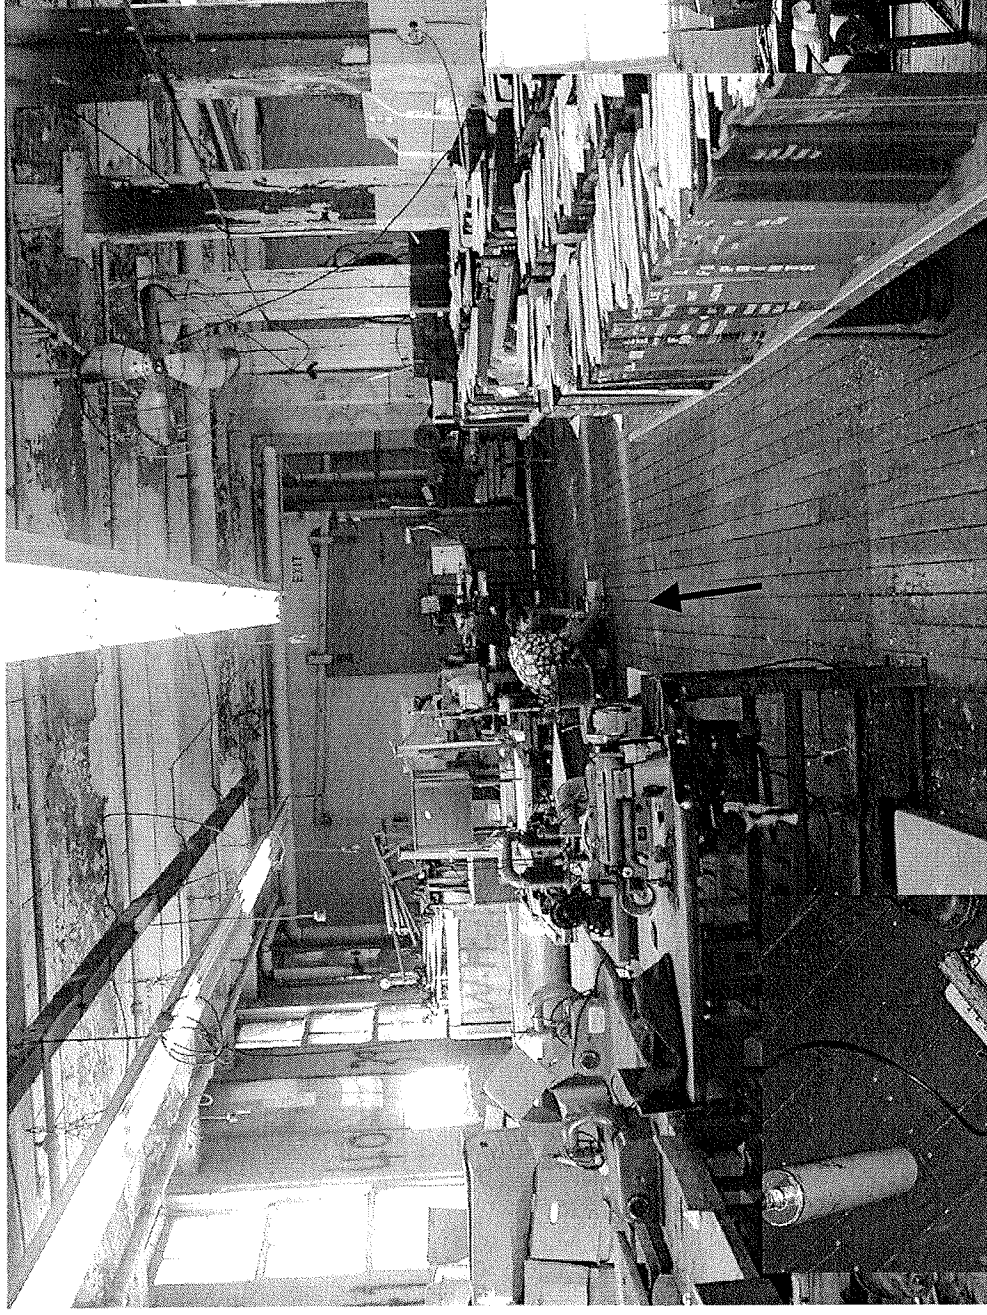
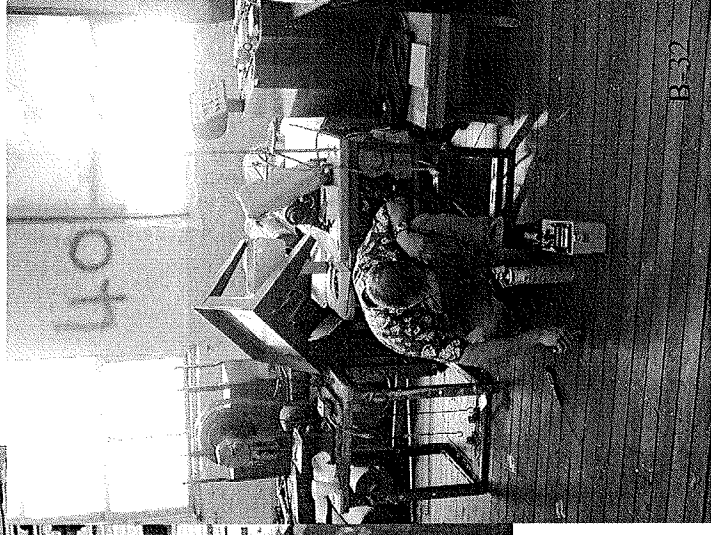
Building 3,
Rental Area-
floor spot

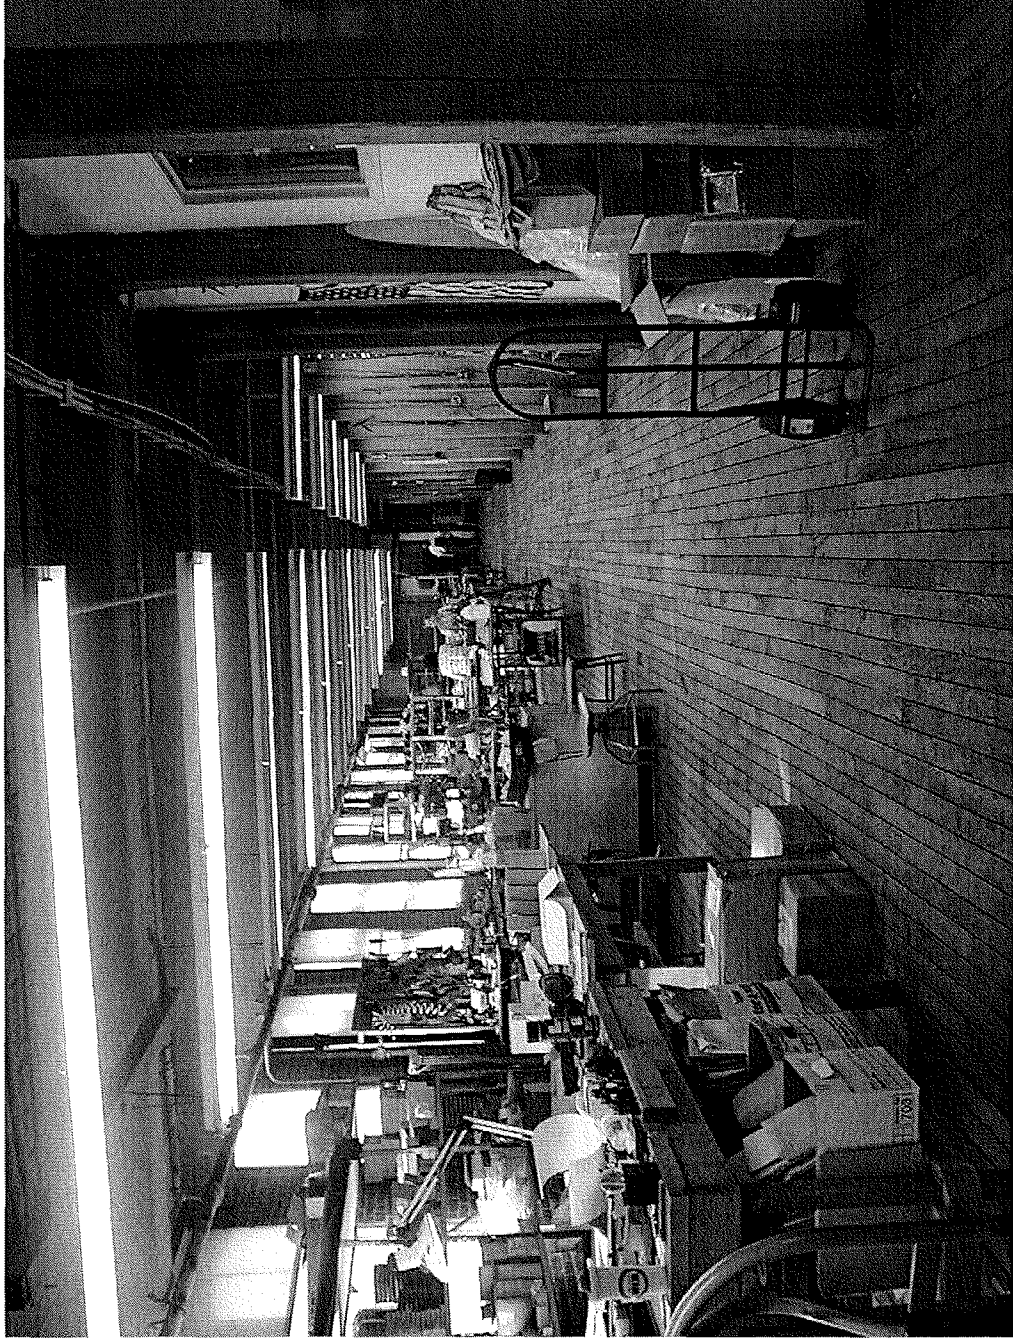
Building 3,
Leatherworks-
possible shine
from floor
below

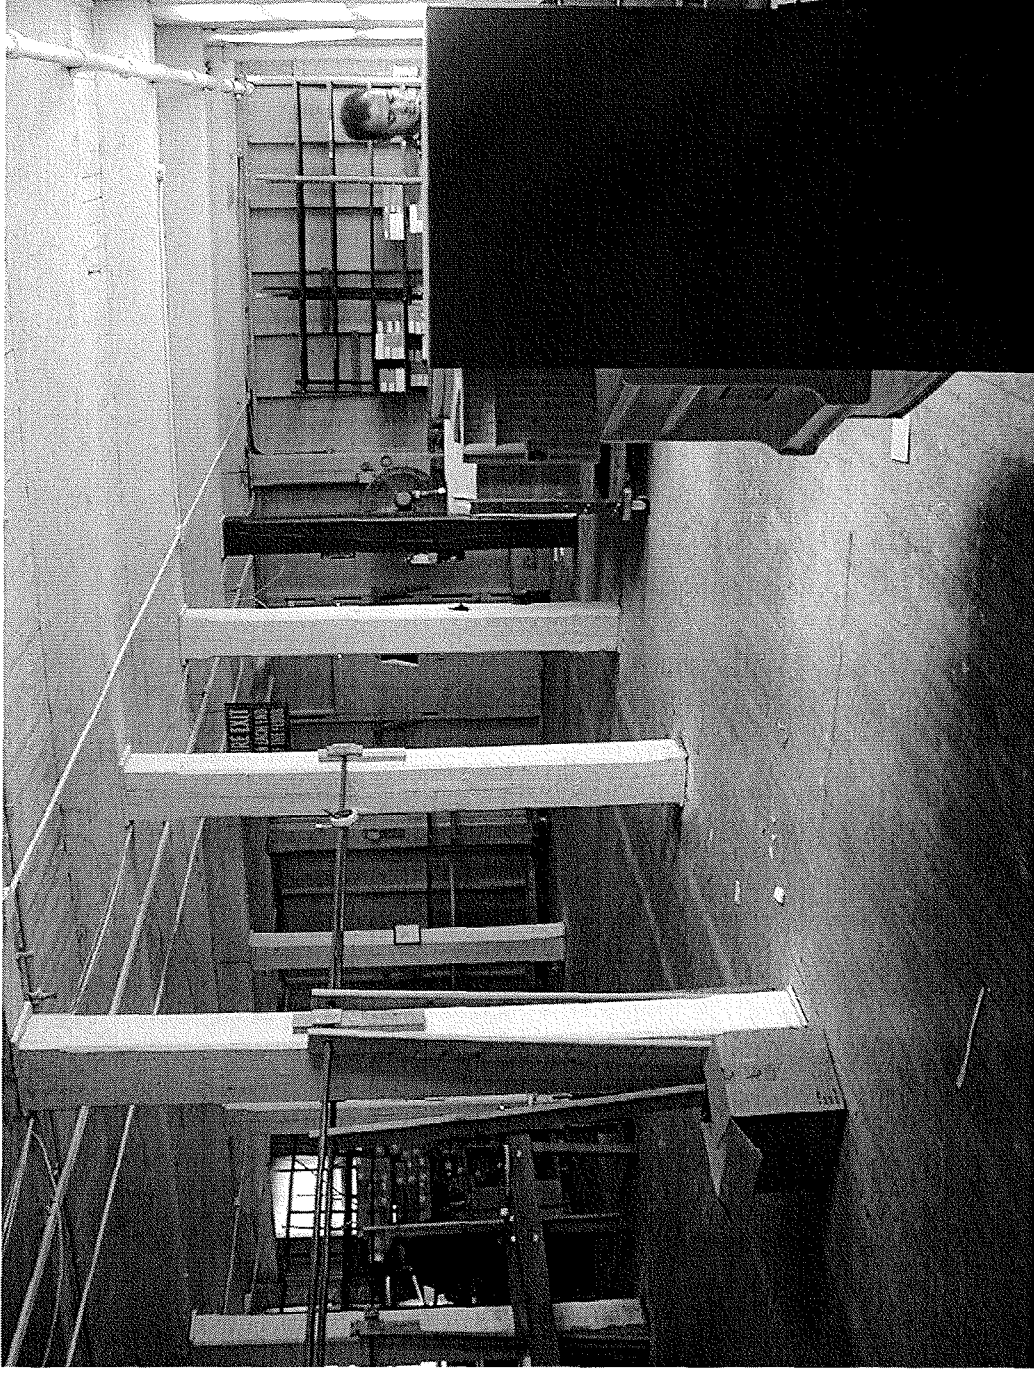
Building 2,
Store Room-
possible shine
from floor
below.

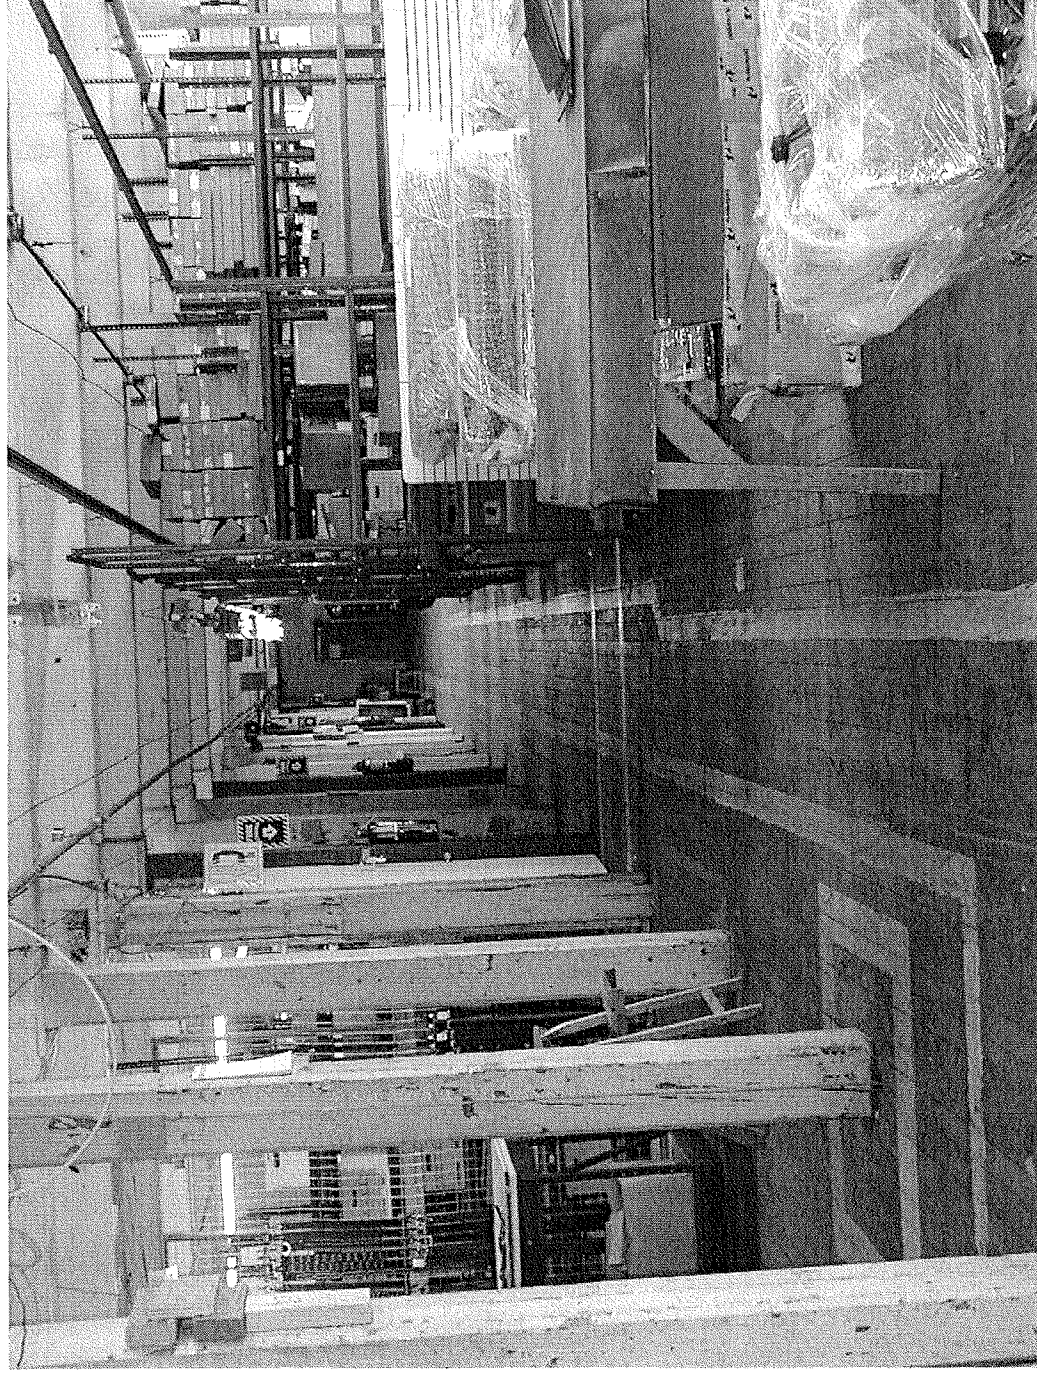
Building 1,
Tie Area

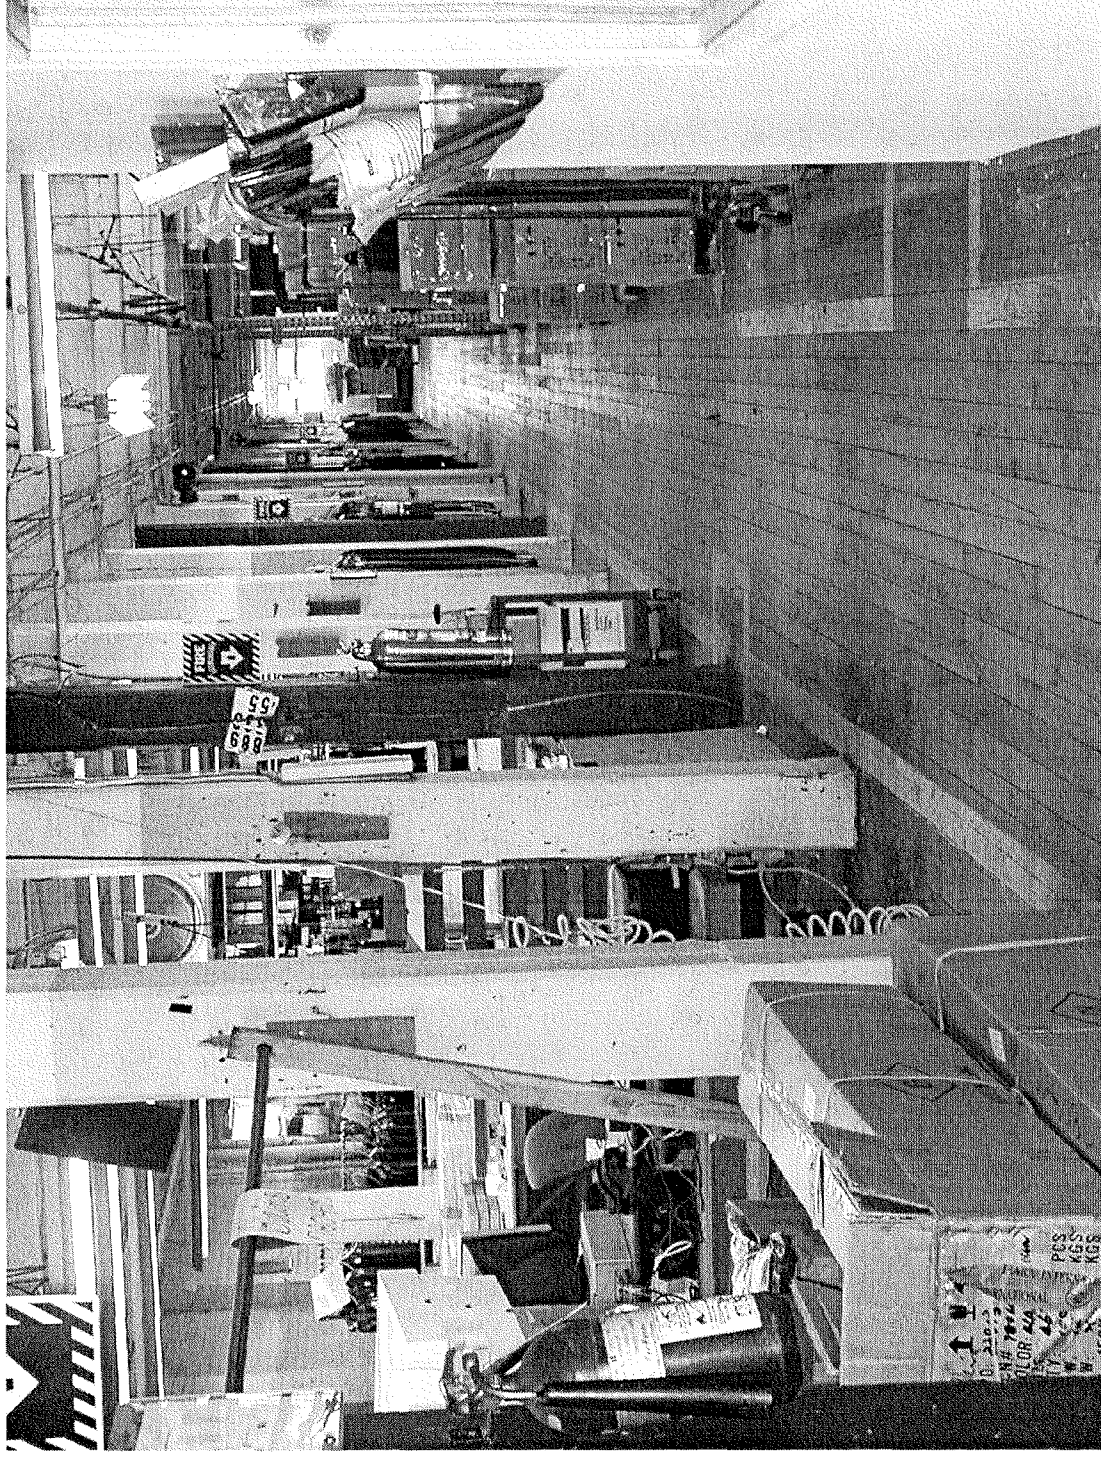
Building 1, Tie Production

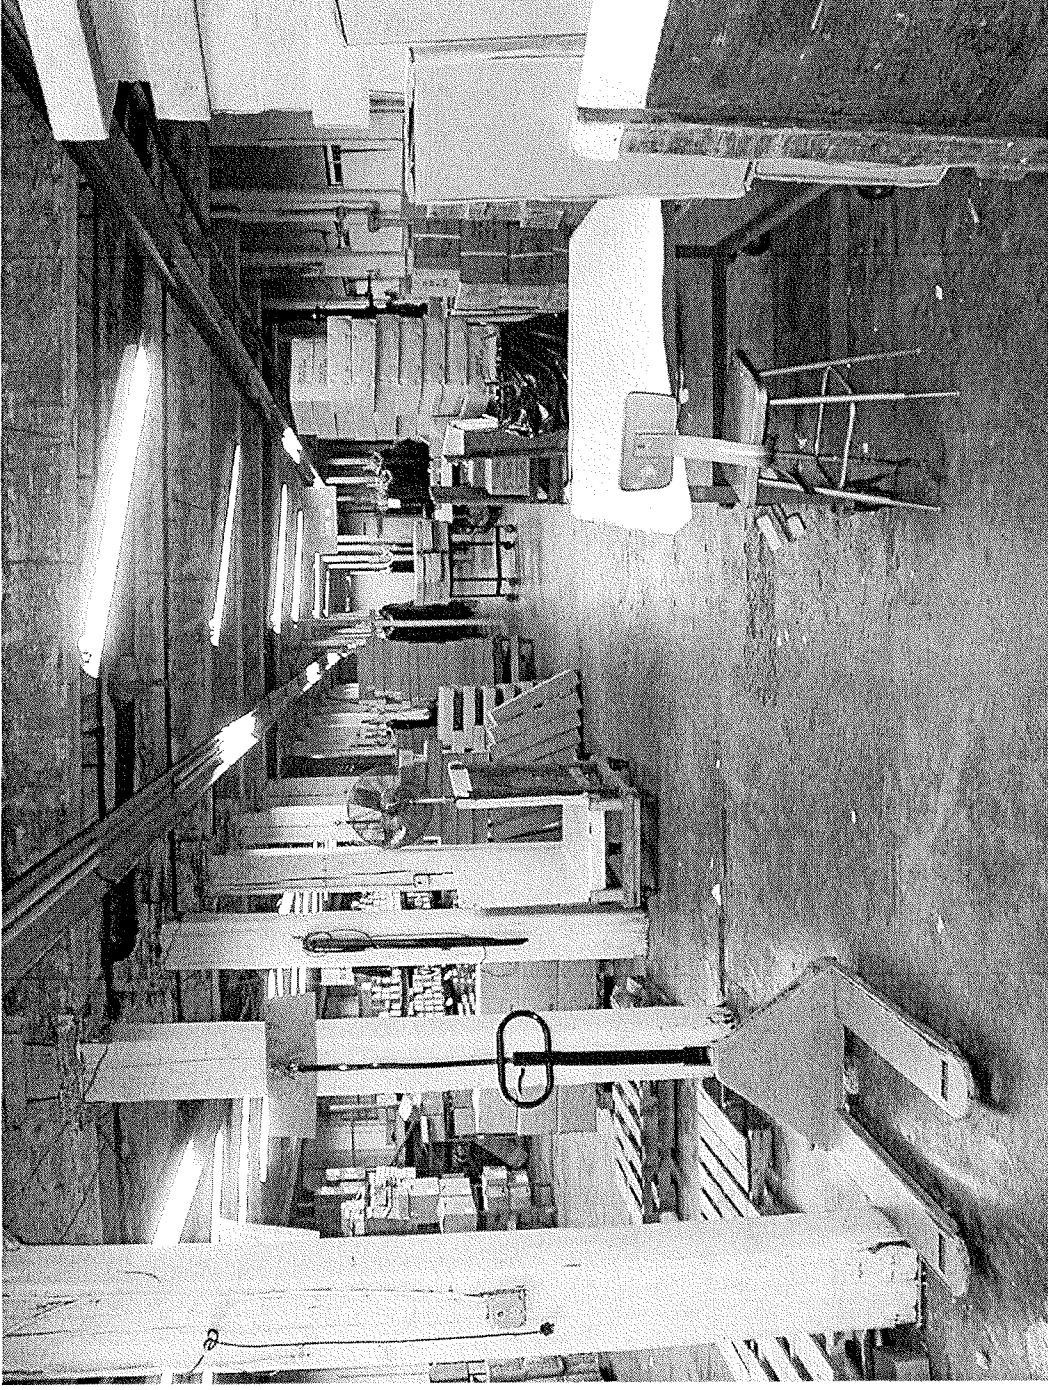
Building 3, Storage Room

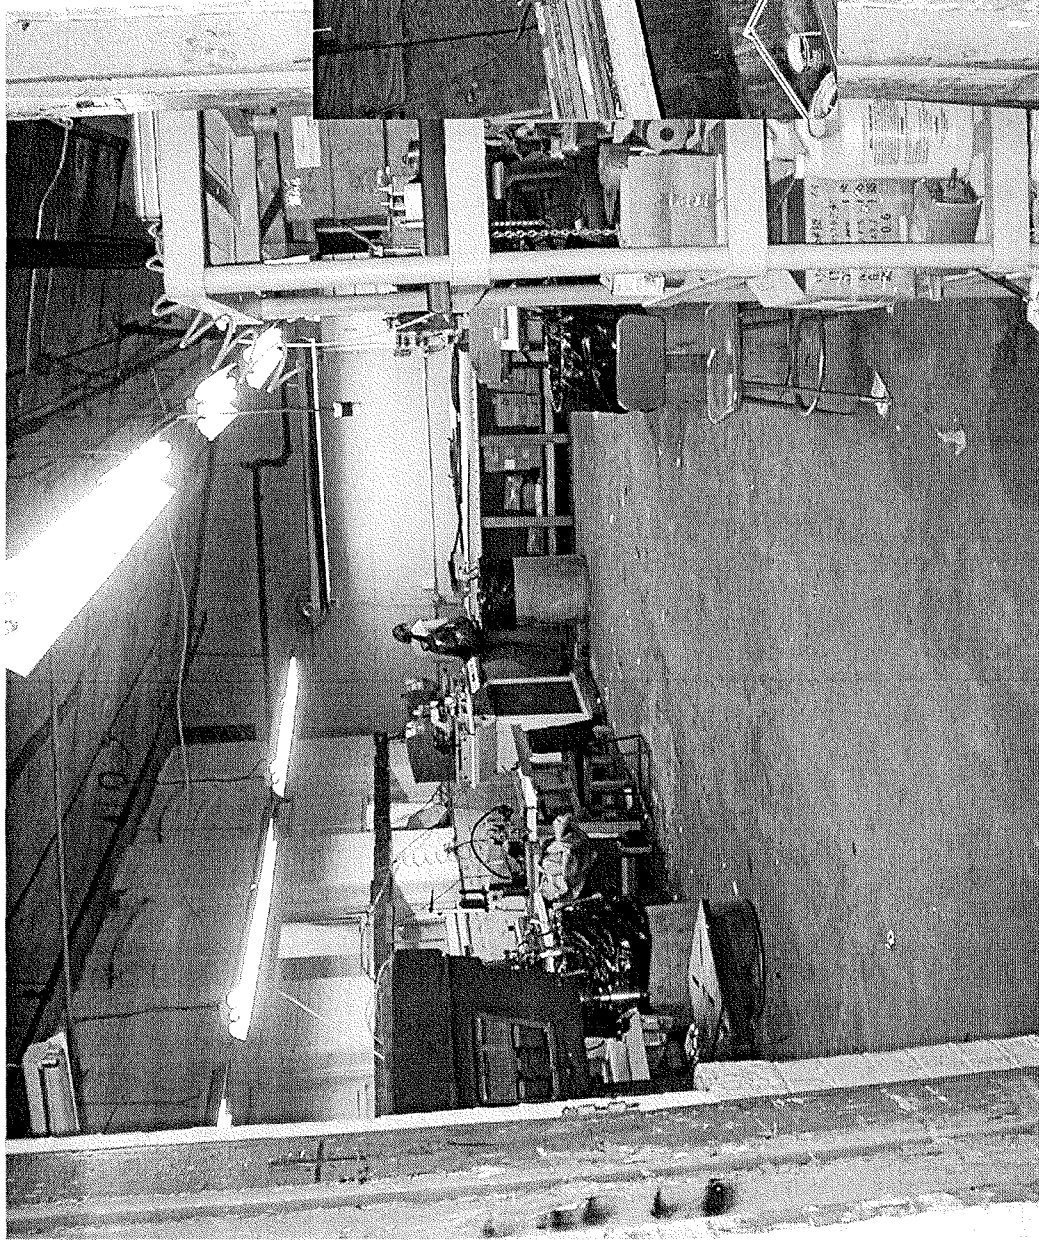
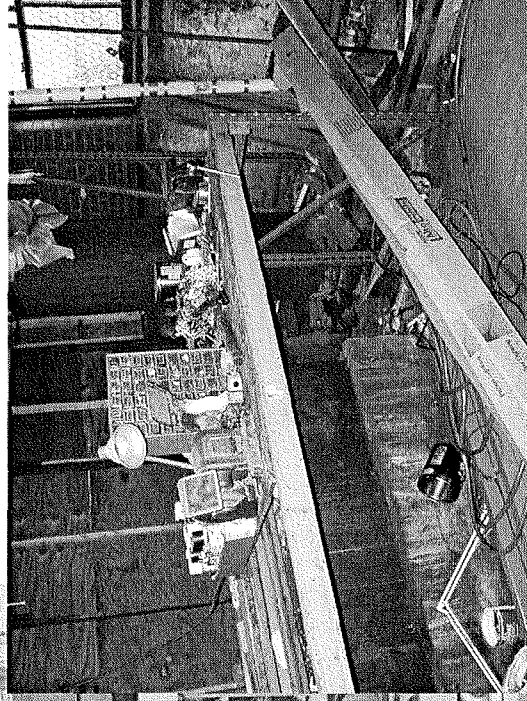
Building 2, Machine Shop

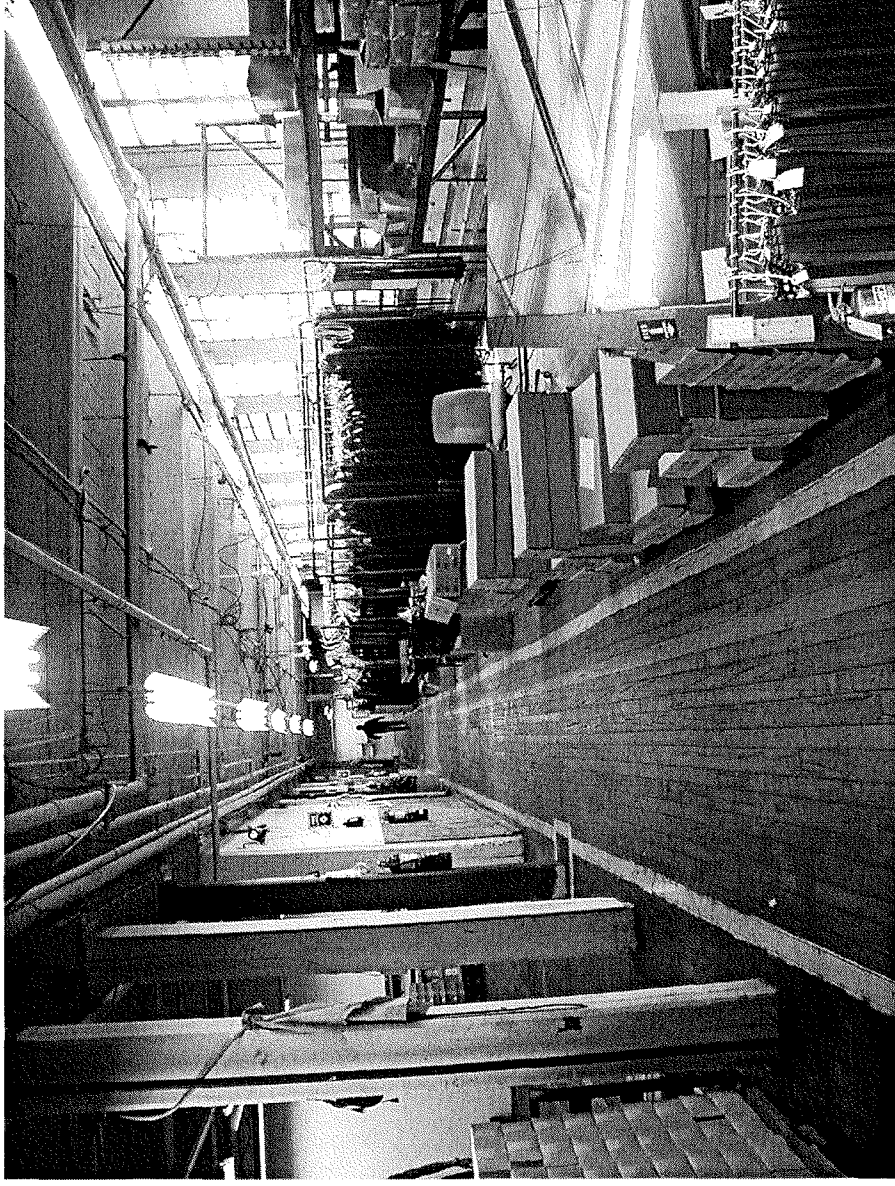
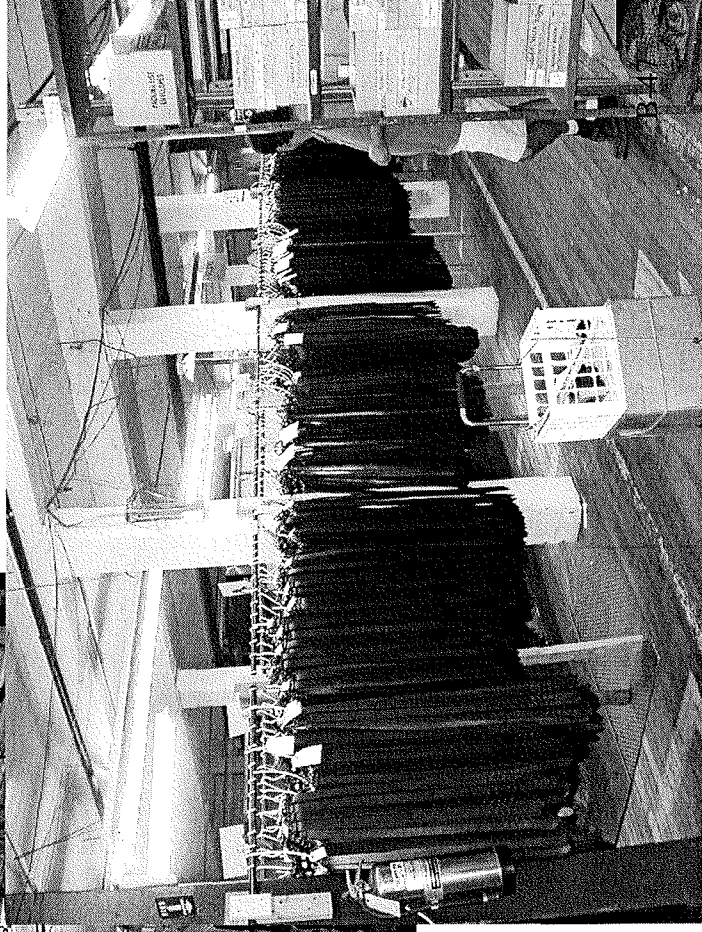
Building 1, Cutting
Room / Belt
Production

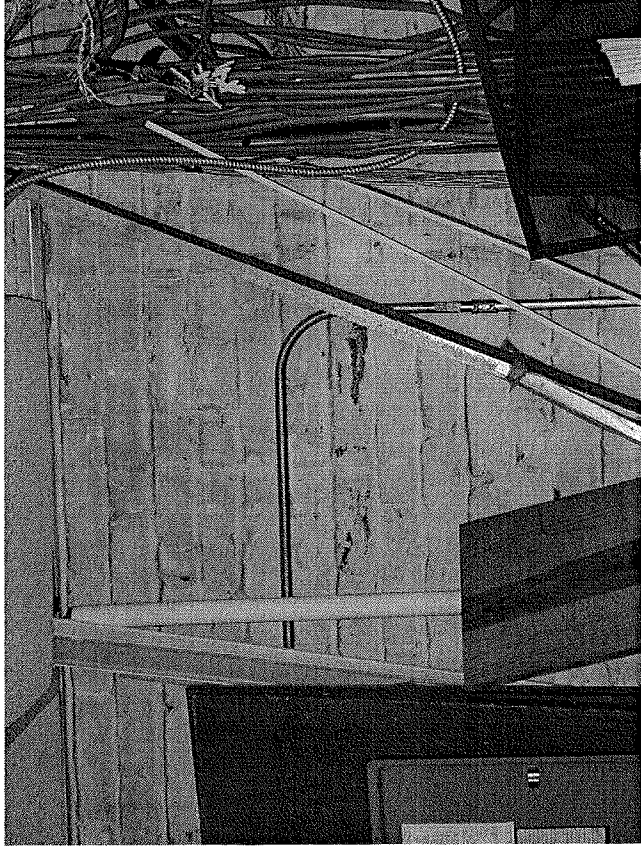
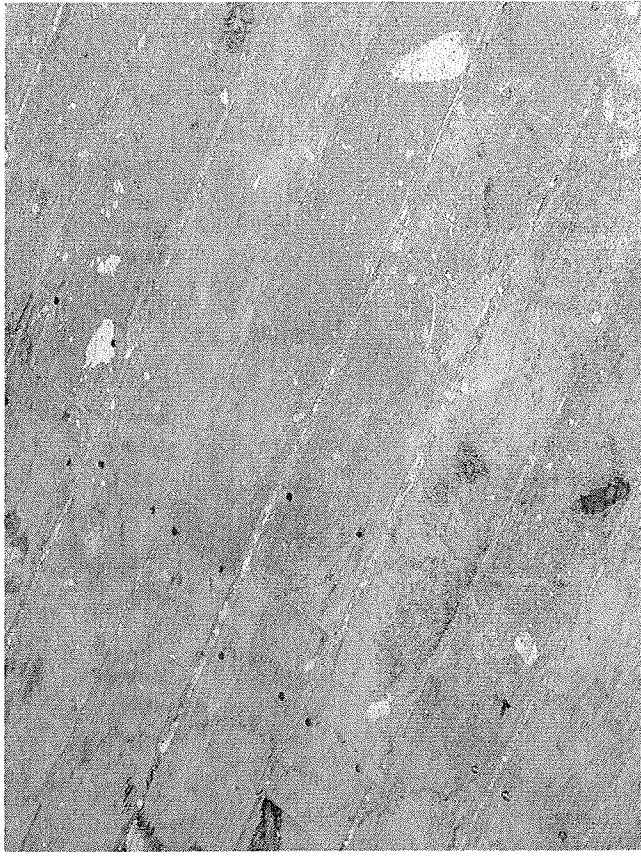
NOW- Example of Walls and Flooring Under Carpet

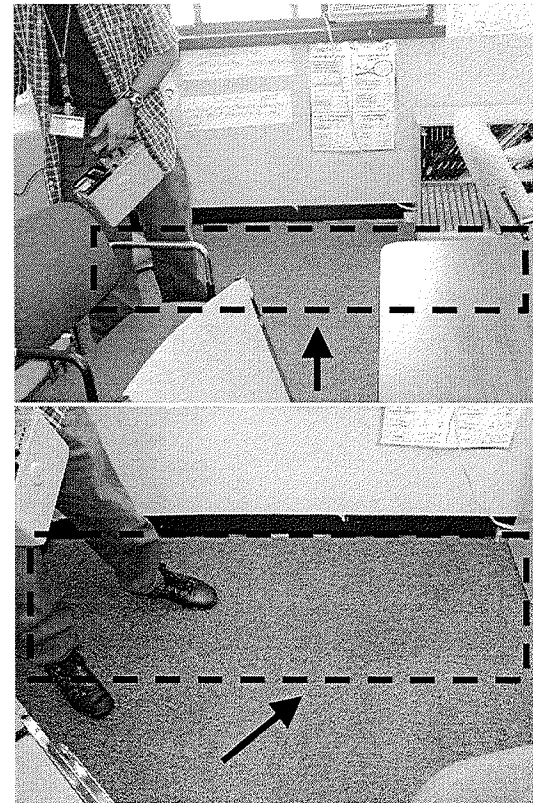
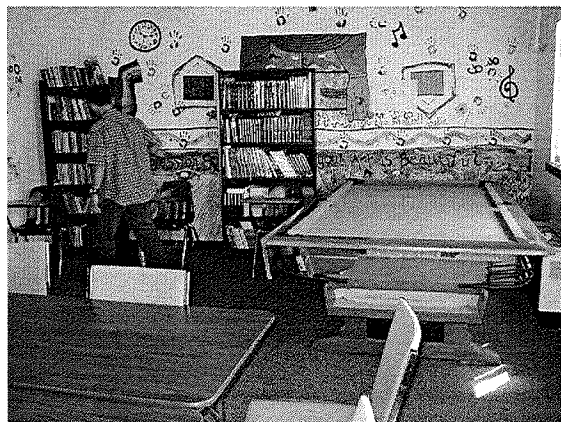
NOW- Reading Room (Rec. Area)

Contamination found along the entire floor area by windows.

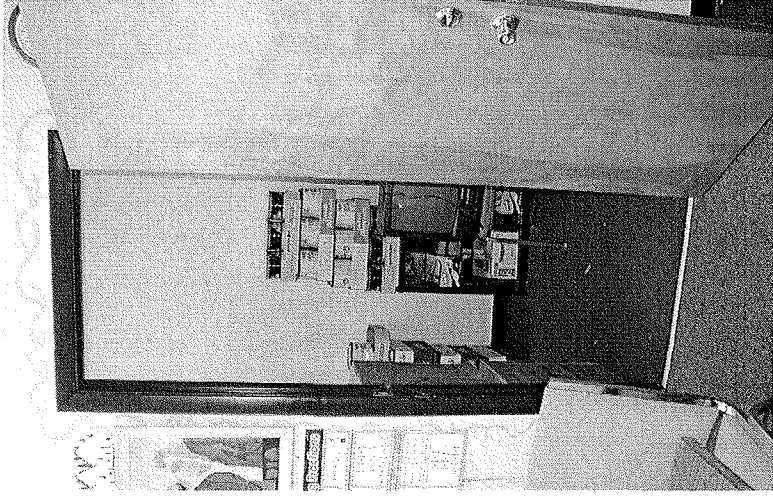
NOW- Storage Room (Rec. Area)

Contamination found
on floor by shelves.

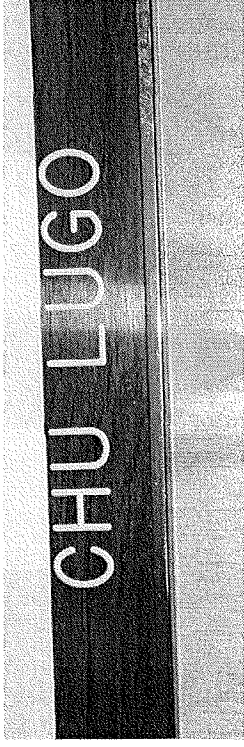
NOW- Office (Computer Room)

Contamination found
on floor spot

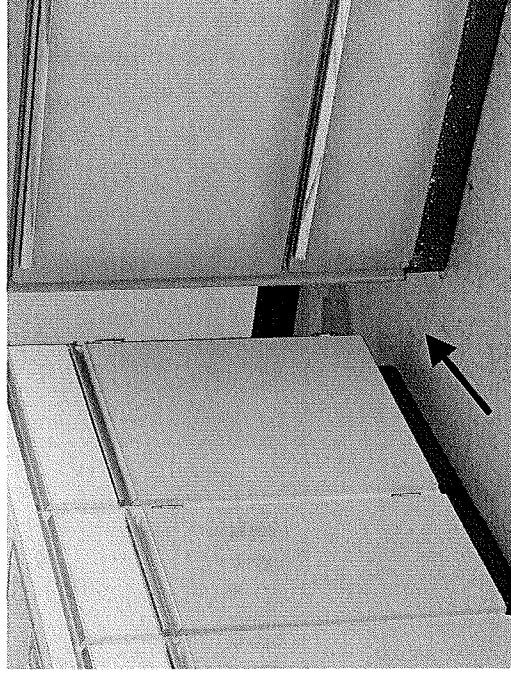
NOW - Kitchen

Contamination found on floor spot behind stove.

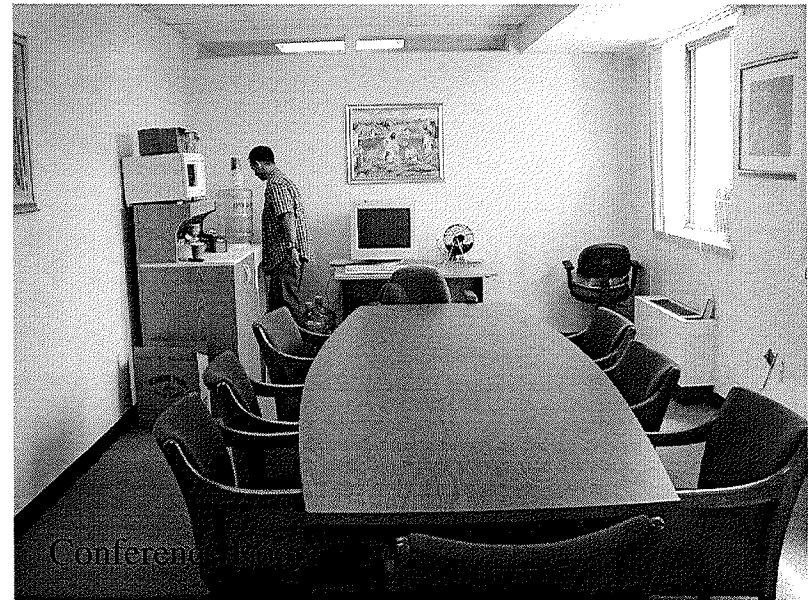
NOW- Family Preservation

Spotty contamination found throughout the Main Room floor.
Entire floor is twice background.

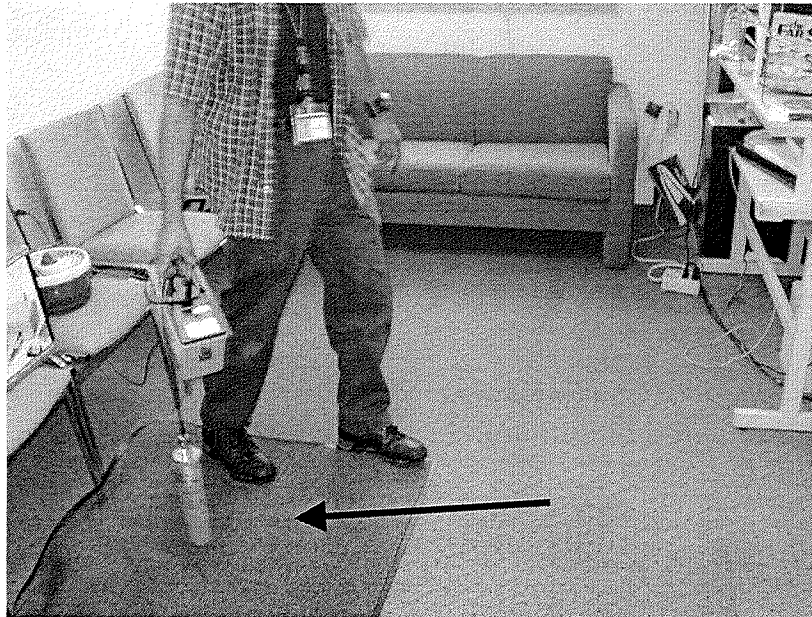
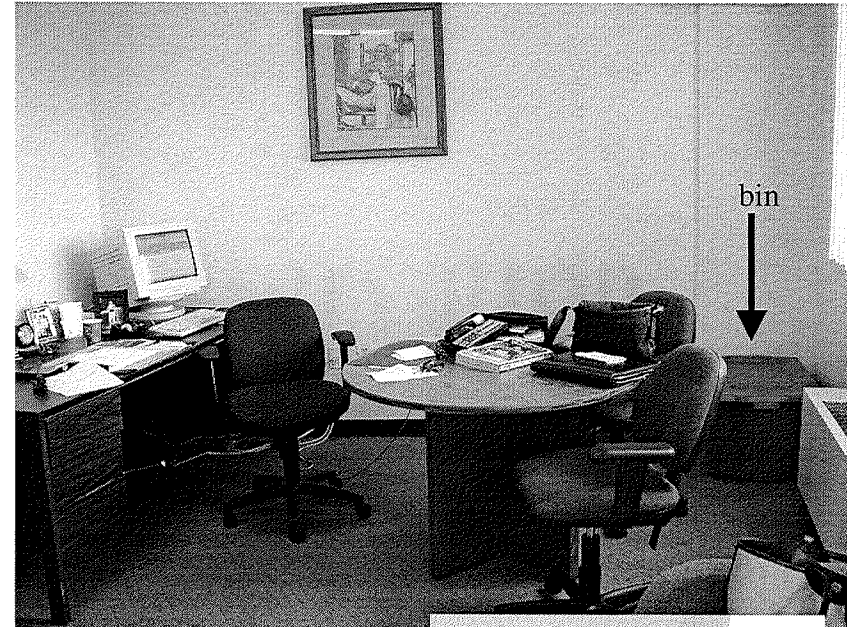
NOW- Family Preservation

Contamination found on floor spots in
Office and Manager's Office (under bin).

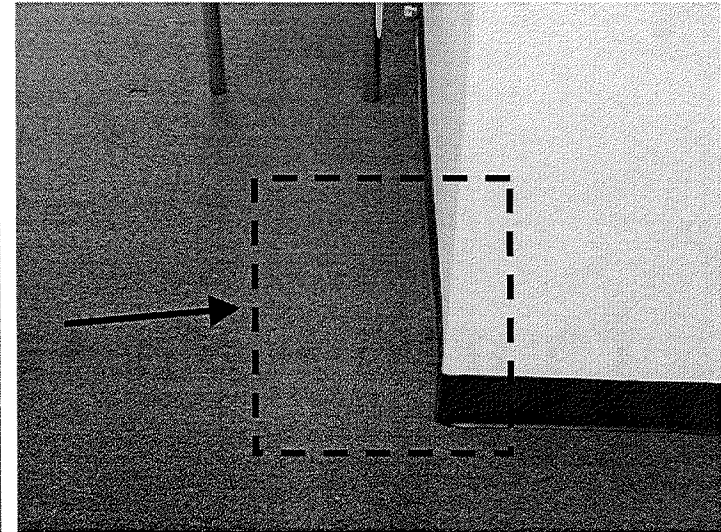
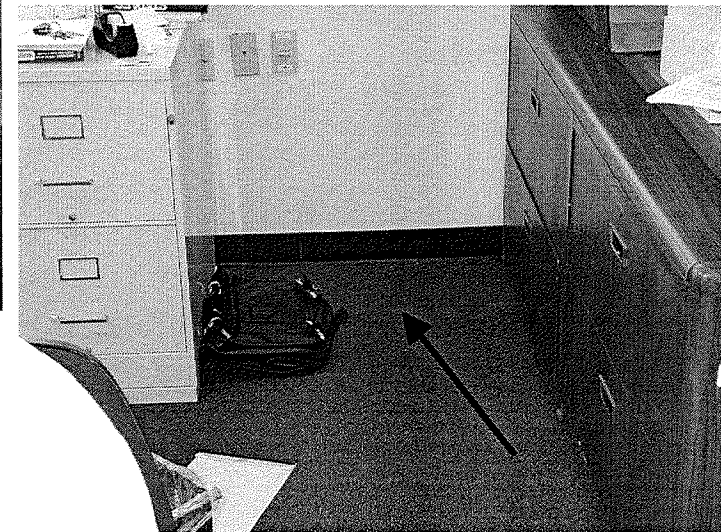
NOW- Head Start (Law Office)

Contamination found on floor spots.

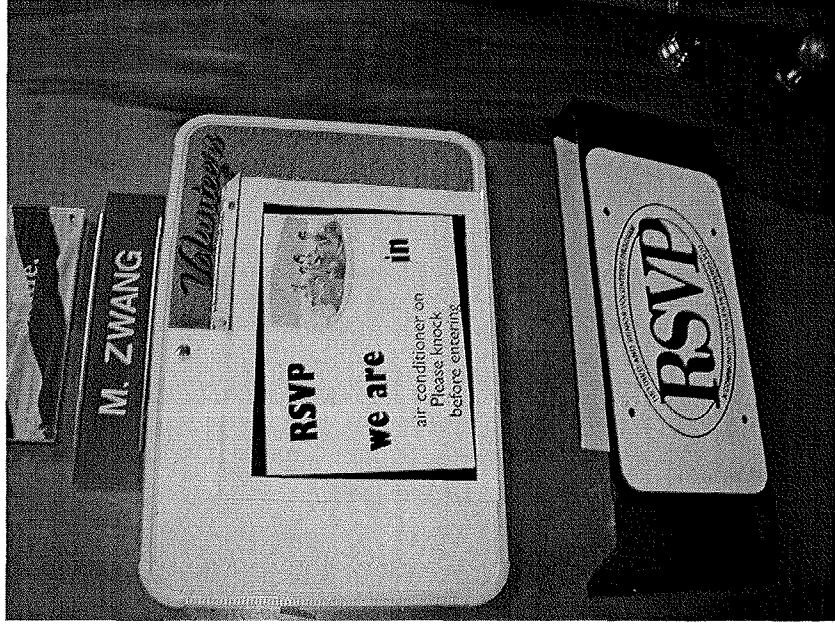
NOW- RSVP Office

Contamination found on floor spot
by window.

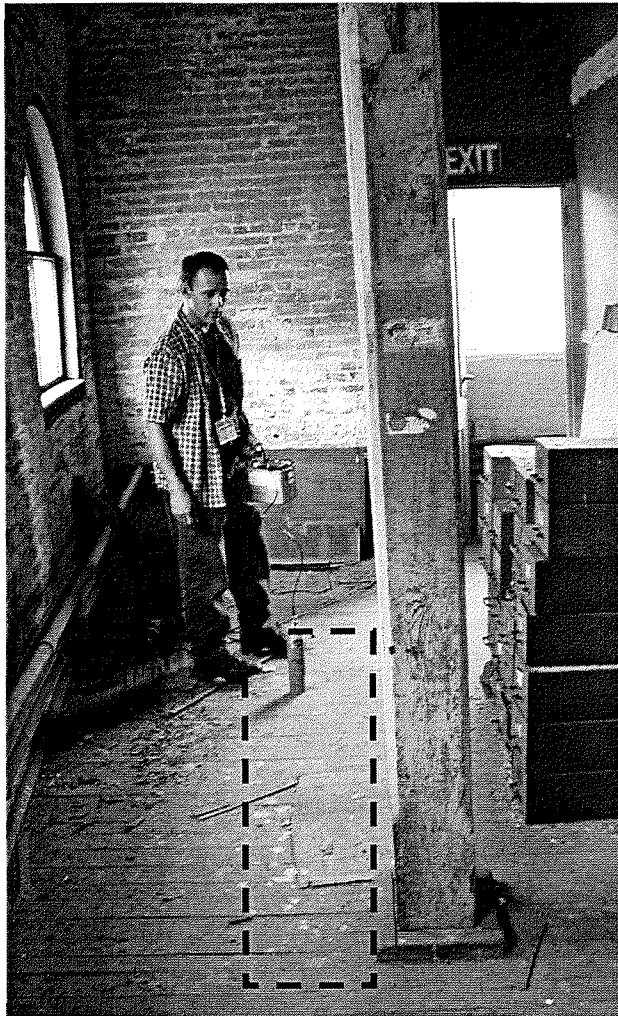
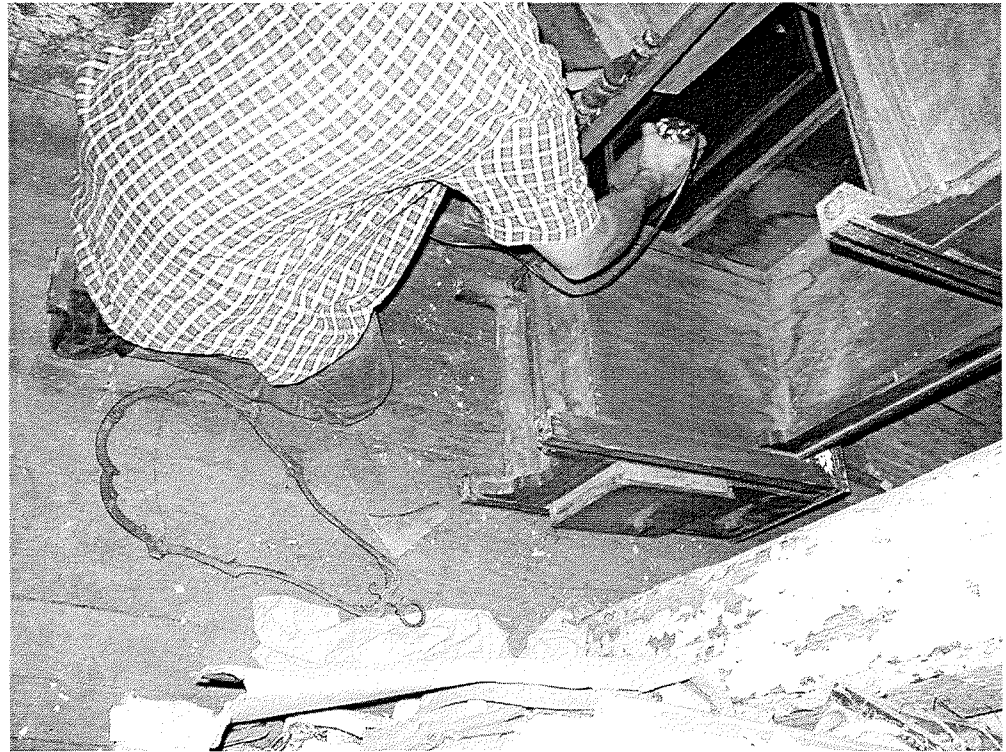
Ville Automatics

Spotty contamination in hall area and behind desk..

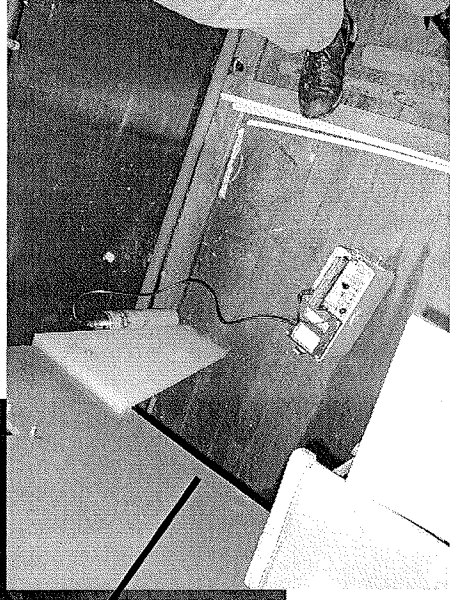
T-6

Contamination
found on floor
spot by bin.

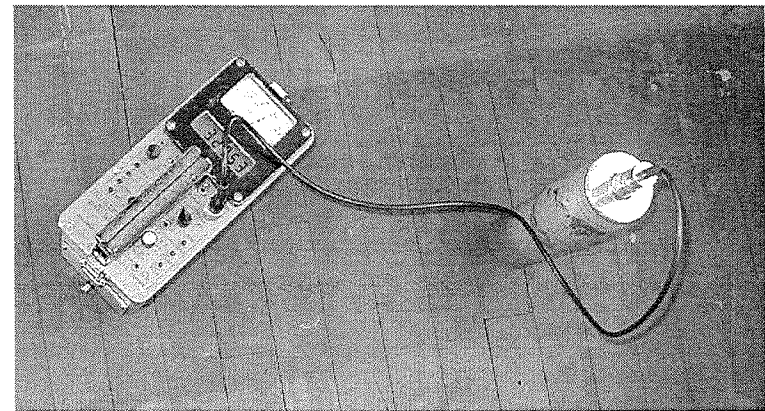
Thomaston- Third Floor Location M

Contamination found
on floor spot (35 feet
from Italian
American Club).

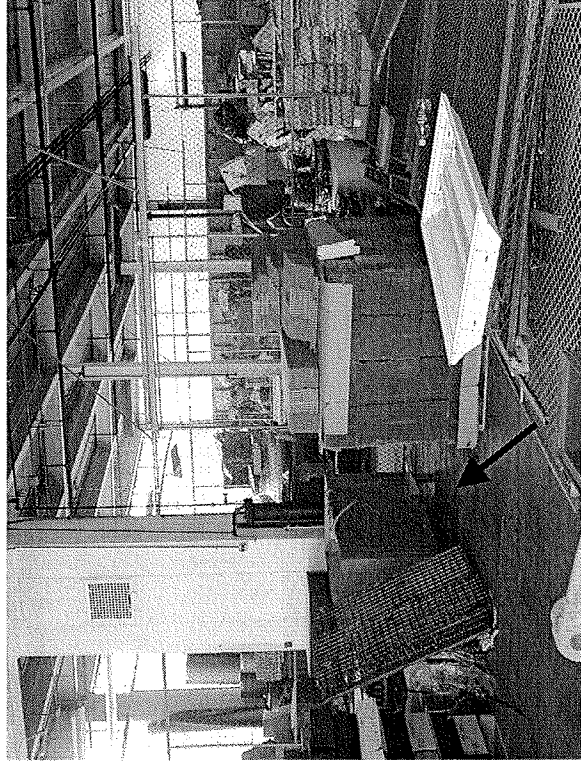
T-8

Contamination
found on floor
spot by cage.

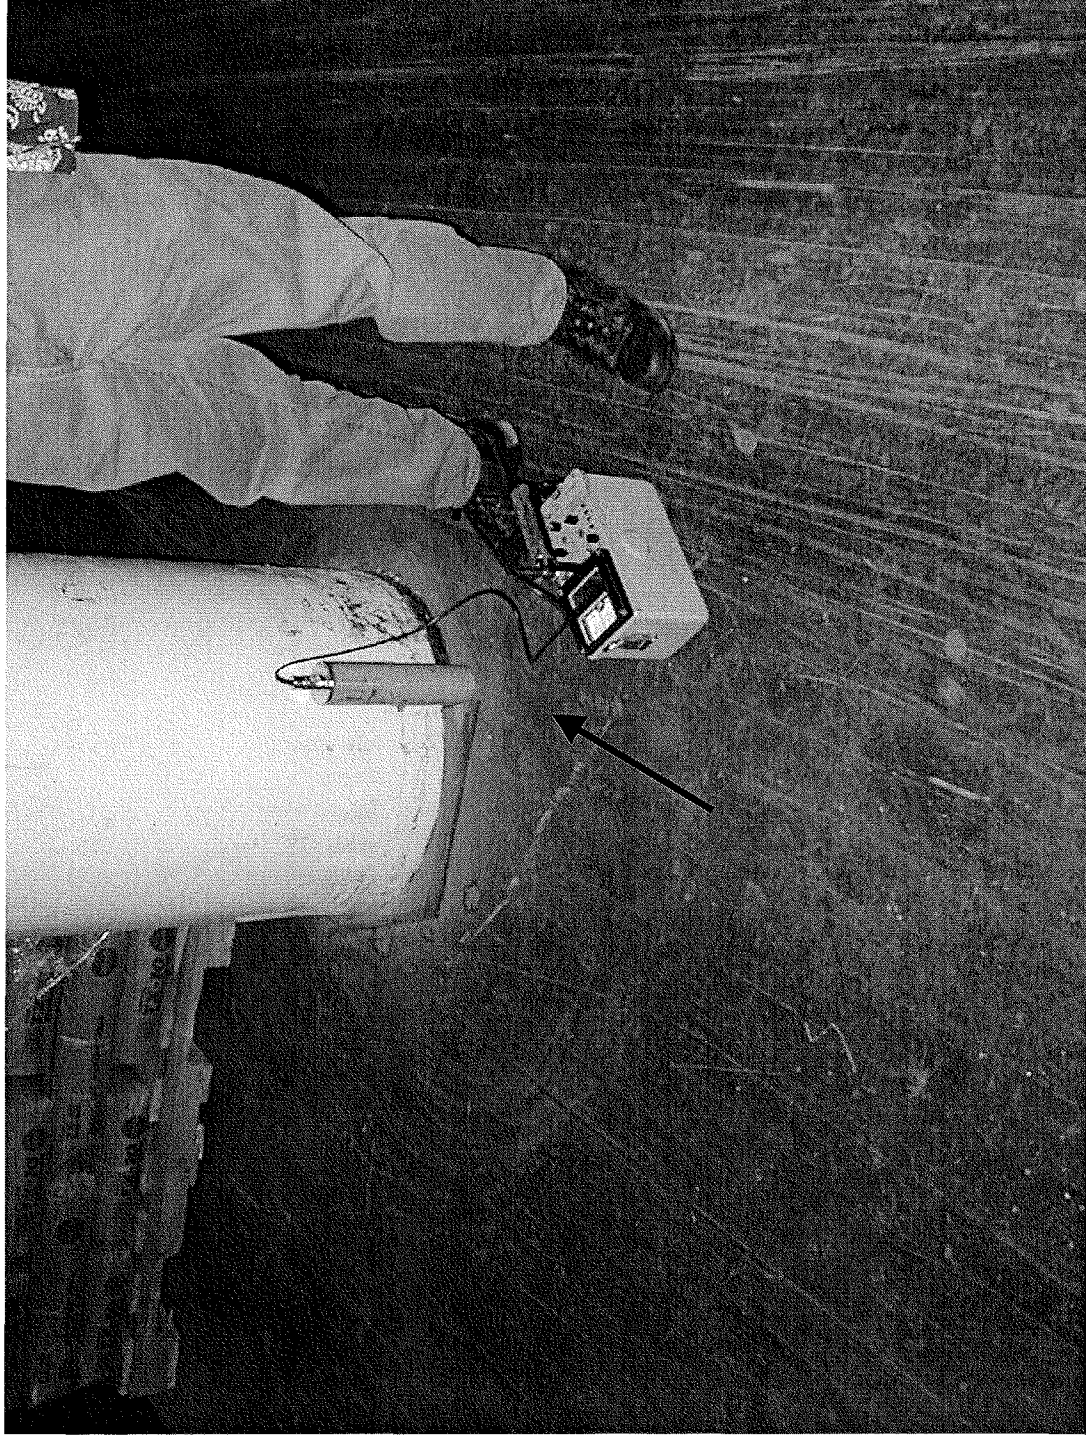
Thomaston- Third Floor Location N

Floor spot by Hallway Pillar
