Valley Council of Governments

Connecticut Radium Sites Verification Survey

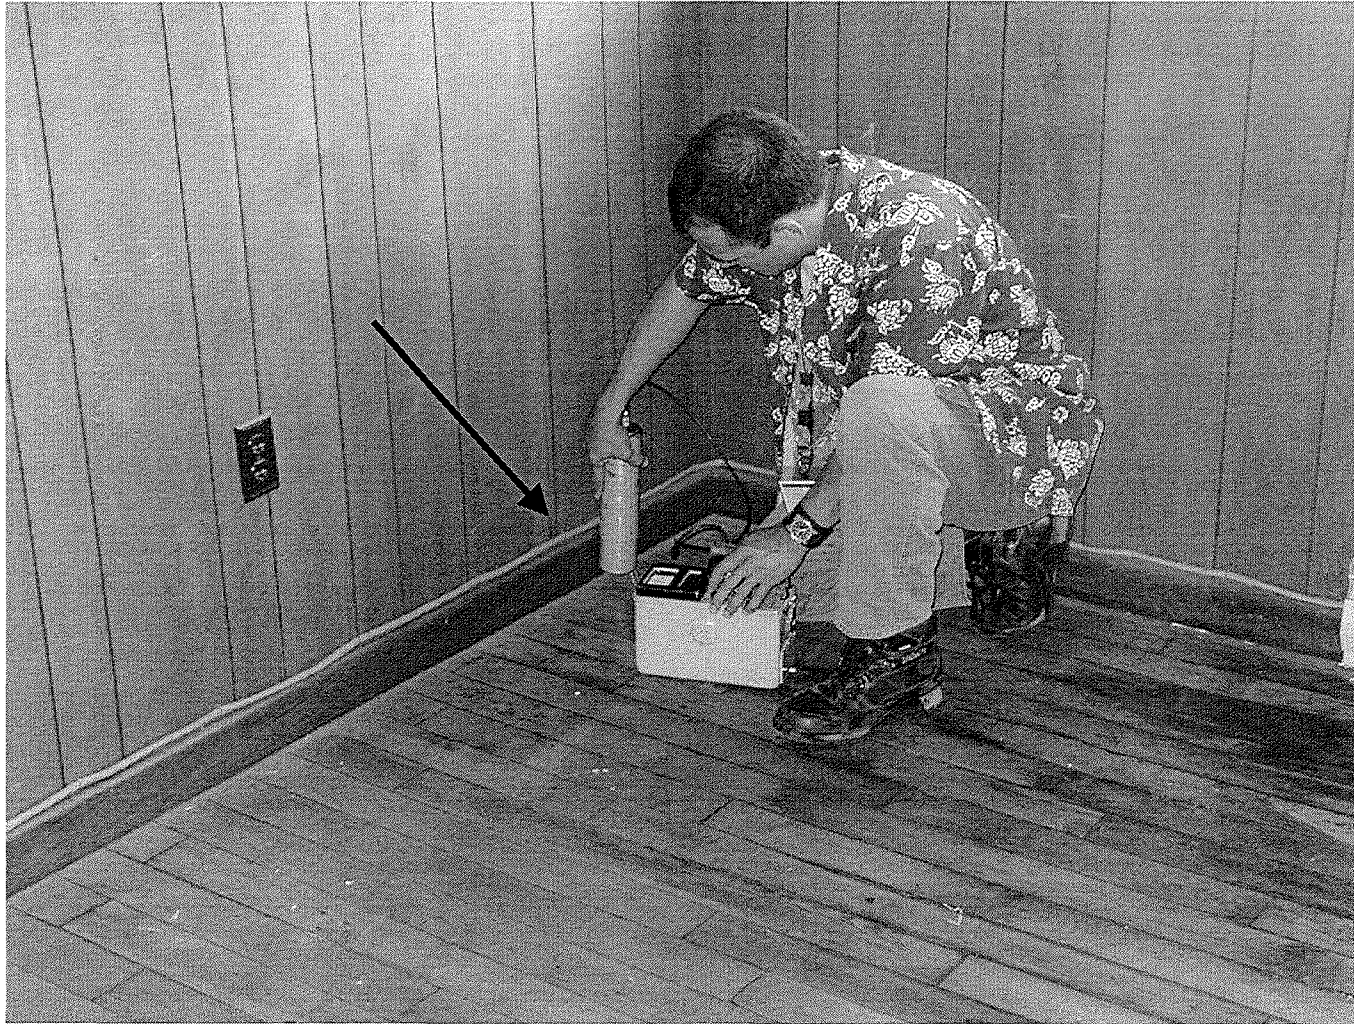
Thomaston- Third Floor Location E

Location E- Floor spot in Spice Co. Storage Room

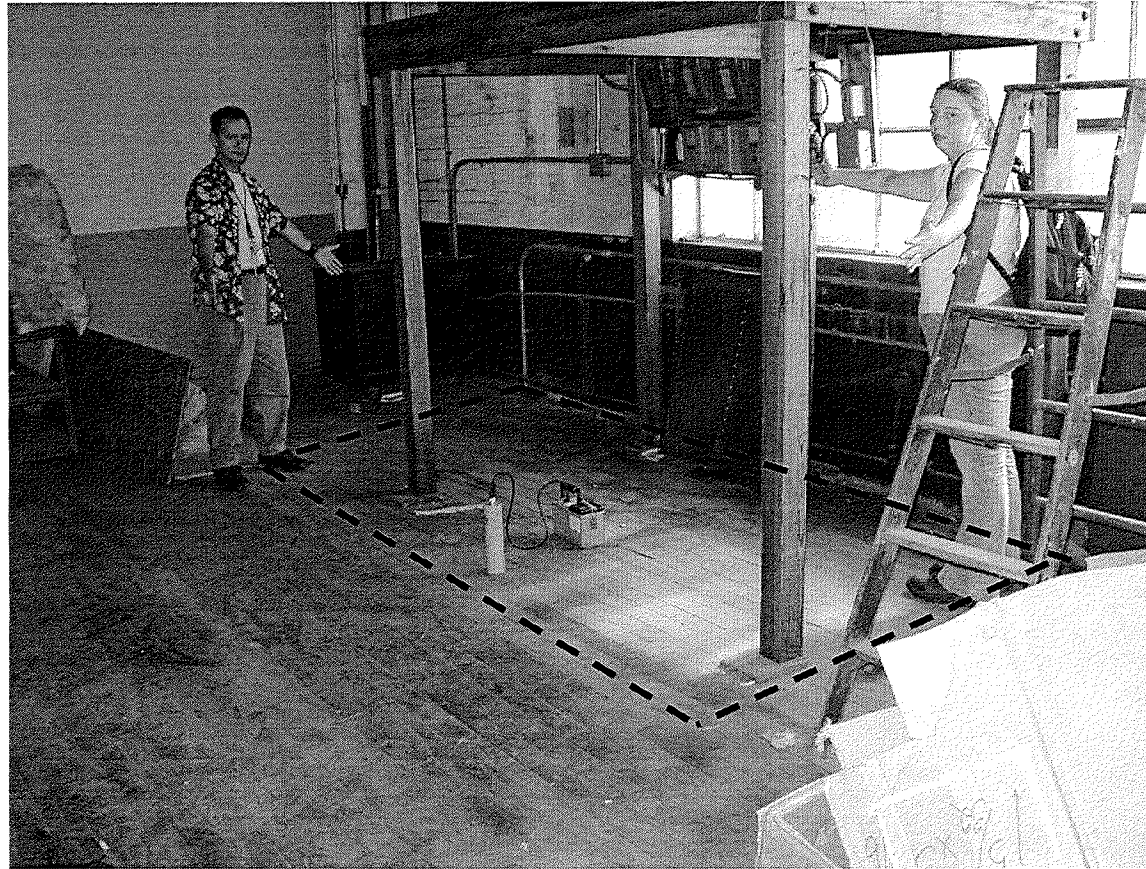
Thomaston- Third Floor Location D

T-13	Thomaston	D	Third Floor	Power Trans floor	Wood flooring	41 ft x 5 ft	6,000	20,000		Entire area indicated is 3 x background, one hot spot by right corner (facing clock)
T-14	Thomaston	O	Third Floor	Floor of Ladies Bathroom	Carpet over lay subflooring	10 ft x 10 ft	6,000	60,000		Generally 30,000-60,000
T-15	Thomaston	P	Third Floor	Floor by closet entrance	Carpet over lay subflooring	2 ft x 2 ft	6,000	150,000		
T-16	Thomaston	G	Third Floor	Floor in ECI office	Carpet over lay subflooring	Various spots	6,000	48,000		W2C: Identified 4 spots 12,000-48,000; found a few spots by filinf cabinets but were unable to complete survey
T-17	Thomaston	F	Third Floor	Floor in Outreach Office	Carpet over lay subflooring	1 ft x 2 ft	6,000

Floor area 5' x 9' in corner of Power Trans. Most are watch parts. In addition, across the entire room by the windows the readings are all 3x background (41' x 5').

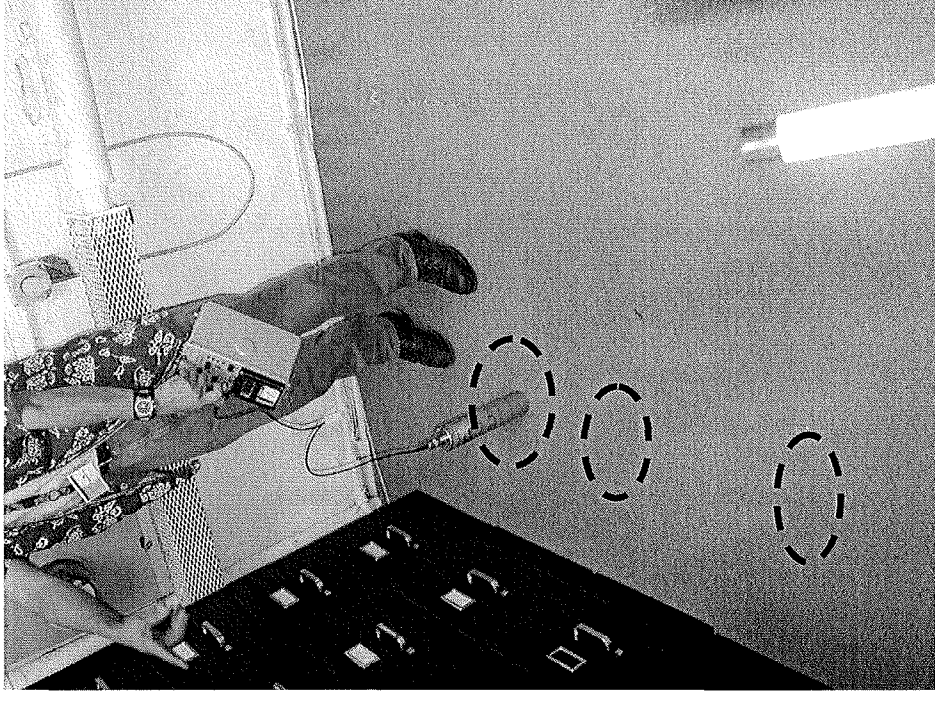
Thomaston-Third Floor Location G

Contamination found on various floor spots in ECI office.

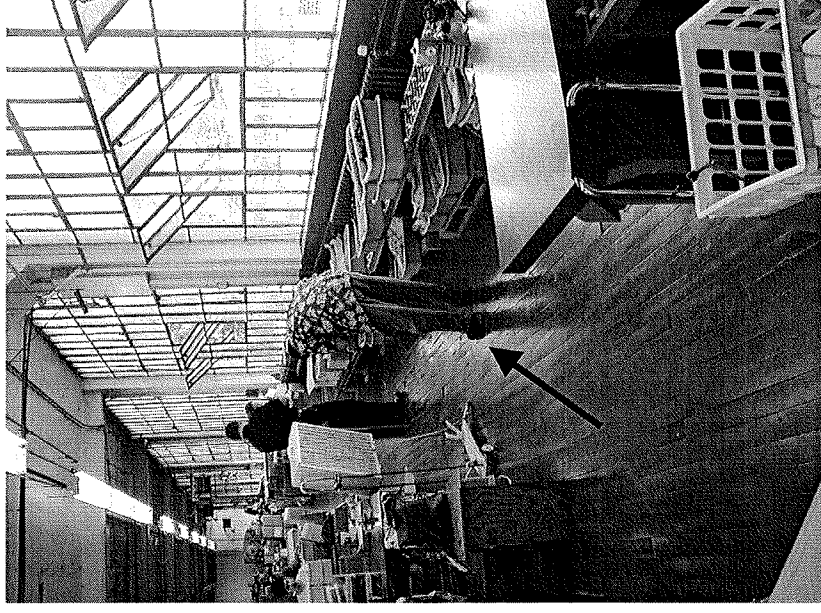
Thomaston-Second Floor Location Q

Contamination found in area 30' x 8' along windows
on finished floor.
