Steam Generator Evaluation
Ginna Steam Generator Tube Failure Incident
January 25, 1982
R. E. Ginna Nuclear Power Plant
Docket No. 50-244

At 9:25 a.m. on January 25, 1982, a tube ruptured in the B-Steam Generator at Ginna Station. A report summarizing the sequence of events, operator actions, emergency procedures, equipment performance, radiological assessment, and recommendations relative to the transient itself was submitted to the NRC by letter dated April 13, 1982. This report provides information specifically related to the tube failure. The work described in this report is a culmination of work performed by several organizations including Rochester Gas and Electric, Westinghouse, EPRI, and Combustion Engineering.

Shortly following the achievement of cold shutdown conditions on January 26, 1982, a comprehensive corrective action program was developed for the B-Steam Generator. The objectives established for this program were:

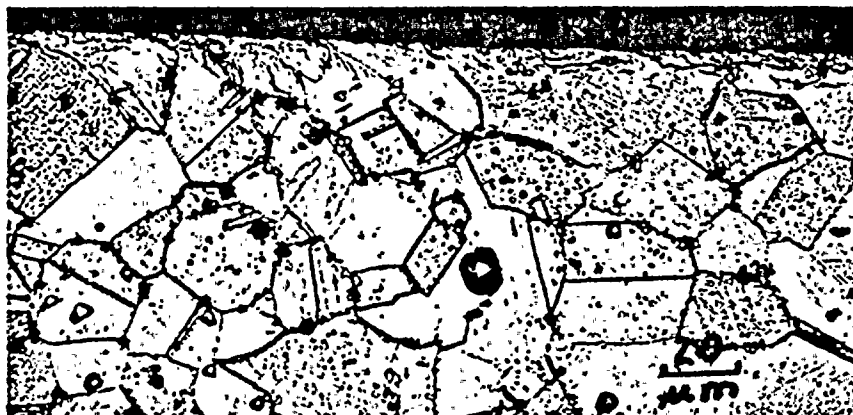
Fig. 3-6. OD surfaces 4" down from the top of the section from Tube R43-C55
