Re: Turkey Point Unit 4  
Docket No. 50-251  
Steam Generator Tube Wastage Information

TURKEY POINT UNIT 4

SUPPLEMENTAL INFORMATION ON

S/G TUBE WALL THINNING

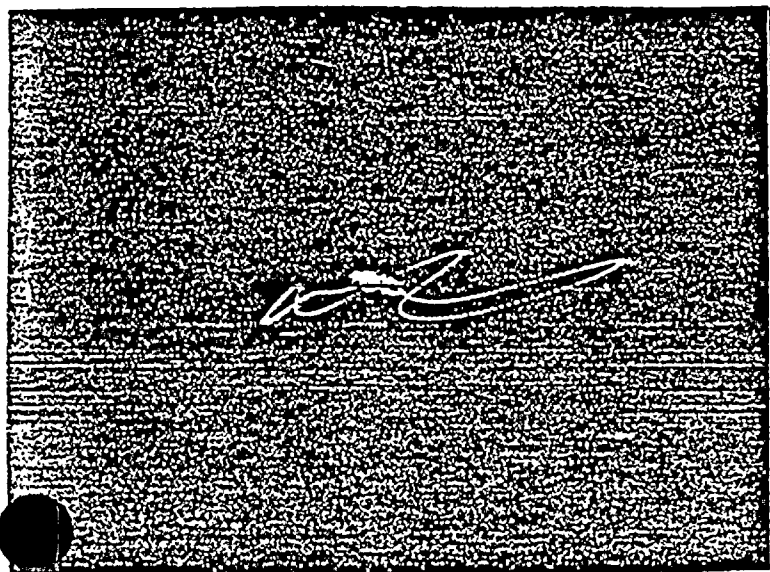
R24C40

< 20%

1/2" ATS

24%

41%

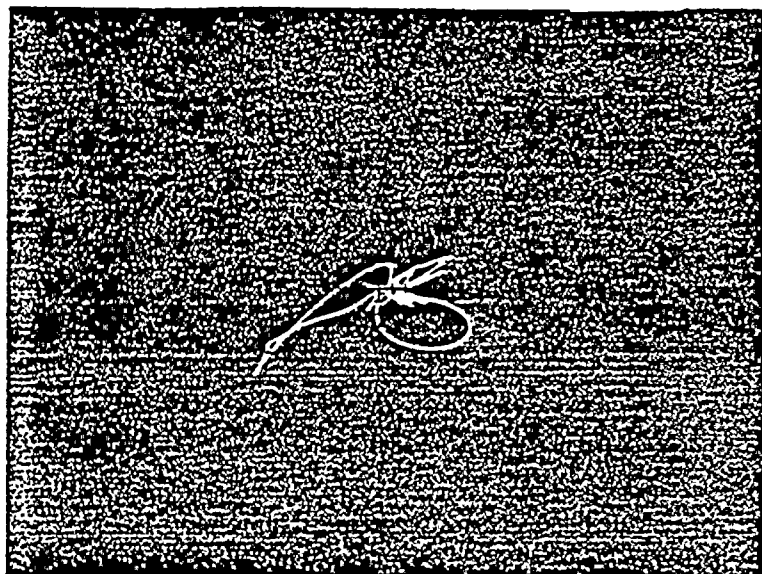
R13C46

33%

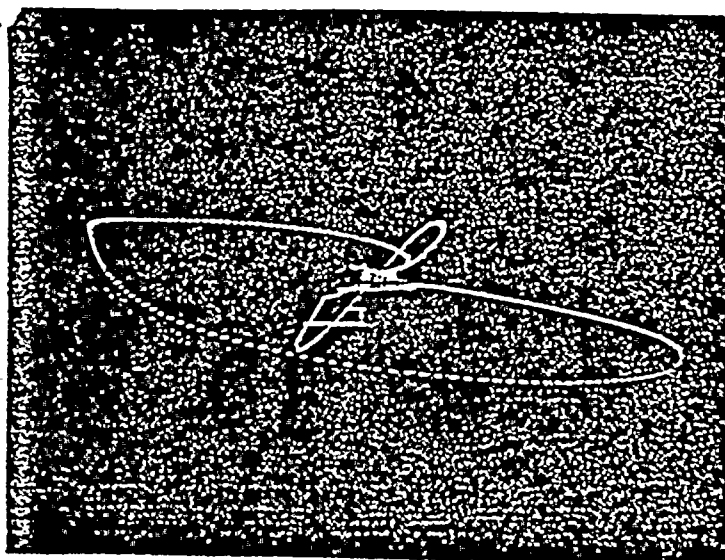
R14C29

2" ATS

46%
