TECHNICAL REPORT
L-1521(6) / 5-93

ASSESSMENT OF AGING
DEGRADATION OF CIVIL/STRUCTURAL FEATURES
AT SELECTED OPERATING NUCLEAR POWER PLANTS

J. Braverman
R. Morante
C. Hofmayer

May 1993

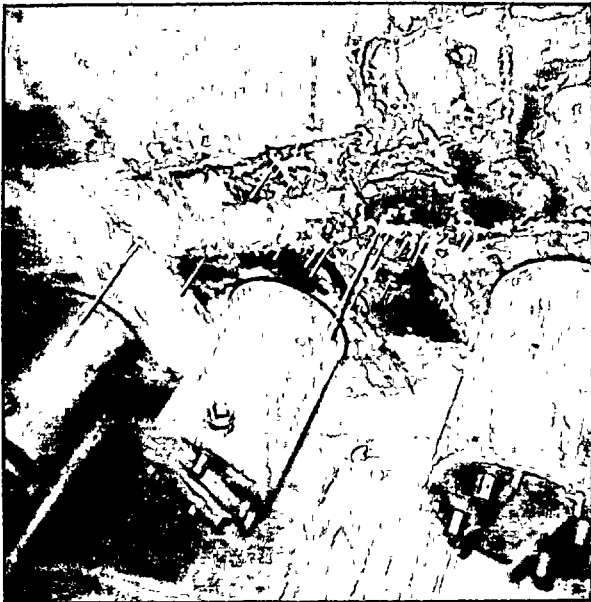
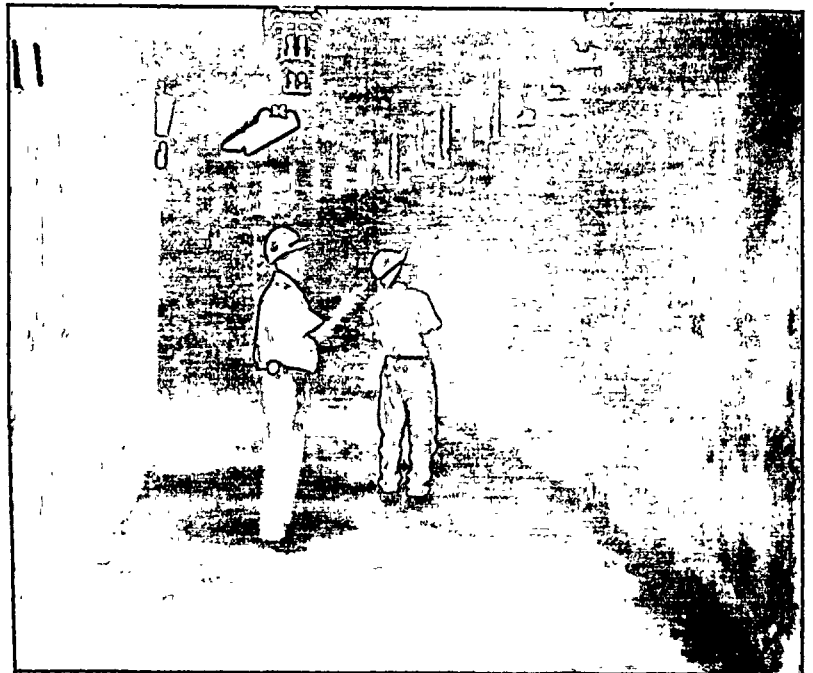
Tendon Gallery - Grease Cap Leakage

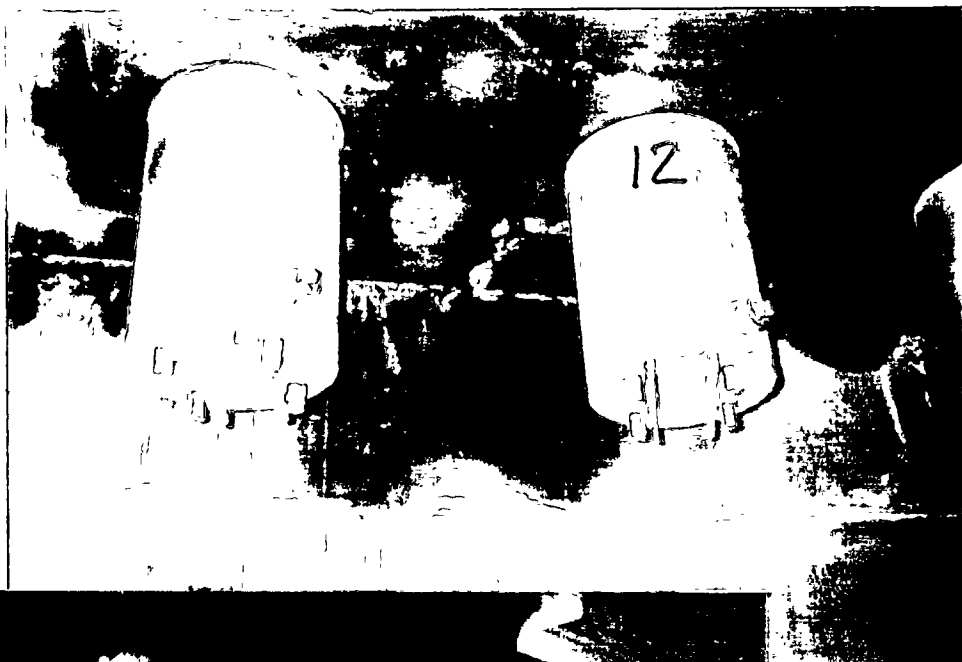
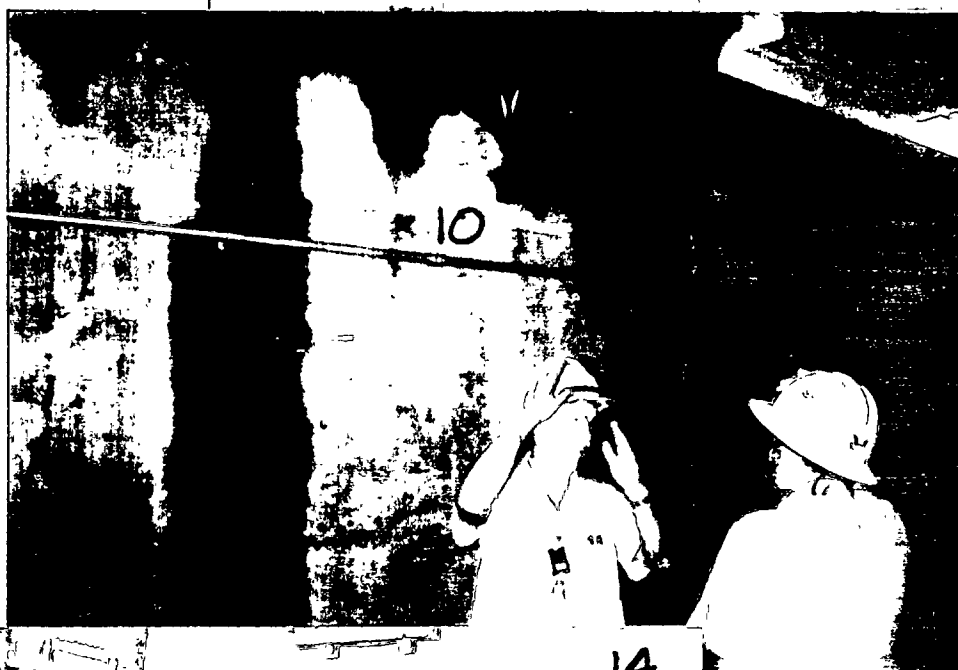
Tendon Gallery
Water Infiltration

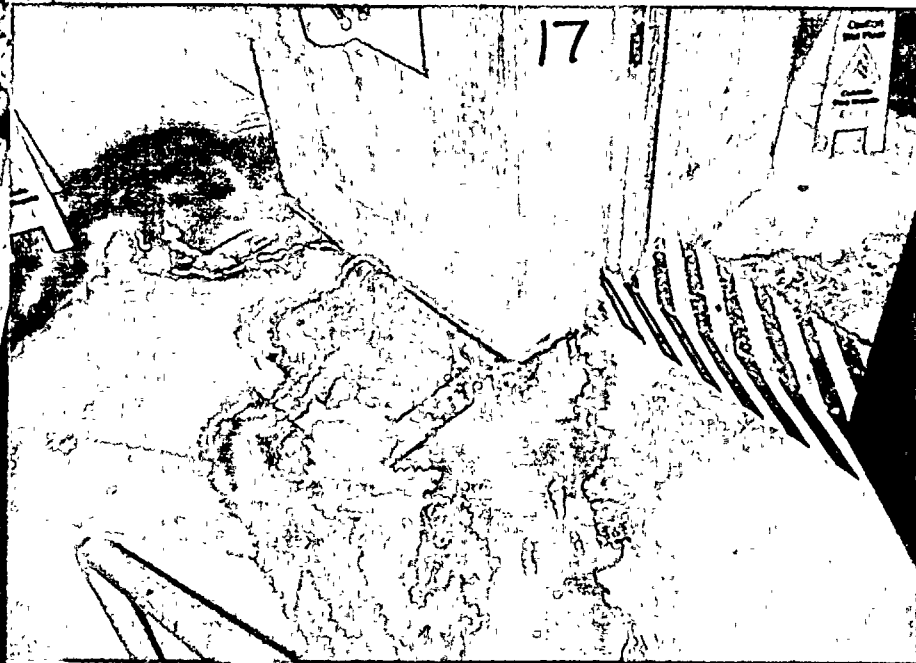
Turbine Bldg. Floor (El. 25')
Water Infiltration

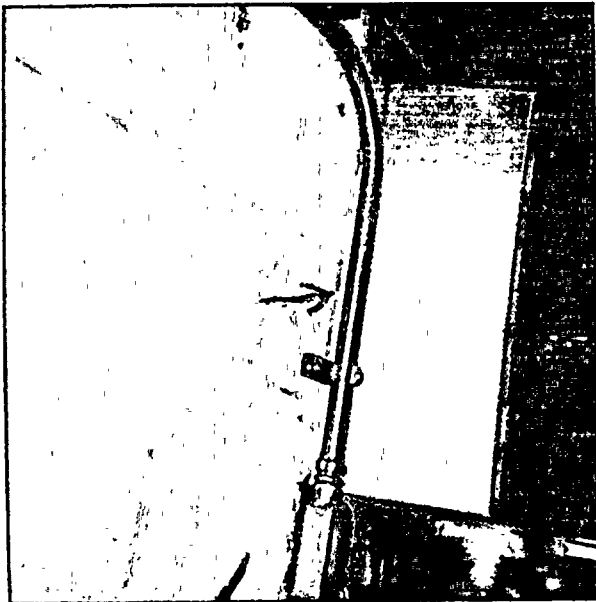
Control Building (El. 61')
Concrete Crack in Floor

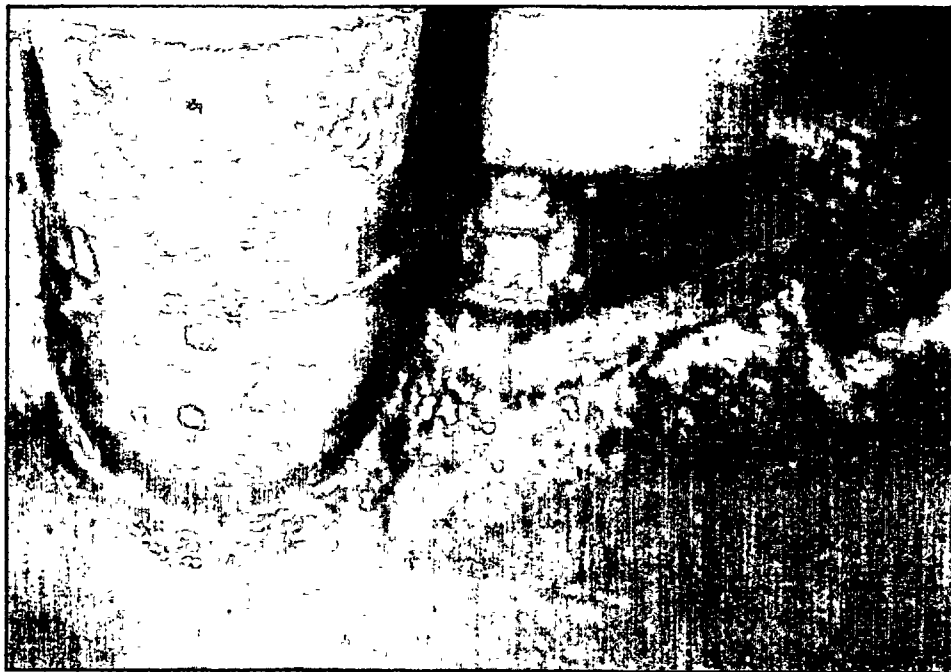
Support for Service Water Pump
