NINE MILE POINT I
PIPE CRACK TASK FORCE REPORT

CONTRIBUTORS TO NINE MILE POINT I

PIPE CRACK TASK FORCE REPORT

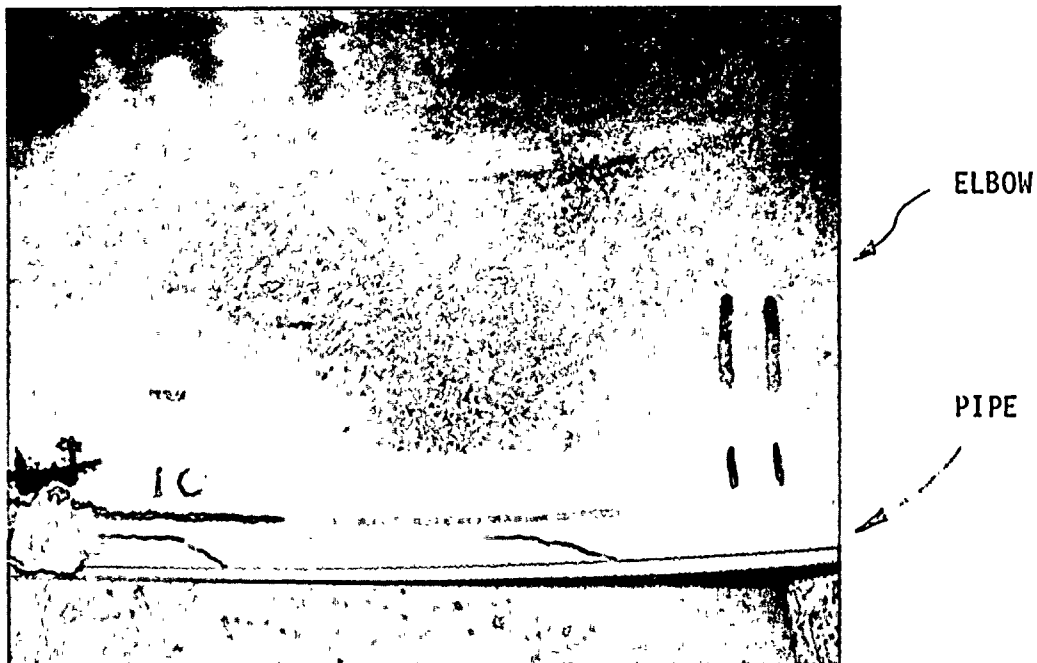
Figure 5. Photo of Indications in Loop 13 Suction Elbow/Pipe Weld (Weld SW-6).

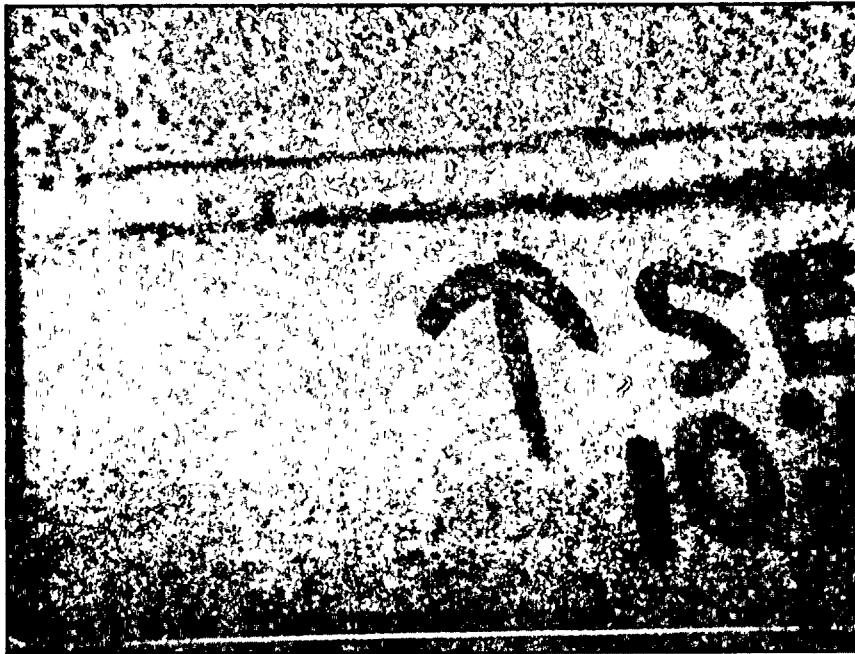
Figure 10. Loop 13 Suction Elbow/Pipe Weld, Showing Results of U.T. Depth Measurements.

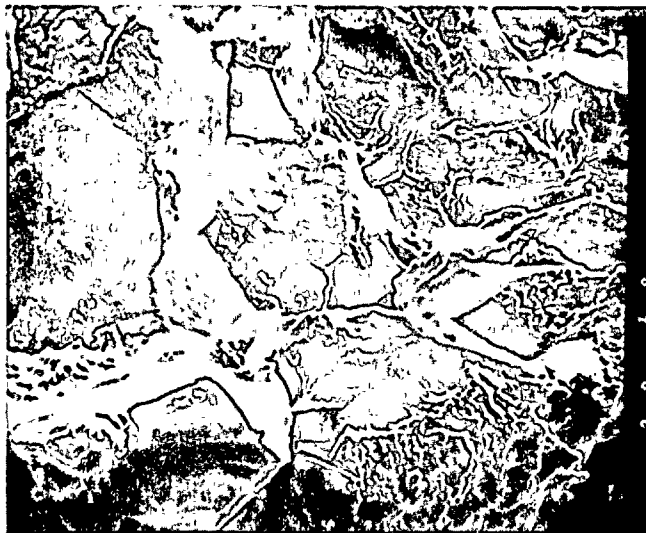
SEM was used to examine the O.D. surface, and the fracture surface after the specimen was broken open. A composite 50X photograph of the axially oriented crack on the O.D. surface is shown in Figure 19. The crack length is about 0.22 in., but this figure is an approximation because the crack becomes very thin, making the tip difficult to locate.

Figure 19. SEM photograph of O.D. surface crack, 50X.

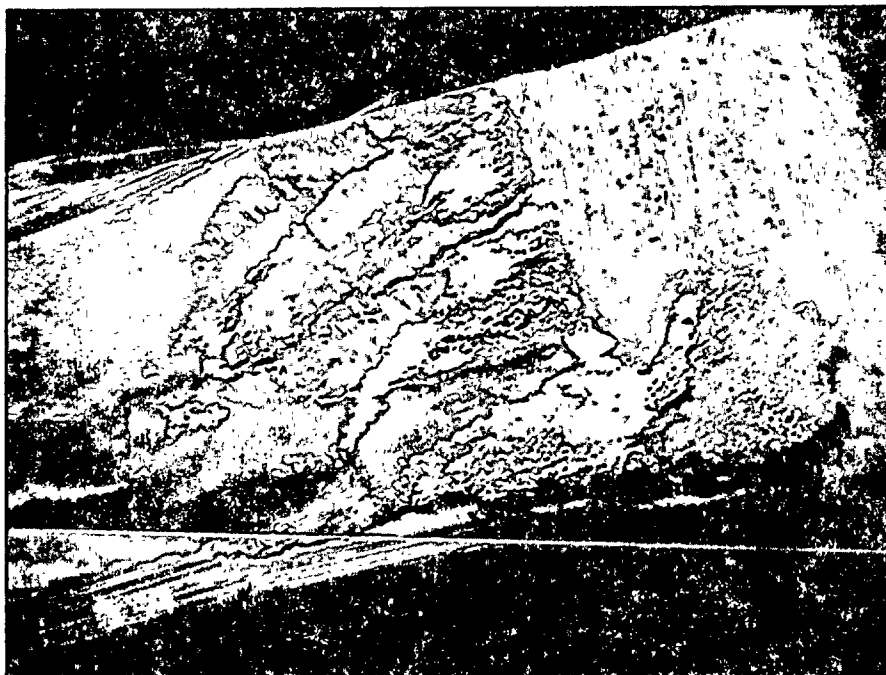
The boat sample shipped to Battelle was a small wedge shaped piece approximately 1 inch long and 1/4 inch thick. Figure 12 shows the schematic sketch of the safe-end and location of sample "B" which was examined at Battelle Columbus Laboratories. The sample was visually examined with a stereomicroscope. One crack approximately 1/2" long was observed on the outer surface. In addition, crusty crystalline-like deposits were observed on the outer surface, along with some rust colored stains. Figure 21 shows the appearance of the specimen in the as-received condition.

Figure 21. Appearance of the Piping Sample from Nine Mile Point Reactor in the As-Received Condition.

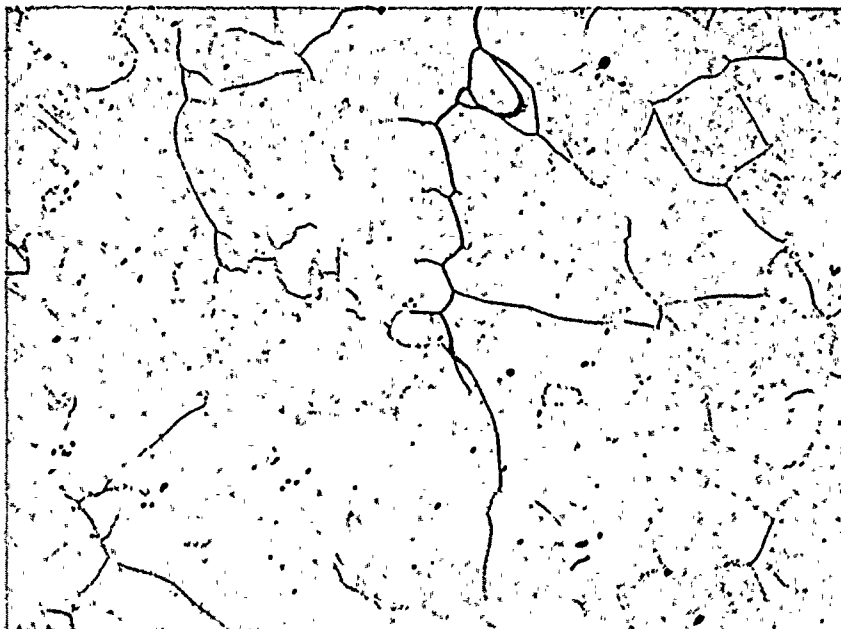
Figure 44. Etched view of Sample D containing
beginning of crack in Figure 43.

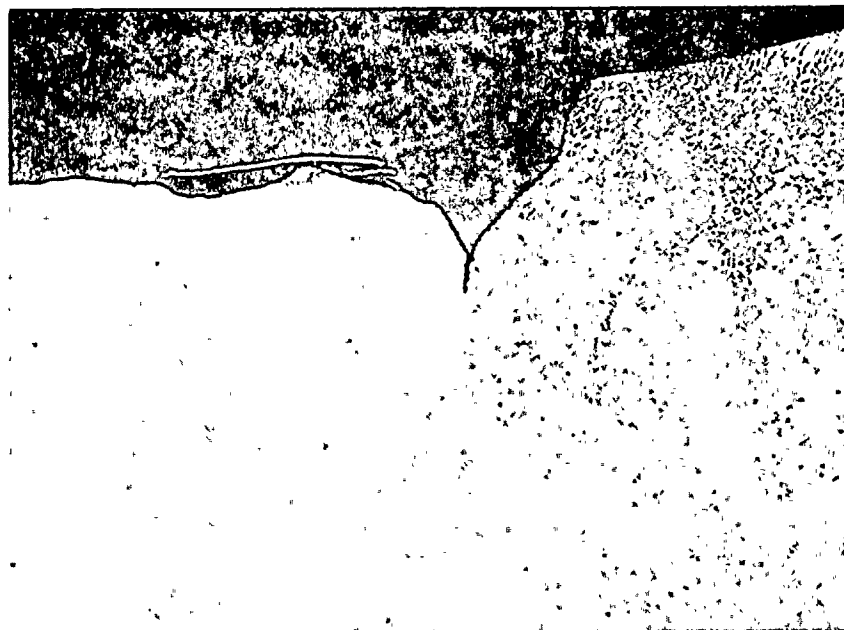
This sample was removed from loop 12, field weld FW-5, between the safe-end and elbow, on the suction side of the pump. An indication was present on the elbow side, as shown in Figure 48. This indication proved to be slight lack of fusion between two weld passes as shown in Figure 49. No propagation had occurred.

Figure 48. Penetrant examined view of Boat Sample F removed from field weld FW-5 of Loop 12.

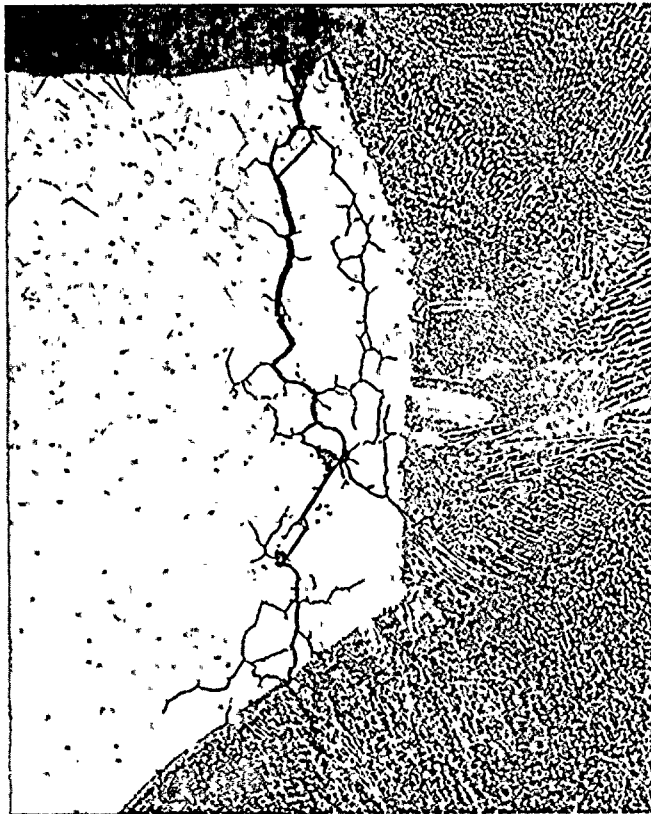
A 90° section of elbow to pipe weld from shop weld SW-12, loop 15, was examined in great detail. (See Figure 5 of Section 2.) The section had been cut through the edge of the weld on the pipe side, and again about 10" into the elbow. Looking at the inside surface, the entire section was 22" long (circumferentially) and 10" axially. It consisted of 5/8" of pipe, the weld, and ~9 1/2" of elbow material. The inside had been decontaminated electrolytically, so the surface was clean and bright except for large areas where slag from the plasma cutting operation had adhered. To simplify handling, a circumferential cut was made about 1" on the elbow side of the weld, resulting in a ring section 22" long and 1 3/4" wide, containing 5/8" of pipe, plus weld, and 1 1/8" of elbow material. This section was cleaned of slag, and examined by dye penetrant. Masking tape marked at 1" intervals was fastened to the inside to map indication locations. Seven indications, varying from 5/16" to 1 1/4" in length, were found on the pipe side, for a total length of 5 1/4" or 24% of the total circumference. One indication 7/8" long was present on the elbow side, 4% of total length. Typical indications are shown in Figures 50 and 51. Assuming that the center of each indication should be the deepest part of the crack, sections from the center of each indication were polished, and the crack depth measured by microscope. The cracks on the pipe side ranged in depth from .100" to .275". The crack on the elbow side was .137". These measurements are in good agreement with the depths estimated previously by ultrasonic examination of .1 to .2".

Figure 51. Penetrant examined view of longest indication, pipe side of pipe-to-elbow weld SW-12 removed from Loop 15. ~2X

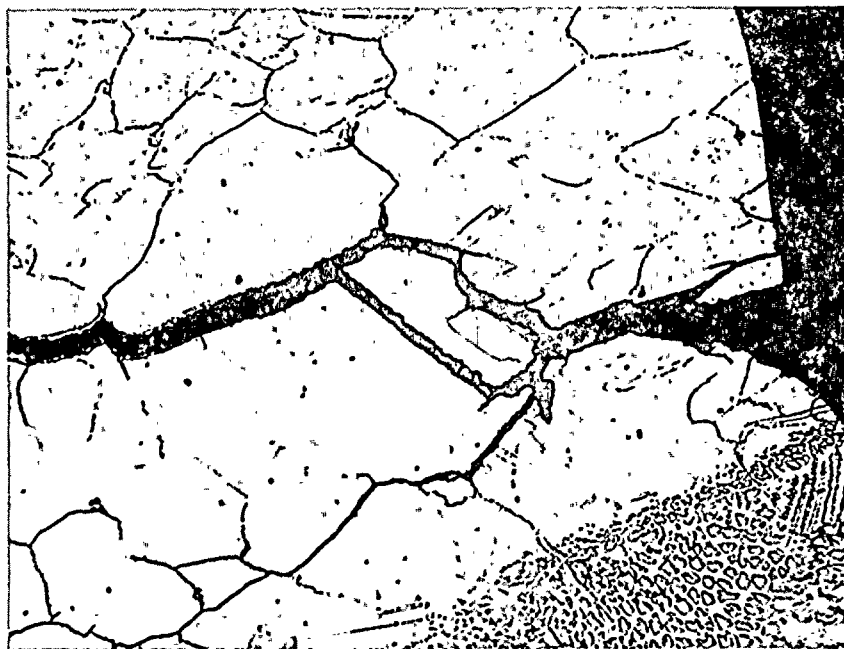
Metallographic sections were prepared from one crack on each side of the weld. The entire crack on the elbow side is shown at low magnification in Figure 52. Crack depth at this plane was .110". It was intergranular, and penetrated into the weld about .015". More detailed views of the beginning and end are shown in Figure 53. Significant grain boundary carbide precipitates are evident in the vicinity of the crack. The section was repolished and etched with Kahlings reagent to emphasize ferrite in the weld. Figure 54 shows the crack arresting when it reaches an area of the weld containing significant ferrite. Figure 55 shows the pipe side of this section. No cracking is present, although grains are outlined by carbides, which is caused by weld sensitization.

Figure 52. Etched view of entire crack, elbow side of SW-12 of Loop 15.

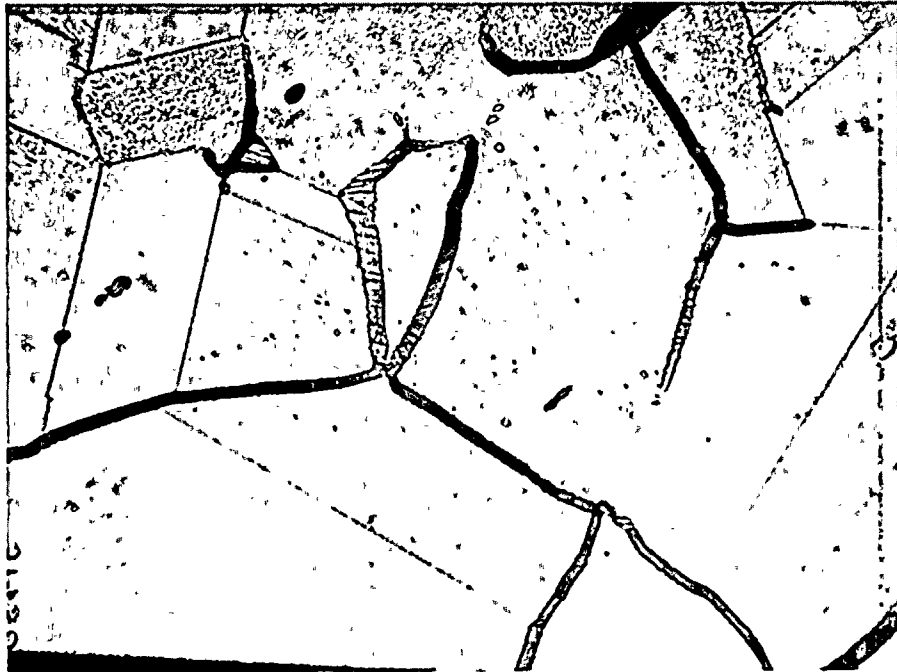
In order to determine the degree of sensitization in the safe-end material, boat sample "B" was repolished and subjected to the ASTM A 262 Practice A Sensitization test. Figures 61 and 62 show the structure observed on the specimen. The evaluation of the etched structure revealed that the sample was primarily a dual structure. Closer examination revealed that several grains were completely surrounded by ditches. Hence, according to Practice A the sample has to be evaluated as having a ditch (sensitized) structure.

FIGURE 61. APPEARANCE OF SPECIMEN MICROSTRUCTURE AFTER THE DEGREE OF SENSITIZATION TEST (ASTM-A-262 PRACTICE A).
