NINE MILE POINT I
PIPE CRACK TASK FORCE REPORT

Approved: G. M. Gordon
G. M. Gordon, Chairman
Pipe Crack Task Force

On March 23, 1982, during a hydrotest at Nine Mile Point-1 (NMP-1) prior to startup, inspection revealed through wall leaking cracks in two of the ten furnace sensitized recirculation safe ends. On March 26, 1982, ultrasonic examinations on these two safe ends and one other confirmed crack-like indications. In mid-April, 1982, two boat samples were obtained from one of the safe ends in the vicinity of the through wall cracks. One each of these samples was sent to General Electric and Battelle Laboratories for evaluation. The results of those evaluations in mid-May confirmed the presence of intergranular stress corrosion cracking (IGSCC). Subsequent ultrasonic examination of the 28" recirculation piping revealed crack-like indications in many of the piping weld heat affected zones examined at both shop and field welds.

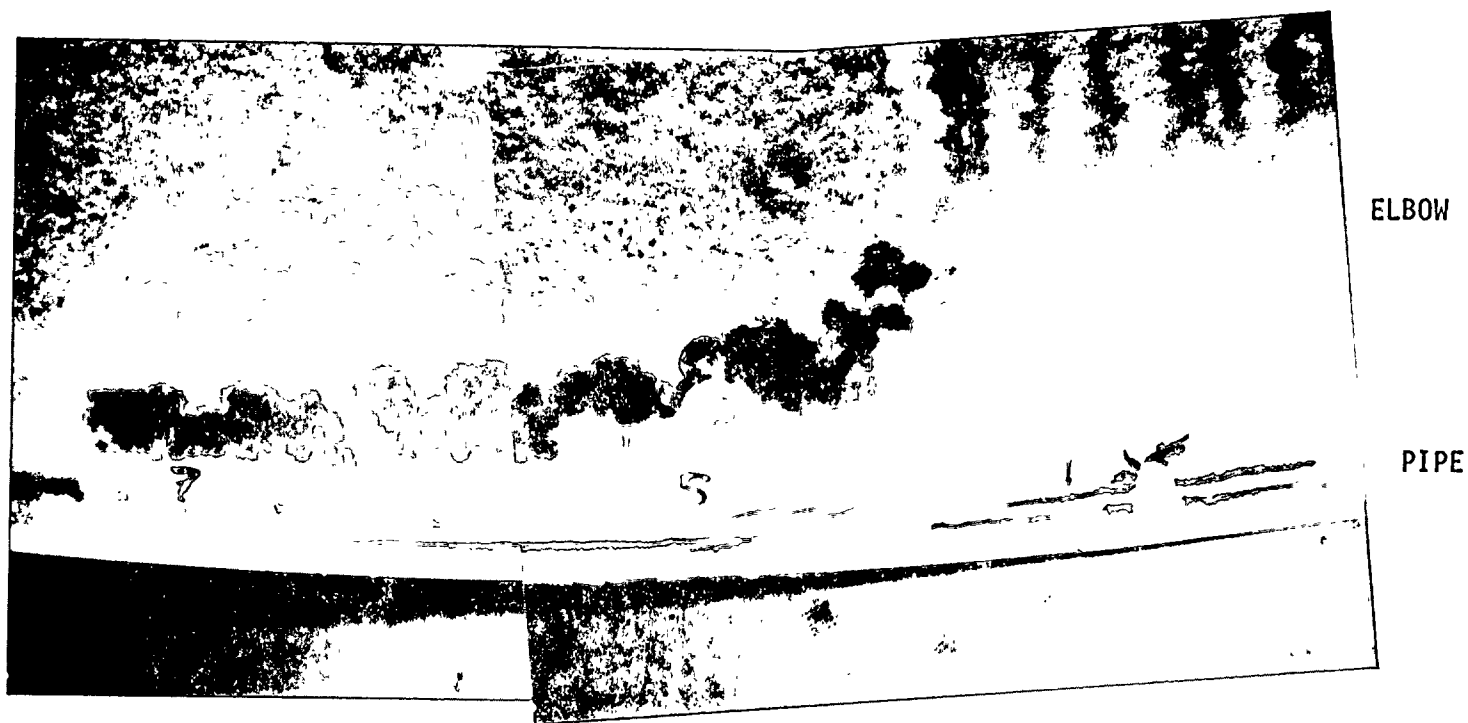
The most extensive PT indications were found in the loop 13 suction elbow-to-downcomer weld (Figures 5 and 6). Approximately 50% of the elbow HAZ and 40% of the pipe HAZ were found to contain circumferential cracks. Several cracks were visible without liquid penetrant. Boat samples were removed near the 9:00* and 10:00 locations using a hand held cutting tool. The excavations that resulted were 1/4-3/8 in. in depth. Figures 7 and 8 show circumferential PT indications running continuously through the excavations, indicating that the cracks are at least 1/4 in. deep. A larger grinding tool equipped with a strawberry burr was used to chase the cracks further into the pipe wall. It was found (Figure 9) that the crack near 10:00 on the elbow side of the weld penetrated nearly 0.50 in. into the pipe wall. Note that the crack turned to follow the weld fusion line after propagating radially for about .30-.35 in.

Figure 5. Photo of Indications in Loop 13 Suction Elbow/Pipe Weld (Weld SW-6).

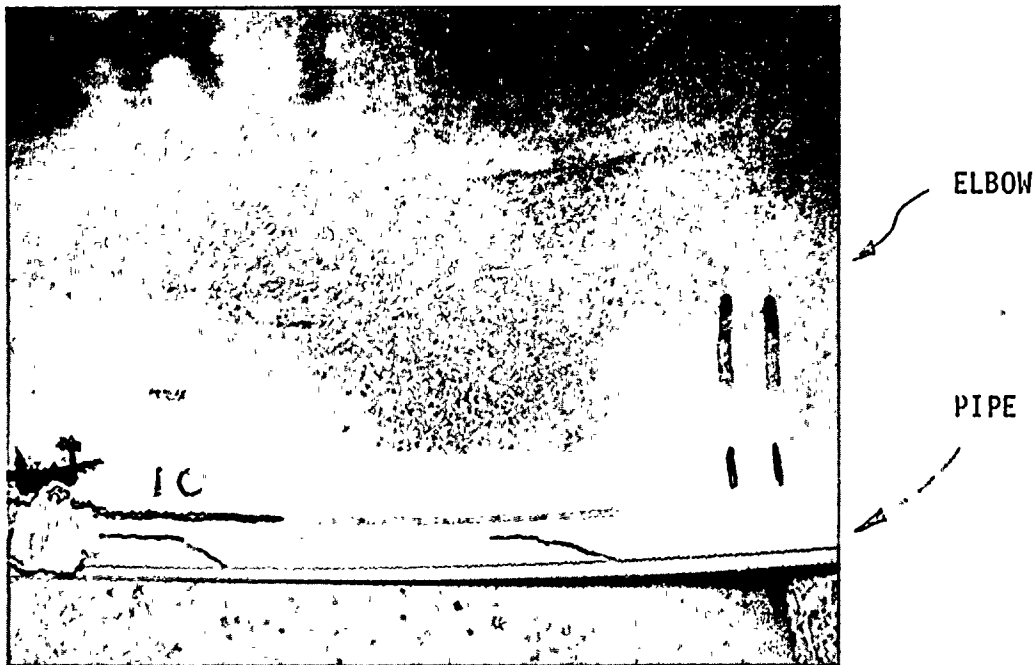
Figure 6. Photo of PT Indications in Loop 13
Suction Elbow/Pipe Weld. (Weld SW-6)

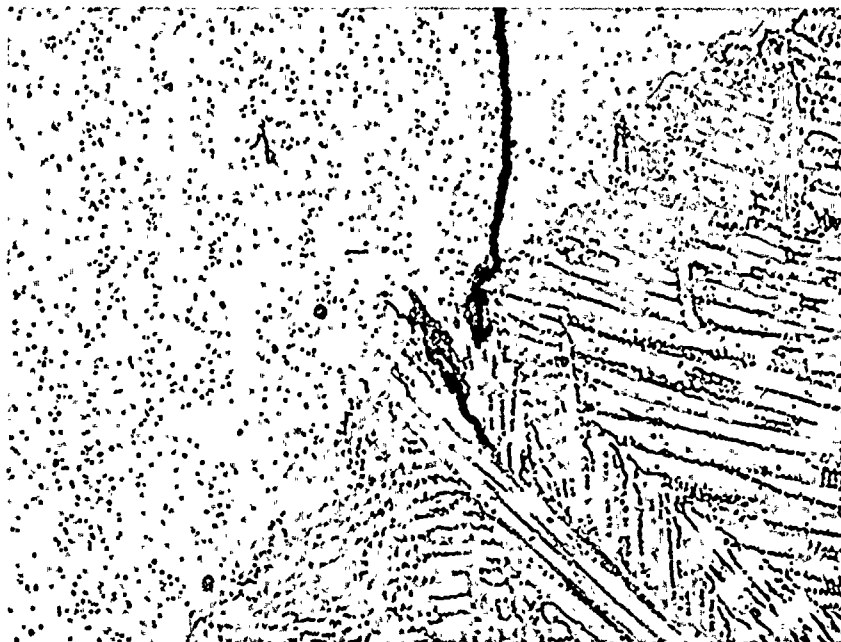
Figure 41. Etched detail at bottom of crack. 250X

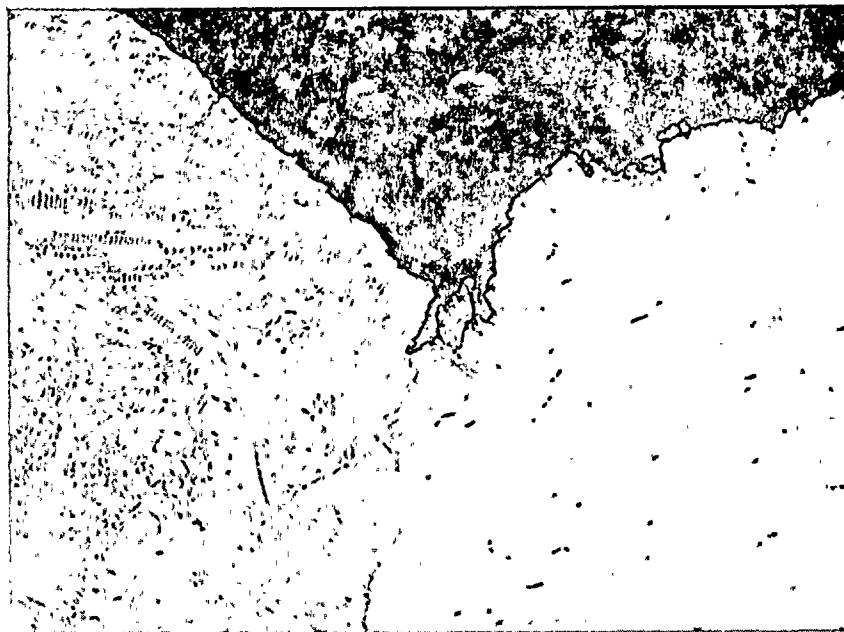
Figure 46. Penetrant examined view of Boat Sample E removed from SW-4 of Loop 12.

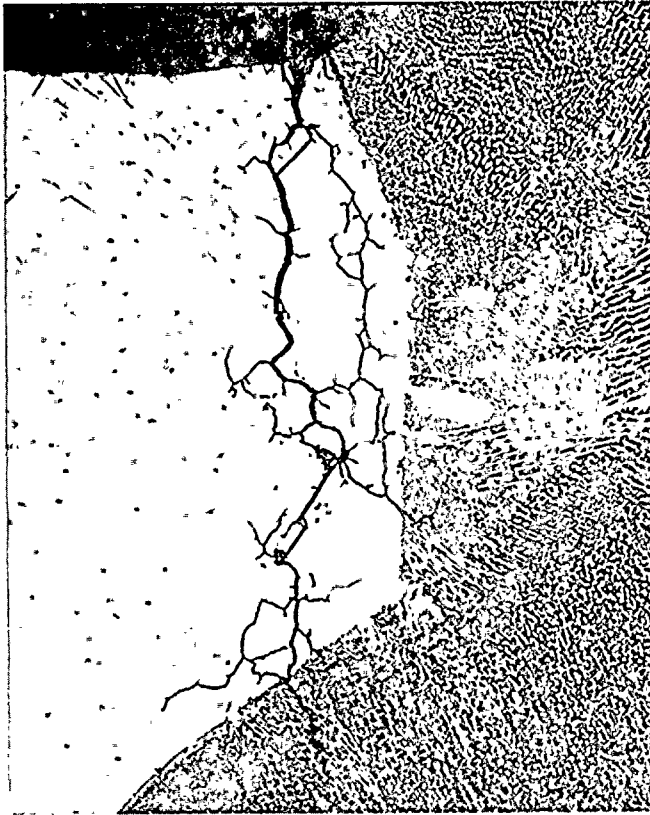
Figure 51. Penetrant examined view of longest indication, pipe side of pipe-to-elbow weld SW-12 removed from Loop 15. ~2X

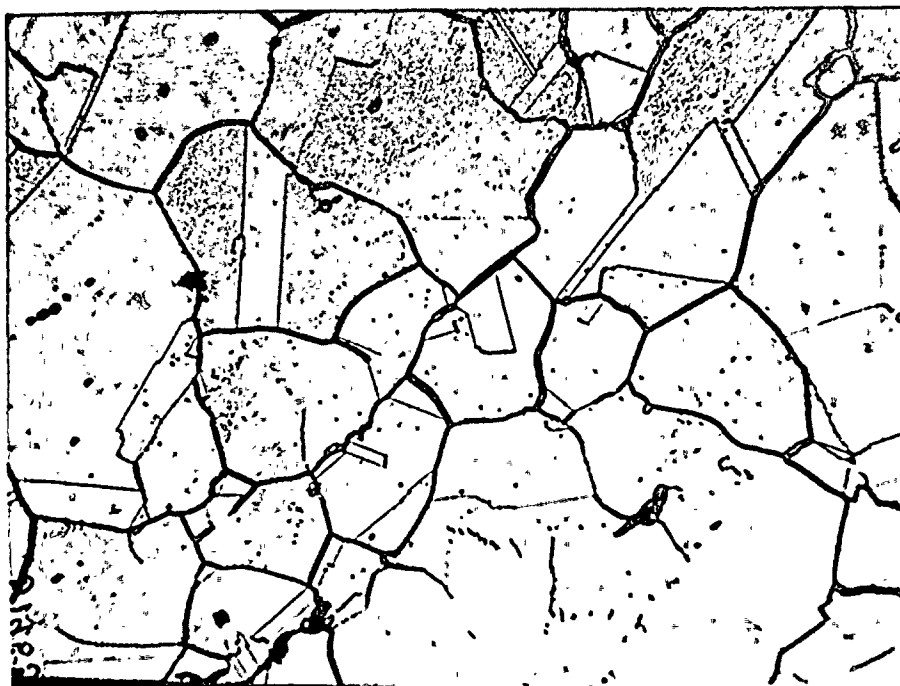
Figure 60. Dark field view of pipe side HAZ, showing carbides precipitated at grain boundaries.

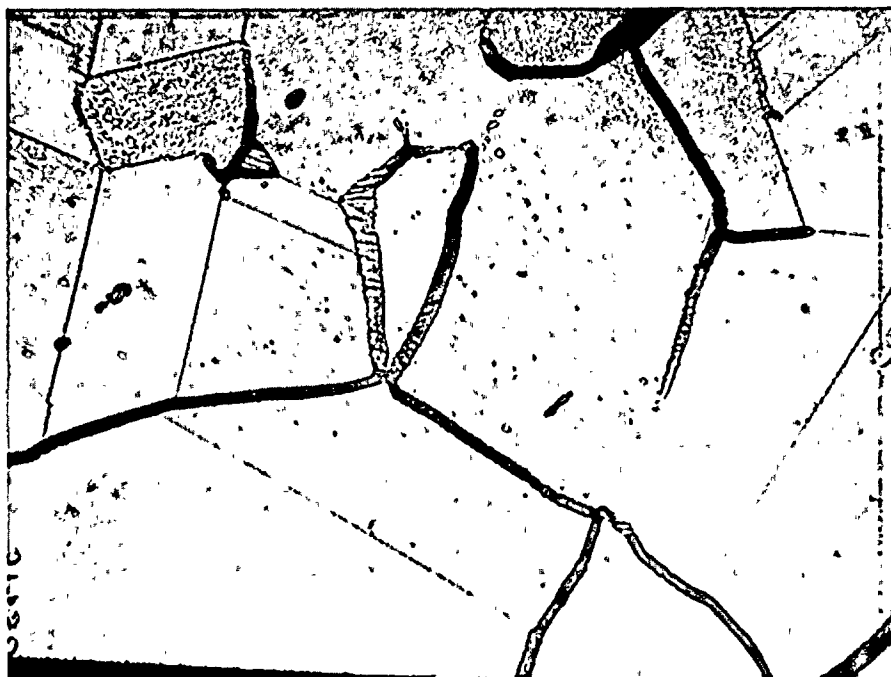
FIGURE 61. APPEARANCE OF SPECIMEN MICROSTRUCTURE AFTER THE DEGREE OF SENSITIZATION TEST (ASTM-A-262 PRACTICE A).
