Humboldt Bay
Independent Spent Fuel Storage Installation
Site-Specific License Renewal Application

Pacific Gas and Electric Company

Revision 0 July 2018
NRC Docket No. 72-27

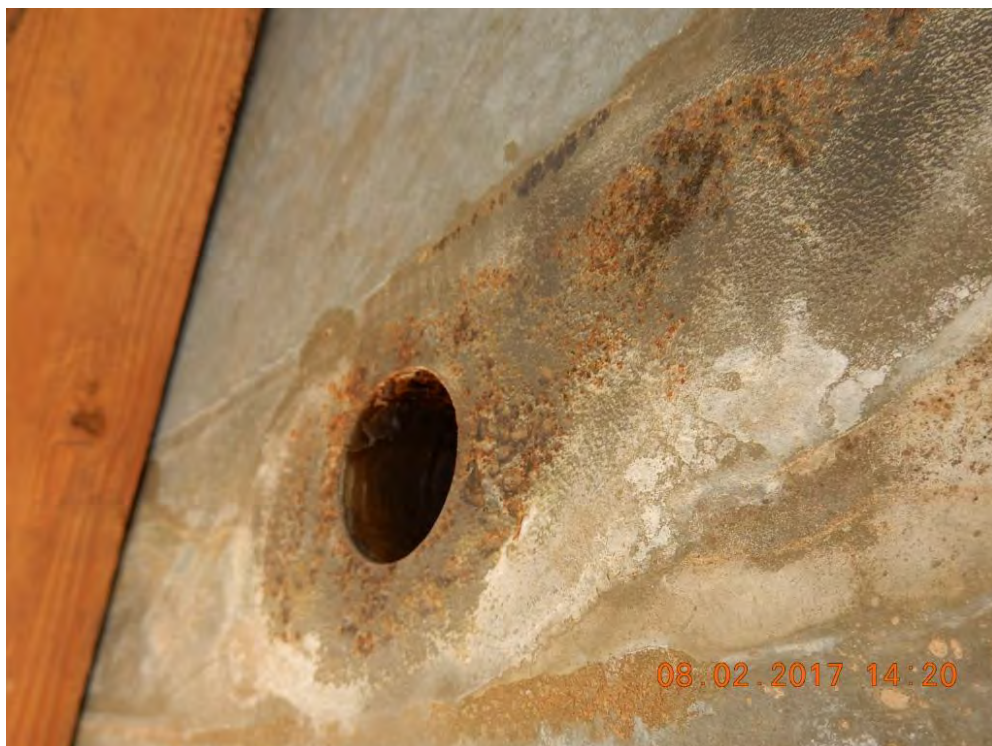
11. Hole #3 after cleaning

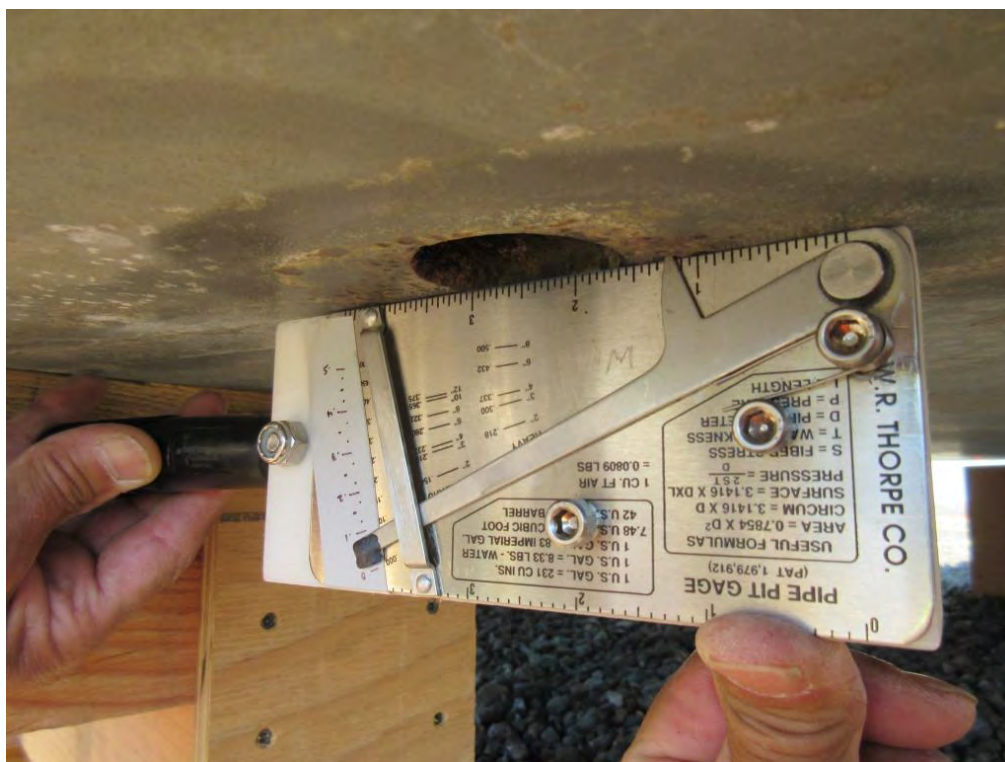
12. Measuring pit depth <1/16"

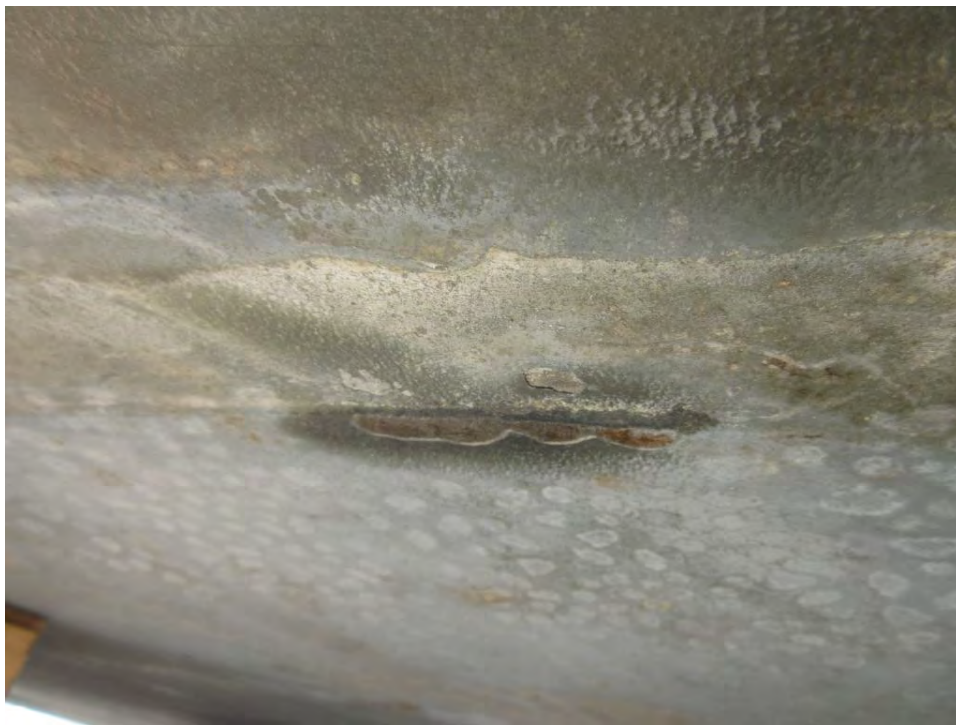
13. Coating chip on underside of lid

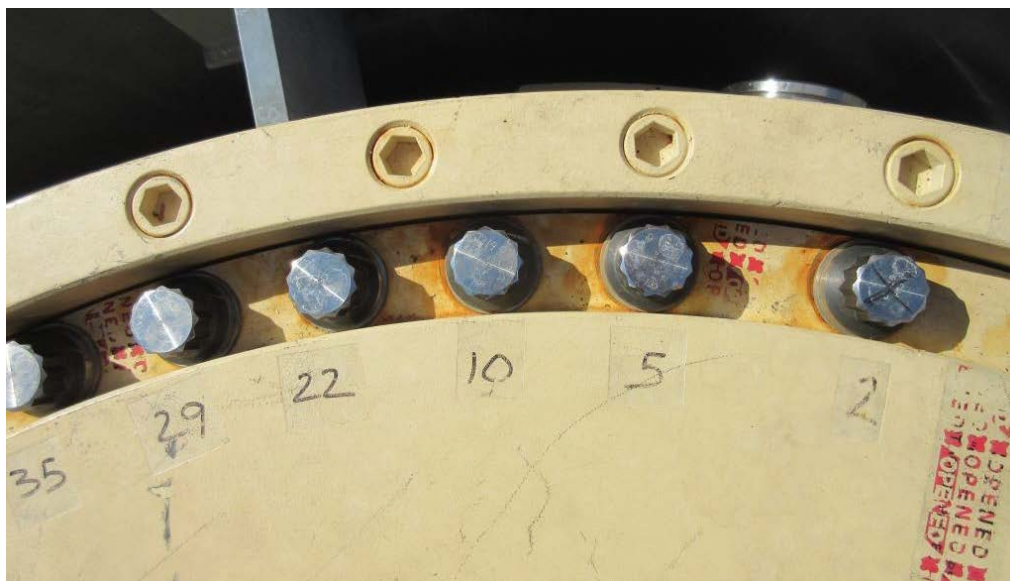
15. Rust staining around overpack lid closure bolting

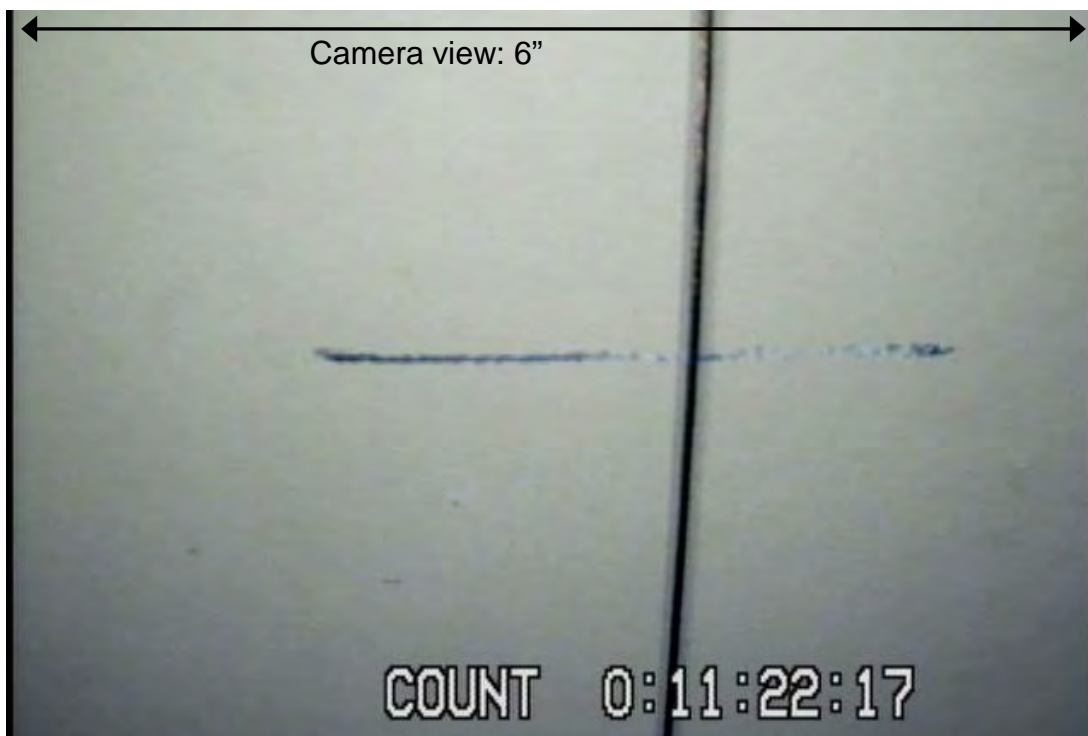
34. Scan 42 coating scrape

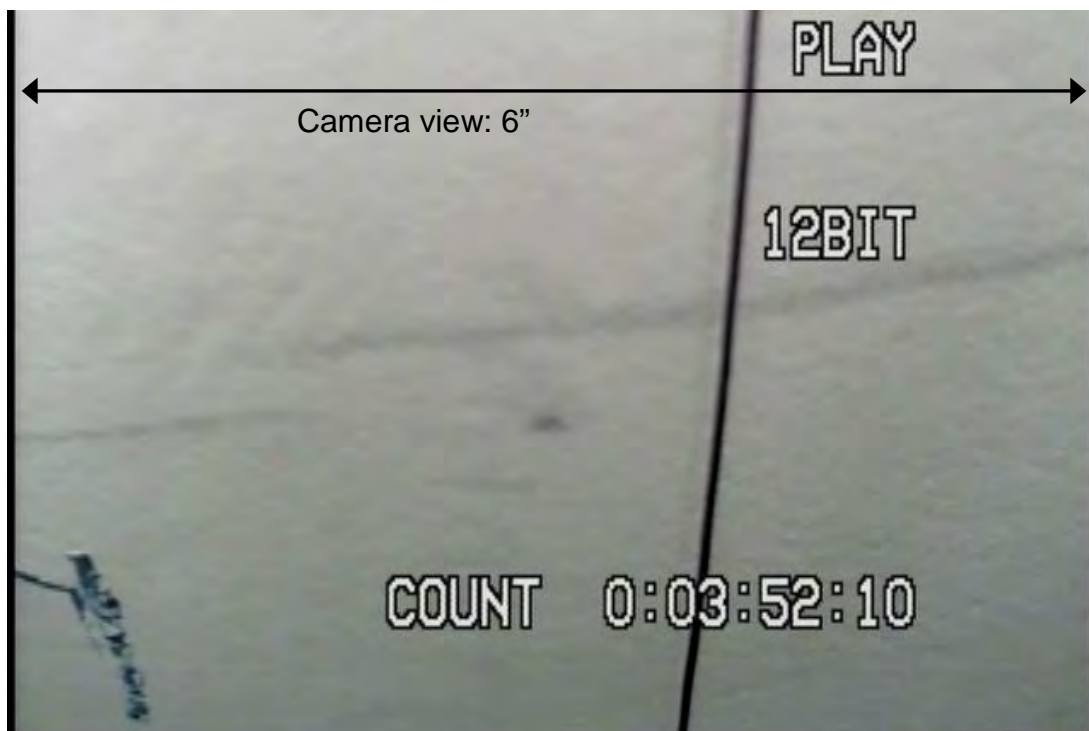
38. Scan 80 coating scrape

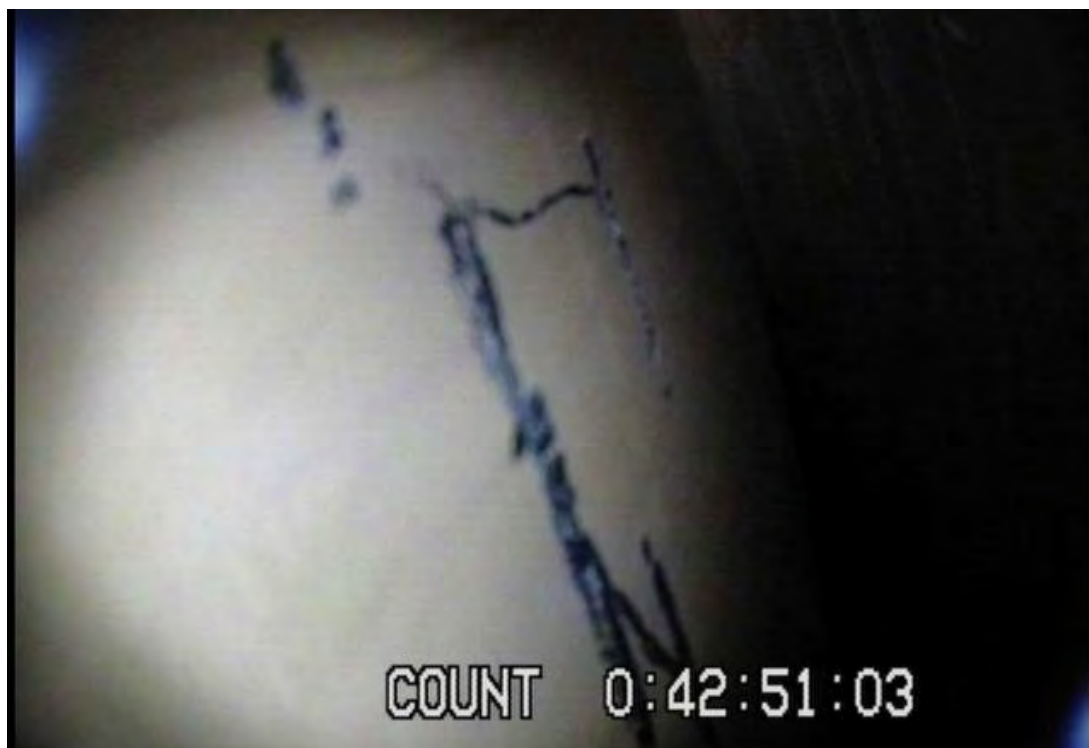
39. Scan 1 / Scan 80 area coating scrape

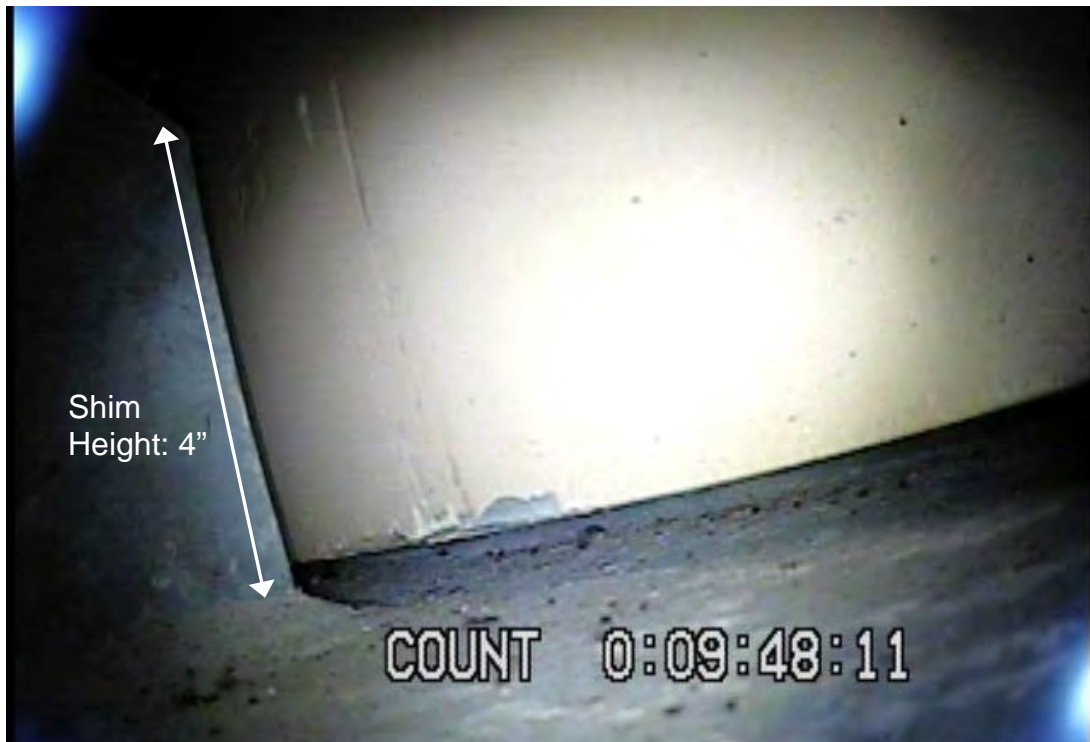
42. Overpack south east section coating scrape adjacent to seismic shim

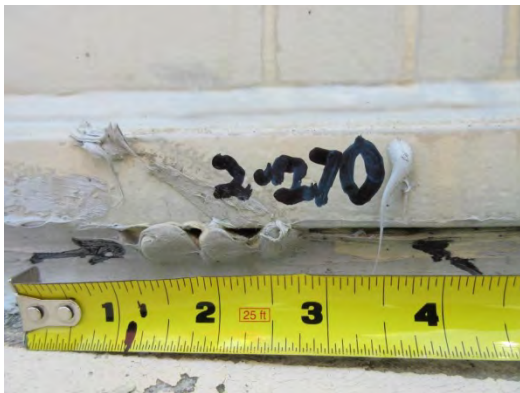
2. Cell 2 Caulking As-Found

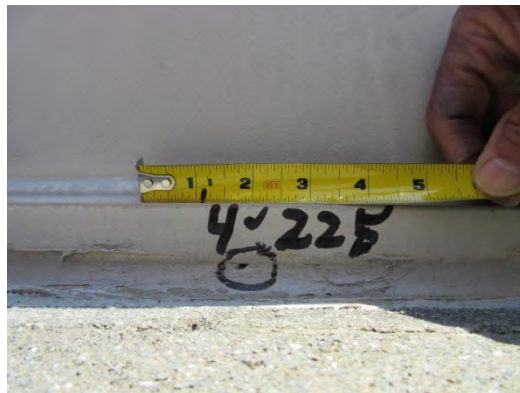
3. Cell 2 Caulking As-Found

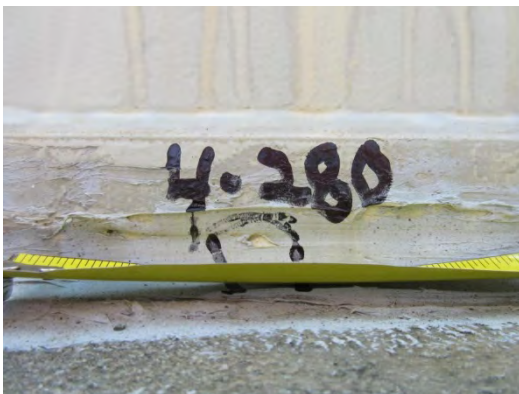
4. Cell 4 Caulking As-Found

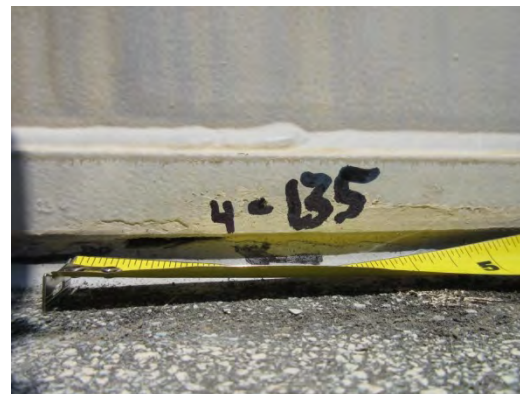
5. Cell 4 Caulking As-Found

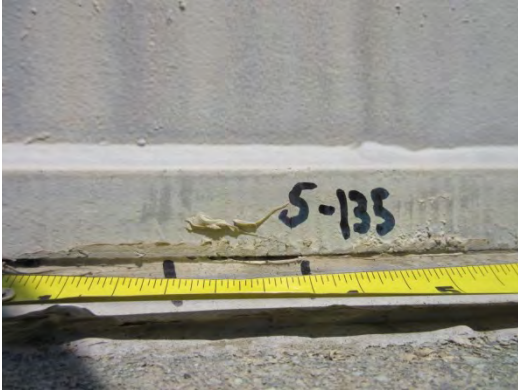
6. Cell 4 Caulking As-Found

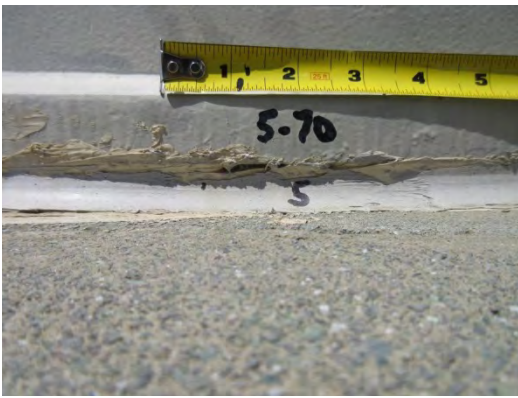
8. Cell 5 Caulking As-Found

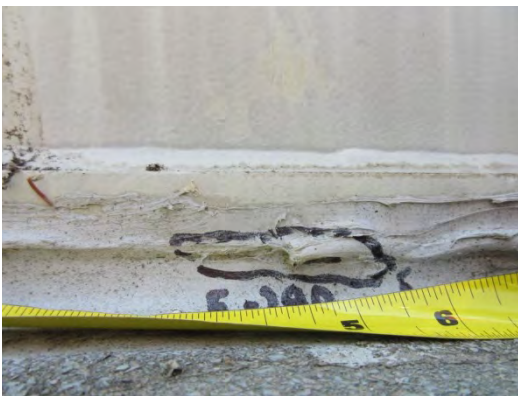
10. Cell 5 Caulking As-Found

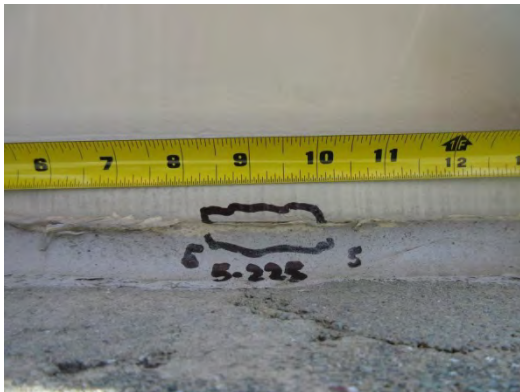
12. Cell 5 Caulking As-Found

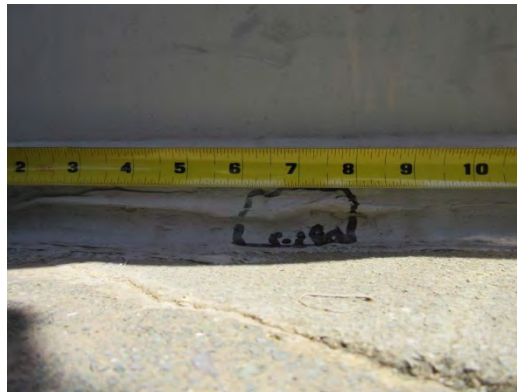
13. Cell 5 Caulking As-Found

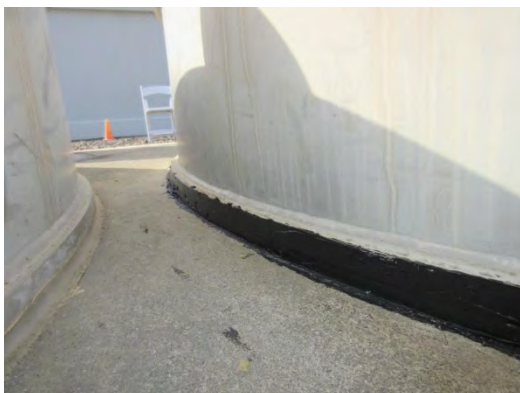
14. Cell 5 Caulking As-Found

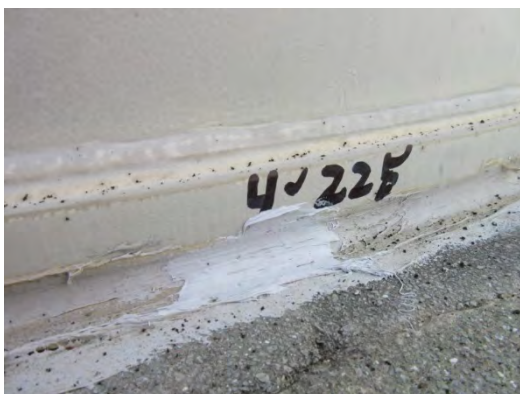
16. Cell 2 Caulking As-Left

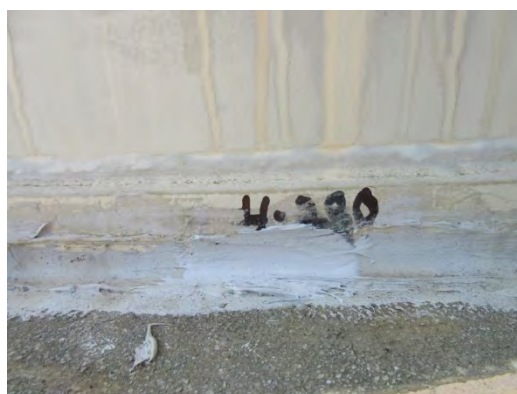
17. Cell 4 Caulking As-Left

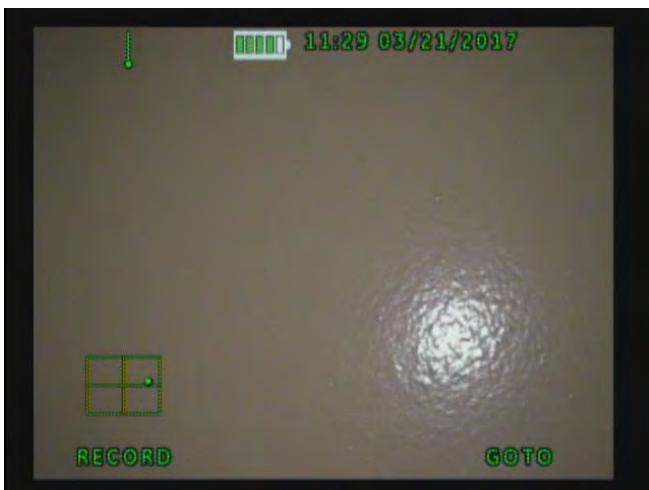
12. Close-up of overpack coating

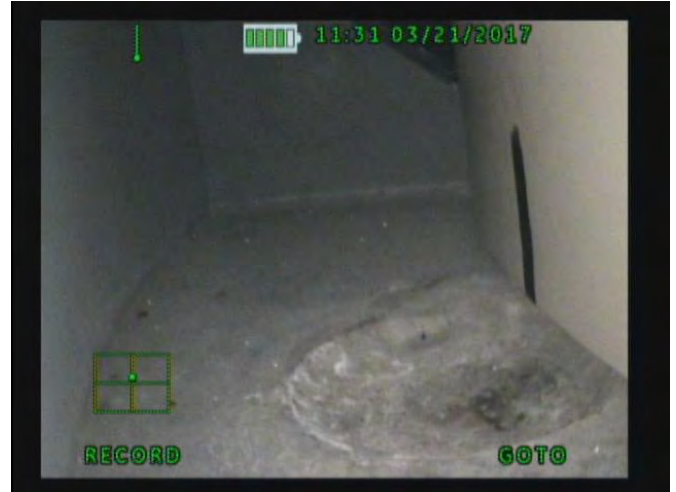
2. As discussed in Sections 3.1, 3.2, 3.3, 3.5, and 3.6, white deposits were noted around the floor drains in cells 1, 2, 3, 5 and 6. The deposit appearance is crystalline with no apparent discoloration, similar to concrete efflorescence or leaching. The boroscope video does not provide enough detail to establish the condition of the drain. It should be noted that the floor drain is not important to safety because of a defense-in-depth design and is not in the scope of license renewal. Although identification of the white deposits are not addressed in the exam acceptance criteria, this finding was entered into CAP as an observation (SAPN 1429074, Task 33) for further evaluation.

21. Vault drain

The July/August inspection scope has been modified to ensure that that inspection crawler captures as-found and as-left images of the drain in vault #2 so that drain functionality can be further evaluated. Further, provisions will be available to clean the white deposit from the drain screen, to the extent possible, for future trending purposes.

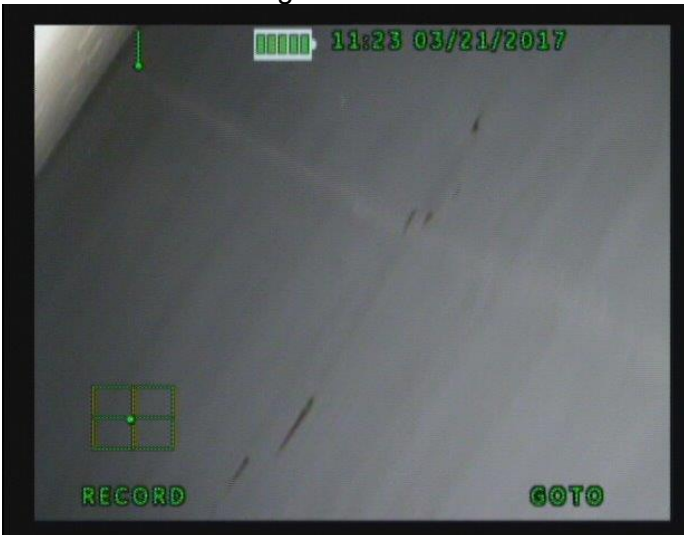
1. As discussed in Sections 3.1 and 3.2, markings were identified on the overpack and vault liner. These markings do not fail acceptance criteria, but will be entered into the CAP as observations (SAPN 1429074, Task 32).

28. Vault liner markings

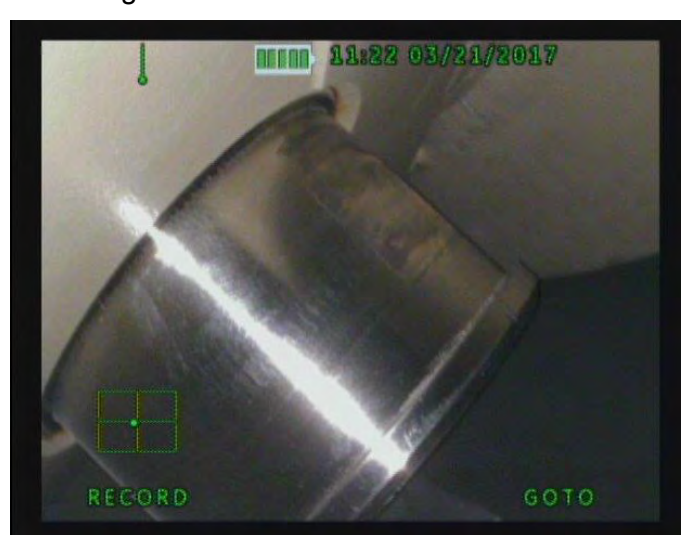
1. As discussed in Section 3.1, orange discoloration was noted at an overpack plug and near the lifting trunnion. Because the discoloration does not meet exam acceptance criteria, this finding was entered into CAP (SAPN 1429074, Task 28) for further evaluation.

29. Lifting trunnion

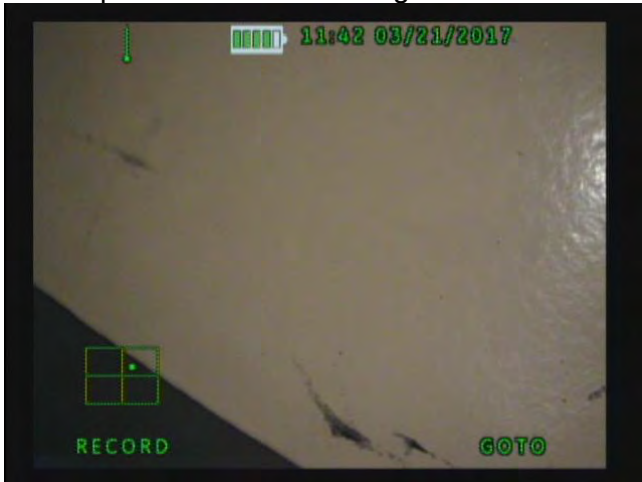
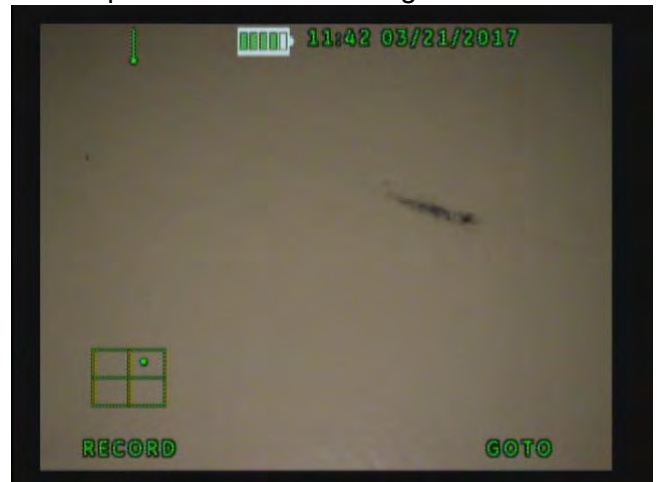
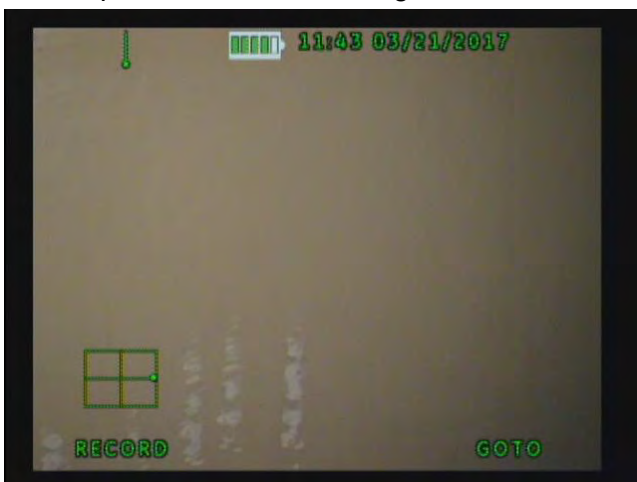
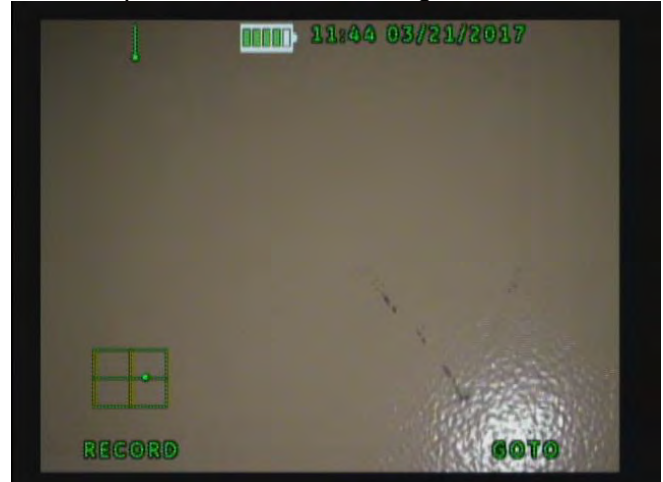
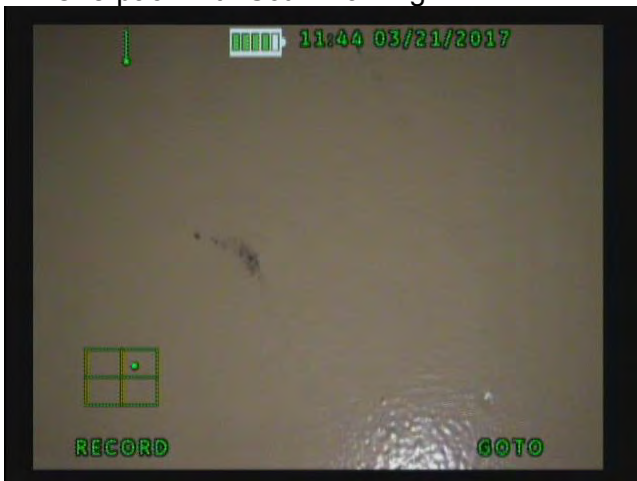
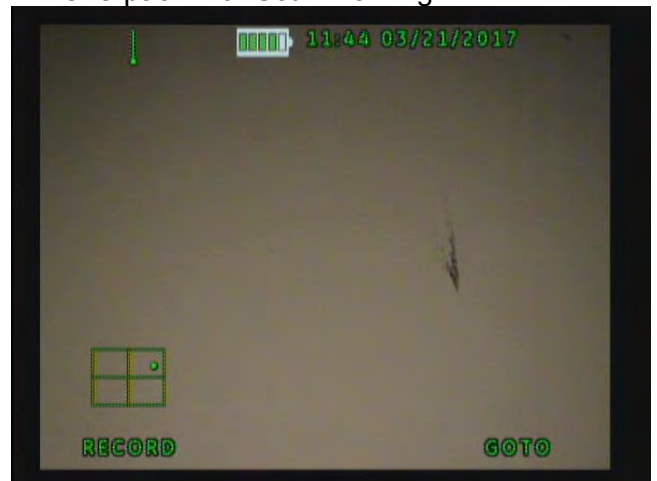
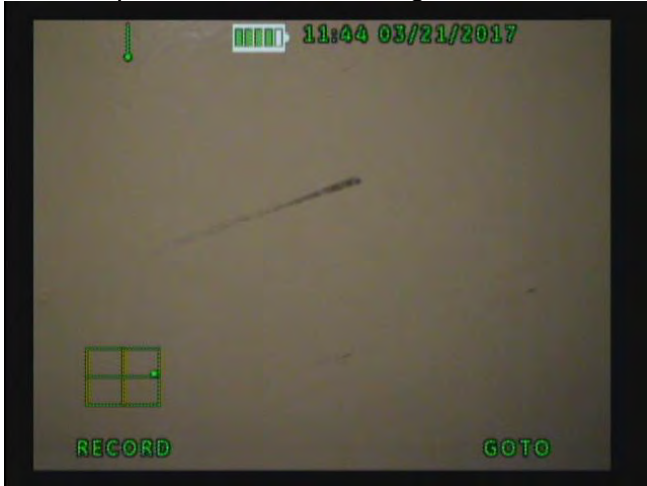
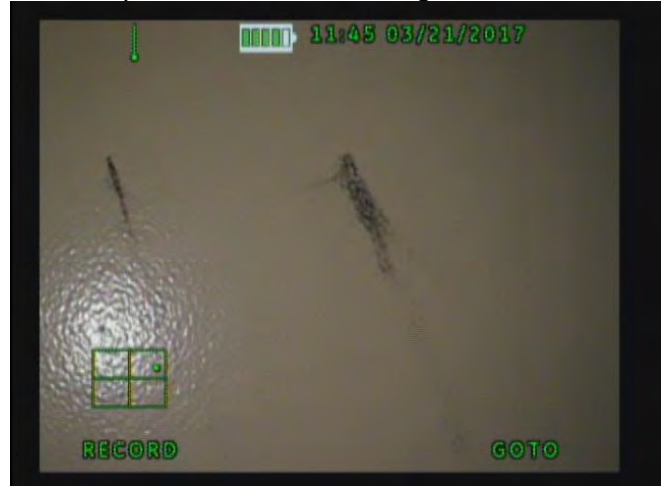
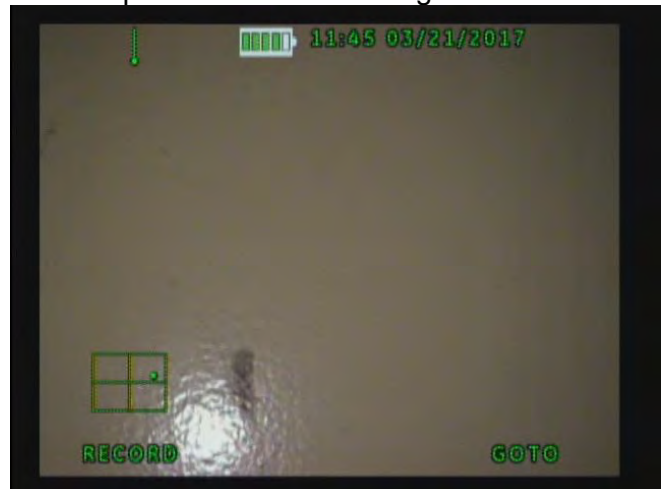
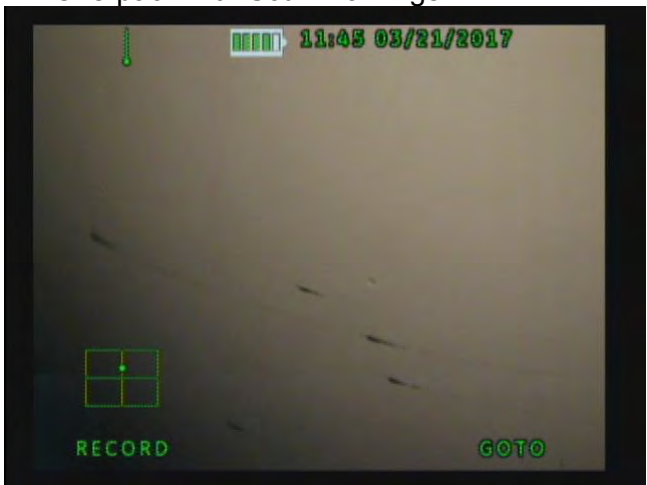
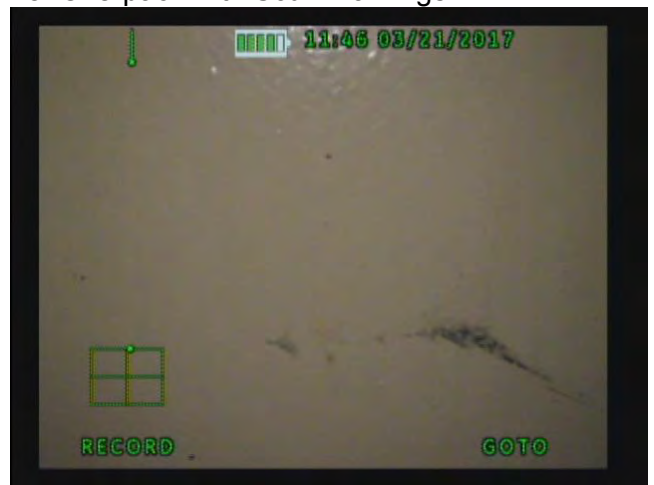
7. Overpack with Scuff Marking

Because of the similar condition of all cells, but the additional mechanical markings noted in cell #2, it is recommended that cell #2 be inspected in the July/August inspection (note that cell #2 also has operating experience with previous water intrusion which may have provided an environment more suitable for degradation).

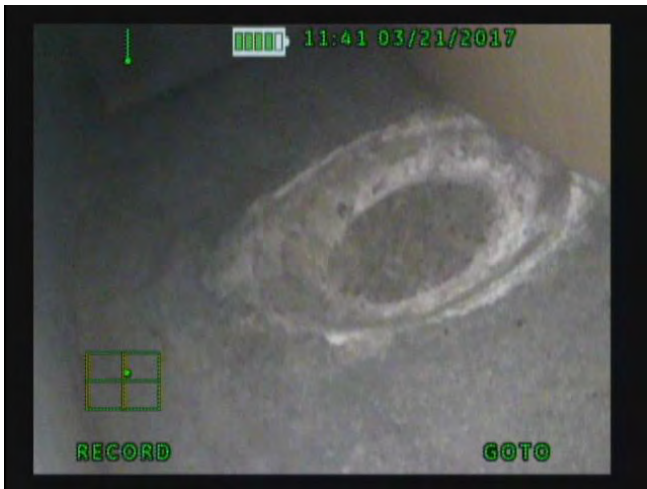
15. Vault Drain
