U.S. DEPARTMENT OF
ENERGY

2018 Annual Site Inspection and Monitoring Report for Uranium Mill Tailings Radiation Control Act Title I Disposal Sites

March 2019

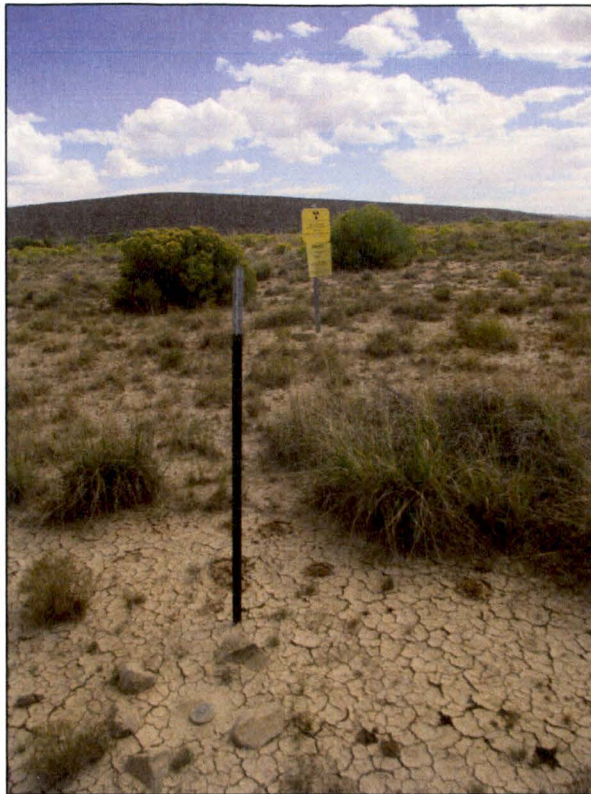
Three combined survey and boundary monuments and five additional boundary monuments delineate the property corners and boundary. Steel T-posts were installed next to boundary monuments during an April 2018 maintenance trip to help inspectors locate the monuments (PL-3). Erosion has occurred around the base of boundary monument BM-8, but the monument is stable (PL-4). No maintenance needs were identified.

PL-3. Boundary Monument BM-6 and Perimeter Sign P10

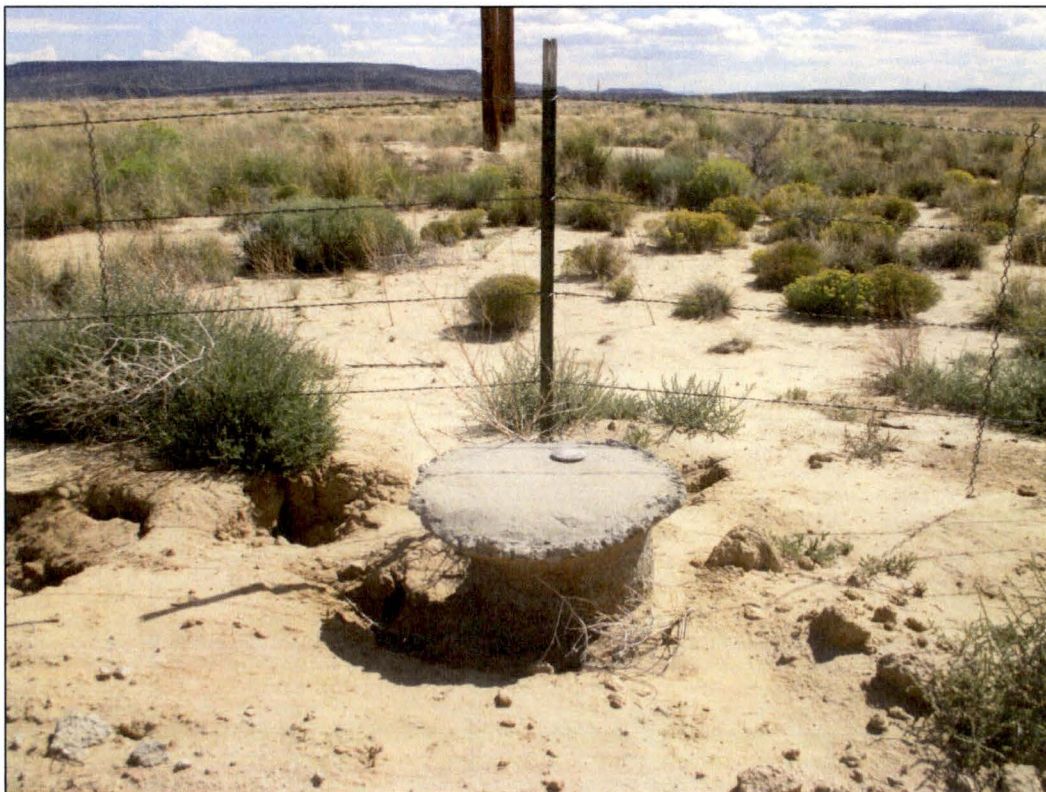
PL-4. Pedestaling at Base of Boundary Monument BM-8

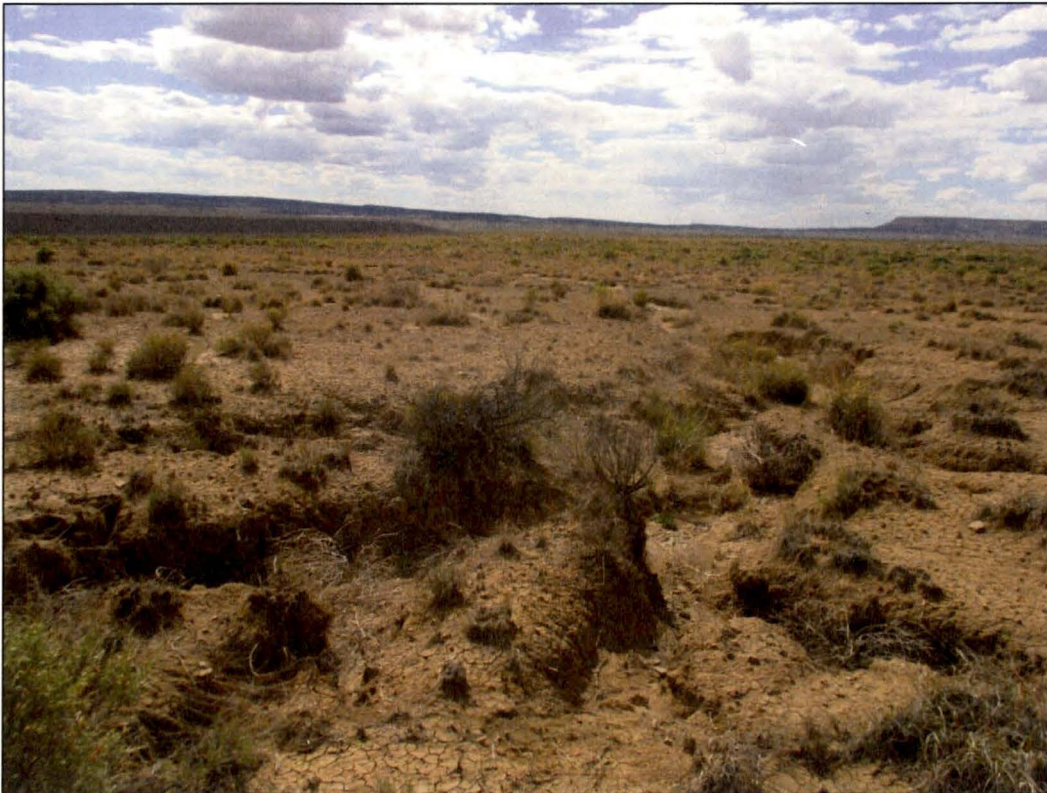
PL-10. Erosion South of Perimeter Sign P30

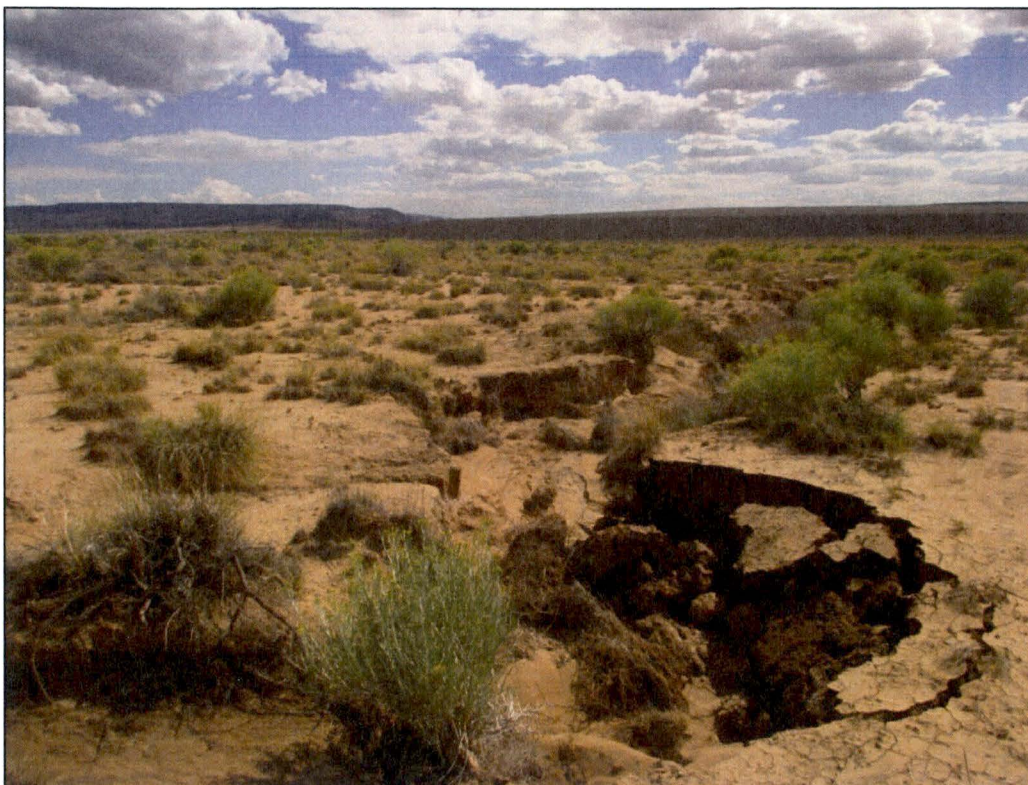
PL-11. Erosion South of Perimeter Sign P26

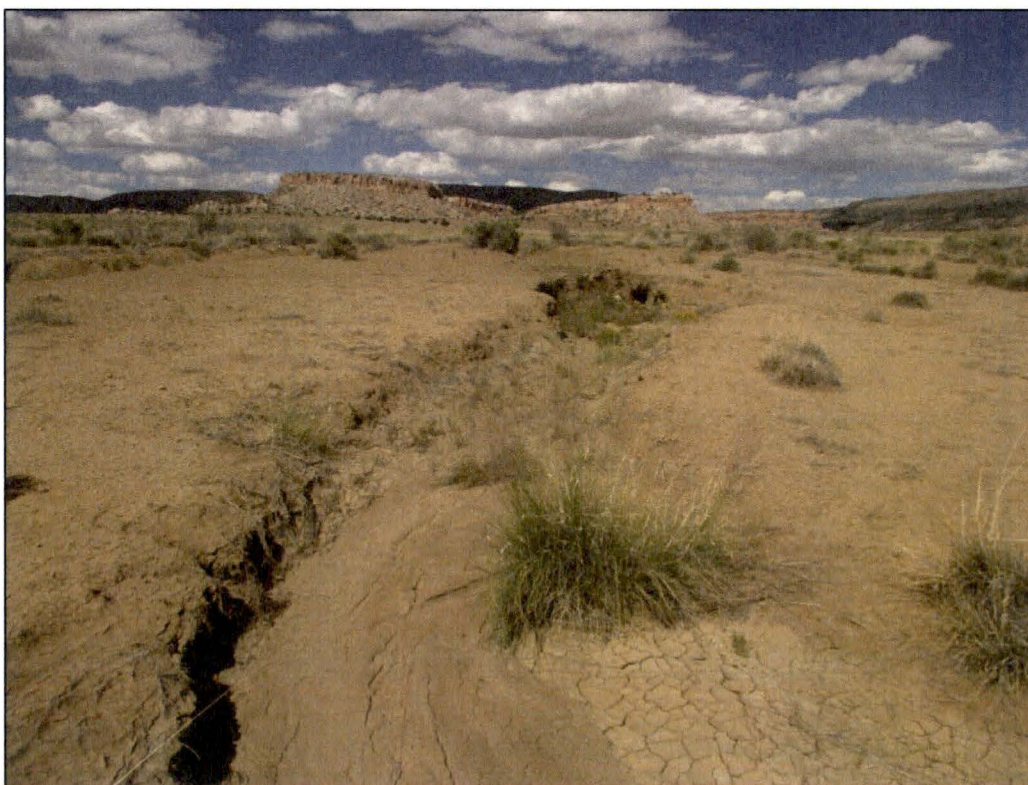
PL-12. Erosion Outside Site Boundary near P41

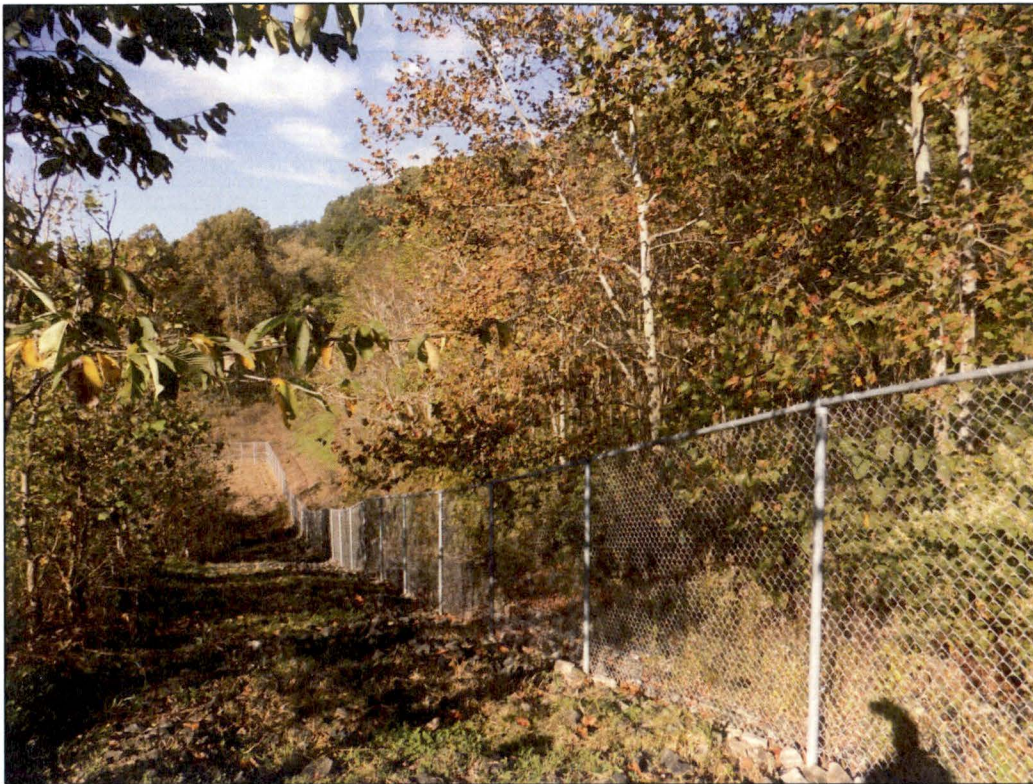
A chainlink security fence encloses the disposal cell and drainage features. The site herbicide subcontractor keeps the fence line clear of vegetation, which should prolong the life of the security fence (PL-1). Tree limbs growing toward, or hanging over, the security fence judged to be a future potential threat to the fence were tagged during the inspection with survey ribbon for removal in 2019.

PL-1. Security Fence Line

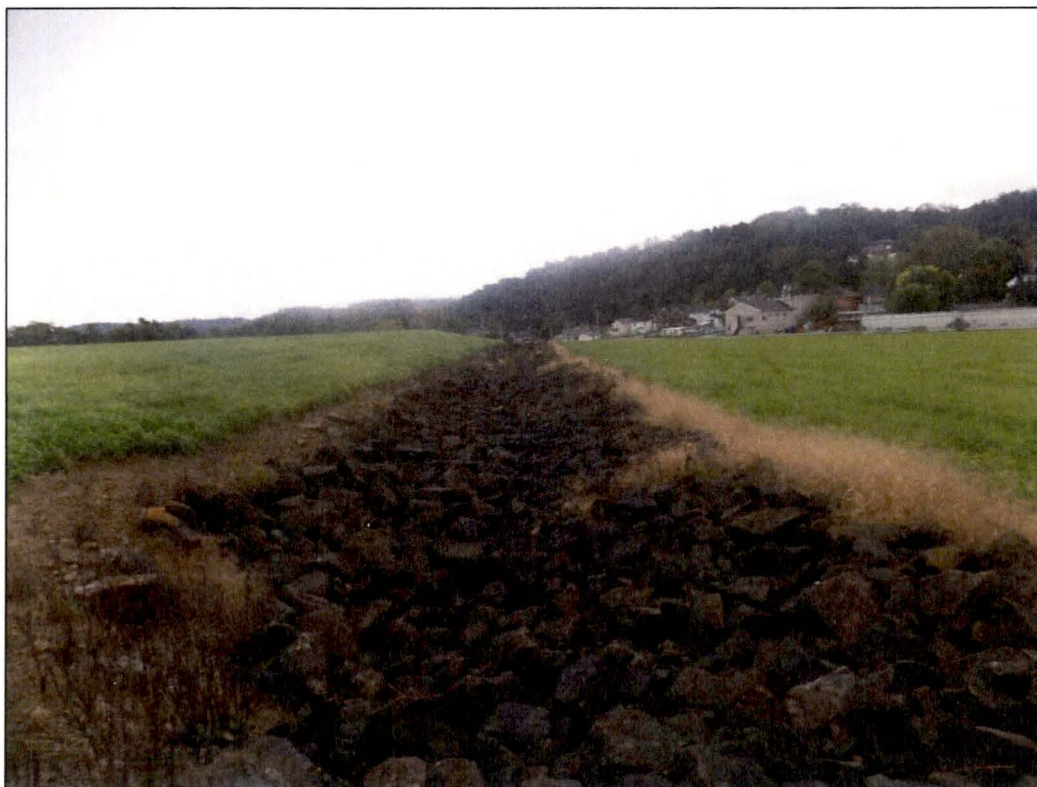
PL-8. Riprap-Armored Diversion Ditch

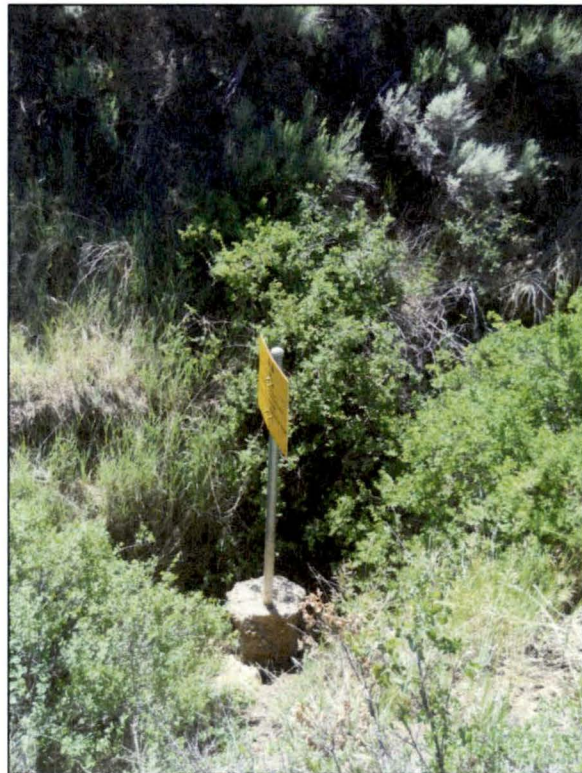
*PL-2. Perimeter Sign P45 in Arroyo
(Sign Moved Following Inspection)*

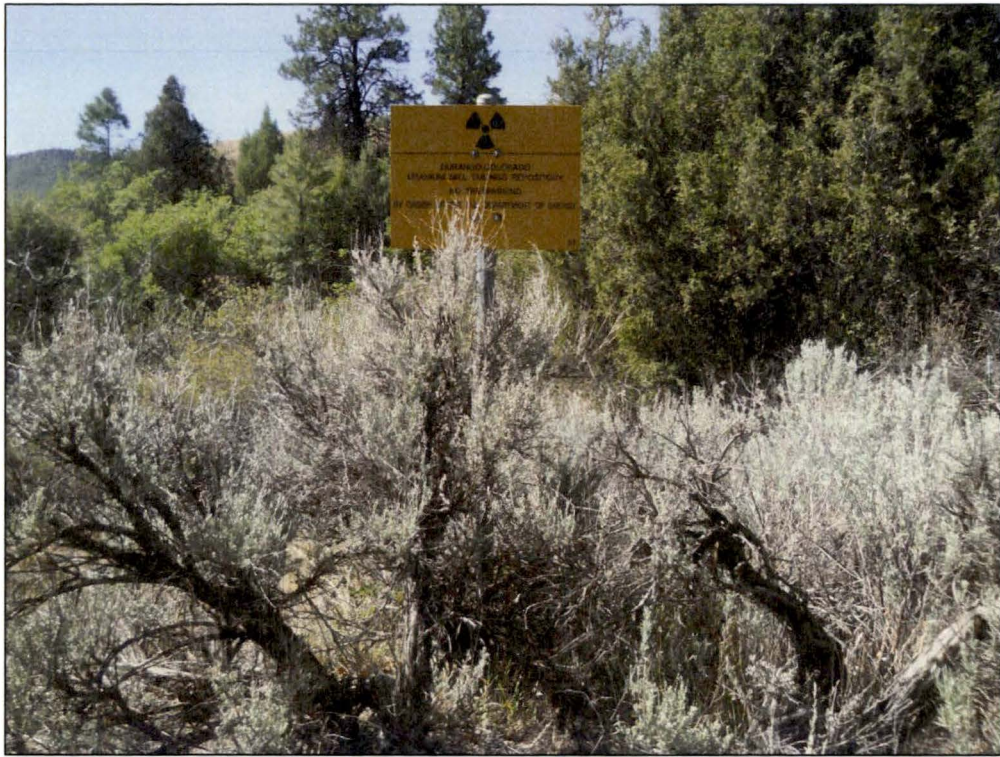
*PL-3. Vegetation Encroaching on Perimeter Sign P51
(Removed Following Inspection)*

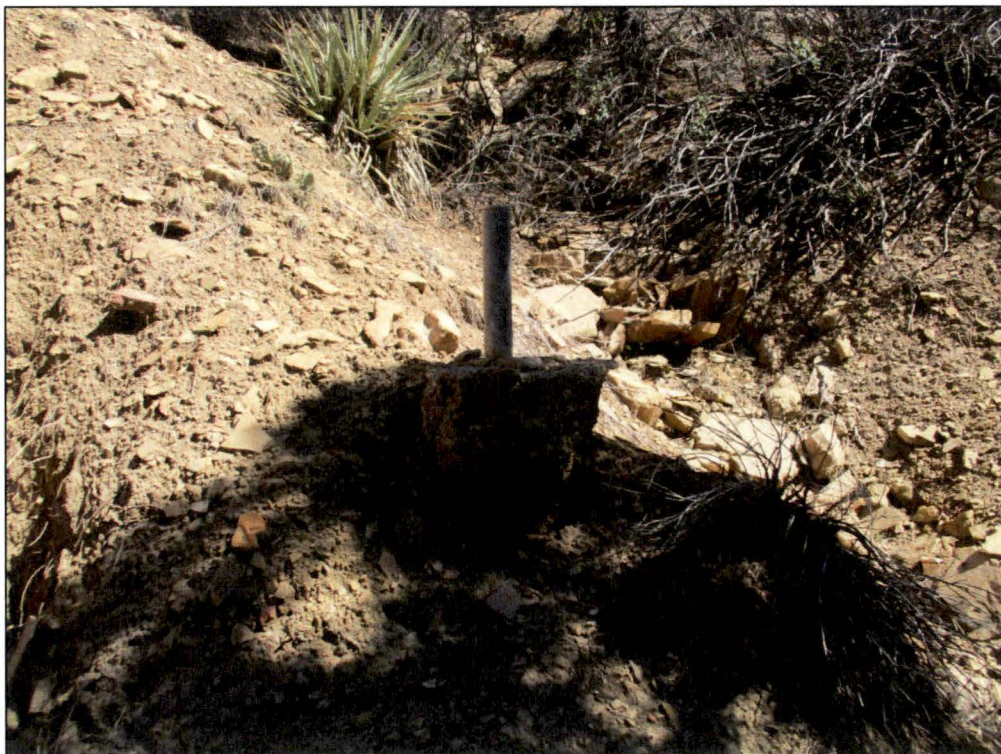
*PL-6. Erosion of North Witness Corner of Boundary Monument BM-3
(Addressed Following Inspection)*

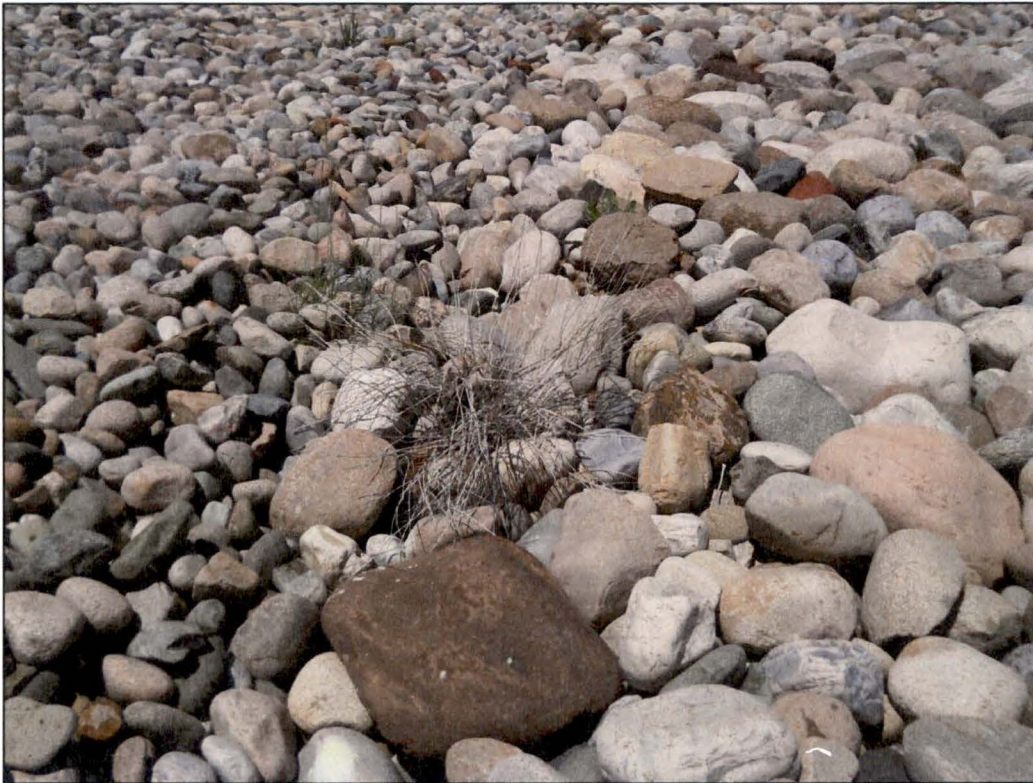
PL-7. 18-Foot Linear Depression (Rocks Have Rotated Inward and Downward)

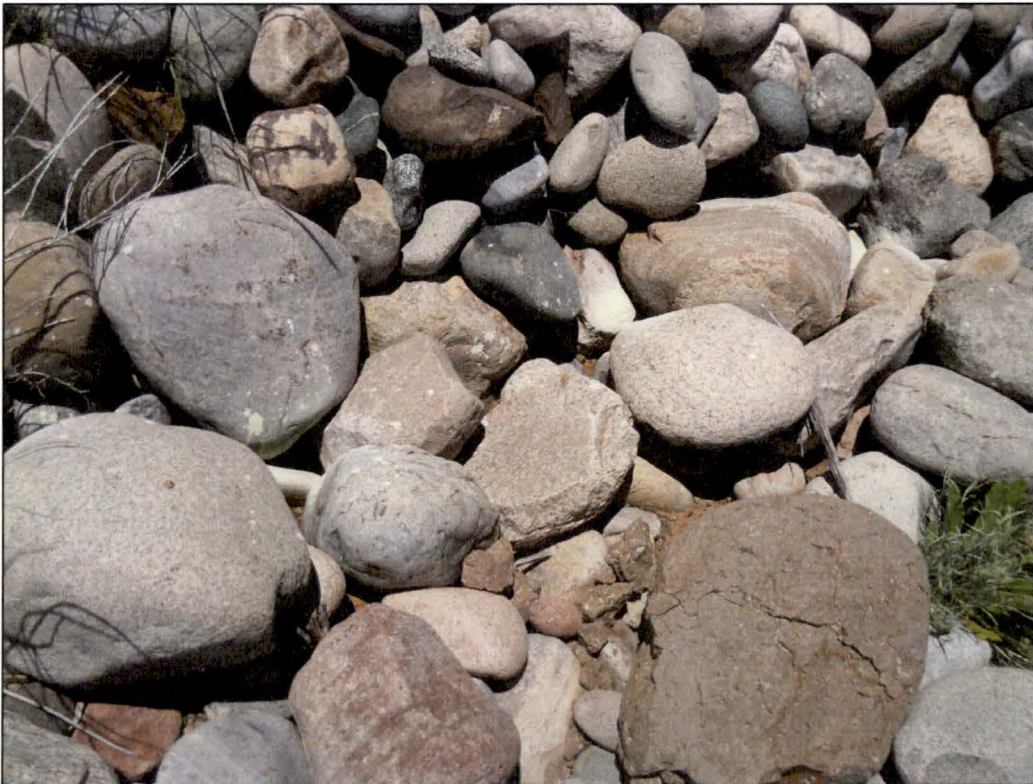
PL-8. 18-Foot Linear Depression (Rocks Have Rotated Inward and Downward)

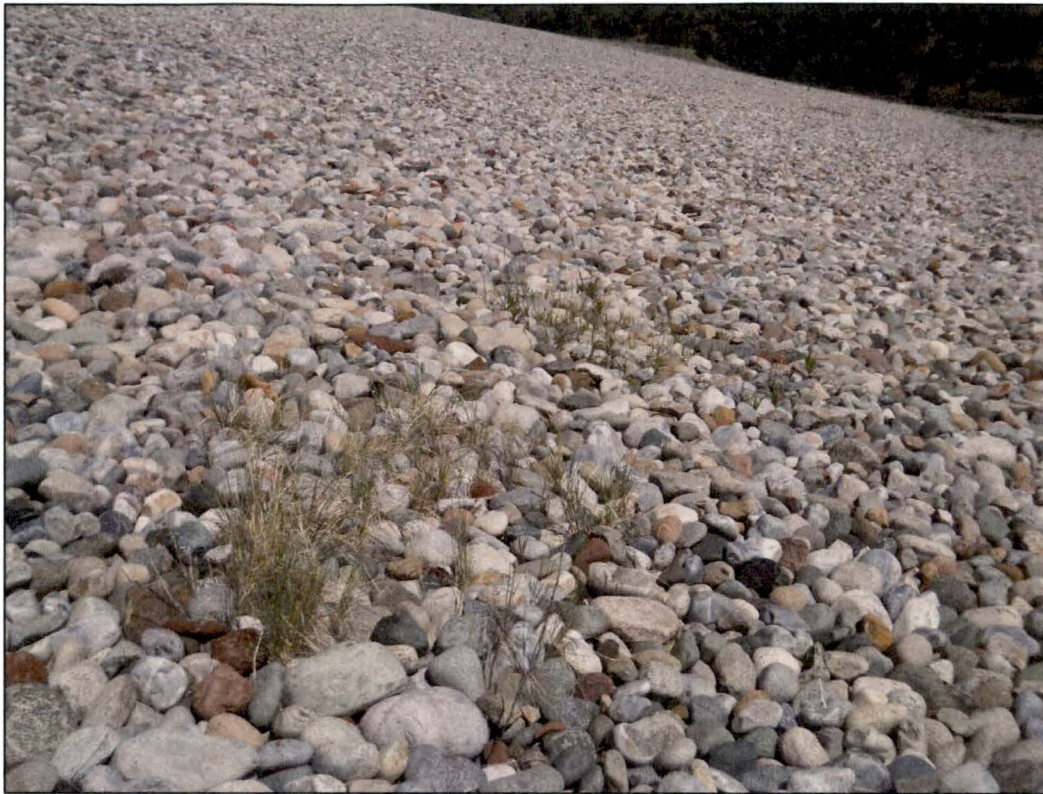
PL-9. Topographic Variation on Northeast Side Slope of Disposal Cell

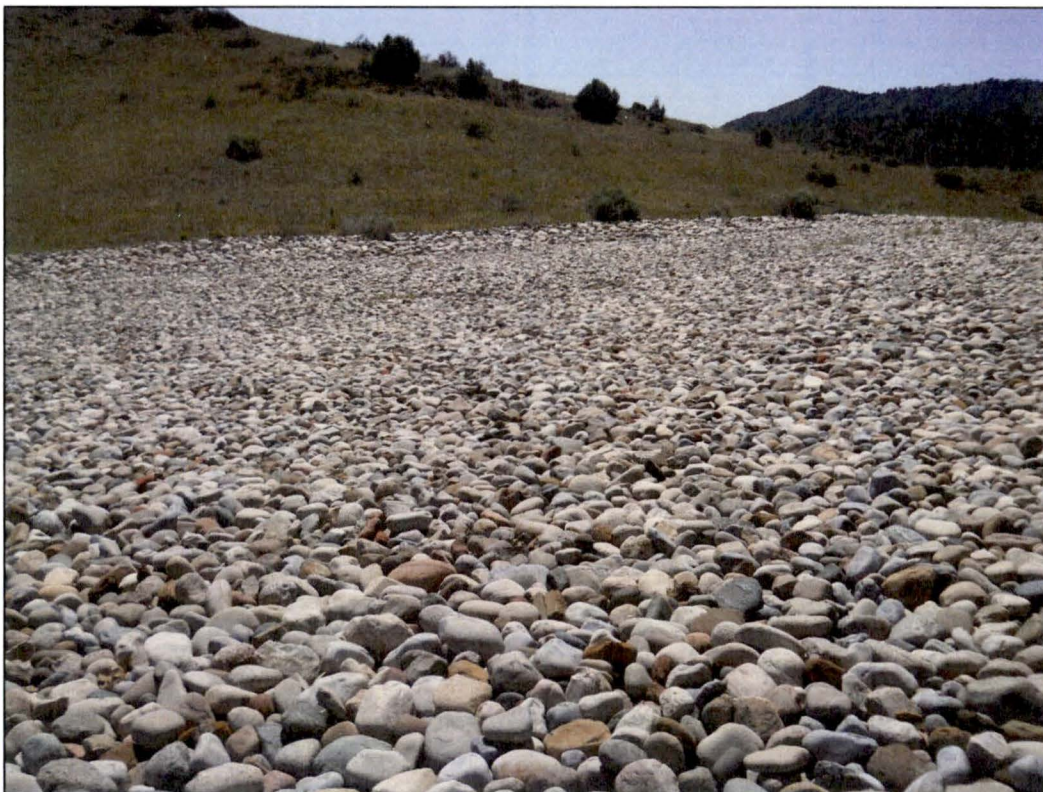
PL-10. Topographic Variation on Northeast Side Slope of Disposal Cell

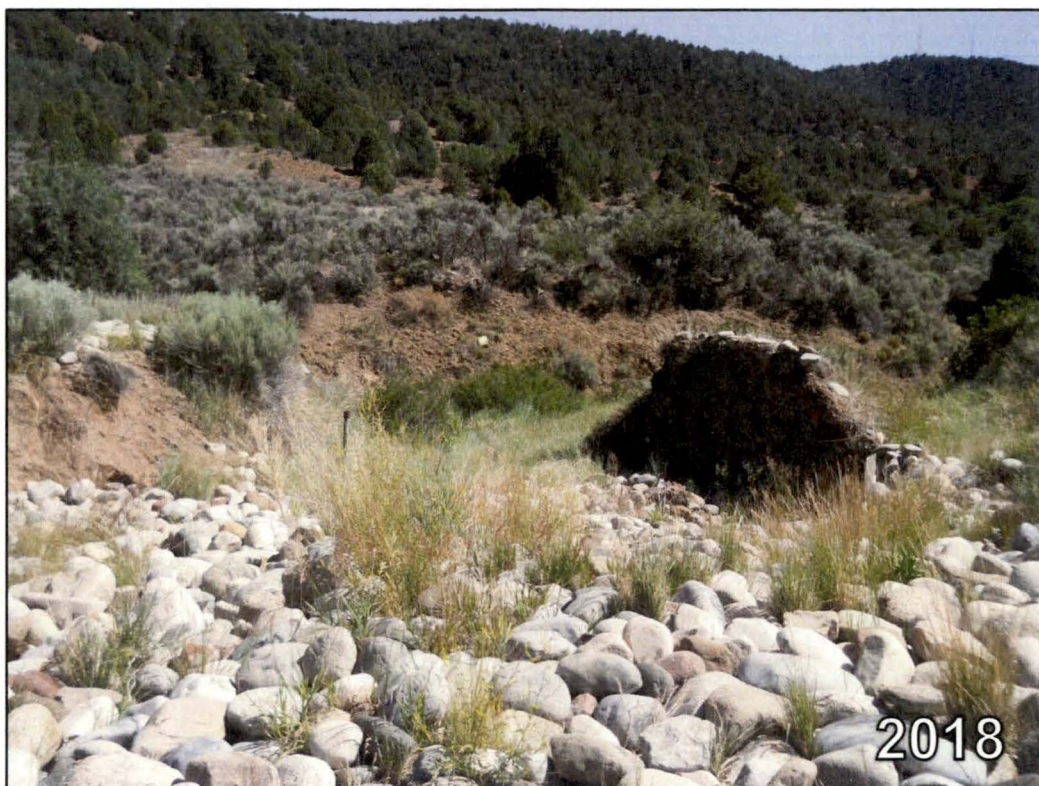
PL-11 (a). Northeast Outflow, 2018

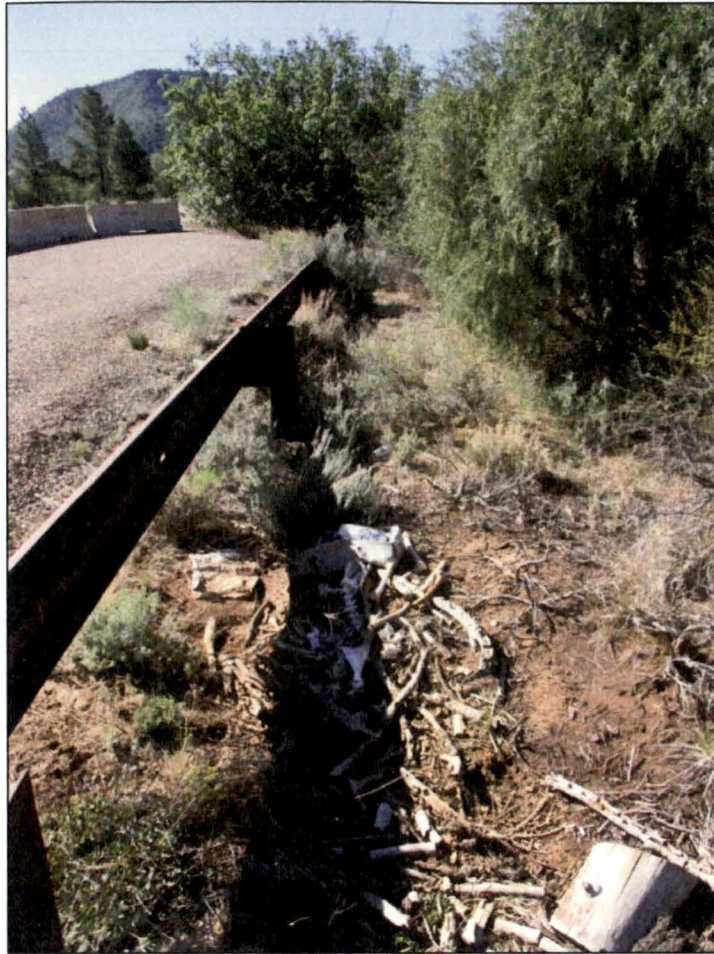
*PL-12. Debris near Site Entrance Gate
(Removed Following Inspection)*

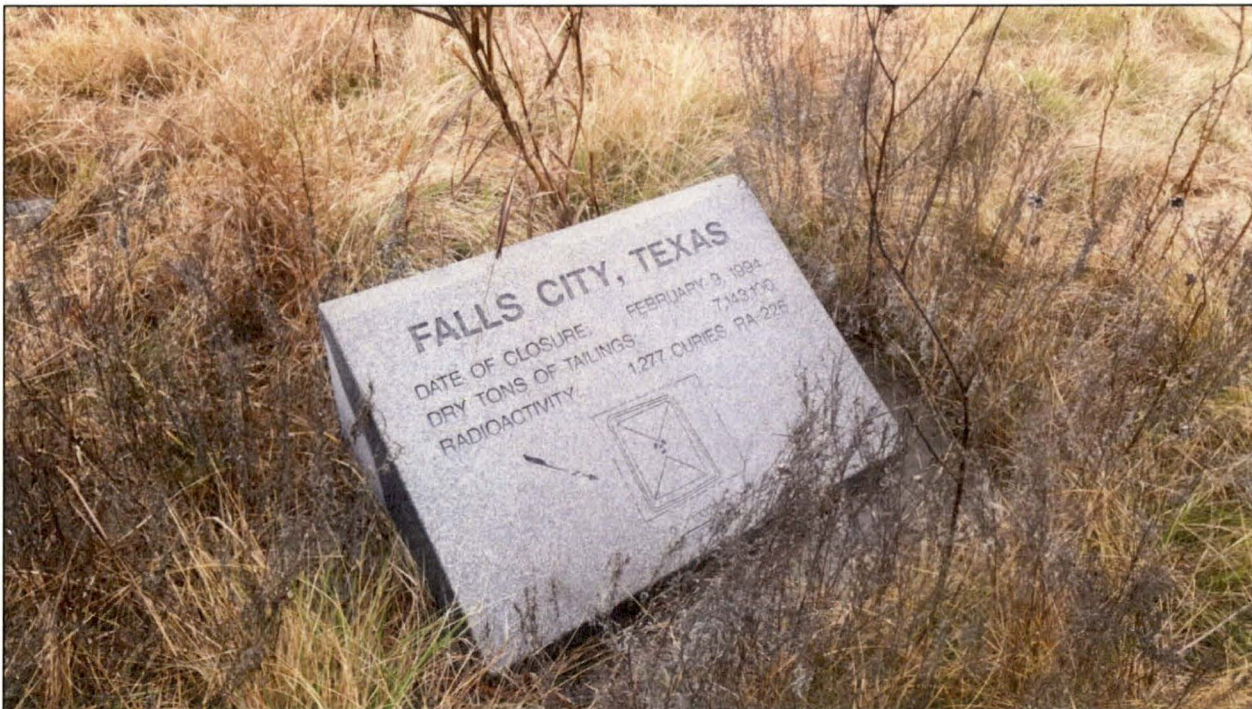
PL-2. Site Marker SMK-1

The site has two site markers. Site marker SMK-1 is just inside the entrance gate. The corners of the concrete base around the marker are cracked (PL-2). The cracks appear to be unchanged from last year, and repairs are not needed at this time. Site marker SMK-2 is on the top slope of the disposal cell. No maintenance needs were identified.

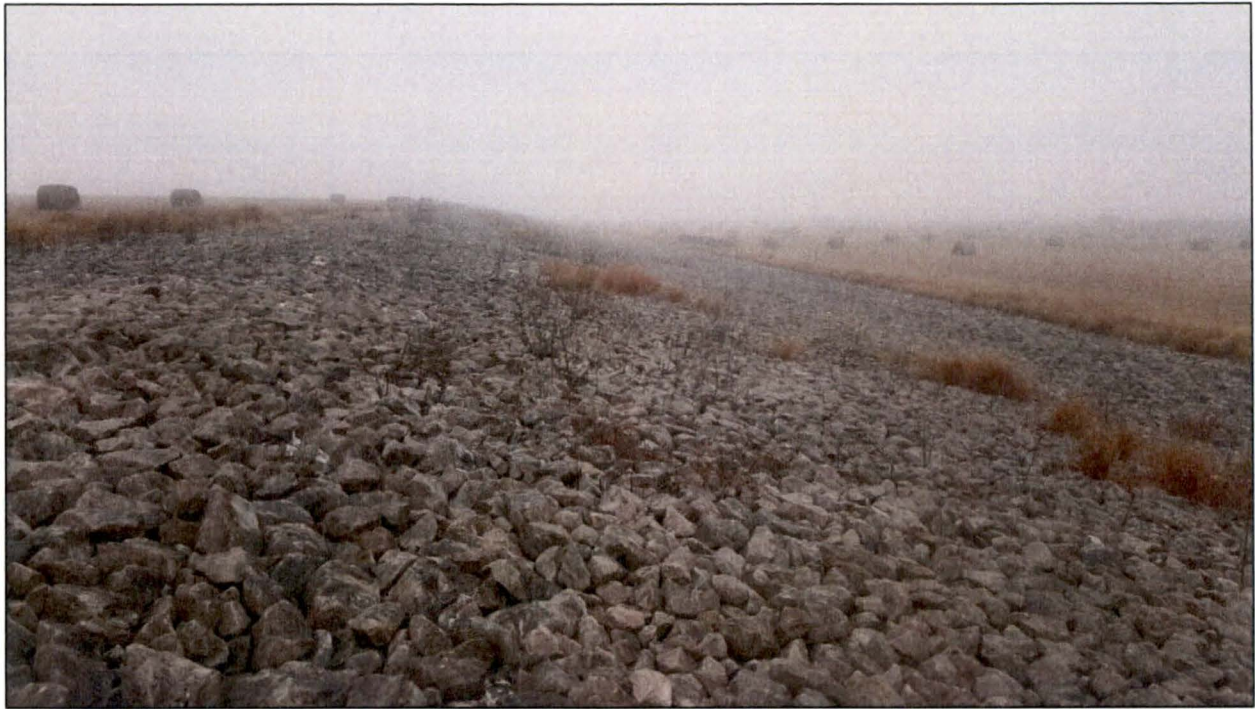
PL-5. Southwest Side Slope

The disposal cell side slopes are armored with riprap (PL-5). LM has monitored several small depressions on the northwest side slope of the disposal cell since 2010. These depressions do not compromise the protectiveness of the riprap side slope, and no changes have been observed since 2010. Inspectors will continue to monitor these areas.

Fractured riprap has been observed on the disposal cell side slopes since it was completed. Pieces of riprap are fractured in place, indicating that the fracturing occurred after placement. Fracturing is likely a consequence of mechanical placement or thermal expansion and contraction; the riprap condition does not appear to be worsening. During the inspection, photos were taken of riprap at the base of T-post 4, on the west corner of the disposal cell (PL-6). These photos were compared to photos taken in previous years at this location. There is no indication that the riprap is degrading, but its durability will continue to be monitored. If the number of fractured rocks appears to be increasing, LM will establish a more quantitative monitoring program.

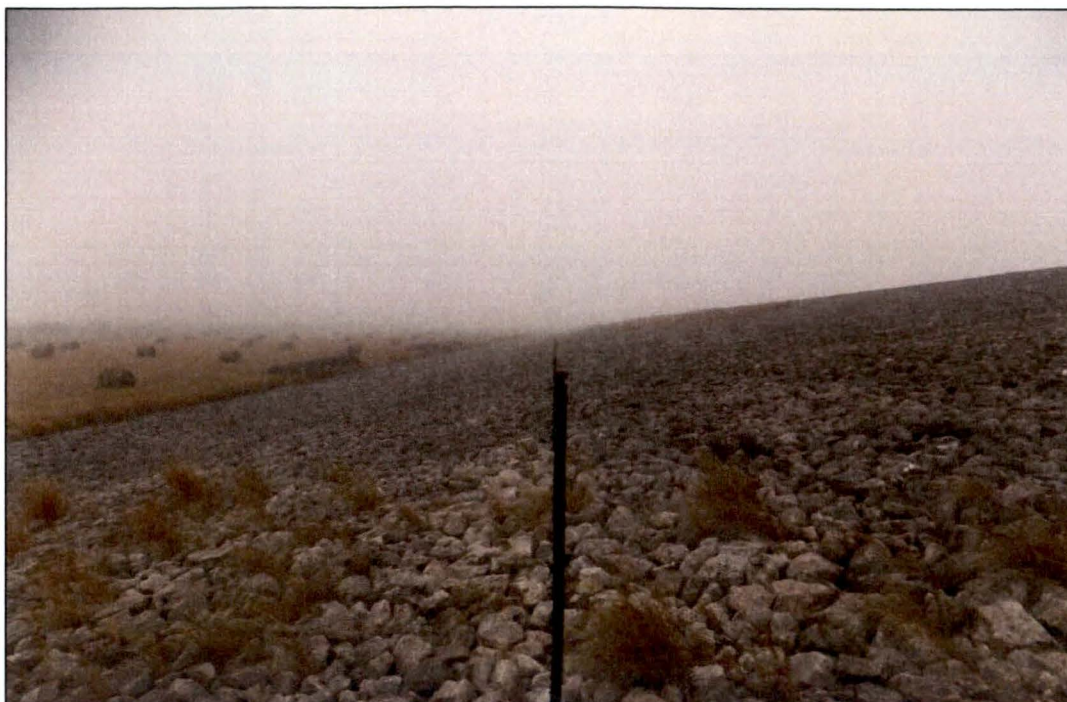
PL-7. Looking Down Line of T-Posts

In 2007, inspectors noted possible subsidence in the riprap at the toe of the south corner of the side slope. In 2008, three T-posts were installed in a straight line running at an orientation of 317 degrees to monitor side slope movement. Each post was installed at a vertical pitch of 90 degrees. These three posts provide reference points to assess whether the area is undergoing movement: If a post moves out of line with the other two posts or the pitch of an individual post changes, it indicates possible movement. The three posts remain in the same straight line in which they were installed and are at the same vertical pitch (PL-7 and PL-8).

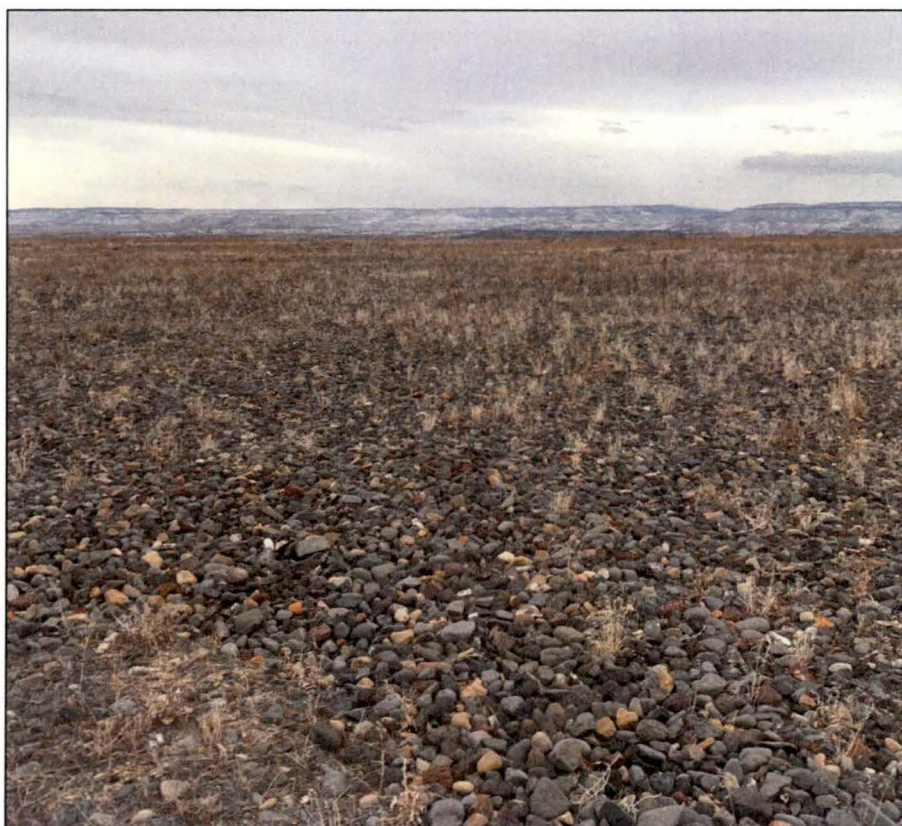
PL-4. Disposal Cell Top Slope with Vegetation Growth

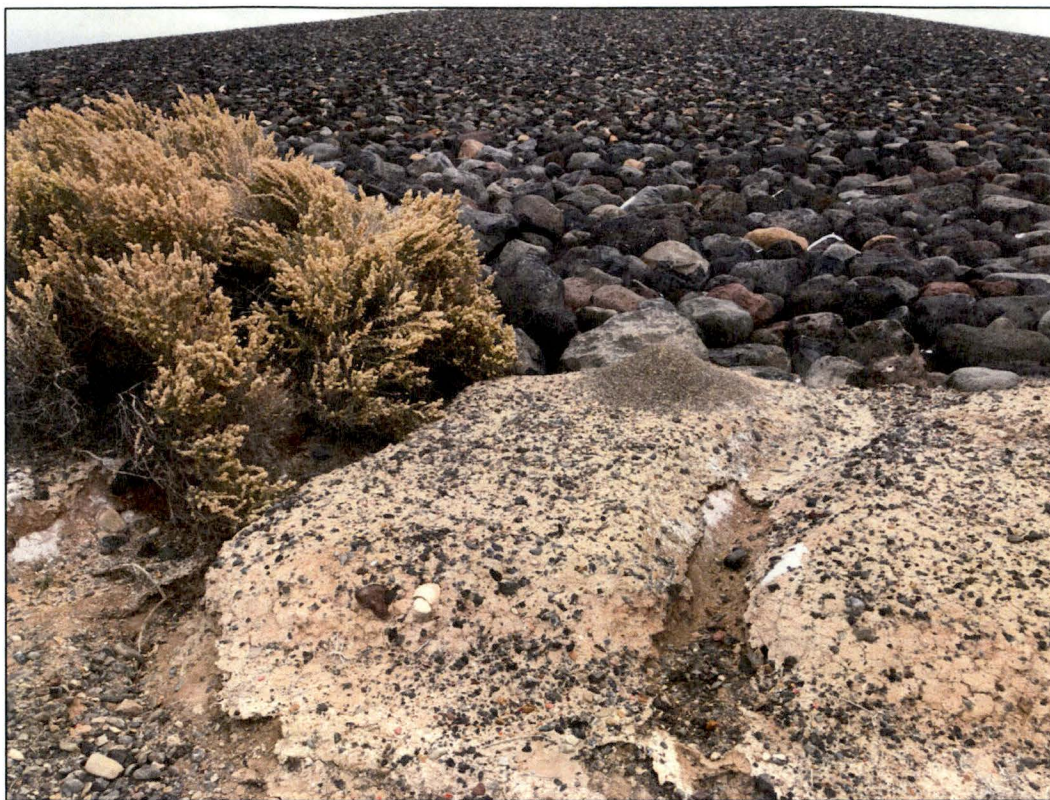
PL-5. Erosion Rills at Base of Southwest Corner of Disposal Cell

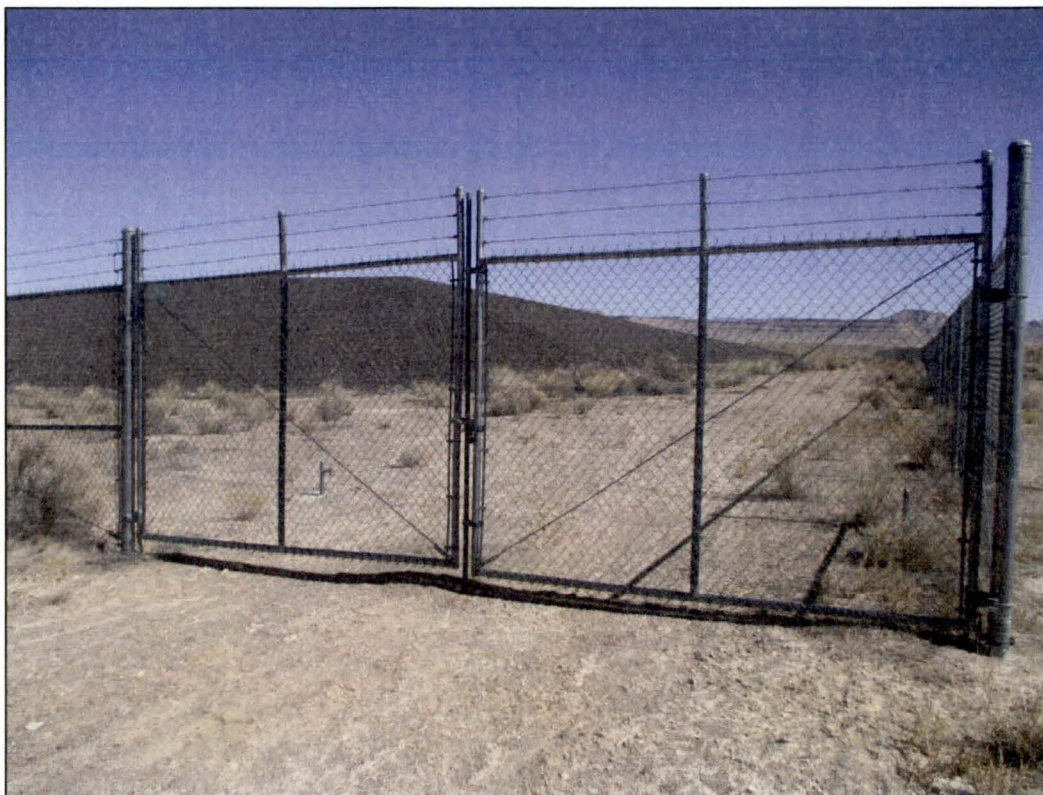
A chain link security fence encloses the portion of the site that contains the disposal cell. Two vehicle gates are at the south and east corners of the security fence line (PL-1), and a personnel gate is at the north corner of the security fence line. The security fence (PL-2) was intact, and the gates were locked.

PL-1. South Vehicle Gate

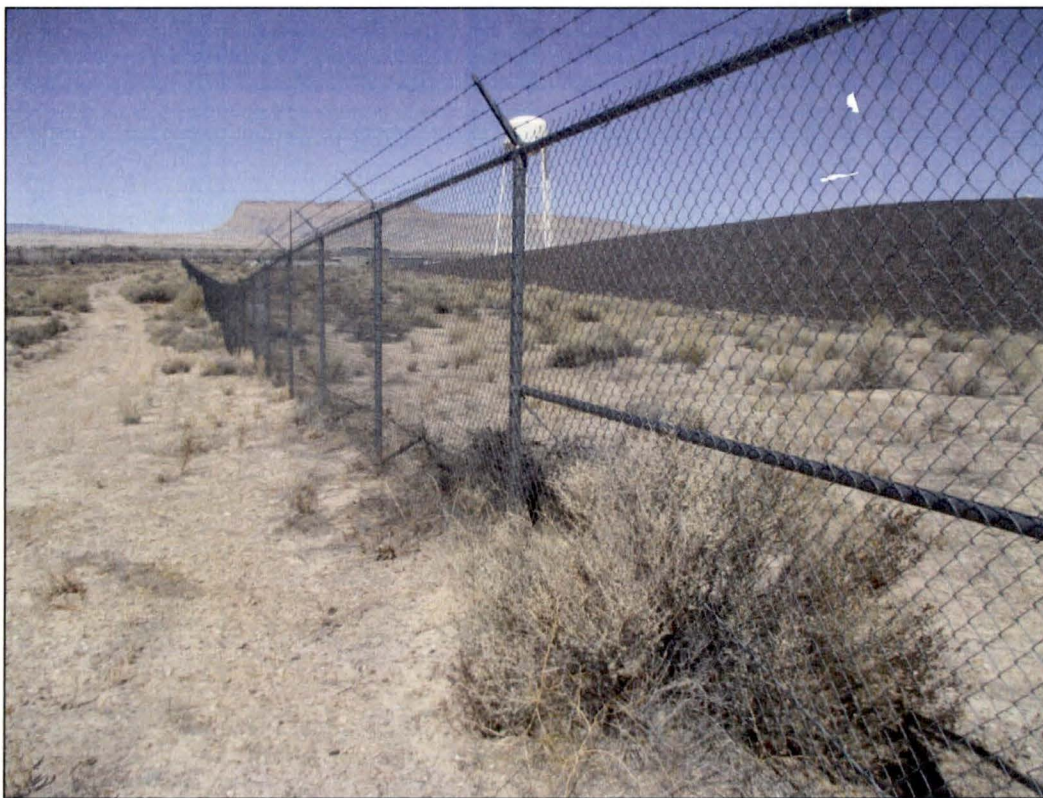
PL-2. Southwest Security Fence (Disposal Cell and Water Tower in Background)

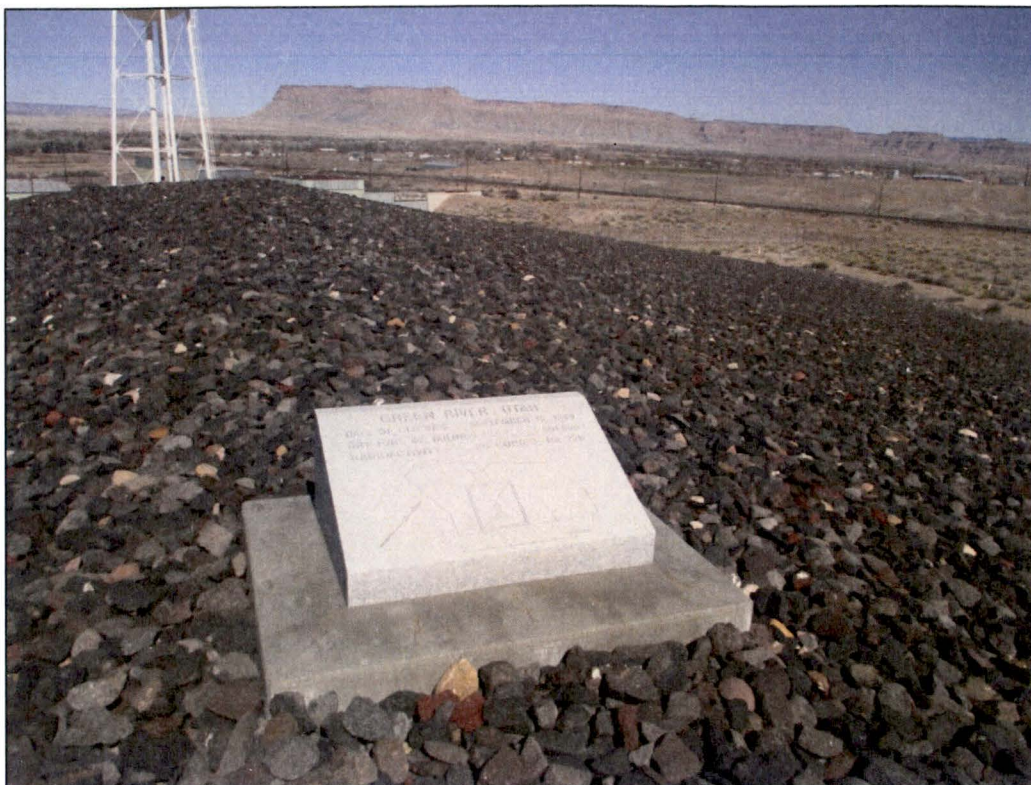
The site has two granite markers. Site marker SMK-1 is inside the security fence near the southwest corner of the site. Its concrete base has several minor cracks, but they do not compromise the integrity of the base, and repairs are not necessary at this time. Site marker SMK-2 is on the crest of the disposal cell (PL-3). No maintenance needs were identified.

PL-3. Site Marker SMK-2

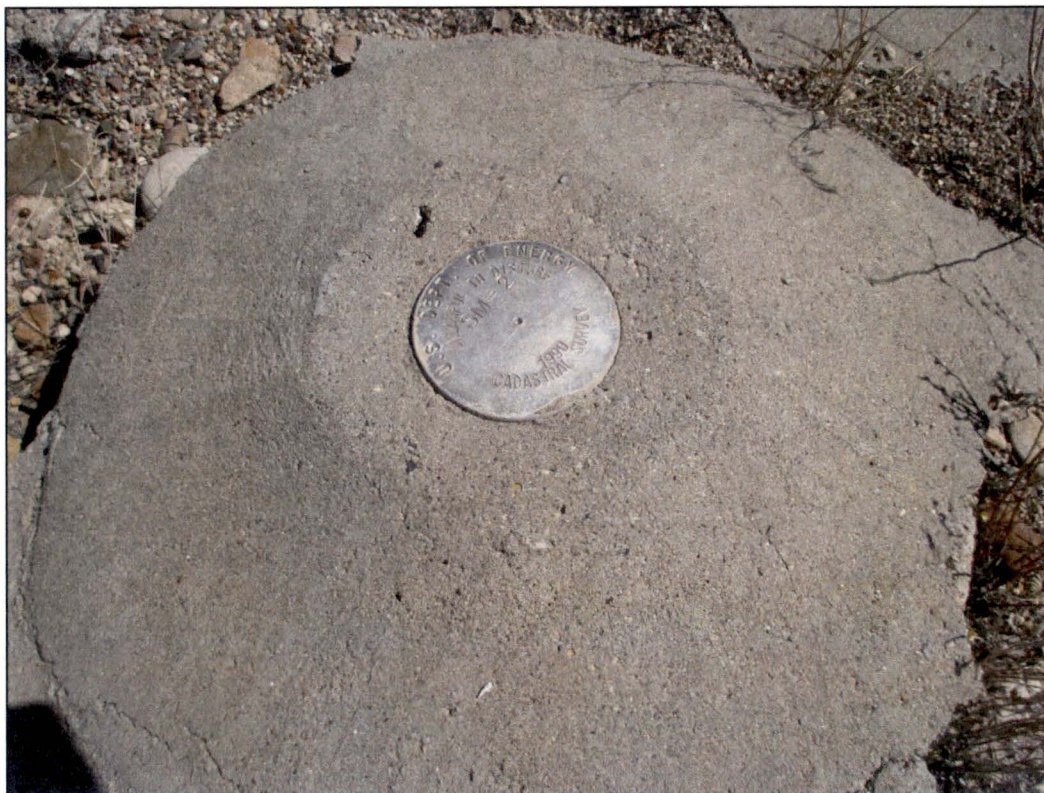
Eleven boundary monuments and three survey monuments (PL-4) delineate the property boundary. Boundary monument BM-5 is damaged (it is bent from being hit by a vehicle), but its condition does not require repair. No maintenance needs were identified.

PL-4. Survey Monument SM-2

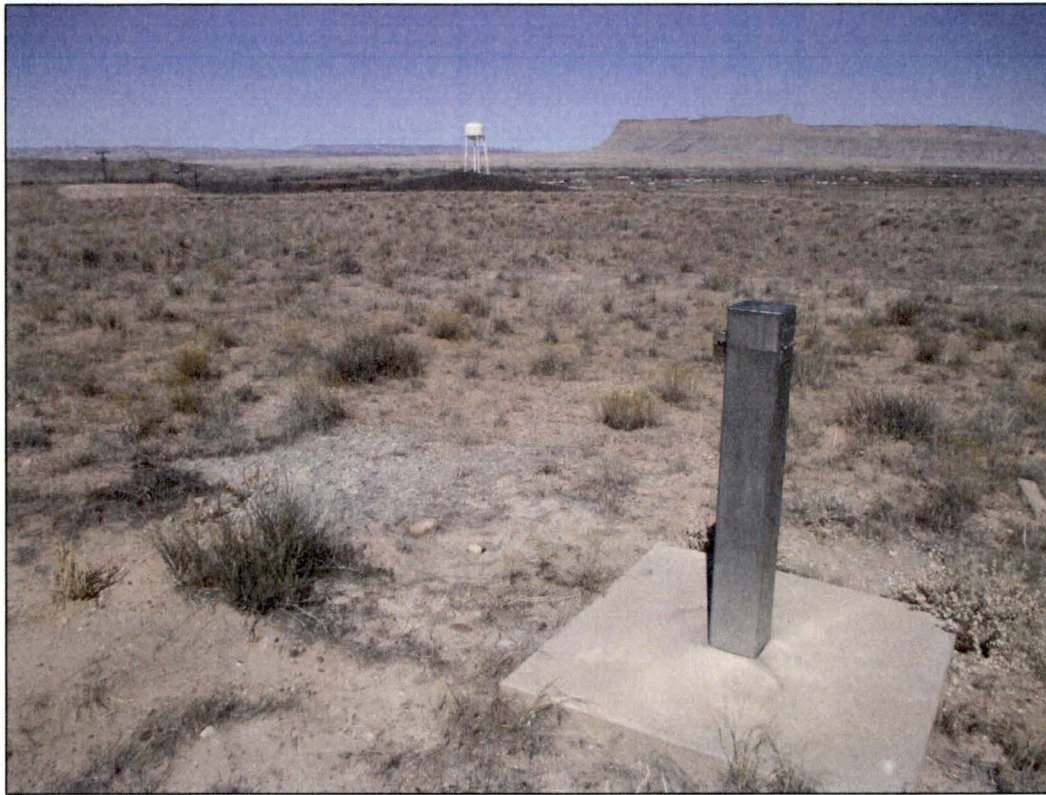
There are 22 monitoring wells on or near the site. Monitoring wells were inspected during the June 2018 sampling event. All wellhead protectors observed during the inspection were undamaged and locked (PL-5). Some of the concrete monitoring well collars are cracked, but the wellhead protectors are stable and repairs are not necessary. No maintenance needs were identified.

PL-5. Monitoring Well 0184 (Disposal Cell in Background)

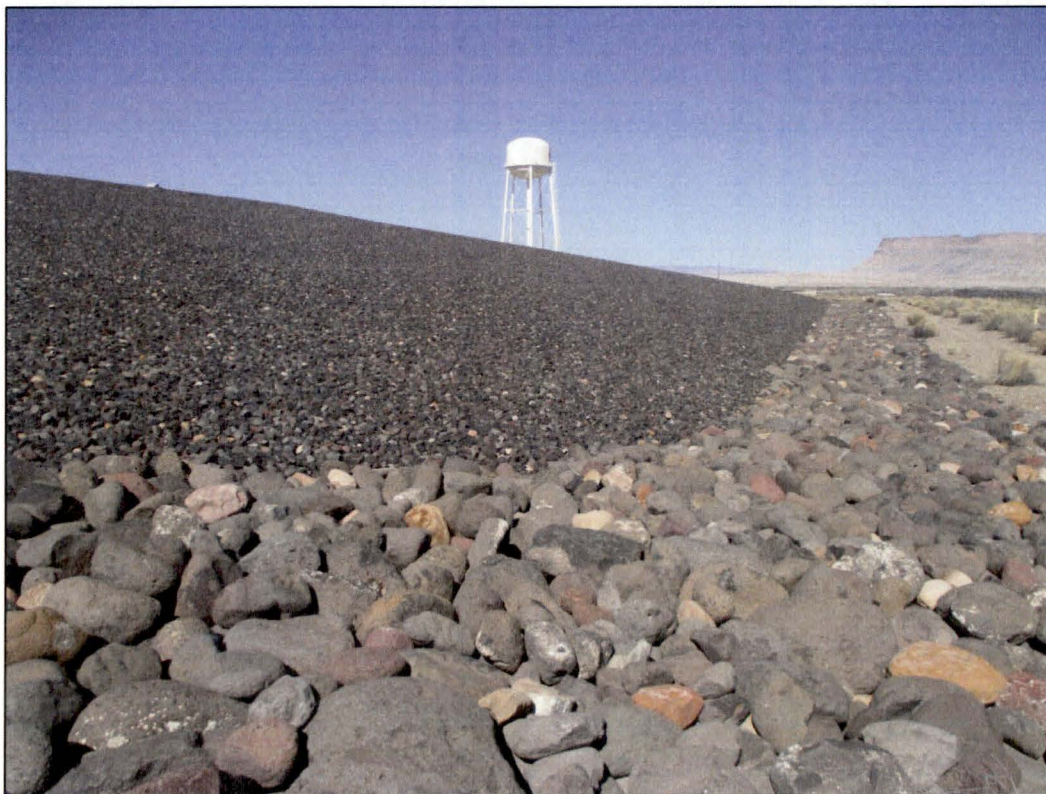
The disposal cell, completed in 1989, occupies 6 acres. The slopes of the disposal cell cover are armored with riprap, consisting primarily of competent basalt with a small fraction of sedimentary rocks, to control erosion (PL-6). A small percentage of the rock, including basalt and sedimentary rock, has degraded, but the riprap cover is functioning as designed. There was no evidence of settling, slumping, erosion, or any other modifying process that might affect the integrity of the disposal cell.

PL-6. Northeast Side Slope and Apron of Disposal Cell
