U.S. DEPARTMENT OF
ENERGY

2018 Annual Site Inspection and Monitoring Report for Uranium Mill Tailings Radiation Control Act Title I Disposal Sites

March 2019

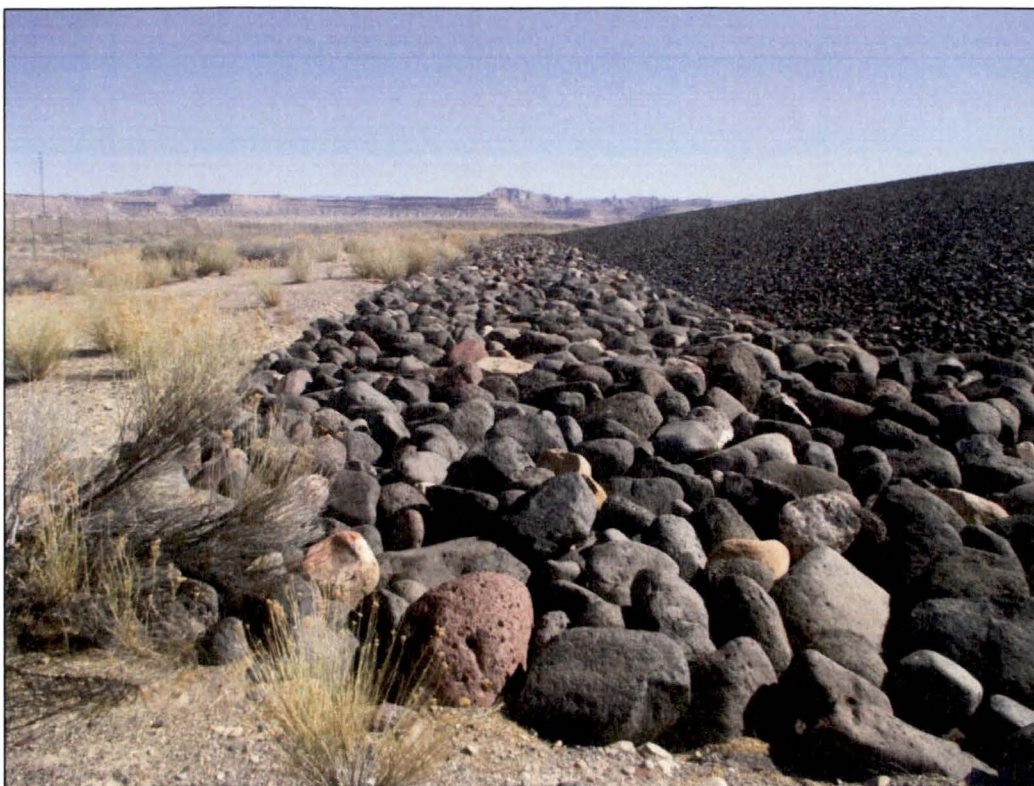
A boulder-filled trench, known as an apron, surrounds the disposal cell (PL-7). The apron was intact and stable, with no observed erosion along the base of the side slopes. Small erosion rills are present along portions of the outside edge of the apron. The rills form as storm water runoff along the disposal cell perimeter road drains into the disposal cell apron. This occurrence is not a concern because the erosion is minor and sedimentation in the apron has not adversely affected the performance of the apron (the sediment has not filled the apron or become visible in the apron). Inspectors will continue to monitor the area.

PL-7. Apron Along Northwest Side of Disposal Cell

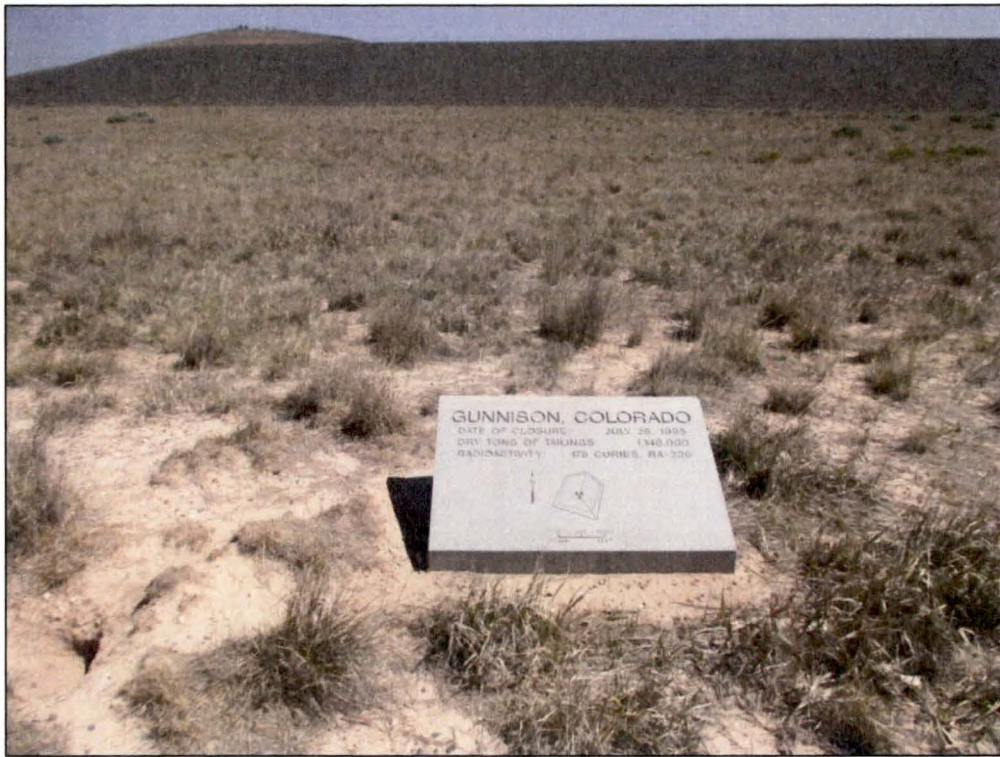
PL-3. Site Marker SMK-1

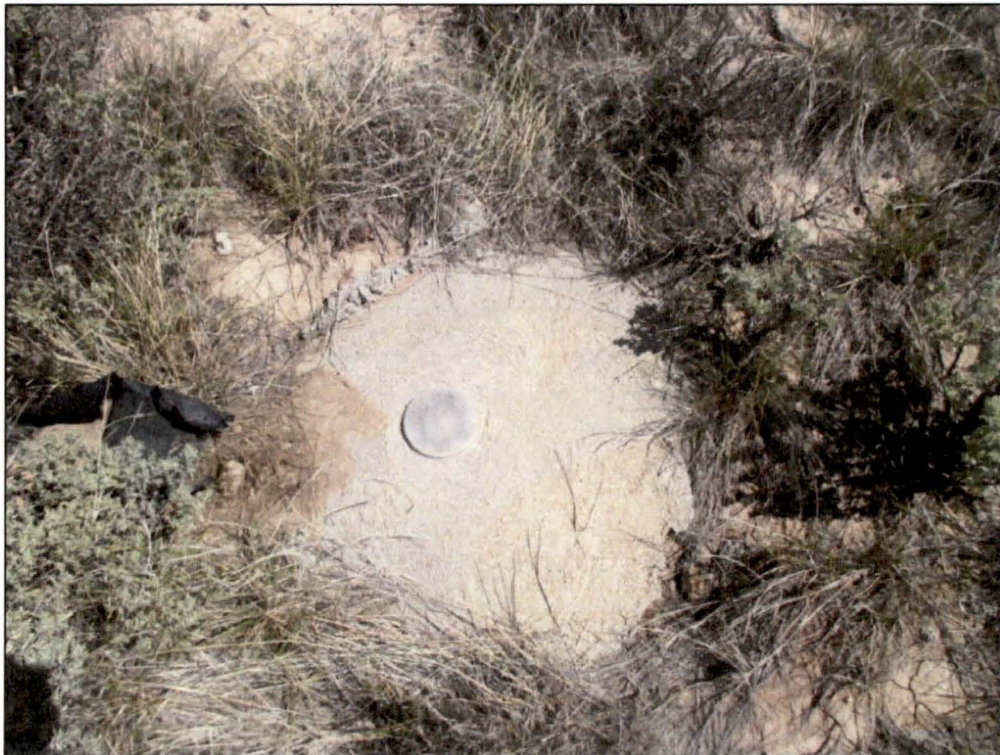
Three combined survey and boundary monuments and eight additional boundary monuments delineate the property boundary (PL-4). No maintenance needs were identified.

PL-4. Boundary Monument BM-7

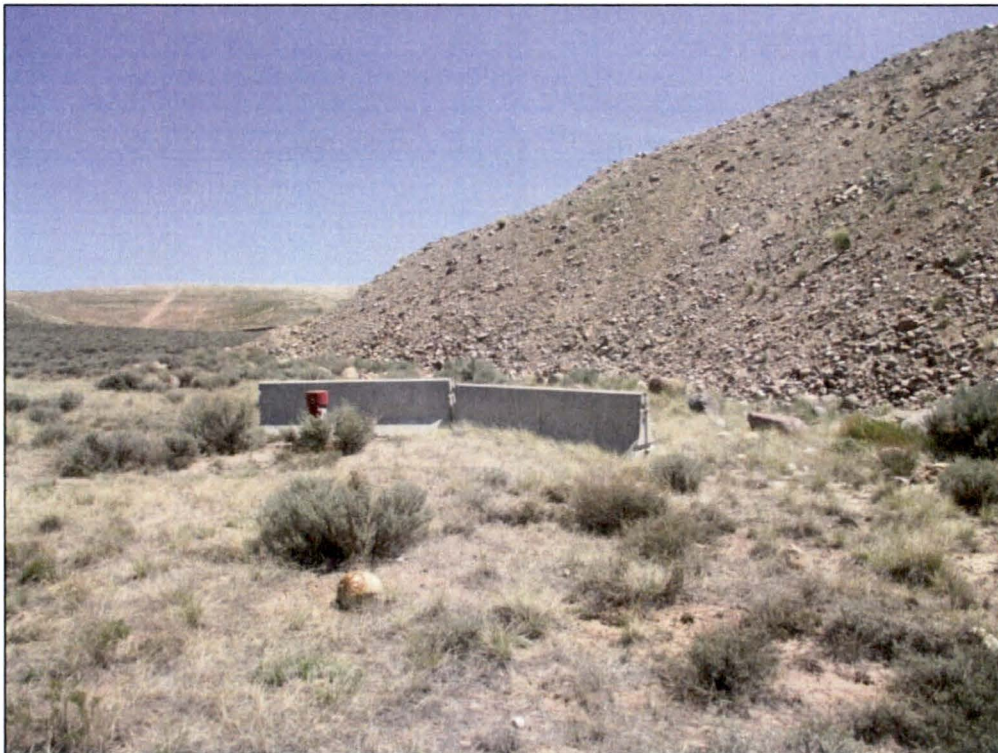
The area beyond the site boundary for a distance of 0.25 mile was visually observed for erosion, changes in land use, or other phenomena that might affect the long-term integrity of the site. Gunnison County owns the land that adjoins the site boundary to the north and east and uses the land for a municipal landfill. The nearest landfill operations continue to be approximately 400 feet north of the site. Although landfill activities do not impact the site, inspectors will continue to monitor the level of activity occurring near the site boundary and surveillance features (e.g., fences and monitoring wells). With regard to groundwater flow, the landfill operations are upgradient from the disposal cell. The proximity of the spoil pile to monitoring well 0716 (see Figure 8-1) is the only current concern for activities that could impact a site asset. Inspectors will continue to monitor this area.

PL-6. Monitoring Well 0716 and County Landfill Spoil Pile

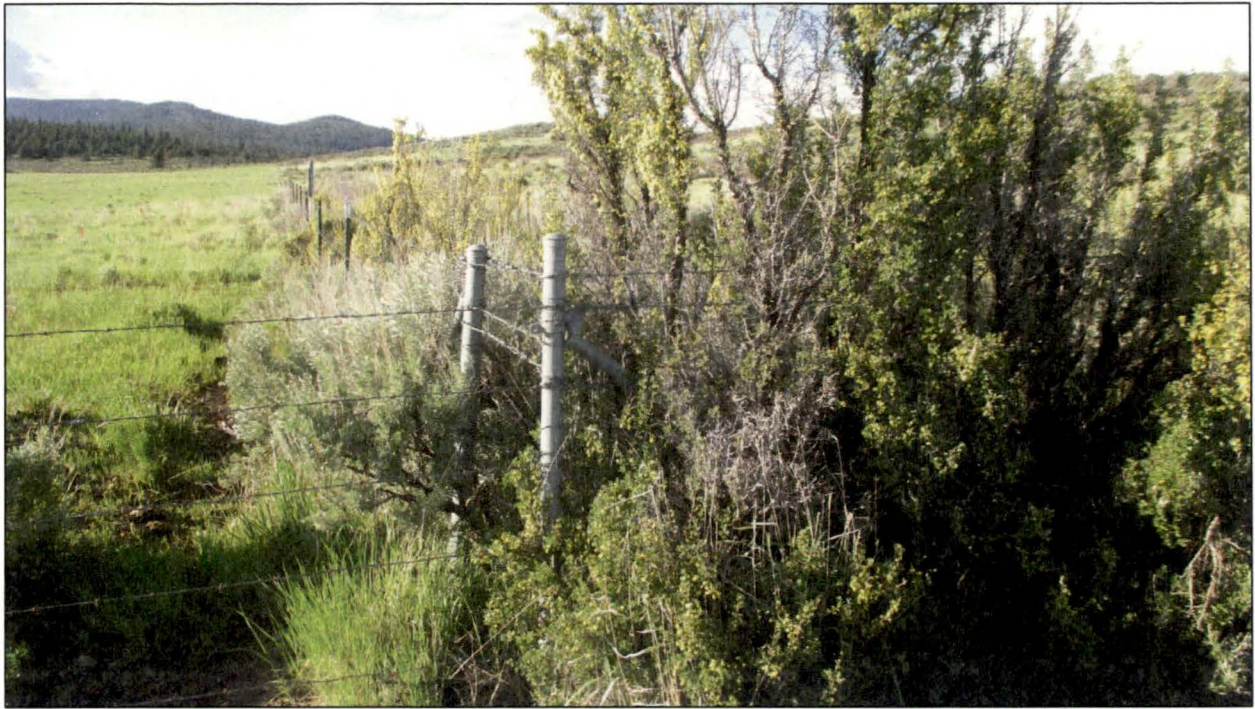
PL-3. Southwest Corner of Fence with Detached Bracket and Encroaching Vegetation

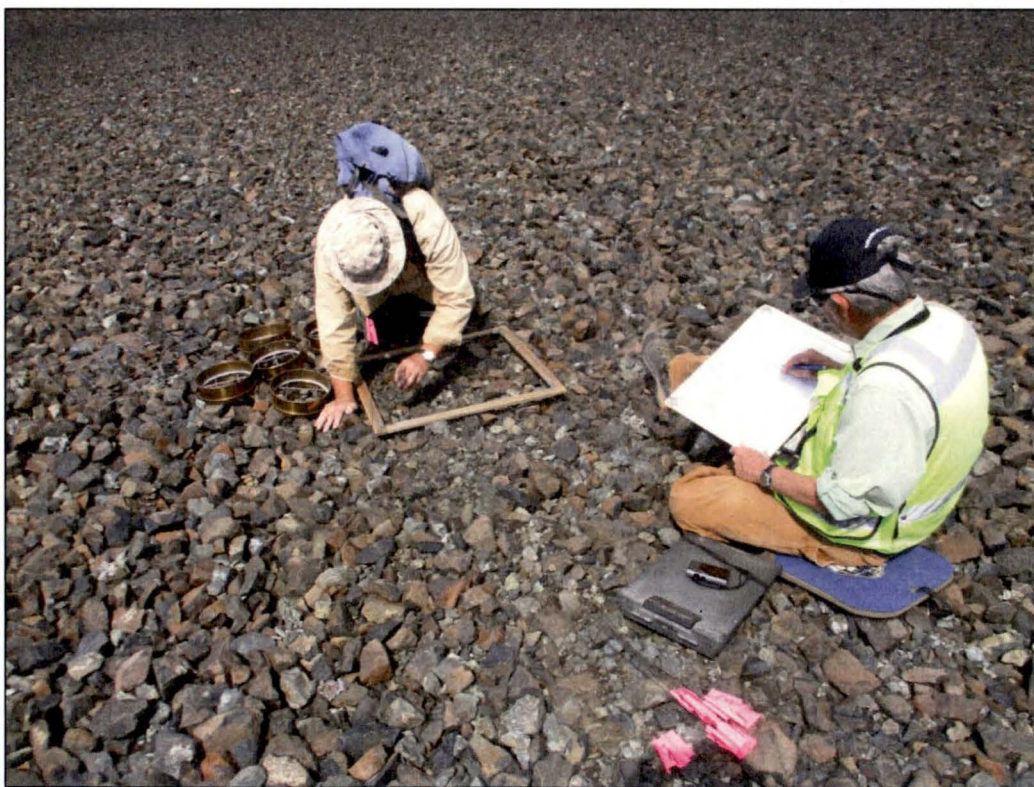
PL-10. Rock Riprap Gradation Monitoring on West Side Slope of Disposal Cell

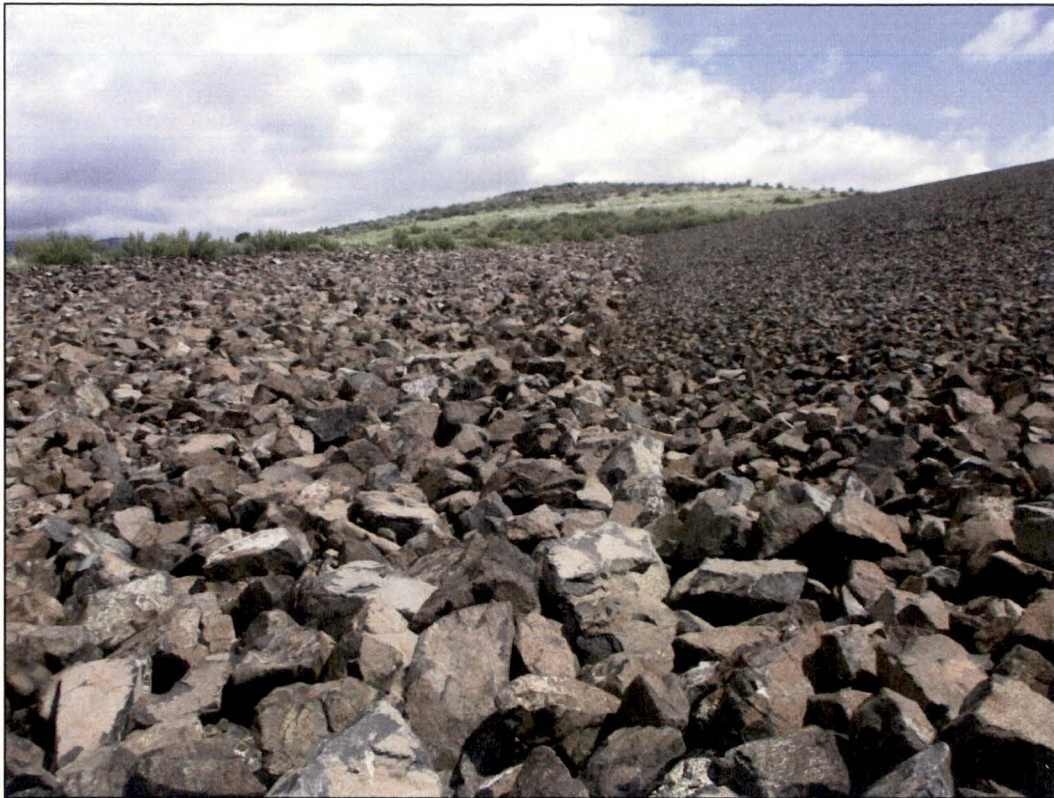
PL-11. Intersection of West Side Slope with Energy Dissipation Area

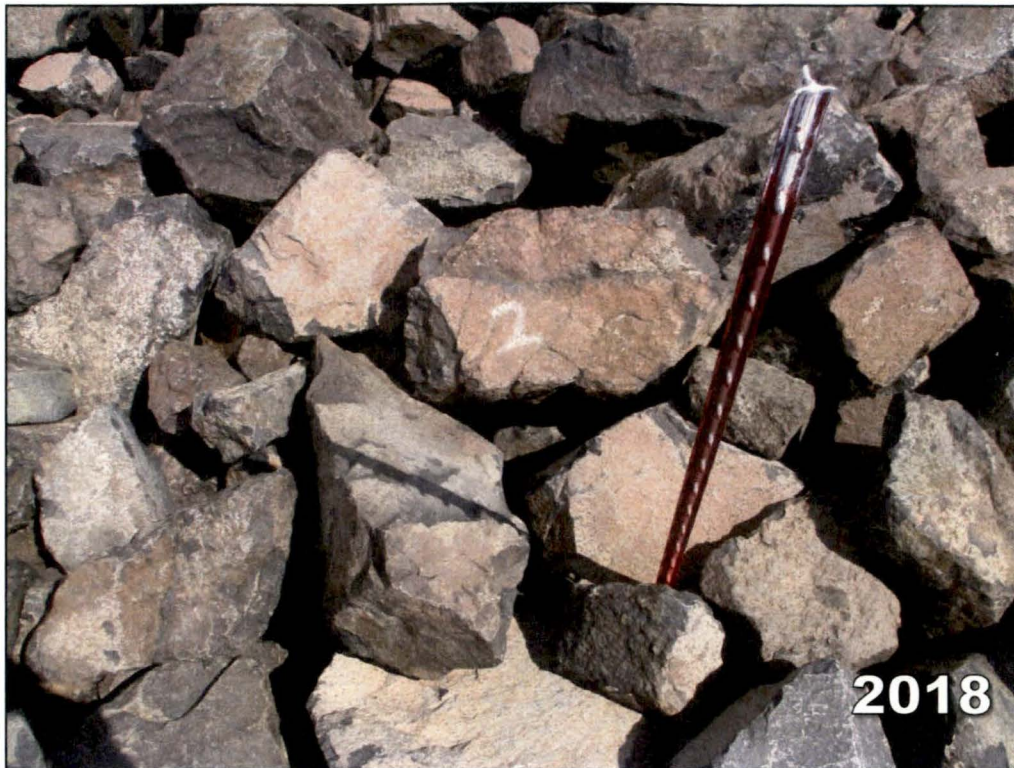
PL-12. (a) Riprap Monitoring Location Number 2 in Energy Dissipation Area–2018

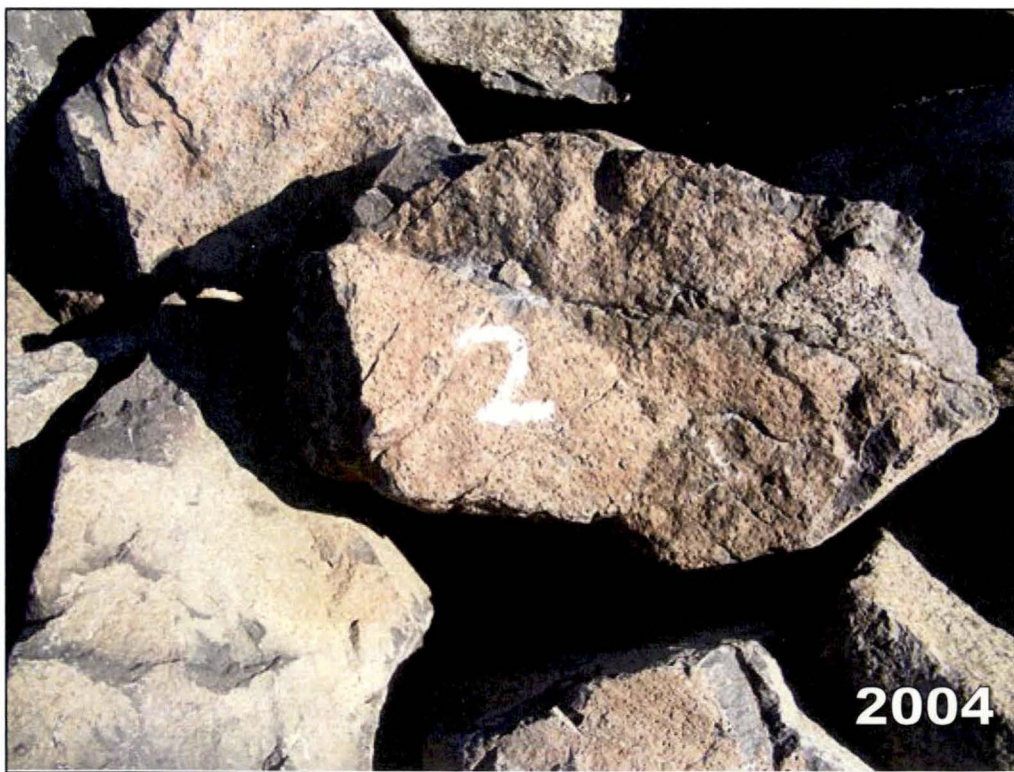
PL-12. (b) Riprap Monitoring Location Number 2 in Energy Dissipation Area–
2004 Photo for Comparison

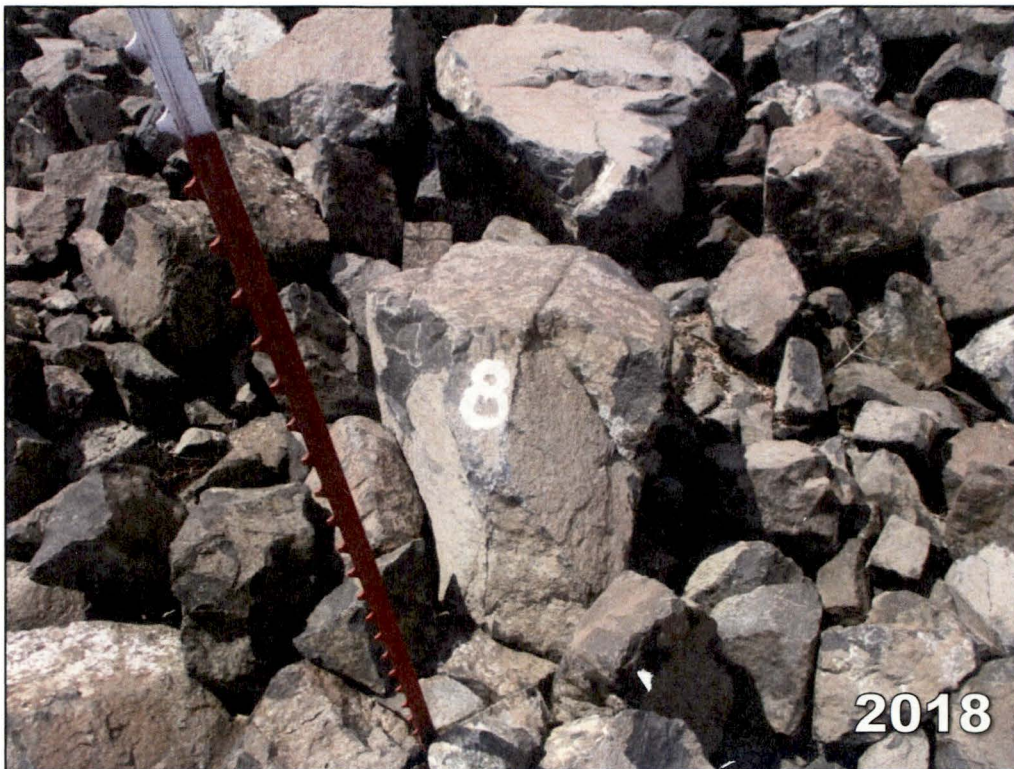
PL-13. (a) Riprap Monitoring Location Number 8 in Energy Dissipation Area–2018

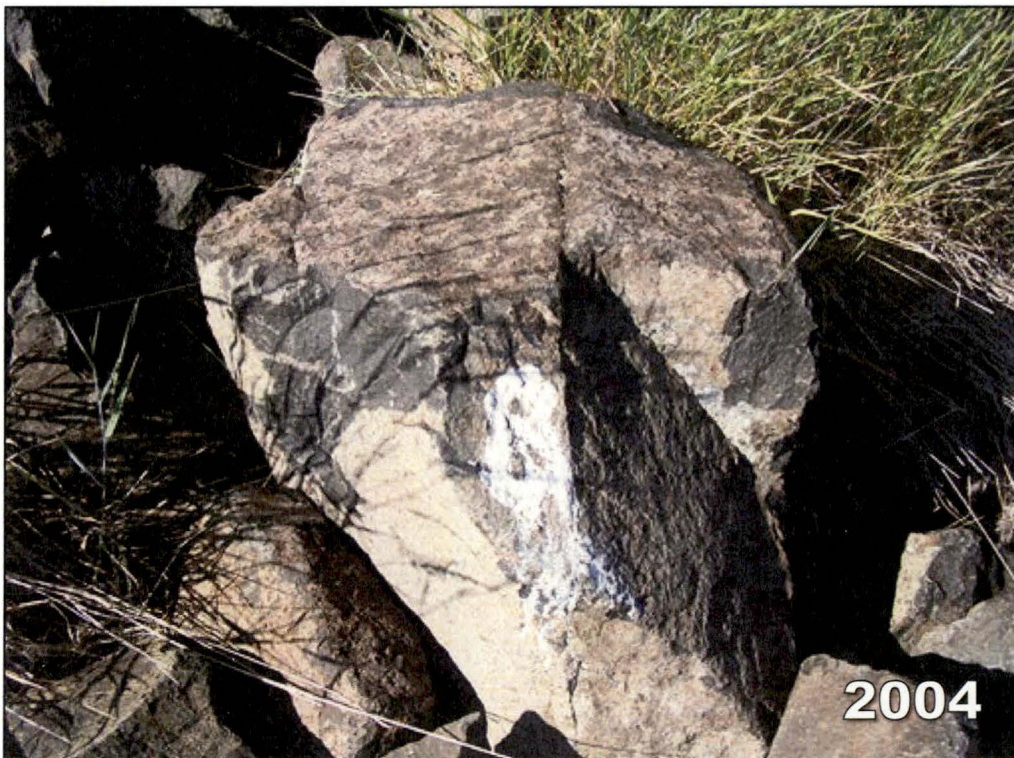
*PL-13. (b) Riprap Monitoring Location Number 8 in Energy Dissipation Area–
2004 Photo for Comparison*

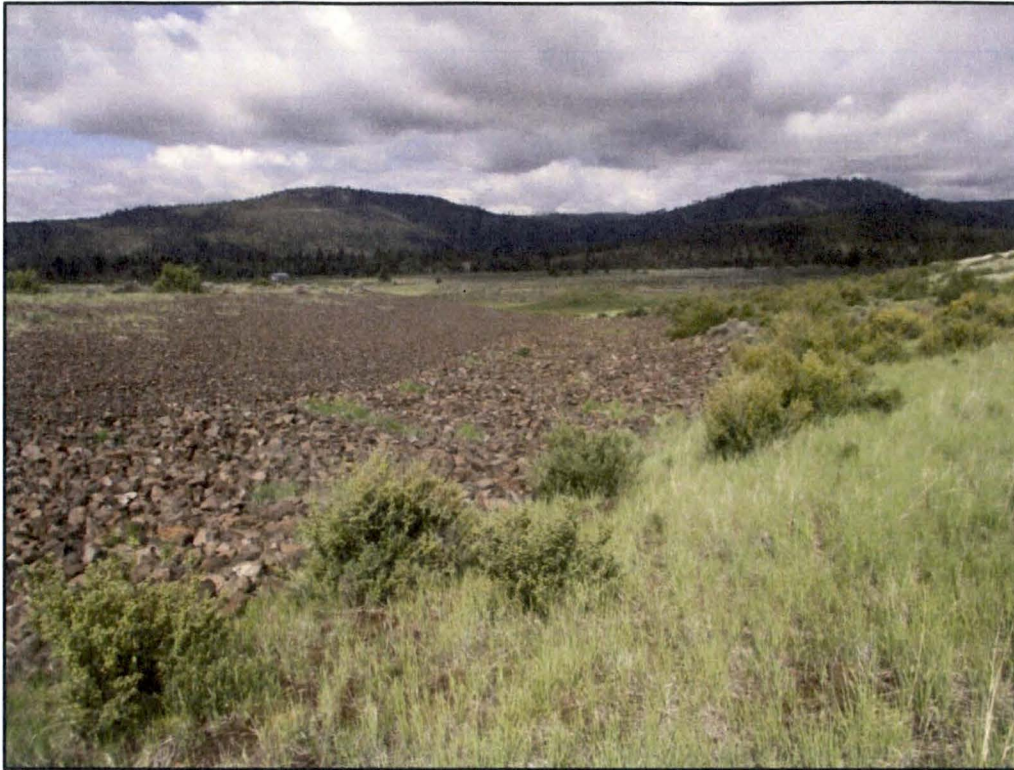
PL-14. Diversion Channel North of Disposal Cell

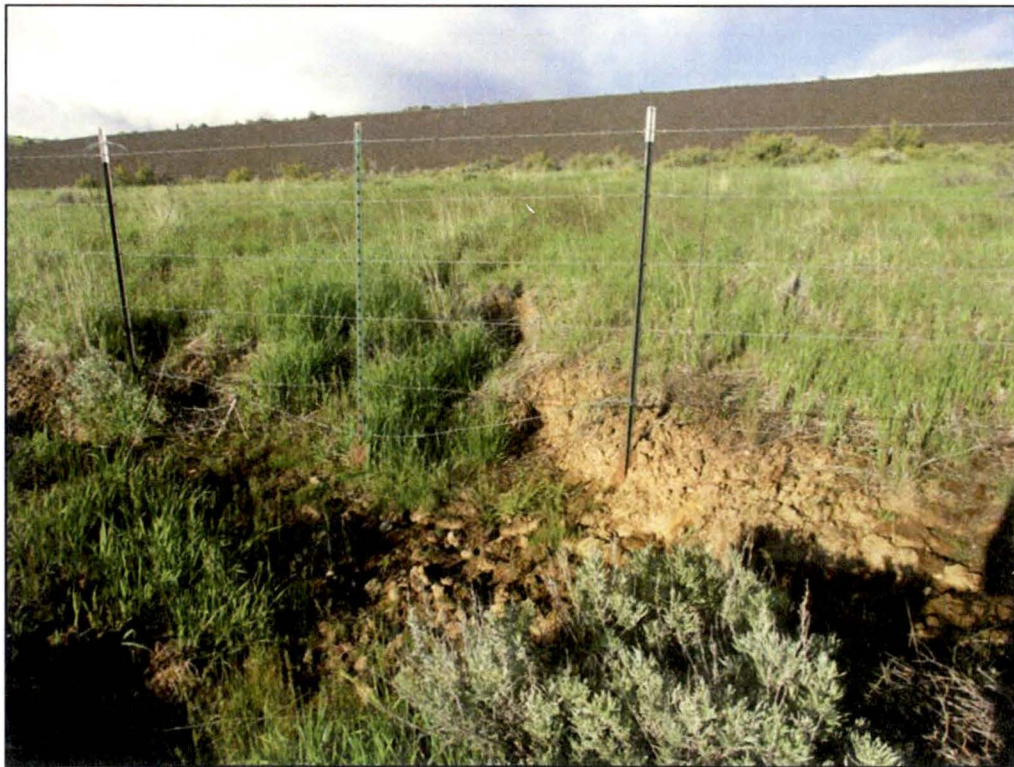
PL-15. Small Gully Along Perimeter Fence Downgradient of Apron Toe Drain No. 3

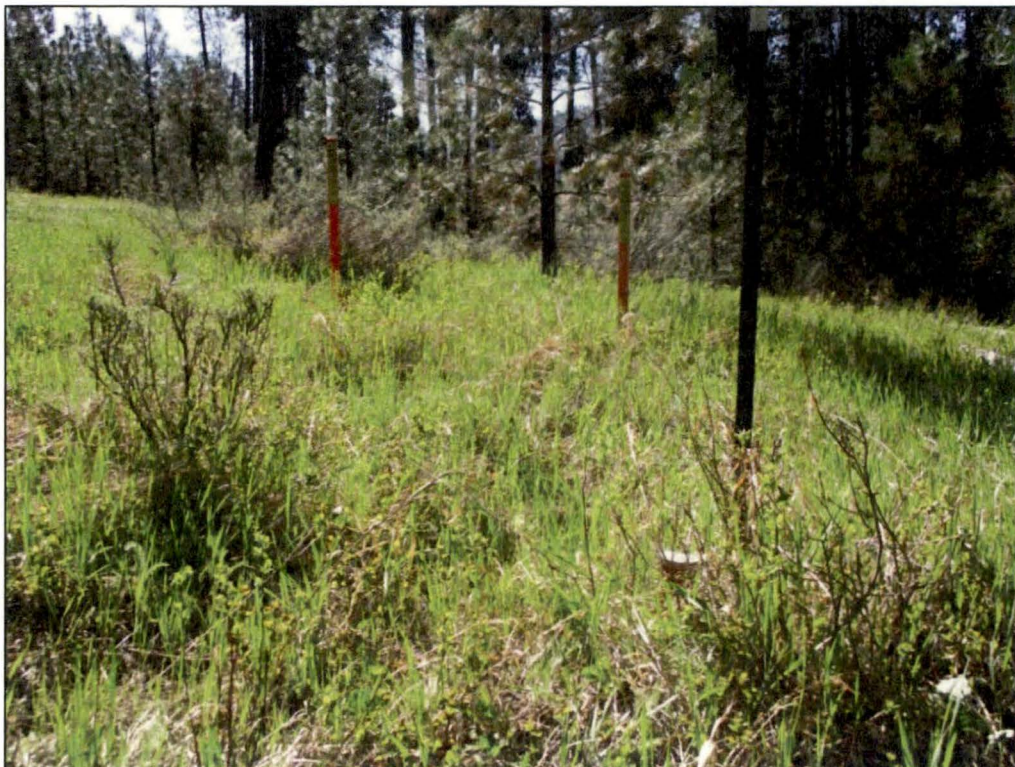
Three combined survey and boundary monuments and four boundary monuments delineate the property boundary. Steel T-posts are installed next to the survey and boundary monuments to help inspectors find the monuments. Several years ago, the U.S. Department of Agriculture (USDA) conducted a survey of its lands and placed its own boundary monuments along the shared DOE-USDA border, and inspectors noted that the USDA survey monuments were about 5 to 15 ft outside the DOE survey monuments (PL-3). No maintenance needs were identified.

PL-3. DOE's Boundary Monument BM-5 in Foreground and USDA Boundary Markers in Background, About 12 Feet Apart

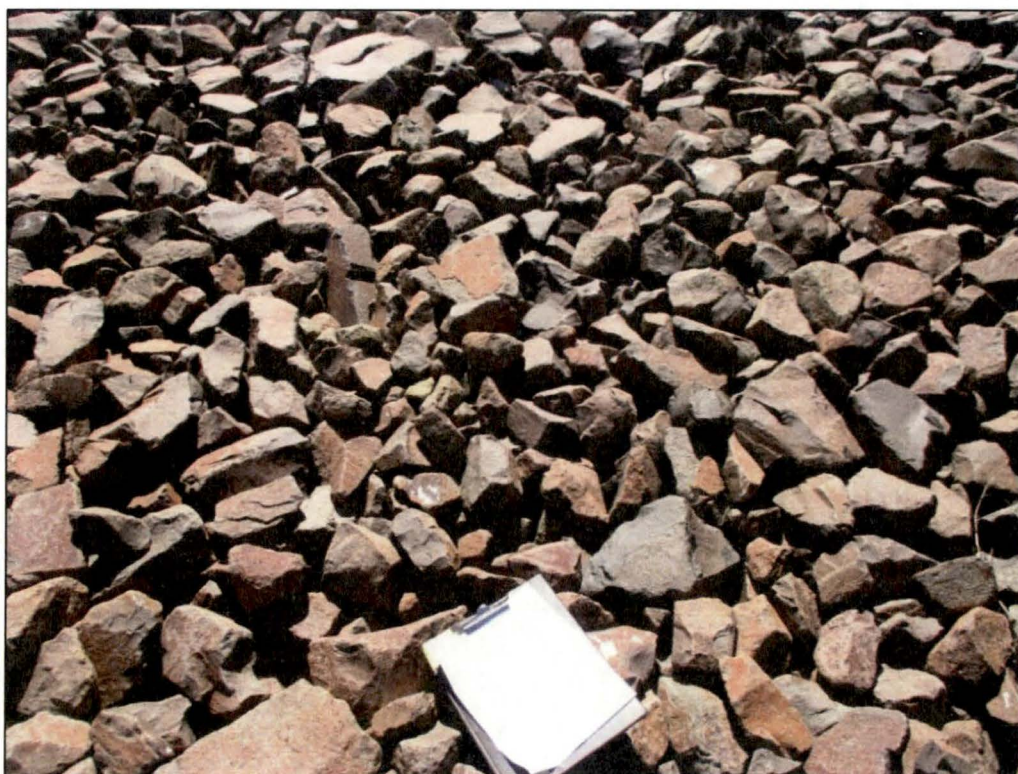
The disposal cell, completed in 1991, occupies 8.29 acres. The disposal cell top and side slope are armored with basalt riprap to control erosion (PL-4). An apron of larger riprap surrounds the disposal cell on all sides (PL-5). There was no evidence of erosion, settling, slumping, rock degradation, or other modifying processes that might affect the integrity of the disposal cell.

PL-4. Riprap Armoring on Disposal Cell Side Slope (Close-Up)

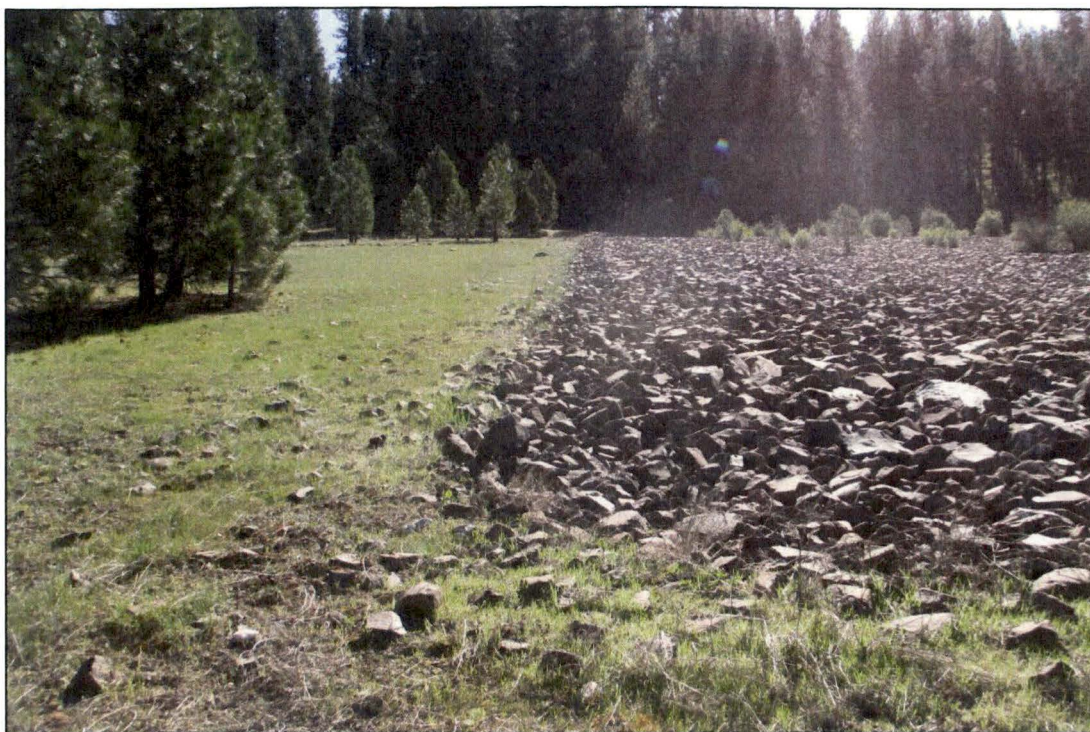
PL-5. Apron Along North Side of Disposal Cell

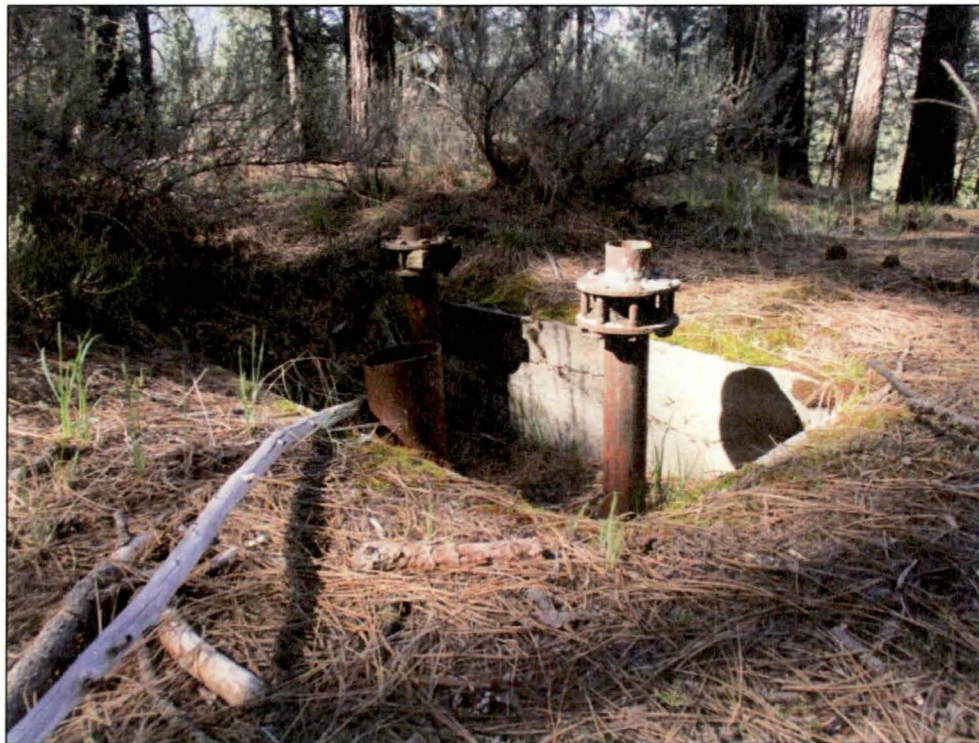
PL-8. Remnants of Concrete Structure and Piping Associated with Former Mill

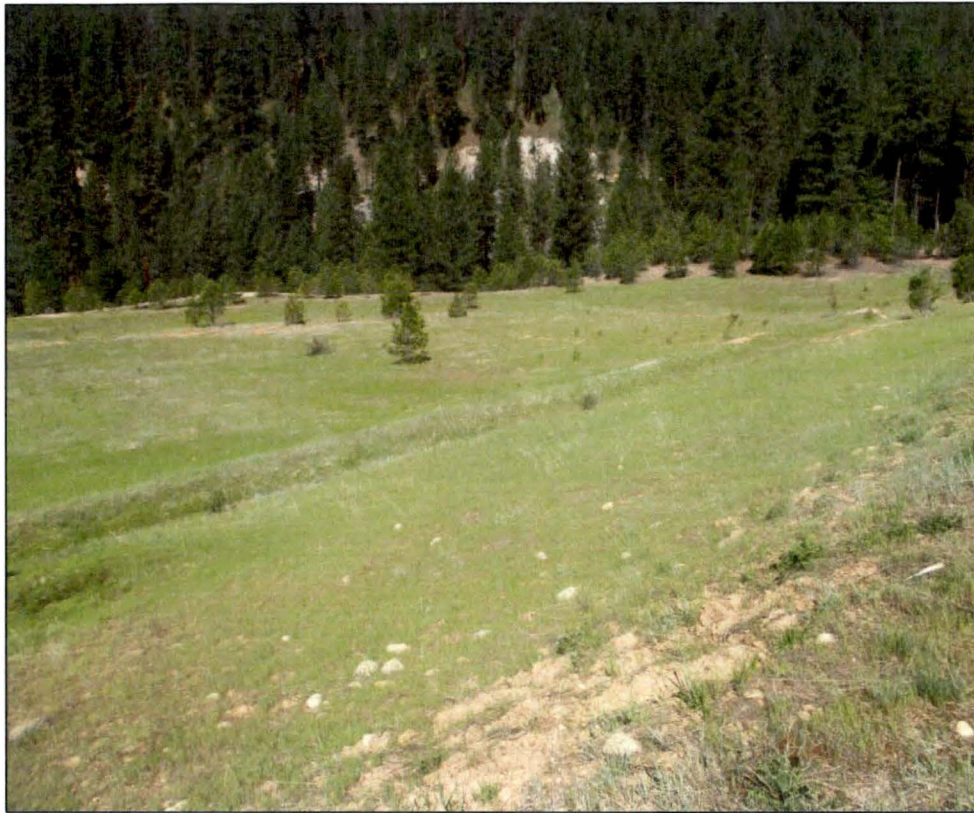
PL-9. Interceptor Bench 1

Over the years, minor erosion has breached the benches in several locations, and LM has conducted repairs on numerous occasions, most recently in October 2016. The three interceptor benches (PL-9) and collection ditch (PL-10) are inspected annually to ensure that erosion in this area does not affect overall site stability. In 2018, inspection of the 2016 repairs showed they remain intact, and LM will continue to inspect as the vegetation continues to establish (PL-11).

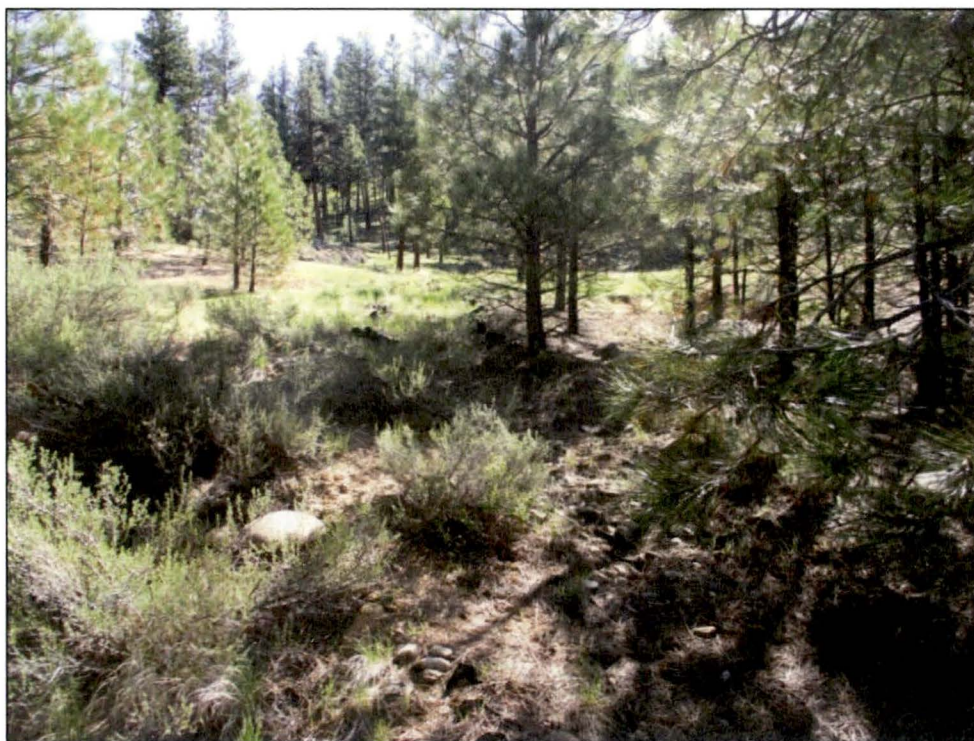
PL-10. View Downslope of Collection Ditch Just Above Interceptor Bench 1
