METALLURGICAL INVESTIGATION OF CRACKING IN A REACTOR VESSEL NOZZLE SAFE-END

FINAL REPORT

SwRI Project 02-5389-001

To
Iowa Electric Light and Power Co.
IE Tower
200 First Street S.E.
Cedar Rapids Iowa 52406

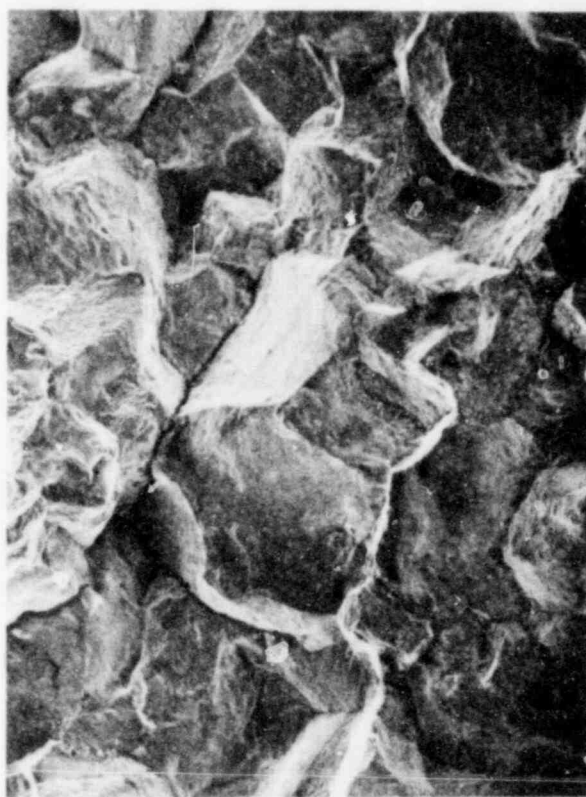
The crack surfaces of all three specimens were characterized by distinct intergranular facets at all locations examined. Figures 4-9, E-1 and E-4 are representative of the fractographic features observed at the intersection of the crack surface with the inside surface of the safe-end. The crack surface was completely intergranular along this edge and there were no features to identify any discrete initiation sites. The features of the crack front, at locations where partial penetration occurred are shown in Figures E-3 and E-5. The transition from the service-induced crack to the laboratory overload fracture is apparent and in each case, intergranular features are evident at the extremities of the crack.

FIGURE 4-9. SEM FRACTOGRAPH FROM CRACK SURFACE, Specimen No. 1, Location 1, Figure 4-8(a).

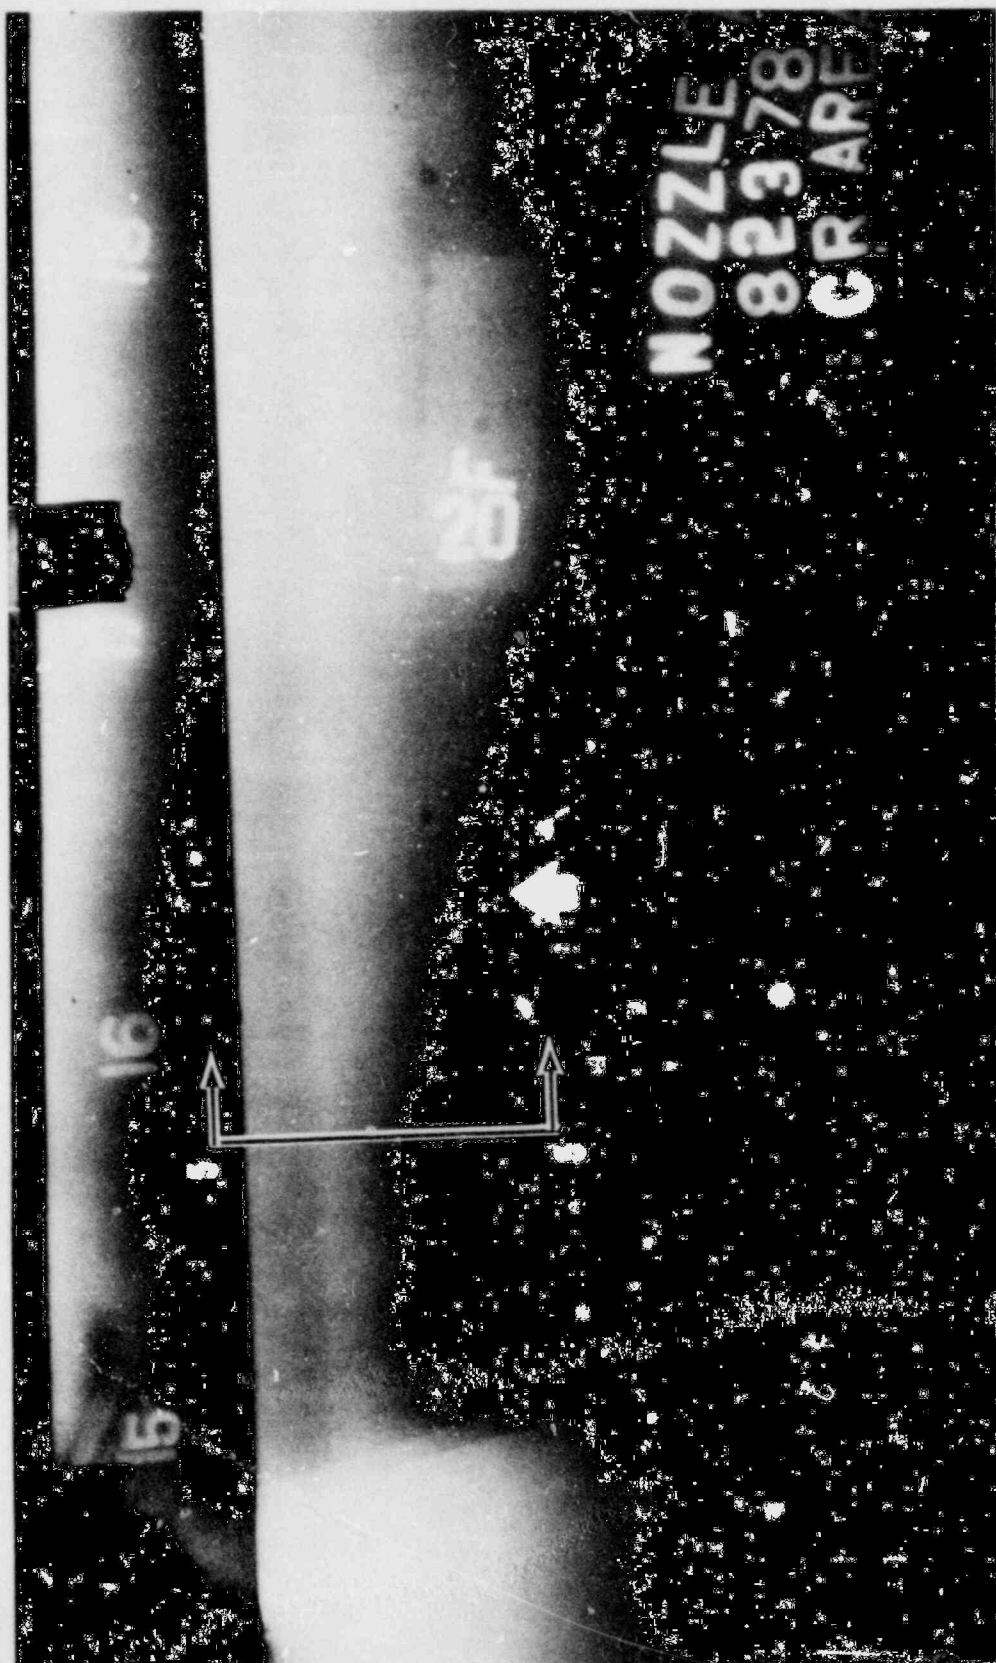
A radiographic inspection of the safe-end was performed on site at the Duane Arnold Energy Center after removal of the safe-end sample from the reactor vessel. This inspection identified major cracking over approximately 280° of the circumference. No identifiable crack indications were noted in the region extending from 270° to 345°. Copies of representative portions of the radiographs are included in Appendix A.

FIGURE A-3. SAFE-END RADIOGRAPH. Stations 15 to 18. See Figure 1-4 for location. Section markers indicate location of metallographic sections. Block arrow indicates direction toward vessel.

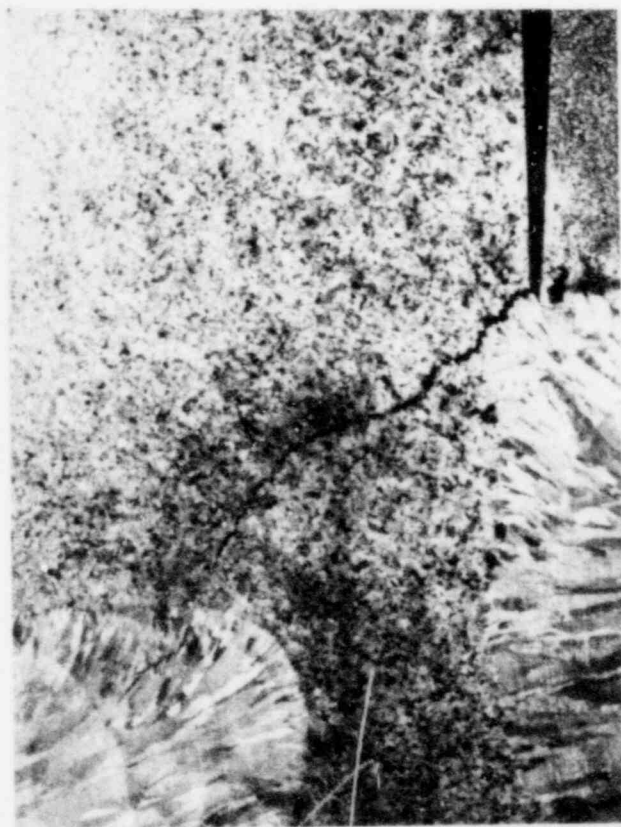
the later stages of cracking propagated through the repair weld, see Figures 2-2, B-1(b), B-1(c) and B-1(d). In the zone from approximately 75° to 125° crack propagation occurred completely within the safe-end base metal and penetrated the outside surface adjacent to the fusion line of the repair weld, (Figure 2-3).

FIGURE B-1. LONGITUDINAL SECTIONS AT THERMAL
SLEEVE ATTACHMENT. See Figure 1-4
for locations.

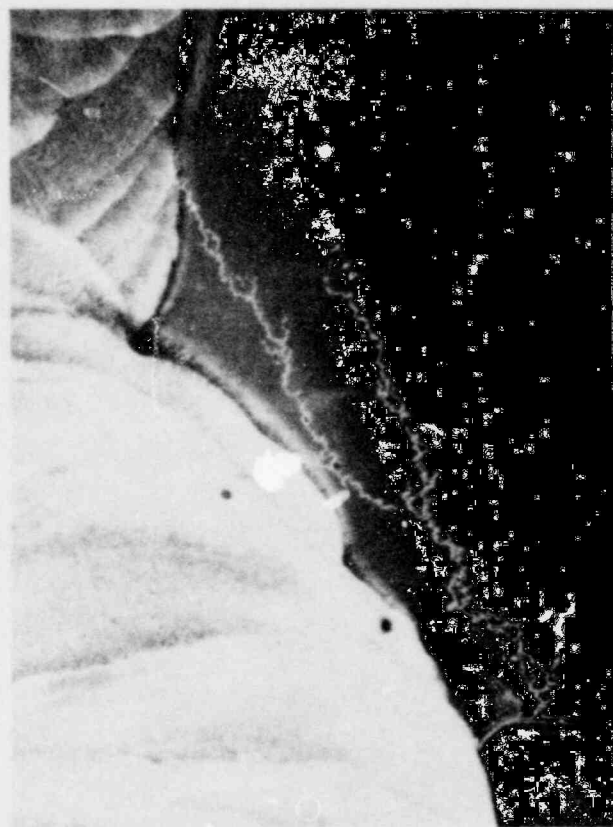
FIGURE B-2. LONGITUDINAL SECTIONS AT THERMAL SLEEVE ATTACHMENT.
See Figure 1-4 for locations.

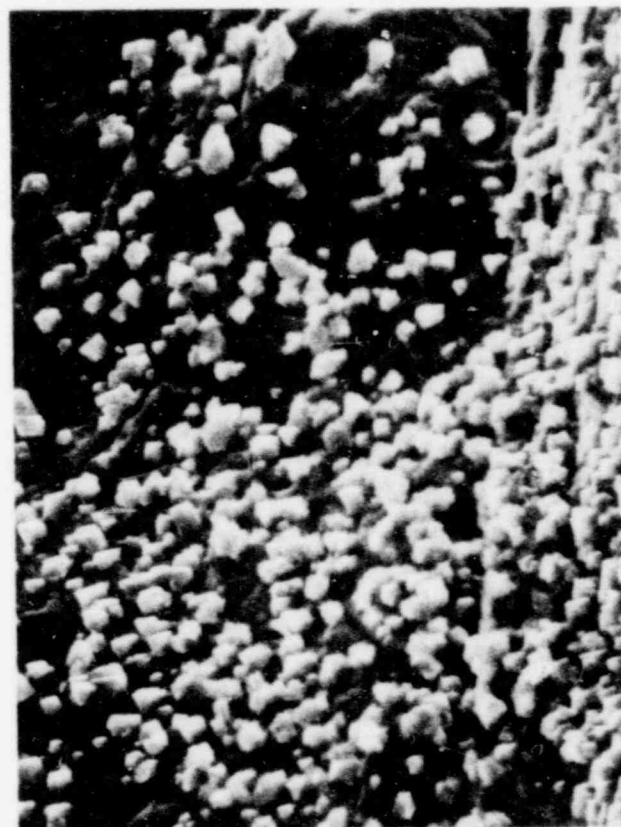
FIGURE E-1. SEM FRACTOGRAPHS FROM CRACK SURFACE.
Specimen No. 2, Location 1, Figure
4-9(b).
