Humboldt Bay
Independent Spent Fuel Storage Installation
Site-Specific License Renewal Application

Pacific Gas and Electric Company

Revision 4 November 2019

NRC Docket No. 72-27

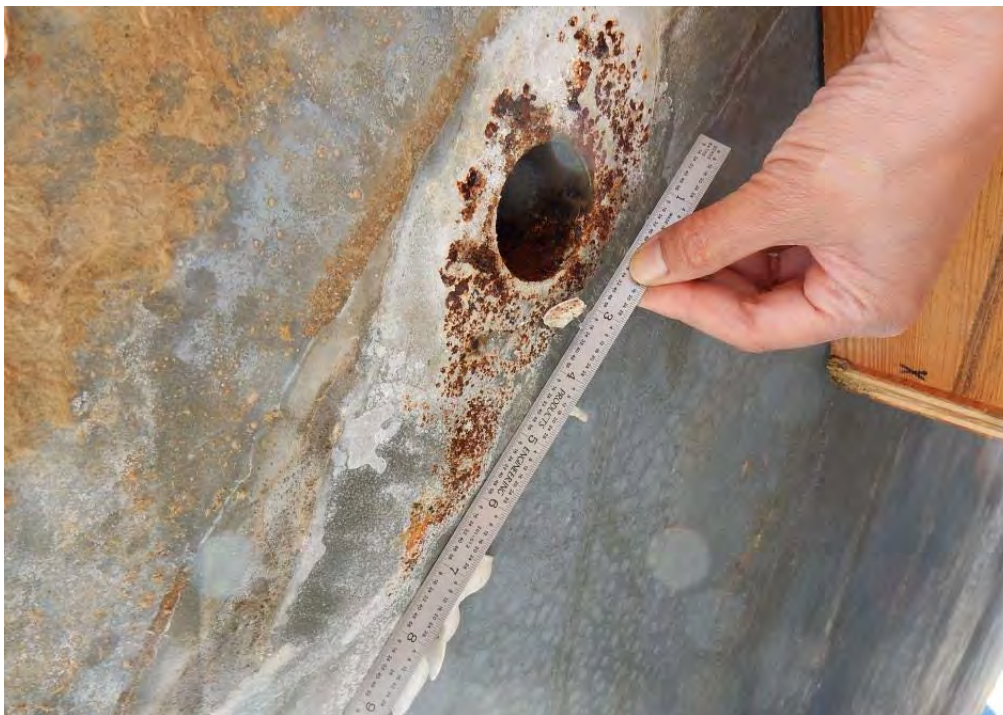
7. Underside hole #3 showing corrosion prior to cleaning

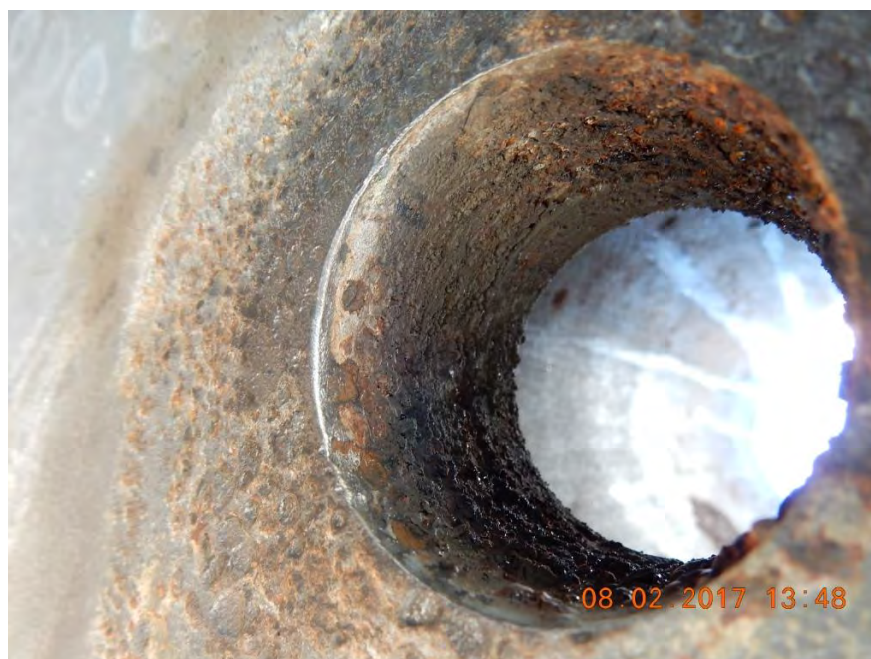
10. Hole #5 after cleaning

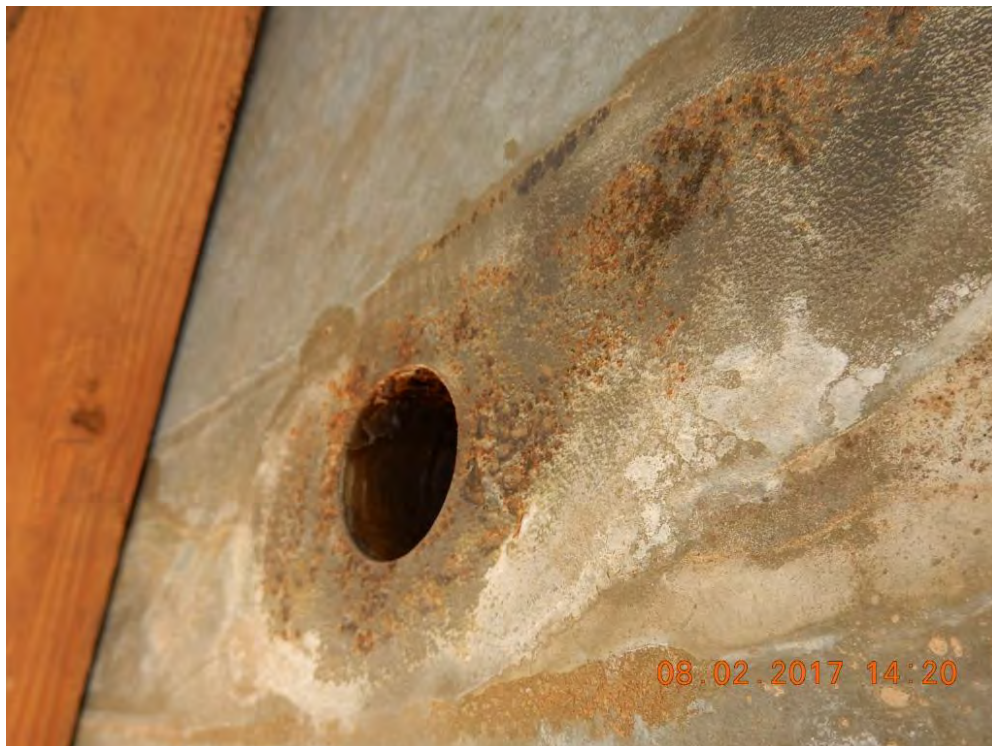
11. Hole #3 after cleaning

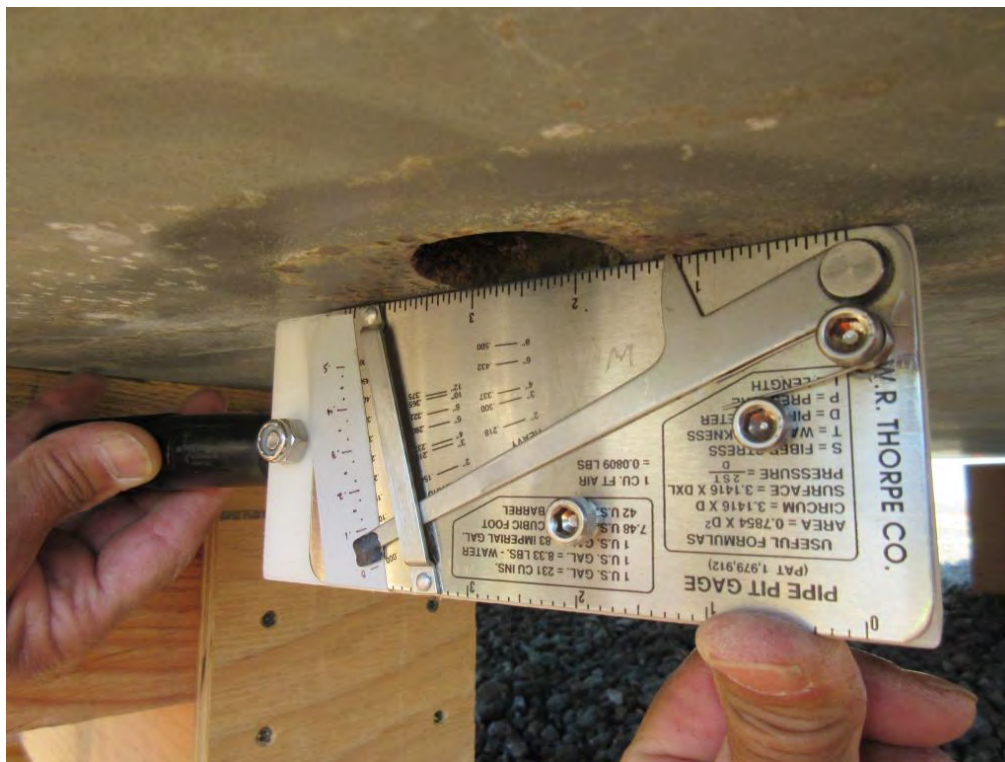
12. Measuring pit depth <1/16"

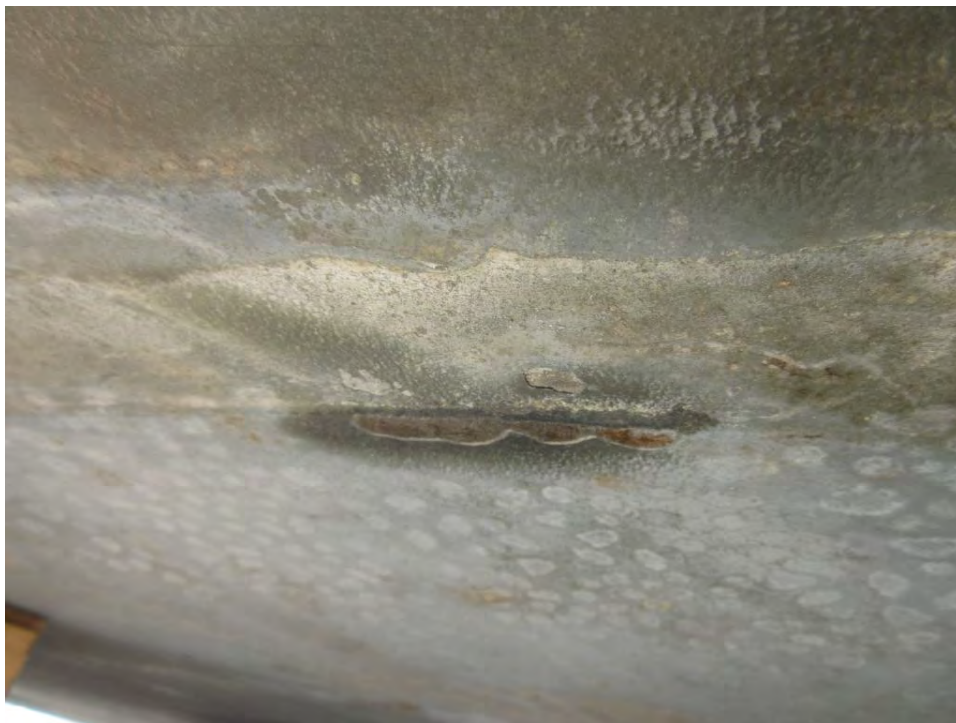
13. Coating chip on underside of lid

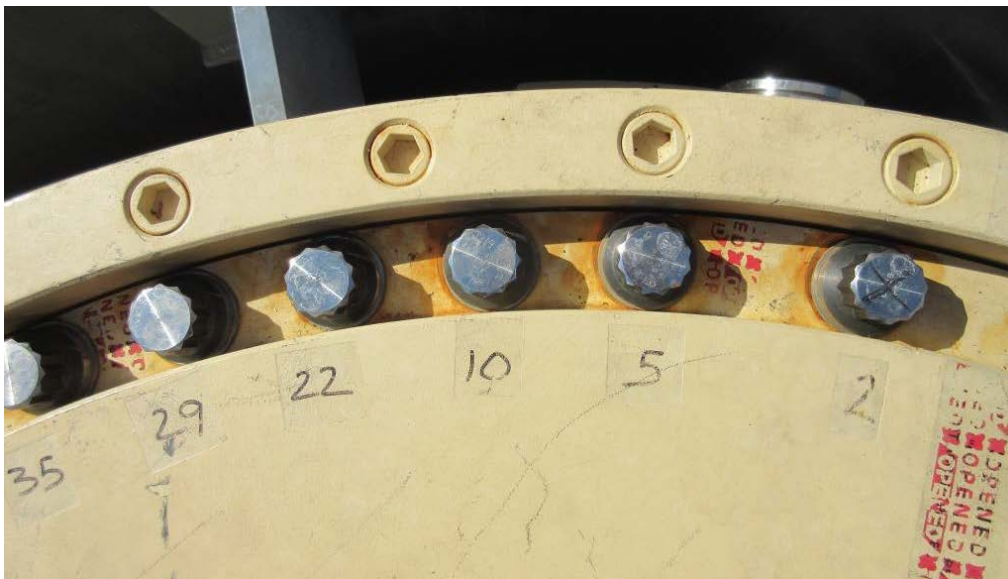
15. Rust staining around overpack lid closure bolting

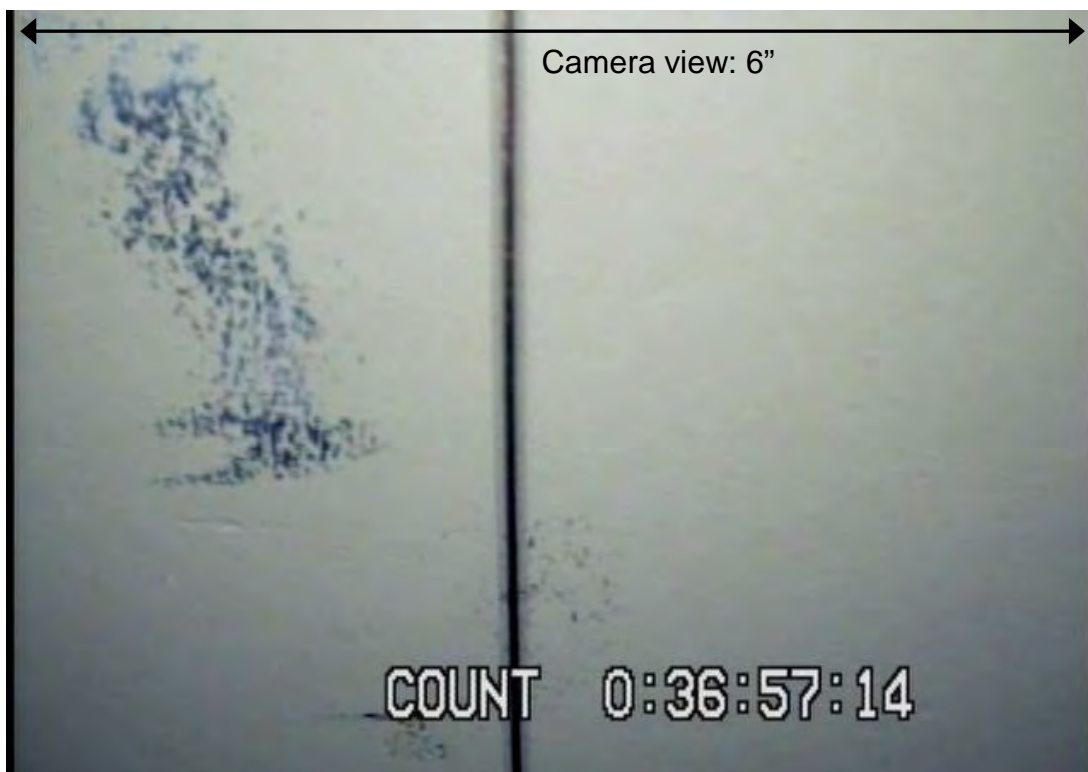
25. Scan 22 rub mark

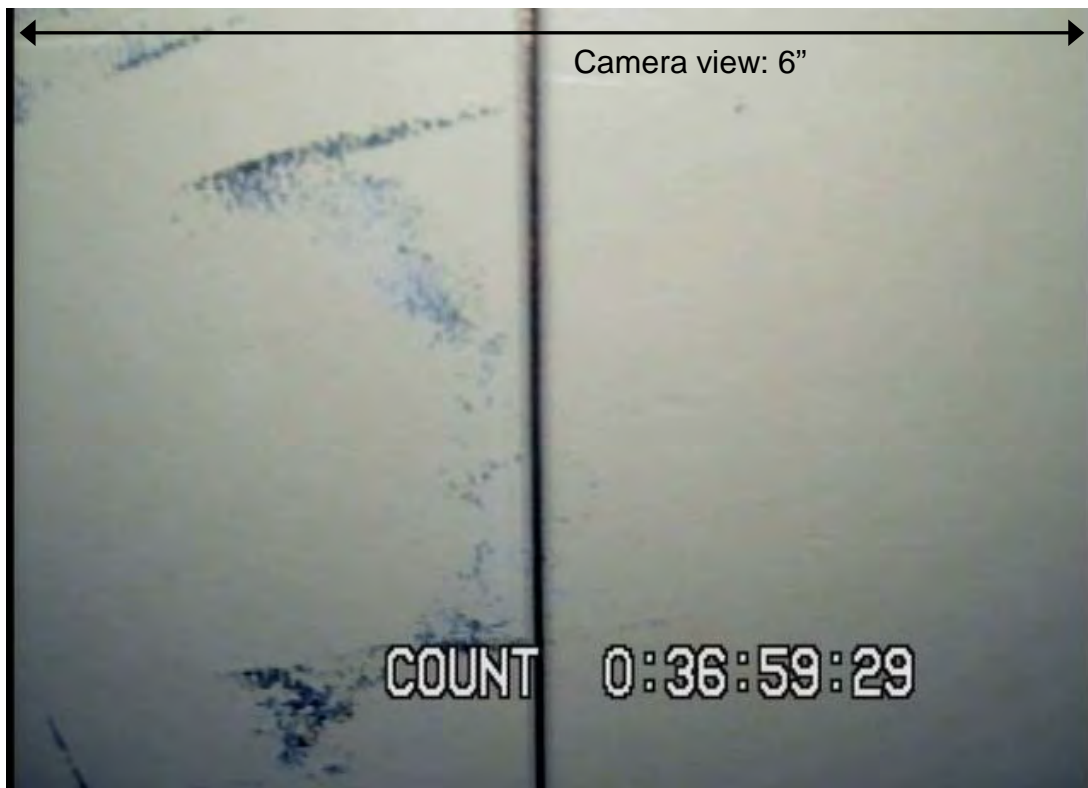
26. Scan 22 rub mark

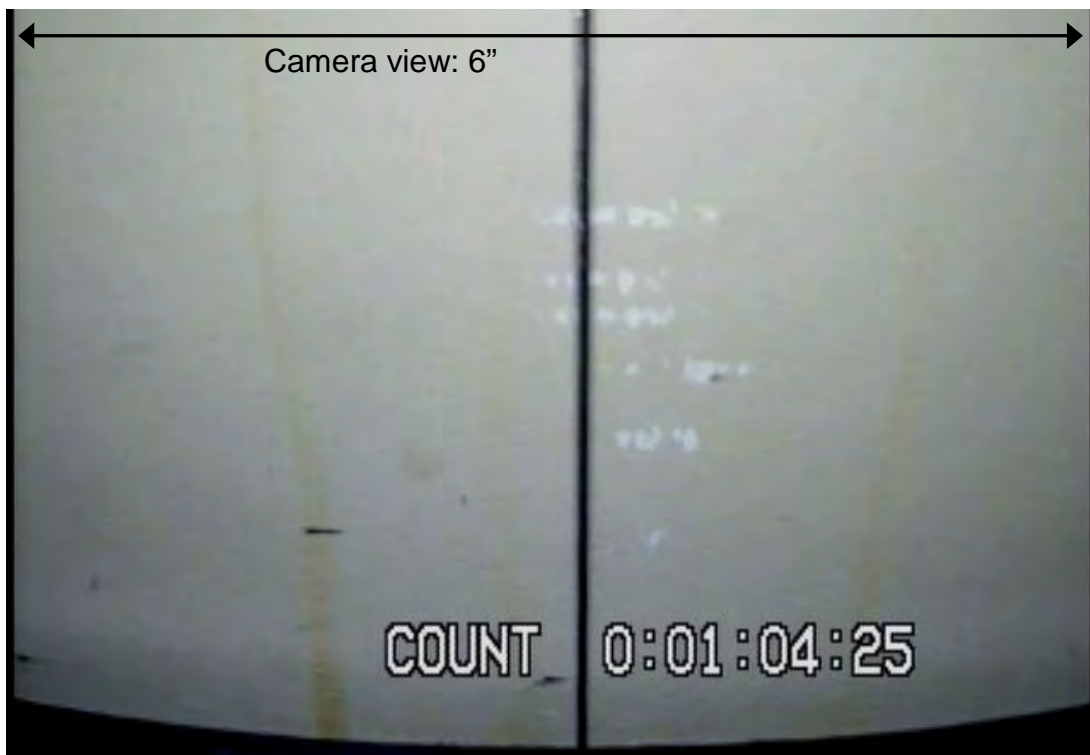
31. Scan 35 coating scrape

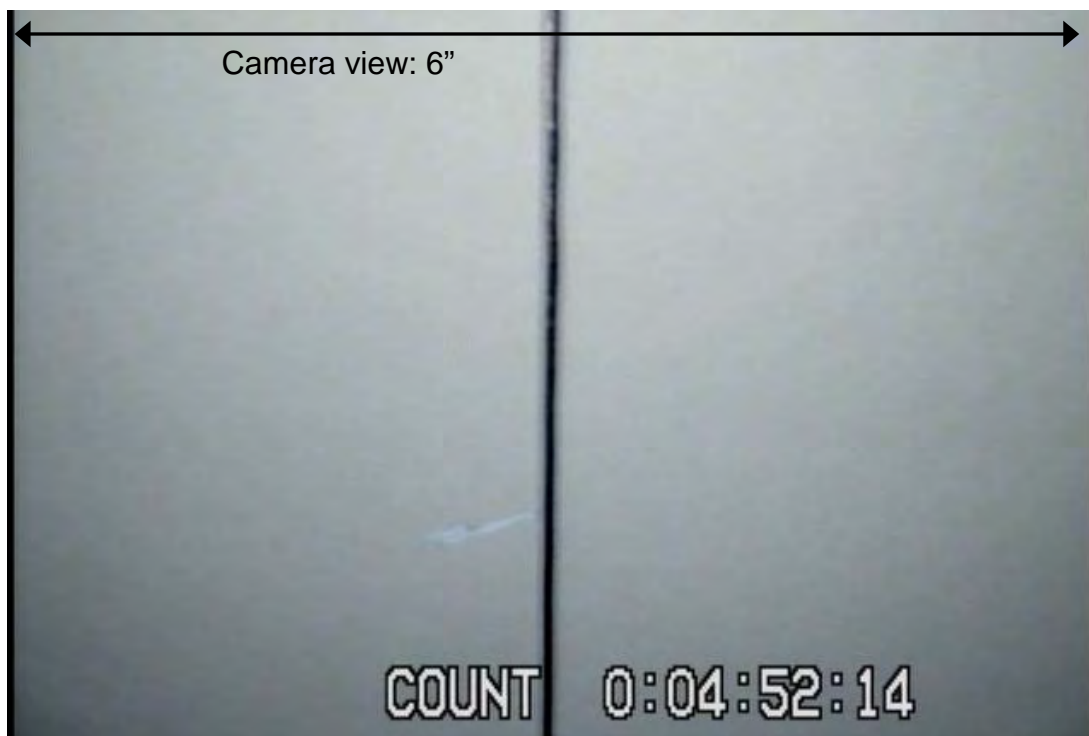
32. Scan 38 coating scrape

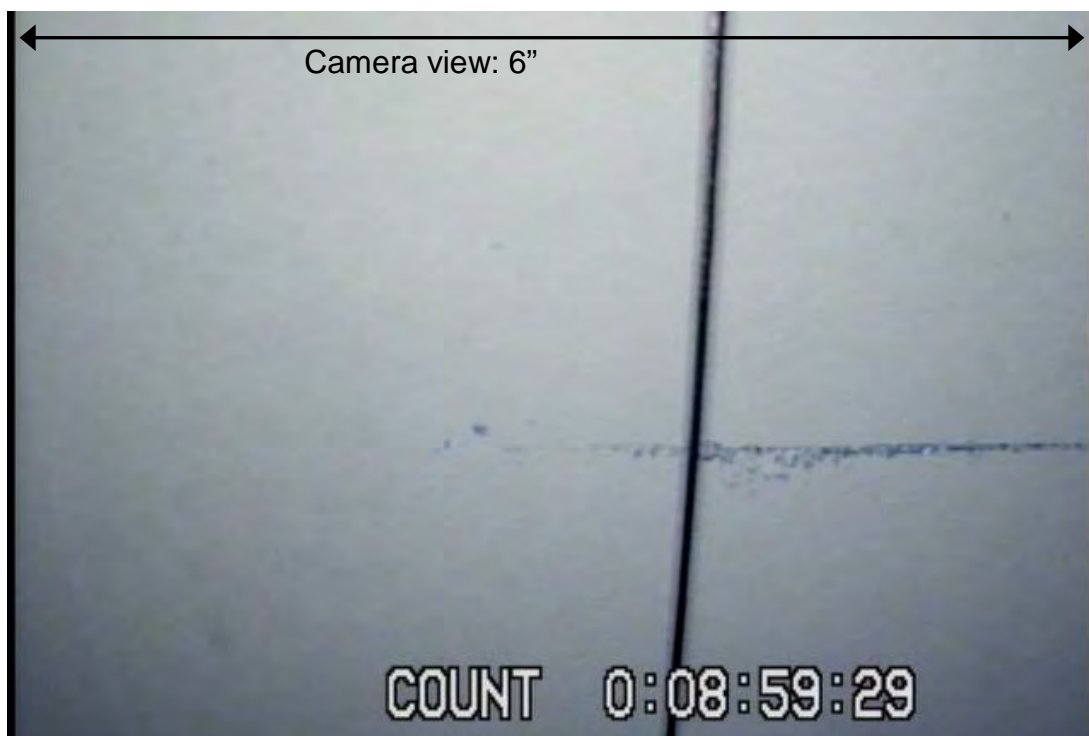
33. Scan 40 coating scrape

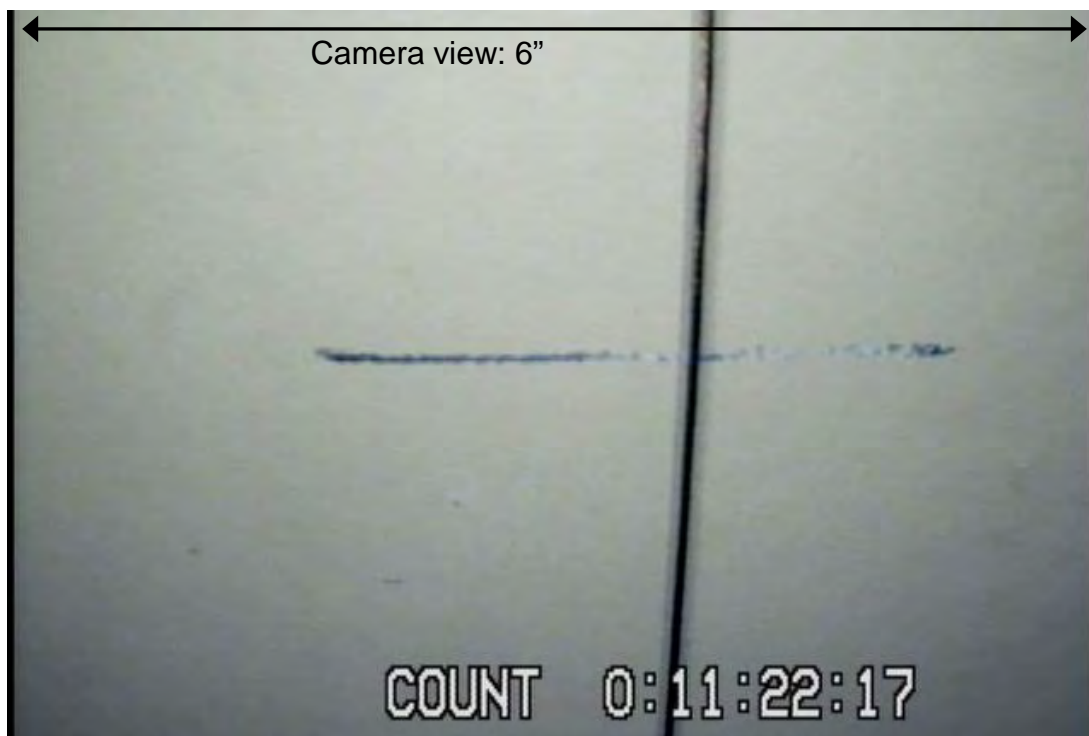
34. Scan 42 coating scrape

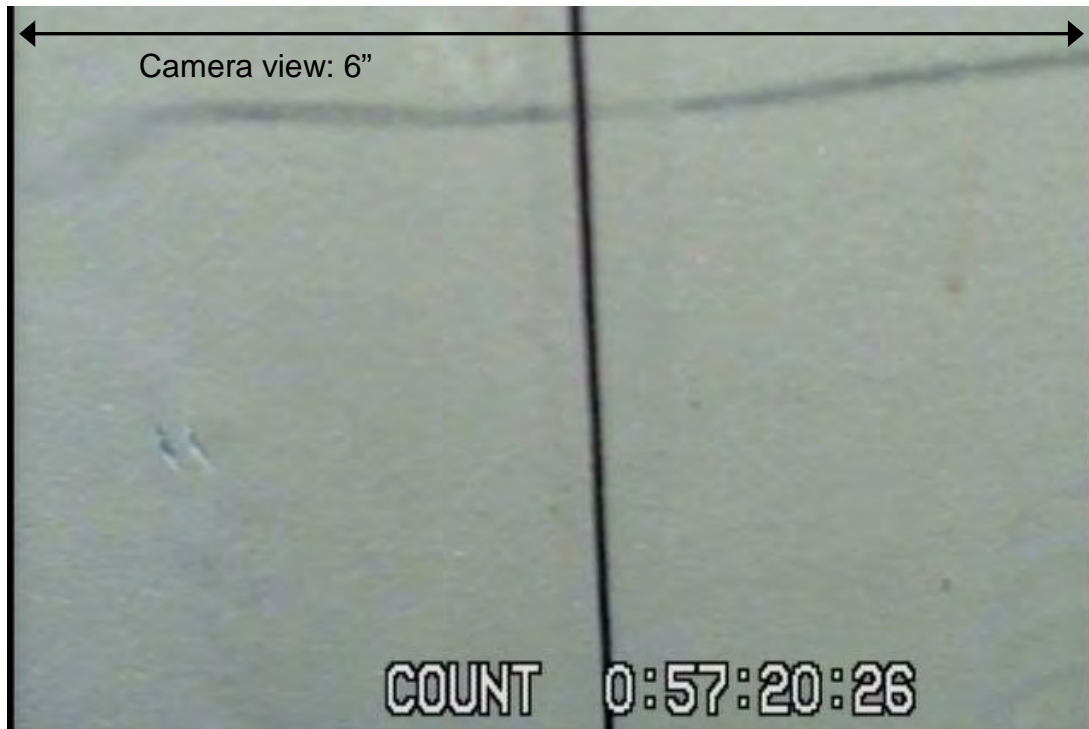
37. Scan 77 coating chips, no discoloration

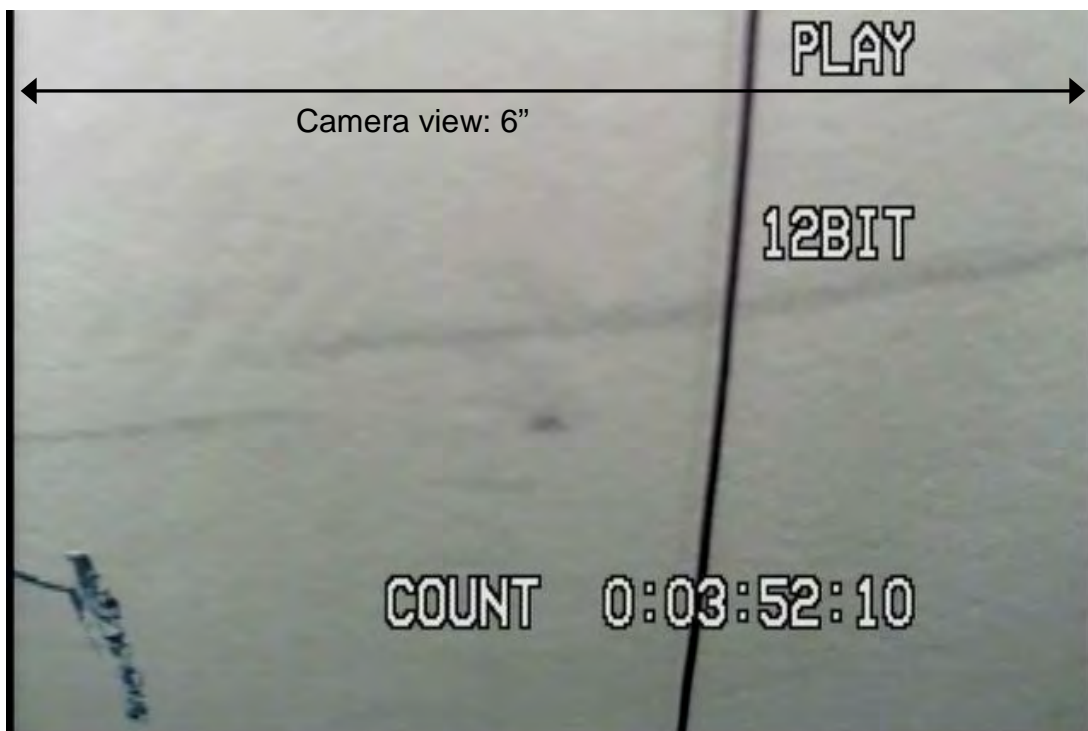
38. Scan 80 coating scrape

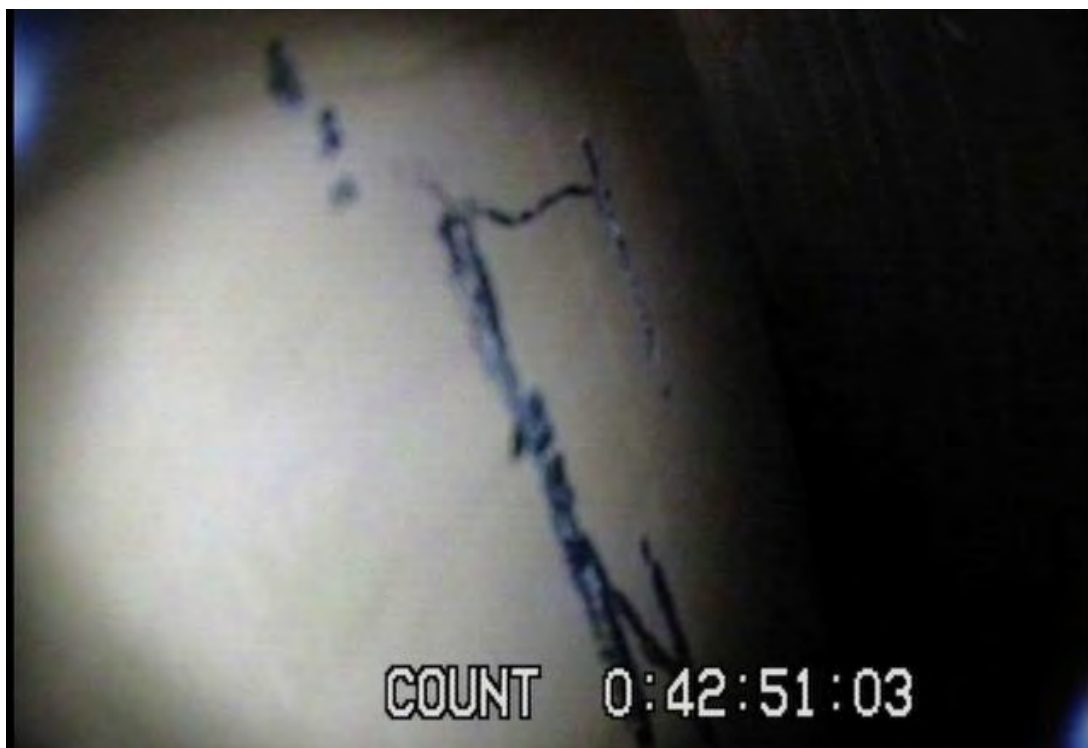
39. Scan 1 / Scan 80 area coating scrape

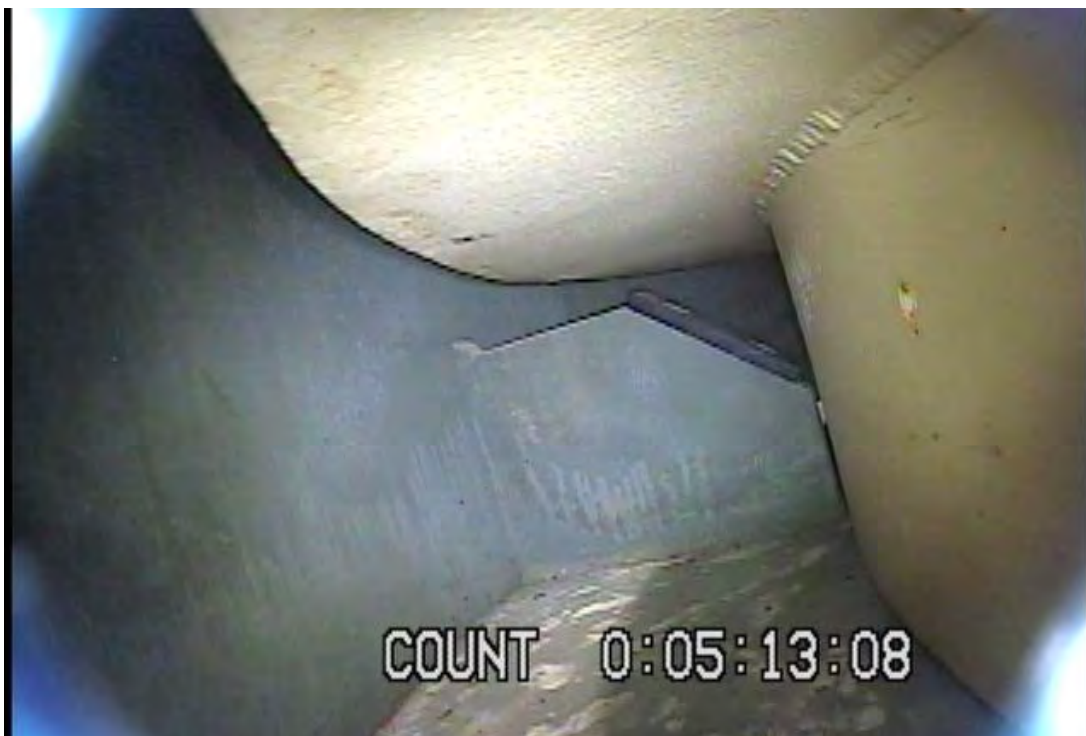
40. Overpack underside northeast section coating chip

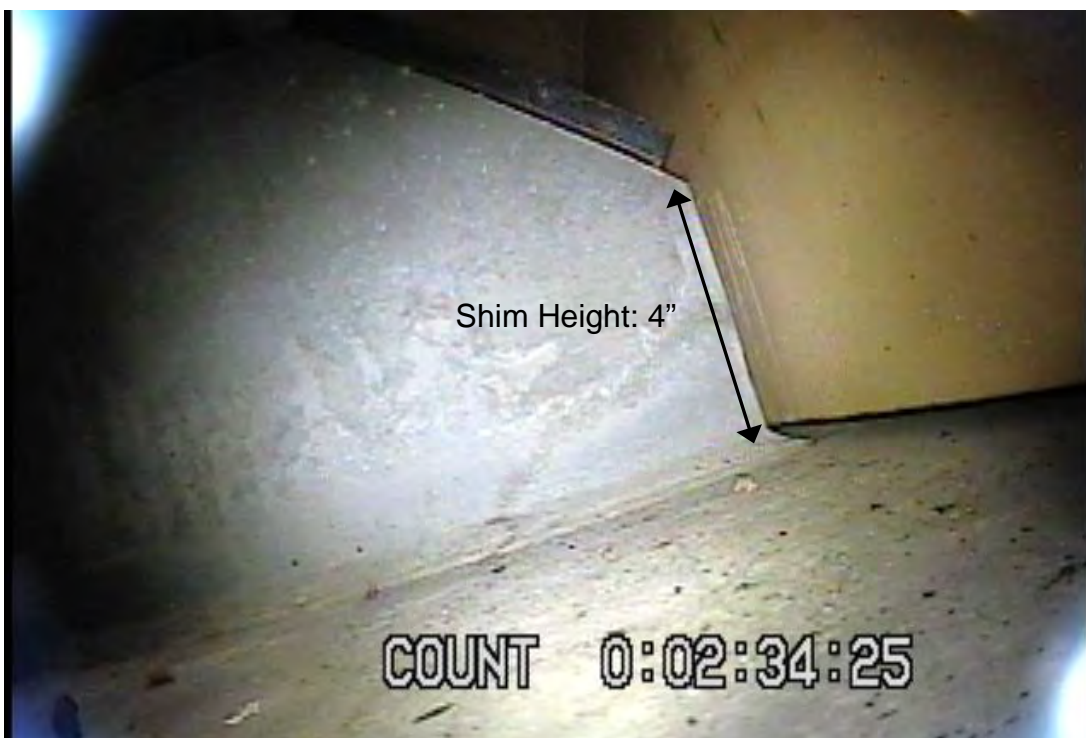
41. Overpack north section coating scrape adjacent to seismic shim

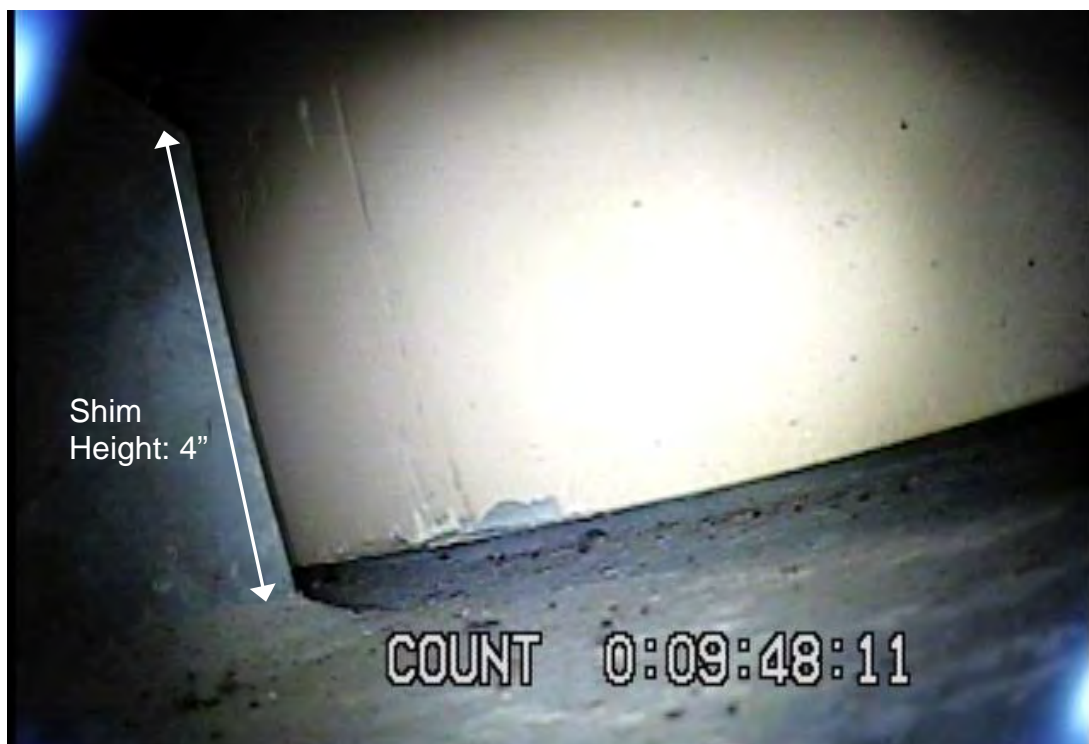
42. Overpack south east section coating scrape adjacent to seismic shim

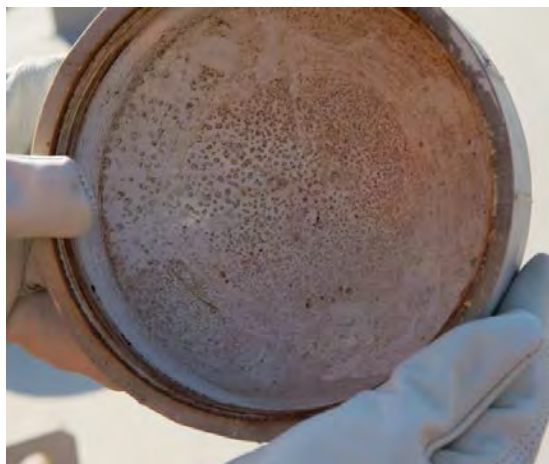
63. Underside of bolting pipe cap showing evidence of condensation

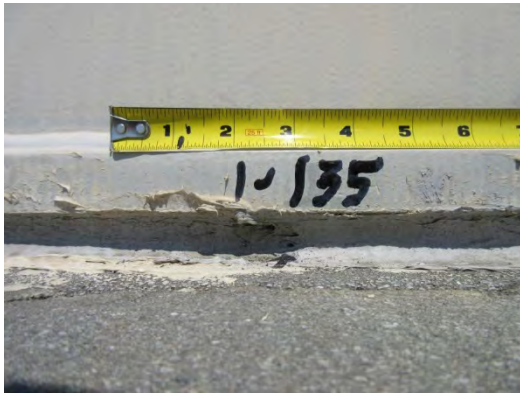
1. Cell 1 Caulking As-Found

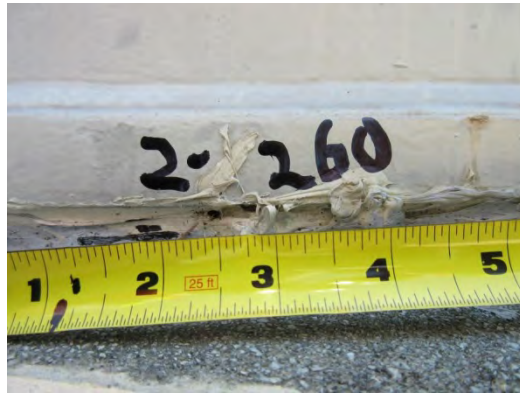
2. Cell 2 Caulking As-Found

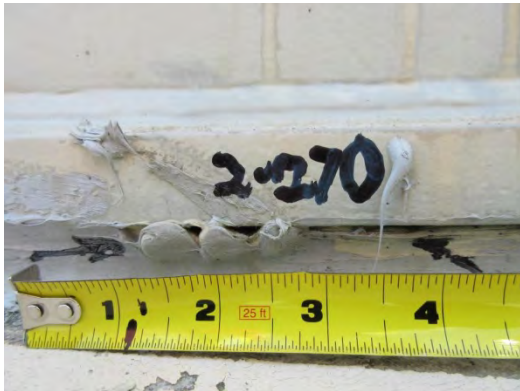
3. Cell 2 Caulking As-Found

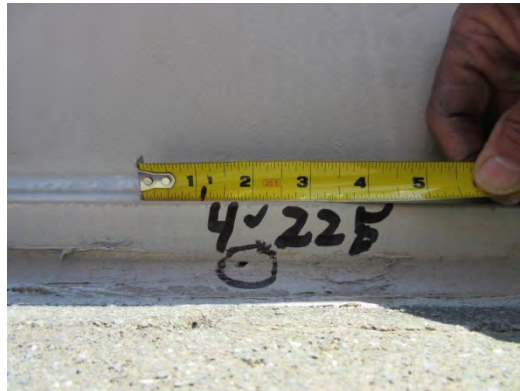
4. Cell 4 Caulking As-Found

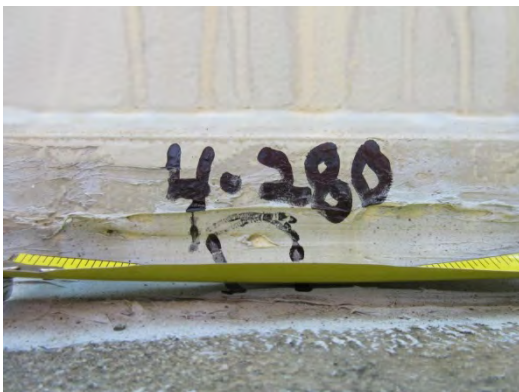
5. Cell 4 Caulking As-Found

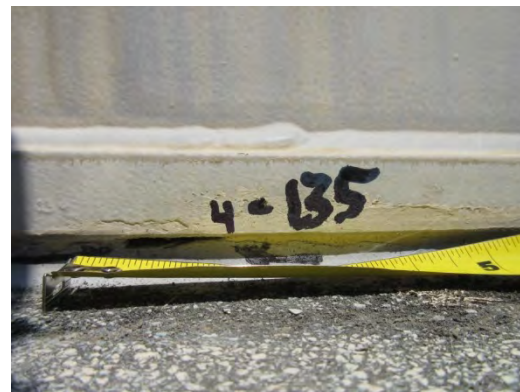
6. Cell 4 Caulking As-Found

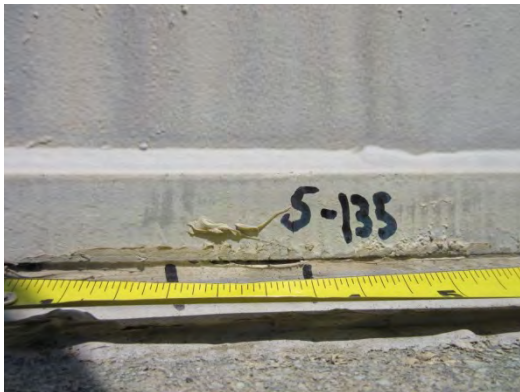
7. Cell 5 Caulking As-Found

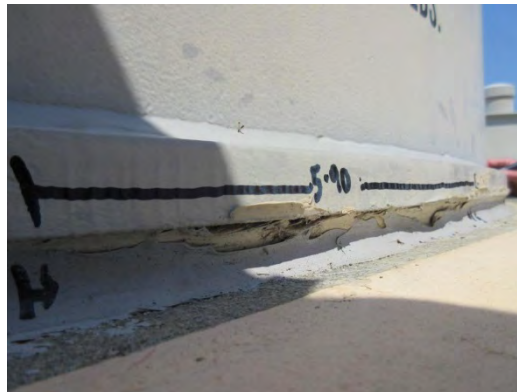
8. Cell 5 Caulking As-Found

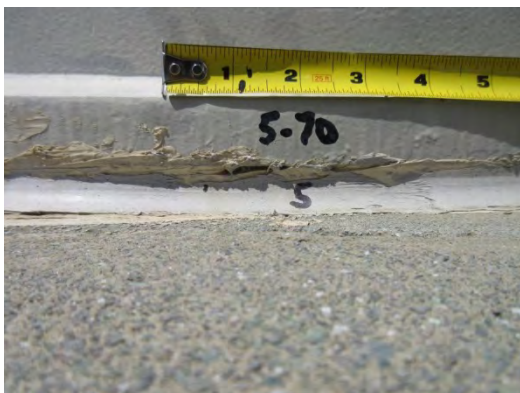
9. Cell 5 Caulking As-Found

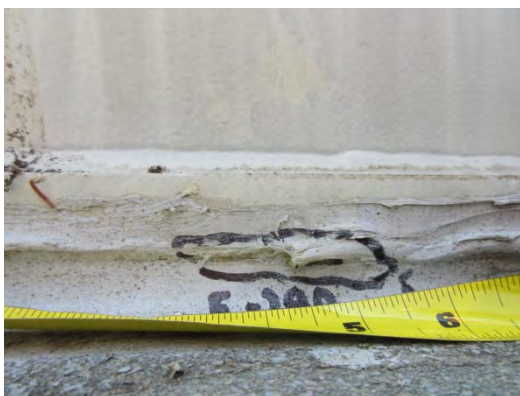
11. Cell 5 Caulking As-Found

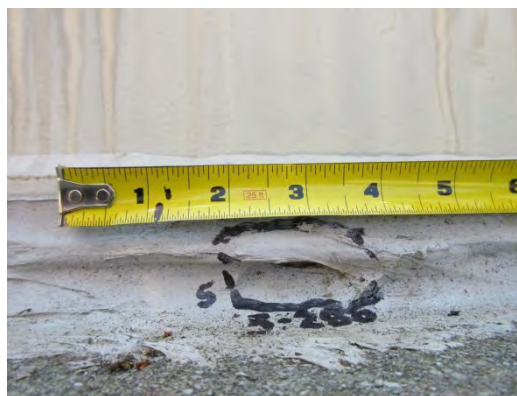
12. Cell 5 Caulking As-Found

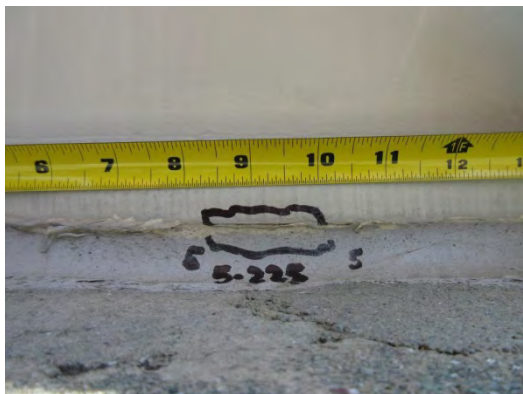
13. Cell 5 Caulking As-Found

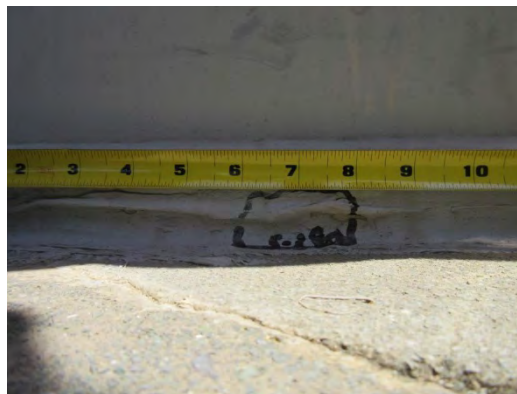
14. Cell 5 Caulking As-Found

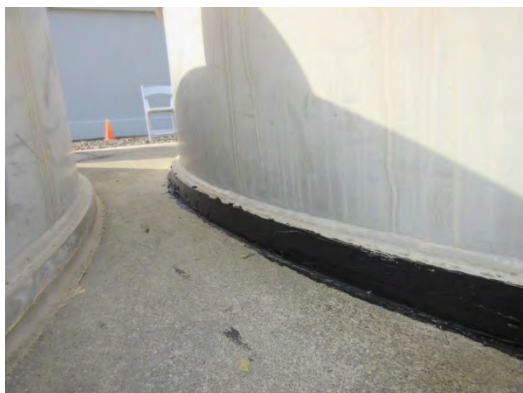
15. Cell 2 Caulking As-Left

8/3/2017 Examination of caulking around interface between vault lid and ring. Exam performed on initial caulking application for cell 2 after lid re-installation. Cells 1, 4, & 5 in areas where incomplete application was previously noted after additional caulking added to those areas. Illumination check 8/3/2017 @ 0945.

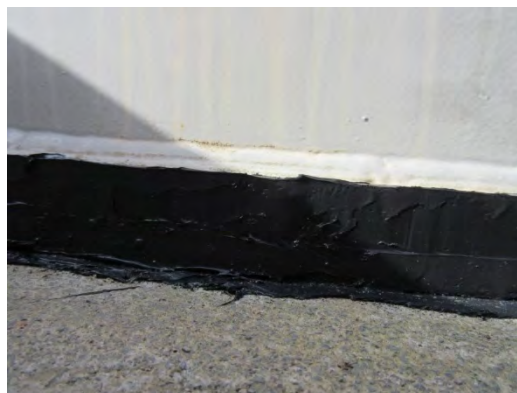
16. Cell 2 Caulking As-Left

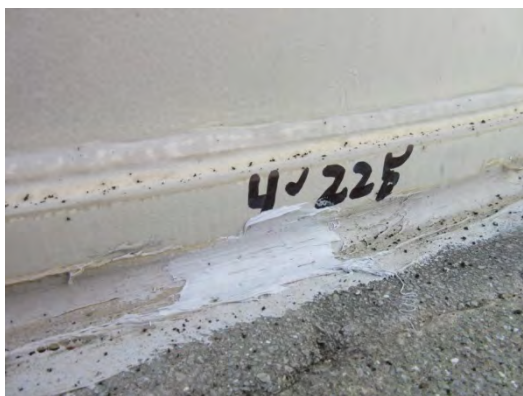
17. Cell 4 Caulking As-Left

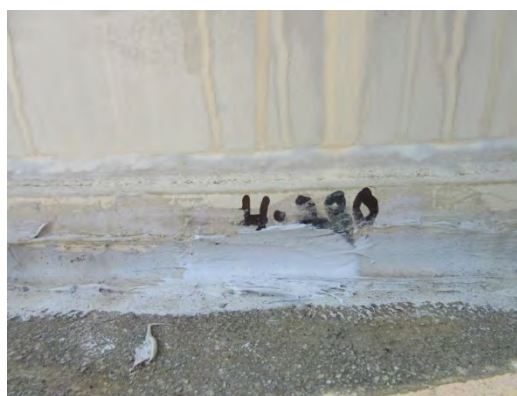
18. Cell 4 Caulking As-Left

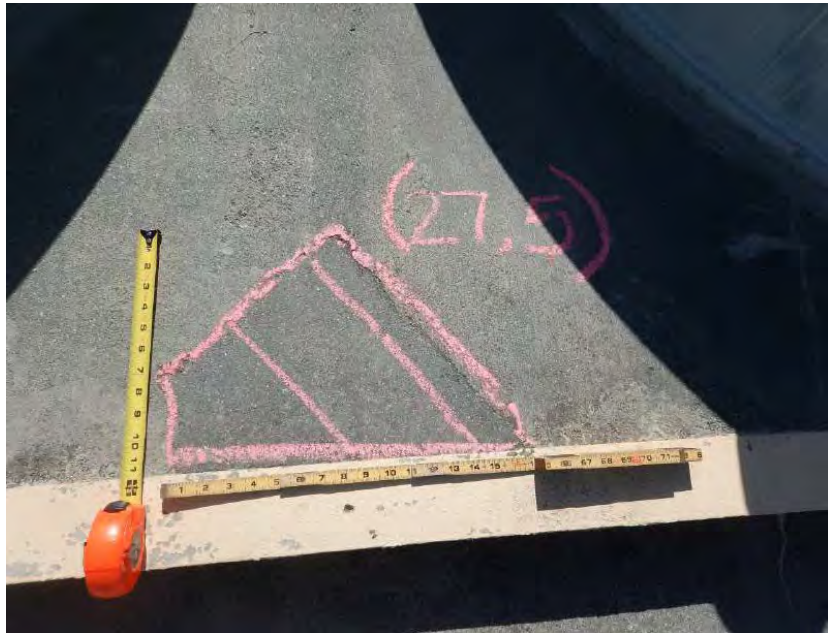
2. Center disbanded patch at (27, 5) that is approximately 17" by 11"

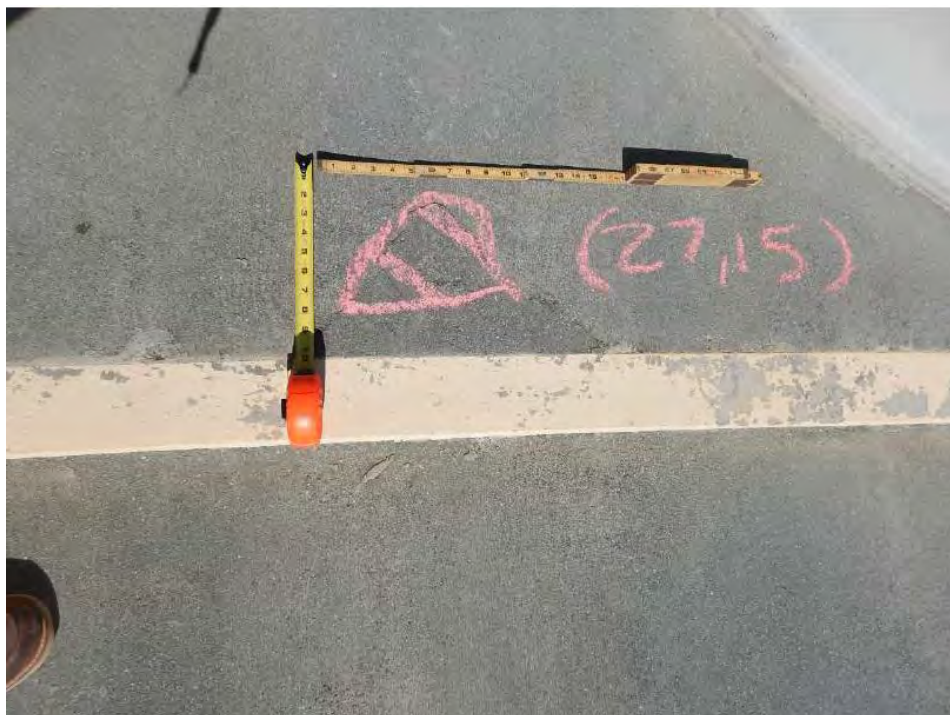
3. Center disbanded patch at (27, 15) that is approximately 8" by 6"

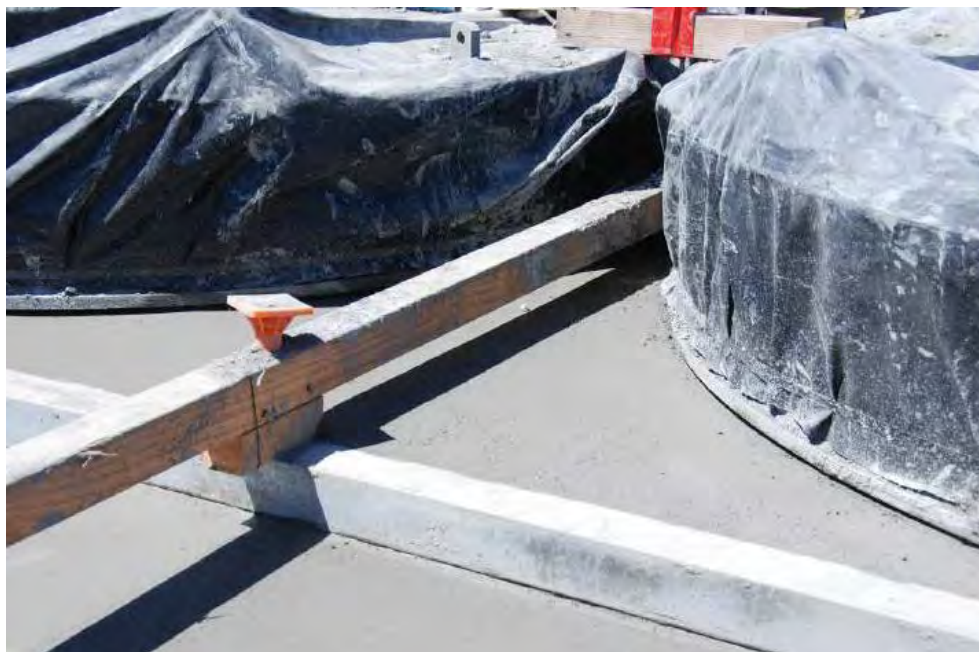
4. Photo taken during HB ISFSI concrete placement showing a construction aid most likely used to keep steel angles from moving during construction

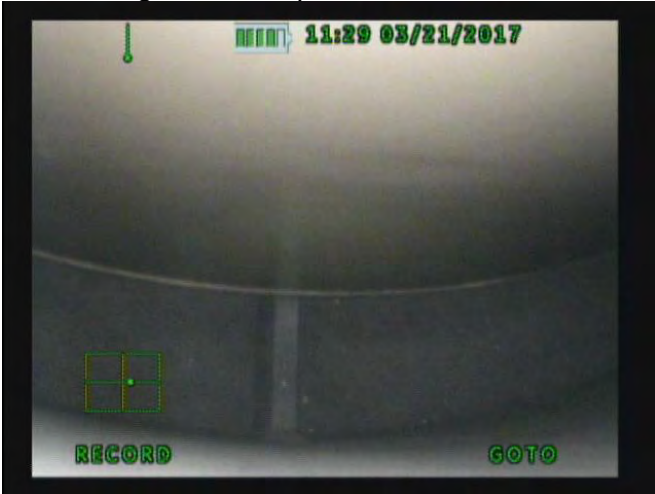
16. Looking down overpack at seismic shim

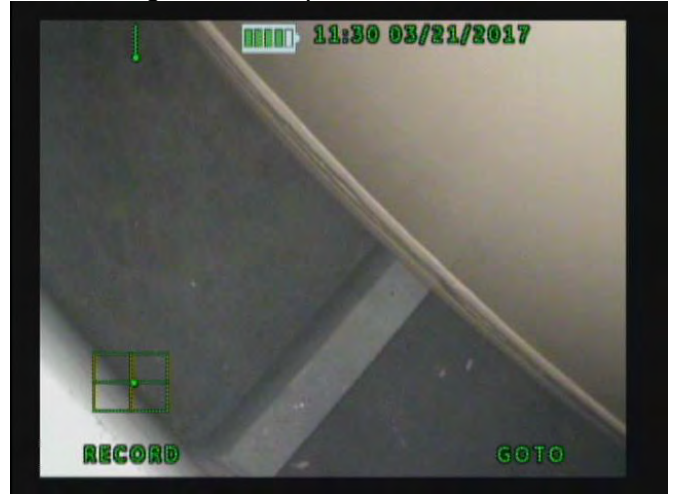
17. Looking down overpack at seismic shim

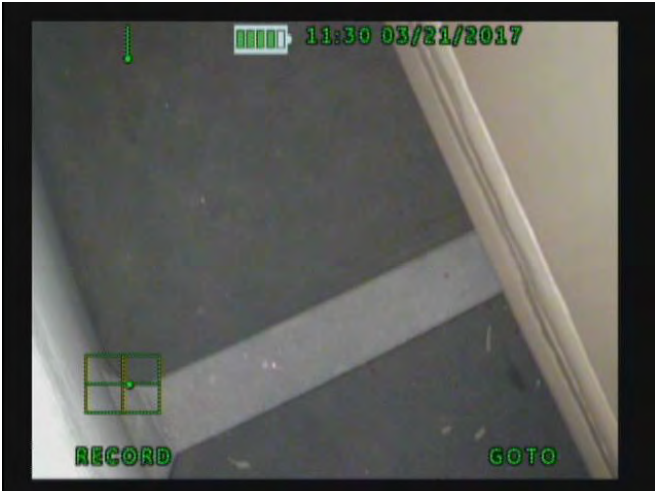
18. Seismic shim and bottom of vault liner

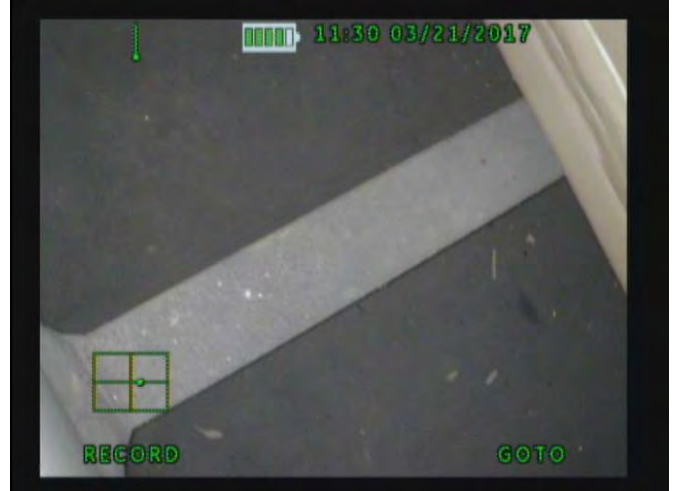
19. Seismic shim and bottom of vault liner

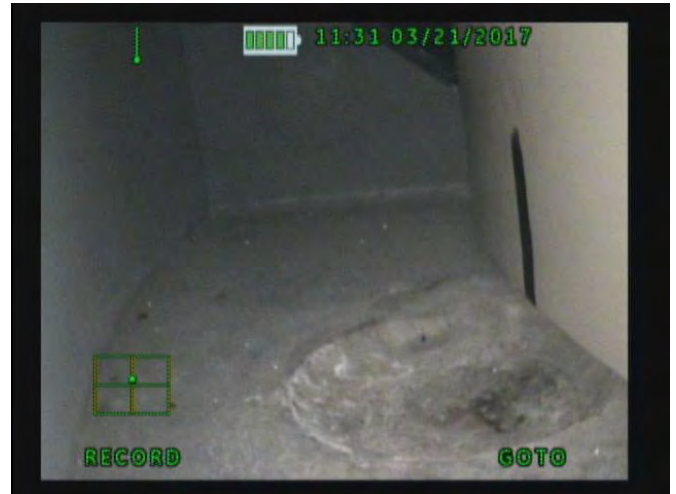
2. As discussed in Sections 3.1, 3.2, 3.3, 3.5, and 3.6, white deposits were noted around the floor drains in cells 1, 2, 3, 5 and 6. The deposit appearance is crystalline with no apparent discoloration, similar to concrete efflorescence or leaching. The boroscope video does not provide enough detail to establish the condition of the drain. It should be noted that the floor drain is not important to safety because of a defense-in-depth design and is not in the scope of license renewal. Although identification of the white deposits are not addressed in the exam acceptance criteria, this finding was entered into CAP as an observation (SAPN 1429074, Task 33) for further evaluation.

21. Vault drain

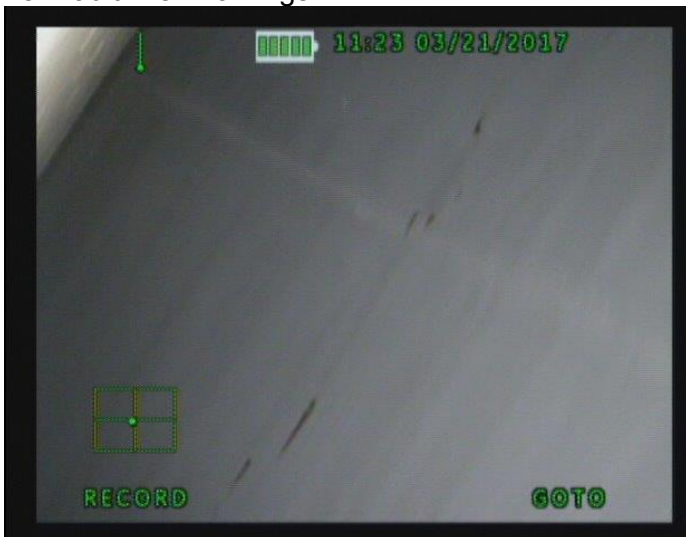
1. As discussed in Sections 3.1 and 3.2, markings were identified on the overpack and vault liner. These markings do not fail acceptance criteria, but will be entered into the CAP as observations (SAPN 1429074, Task 32).

28. Vault liner markings

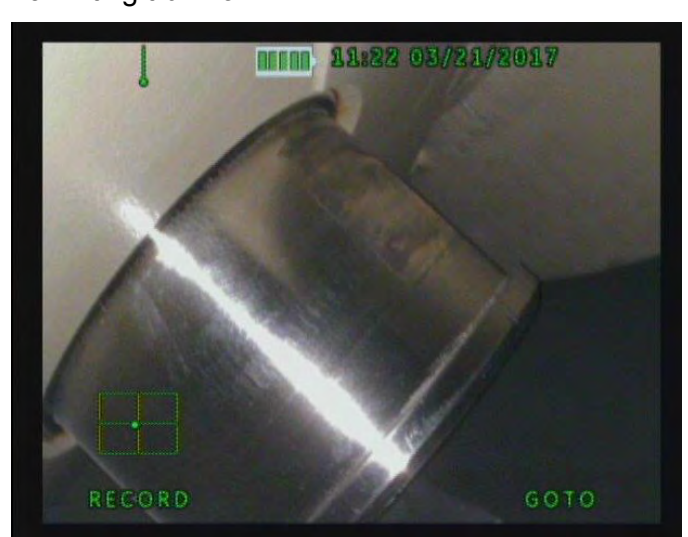
1. As discussed in Section 3.1, orange discoloration was noted at an overpack plug and near the lifting trunnion. Because the discoloration does not meet exam acceptance criteria, this finding was entered into CAP (SAPN 1429074, Task 28) for further evaluation.

29. Lifting trunnion
