Humboldt Bay
Independent Spent Fuel Storage Installation
Site-Specific License Renewal Application

Pacific Gas and Electric Company

Revision 4 November 2019

NRC Docket No. 72-27

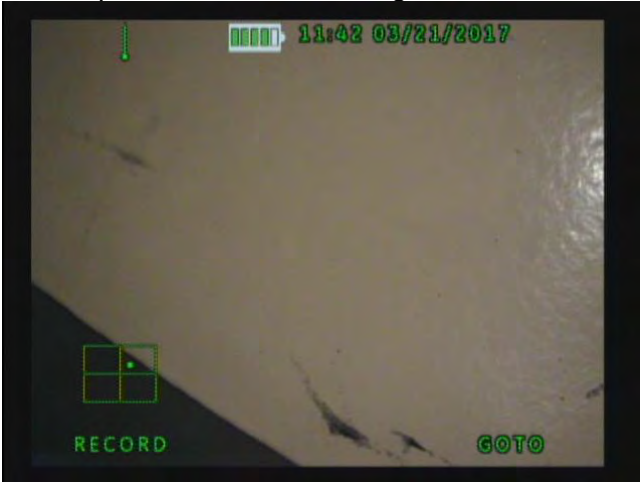
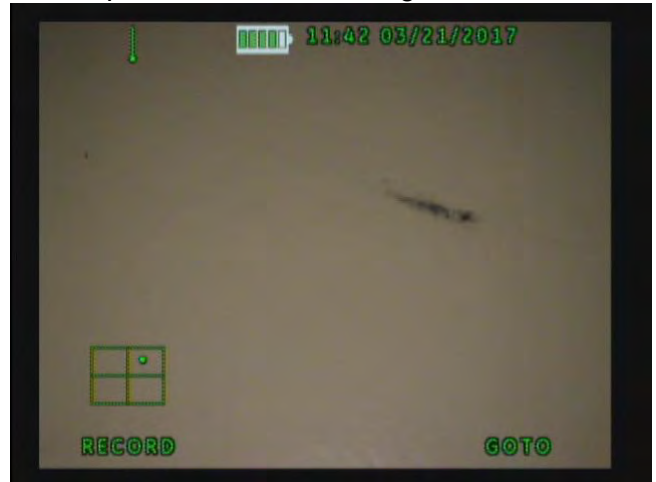
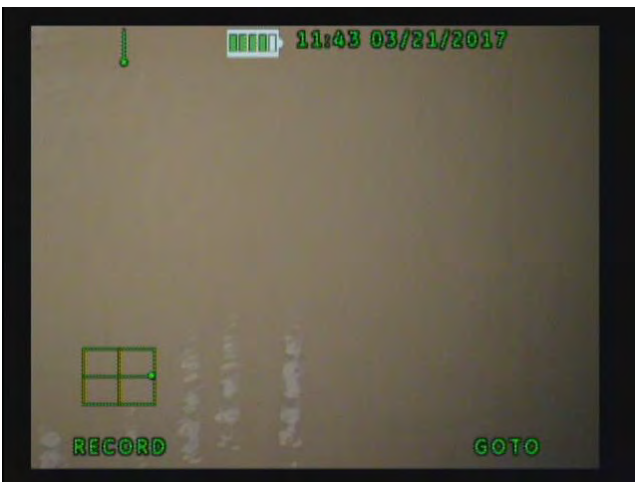
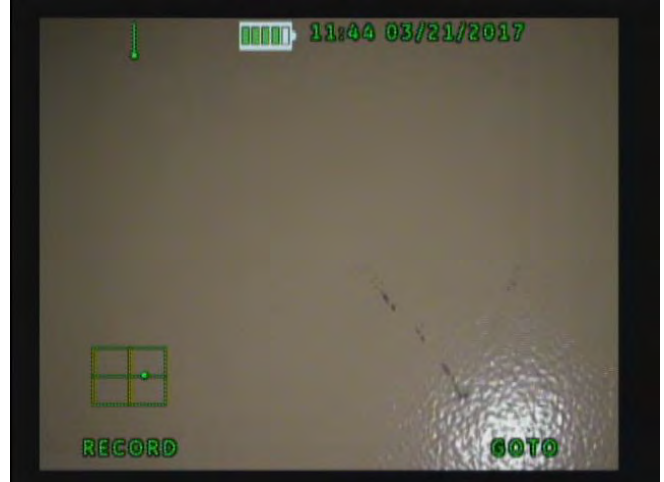
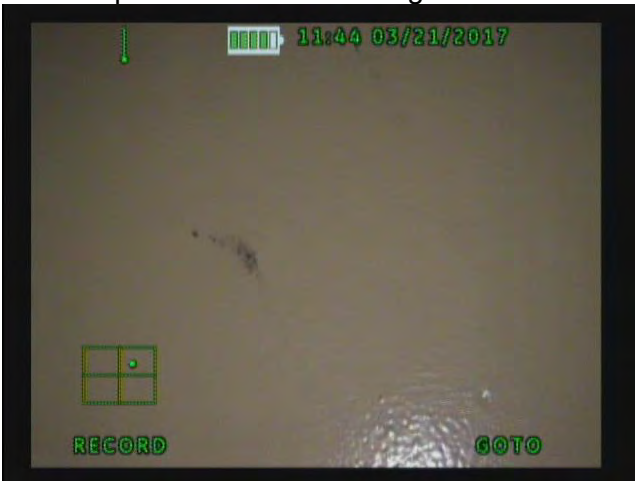
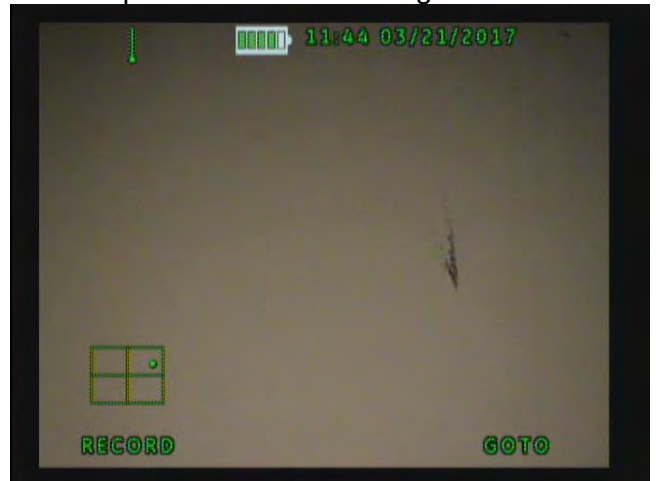
1. As discussed in Sections 3.1 and 3.2, markings were identified on the overpack and vault liner. These markings do not fail acceptance criteria, but will be entered into the CAP as observations (SAPN 1429074, Task 32).

7. Overpack with Scuff Marking

Because of the similar condition of all cells, but the additional mechanical markings noted in cell #2, it is recommended that cell #2 be inspected in the July/August inspection (note that cell #2 also has operating experience with previous water intrusion which may have provided an environment more suitable for degradation).

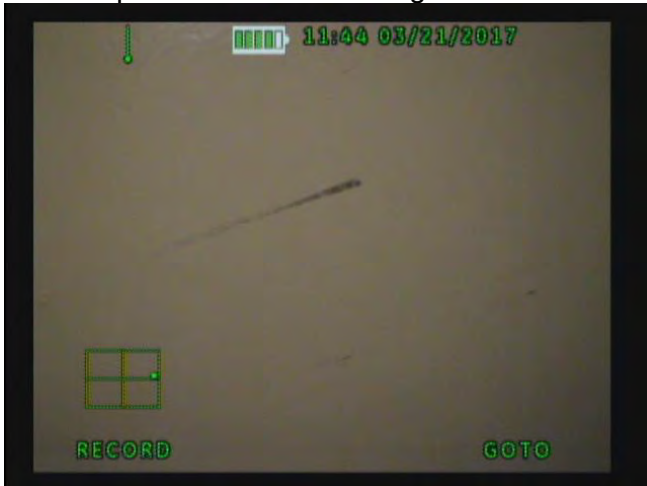
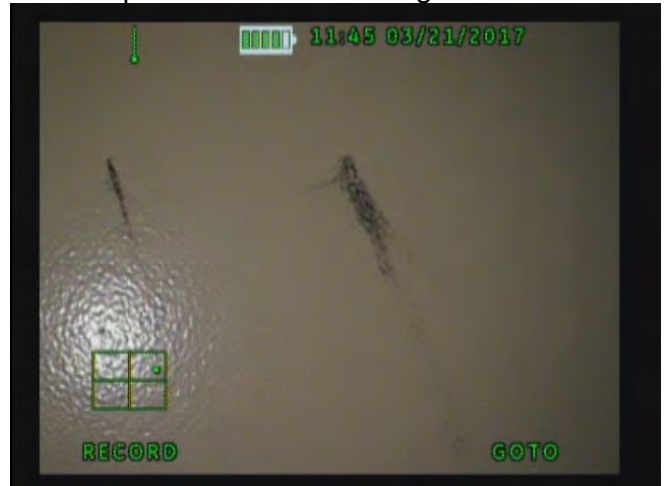
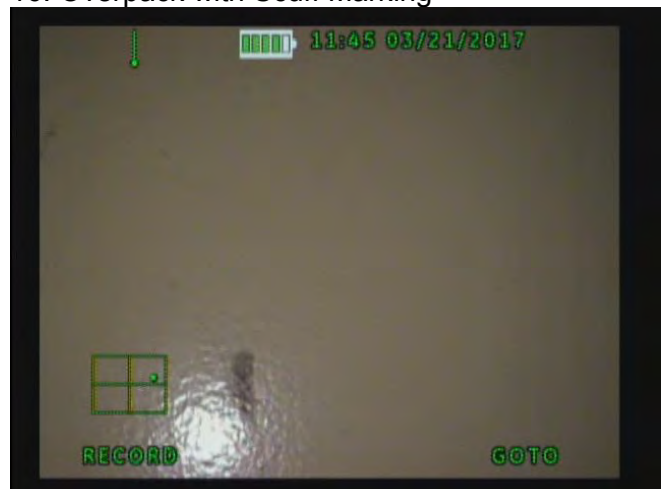
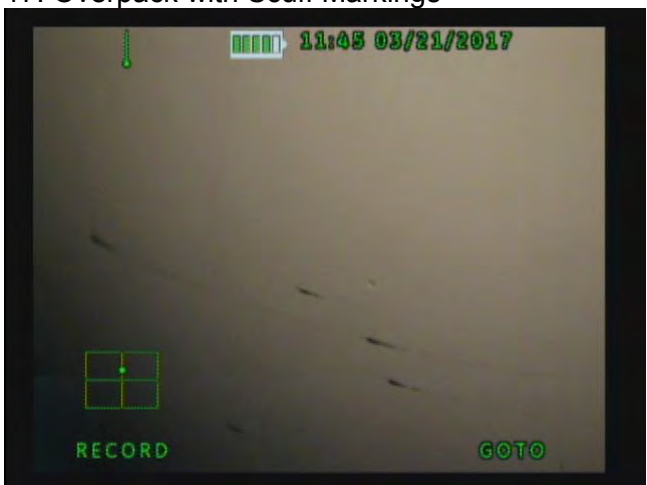
13. Overpack with Scuff Marking

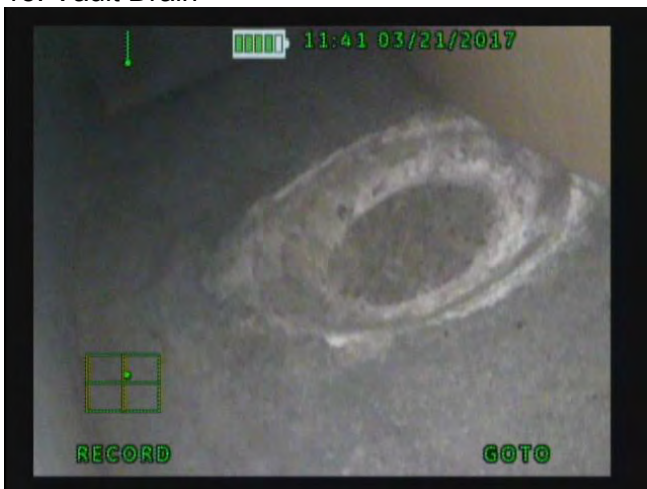
2. As discussed in Sections 3.1, 3.2, 3.3, 3.5, and 3.6, white deposits were noted around the floor drains in cells 1, 2, 3, 5 and 6. The deposit appearance is crystalline with no apparent discoloration, similar to concrete efflorescence or leaching. The boroscope video does not provide enough detail to establish the condition of the drain. It should be noted that the floor drain is not important to safety because of a defense-in-depth design and is not in the scope of license renewal. Although identification of the white deposits are not addressed in the exam acceptance criteria, this finding was entered into CAP as an observation (SAPN 1429074, Task 33) for further evaluation.

- The inspection identified white deposits around the floor drains of cells 1, 2, 3, 5, and 6. The boroscope video does not provide enough detail to establish the condition of the drain. It should be noted that a picture of a vault prior to loading showed similar deposits around at least one of the vault drains. A SAPN task was initiated as an observation for future trending and the July/August inspection scope has been modified to ensure that that inspection crawler captures as-found and as-left images of the drain in vault #2 so that drain functionality can be further evaluated.

15. Vault Drain

The July/August inspection scope has been modified to ensure that that inspection crawler captures as-found and as-left images of the drain in vault #2 so that drain functionality can be further evaluated. Further, provisions will be available to clean the white deposit from the drain screen, to the extent possible, for future trending purposes.

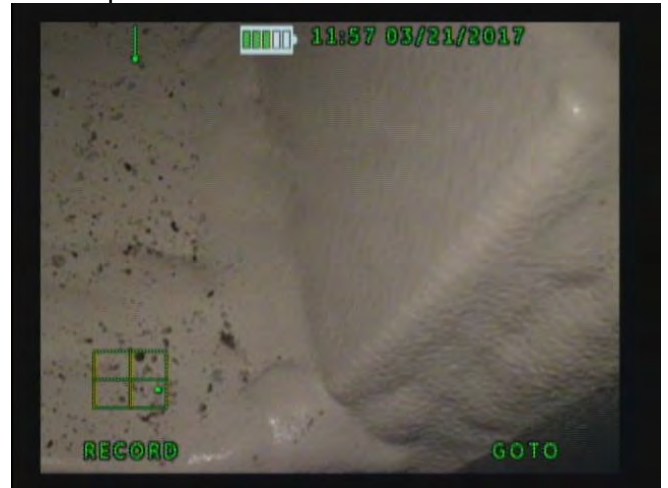
2. Overpack with Debris

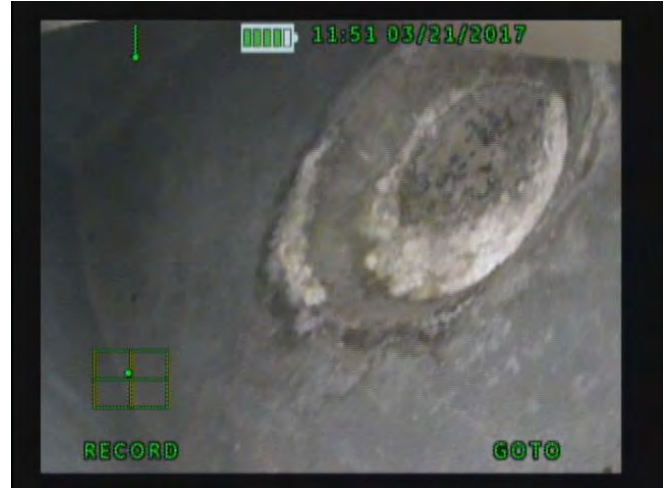
8. Vault Drain

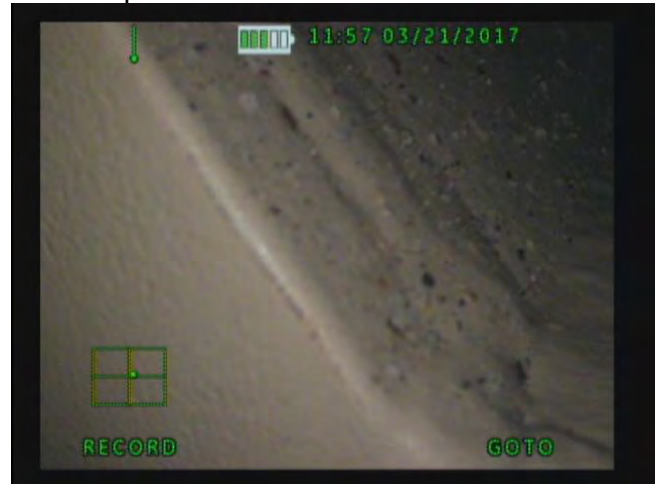
14. Overpack with Debris

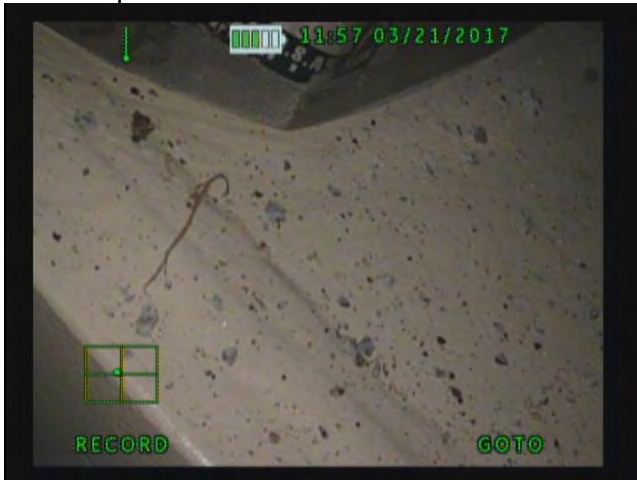
15. Overpack with Debris

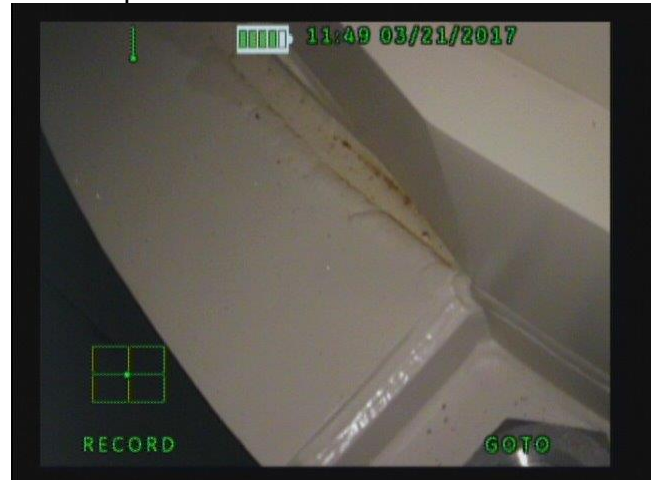
3. As discussed in Section 3.3, orange discoloration was noted at an overpack weld. Because the discoloration does not meet exam acceptance criteria, this finding was entered into CAP (SAPN 1429074, Task 30) for further evaluation.

16. Overpack weld

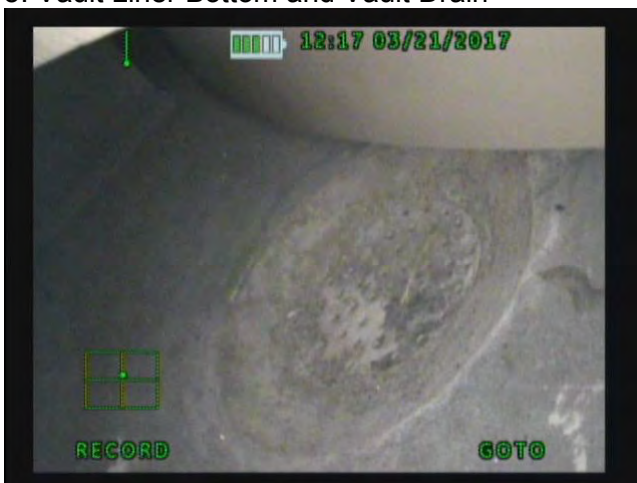
5. Vault Liner Bottom and Vault Drain

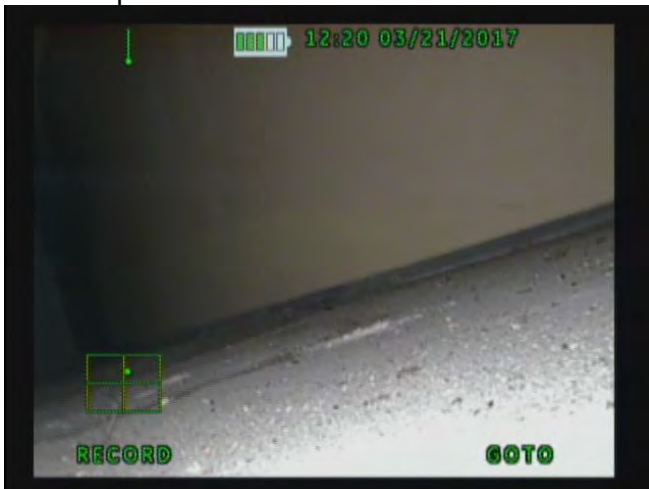
11. Overpack and Vault Liner Bottom with Debris

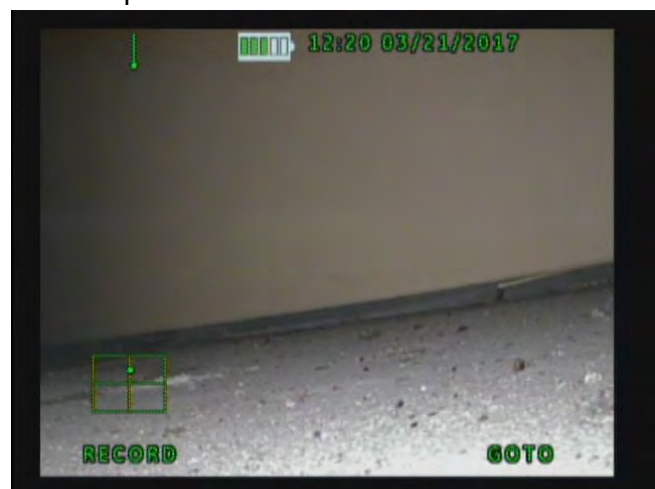
12. Overpack and Vault Liner Bottom with Debris

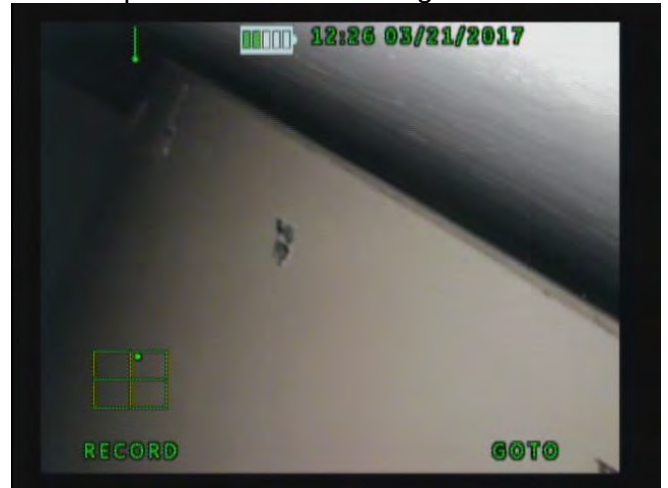
14. Overpack with Scuff Marking

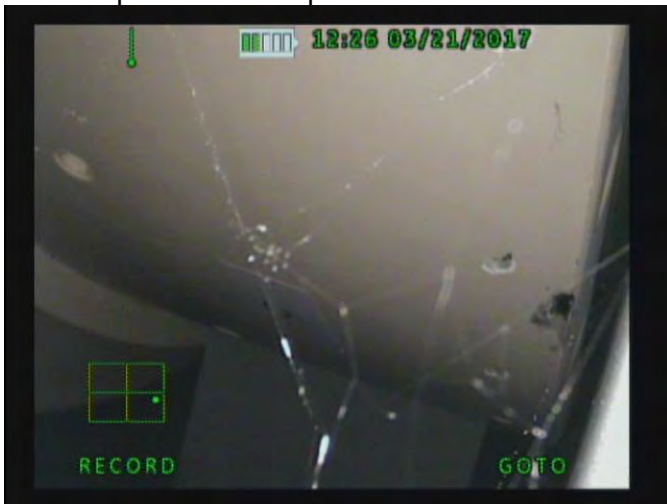
15. Overpack with Scrapes

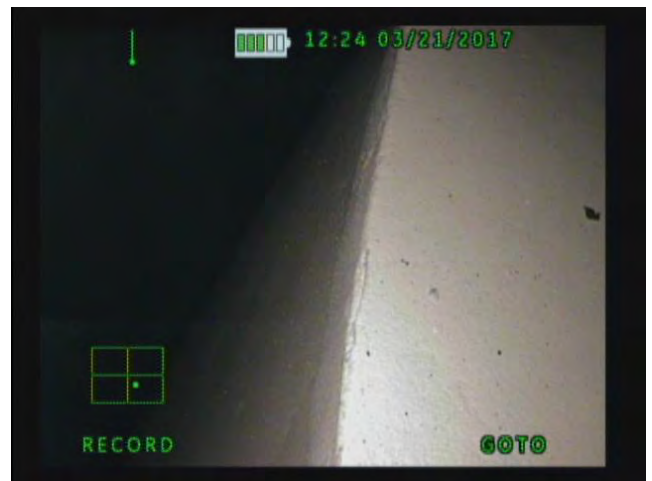
16. Overpack with Debris

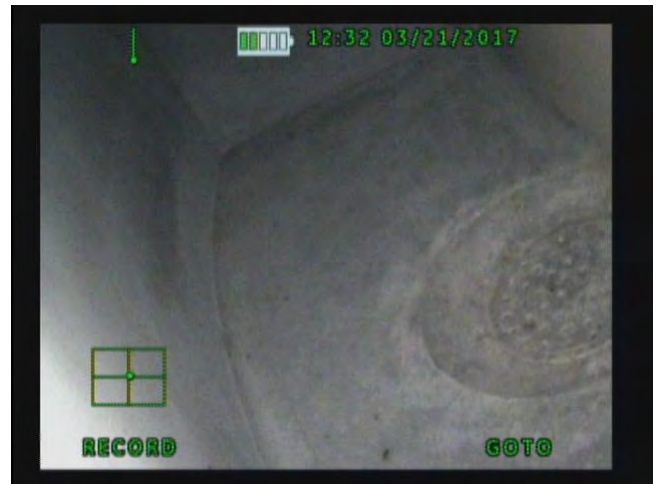
4. Vault Liner Bottom and Vault Drain
